# Appendix A – Crash Data

Date: March 2021

This memo documents crash data from 2015 through 2019 near railroad crossings within the bus rapid transit project corridor.

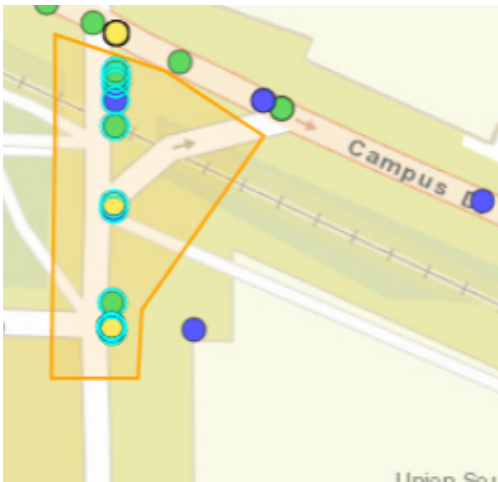
Figure 1 - Randall Avenue Crash Study Limits

Right turning vehicles on Randall Avenue cross four pedestrian crossings and one bike lane, in addition to the railroad crossing. Drivers need to also monitor the signal and Johnson Street traffic to complete the turning movement, an acute angle that allows traffic to turn into the shoulder lane where buses are attempting to merge prior to the downstream bus stop. There are two stop bars due to the railroad crossing, with minimal storage between the far stop bar and the railroad tracks. Currently there is less than 12' of pavement from the railroad tracks to the stop bar on the right edge of the turn lane. The skew with Johnson Street, limited storage between the stop bar and railroad tracks, and merges between buses and right turning vehicles are all safety concerns.

The Randall Avenue railroad crossing has minimal crashes but still has safety concerns. Realigning the right turn lane to intersect Johnson Street closer to perpendicular would keep pedestrians and vehicular traffic within the field of vision of turning vehicles and would increase the storage between the railroad crossing and the stop bar. The City of Madison recommends realigning the northbound right turn lane.

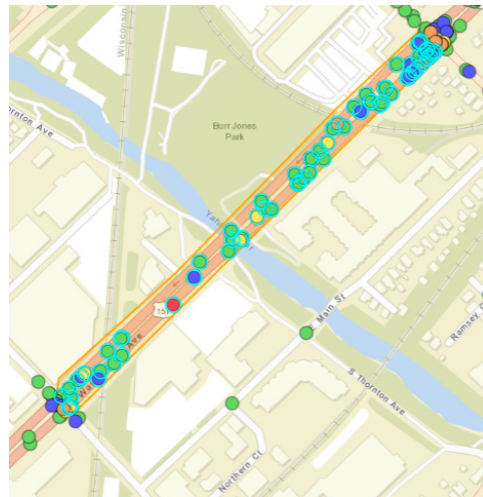
Figure 2 - East Washington Crash Study Limits

The East Washington Avenue crossings have intersections directly upstream of the crossings, within 140' of the crossing near Dickinson Street and within 350' of the crossing near First Street. Additionally, there are driveways within 30' of the railroad crossings for three of the approaches, with one of the driveways located between the stop bar and railroad crossing. The proximity of intersections and access points adds complexity, on top of the acceleration and deceleration of vehicles required to stop at the railroad crossings which can surprise drivers. City buses have four potential stopping points per direction between the Dickinson Street to First Street block, with one signalized intersection, two railroad crossings, and two bus stops. The proposed BRT routes would reduce the stopping points to four (one signalized intersection, two railroad crossings and one bus stop) but would not eliminate the safety concern.

The East Washington railroad crossing locations have lower crash rates than the statewide average, however 51% of the crashes are rear-end collisions with specific cases of crashes caused by buses stopping at the railroad tracks. Signing the crossings as exempt would eliminate situations where required vehicles are stopping at the crossing when there is no train, therefore reducing rear-end collision potential. The City of Madison recommends signing the crossings as exempt to eliminate stopping requirements, and thus potential crashes, when no train is present.

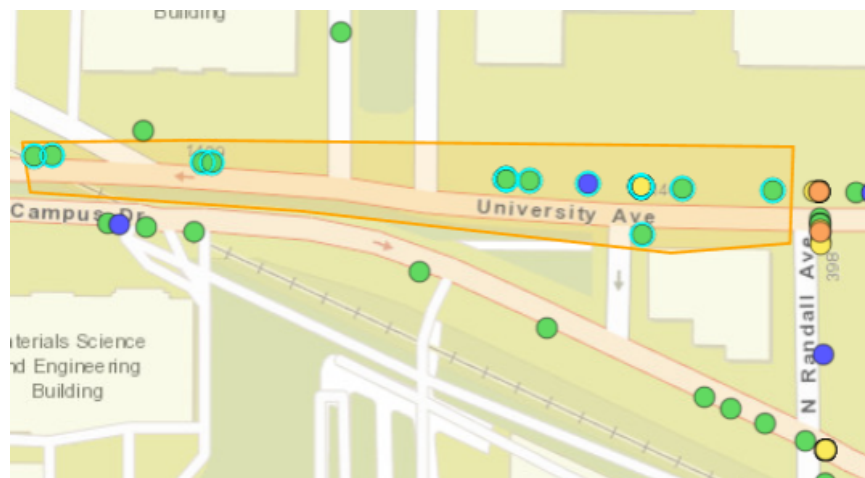
Figure 3 - University Avenue Crash Study Limits

The University Avenue railroad crossing is within an intersection, with the Babcock Drive right turn upstream and the Campus Drive/University Avenue turn lanes developing across the railroad crossing. Campus buildings north and south of the roadway require pedestrian and bicycle accommodations. Buses continuing on University Avenue or Campus Drive need to merge from the outside shoulder lane upstream of the railroad crossing. The multiple merging and diverging for various roadway users within the short distance is a safety concern.

The University Avenue railroad crossing location, possibly the most complex location with the split of University Avenue, has the highest crash rate. The City of Madison recommends increasing roadway width to allow a transit lane to continue through the railroad crossing, shifting the bus merge downstream of the traffic signal.
