Regarding: 210 Langdon Street – Demolish the existing building and construct a 3-story fraternity house adjacent to a designated landmark (Chi Phi Fraternity) and in the Langdon Street National Register Historic District.
 2nd Ald. District
Contact: J. Randy Bruce
 (Legistar #28485)

Date: December 10, 2012
Prepared By: Amy Scanlon, Preservation Planner

Re: Theta Chi Fraternity House
210 Langdon
Madison, WI

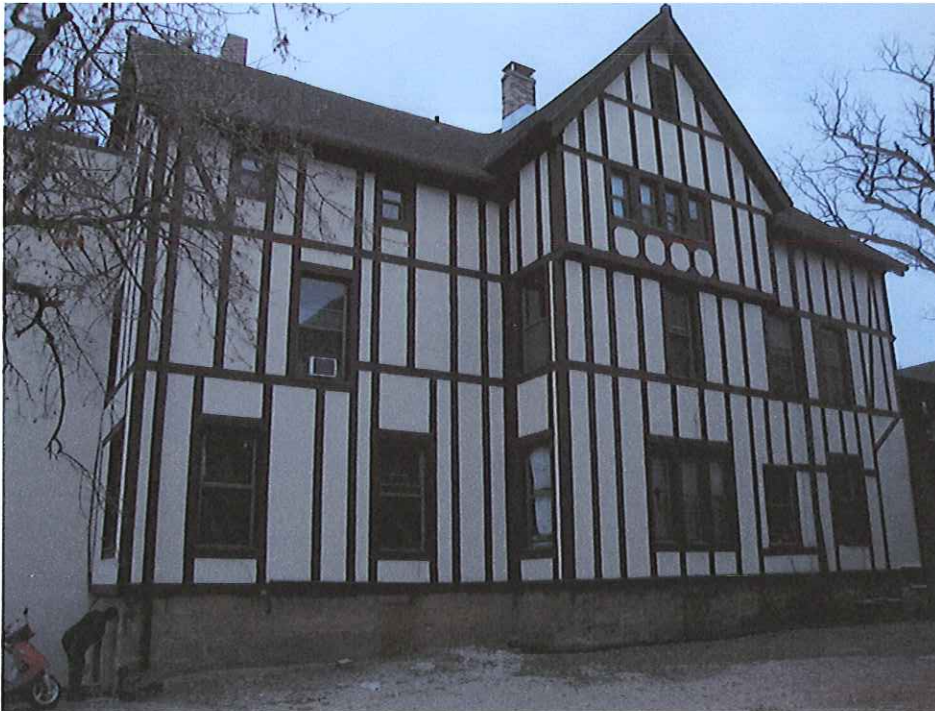
The floor framing of second and third floors slopes considerably across the central corridor of the building and the joists are likely significantly overstressed. The magnitude of the floor deformation is in the range of 2" to 3" across the corridor. The floors slope back upwards on the other side of the corridor walls in the eastern bedrooms. So, the second floor, third floor and possibly roof loads are being transmitted downward through the building through both sets of corridor walls. But only the west wall is truly a bearing wall, causing the significant deformations in the relatively soft floor joists of third and second floors. Although further investigation would be required, sagging in the floors may yet be ongoing.

Noting that the original building was two stories and that it is now three stories, we have a major concern that the third floor framing may not be contributing much (or any) to the support of the eastern-most wall stack. Since at one time the third floor was framed as a ceiling joist system or a lightly loaded attic, it is logical to believe that the framing supporting third floor may contain the smaller members left from the ceiling construction or attic floor, rather than stouter members typically used in the floor systems (present in second floor). It follows that second floor joist framing may be supporting both the second, and third floors, and part of the roof, all by itself.

Image showing the east exterior of the building. The floor deformations are occurring generally in the longer joist spans of the middle third of the building; in the section under the east west framed gable.

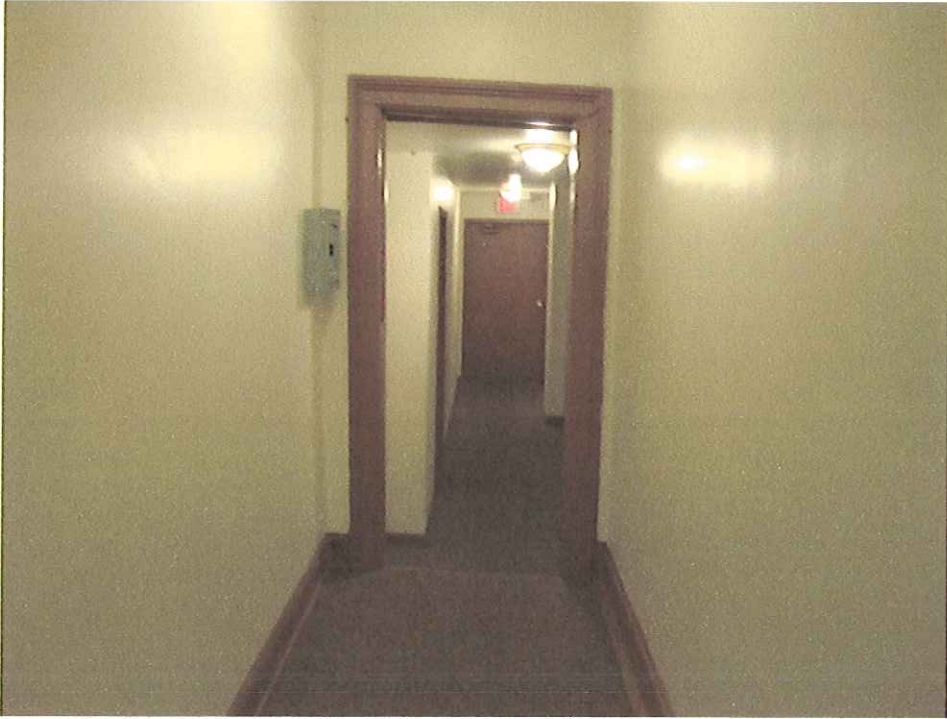
Image showing the sloping in the corridor of second floor from west downward to the east.
