LANDMARKS COMMISSION APPLICATION

Project Address: 126 N. Spooner Street

Project Title/Description: Garage and 4-Season Room Addition and General Repairs

Landmarks Window Replacement Request

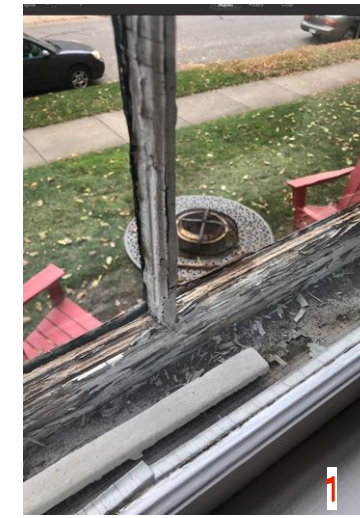
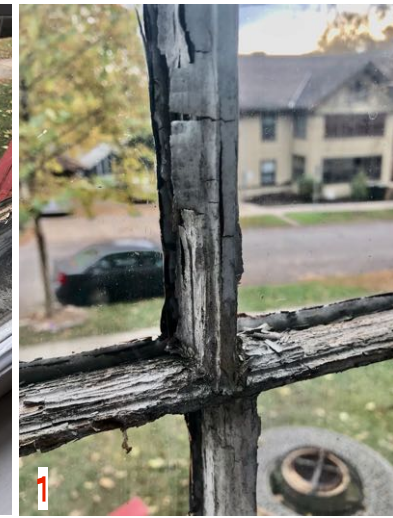
VIEW OF DRY ROT AND DISINTEGRATION FROM INTERIOR AND EXTERIOR. THE EXTERIOR FRAMES ARE OUTSWING CASEMENT WINDOWS, THE INTERIOR FRAMES ARE THE STORM WINDOWS. THE EXTERIOR WINDOWS HAVE NOT OPENED SINCE THESE HOMEOWNERS PURCHASED THE HOUSE.

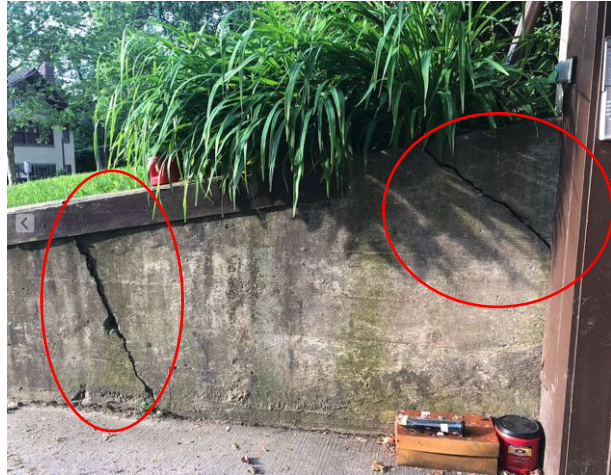
There is a need to replace the concrete retaining walls on either side of the driveway. The western wall has structural failure and needs to be replaced. The eastern wall is proposed to move towards the east to provide more space for both the diver and passage to open doors for unloading.

STRUCTURAL FAILURE OF THIS WALL

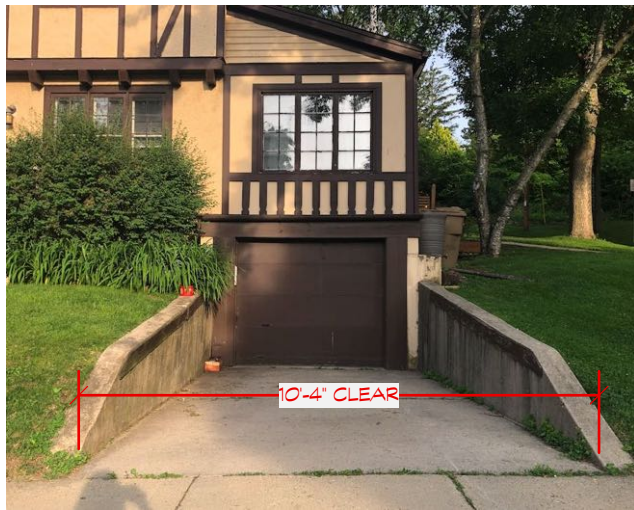
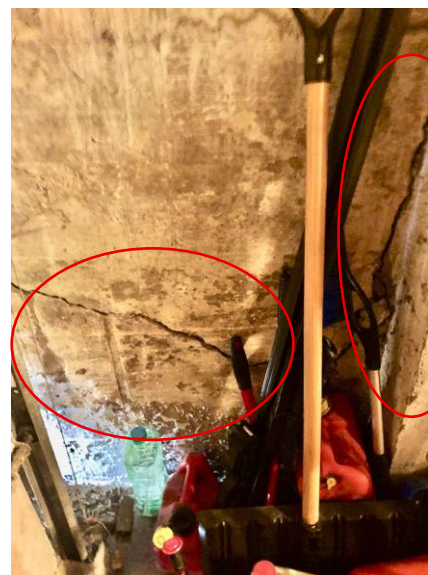
CRACKED FOUNDATION INSIDE GARAGE

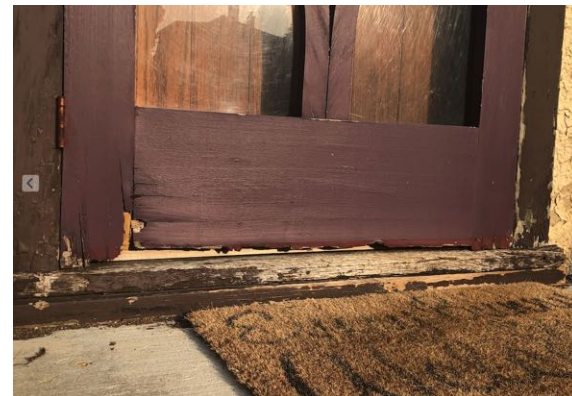
ROTTED SILL AND BASE OF STORM DOOR

REPLACE WITH NEW STORM DOOR OF REPLICA DESIGN IN PAINTED OAK.

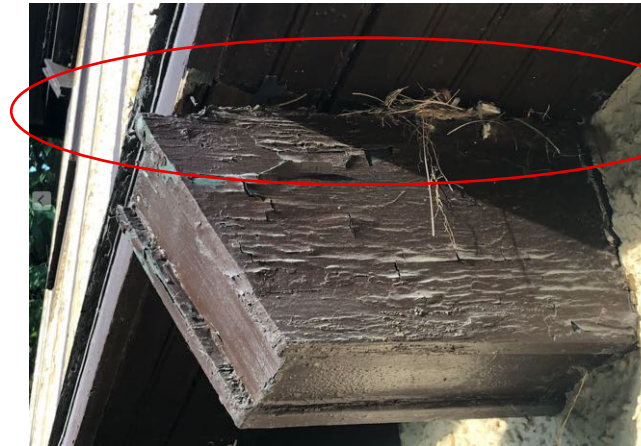
EXAMPLE OF CORBEL FALLING OFF HOUSE (BIRD'S NEST IN THE GAP)

CONDITION OF THE EXISTING HOUSE TRIM TO BE REPLACED/REPAIRED WITH PAINTED WOOD OR BORAL COMPOSITE

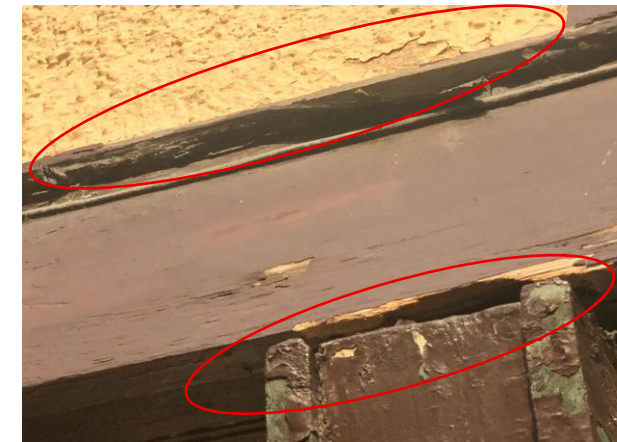
ROTTING DRIP EDGE AND FASCIA OVER BRACKETS

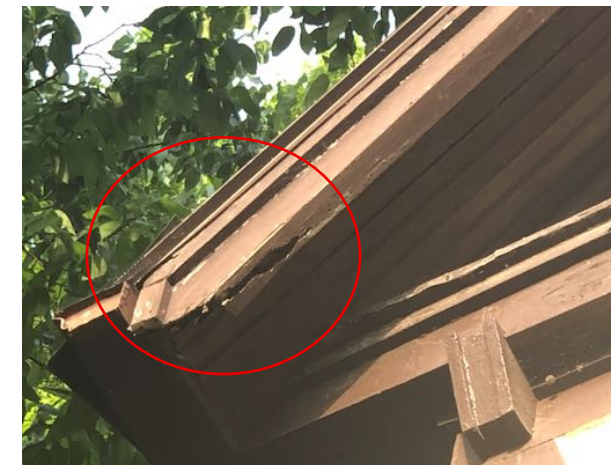
ROTTING FASCIA BOARDS

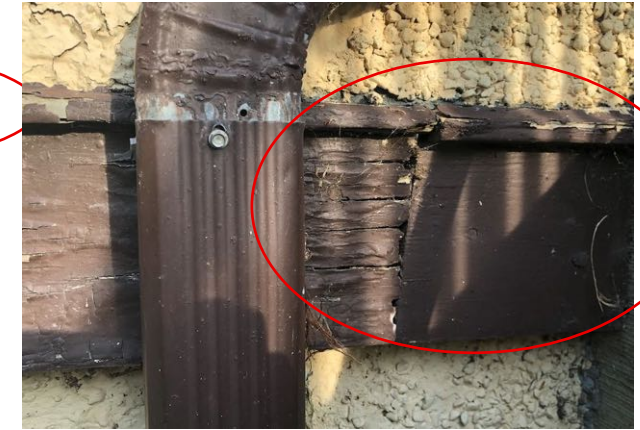
ROTTING DRIP EDGE AND BRAND BOARD AT WATER TABLE DETAIL

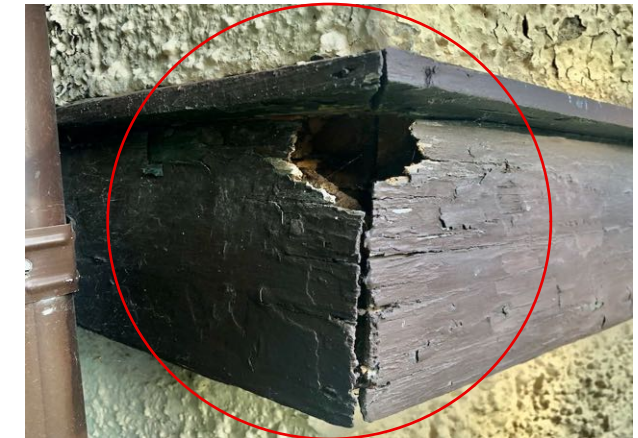
ROTTING DRIP EDGE AND BRAND BOARD AT WATER TABLE DETAIL

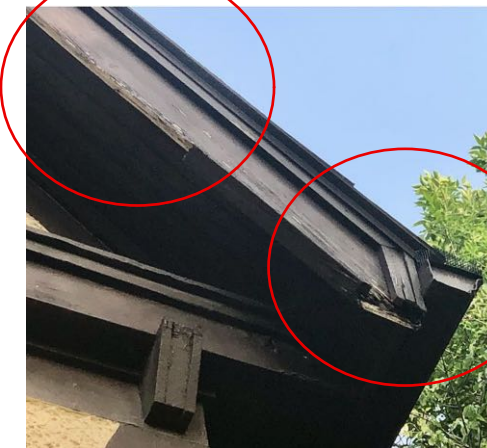
ROTTING FASCIA BOARDS

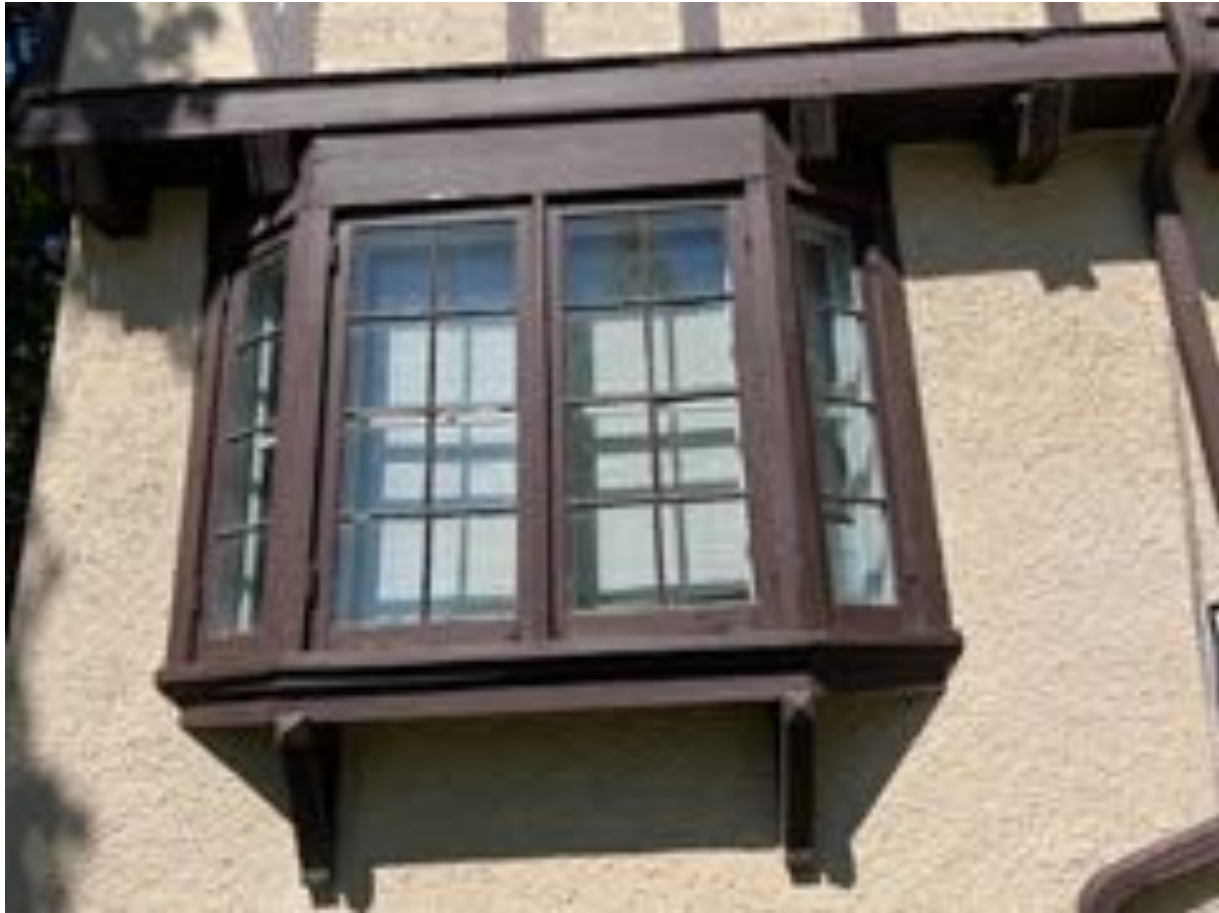
Window #1 – 4 Casement 30° bay

- Location: front left 1st story as viewed from exterior.
- Age: appears to be original to the 1923 home
- Presence of Lead Paint: highly likely given the year built.
- Component evaluations:
 - Jambs/sill & exterior trim are in typical condition for a 100 year old window poorly maintained off and on through the years; not holding paint well with underlying wood surface showing deterioration. Repair would entail complete stripping, repair (fillers/epoxy stabilizers) sanding, prime and paint.
 - Outer sashes are in very poor condition: currently inoperable due to paint buildup and sash component and joinery deterioration/failure especially along the bottom rails where interior and exterior water problems typically manifest. Sticking has lost definition to

deterioration so as to be unrecognizable in sections. Repair would entail complete sash rebuilds with some rails, stiles &/or muntins fully replaced. Complete reglazing. Weatherstripping likely needing replaced – assumed copper. Complete stripping, sanding, prime and paint. Completely new sashes may be indicated upon disassembly/more invasive investigation.

- Inner storms are in better shape. Repair would entail joinery inspection and reinforcement &/or reglue as needed, strip, sand, prime and paint plus complete reglaze.
- Glass: most panes appear original/wavy and could be reused if successfully extracted.
- **Recommendation:** Replacement. Marvin Signature window custom sized to replicate the original windows ODs, with simulated divided light pattern and exterior trim details that match existing and with sashes and muntins that closely approximate the existing in dimension. These will also match the previous replacements bringing uniformity to the fenestration. Note: in the case of this bay the brackets, seat board and head framing will likely all remain and experience repair/rehab.

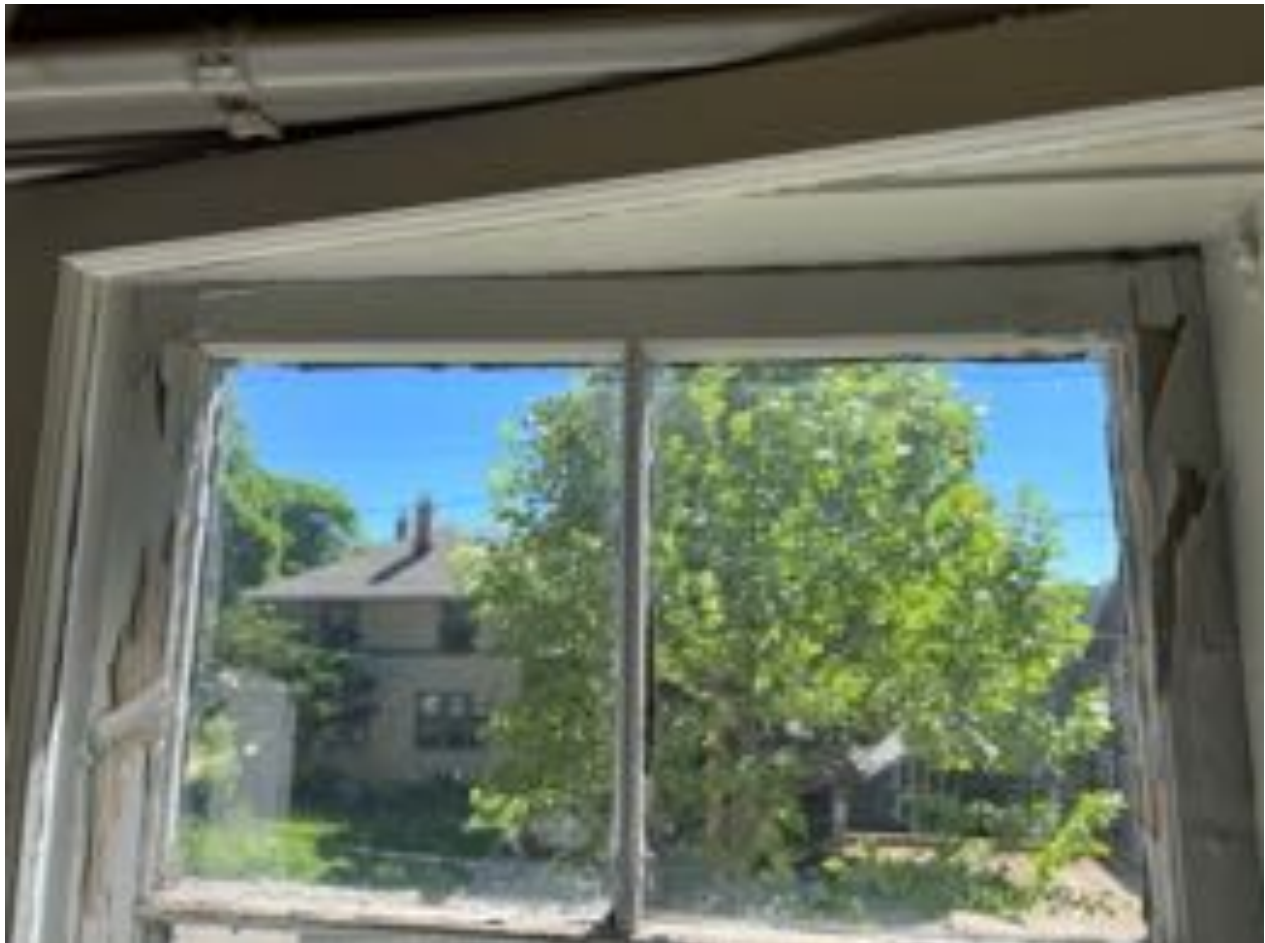
Window #1 - Typical condition of interior of outer sash. Peeling paint revealing deteriorated substrate. Sash sag is evident in the top rail to jamb taper. Horizontal muntin definition lost to deterioration (condensation the likely culprit). Note: inner storm sash slightly ajar with blinds resting atop in this photo.

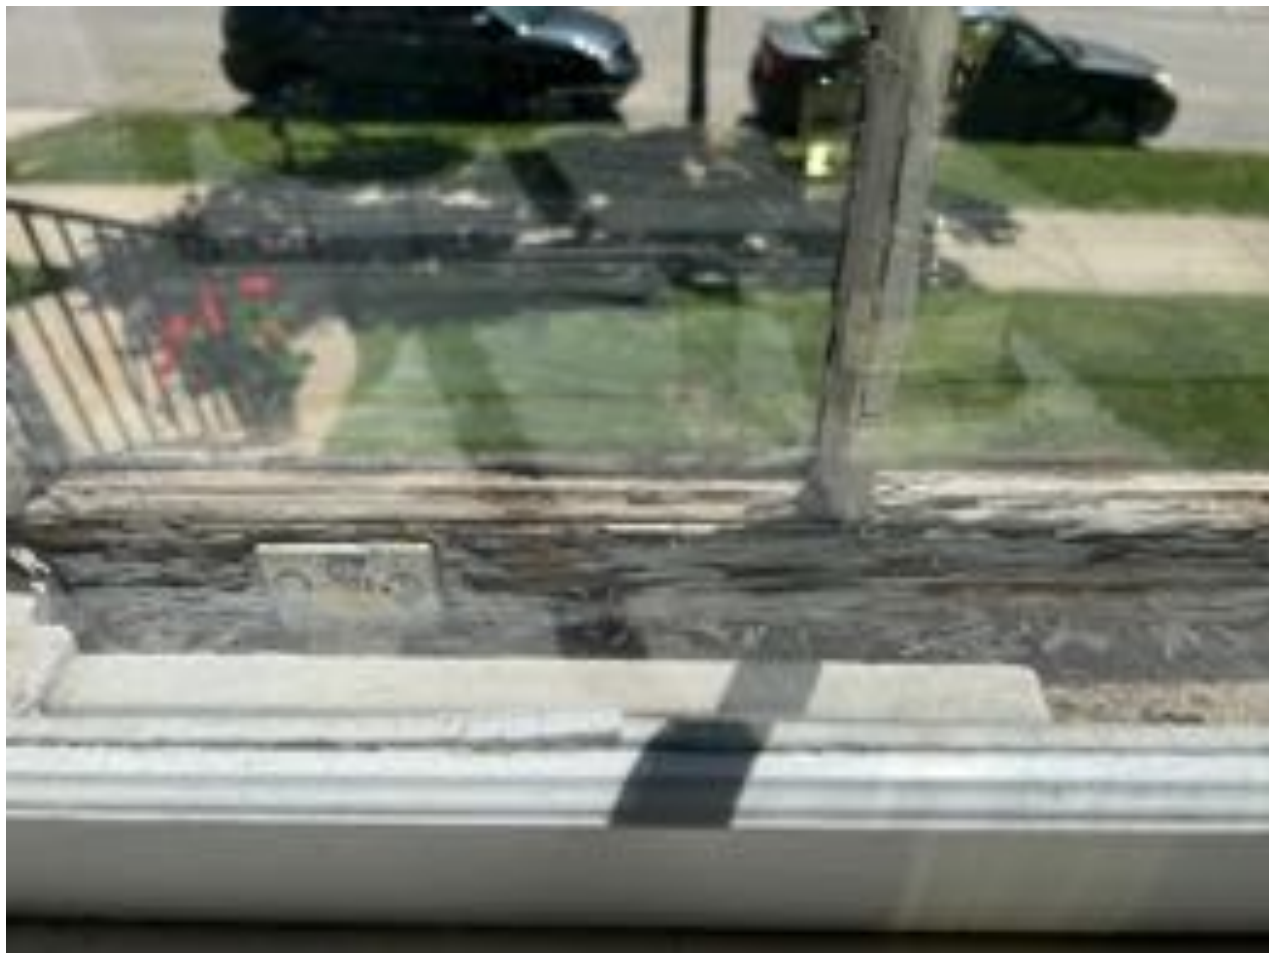
Window #1 - Even worse deterioration along bottom rails where water collection is most intense inside and out. Inner storm sash in foreground in good shape needing new glazing and lead paint

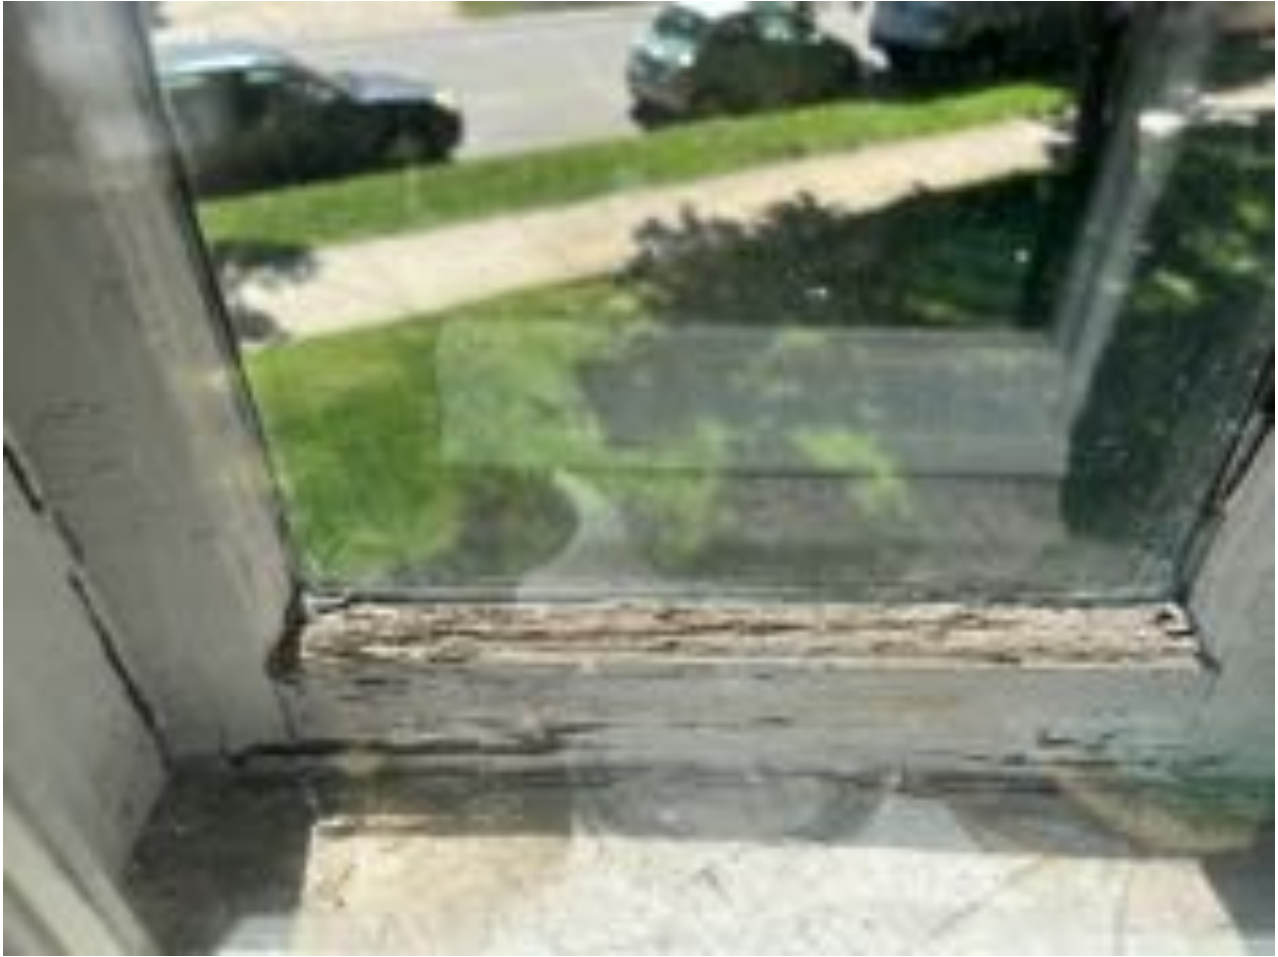
Window #1 - Another bottom rail in poor condition. Lower stile ends also compromised and rail/stile joinery suspect in most instances.

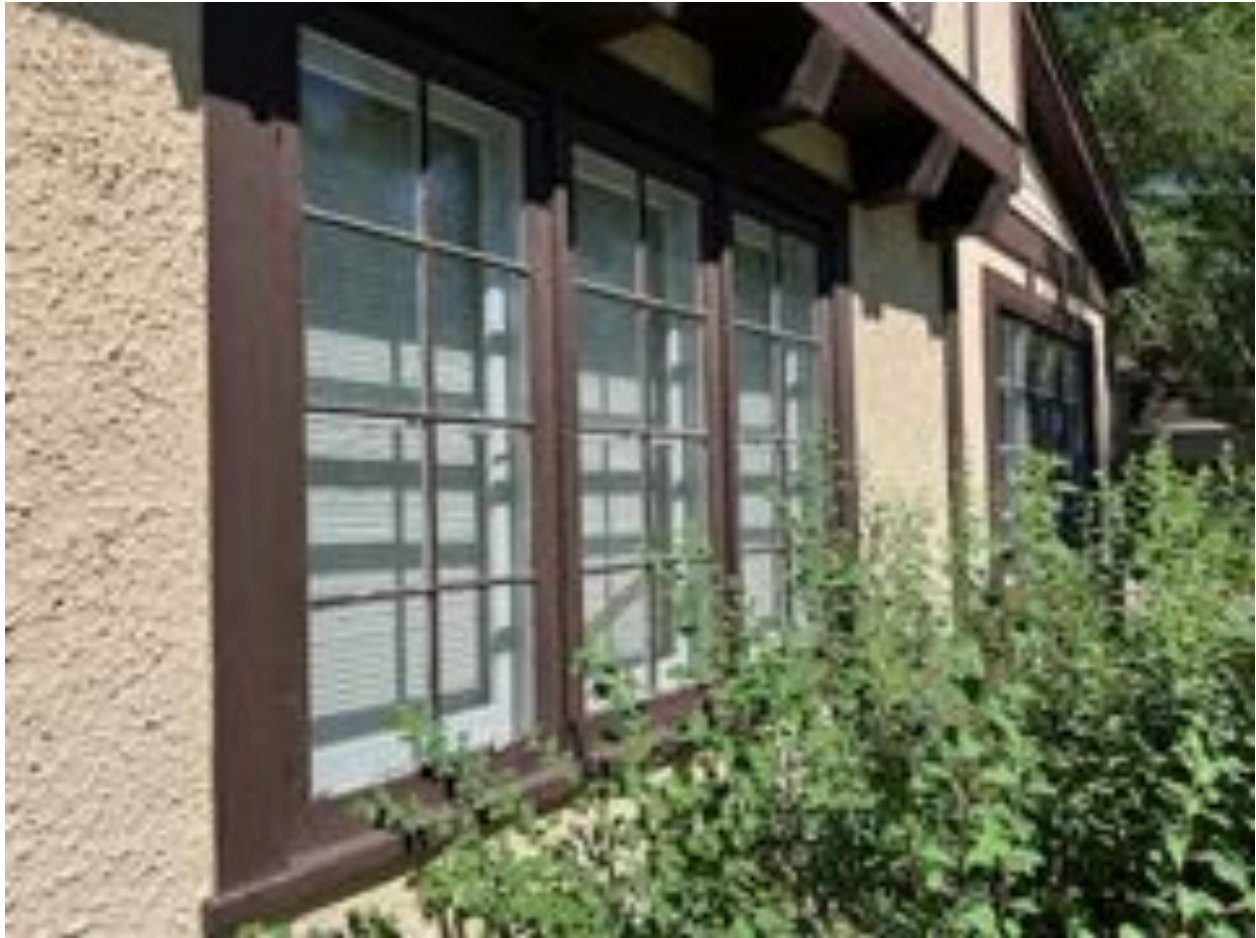
Window #2 – 3-Wide Casement

- Location: front right 1st story as viewed from exterior.
- Age: appears to be original to the 1923 home
- Presence of Lead Paint: highly likely given the year built.
- Component evaluations:
 - Jamb/sill & exterior trim are in typical condition for a 100 year old window poorly maintained off and on through the years; not holding paint well with underlying wood surface showing deterioration. Repair would entail complete stripping, repair (fillers/epoxy stabilizers) sanding, prime and paint.
 - Outer sashes are in poor condition: currently inoperable due to paint buildup and sash component and joinery deterioration/failure especially along the bottom rails where interior and exterior water problems typically manifest. Sticking has lost definition to

deterioration in sections. Repair would entail sash rebuilds with some rails, stiles &/or muntins fully replaced. Complete reglazing. Weatherstripping likely needing replaced – assumed copper. Complete stripping, sanding, prime and paint. Completely new sashes may be indicated upon disassembly/more invasive investigation.

- Inner storms are in better shape. Repair would entail joinery inspection and reinforcement &/or reglue as needed, strip, sand, prime and paint plus complete reglaze.
- Glass: most panes appear original/wavy and could be reused if successfully extracted.
- **Recommendation:** Replacement. Marvin Signature window custom sized to replicate the original windows ODs, with simulated divided light pattern and exterior trim details that match existing and with sashes and muntins that closely approximate the existing in dimension. These will also match the previous replacements bringing uniformity to the fenestration.

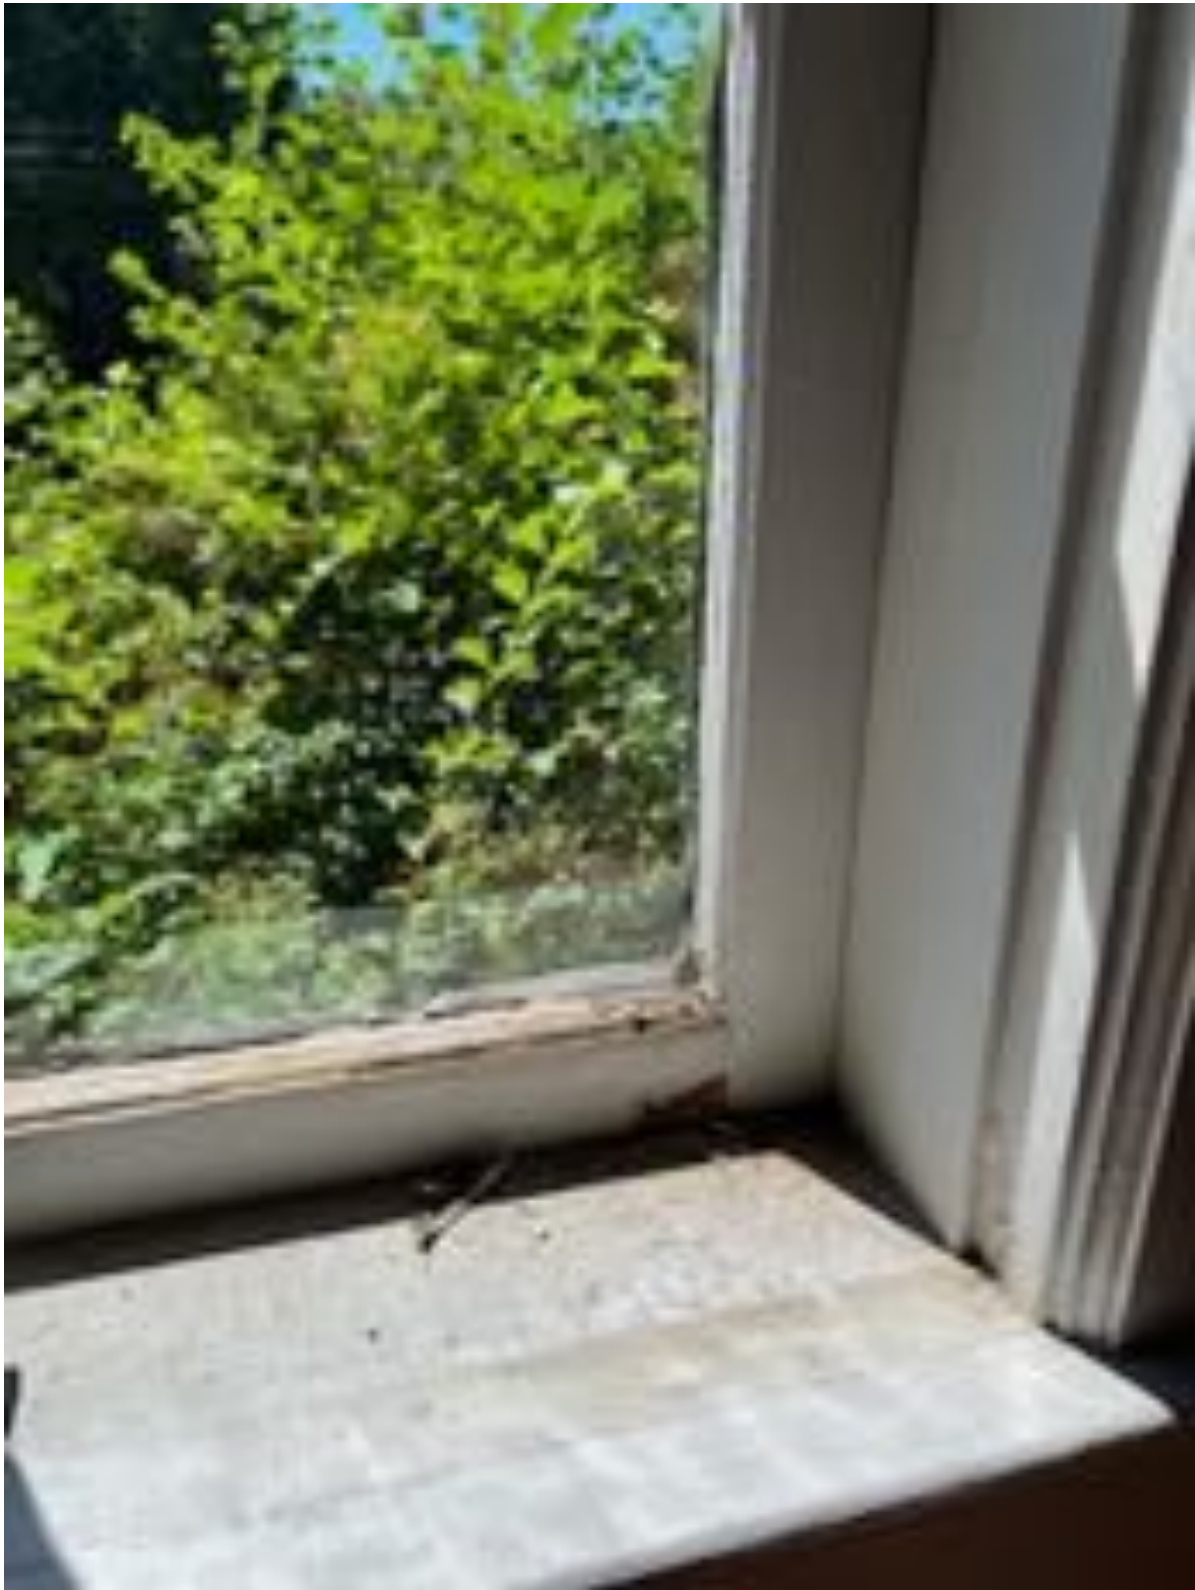
Window #2 – Deterioration of lower rail and rail/stile joinery evident.

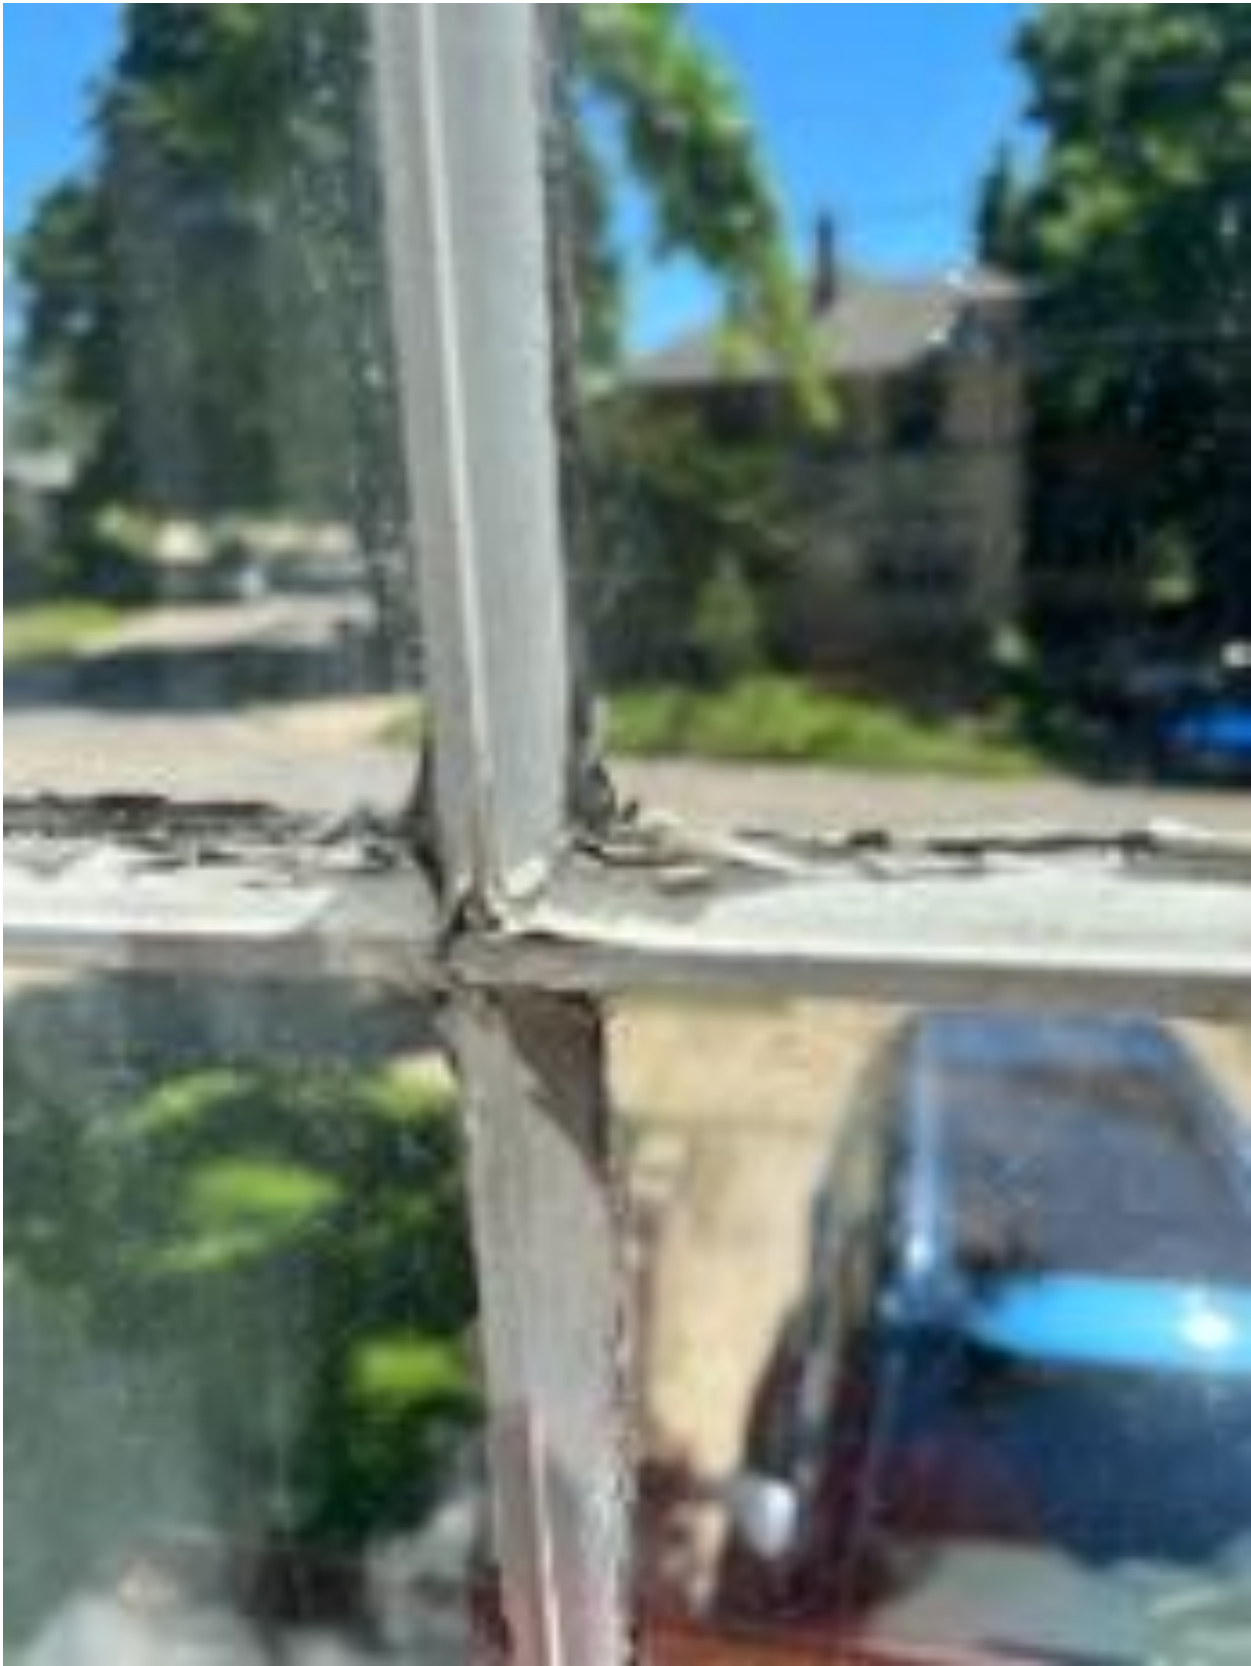
Window #2 – Interior paint deterioration.

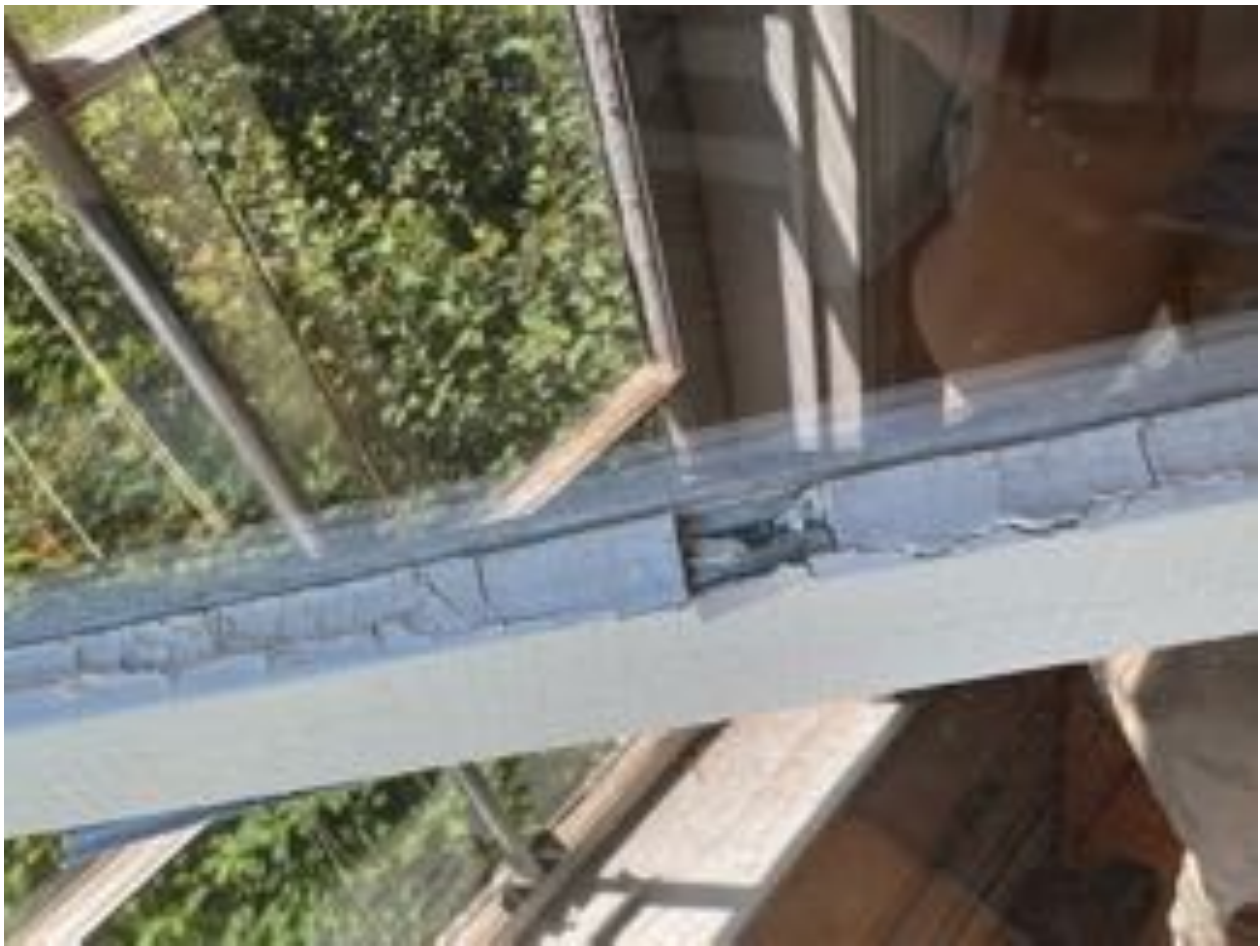
Window #2 – Exterior glazing deterioration.

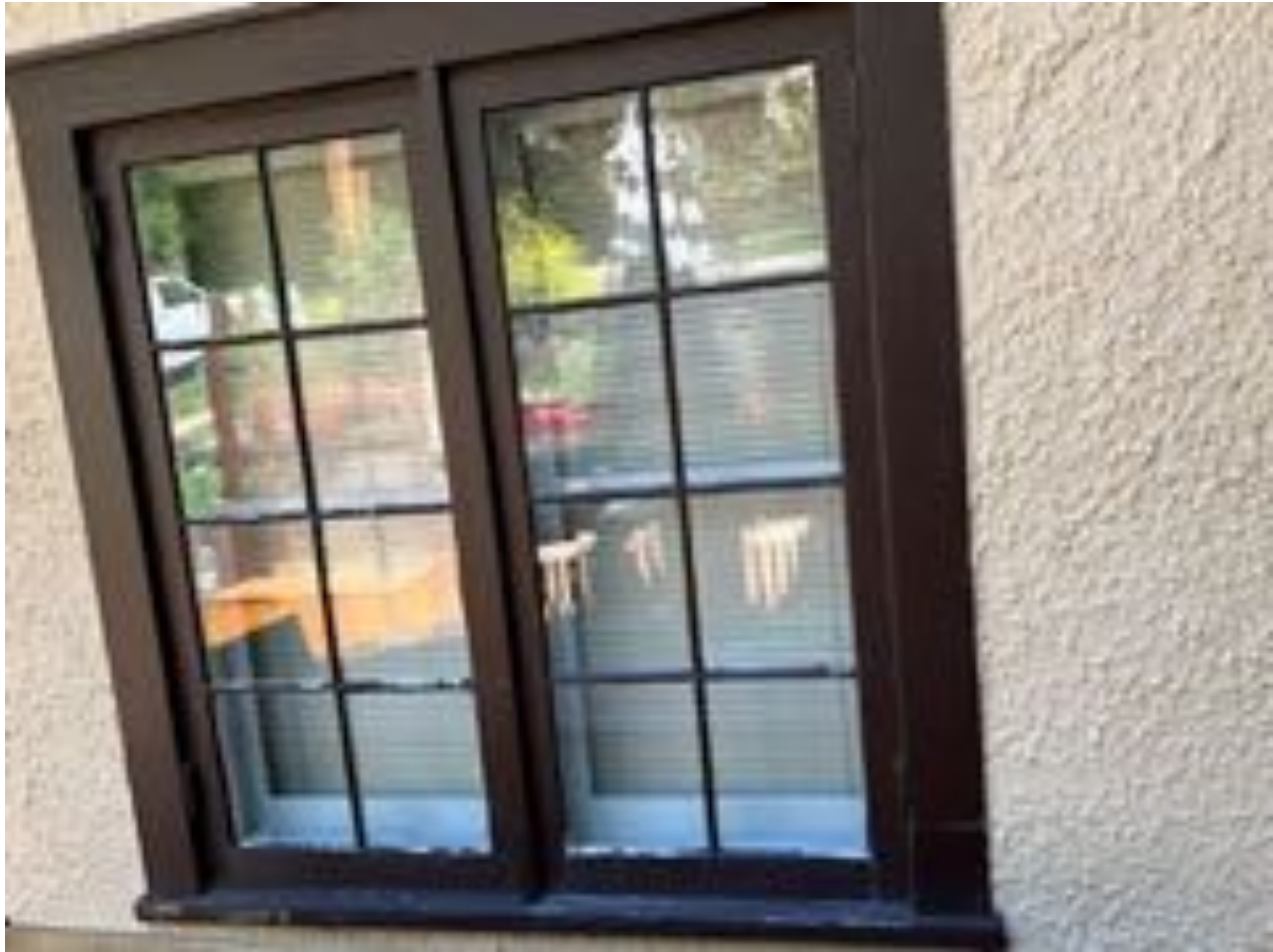
Window #3 – 2 wide casement

- Location: back left 1st story as viewed from exterior.
- Age: appears to be original to the 1923 home
- Presence of Lead Paint: highly likely given the year built.
- Component evaluations:
 - Jamb/sill & exterior trim are in typical condition for a 100 year old window poorly maintained off and on through the years; not holding paint well with underlying wood surface showing deterioration. Repair would entail complete stripping, repair (fillers/epoxy stabilizers) sanding, prime and paint.
 - Outer sashes are in poor condition: currently inoperable due to paint buildup and sash component and joinery deterioration/failure especially along the bottom rails where

interior and exterior water problems typically manifest. Sticking has lost definition to deterioration in sections. Repair would entail sash rebuilds with some rails, stiles &/or muntins fully replaced. Complete reglazing. Weatherstripping likely needing replaced – assumed copper. Complete stripping, sanding, prime and paint. Completely new sashes may be indicated upon disassembly/more invasive investigation.

- Inner storms are in better shape. Repair would entail joinery inspection and reinforcement &/or reglue as needed, strip, sand, prime and paint plus complete reglaze.
- Glass: most panes appear original/wavy and could be reused if successfully extracted.
- **Recommendation:** Replacement. Marvin Signature window custom sized to replicate the original windows ODs, with simulated divided light pattern and exterior trim details that match existing and with sashes and muntins that closely approximate the existing in dimension. These will also match the previous replacements bringing uniformity to the fenestration.

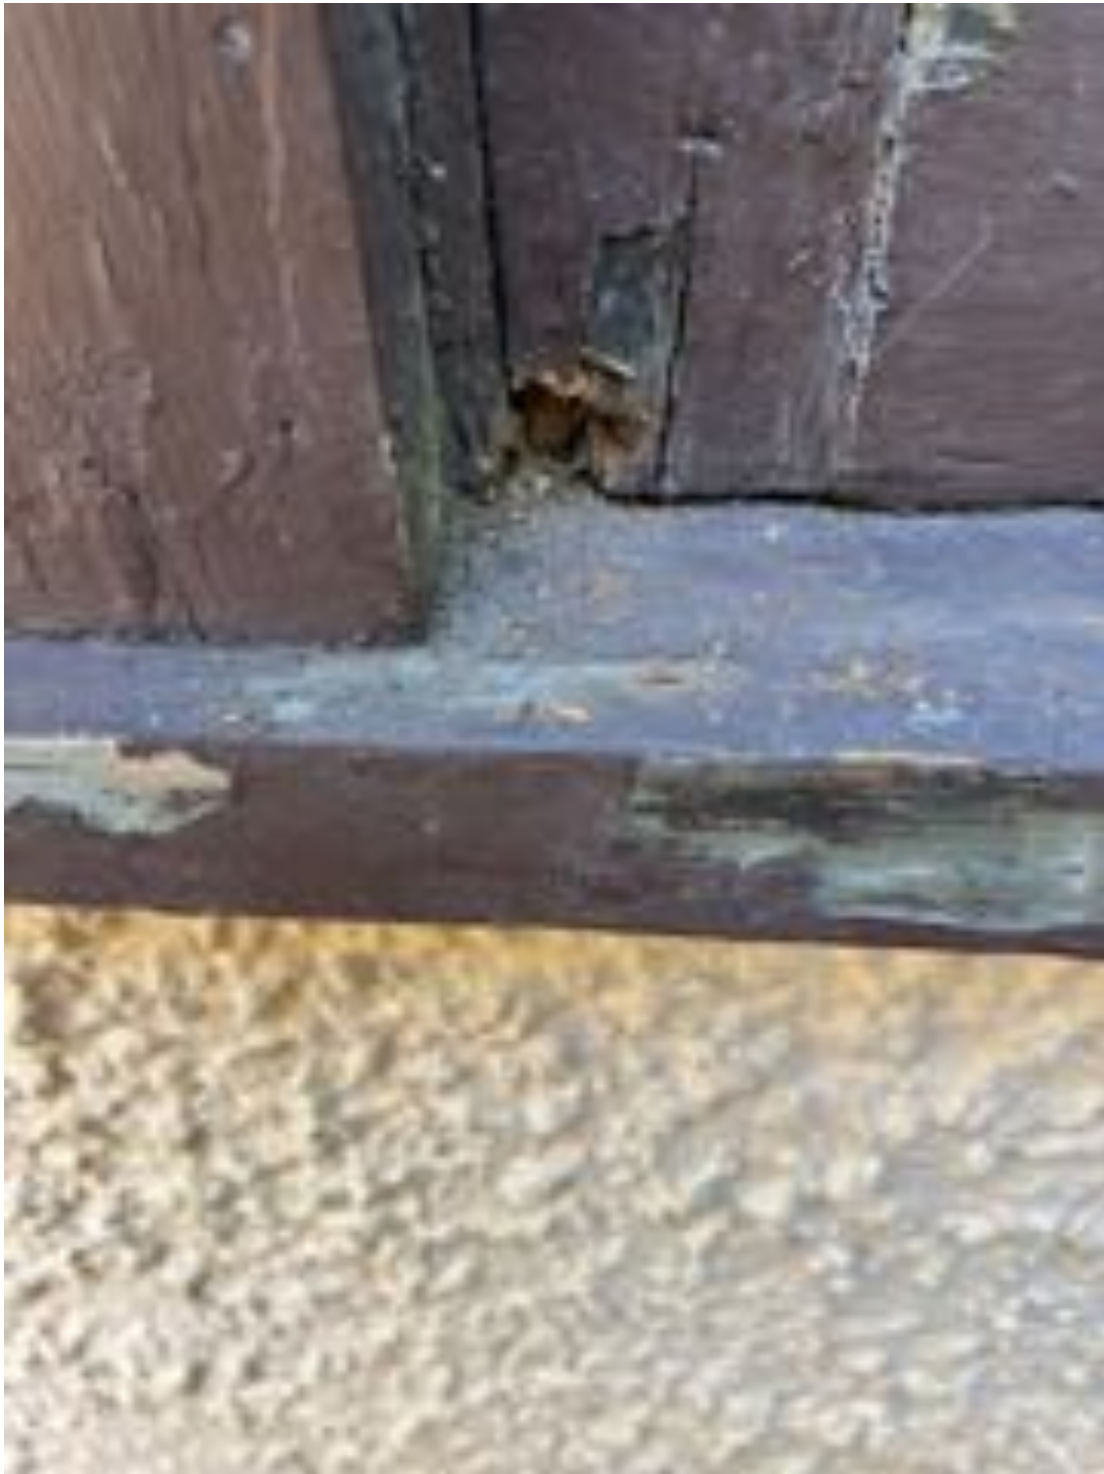
Window #3 – Exterior view of the 2-wide casement. Note exterior sill has lost thickness to deterioration. Lower end of stile has rotted away all the way back to the rail tenon compromising joinery strength.

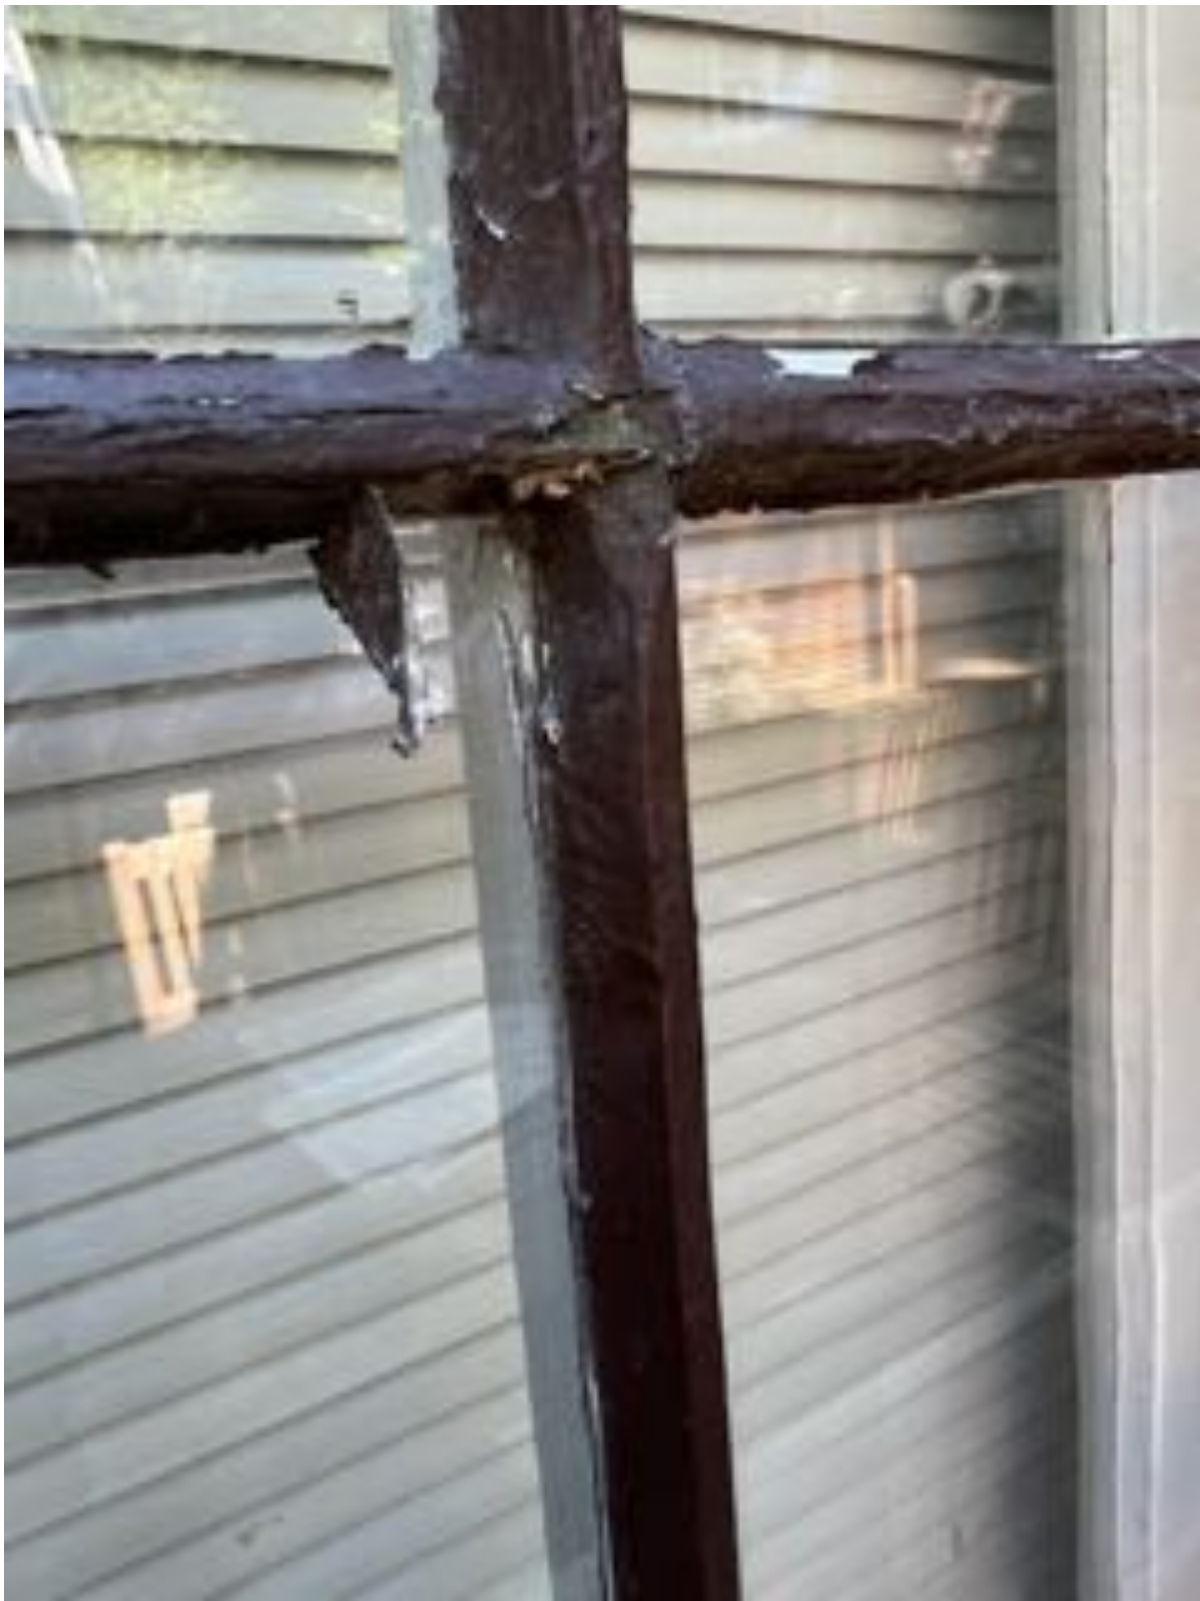
Window #3 – Exterior muntins & glazing needs complete replacement. Deterioration of underlying wood requires more aggressive rehab to get to suitable paint substrate.

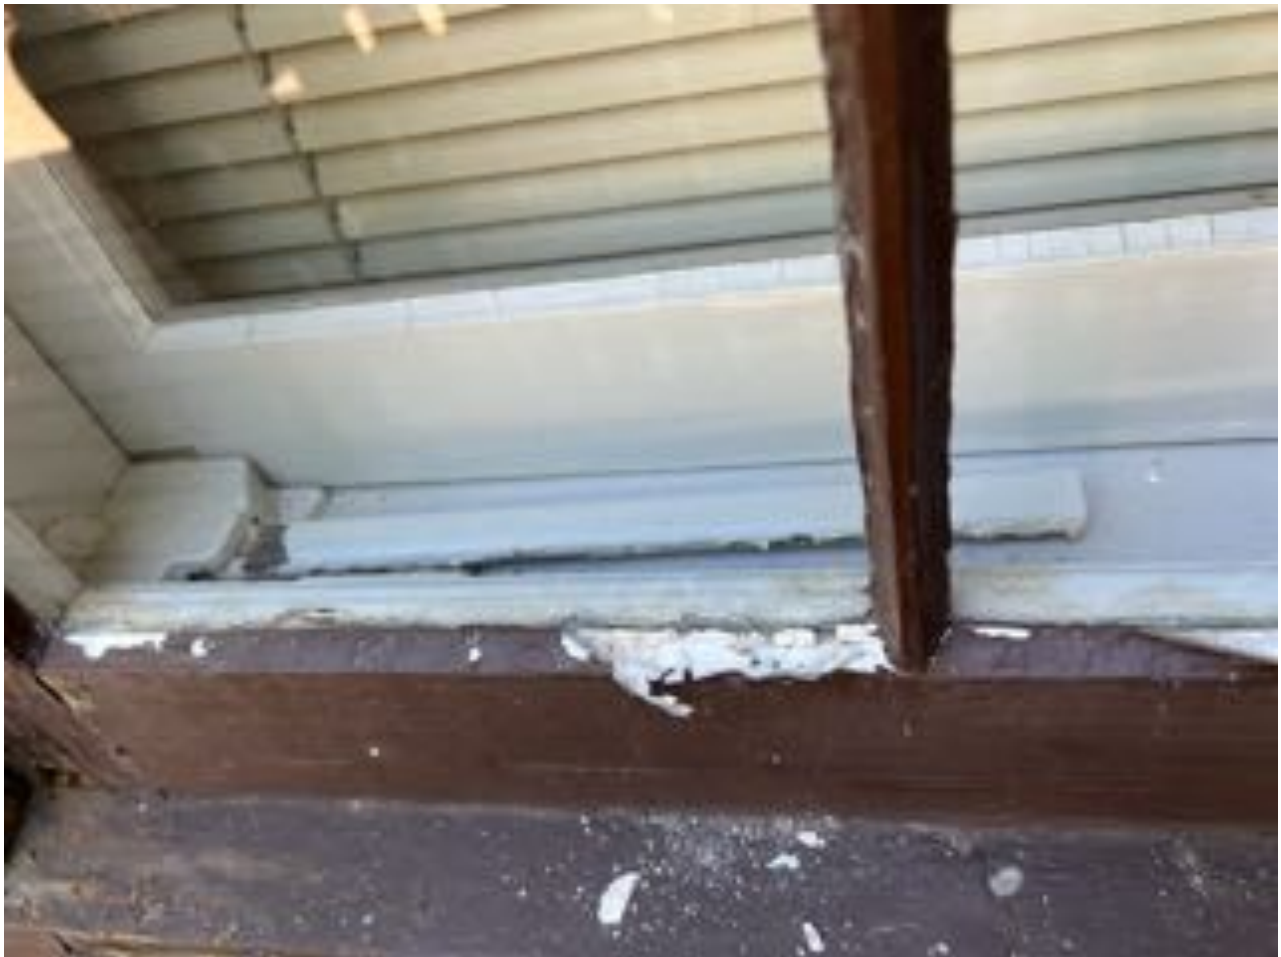
Window #3 – Another exterior showing glazing failure and, in the lower left, degradation of the rail/stile joinery.
