LANDMARKS COMMISSION APPLICATION

Project Address: 126 N. Spooner Street

Project Title/Description: Garage and 4-Season Room Addition and General Repairs

Landmarks Window Replacement Request

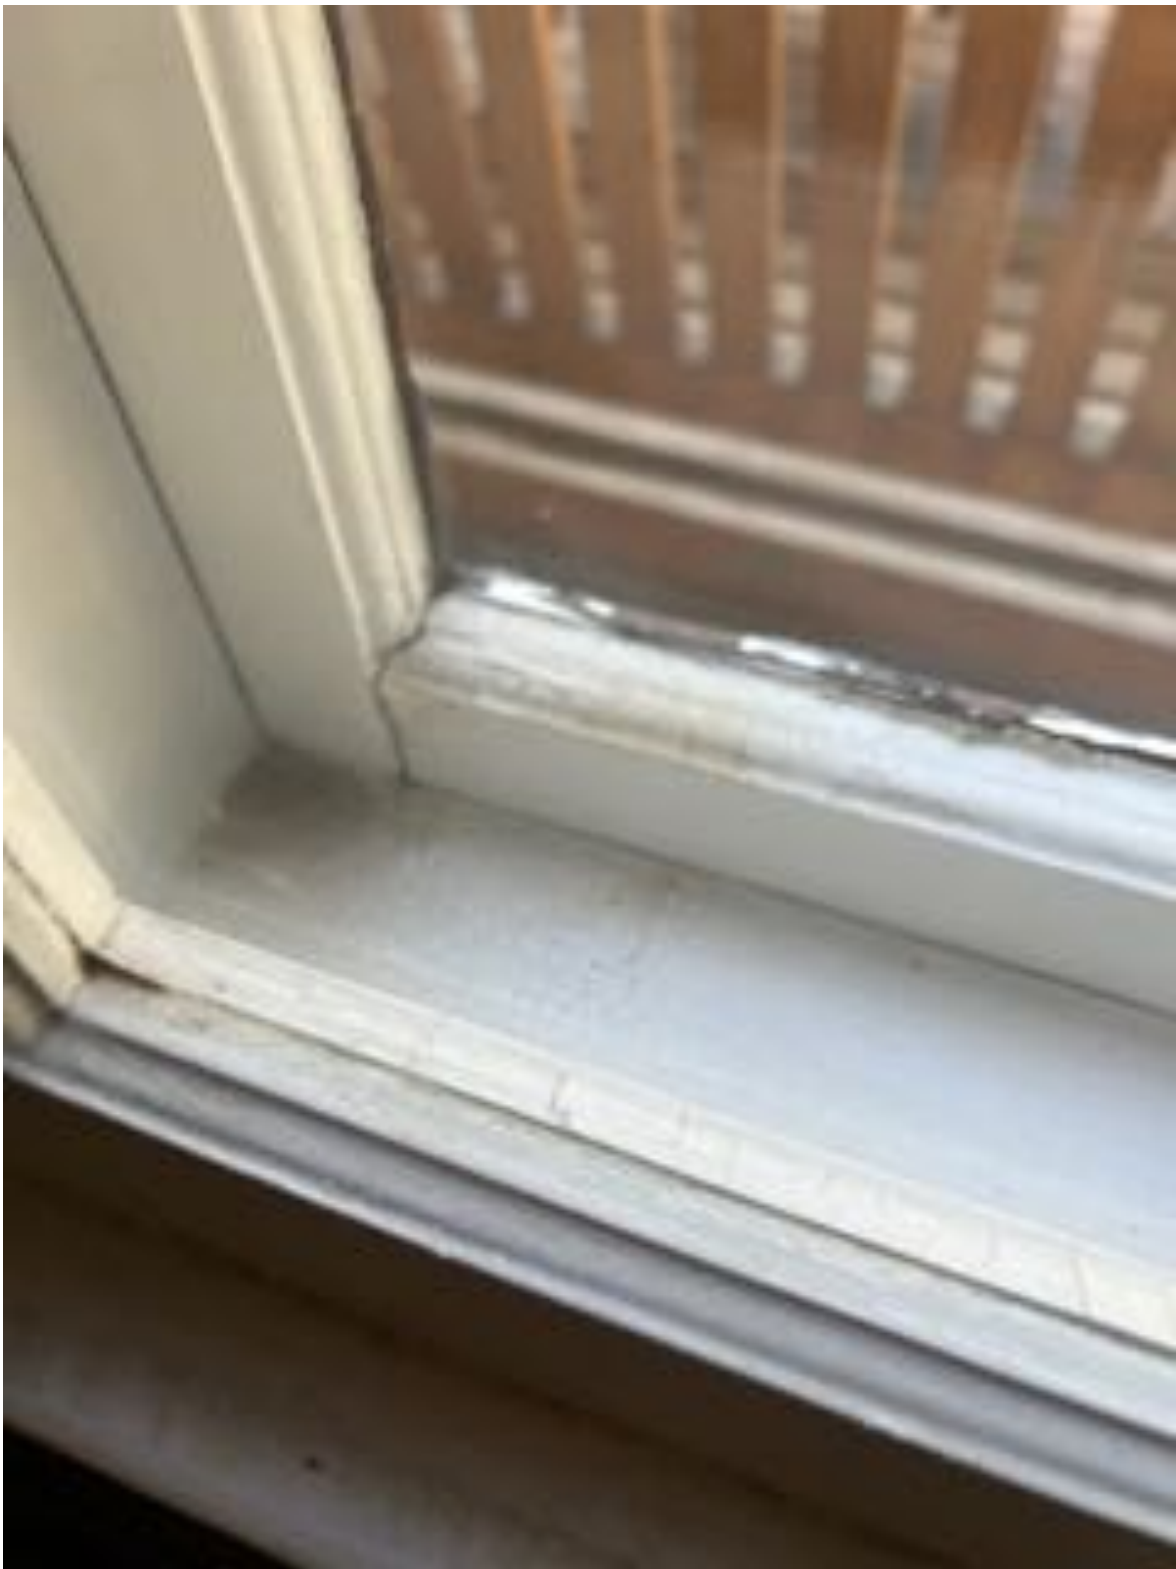
Window #3 – Interior view also suggest rail/stile joinery failure.

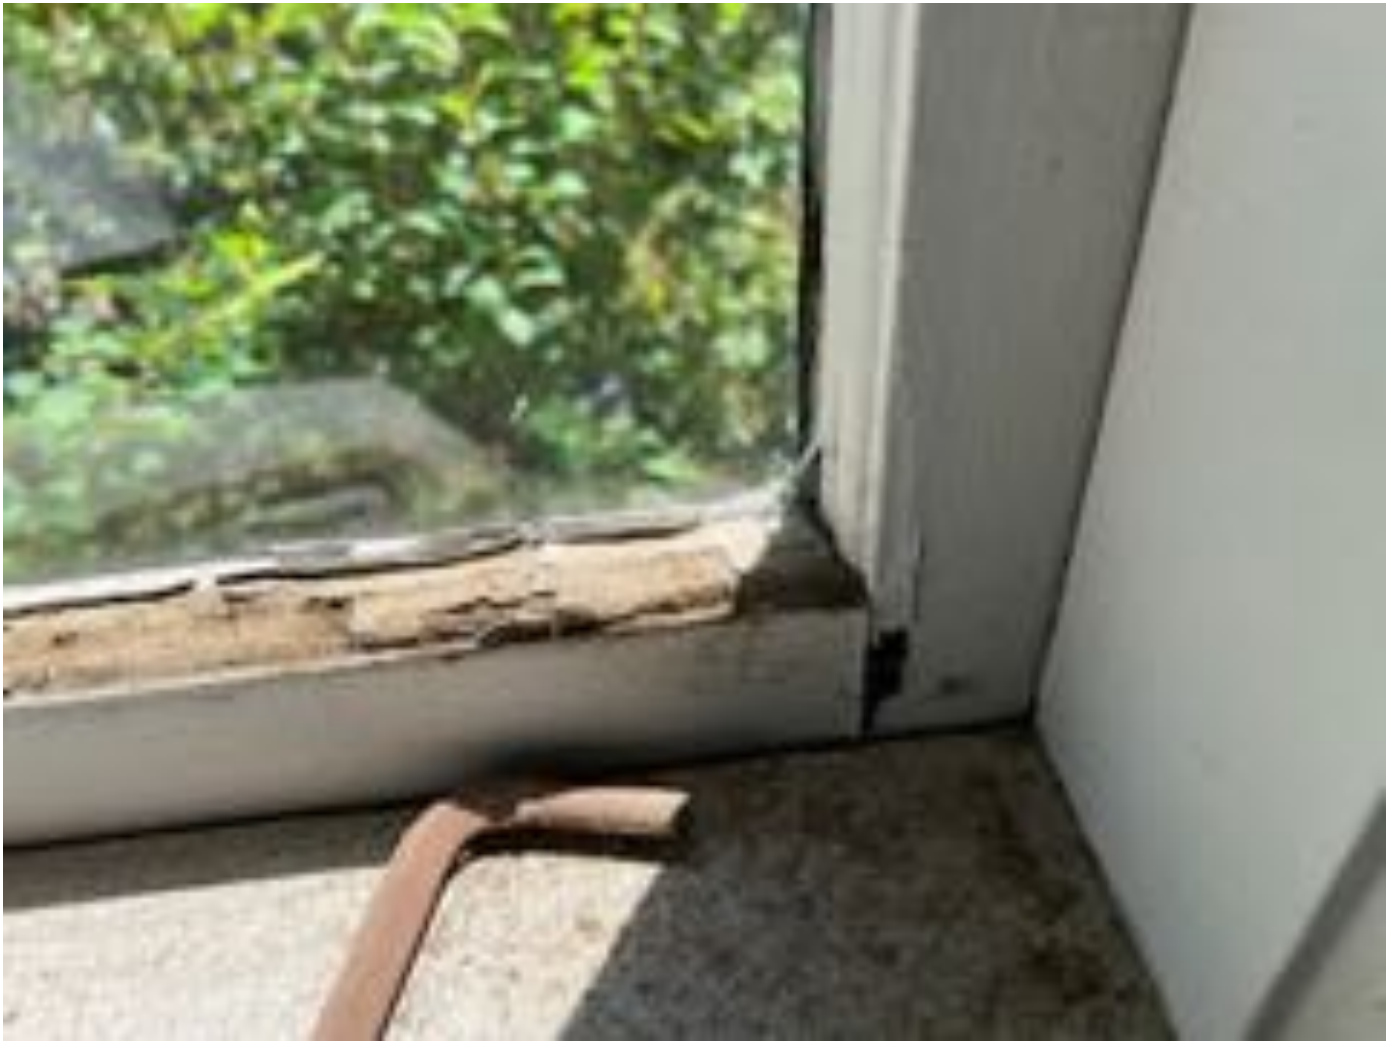
Window #3 – Interior view documents the sticking deterioration along with sash joinery failure.
