SURVEY OF CONDITIONS FOR PROPOSED DON MILLER REDEVELOPMENT PROJECT

Report on Blight Determination

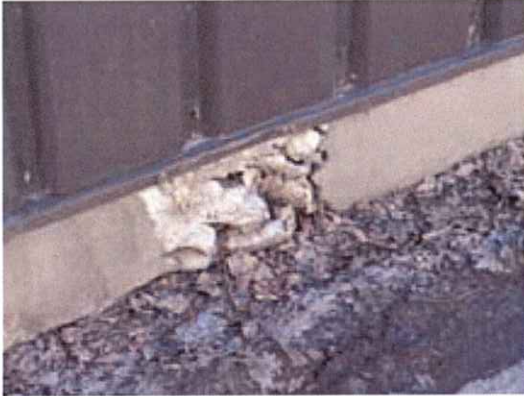
Broken Foundation – 837 E. Mifflin Street

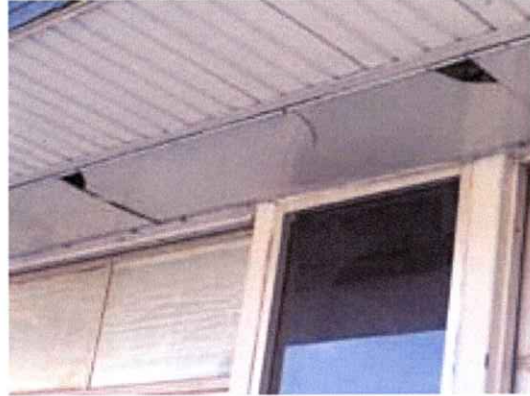
Broken Soffit – 854 E. Washington Ave

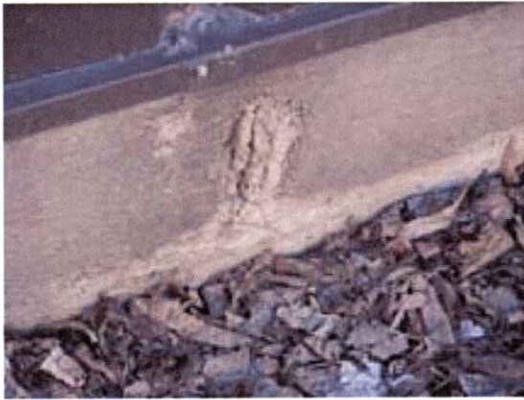
Deteriorating Foundation-837 E Mifflin Street

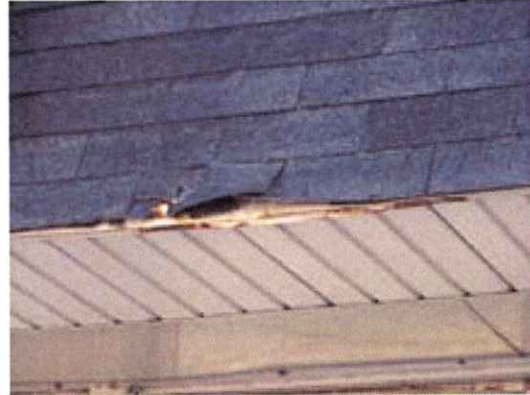
Deteriorating Fascia 854 E. Washington Ave

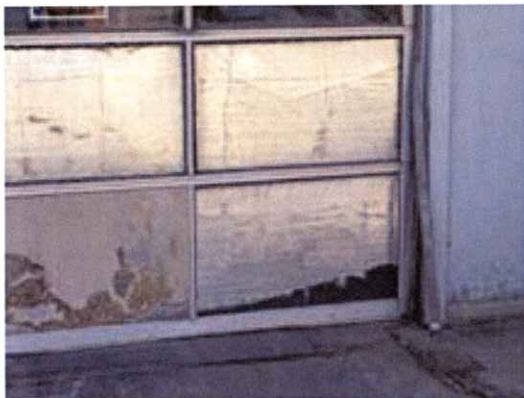
Cracked Glass – Loose Door Frame-
854 E. Washington Avenue

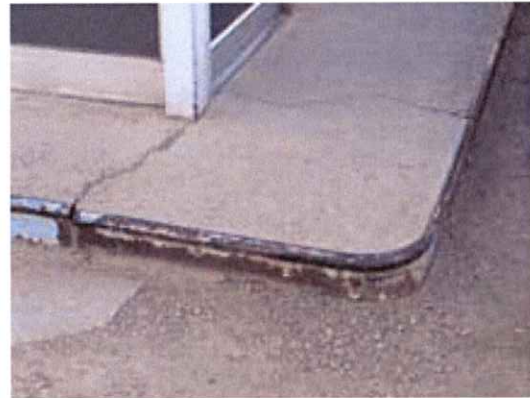
Cracked Sidewalk
854 E. Washington Avenue

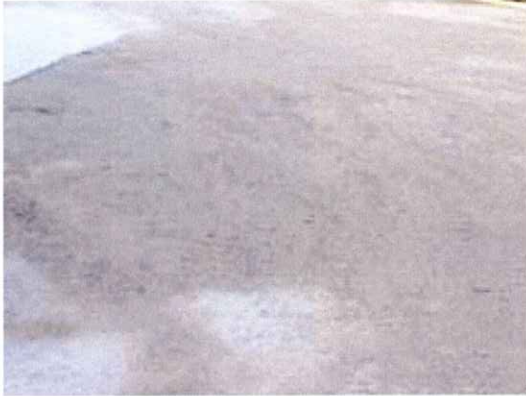
Gravel and Paved Parking Area
854 E. Washington Avenue

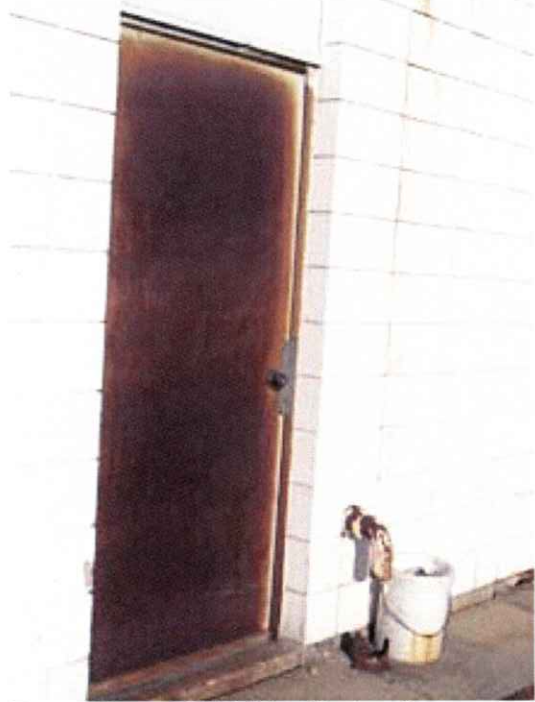
Rusted Door-854 E. Washington Avenue

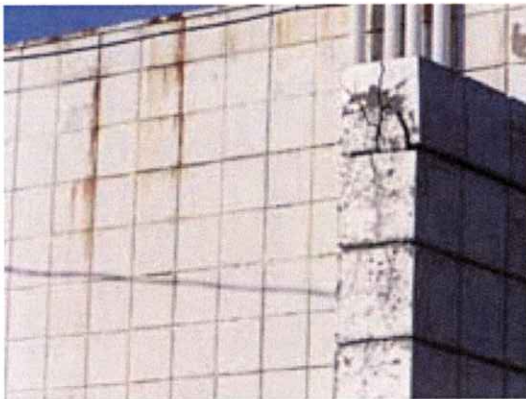
Broken & Deteriorating Block
854 E. Washington Avenue

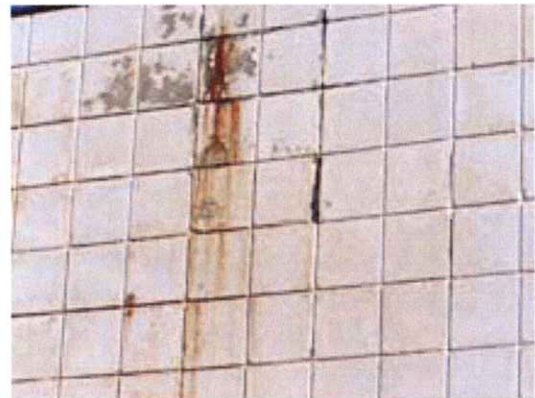
Deteriorating Block-854 E. Washington Ave

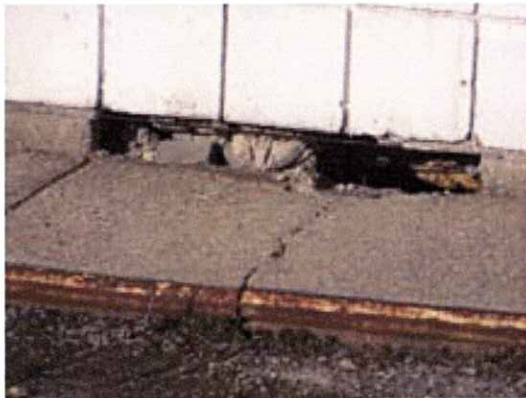
Broken Foundation & Sidewalk
854 E. Washington Avenue

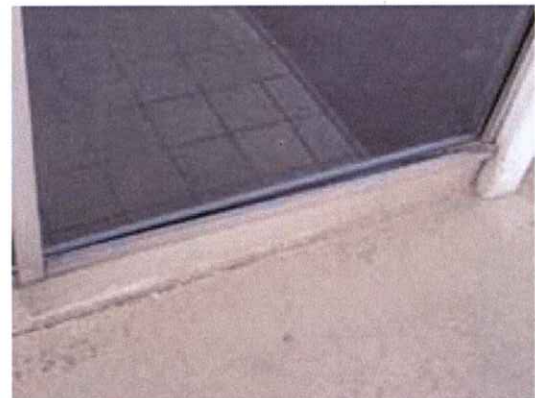
Loose Window Trim
854 E. Washington Avenue

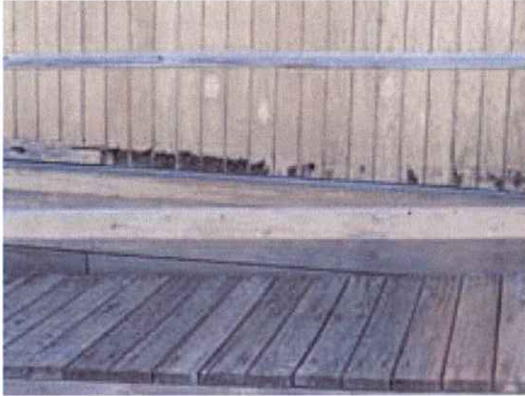
Missing Trim & Deteriorating Siding
826 E. Washington Avenue

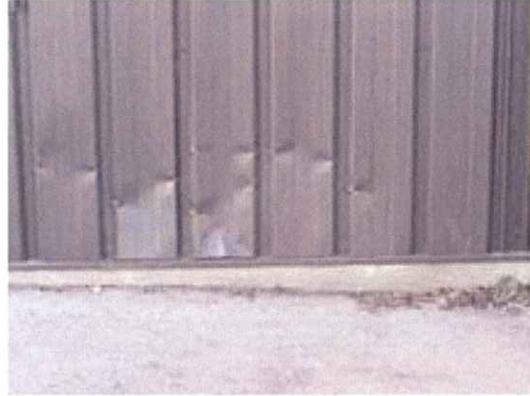
Dented Siding – 837 E. Mifflin Street

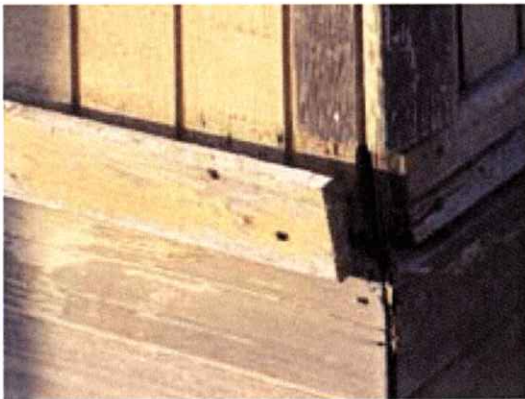
Loose Trim & Deteriorating Siding
826 E. Washington Avenue

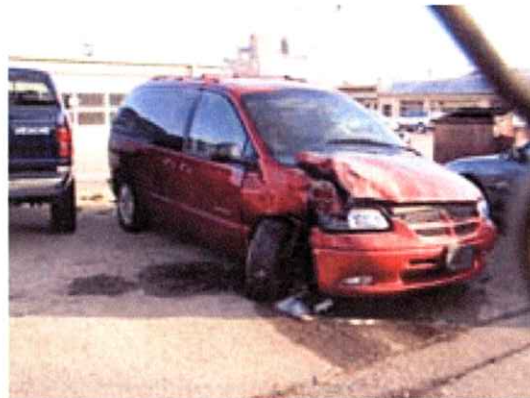
Damaged Vehicle – 837 East Mifflin Street

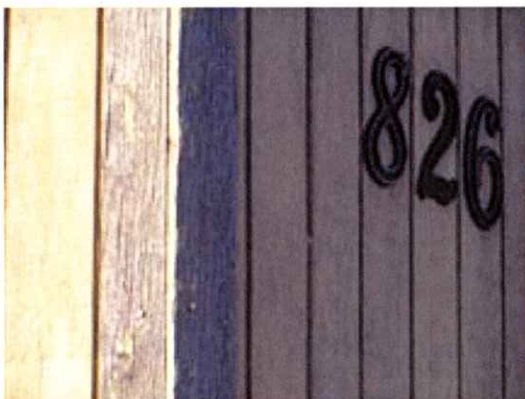
Deteriorating Siding
826 E. Washington Avenue

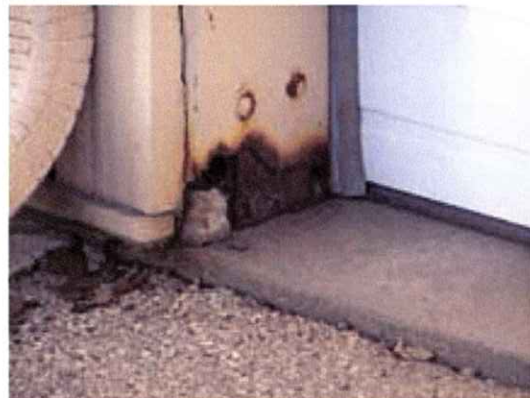
Rotted Door Frame – 835 East Mifflin Street
