Contract Name  
 Tenney Park Pavilion

Change Order No. CO 1  
 Contract No. 6308  
 Project No. 53W0771  
 Change Order Project No.

Change Order Description  
 Overexcavate poor soil conditions under structural concrete footing areas and install clear stone foundation base material.

DESCRIPTION: Mass Undercutting - Proposed Alternate - Version 3

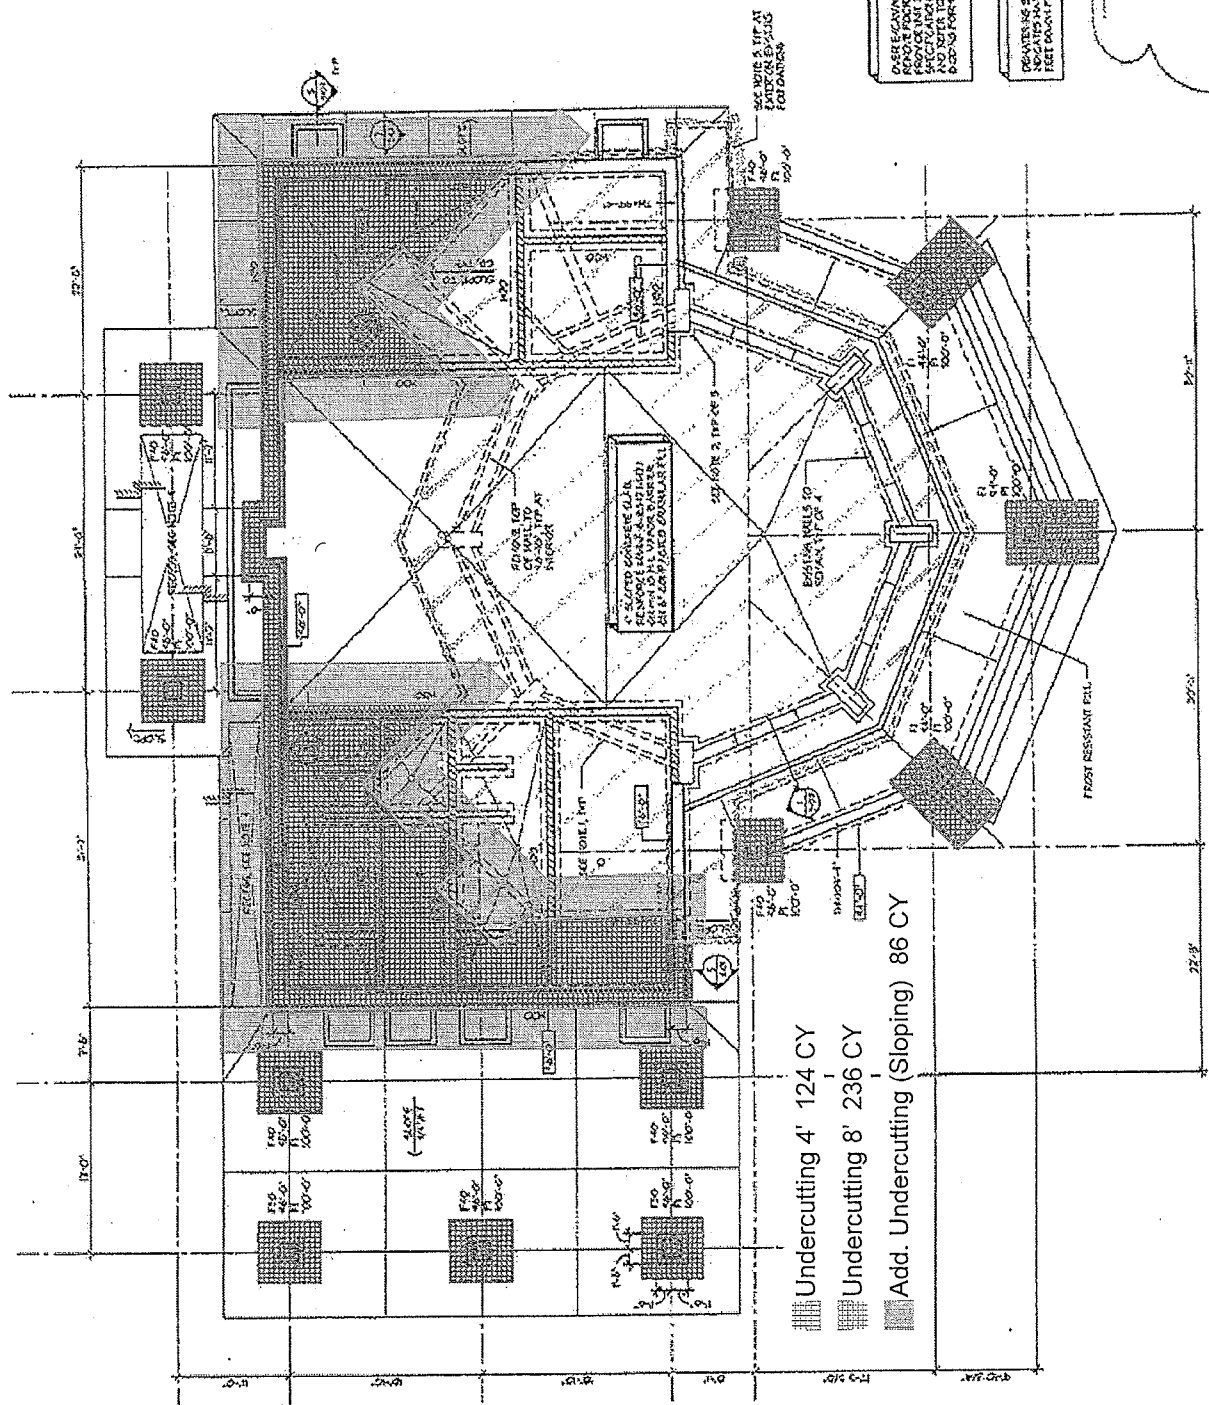
1 FOUNDATION PLAN  
 SCALE: 1/8" = 1'-0"

DESCRIPTION	QTY	UM	HRS	UNIT LABOR	UNIT MAT	LABOR	MATERIAL & EQUIP	SUB QUOTES	TOTALS
<p>Undercut existing subgrade per CGC field report #1 dated 4/12/2011 and A&amp;O proposed undercutting drawing (\$100) dated 4.29.2011 . Includes 446 CY of additional undercutting including sloping per attachments.</p> <p>Any additional undercutting beyond this scope of work will be billed at the following unit prices plus mark-up for overhead and profit.</p> <p>Excavation Cut - \$16/CY            Fabric - \$3/SY            3" Clear Stone - \$14/Ton            Sand Backfill - \$12./Ton</p> <p>Includes Type 1 dewatering per construction documents (C2.0) Note 9. If Type 2 or additional dewatering is required it will result in additional charges.</p> <p>General Conditions adjustment for adding (7) days to project duration. As a result of the unforeseen soil conditions, we stand to lose (15) days from the current project schedule if work cannot commence until 5/9/2011. To account for the additional work in this change order, (7) days need to be added to the project schedule.</p>							\$4,280	\$20,802	\$20,802
