ANALYSIS OF WATER QUALITY MEMO

Madison Water Utility
Madison, Wisconsin
119 East Olin Avenue
Madison, WI 53713

December 6, 2010

To: Al Larson
From: Steve Gaffield (Montgomery Associates) and Ken Quinn (RMT)
Date: December 6, 2010
cc: Paul Boersma, Black & Veatch
Re: Analysis of water quality data for East Side Master Plan

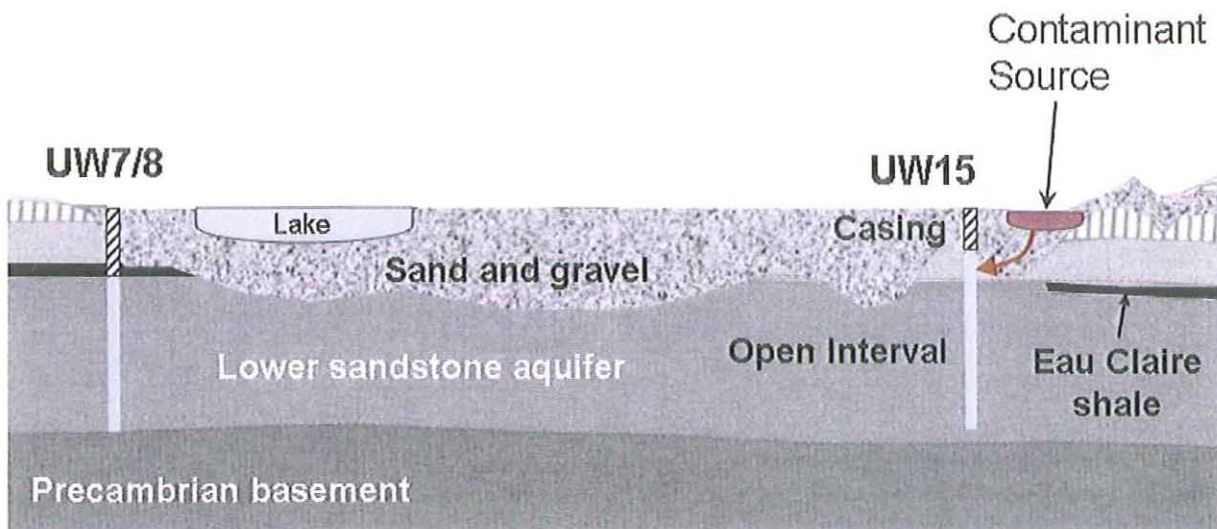
The Madison groundwater system includes two bedrock aquifers, the shallow sandstone and deep sandstone, which are separated in much of the City by the Eau Claire Shale (**Figure 1**). This thin shale layer has a very low permeability and helps protect the deep aquifer from contamination that originates near the land surface. This protection is incomplete, however, because the shale is not completely impermeable; it is missing in some locations, such as below the lakes; and some wells are open to both the shallow and deep sandstone aquifers, creating a conduit between the aquifers.

The elevations of the open well interval and of the Eau Claire Shale were compiled from available data from the WGNHS and WDNR (Table 1). This data indicates that UW7 and UW8 are open only to the lower aquifer, although the UW7 casing appears to only partially penetrate the Eau Claire Shale. Although the Eau Claire Shale is present at UW7 and UW8, it is believed to be missing nearby under Lakes Mendota and Monona, where the bedrock surface has been eroded below the level of the shale (Figure 1).

Figure 1. Conceptual geologic cross section showing construction of UW7, UW8 and UW15. Not to scale.

Based on the well construction, hydrostratigraphic and chloride data discussed above, UW15 does not appear to be protected by a confining unit between the shallow and deep sandstone aquifers. This creates a direct connection to shallow groundwater and susceptibility to contaminants that originate near the land surface (Figure 1).

- Extending either well's casing deeper would probably not significantly improve the Fe and Mn concentrations, because the wells are already cased through the Eau Claire Shale. If the Fe and Mn concentrations are related to induced flow from the lakes, however, there could be some benefit to extending the casing and creating a longer flow path from the lakes to the well.

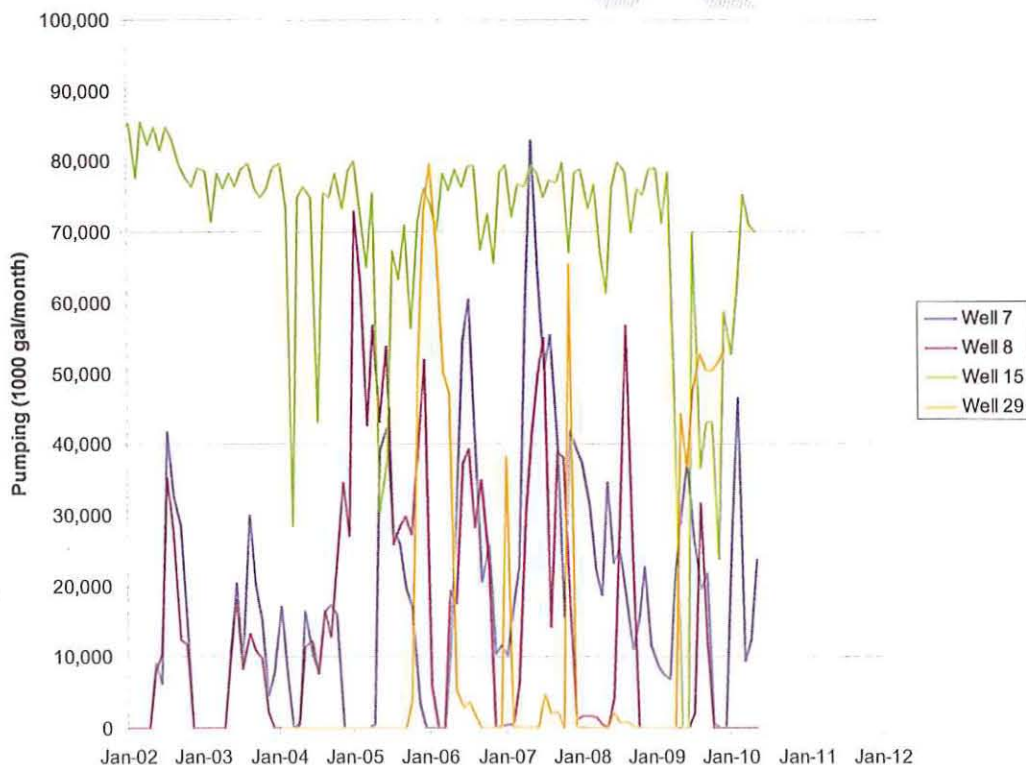
Monthly pumping rates are plotted in **Figure 2** for January 2002 through mid-2010. Pumping rates are highly variable from month to month due to seasonal operation differences, down time for maintenance, and other factors. This variability makes long-term trends somewhat difficult to identify. Smoothing the data by computing the average of the previous 6 months of pumping (i.e. a 6-month moving average) more clearly shows these patterns (**Figure 3**). Note that pumping of UW7 has been relatively steady, except for a period of higher pumping in 2007 and 2008; pumping of UW8 has declined over the past 5 years; UW15 has typically been pumped at a higher rate than UW7, UW8 and UW29; UW15 had 2 periods of decreased pumping in 2005 and 2009; and pumping of UW29 has markedly increased since 2009 after its Fe and Mn filtration system went on-line.

Figure 2. Monthly pumping rates for UW 7, 8, 15 and 29 for January 2002 through mid-2010.

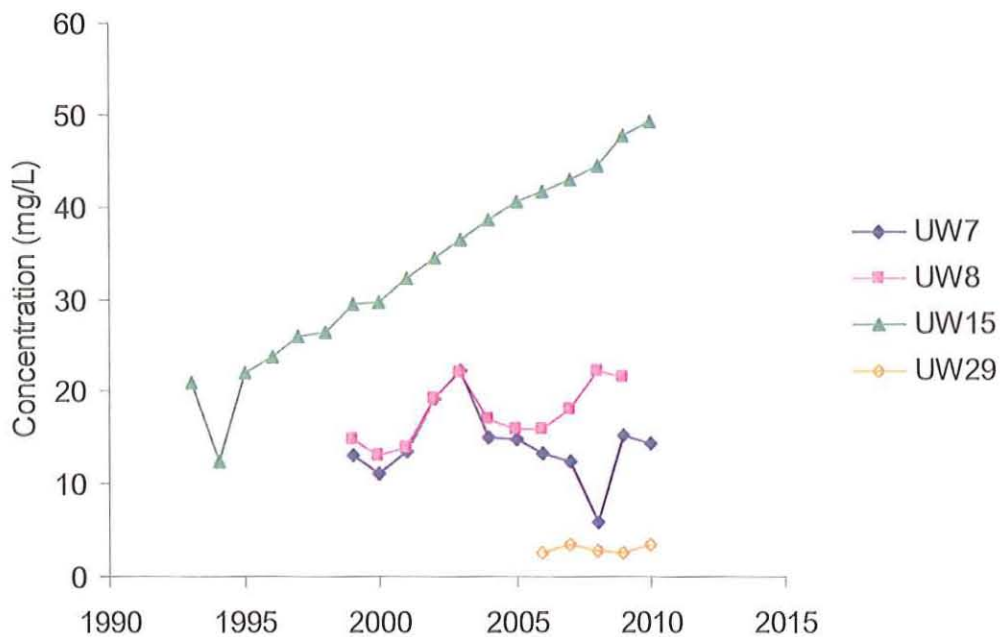
Winter use of road salt has led to an increasing trend in chloride levels in Madison-area lakes for the past several decades (Figure 4). This trend has also been observed in the groundwater in some of the MWU's unit wells. This effect of road salt on the groundwater demonstrates the interaction between the surface and Madison's aquifers. Road salt can reach the aquifer through either direct recharge of water containing road salt, rainfall percolation through soil that contains residual road salt, or recharge of surface water containing road salt. Figure 5 shows chloride trends in Unit Wells 7, 8, 15 and 29 since the 1990s. Unit Well 29 is open only to the deep aquifer and has very low chloride concentrations. In contrast, UW15 has experienced a persistent increase in chlorides since at least 1993. The concentration is currently about 50 mg/L and increasing at a rate of about 2 mg/L per year. If it maintains this trend, it would require many years to exceed chloride's secondary drinking water standard (250 mg/L). However, the increasing chloride trend indicates that UW15 is susceptible to contaminants in the shallow aquifer, consistent with the increasing trend in PCE concentrations discussed later in this report.

Chloride levels in UW7 and UW8 are slightly elevated, but lower than the current concentrations in the Madison lakes. Concentrations have fluctuated during the past decade with no clear trend. It appears likely that UW7 and UW8 are pumping some water from the shallow aquifer and/or lakes, with dilution by groundwater with lower chloride levels from the deep aquifer.

Figure 5. Chloride trends in UW7, 8, 15 and 29

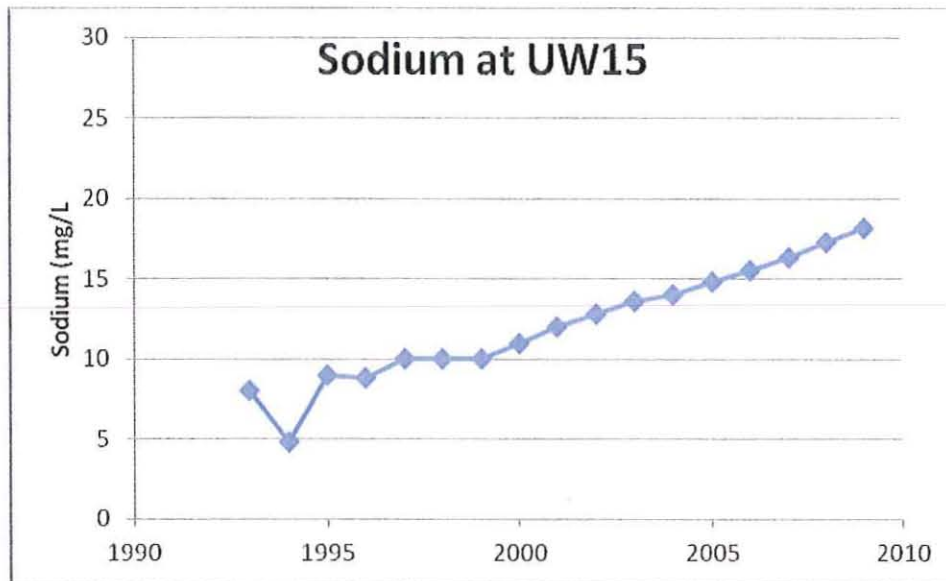
Changes in sodium in groundwater are also associated with road salt affects on Madison's aquifers. While there is no MCL for sodium, the United States Environmental Protection Agency has issued a health-based drinking water guideline of 20 mg/l or less for individuals with a restricted sodium diet, and a concentrations exceeding 30 to 60 mg/L can create a taste issue¹. The sodium concentration in UW15 is approaching this EPA guideline of 20 mg/L (Figure 6).

Figure 6. Sodium trend in UW15.

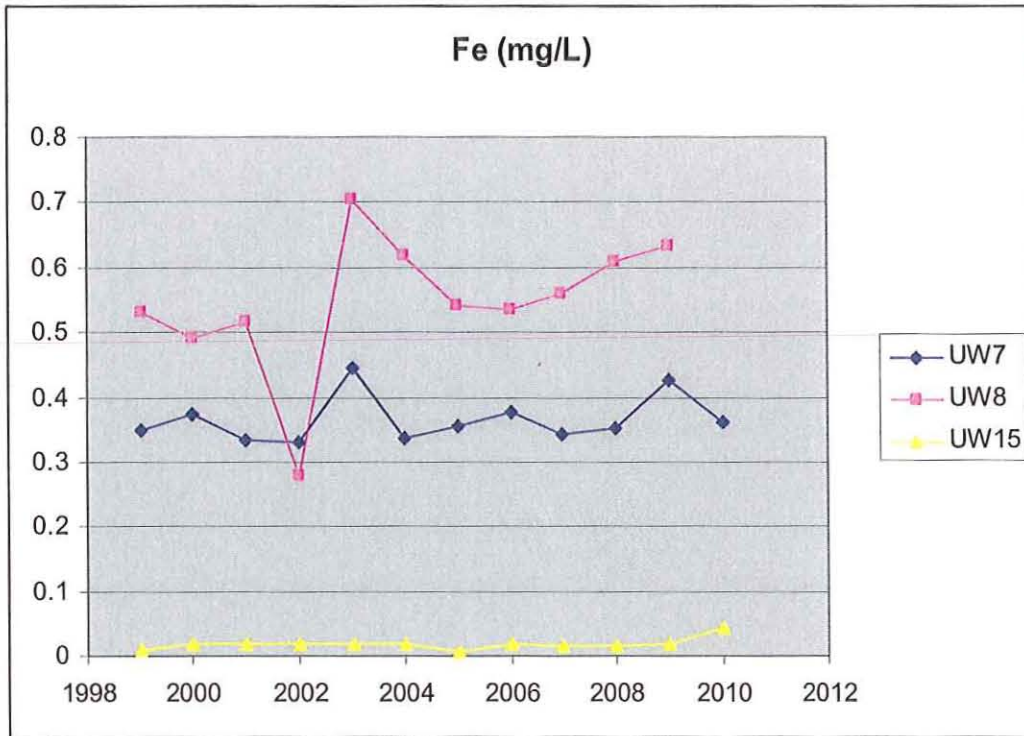
The Madison Water Utility collects water quality samples at least annually from each of its unit wells. Annual data for iron (Fe) and manganese (Mn) in Unit Wells 7, 8 and 15 are plotted in Figures 7 and 8. In addition, samples were collected each month for four years from 2006 – 2009; these results are plotted in Figures 9 and 10. Since 1999, a weak upward trend in Fe and Mn concentrations is apparent at UW8. No obvious trend is visible for UW7 or UW15. Unit Well 15 has much lower Fe and Mn than UW7 and UW8.

The probable cause of the difference in Fe and Mn between UW7/UW8 and UW15 is differences in the groundwater chemistry. Specifically, reducing conditions are present in the aquifer near UW7/UW8 and not at UW15. Under reducing conditions, Fe and Mn dissolve from the bedrock of the aquifer. The MWU does not routinely test for redox potential, however the MWU's sampling for nitrate, Mn, Fe, and SO₄ provides a very good indication of redox conditions. For example, nitrate has consistently not been detected in UW7 and UW8, where reducing conditions presumably have converted this aerobic species to a reduced species (e.g., ammonia or nitrogen gas). The nitrate concentrations at UW15 reflect surficial conditions, with a concentration of around 2 mg/L.

Figure 7. Annual iron concentrations in UW7, UW8 and UW15.

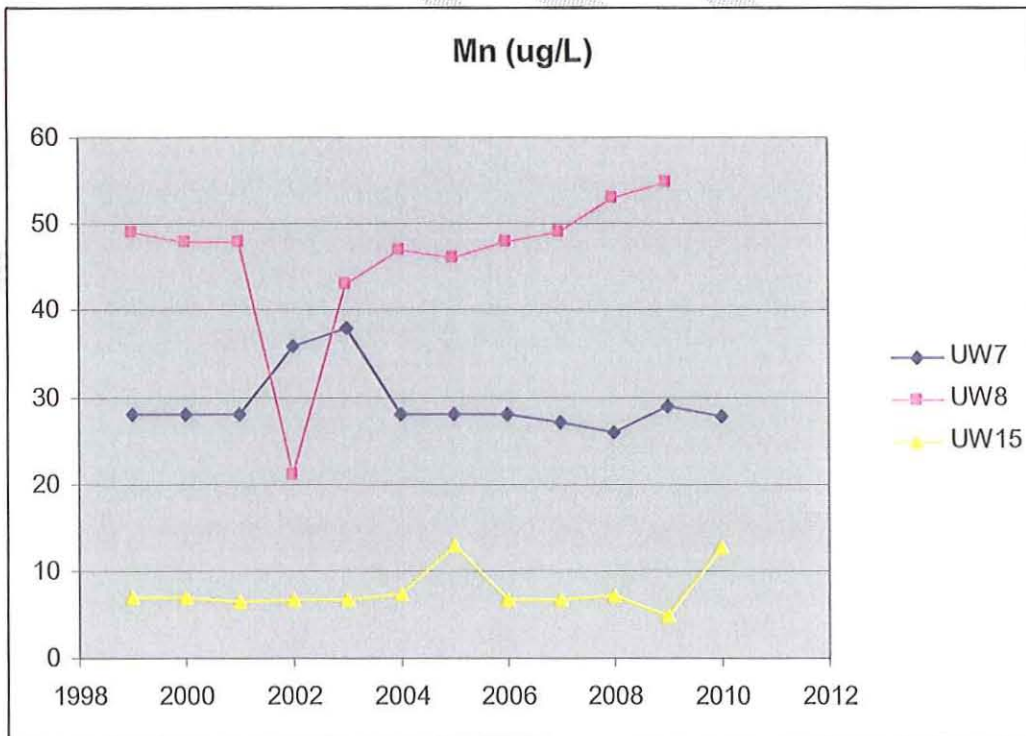
Figure 8. Annual manganese concentrations in UW7, UW8 and UW15.

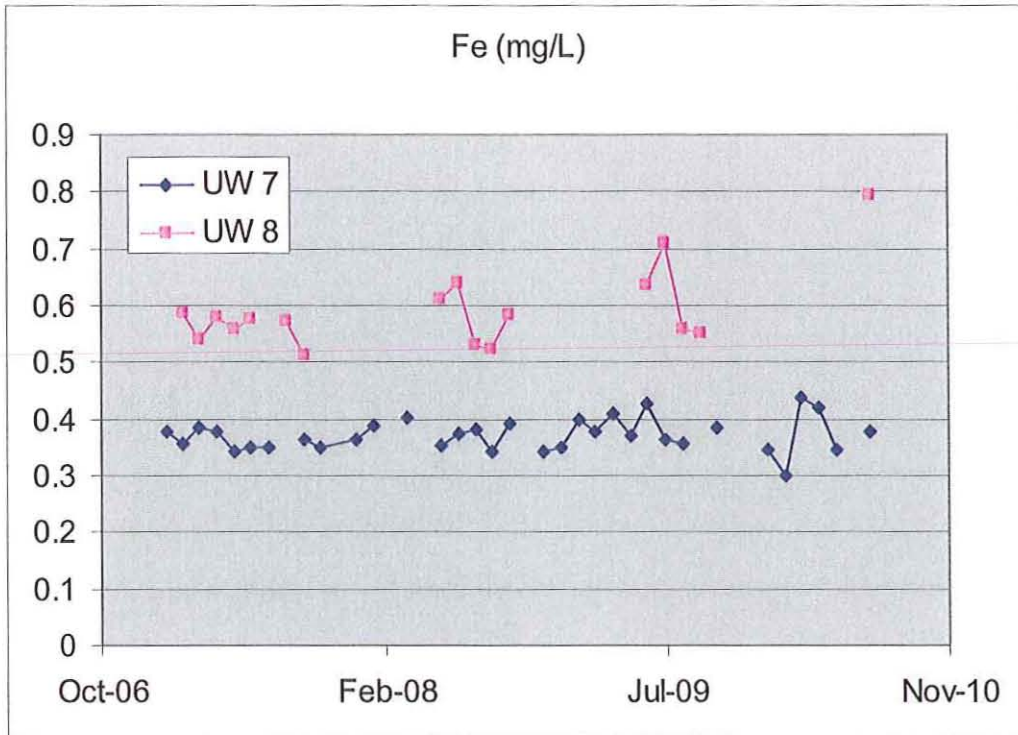
Figure 9. Monthly iron concentrations in UW7 and UW8.

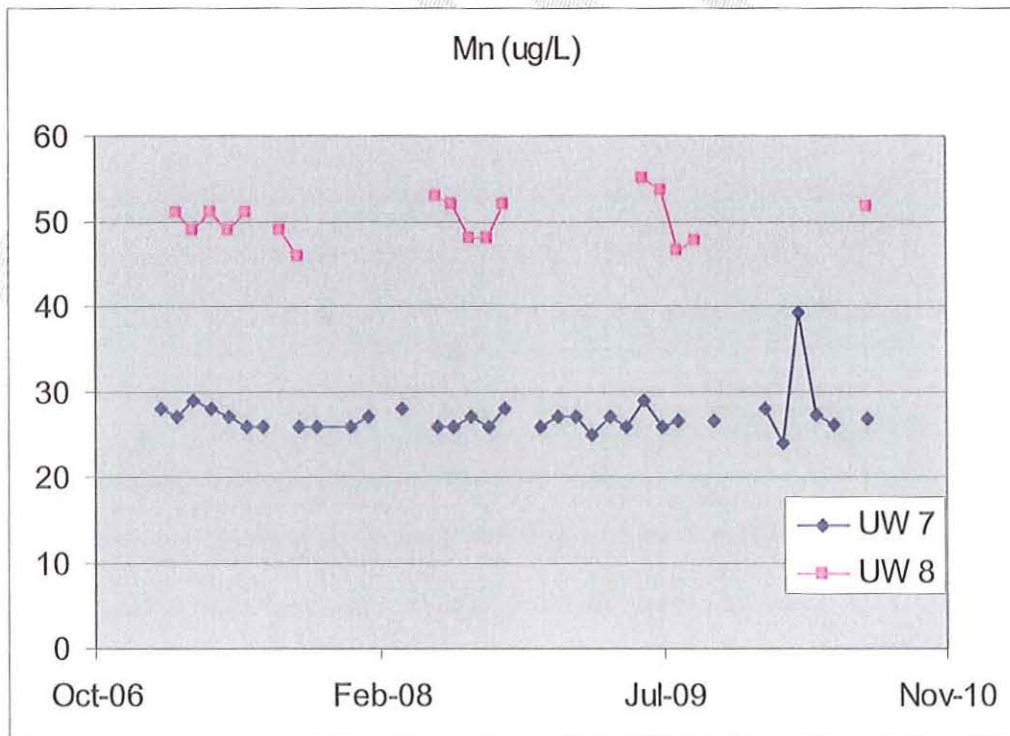
Figure 10. Monthly manganese concentrations in UW7 and UW8.

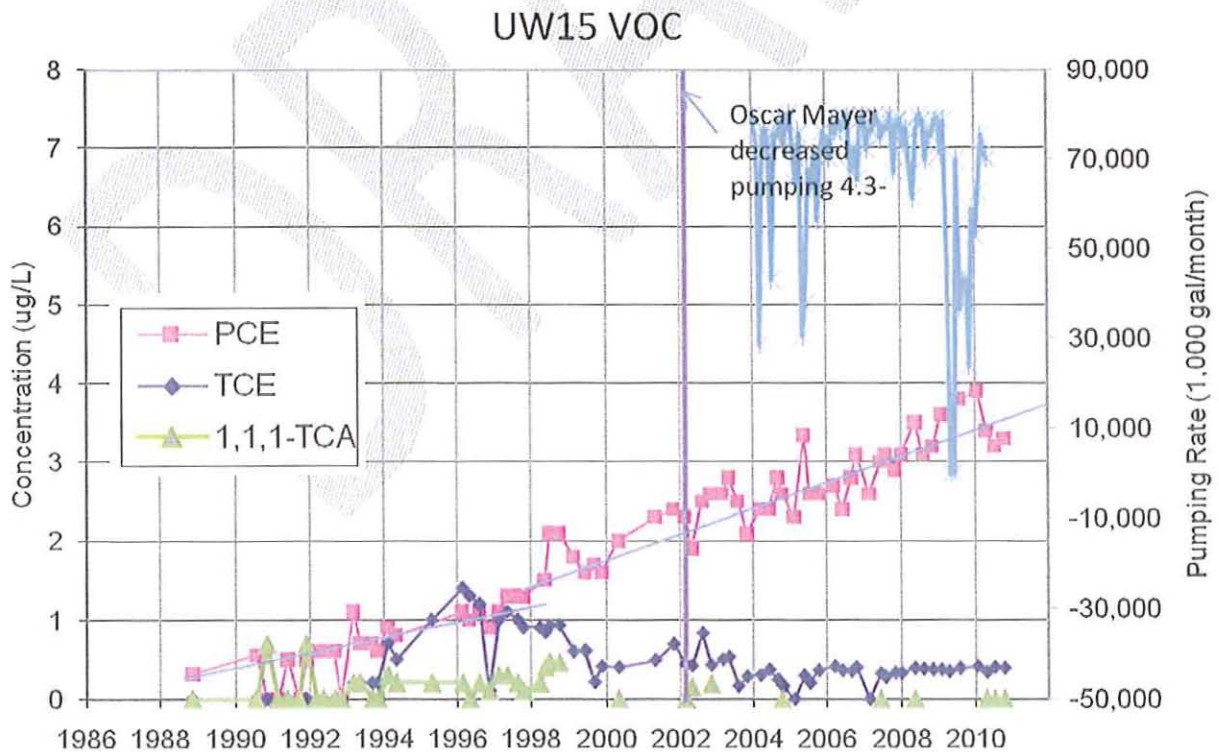
VOCs have been present since monitoring began in the late 1980s, as shown in Figure 11. Initial VOCs detected were PCE, TCE, and 1,1,1 TCA. In 1996, the TCE concentration started to decline and has leveled off at 0.33 ug/L in the last several years. This concentration is a small fraction of the 5 ug/l Maximum Contaminant Level (MCL), which is the concentration considered by the EPA acceptable for drinking water. The 1,1,1-TCA has always been low relative to its MCL (200 ug/L) and has very generally followed the TCE trend, in that it has decreased over the last decade.

Figure 11. Volatile Organic Compound concentrations in UW15. Pumping rate shown in light blue.

The PCE concentration has an upward trend since monitoring started in November 1988. The trend is shown as two separate trend lines on **Figure 11**. From November 1988 through about May 1996, the PCE trend was similar to that for TCE, increasing at a relatively slow rate. From about May 1996 through October 2010, the rate of concentration increase has been slightly higher. If the recent trend continues, PCE will exceed the 5 mg/L standard within the next year or two.

Between 2004 and 2010, UW15 has had two periods of time of decreased pumping rate³ of more than one month duration, in approximately May through June 2005 and April 2009 through February 2010. During both of these periods, it appears that the PCE concentration at UW15 increased above the trend line. These increases have been small (less than 1 ug/L), but they are significant with respect to the change that would exceed the MCL (i.e., from about 3 ug/L to 5 ug/L). These small increases appear to be temporary, potentially because of the short-term reduction in pumping rate. A correlation between lower pumping rate and increased PCE concentration at UW15 would suggest that the PCE:

- It may be possible to manage PCE concentrations by:
 - Maintaining a relatively high average monthly pumping rate to dilute the PCE; or
 - Extending the casing deeper to draw less shallow groundwater and more water from deeper parts of the aquifer.
