Madison Landmarks Commission APPLICATION

Project Title / Description: Chabad House-Jewish Student Center - Expansion

CHABAD HOUSE JEWISH STUDENT CENTER – Addition and Renovation
223 and 219 West Gilman
Madison, Wisconsin

Re: 219 Gilman Street Evaluation

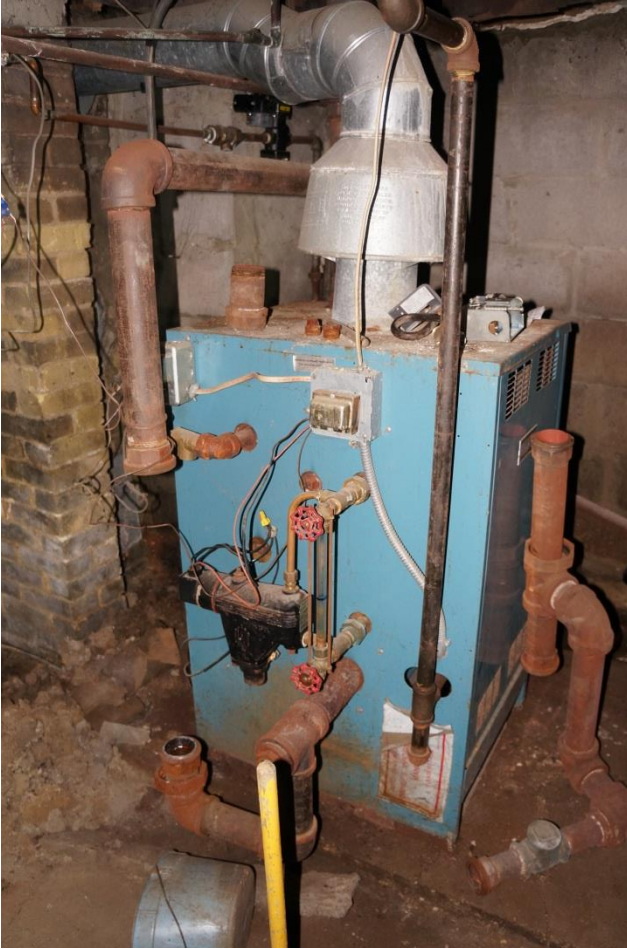
1. Basement – Boiler

The existing systems were not reviewed but the owner indicated the boiler and the water heater were fairly new. The boiler feeds old radiators with a one pipe system. This system is operational but the overall condition is not known. The electrical system is likely a combination of old knob and tube wiring and recent conduit and romex cable wiring. A small panel board is located in the basement. This is fed from an electrical meter and service entrance on the north exterior wall. The plumbing system is vintage 1900 with modification to accommodate the added bathrooms. The existing mechanical, electrical and plumbing systems are functional and apparently somewhat code compliant. These systems were not reviewed in detail. The age and state of maintenance of the equipment indicates upgrades and replacement that are not too far in the future.

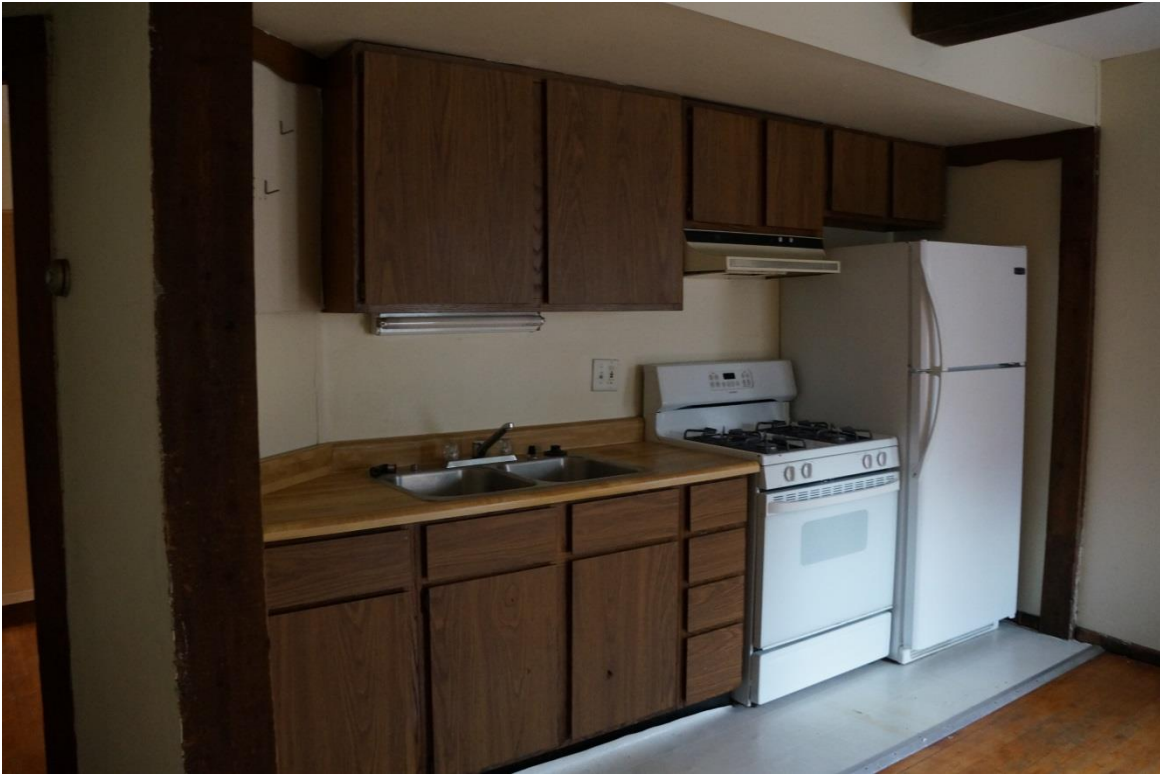
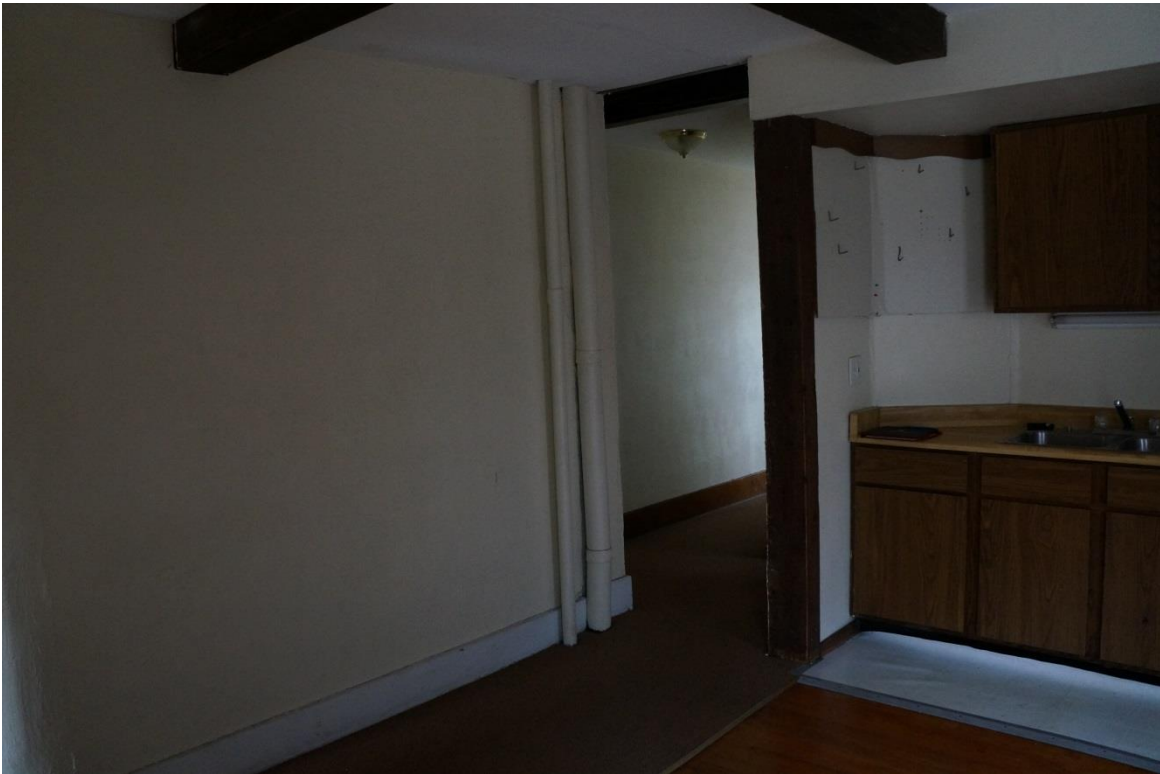
4. Kitchen 1

The kitchen has some contemporary low budget cabinets, laminate counter tops and vinyl floor. The bathrooms are typically in poor to fair condition with leaks present and the need for constant caulking and minor repairs very evident. Water leakage is anticipated to be causing deterioration of adjacent wood framing in every bathroom observed.

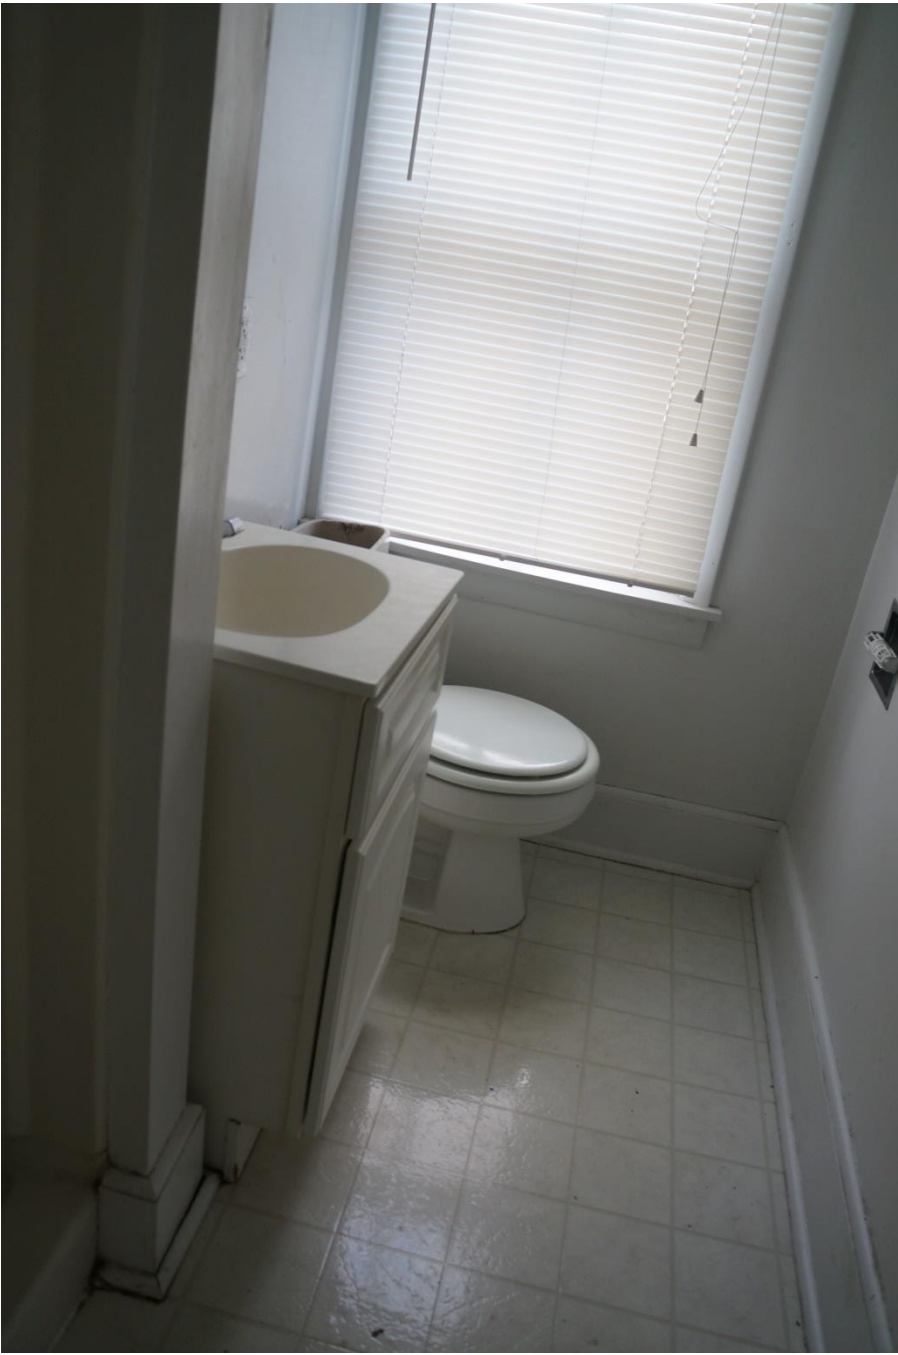
6. Interior – Bathrooms

A bathroom was added on second floor. This includes a toilet, small corner sink and plastic freestanding shower stall. The flooring here is vinyl. This is in poor condition. The plaster walls are in poor condition. Some areas have been poorly patched with dray wall pieces. The plaster ceiling is in fair condition with many observed cracks. The kitchen and bath on this level are in good to fair condition.

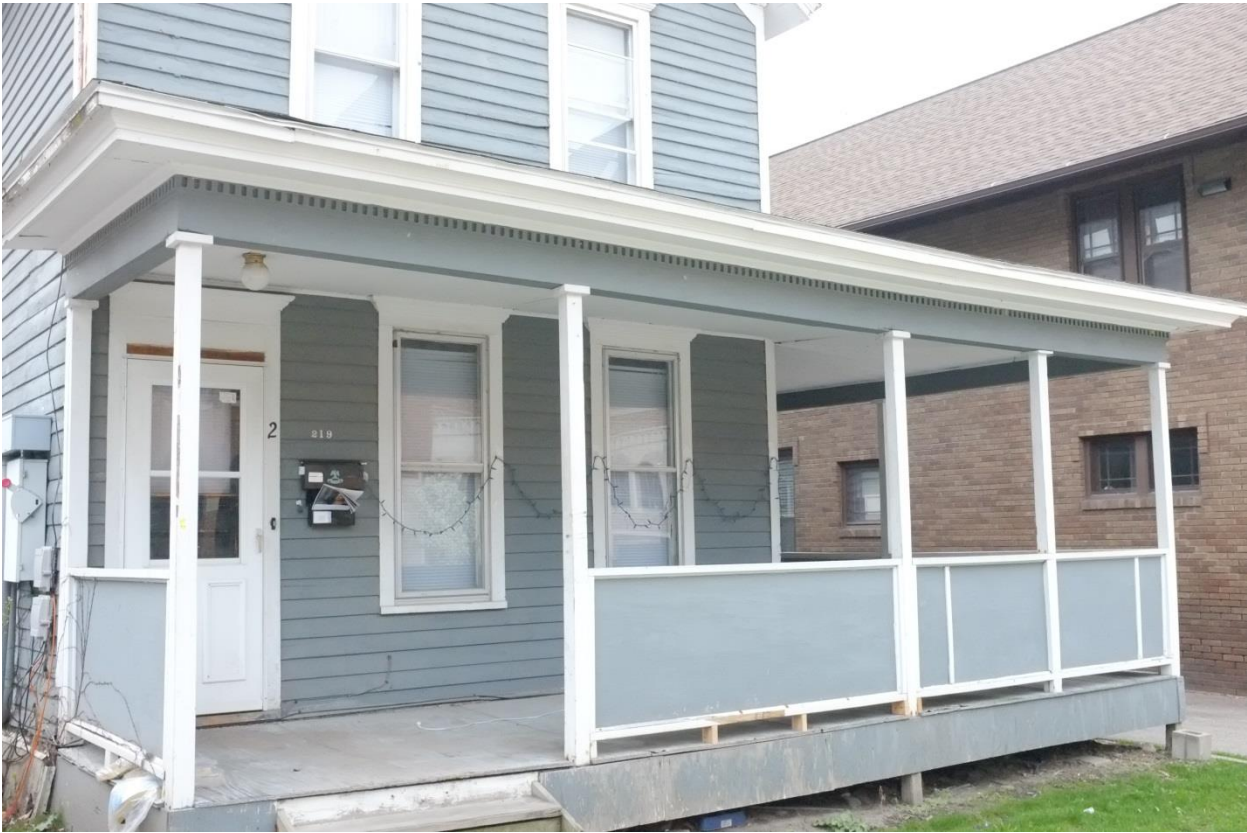
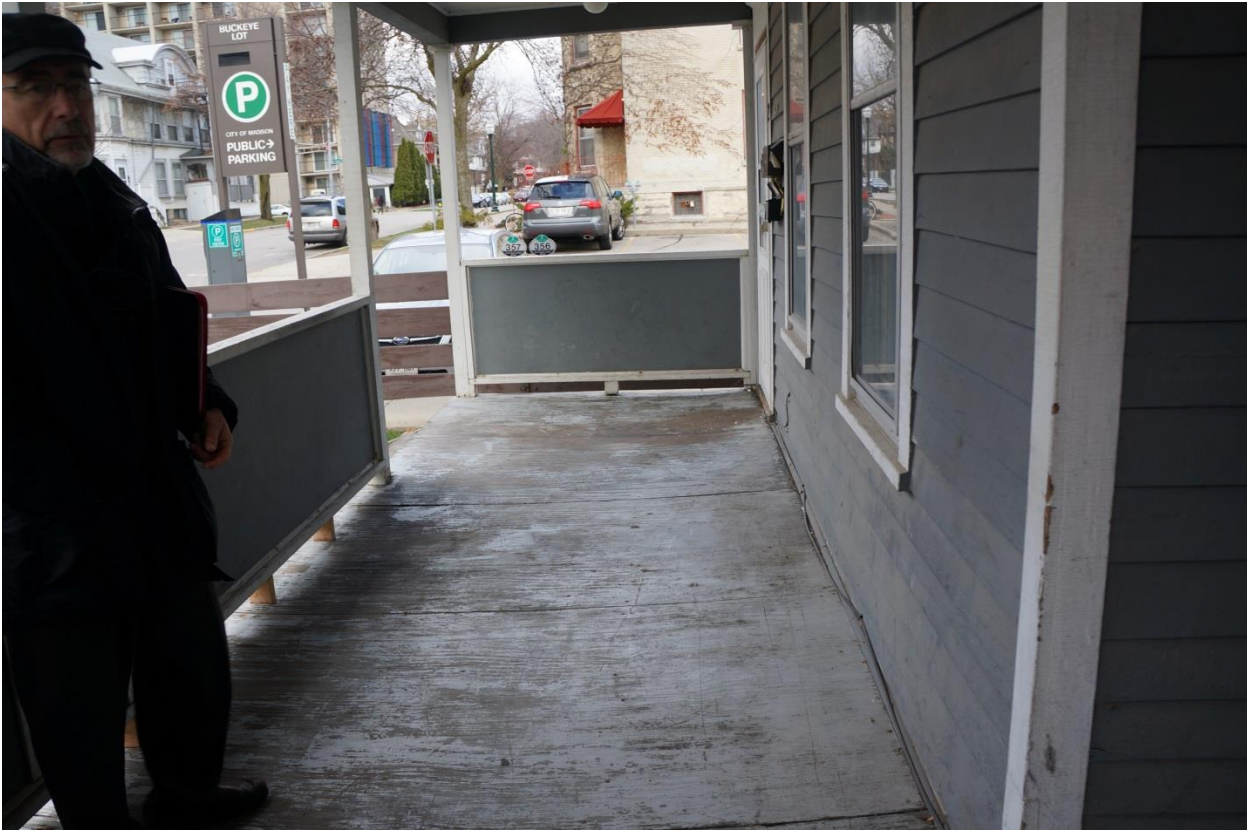
10. Front Porch

The porch roof is a newer asphalt-fiberglass 3-tab shingle with old flashing at the clapboard wall. Overall this is in good condition and functional. The roof of the bay is an asphaltic membrane material that appears to be applied over the original tin roof. This is deteriorated and near the end of serviceable life but currently weather tight.

The porch floor framing is spongy and is sagging. This framing is quite close to grade and may have deterioration in the members. The plywood decking is not a proper material for the top surface of the deck. This type of decking can actually trap moisture in the wood framing and accelerate the deterioration process.

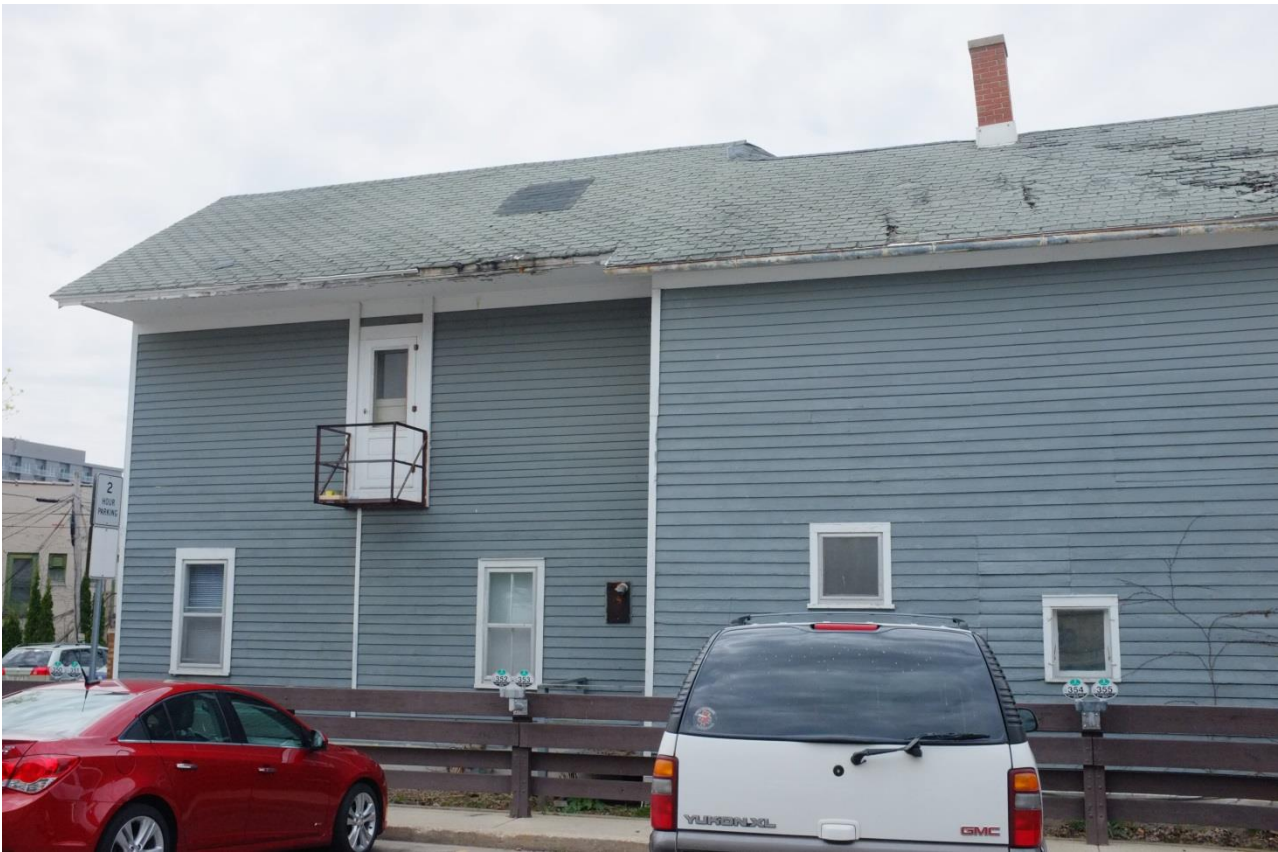
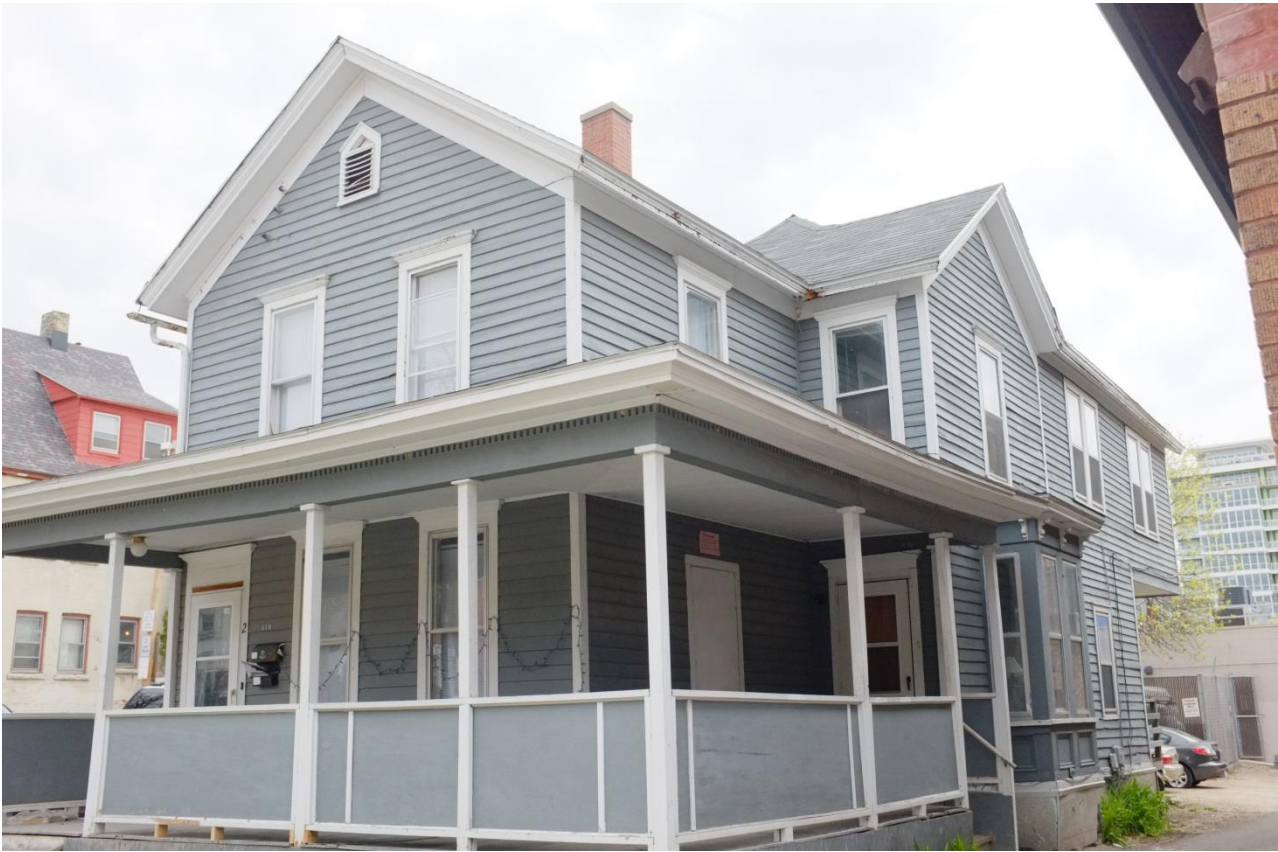
11. Exterior - Existing

The house is sheathed in wood clap boards with an average 4” exposure, 4” corner trim and 7” window heads. Much of the wood siding is original and is in fair to poor condition with failing paint, multiple splits, openings and cracks. Corner boards and window trim are in generally good condition. The horizontal wood trim and banding is generally in poor condition. Overall the exterior walls no longer provide an effective weather barrier.

Much of the original ornament and detail has been removed from the house, but remnants of the original may be found on the bay. Brackets, panels and decorative banding are intact here but are in poor condition.

The upper roof is a 3-tab asphalt shingles well past their service life with significant deterioration and delamination. Multiple patches of non- matching shingles are evident. The owner relates that previous roof leaks are now repaired.

The exterior chimney of the house is brick masonry. This appears to be leaning slightly to the east. This is a second generation chimney as the brick and mortar do not look like that of 1800s, local yellow brick. This chimney dates to perhaps the 1950s era of construction. The chimney does have a concrete cap but no drip. Flashing at the roof line appears to be in good condition and functional.

The exterior exhibits significant deferred maintenance issues, serious degradation and deficiencies contributing to building deterioration. Replacement of roof, 25% of siding, 75% of horizontal trim, and rehabilitation of most windows will be necessary as well as adding a vapor barrier and code compliant thermal insulation.
