City of Madison

Proposed Demolition

Location
 219-223 West Gilman Street
 Project Name
 Chabad House Addition and Renovation
 Applicant
 Rabbi Menachem Mendel Matusof-
 Chabad Lubavitch/Hamid Noughani-
 Assemblage Architects

Re: 219 Gilman Street Evaluation

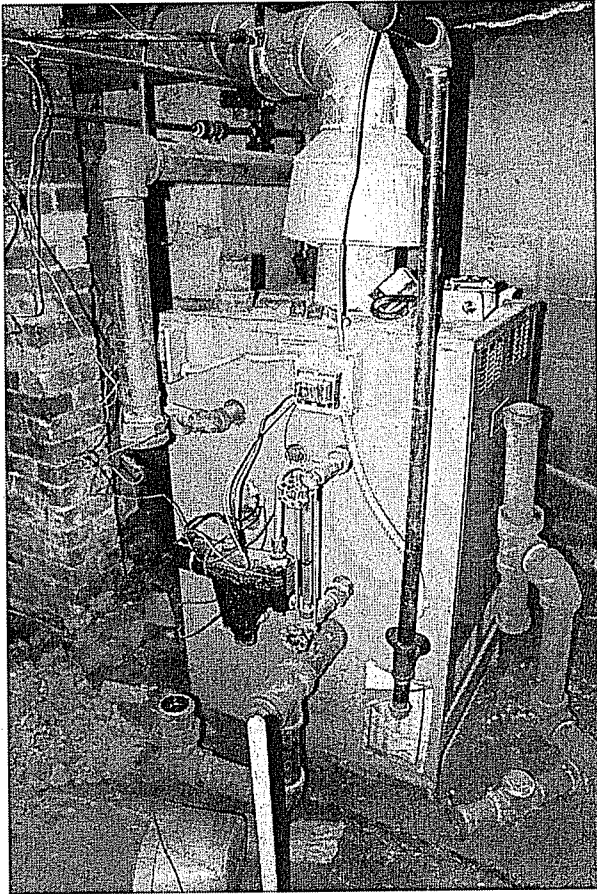
1. Basement – Boiler

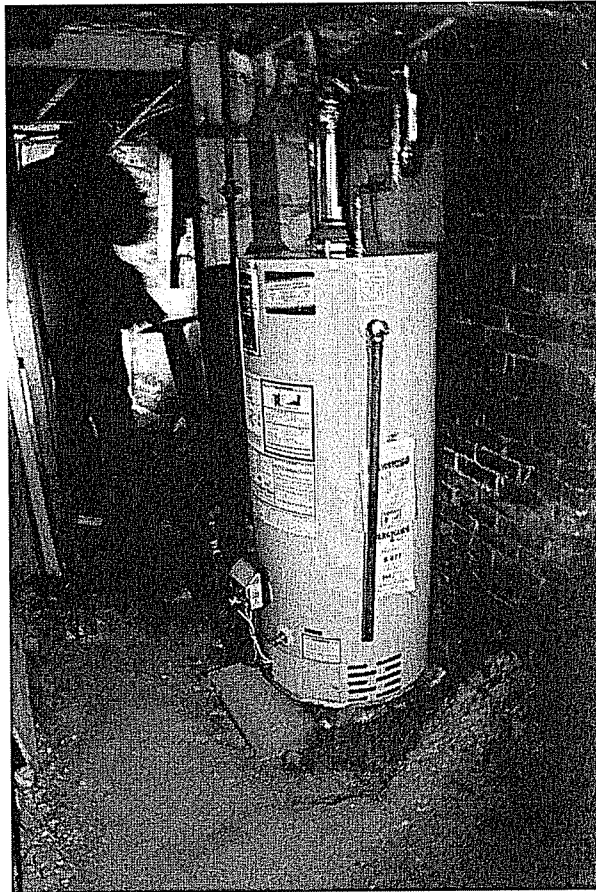
2. Basement – Water Heater

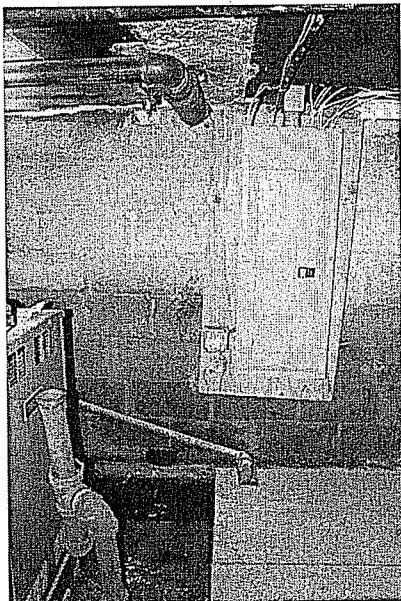
3. Basement – Electrical Panel

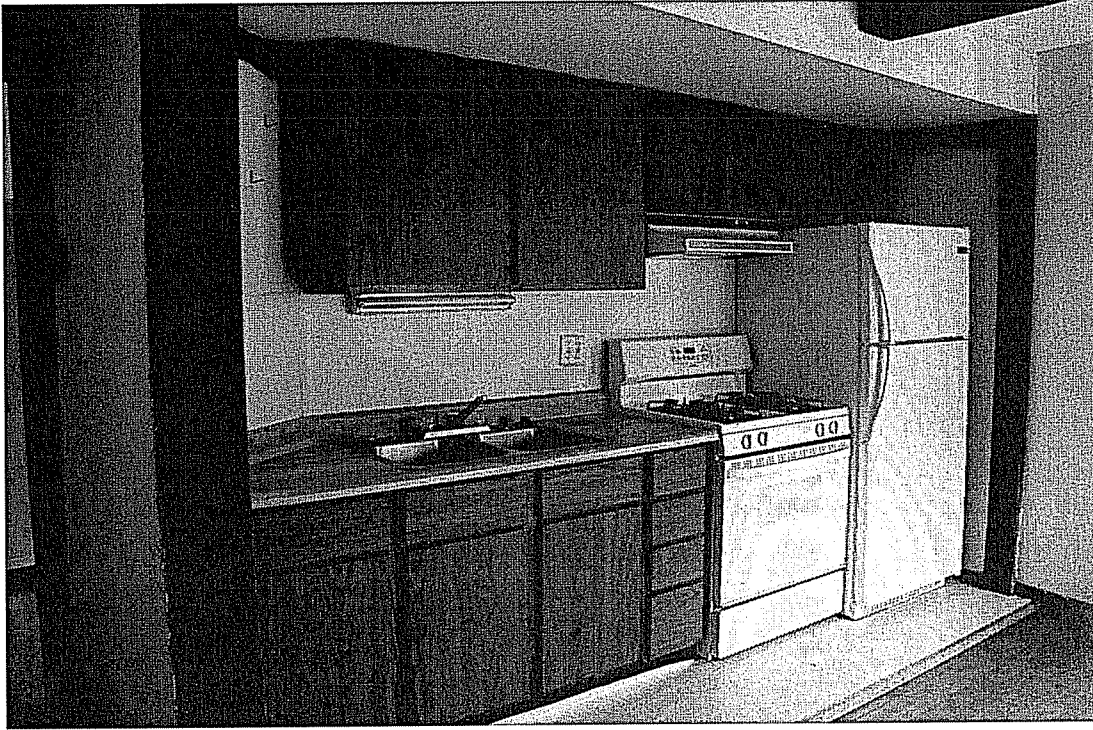
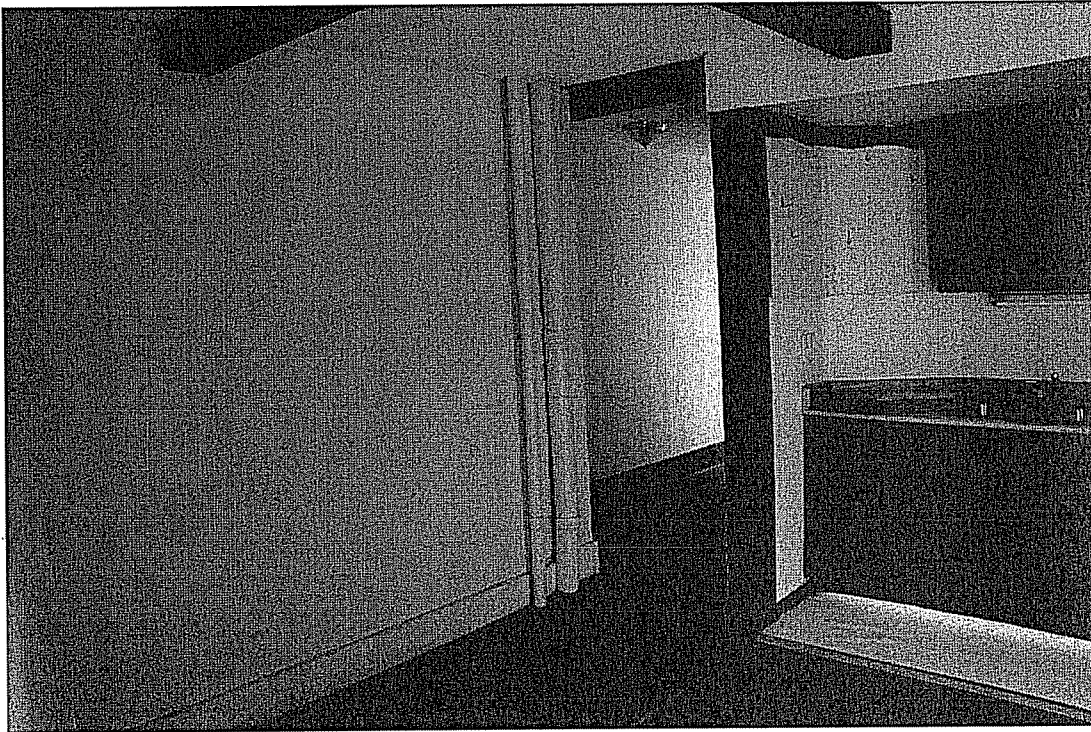
4. Kitchen 1

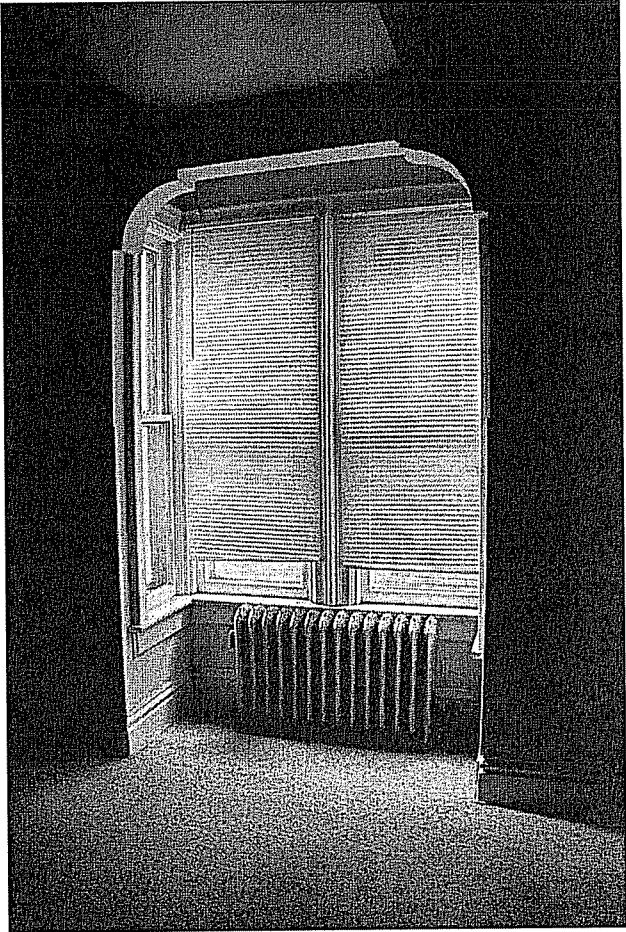
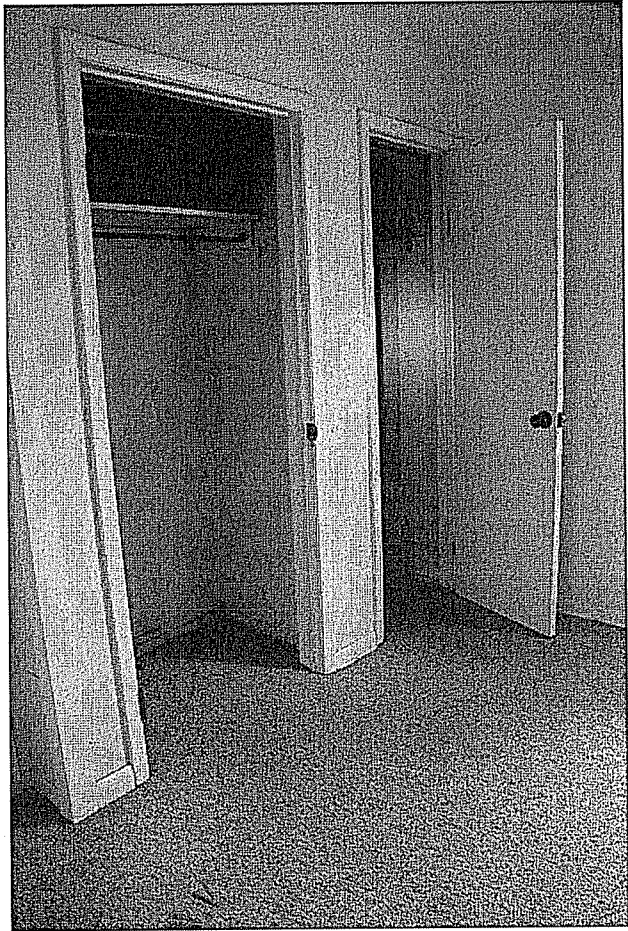
5. Interiors – Typical

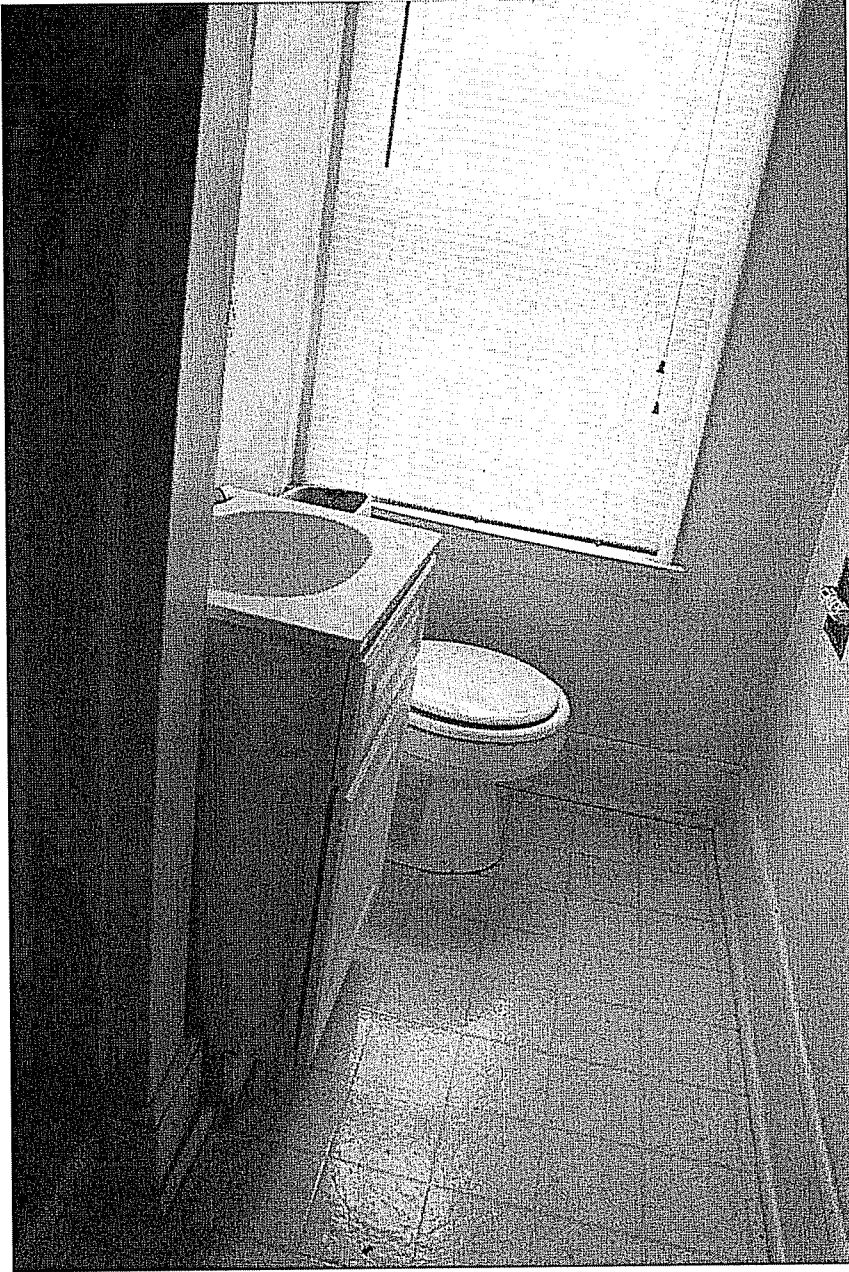
The kitchen has some contemporary low budget cabinets, laminate counter tops and vinyl floor. The bathrooms are typically in poor to fair condition with leaks present and the need for constant caulking and minor repairs very evident. Water leakage is anticipated to be causing deterioration of adjacent wood framing in every bathroom observed.

6. Interior – Bathrooms

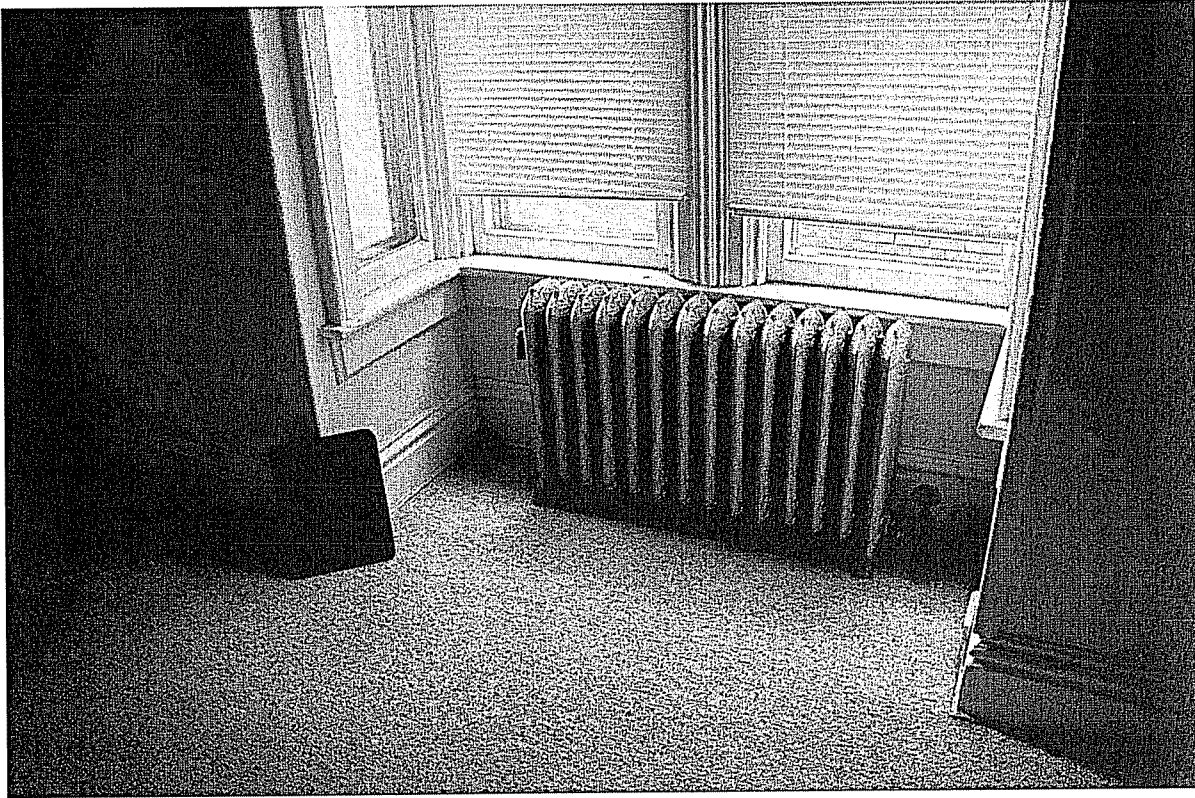
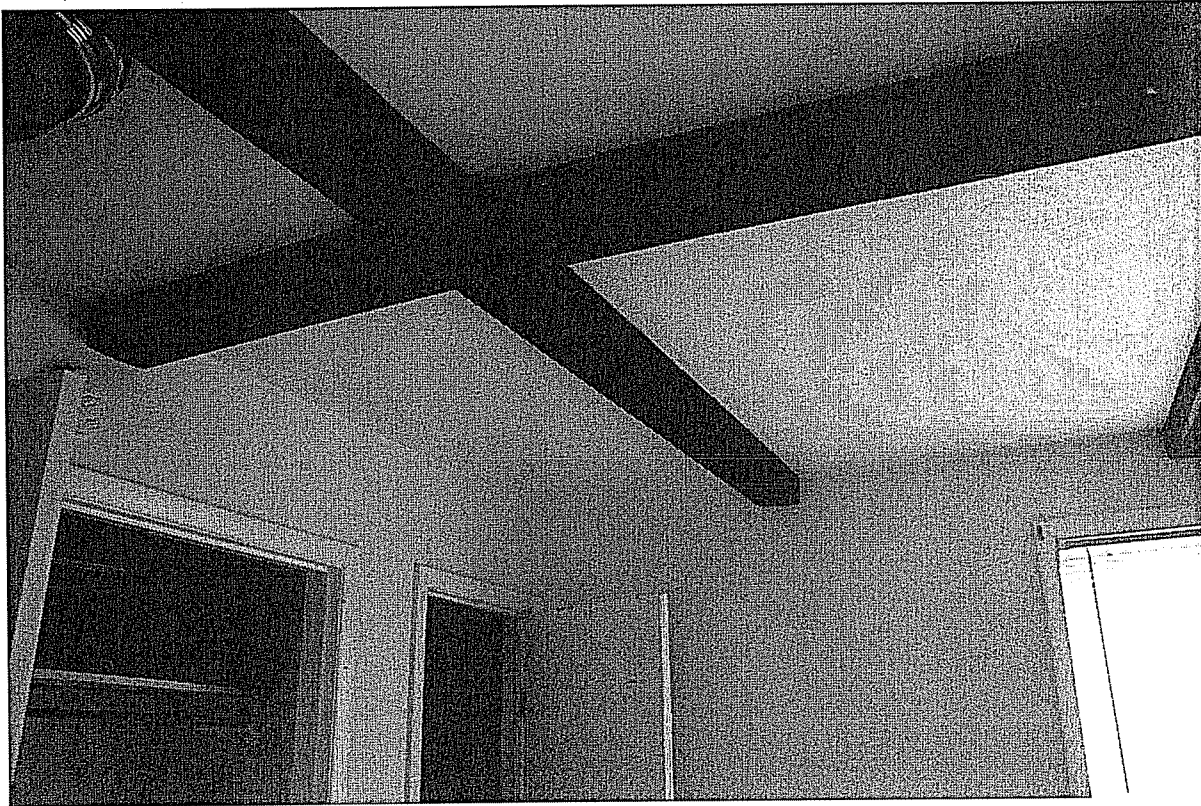
7. Interior – Typical

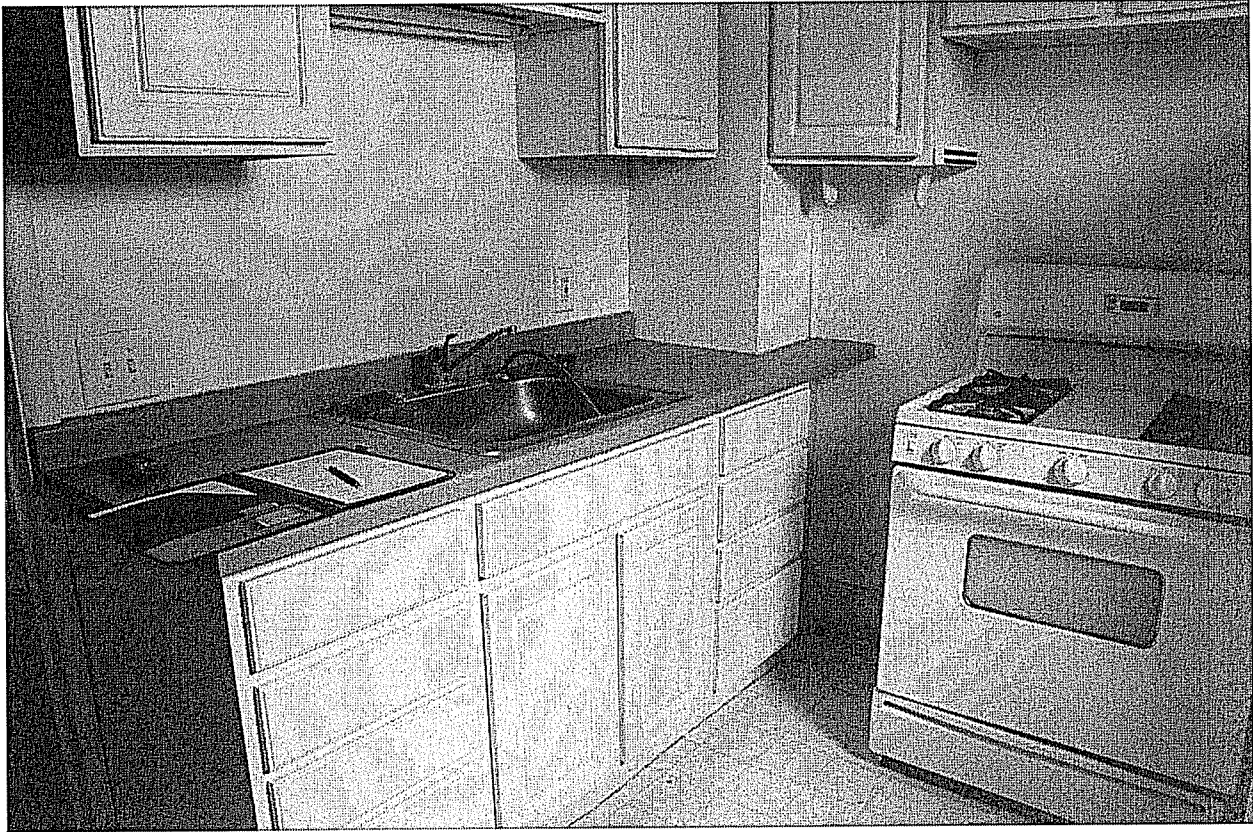
8. Interior – Kitchen 2

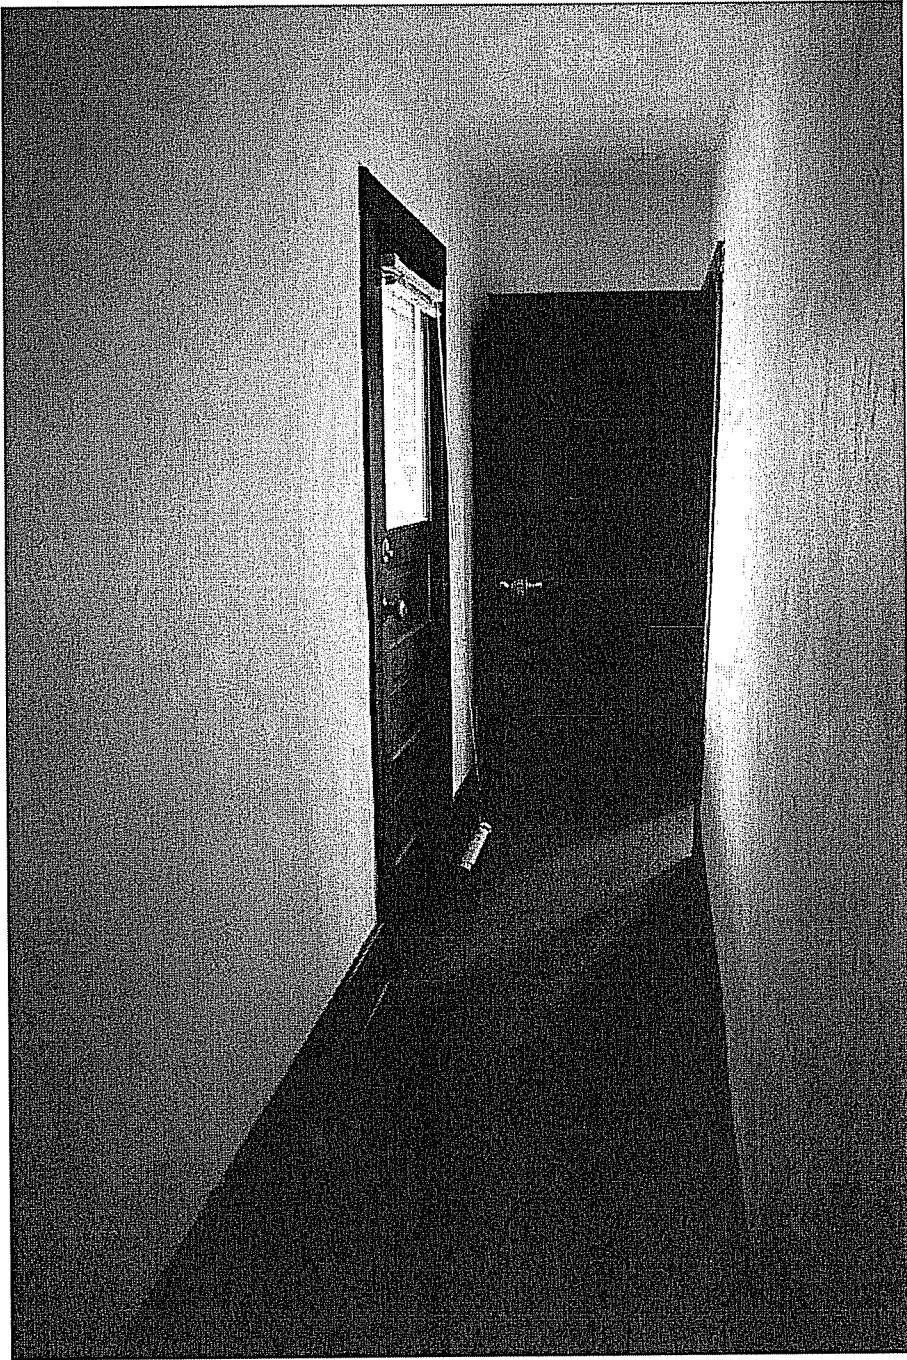
9. Interior – Typical Corridor

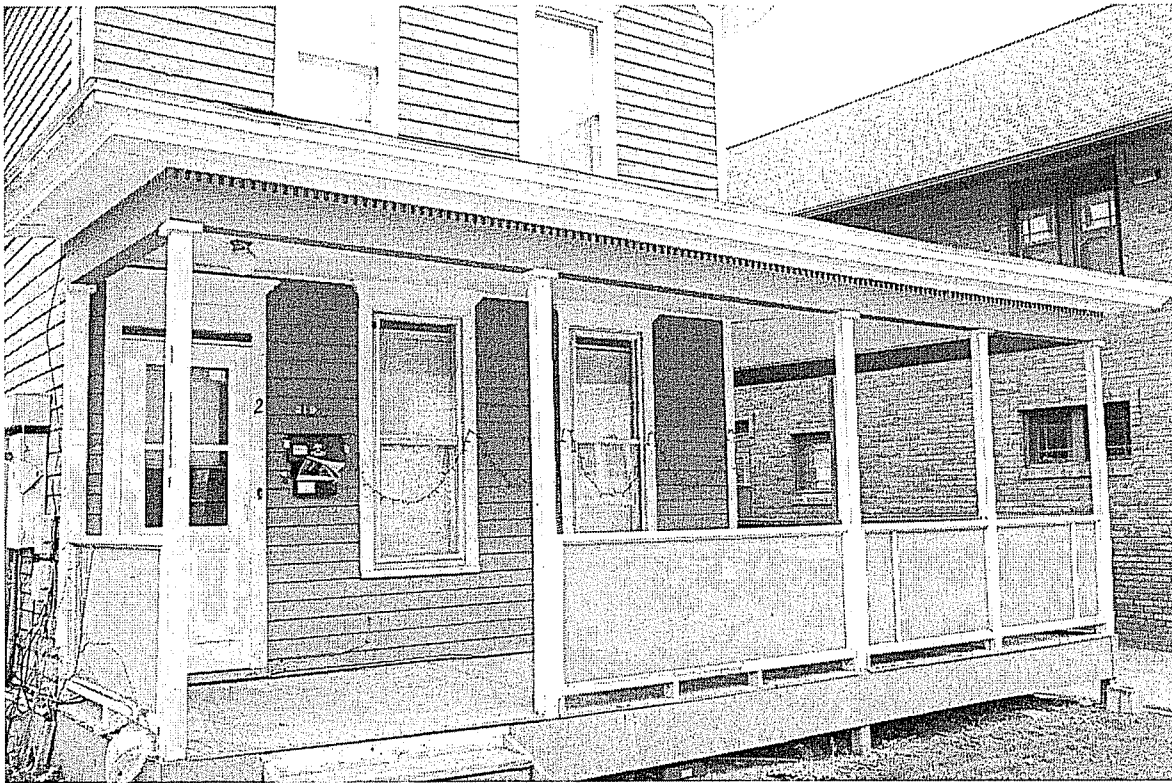
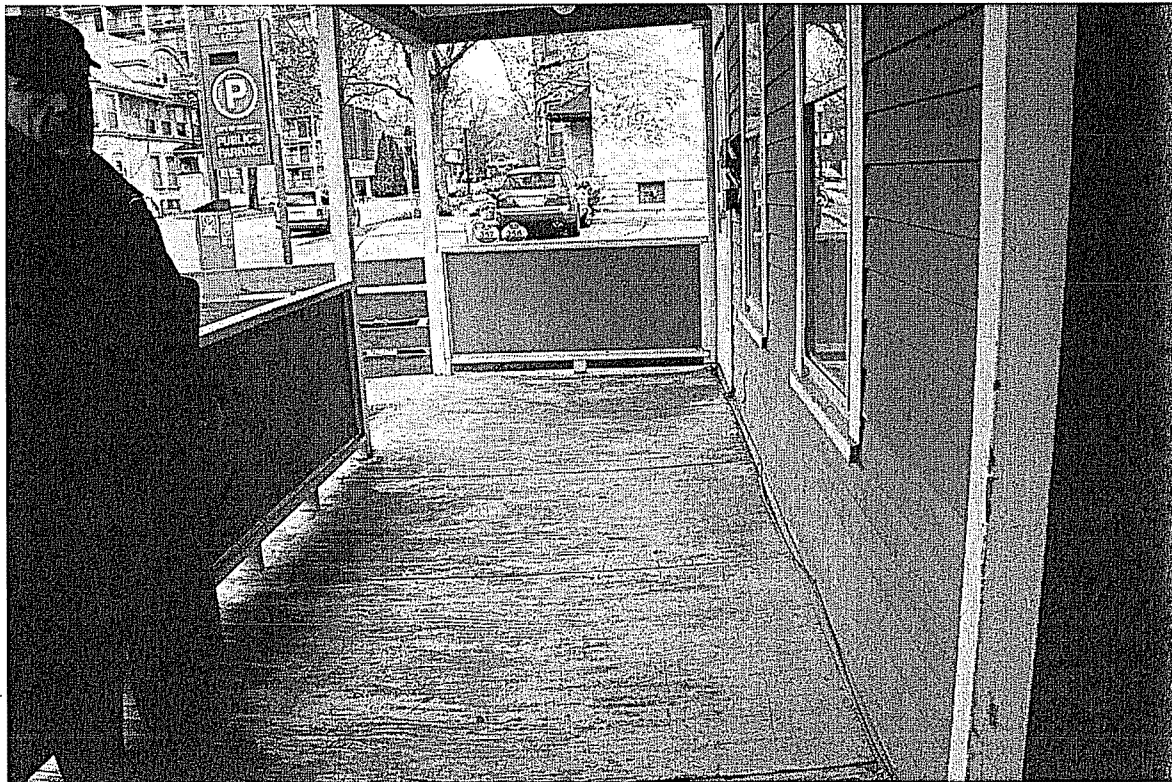
The porch floor framing is spongy and is sagging. This framing is quite close to grade and may have deterioration in the members. The plywood decking is not a proper material for the top surface of the deck. This type of decking can actually trap moisture in the wood framing and accelerate the deterioration process.

10. Front Porch

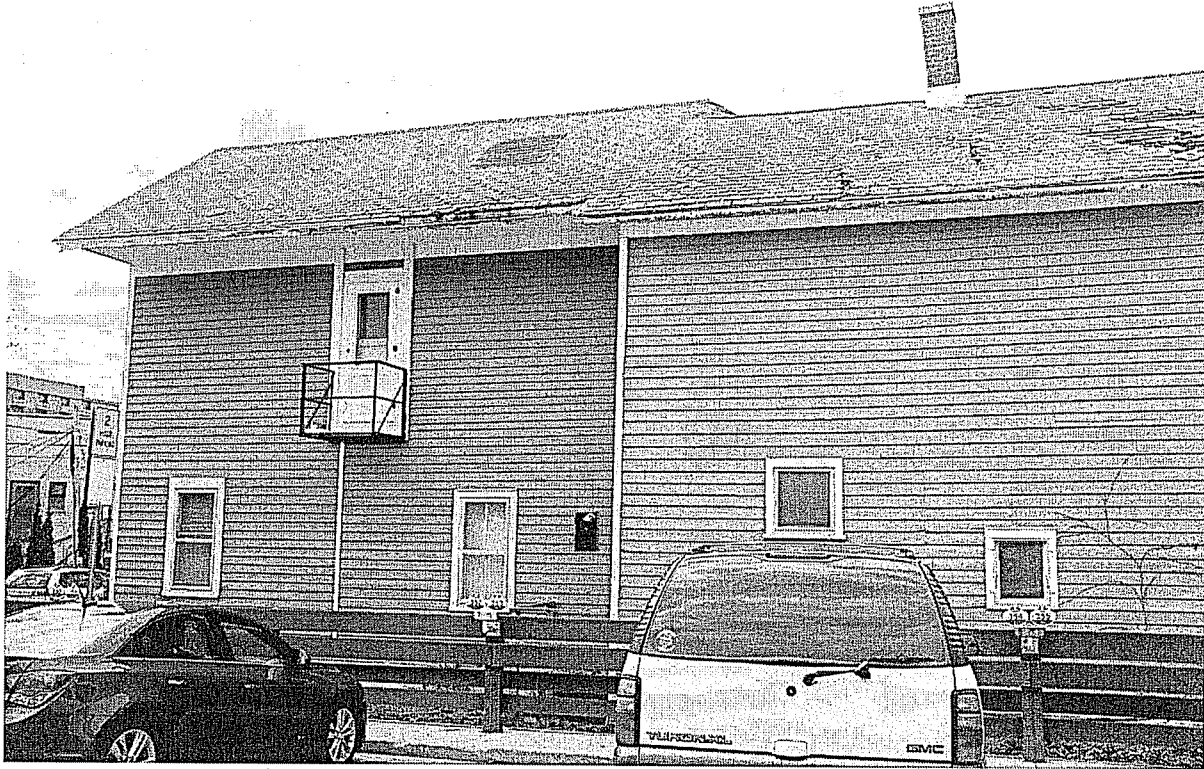
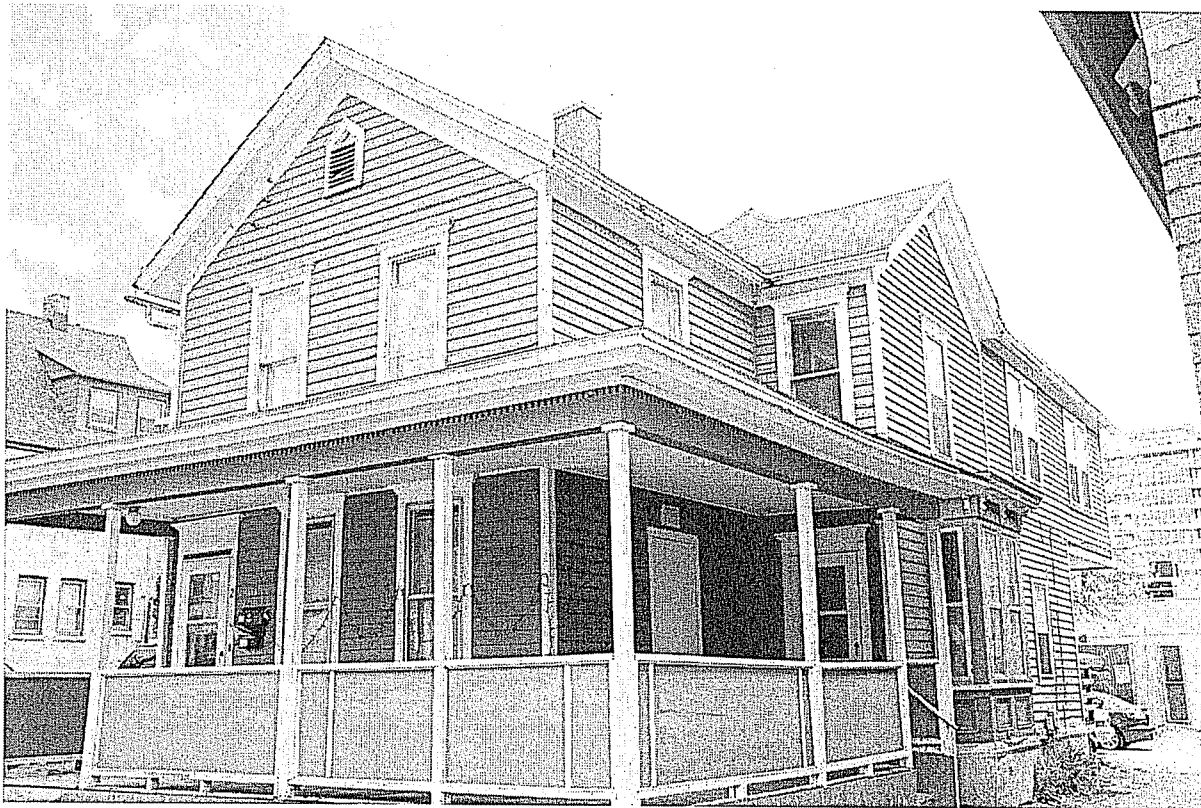
The house is sheathed in wood clap boards with an average 4" exposure, 4" corner trim and 7" window heads. Much of the wood siding is original and is in fair to poor condition with failing paint, multiple splits, openings and cracks. Corner boards and window trim are in generally good condition. The horizontal wood trim and banding is generally in poor condition. Overall the exterior walls no longer provide an effective weather barrier.

11. Exterior - Existing

The exterior exhibits significant deferred maintenance issues, serious degradation and deficiencies contributing to building deterioration. Replacement of roof, 25% of siding, 75% of horizontal trim, and rehabilitation of most windows will be necessary as well as adding a vapor barrier and code compliant thermal insulation.
