An Architectural and Historical Study of Seven properties along the 400 Block of East Washington Avenue, Madison, Wisconsin

Rowan Davidson, Associate AIA &
Jennifer L. Lehrke, AIA, NCARB, LEED AP
Legacy Architecture, Inc.
605 Erie Avenue, Suite 101
Sheboygan, Wisconsin 53081

February-March 2020

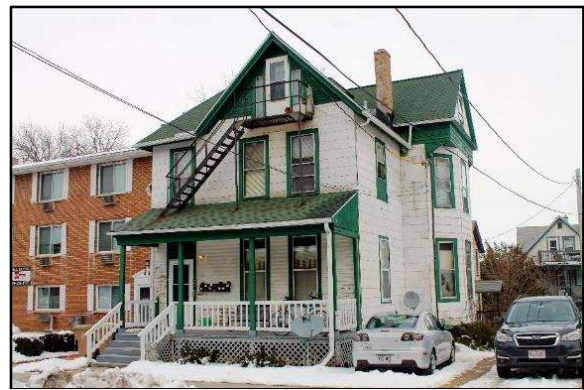
9 North Hancock Street

The house lacks architectural integrity due to its replacement siding and interior layout. The siding is in poor condition, there are extensive cracks and warping in the plaster walls, and the foundation requires repairs. Some elements, especially the historic window sashes and radiators, could be salvaged and repurposed.

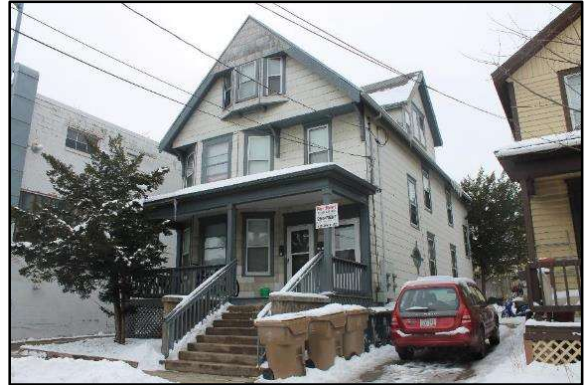
8-10 North Franklin Street

The house lacks architectural integrity due to its replacement siding and interior layout. The siding is in poor condition. Few if any of the architectural elements could be salvaged and repurposed.

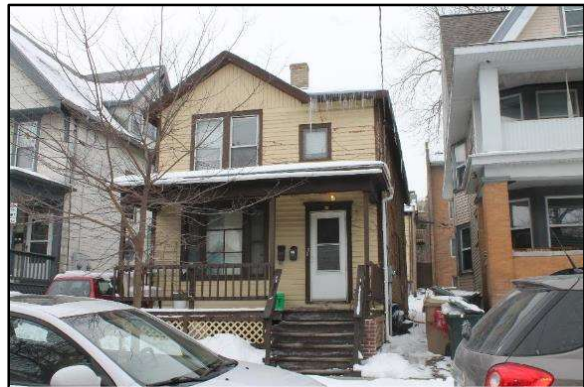
12 North Franklin Street

The house lacks architectural integrity due to its replacement siding and interior modifications. The siding is in poor condition everywhere, and the foundation requires repairs. Few if any of the architectural elements could be salvaged and repurposed.

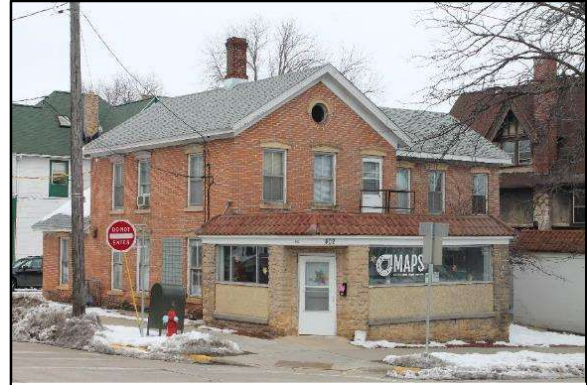
402-408 East Washington Avenue

The house lacks architectural integrity due to its additions, damaged exterior, and interior layout. The brick and stone exterior is in poor condition due to past painting and sandblasting. There are extensive cracks and warping in the plaster walls and ceilings, and water damage in ceiling locations. There is also evidence of termite damage on wood structural members in the basement, and there is mold in nearly every damp interior space such as bathrooms and kitchens. Some elements, especially the historic windows, doors, glass block, and radiators, could be salvaged and repurposed. The brick and sandstone on the exterior are likely too damaged from sandblasting and cleaning to reuse.

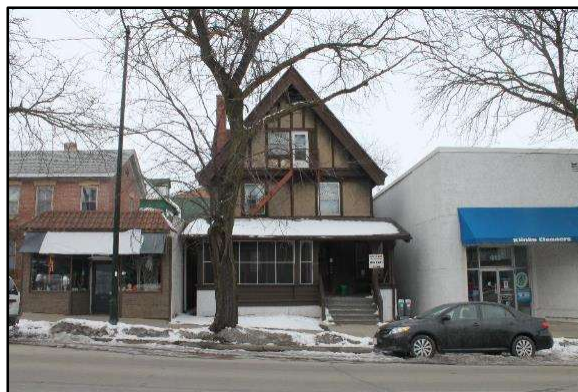
410 East Washington Avenue

The house lacks architectural integrity due to its interior layout. The exterior stucco is poor condition with mold and occasional damage, and there is mold in many of the damp spaces of the building including the basement. Some elements, especially the historic windows doors, wood trim, and built-ins could be salvaged and repurposed.

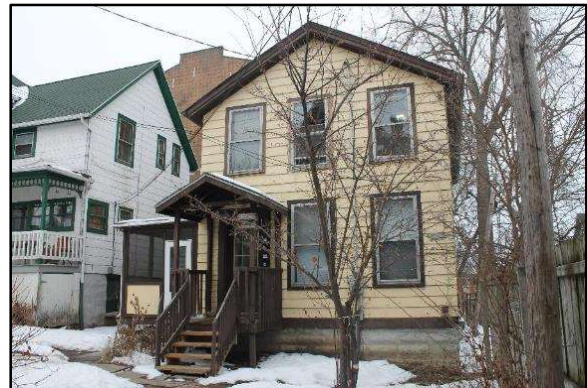
410 1/2 East Washington Avenue

The house lacks architectural integrity due to its interior layout and the foundation requires repairs. Few if any of the architectural elements could be salvaged and repurposed.

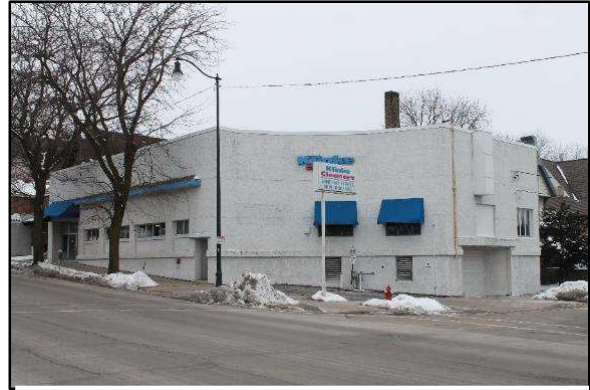
412-414 East Washington Avenue

The building lacks architectural integrity due to its exterior remodeling. It is likely, due to the nature of the structure and its use and various owners that this building has been altered several times throughout its history as various exterior concrete patching is evident. The interior has a series of different structural grid patterns as well. There is water damage at both the ceilings and floors of the main warehouse space on the interior. It is unlikely that any elements could be salvaged and repurposed.
