City of Madison Landmarks Commission

APPLICATION

Project Address: 1806 SUMMIT AVE.

Re: Replacement of windows at 1806 Summit Ave.
Case No. CB2016-181-11068

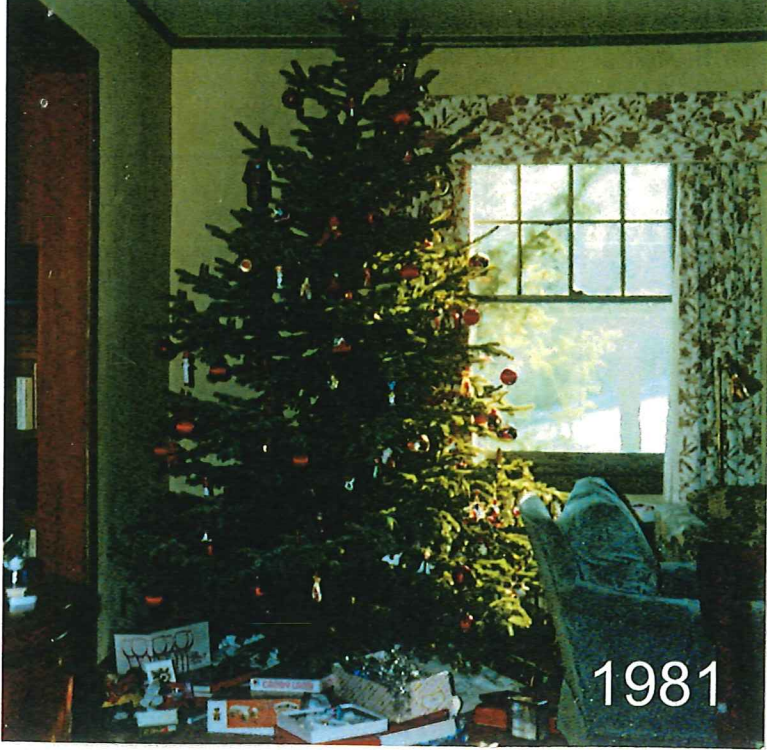
- ① Mrs. Schnoes could not open the windows for ventilation because of the poor condition of the windows and the frames
- ② The bottom sashes (double hung windows) were extra tall and extra heavy. To compound the problem, the frames were swelled and warped. The check rails did not line up with each other, so the sash locks would not work. You could not lock the windows.

- ③ The window weights that were removed weighed 9 pounds each! That's huge. Some ropes were broken. Some pulleys were rusted.
- ④ The energy efficiency of the windows was very low, with of course no insulation around the units.

Fig. 1
Interior view of one of the old
living room windows (1981)

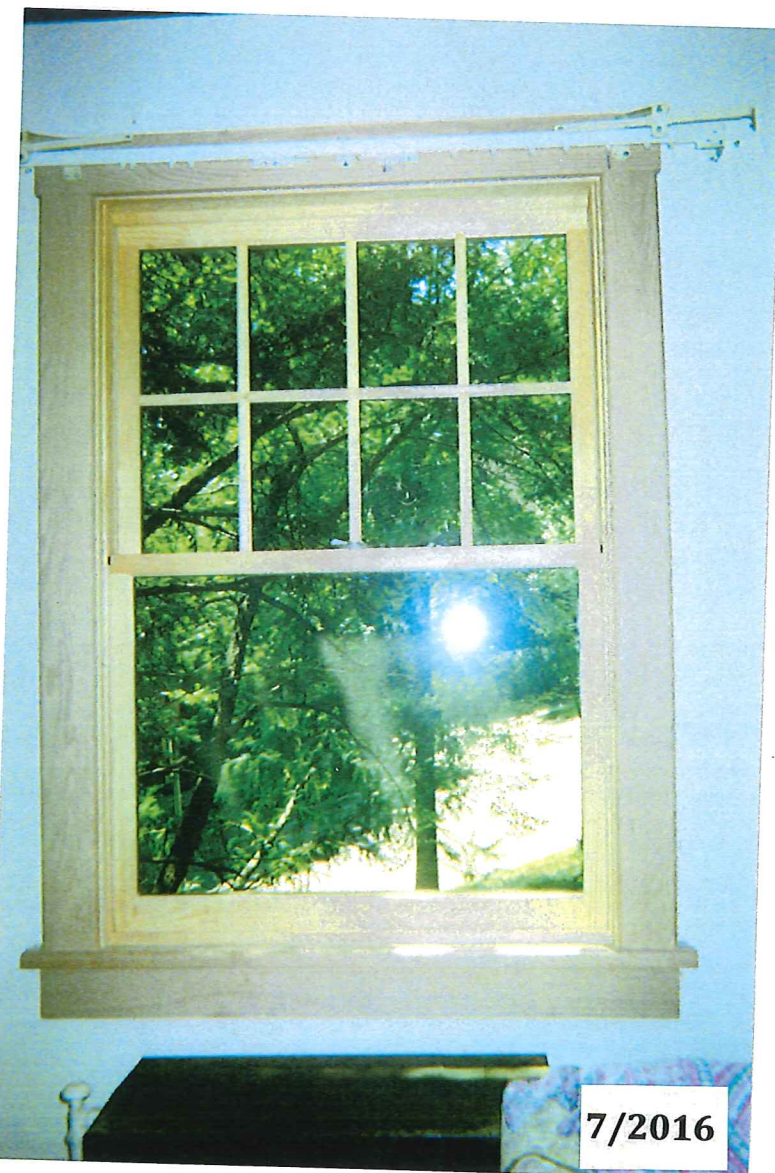
Fig. 2
Interior view of one of the new
Marvin windows in the living
room (the replacement of the
window shown in Fig. 1)

The replacement windows, as now installed, are Marvin windows with insulating argon-filled double panes. With respect to size, design and appearance, they match the previously existing windows (see attached summary of window specifications, provided by the Window Design Center). I believe these are among the very best windows currently available, and in terms of form and function they certainly seem to me a great improvement over their decaying precursors: they truly look good, from inside and out, they seal tightly, they work properly, and the absence of storm windows enhances the street front attractiveness of the house.

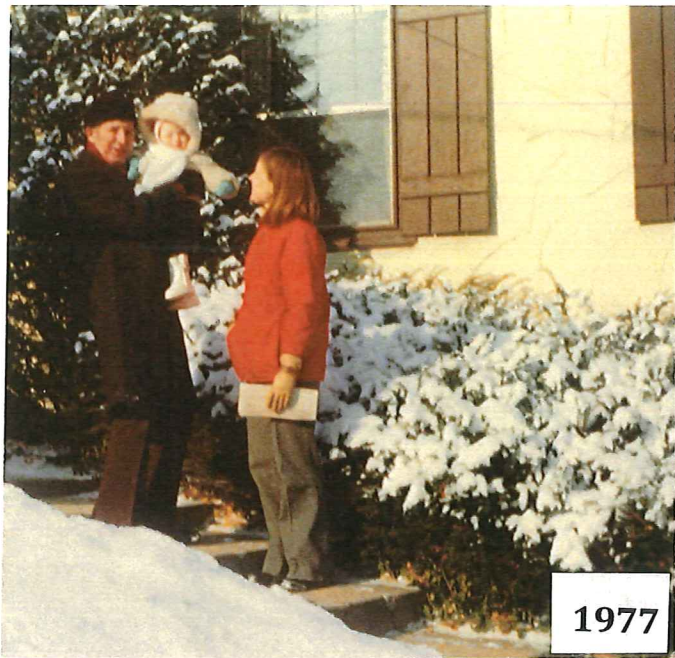
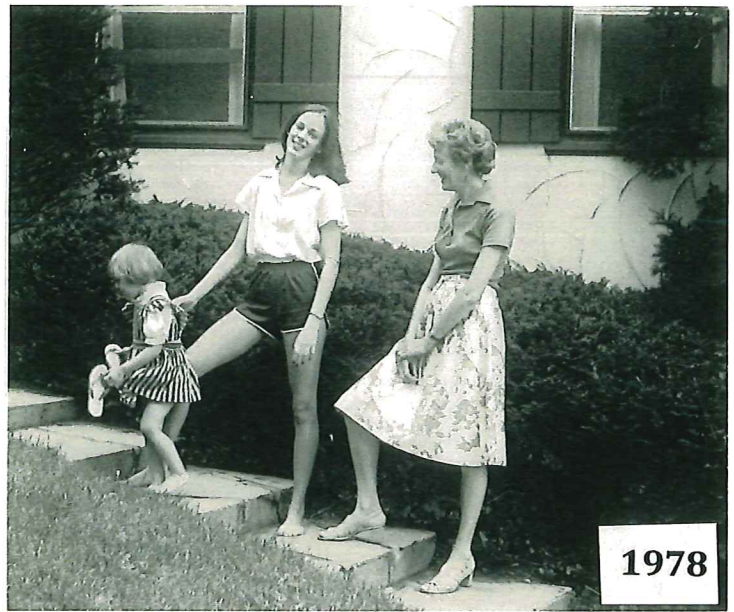
- ⑤ The exterior window frames were found to be in poor condition also. Dry rot and wet rot caused the frames to swell and also deteriorate the wood.
- ⑥ An existing window in the Kitchen is a good example of the windows that were replaced. A large hole in the exterior window sill lets in cold, water, and bugs.

Fig. 3
Exterior (street side) views of the old living room windows

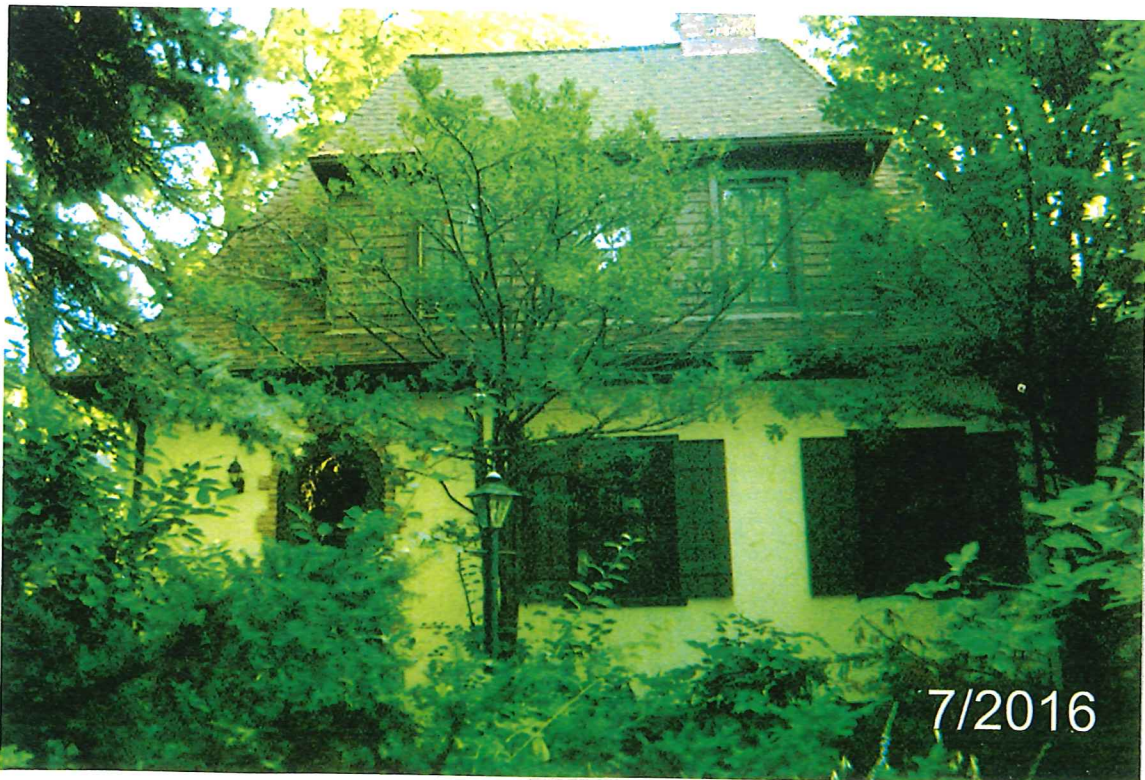
Fig. 4
Street view of 1806 Summit Ave. with new Marvin windows in place (7/2016)

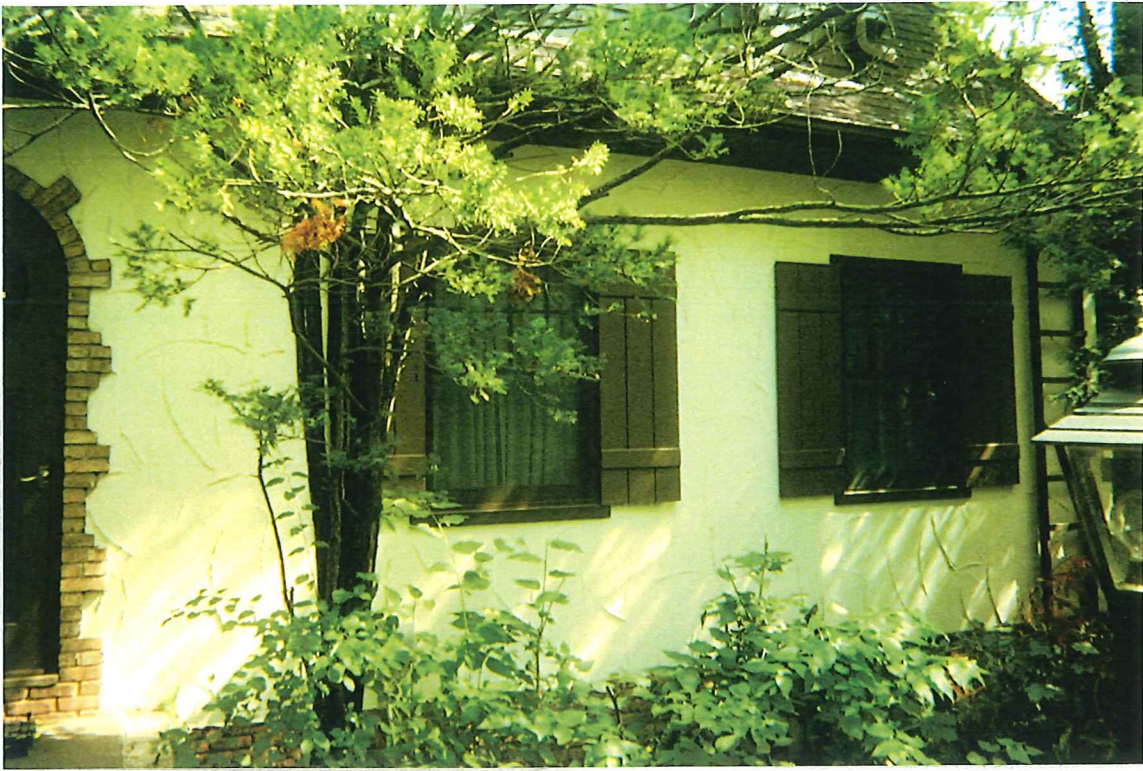
Fig. 5
Exterior (street-side) view of the new Marvin living room windows (7/2016)

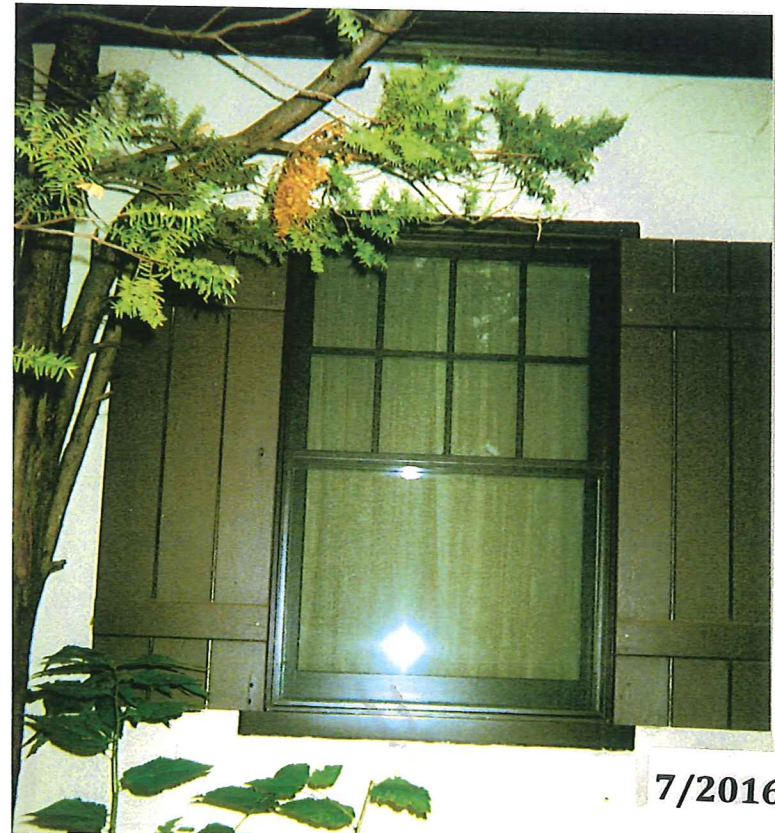
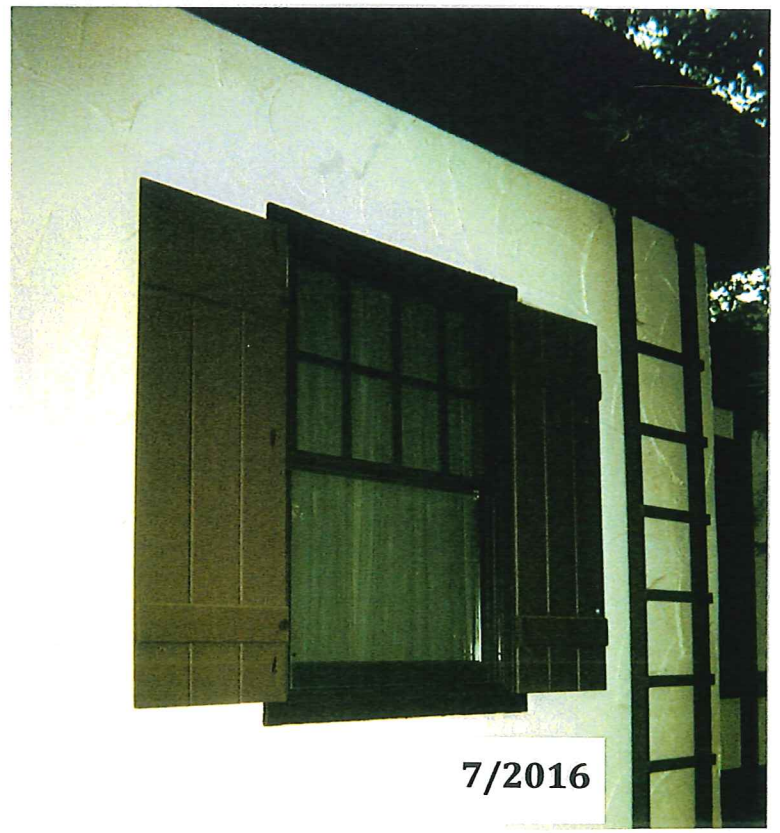
Fig. 6
Close-up views of the two windows shown in Fig. 5

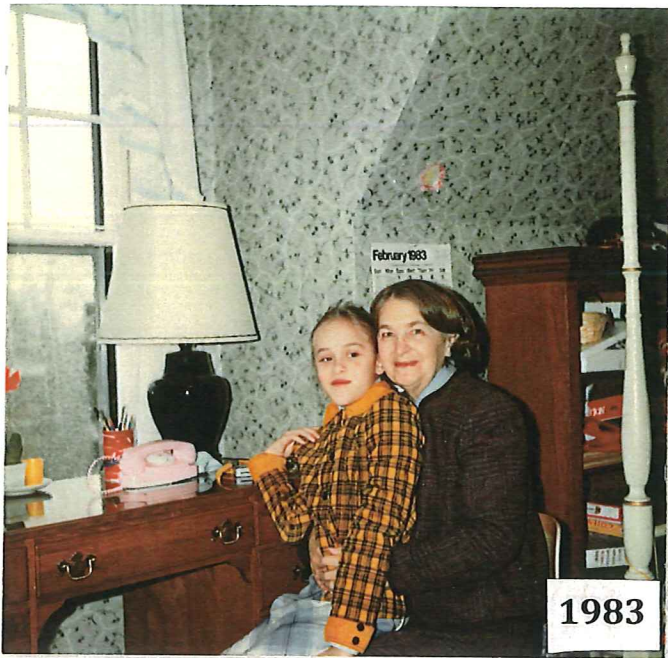
Fig. 7
Interior view of one of the old
north-facing 2nd floor windows

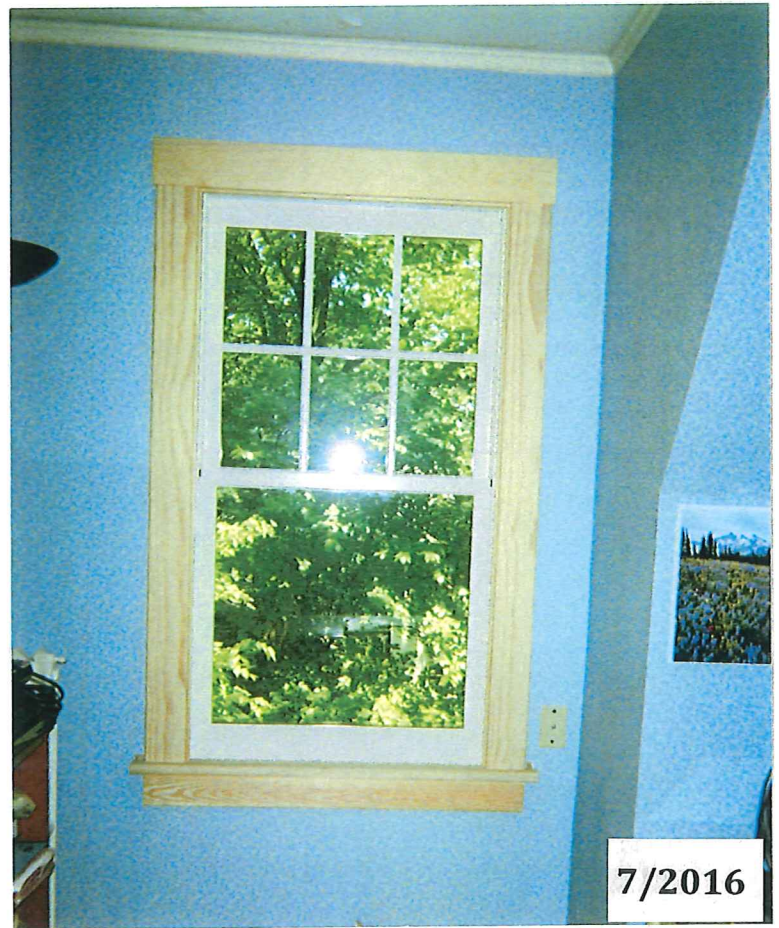
Fig. 8
Interior view of one of the new
2nd floor north-facing Marvin
windows (the replacement of
the window shown in Fig. 7)

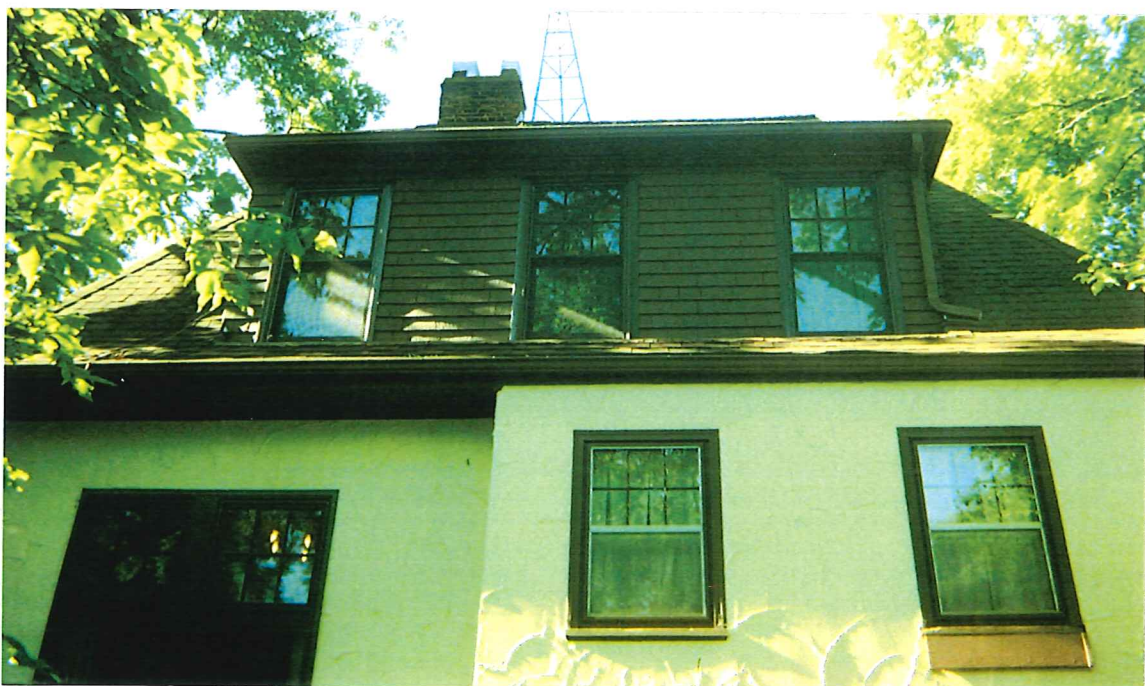
Fig. 9
Exterior view of the three newly installed 2nd floor Marvin windows (7/2016)
