MEMORANDUM

Date:	July 21, 2015
То:	Arthur Ross
From:	Kevin Luecke
Project:	Downtown Madison Bicycle & Moped Parking Study (TDG #8019)
Re:	Existing Conditions

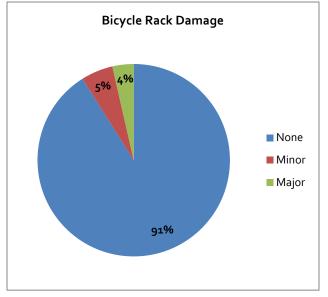
When bicycle racks were initially inventoried, levels of damage and corrosion were generally noted, with ratings of none, minor, and major. Figures 1 and 2 display the percentages of rack locations, not necessarily individual racks, which displayed each level of corrosion or damage. The inventoried racks are generally in good condition, with few racks showing any significant damage. However, a notable number of racks do display signs of corrosion, with approximately one third of the rack locations having minor or major corrosion. The final project GIS database will include these notations.

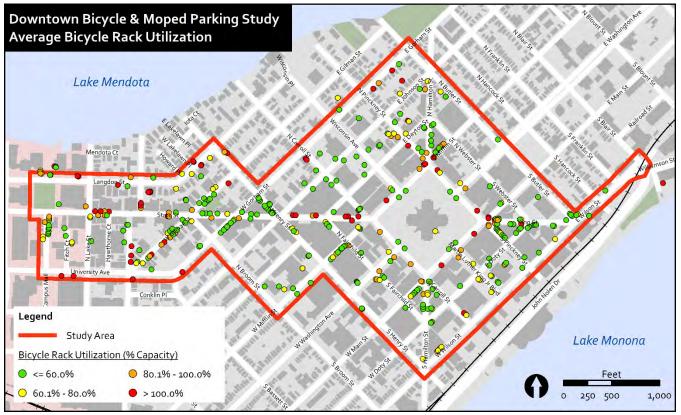
Map 2: Average rack utilization across all bicycle count events

Partial counts were conducted for a number of days/events to focus on the area around the Capitol Square where rack usage was expected to be high due to the event occurring; partial counts generally included racks within the Outer Square as well as the o – 300 blocks of State Street. Map 2 displays the average rack utilization across all of the count events.

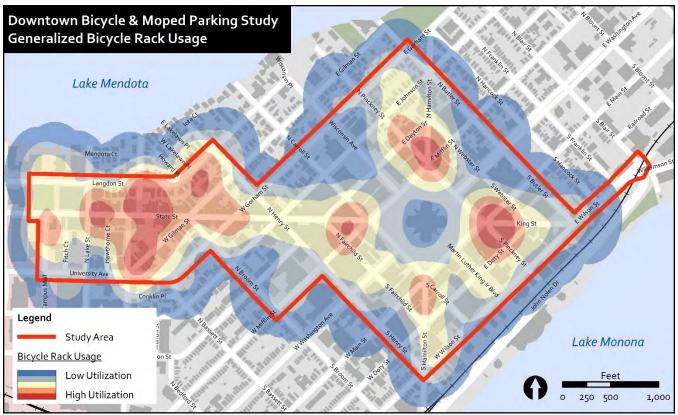
Map 3: Generalized bicycle rack utilization

Map 3 displays a "heat map" of rack utilization with blue areas having lower average utilization and red areas having higher average utilization. It should be noted that both Maps 2 and 3 display average utilization across all count events – certain areas may experience significantly higher utilization than average when an event is occurring. An example of this may be a large event at the Orpheum Theatre or Overture Center which can bring large numbers of bicyclists to the 200 block of State Street.

In general, a number of locations stand out where bicycle racks are often full, or nearly full, to capacity:

- 100 block of State Street
- 200 block of State Street
- 500 block of State Street
- 600 block of State Street
- Racks near the south end of North Frances Street
- Racks near the intersection of East Mifflin Street and North Pinckney Street
- Racks near the intersection of East Main Street, King Street, and South Pinckney Street
- Racks on Martin Luther King, Jr. Boulevard

Racks in these areas are often at capacity under normal usage conditions, that is, not during an event that brings large numbers of bicyclists to the area. Additional bicycle parking should be provided in all of these areas to address constant overcrowding of racks.
