Madison Landmarks Commission APPLICATION

Project Address: 122 Bascom Place, Madison, WI 53726 Aldermanic District: 5

Project Title / Description: 3 basement windows - 1 basement door - 1 side door

Request to replace two doors and three basement windows at 122 Bascom Place. Homeowners: Benjamin Ball and Mindi Thompson.

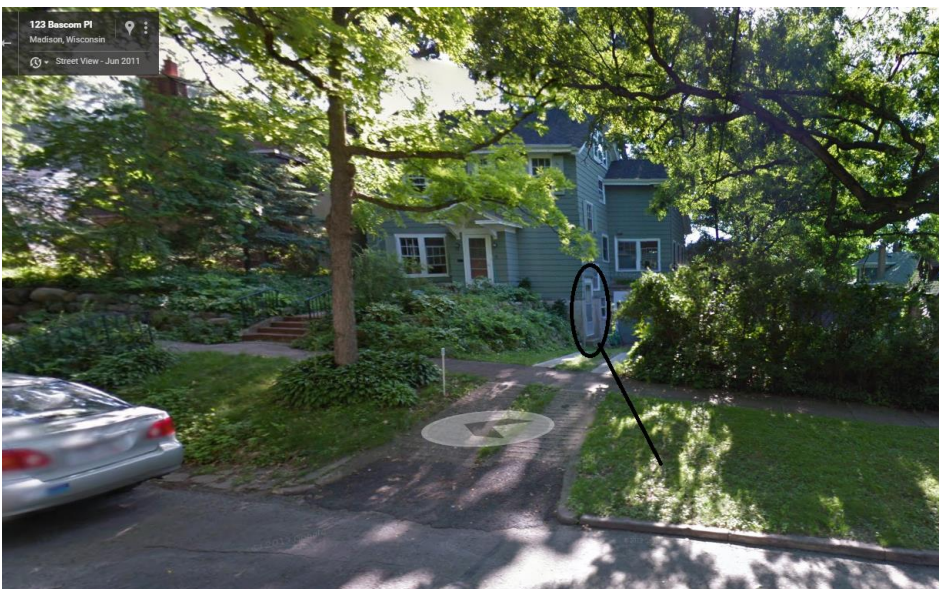
This is a road view from the front of the house on Bascom Place. It depicts the side door (door #1) that is being replaced. It will be replaced with a Thermo-Flu door that will have window panels/grilles that will be historically appropriate to match the current windows and doors.

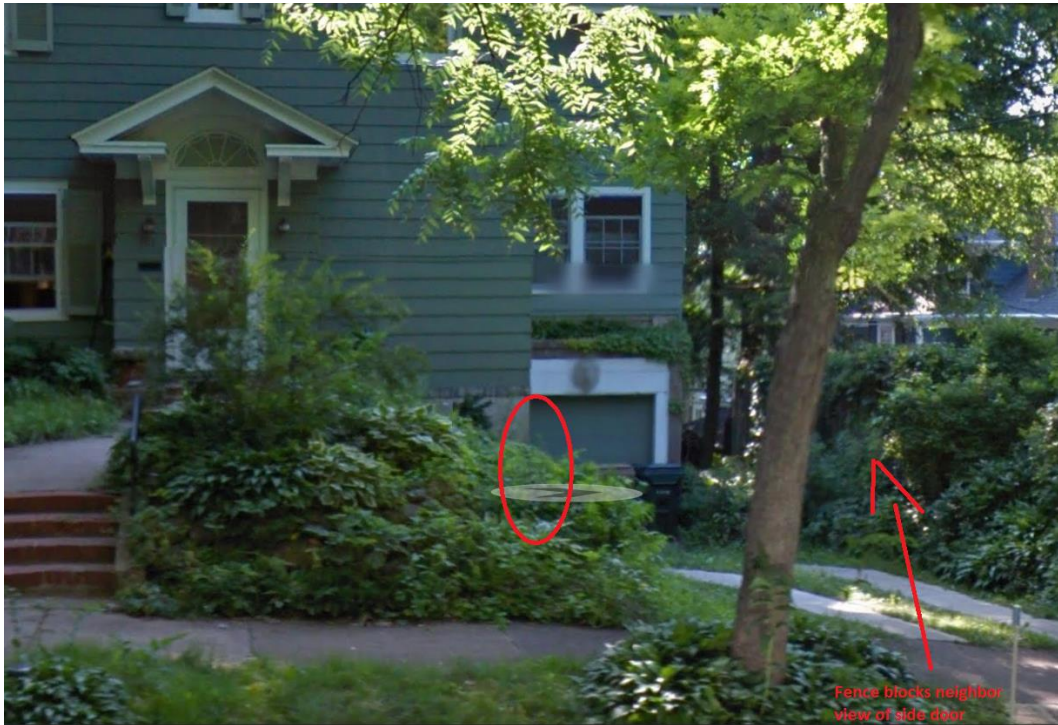
The side door is not visibly by our neighbor as it's blocked by a fence.

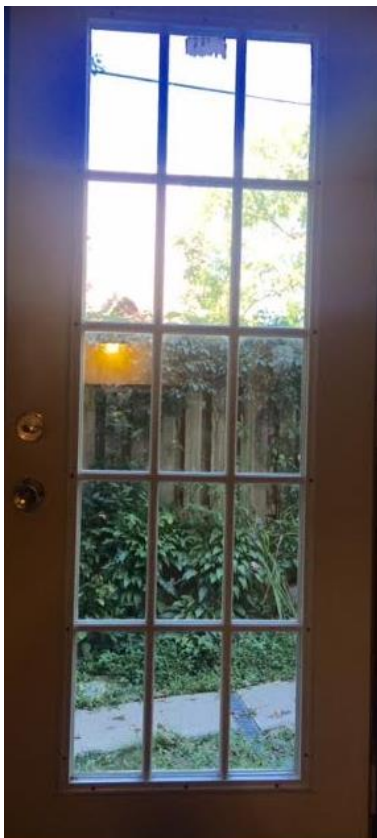
The door on the side of the house (door #1) isn't original to the house and is not very secure when closed and locked (gaps). This is an inside picture of current side door (door #1) being replaced. Note - This is not the original door to the house.

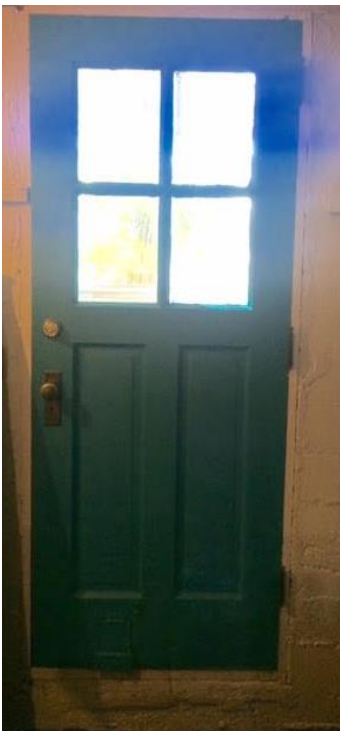
Below is an inside picture of door #2 in the basement

The door in the basement (door #2) that leads out to the backyard might be original, but is warped and beginning to show rotting at the base. It doesn't shut or lock properly as a result. The sill and sub sill will also be replaced as they're rotted. This is most likely a result of the damp location of the door. It is not visible from any surrounding streets or neighbors. Similar to the side door it will also be a Therma-Flu door that will have pane/grilles that will be historically appropriate to match the current windows and doors.

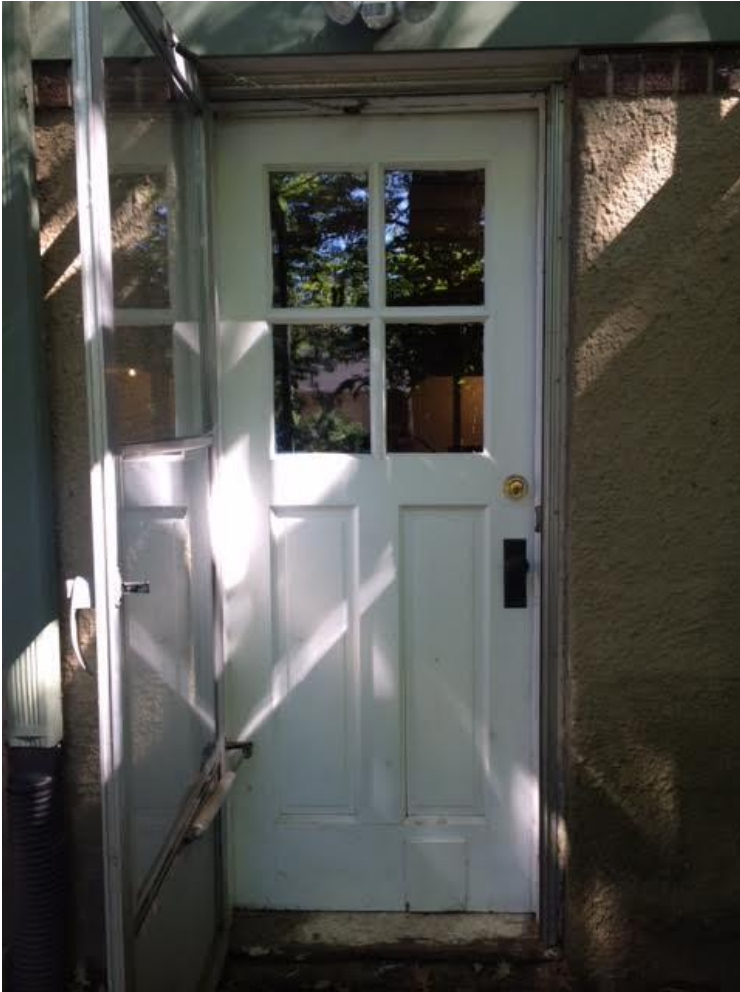
Outside pic of door #2 from the backyard. Note - Base of door and sub sill are rotted.

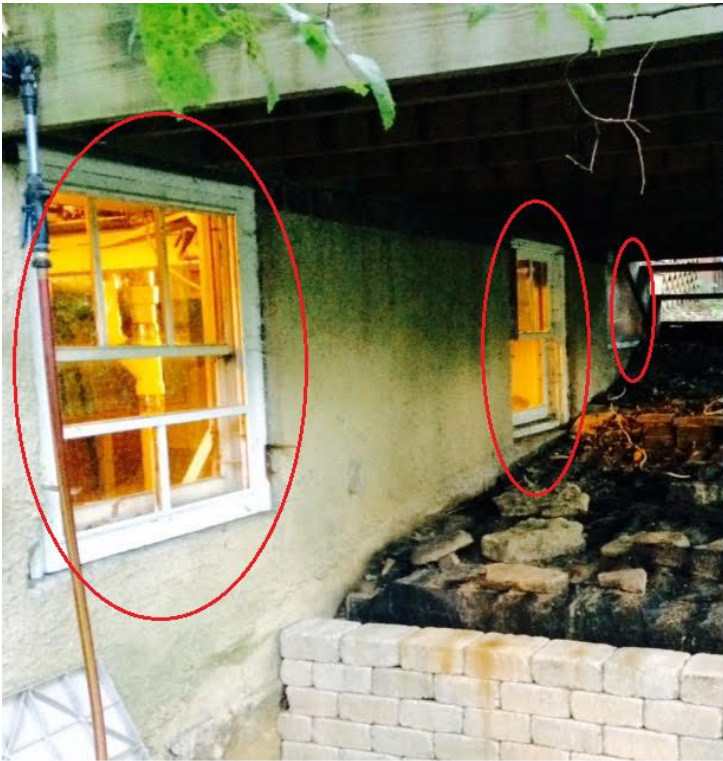
Below are inside and outside pictures of the three basement windows that will be replaced as the current windows are rotting and not functional. All three windows are face the backyard and are covered by a deck. The replacement of the door and windows in the basement will maximize lighting in an otherwise dark basement. Replacement will also benefit energy efficiency efforts. Due to the location of the windows, there is a lot of moisture. The windows will be replaced with wood windows that have panes/grilles that match the current windows.

Outside pic of all three windows under deck.

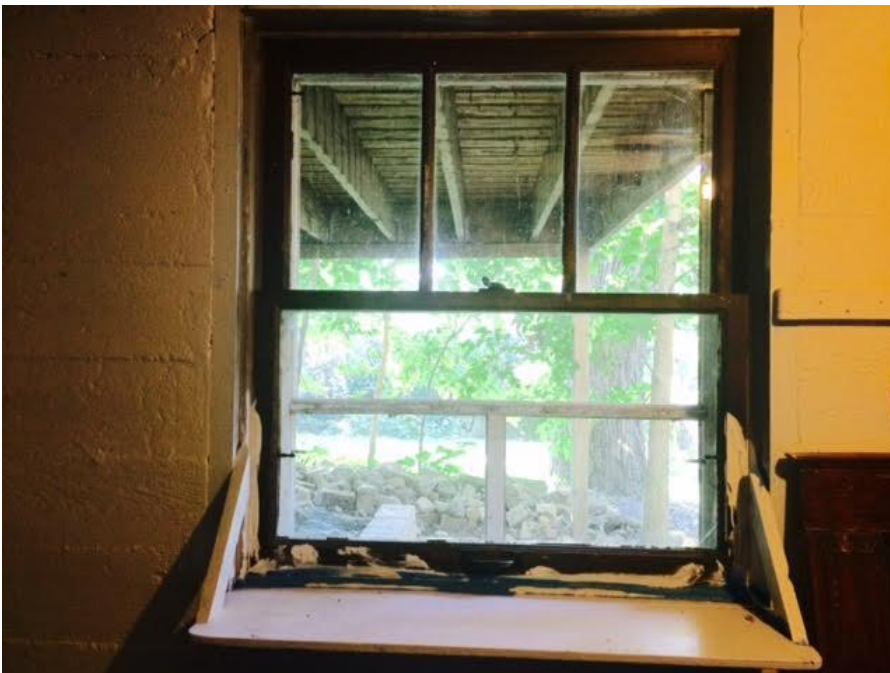
Inside of window #1. Note - The outside pane on this window is a result of a broken and no longer used storm window that previous owners tried to install. It's not actually part of the window.

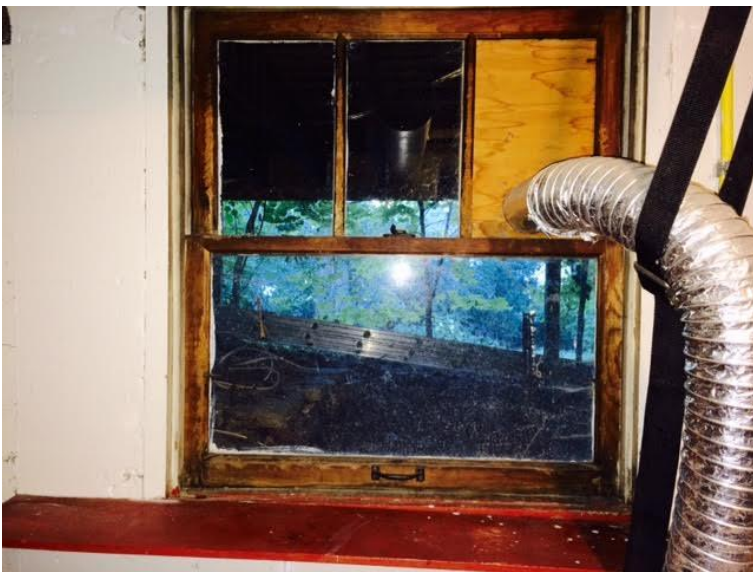
Inside of window #2. Note - The dryer vent (installed by previous owners) will be vented through the wall (not through the window).

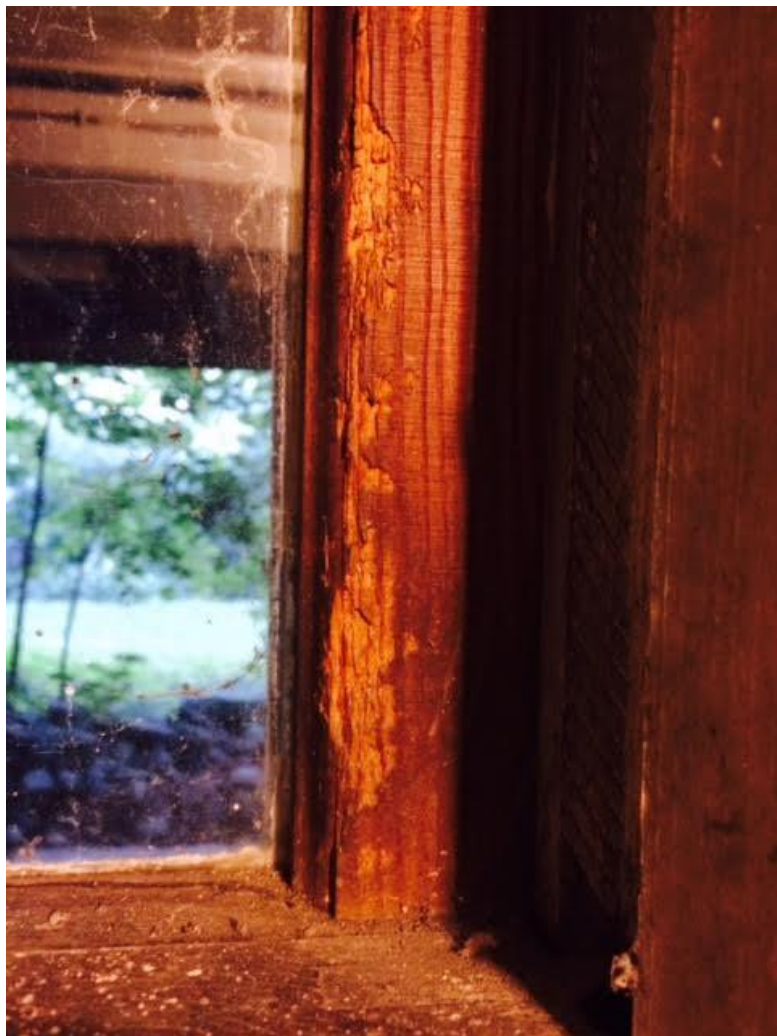
This pic captures the rotting taking place on the window

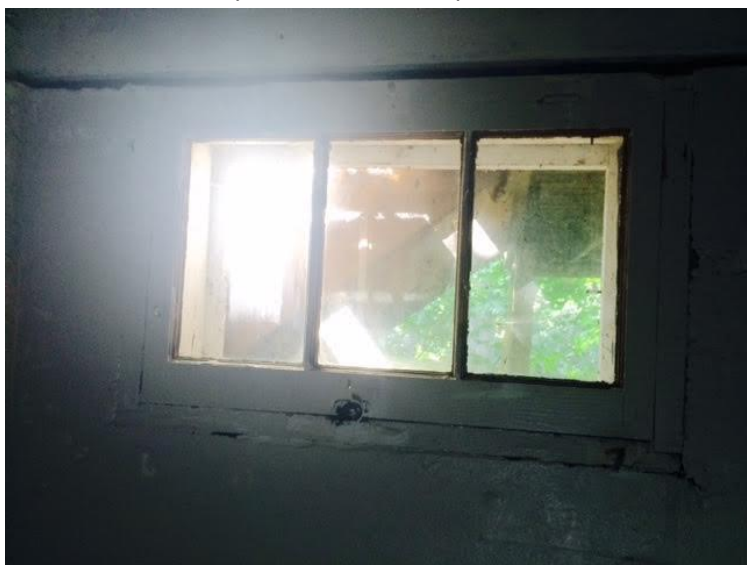
Inside window #3. This window isn't as large as the other windows, but will none the less be replaced. It faces the steps off the deck, which you can see in the picture.
