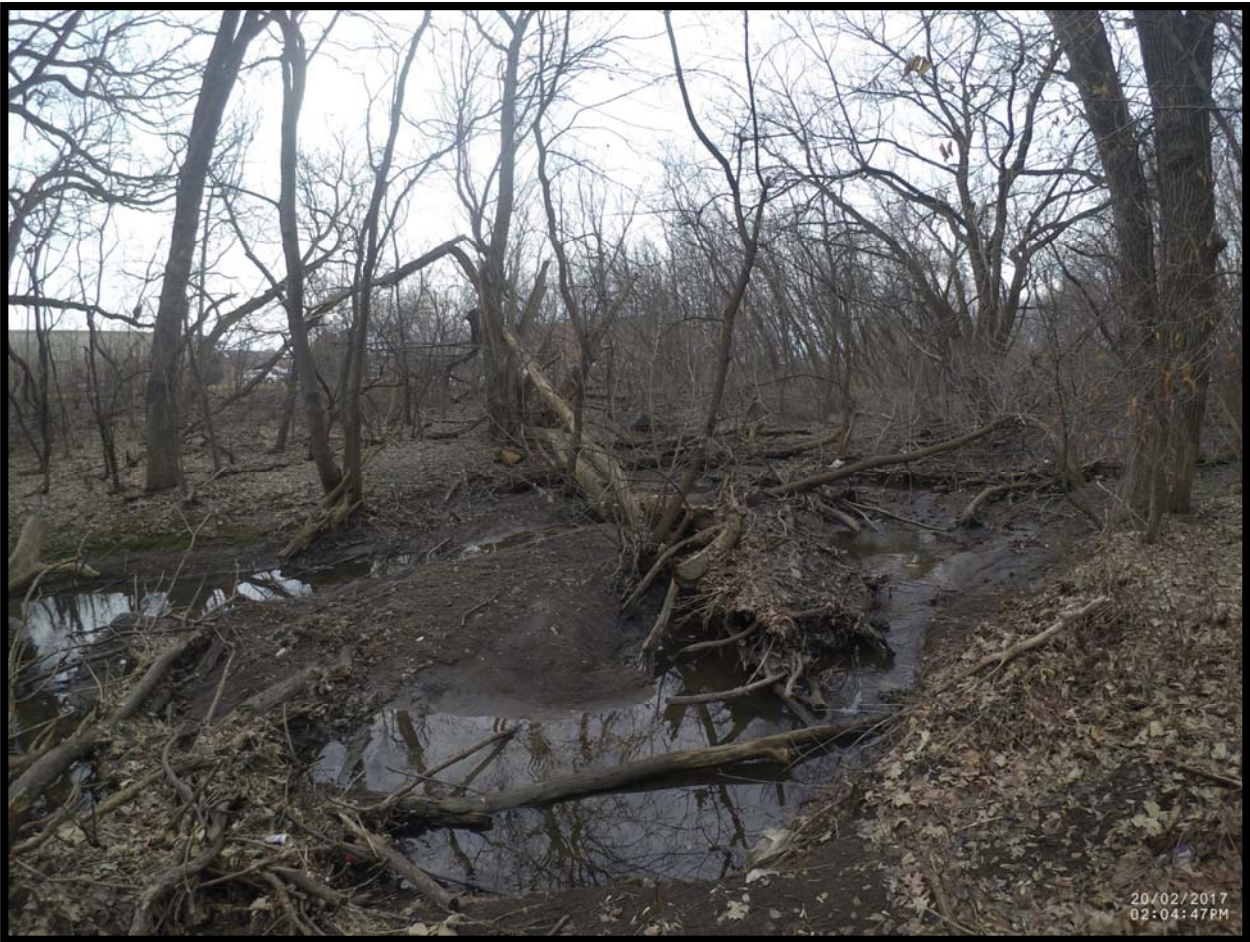
Figure 1: Trees down in greenway, blocking flow and causing drainage ditch to braid.

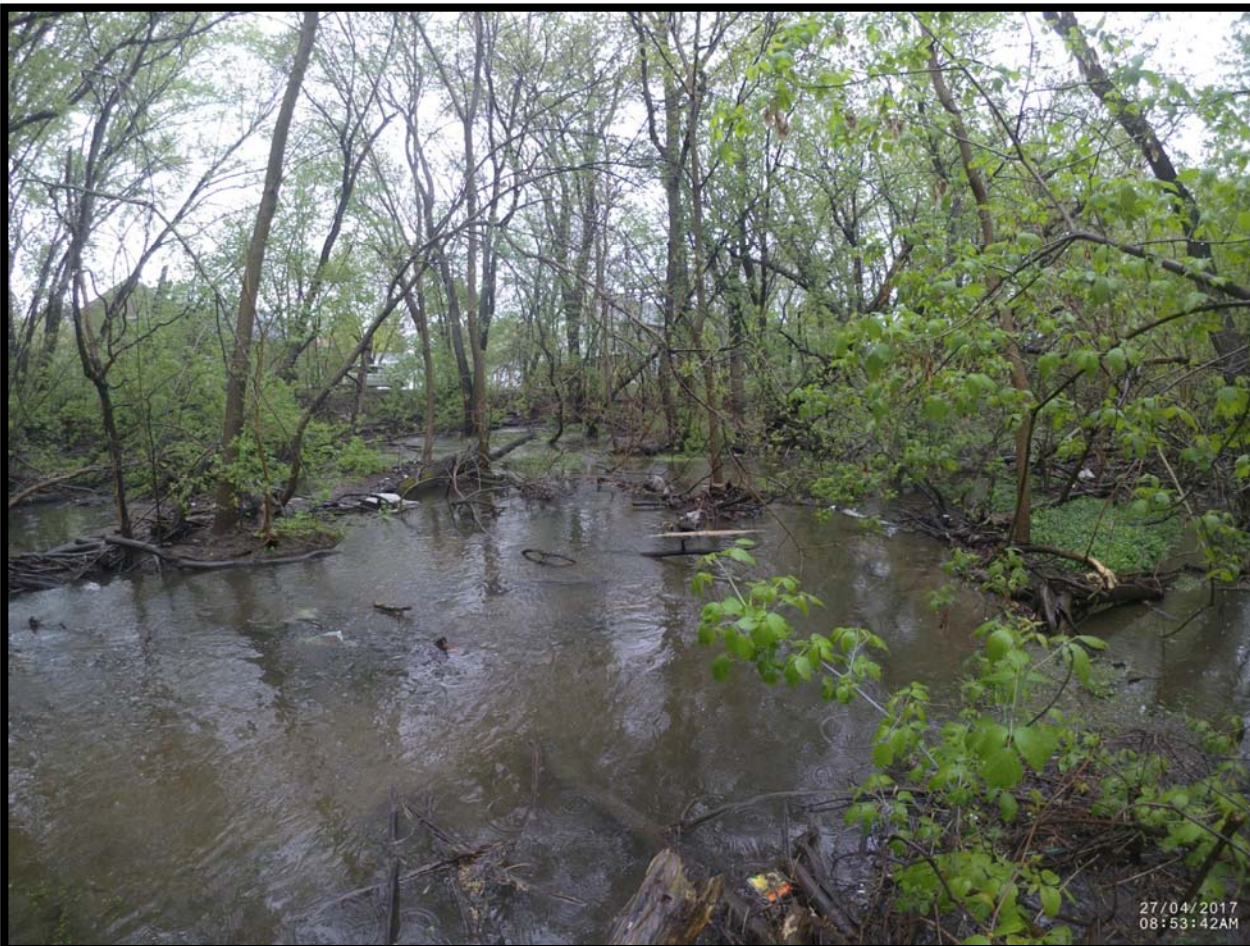
Figure 2: Tributary carrying stormwater through greenway. Photo clearly shows entire floodplain forest wetland conveying flows of 0.6", 24 hr storm.

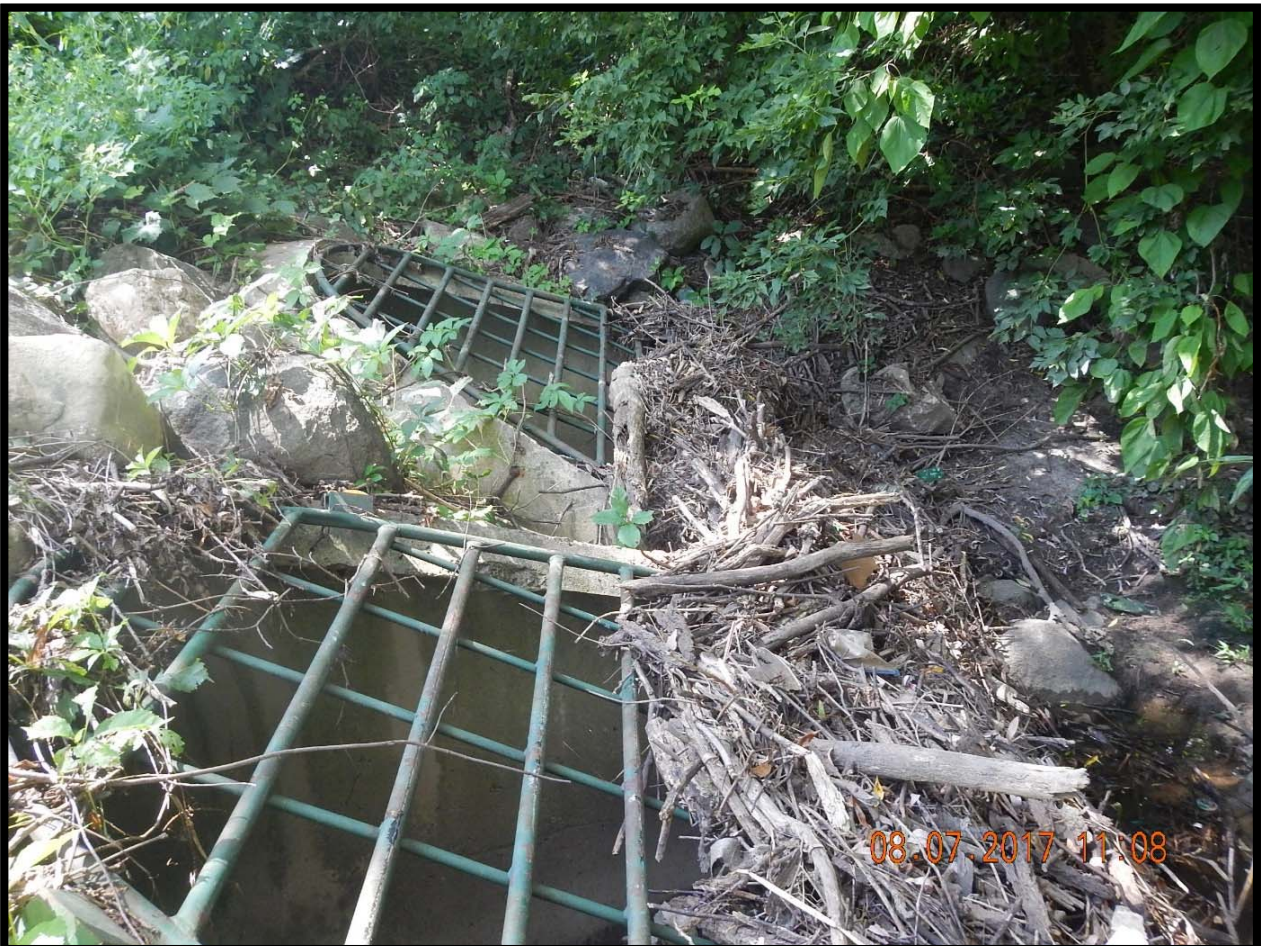
Figure 4: Outlet grates clogged with debris exemplify why access road is needed and why silver maples are often removed from greenway systems.
