Building Permit Items for 807 Jenifer Street

EXTERIOR REPAIRS for 807 JENIFER STREET

807 JENIFER STREET - AREAS OF PROPOSED REPAIRS

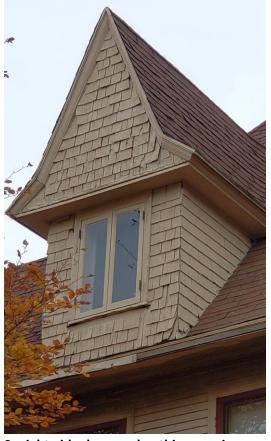
Spaight-side dormer sheathing repairs

The original sawn cedar shingles sheathing the attic dormer on the Spaight side have some warped and curled shingles and some of the small ones along the edge are missing. The curled pieces will be removed and replaced with sawn cedar shingles to match. Missing cedar shingles will be replaced, as well. Any original areas that remain intact may be left in place, such as on the sides. There were small bracket details on the dormer front that were removed at the time when all protruding trims on the house were removed to re-side it with aluminum siding in the 1970s by the previous owner. Only the outlines remain where they were located below the window. Simple flat pieces will be installed to the same dimensions as the missing brackets.
