Re: 104 East Gilman

Front Entrance Replacement Plan

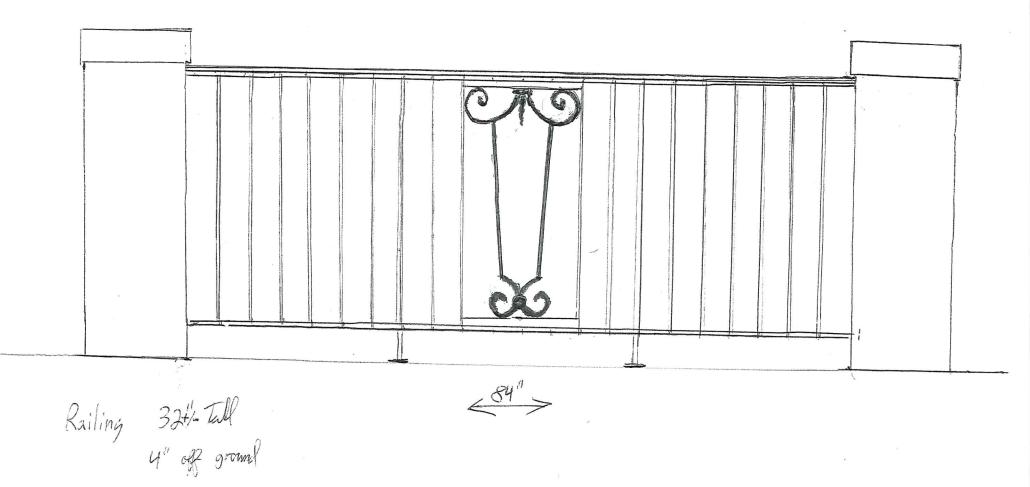
Railing Detail Center detail salvaged from original railings

We are submitting plans for a new wrought iron railing. The original railings were in poor condition, but the artistic panel can be salvaged and incorporated into the new design (see drawing). Though the porch height is currently over 24 inches we propose to alter the landscaping to allow for the use of more historically appropriate 36 inch railing height.
