Certificate of Appropriateness for 2115 Kendall Ave.

September 16, 2019

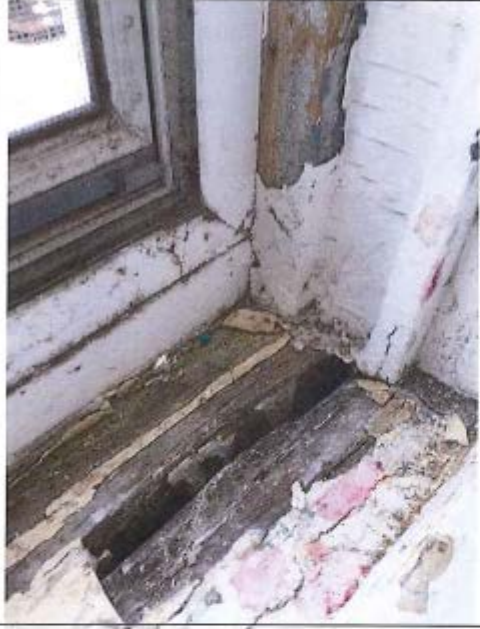
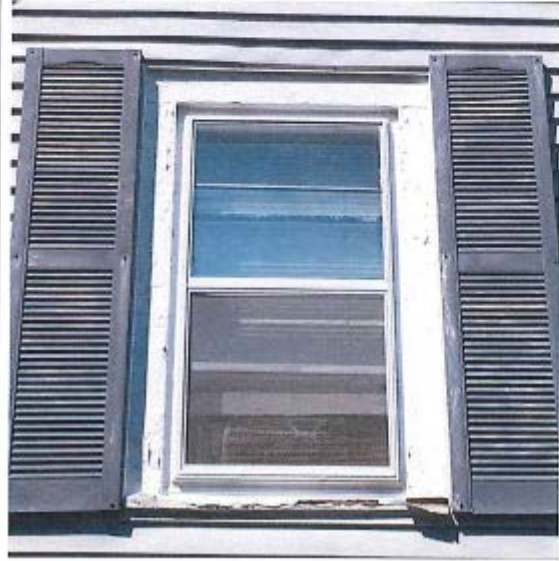
Window 11 bedroom 1, driveway facing 28" by 55"

Major rot and chipping on external frame and sill. Lead swab test positive.

Replace with: similar dimension 28" by 55" double hung Okna 500 series.

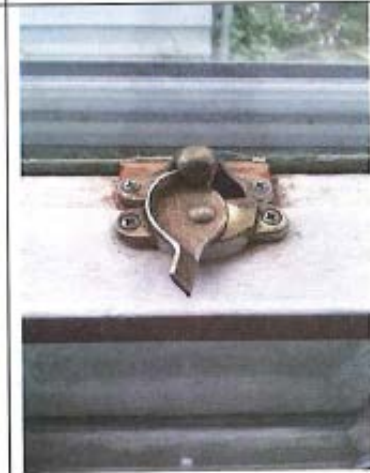
Window 4: Living room west-facing, approx. 28" by 61"

This window has significant paint chipping on the sill and external frame. Opens (doesn't stay open), but lock mechanism was altered and is unstable.

Replace with: similar dimension 28" by 61" double-hung Okna 500 series.
