LANDMARKS COMMISSION APPLICATION

2114 Chamberlain Ave, Madison

New siding on Addition & Deck Rebuild Replace Front Entry, Attic Wxs, and Garage Door

December 18th, 2019

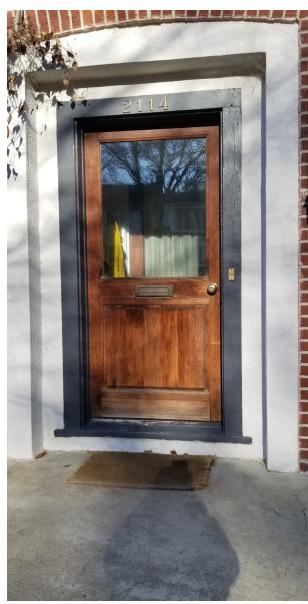
The home owner would like to replace the front door to a 1920's style door to match the historic nature of the home. The door that is currently in place was installed in 1991 as a replacement door. The current door has air leaking issues due to its lack of weather stripping and a mail slot. Another main reason the homeowner wants to replace the door is because she would like additional security with a deadbolt. On the existing door, the styles are too narrow to allow for a deadbolt to line up with the knob below. I attached a door to my original email to you that was proposed by my lumber rep to match what was existing, but it turns out, we would be matching a door from 1991 vs. a door from the 1920's. The internet shows the existing door in a black and white photo, which according to the homeowner was taken post 1991. Attached are photos of the door, weather stripping issues, dead bolt issues, and receipts from replacing the old door with what exists there now. I am also adding a series of 1920's style doors that the homeowner is interested in.

1. This is a picture of the existing door.

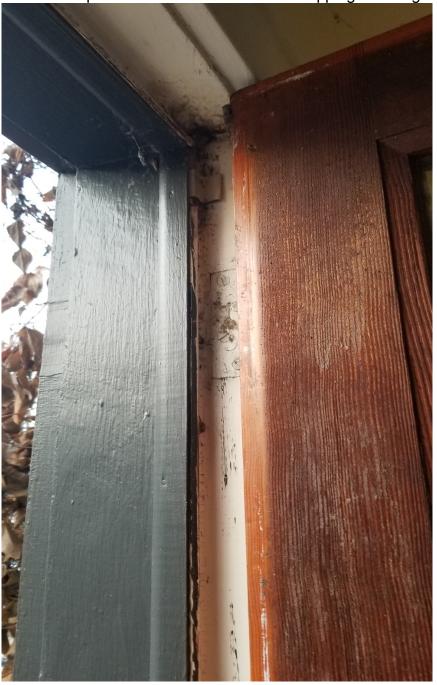
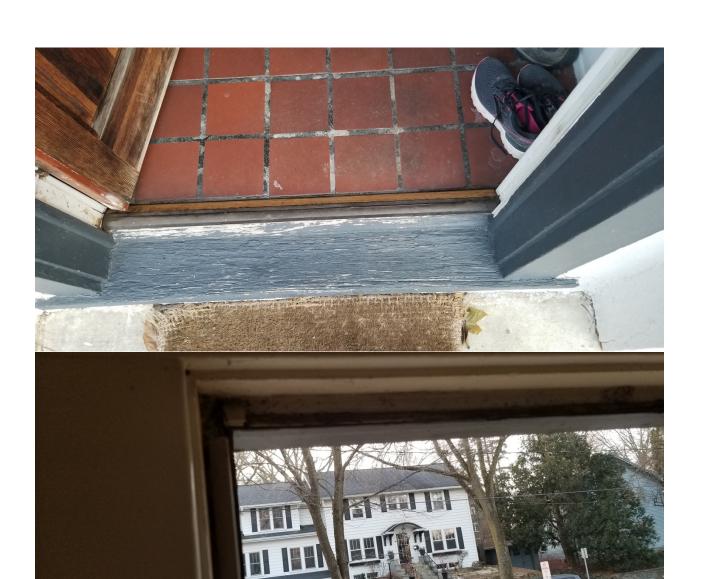
2. Here are photos of the lack of weather stripping or failing weather stripping.

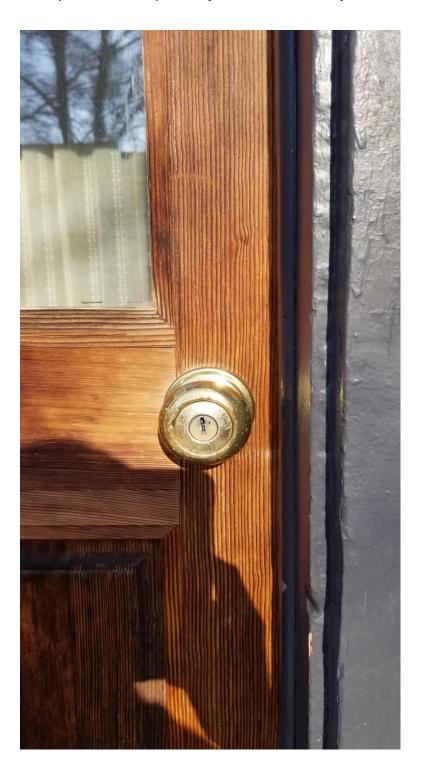
3. This is a picture showing that a dead bolt would impede into the window stop. There is no way to line up a dead bolt perfectly for added security.

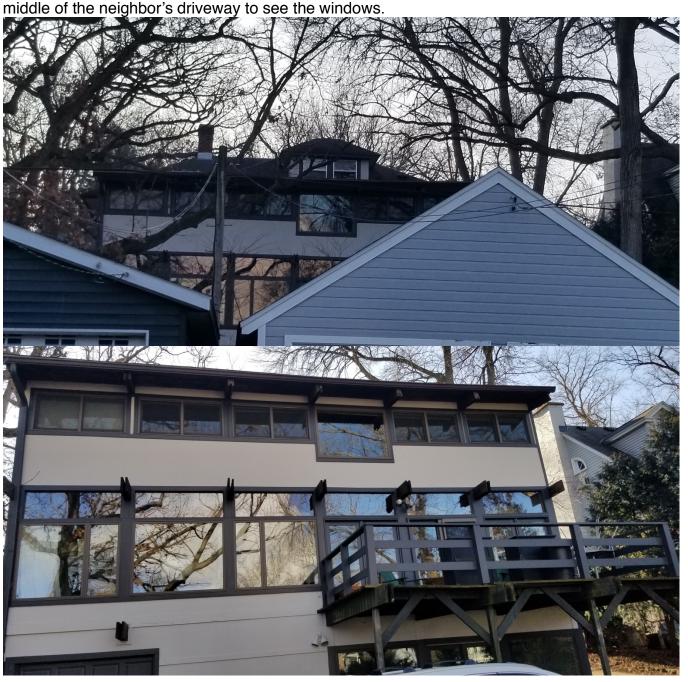
The two existing attic windows are framed <u>below</u> the roof line of the 1970's addition. The homeowners have had snow and debris fall into this cavity and sit right up against the window. This has allowed moisture to make its way into the (now interior) walls. We will frame up the sills (shrinking the window openings by about 8 inches) and weather proof the new windows to keep the moisture out. The replacement window will match the windows from the addition which will make the entire back of the house consistent. These windows are only visible from the backyard neighbor's driveway. Attached are photos of the attic windows from the backyard neighbor's driveway and from the inside showing how the sill is below the addition roof line. Attached are also photos showing moisture damage. The replacement window specs are included, and as you see will match all the windows on the backside of the house.

1. Here is a picture of the attic windows from the exterior. I had to walk through the back yard to the

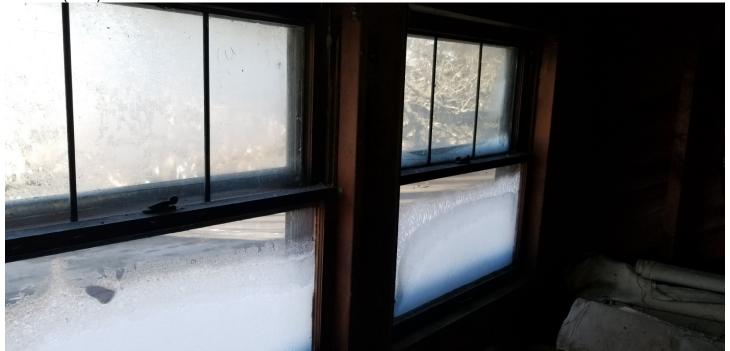
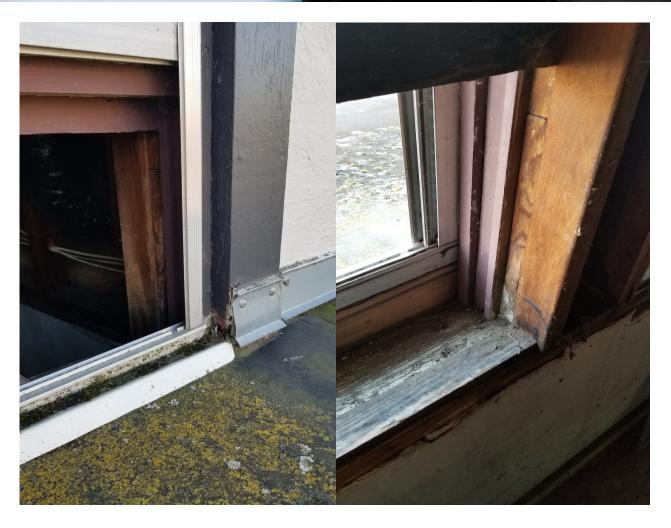
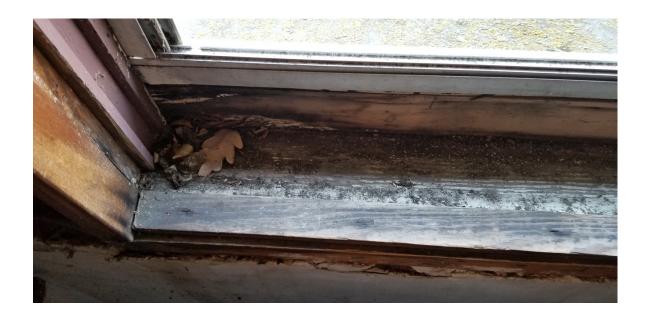
2.Here are pictures of the interior and from the roof line of the addition. Showing how the window sills sit **below** the addition's roof line. This shows where debris sits and where moisture has made its way

into the (now) interior walls.

- 3. These are the new proposed windows that will be the same width as the existing RO, but about 8" smaller in height, so we can properly frame in and weather proof to the addition roof. Attached is the proposed new window to match the addition's Wxs. Also included the cut sheet of the Marvin Wx for committee review.
- -This shows what the window will match.

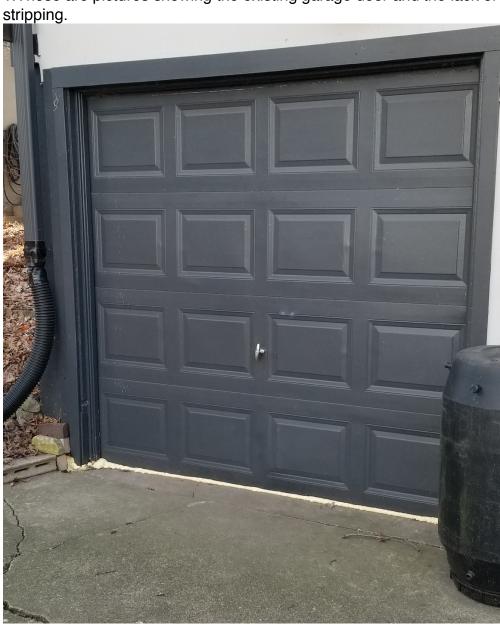
The home owner wants to replace their existing garage door with an insulated garage door that is run by a motor. Their one car garage is under living finished living space and the manual garage door has no weather stripping or insulation whatsoever letting outside air directly under the floor joists. The proposed, 18.4 R-value garage door, with new weather stripping, is mainly an attempt to reduce the overall heating bill and to keep drafts out. The garage door is a flat panel vs a raised panel and the color scheme is the same. The trim will remain. Attached are pictures of the current conditions and the quote for the replacement.

1. These are pictures showing the existing garage door and the lack of insulation and weather

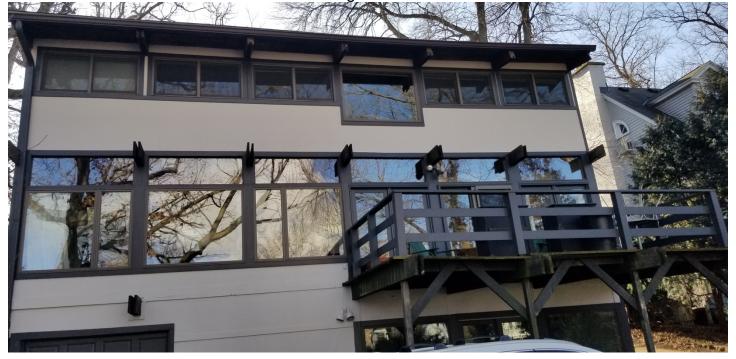
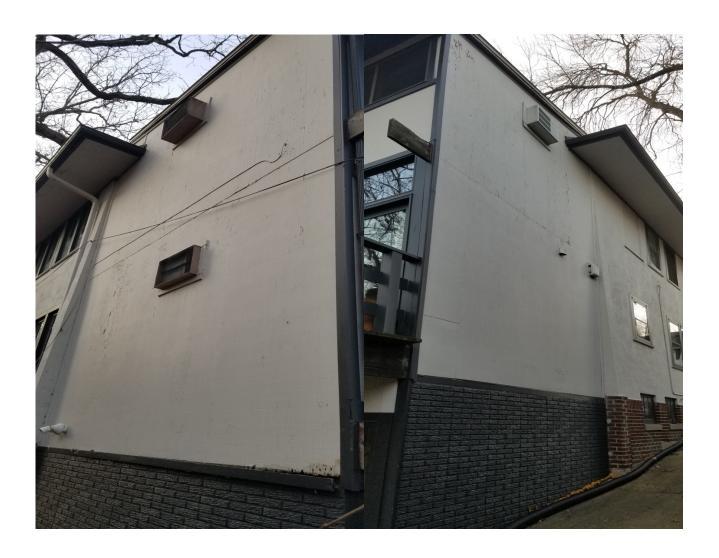
The original house has a hard, cementitious coat of stucco. The addition from the 1970's, on the backside of the house, was sided with painted plywood. There is evidence of water issues that will be fixed prior to the new siding. The proposed plan is to reside the addition with a cementitious stucco to match the original house. There are three faces that will have the cementitious stucco coat applied. The same colors will be used and the original stucco will not be impacted. Attached are photos of the three faces to be resided and a picture of the front side of the house that we will be matching.

These are the three faces that we will be residing. AC units will be removed on side walls.

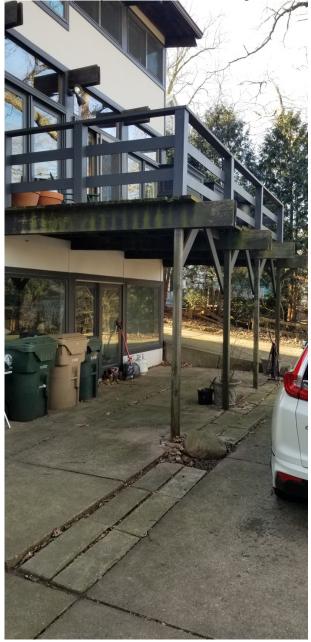
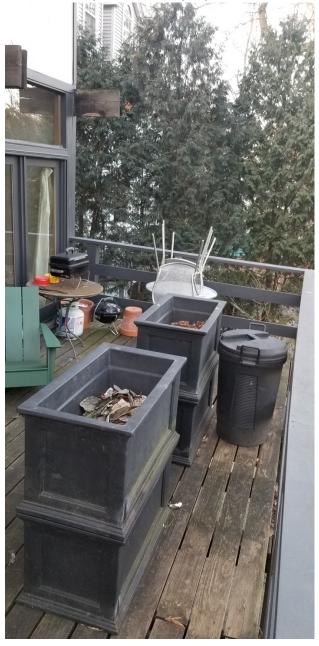
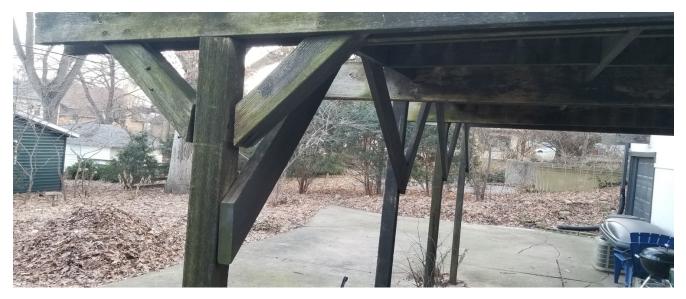
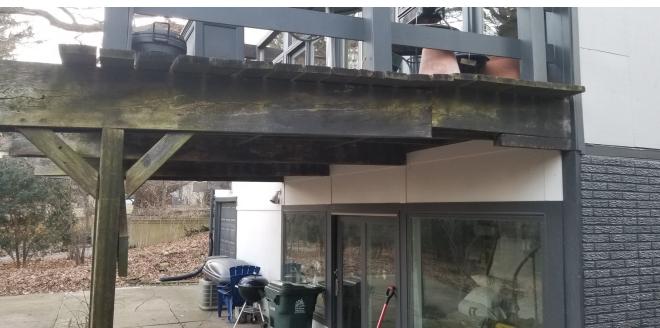
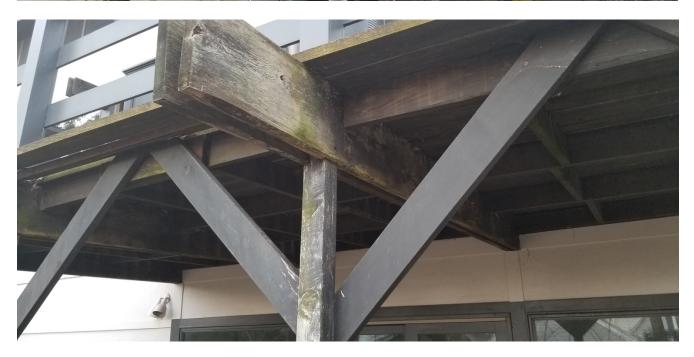
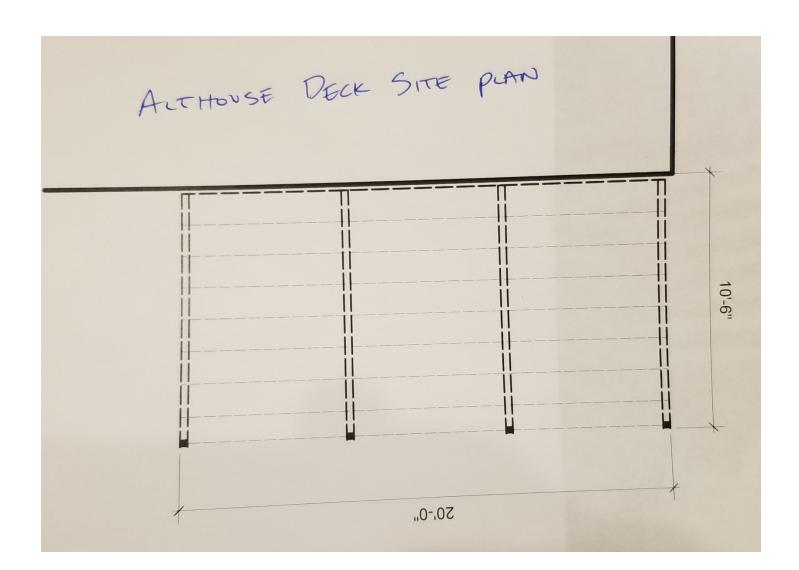
Lastly, the homeowners would like to replace the deck that comes off of the 70's addition. The existing deck has serious structural issues due to poor craftsmanship and weathering. The plan is to rebuild the deck in the same footprint that it exists now. We will shore up the structure with all new framing. The only difference proposed is to run Azek composite decking and a painted cedar railing.

Attached are photos of the existing deck. I have also included a photo of the proposed cedar railing.
