Alpha Chi Sigma Housing, Maintenance, and Financial Overview

Exhibit 1: Pierce Engineering Report & Engineer Diagram

Report for 621 North Lake Street
Madison, WI
Date visited: 6/02/2014
Met with Nick Herman representing the Owner

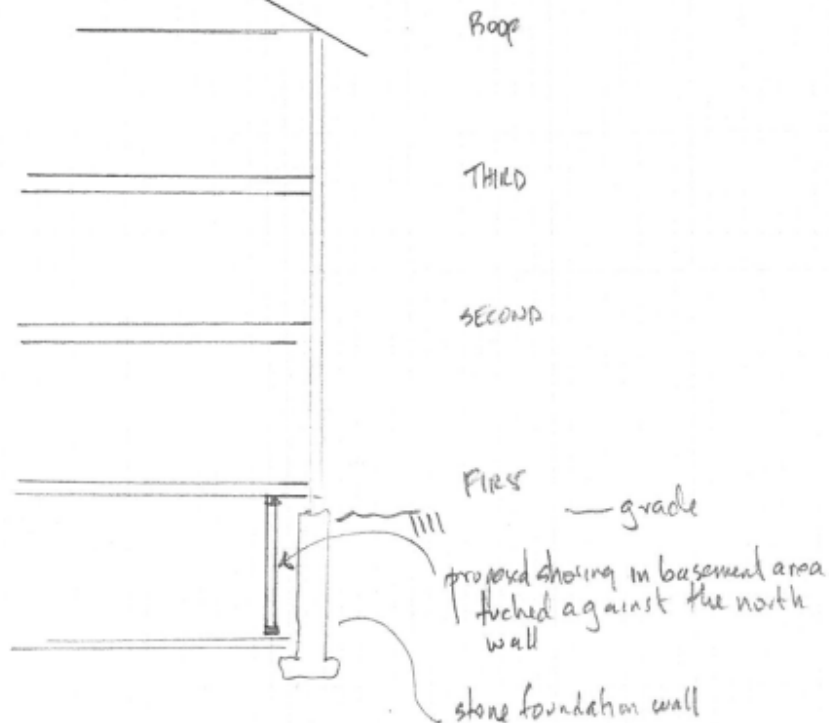
Section looking West @ North Wall
 ntc

The north side exterior wall is moving and causing a loss of support for the first floor joists in the area of the movement. From the outside the top of the basement wall can be seen to be moving to the north. The upper wall area directly above is being pulled outward with the basement wall. The result is a hinge forming at the top of the basement wall level.

In the living room on the first floor the north side of the exterior wall can be observed to be pulling away from the floor. In the basement the stone wall can be seen to have lost much of its mortar in the lower 2-3' of the wall. The stones in this area are loose to hand pressure. There is noted a downspout in the area with no horizontal leader on it. The soil has been eroded below the downspout. The stone wall in the vicinity of the downspout has a large horizontal separation (roughly 4") where the upper portion of the wall has tilted and moved north relative to the bottom portion of the wall.

- b. Place shoring in the basement per the attached sketch. This will hold up the upper wood framing levels best as possible when the basement wall gives up all supporting abilities. There is no estimate that can be provided when this might occur.
 - c. Remove and repair bulged exterior plaster.
2. Longer term
- a. Remove and rebuild the stone wall in the 15' area of the living room. Use reinforced CMU or concrete. Anchor the upper stud wall into this new foundation.
 - b. Remove the exterior plaster in the living room area to view the wood framing conditions behind. The wood wall may be rotted and certainly is out of alignment. The worst case scenario would be to have to re-frame the exterior wood wall in the area of concern.
