LANDMARKS COMMISSION APPLICATION

Project Title/Description: Window replacement on 2nd story

Re: Historic Window Assessment
Jaimie Aranda Residence
115 N. Spooner Street
Madison, WI 53726

Initial Window Condition Assessment

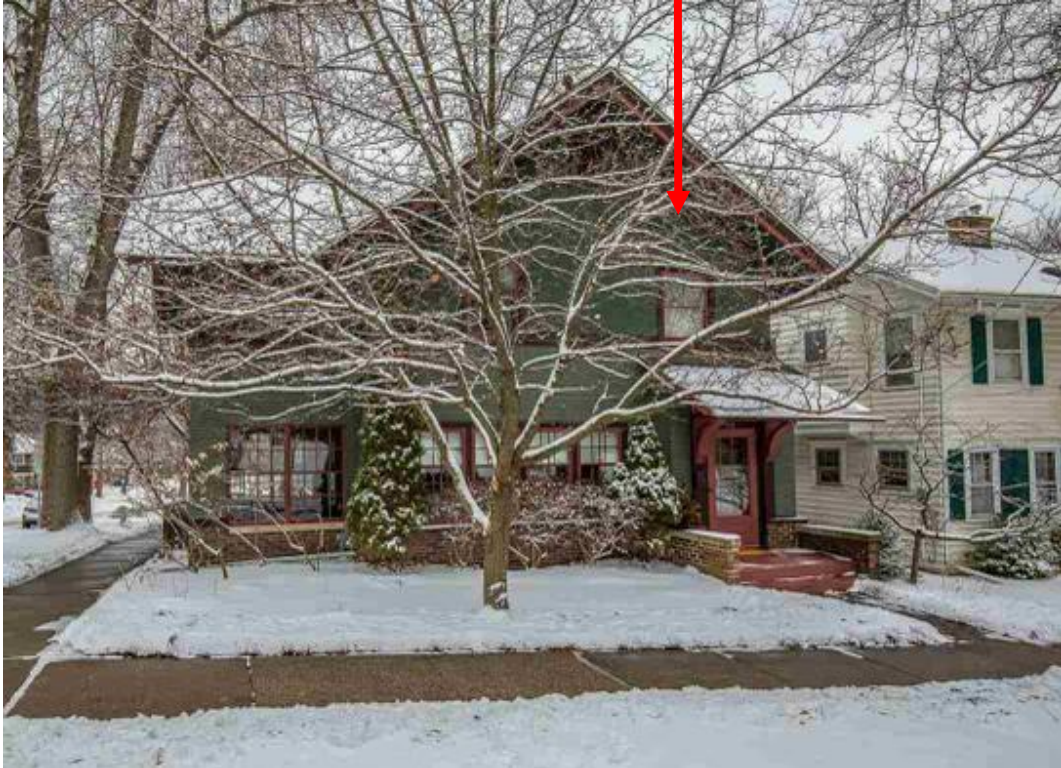
Front of house, Spooner Street view (West side)

- We would like to replace the windows for the following reasons:
 - 7 of the windows to be replaced are in bedrooms on the second story. They are broken or difficult to operate (difficult to open and sometimes fall shut). They do not provide adequate egress for us and our small children.

- Work will be completed by AHT Windows:
 - 4801 Voges Road, Madison, WI 53718; (800) 387-9450 or (715) 823-2125
- Remove 7 windows from upstairs bedrooms (see attached images, windows 1-3 and 5-8) and 1 window in stair landing (south side of home, window 4 in attached images) and replace with new windows that will match the size, operation and grid pattern of the original windows.
- The new windows will be composite that closely resembles wood appearance.
- The new windows will be custom painted to match the existing color.
- Original window frames/jambes will remain intact and not modified.

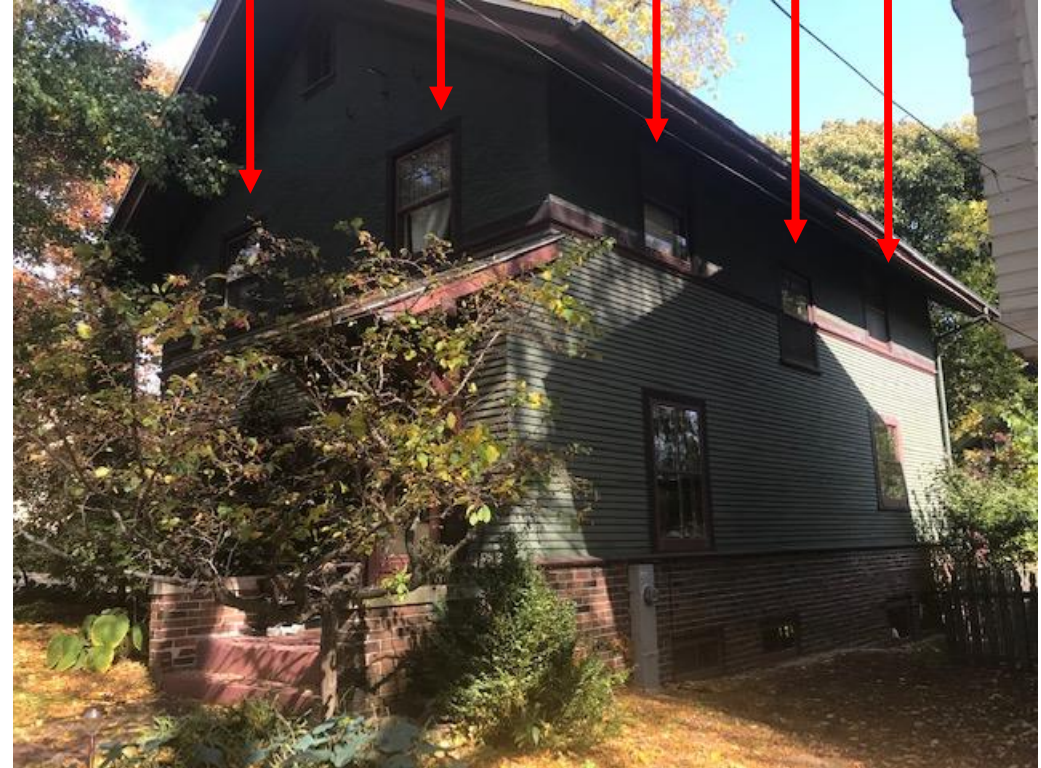
(West side and South side)

- 8th window is on the stair landing and is non-tempered. For additional safety, we want to replace this window.
 - Replacing the windows will improve energy efficiency and allow us to discontinue using the metal storm windows in the colder seasons. These storm windows are metal and not original to the home.
