# History of Metal Roofing

# 4 PRESERVATION BRIEFS

### Roofing for Historic Buildings

#### ROOFING FOR HISTORIC BUILDINGS

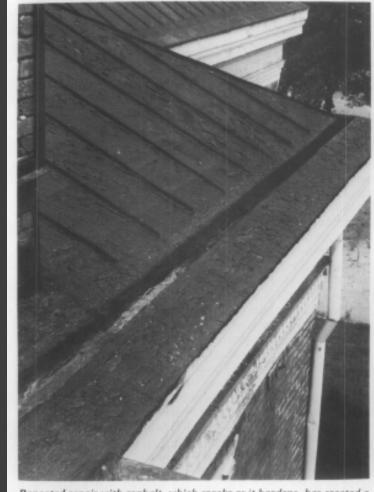
Repeated repair with asphalt, which cracks as it hardens, has created a blistered surface on this sheet-metal roof and built-in gutter, which will retain water. Repairs could be made by carefully heating and scraping the surface clean, repairing the holes in the metal with a flexible mastic compound or a metal patch, and coating the surface with a fibre paint. (Roane County Courthouse, Kingston, Tennessee, photo courtesy of Building Conservation Technology, Inc.)

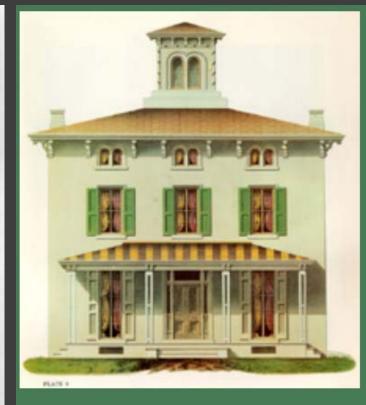
Painting the verandah roof in stripes following the seams in the metal was a fashionable treatment before the Civil War. Manufacturers and technical manuals recommended painting the underside of the metal as well as applying two or three coats to the top. Paints of iron oxide in linseed oil and white lead paint were variously recommended. Since the iron oxide produced a red or brown color, the stripes depicted would have required a tinted white lead paint. (Courtesy of The Athenaeum of Philadelphia)

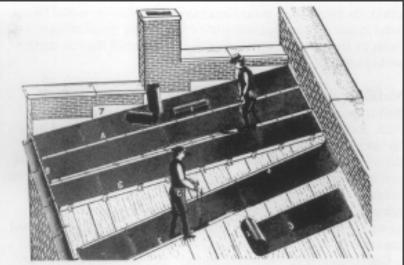
A Chicago firm's catalog dated 1896 illustrates a method of unrolling, turning the edges, and finishing the standing seam on a metal roof.

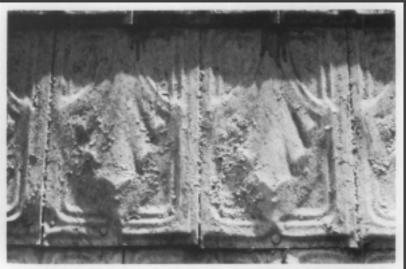
Tin shingles, commonly embossed to imitate wood or tile, or with a decorative design, were popular as an inexpensive, textured roofing material. These shingles 8<sup>3</sup>/<sub>8</sub> inch by 12<sup>1</sup>/<sub>2</sub> inch on the exposed surface) were designed with interlocking edges, but they have been repaired by surface nailing, which may cause future leakage. (Ballard House, Yorktown, Virgina, photo by Gordie Whittington, National Park Service)

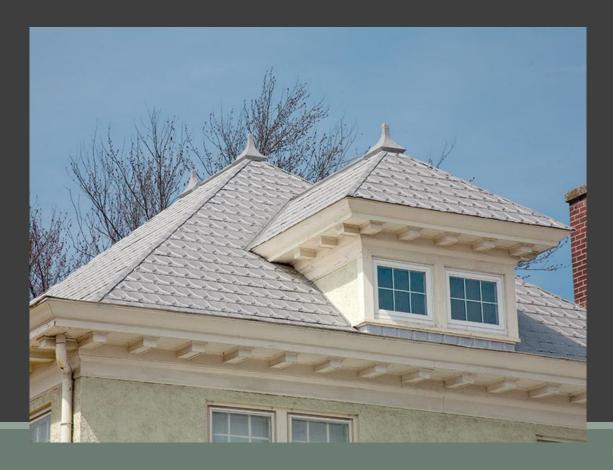
Fac-simile of beginning of first two courses.

As seen by the cut, our shingles are the same to-day as when first introduced. Remember, no cleats or springs are necessary in using our shingles. The lock is simple and perfect, with corrugations across the top, and bracing corrugations across the exposed end of the shingles, which stiffen and hold the shingles firmly to the underlying courses. They are easily applied, and any one who can lay a wood shingle can lay these. We furnish them in four sizes, made from charcoal roofing-tin, painted both sides, and unpainted; galvanized tin plate, which is superior to galvanized iron; cold rolled copper and steel plates. We keep on hand a full line of roofing sundries.

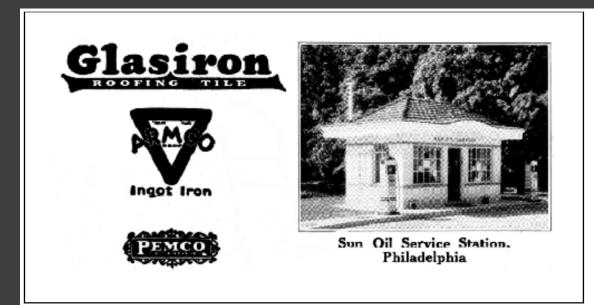
Emphasizing its two trademark components this enameled shingle was described in the 1929 **Sweet's Architectural Catalogue**: "The base Armco ingot iron and the two coats of Pemco glass fused together at 1600 degrees F., produce a roofing tile extremely durable and of permanent beauty." (**Sweet's Architectural Catalogue**, 1929. Courtesy of The Sweet's Group, The McGraw-Hill Companies, Inc.)

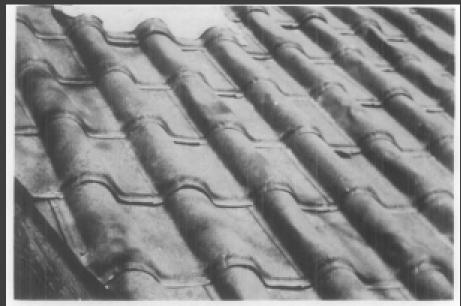
Galvanized sheet-metal shingles imitating the appearance of pantiles remained popular from the second half of the 19th century into the 20th century. (Episcopal Church, now the Jerome Historical Society Building, Jerome, Arizona, 1927)
