2023 E Washington Avenue (TID 52) Blight Study

Madison, WI

Prepared by MSA Professional Services, Inc.
April 14, 2023

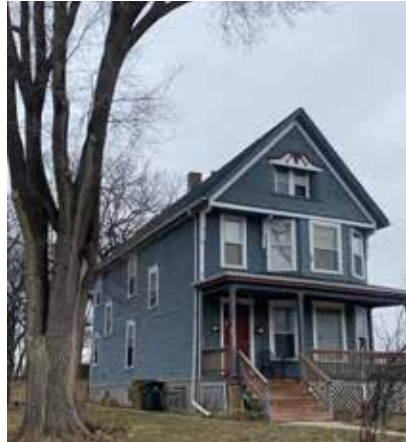
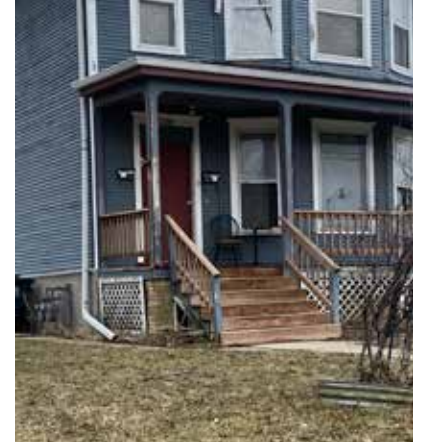
PARCEL NO. 8 (3230 Commercial Ave)

Score: 32.5

Drives/Parking/Walks: significant pavement deterioration, Erosion and Stormwater: evidence of water pooling, Major Maintenance: trash, Public Sidewalk: no public sidewalk, Storage & Screening: none.

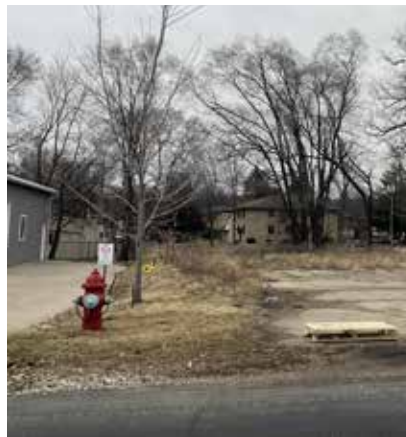
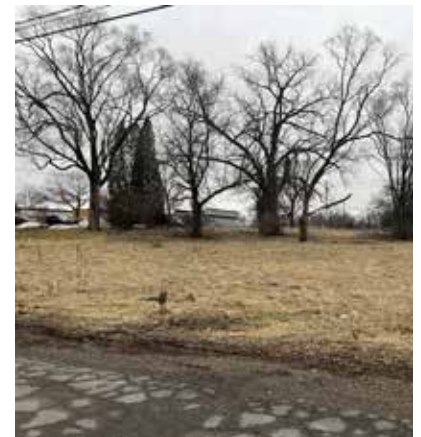
PARCEL NO. 15 (3553 Ridgeway Ave)

Score: 33.4

Accessory Structures: garage: missing door and unsightly temporary entrance covering; paint peeling; sagging gutter and missing downspouts, Building not Handicap Accessible: true, Chimneys & Vents: rust on vent, Drives/Parking/Walks: unpaved and flooded, Erosion and Stormwater: water pooling, Exterior Doors & Entrances: door: faded; entranceways: flooded, Exterior Stairs/Stoops/Ramps: discolored, rotten and worn wooden stairs, Foundation: discolored, chipping concrete, and peeling paint, Major Maintenance: piled up trash, Porches & Overhangs: porches: discolored and rotten wood; Public Sidewalk: none, Roof: missing fascia covering, Storage & Screening: storage: piled up trash; screening: discolored and missing element on wooden fence.

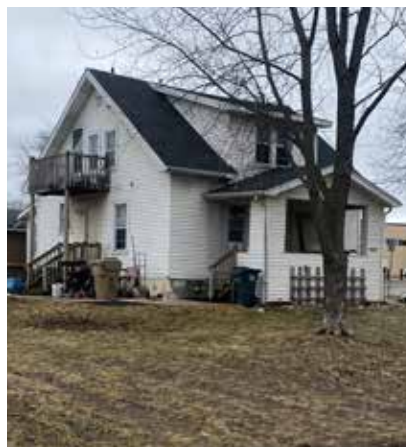
**PARCEL NO. 21 (3608 E Washington Ave)
Score: 48**

Drives/Parking/Walks: cracks, Erosion and Stormwater: water pooling, Major Maintenance: trash; unsightly concrete barriers, Occupancy: small, irregularly-shaped lot.

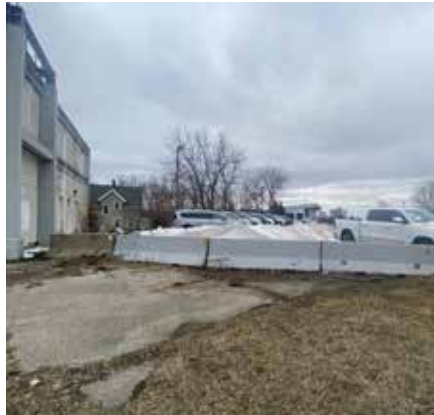
**PARCEL NO. 23 (3566 E Washington Ave)
Score: 51.6**

Building not Handicap Accessible: true, Drives/Parking/Walks: cracking and deterioration throughout, Erosion and Stormwater: evidence of water pooling, Exterior Stairs/Stoops/Ramps: rust on stairs handrail, Foundation: discolored and unmatched painting, Major Maintenance: large tree stump, Signage & Lighting: rust and missing element on sign post, Storage & Screening: discolored and missing element on wooden fence, Walls & Cladding: cladding: dented, Windows & Awnings: front window frame rotted.

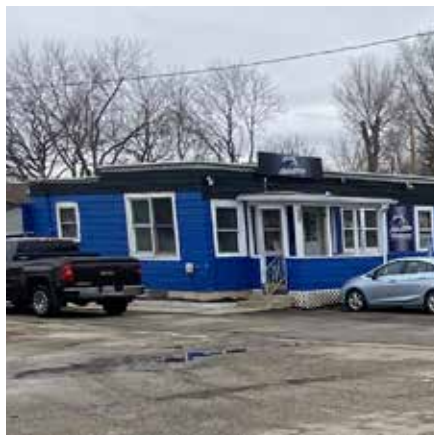
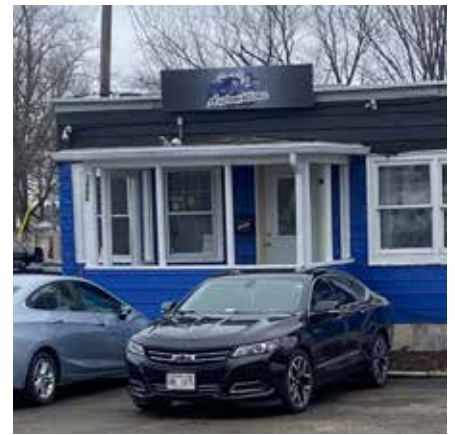
**PARCEL NO. 25 (3582 E Washington Ave)
Score: 54.7**

Chimneys & Vents: discolored and rust on vent, Drives/Parking/Walks: minor cracking, Exterior Doors & Entranceways: faded; and dent and opening on the garage door, Foundation: discolored, paint peeling, and minor crack, Minor Maintenance: rusty guard rail, Occupancy: does not appear to be in use as a garage, Storage & Screening: rust on post and chain fence, Walls & Cladding: wall: faded, crack, mismatched painting and missing mortar, rusty.

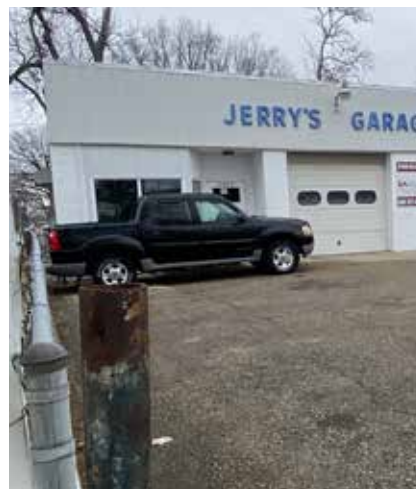
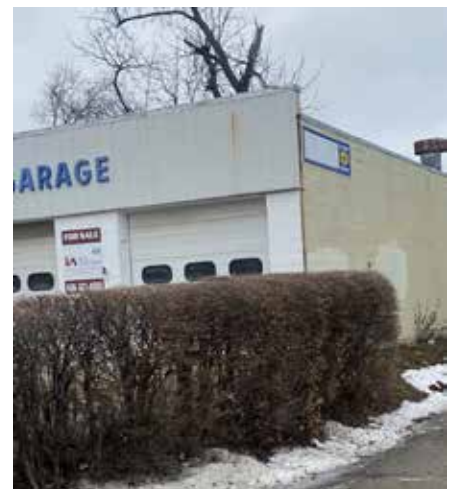
PARCEL NO. 26 (3586 E Washington Ave)
Score: 47.9

Chimneys & Vents: missing vent cap, Drives/Parking/Walks: cracked and water pooling, Erosion and Stormwater: water pooling, Exterior Doors & Entrances: door: rust on handle; and garage door and frame, Major Maintenance: piled up trash, Signage & Lighting: missing element on signage, Storage & Screening: storage: piled up trash; screening: missing element and falling fence, Walls & Cladding: cladding: dented at corners.

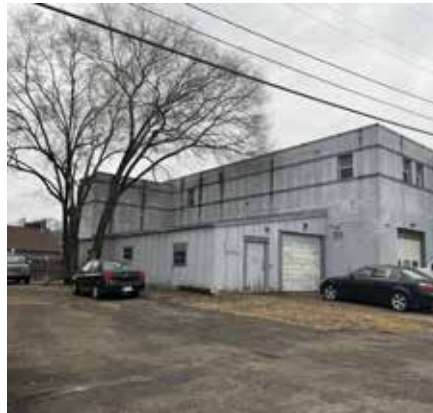
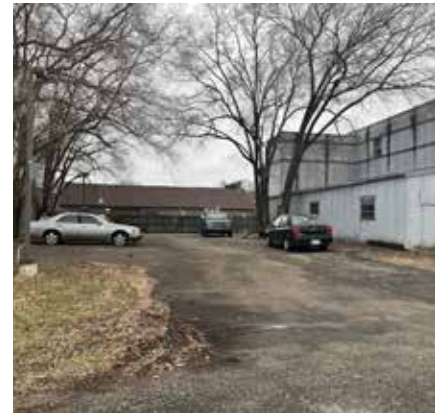
PARCEL NO. 37 (3539 E Washington Ave)
Score: 51.2

Drives/Parking/Walks: pavement cracked and deteriorating, Erosion and Stormwater: water pooling in parking lot, Porches & Overhangs: discolored roof and canopy; chipping on exposed wood joist; Walls & Cladding: discolored, paint peeling, water damage.

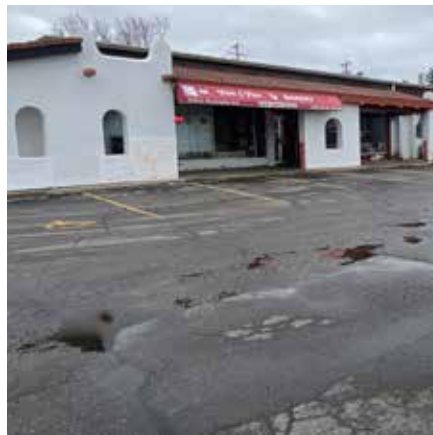
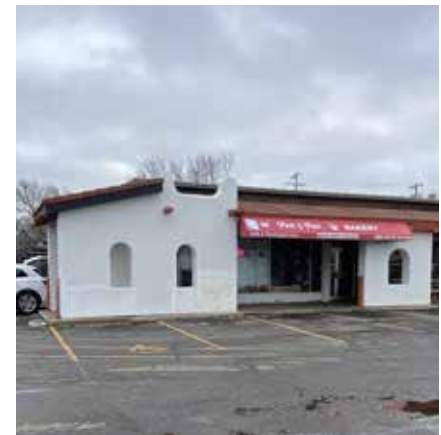
PARCEL NO. 38 (3366 E Washington Ave)

Score: 52.9

Accessory Structures: garage: discolored, missing, and rotten cladding, Building not Handicap Accessible: true, Chimneys & Vents: discolored and rust, Drives/Parking/Walks: minor crack, Exterior Doors & Entrances: door: faded; entranceway: not visible, Exterior Stairs/Stoops/Ramps: stair: peeling paint; chipping concrete; and missing rail, Foundation: discolored, peeling paint and chipping concrete, Major Maintenance: piled up trash, Porches & Overhangs: discolored, rotten and deteriorating wooden porch at the rear second floor, Roof: discolored, Storage & Screening: storage: piled up trash; screening: discolored and rotten wooden fence, Walls & Cladding: faded.

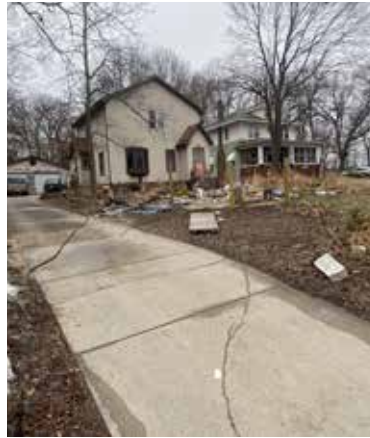
PARCEL NO. 46 (1618 Rowland Ave)

Score: 35.9

Accessory Structures: Garage: missing fascia board; missing door; falling off window; and mismatched siding color, Building not Handicap Accessible: true, Drives/Parking/Walks: unpaved driveway and parking, Erosion and Stormwater: water pooling, Exterior Doors & Entrances: door: discolored; graffiti on door glass; deteriorating wooden frame; entranceways: discolored; crack, Exterior Stairs/Stoops/Ramps: stair: discolored; missing rail; and deteriorating wooden stairs, Foundation: discolored and chipping concrete at the front edge, Major Maintenance: piled up trash, Porches & Overhangs: rear porch roof: discolored, Public Sidewalk: none, Storage & Screening: piled up trash; rust on post and wire fence, Walls & Cladding: Cladding: discolored and peeling paint, Windows & Awnings: Window: discolored and deteriorated wooden frame; and graffiti on exterior glass.

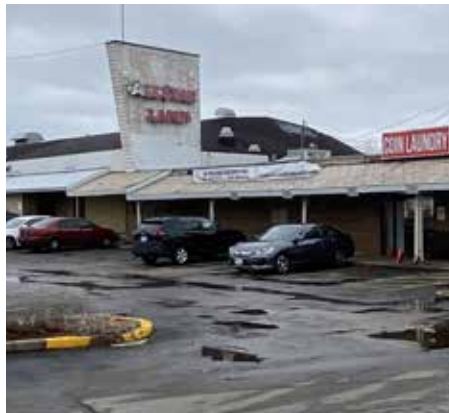
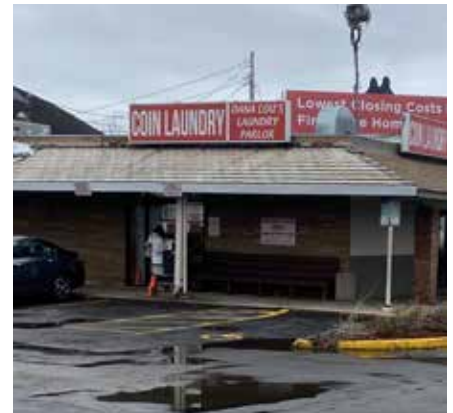
PARCEL NO. 42 (3396 Ridgeway Ave)
Score: 53

No public sidewalk.

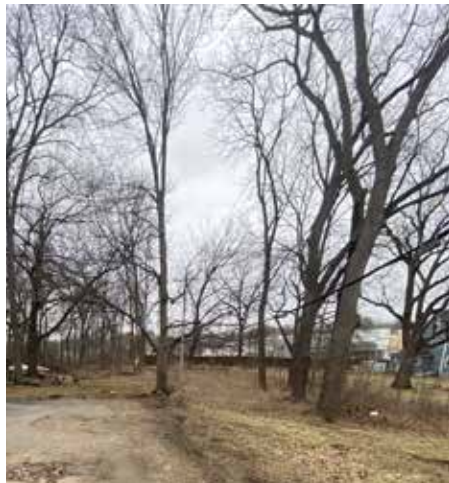
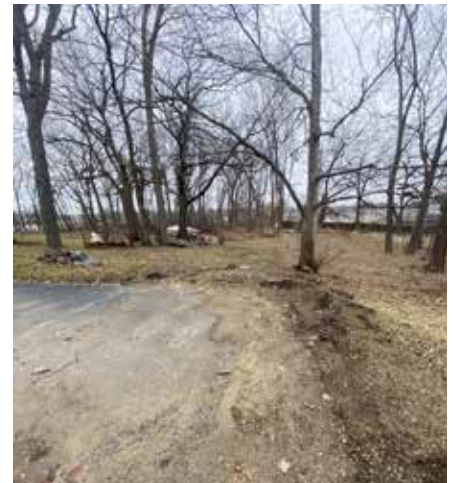
PARCEL NO. 51 (3102 Commercial Ave)
Score: 48.6

Accessory Structures: Rear storage structure: In extremely poor condition, Drives/Parking/Walks: Parking pavement: discolored and minor cracks, Exterior Doors & Entranceways: Doors: discolored, interior glass has a ripped plastic over it, Exterior Stairs/Stoops/Ramps: none, Gutters & Downspouts: gutters: Missing and falling gutters; downspouts: stained, Minor Maintenance: Overgrown shrubs, Public Sidewalk: No public sidewalk, Signage & Lighting: Side signage area: missing sign remnant support in poor condition with a sagging wall lighting; Address sign rusted, Storage & Screening: Faded pole fence, collapsing and rusting iron pipe gate, and discolored wall fence, Walls & Cladding: siding: faded, mismatch paint treatment on the side and bent siding at the base.

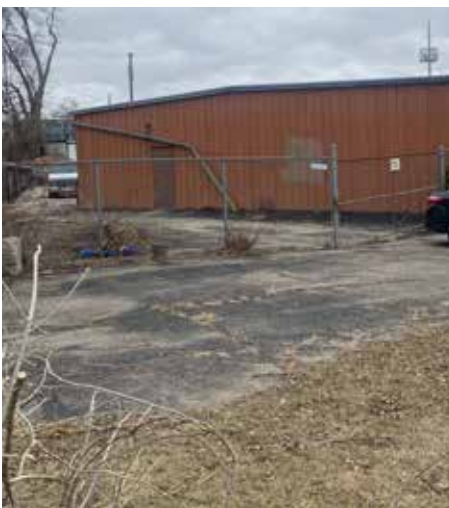
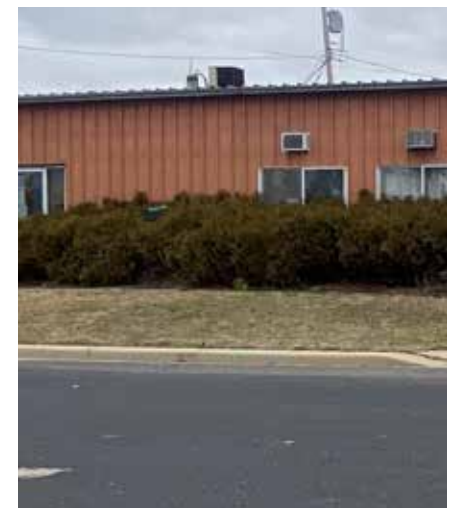
PARCEL NO. 53 (3165 E Washington Ave)

Score: 58.8

Accessory Structures: none, Drives/Parking/Walks: minor cracking all through the parking and driveway; chipping along curb, Foundation: Rear side: minor cracking, stain and paint chipping off, Gutters & Downspouts: slight displacement of the downspout cap at the rear, Major Maintenance: graffiti on curbing, Minor Maintenance: overgrown shrubs, Public Sidewalk: No public sidewalk, Signage & Lighting: crooked sign post, Storage & Screening: fence: bent, Walls & Cladding: Block wall: cracked, stained, and paint peeling at the side and rear; Brick: discolored ; parapet wall: discolored, missing mortar, chipping and discolored cap, Windows & Awnings: Front Window: wooden plastic behind window ; concrete seal chipping and discolored; window frame deteriorating ; bent awnings support.

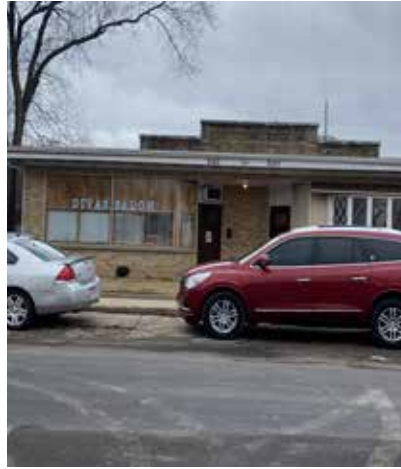
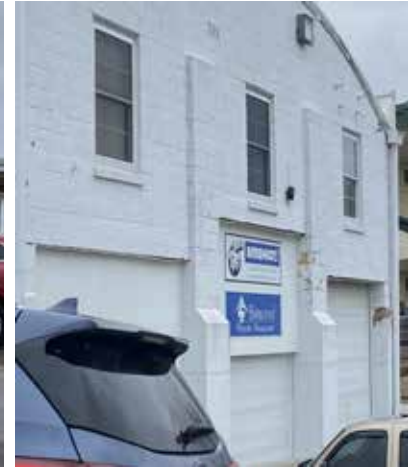
PARCEL NO. 62 (3575 E Washington Ave)

Score: 29

Accessory Structures: faded; peeling paint; rust at the base of the cladding; chipping and discolored fascia, Building not Handicap Accessible: true, Chimneys & Vents: rust on chimney, Drives/Parking/Walks: major cracks and potholes, Erosion and Stormwater: water pooling, Exterior Doors & Entranceways: doors: faded, Exterior Stairs/Stoops/Ramps: stairs: discolored, chipping concrete, and rust on hand rails, Gutters & Downspouts: discolored, Major Maintenance: piled up trash, Roof: discolored, mismatched shingles, Signage & Lighting: signage: rust on pole and frame; missing component and faded board, Storage & Screening: piled up trash; rusty and discolored post and chain fence, Walls & Cladding: wall: faded and peeling paint; crack; and missing mortar; cladding: faded, Windows & Awnings: deteriorating window frame, unsightly reflecting plastic cover behind class; missing glass at the gable window.

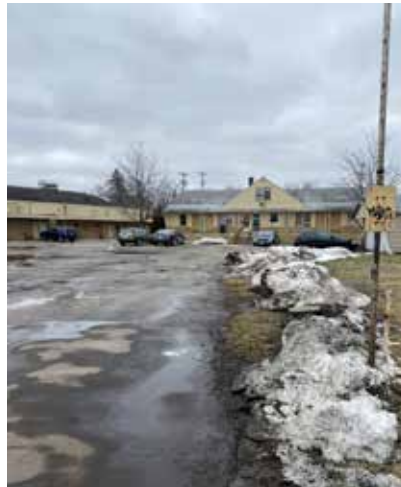
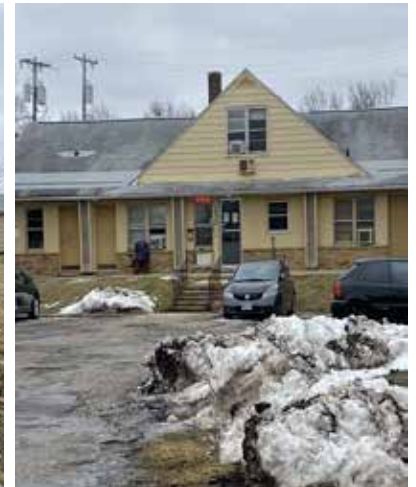
PARCEL NO. 65 (3361 E Washington Ave)

Score: 51.3

Drives/Parking/Walks: crack, Erosion and Stormwater: water pooling, Exterior Doors & Entranceways: door: okay; entranceway discolored and cracked, Foundation: foundation: faded and peeling paint; and minor crack, Porches & Overhangs: discolored, rust on cladding and supporting rods, Signage & Lighting: signage: rust on the post and frame, Walls & Cladding: wall: discolored, cracked ,and chipping brick at the base of the front wall.

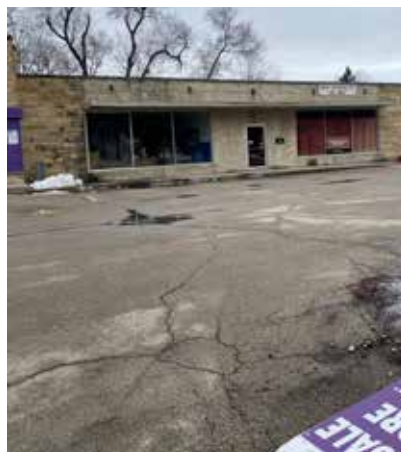
PARCEL NO. 77 (1010 Mayfair Ave)

Score: 59

Drives/Parking/Walks: driveway: cracked, deteriorating, Exterior Stairs/Stoops/Ramps: stair: chipping concrete on edges, Storage & Screening: screening: faded wooden fence; rust on pole and chain fence, Walls & Cladding: siding: faded, discolored, Windows & Awnings: rust on window frame.

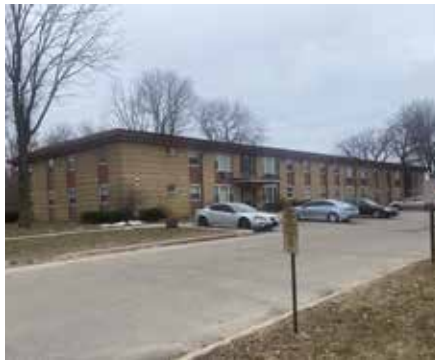
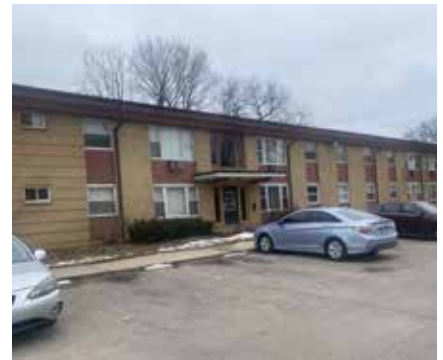
PARCEL NO. 78 (3392 Ridgeway Ave)

Score: 47

Major Maintenance: piled up trash, Public Sidewalk: none, Signage & Lighting: none.

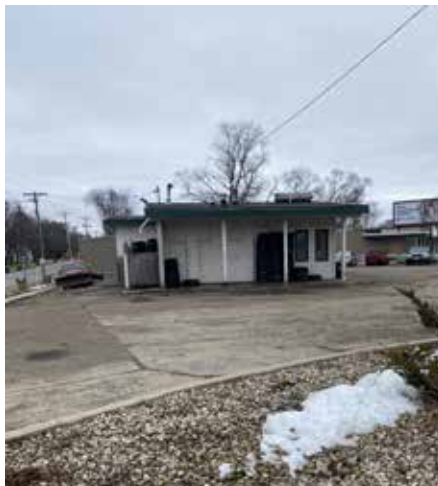
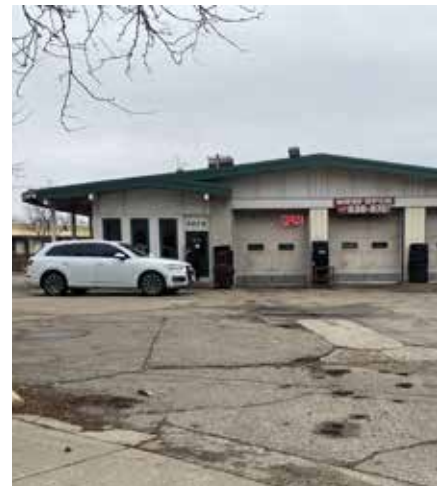
PARCEL NO. 83 (3100 E Washington Ave)
Score: 55.7

Drives/Parking/Walks: minor cracking, Erosion and Stormwater: evidence of water pooling, Minor Maintenance: landscaping plastic showing through in places, Occupancy: building appears to be vacant, Roof: missing element on roof covering; little rust on fascia cover, Walls & Cladding: wall: discolored.

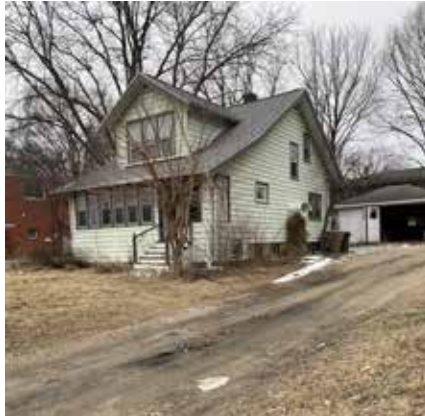
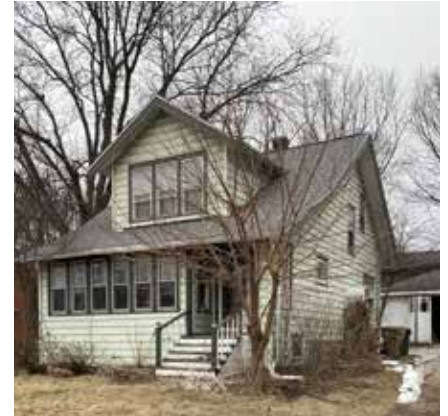
PARCEL NO. 87 (3230 E Washington Ave)
Score: 56.4

Building not Handicap Accessible: true, Drives/Parking/Walks: driveway unpaved, rutted, Exterior Doors & Entranceways: entranceways not paved, Exterior Stairs/Stoops/Ramps: stair: rust on handrail and concrete chipping at the base, Foundation: peeling paint; and chipping concrete, Porches & Overhangs: peeling paint and discolored on front porch, Roof: discolored; missing component and peeling paint on the fascia, Walls & Cladding: faded, peeling paint, and chipping wooden wall frame at the rear, Windows & Awnings: window: chipping wooden frame at the rear.

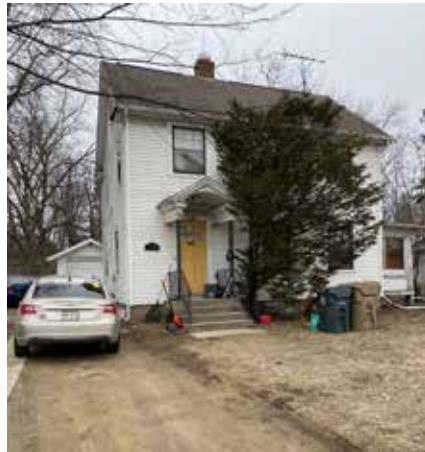
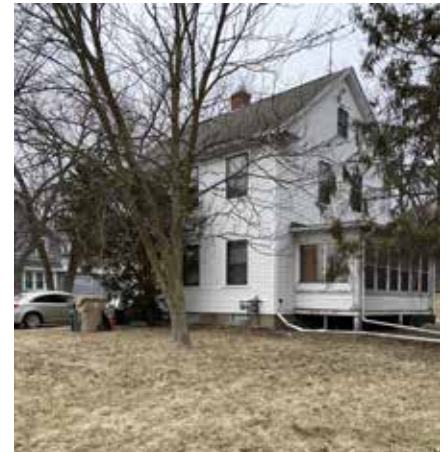
PARCEL NO. 94 (3715 E Washington Ave)

Score: 56.7

Chimneys & Vents: rust on chimneys,
 Drives/Parking/Walks: major cracks,
 Erosion and Stormwater: water pooling,
 Exterior Doors & Entranceways: discolored,
 Exterior Stairs/Stoops/Ramps: discolored,
 Foundation: crack, stain, and discolored,
 Gutters & Downspouts: Downspouts:
 disconnected ; Gutter: discolored and bent,
 Major Maintenance: broken retaining wall,
 Roof: discolored; sagging eaves; and rotten
 wooden fascia boards, Signage & Lighting:
 Signage: discolored, Storage & Screening:
 dumpsters unscreened, Walls & Cladding:
 stained and discolored brick wall.

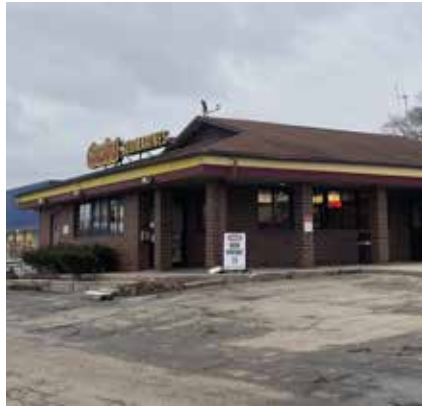
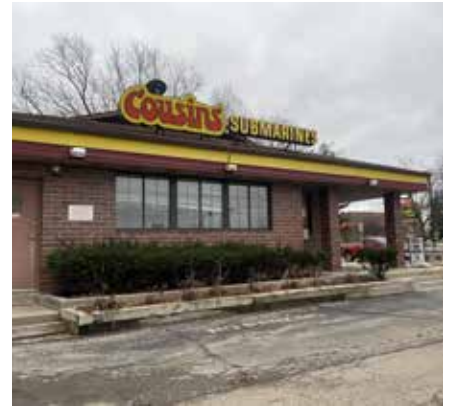
PARCEL NO. 99 (3401 E Washington Ave)

Score: 52.1

Drives/Parking/Walks: minor cracking,
 Occupancy: vacant building, surrounded
 by fencing, Porches & Overhangs: rust and
 paint peeling on entrance porch, Storage
 & Screening: rust on pole and chain fence,
 Walls & Cladding: discolored and missing
 mortar, Windows & Awnings: missing
 element on frame; discolored wooden
 covering; and chipping concrete seal.

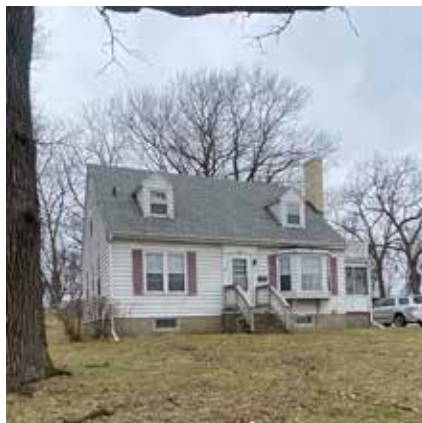
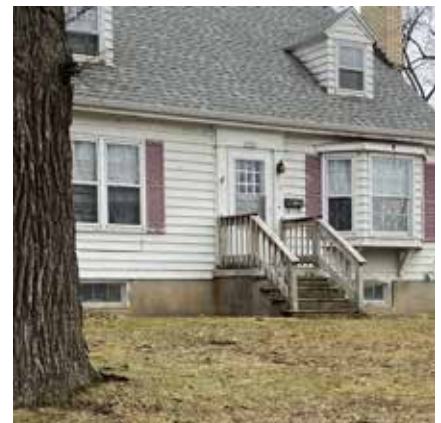
PARCEL NO. 101 (1013 Grover St)

Score: 56.3

Building not Handicap Accessible: true, Drives/Parking/Walks: pavement: cracked and deteriorating, debris accumulating, Exterior Doors & Entranceways: entrance way: piled up trash; door: missing panel on garage door; screen porch door screening ripped open, Exterior Stairs/Stoops/Ramps: discolored and cracked concrete stairs, Minor Maintenance: toys in yard, Porches & Overhangs: faded and unstained wooden porch, Public Sidewalk: no sidewalk, Roof: peeling paint on garage fascia, Storage & Screening: wooden retaining wall: discolored, rotten, and collapsing, Walls & Cladding: cladding: stained and paint peeling.

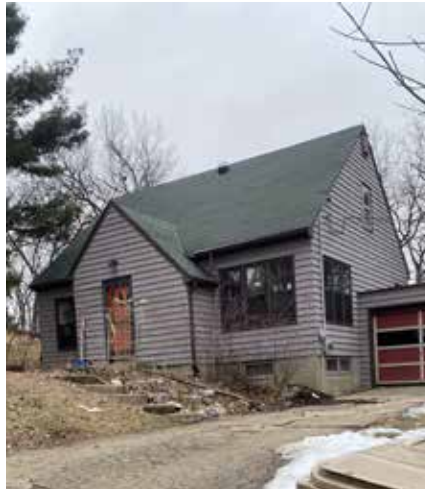
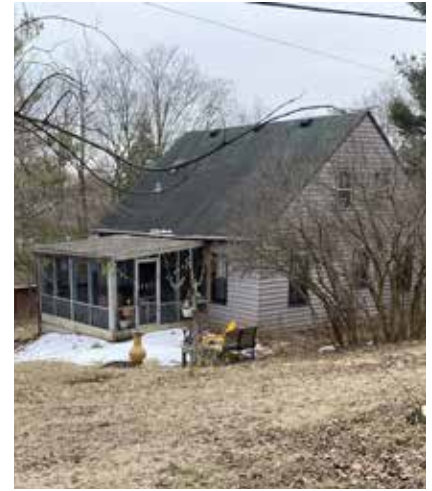
PARCEL NO. 102 (1413 Reindahl Ave)

Score: 55.5

Accessory Structures: Garage: damage roof; missing fascia cover and garage door; fallen cladding at the front edge; Store: discolored door frame and rust on cladding at the base, Drives/Parking/Walks: no walkways to house; driveway pavement breaking down, growing grass, Erosion and Stormwater: water pooling, Exterior Doors & Entranceways: door: discolored, unpainted wooden frame, Exterior Stairs/Stoops/Ramps: ramp: discolored and chipping concrete, Major Maintenance: trash in yard, Roof: fascia discolored, Signage & Lighting: trash container in front of house, Storage & Screening: piled up trash; fence rusty and crooked.

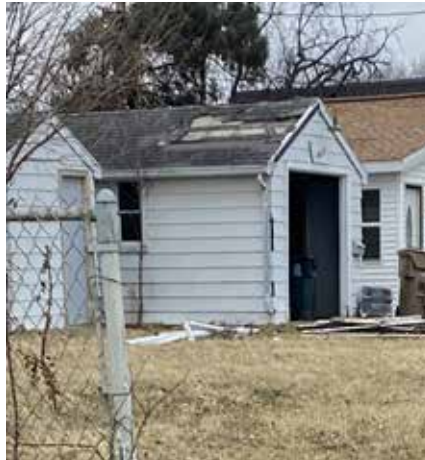
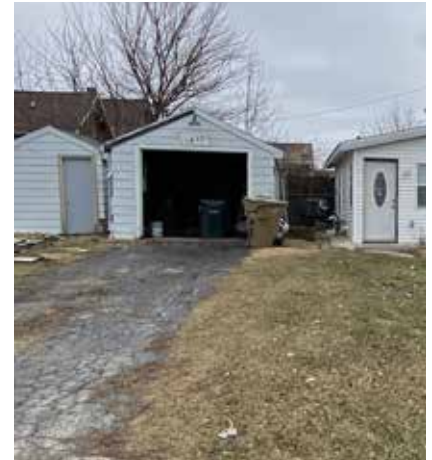
PARCEL NO. 103 (3585 Ridgeway Ave)

Score: 49.6

Building not Handicap Accessible: true, Drives/Parking/Walks: minor crack, Exterior Doors & Entranceways: Door: discolored, rotten wooden frame, and stained panel, Exterior Stairs/Stoops/Ramps: Stair: discolored and chipping concrete, Gutters & Downspouts: dirt in the gutters and broken downspout at the side, Major Maintenance: piled up trash, lawn damaged by vehicle parking, Porches & Overhangs: porch: peeling paint on eaves; stain and faded wooden frame, Roof: rotten fascia board, Storage & Screening: piled up trash; rust on fence, Walls & Cladding: Cladding: discolored, stained, and peeling paint, Windows & Awnings: discolored and chipping window frame.

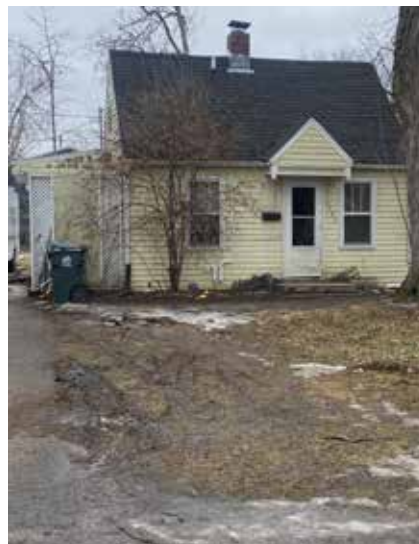
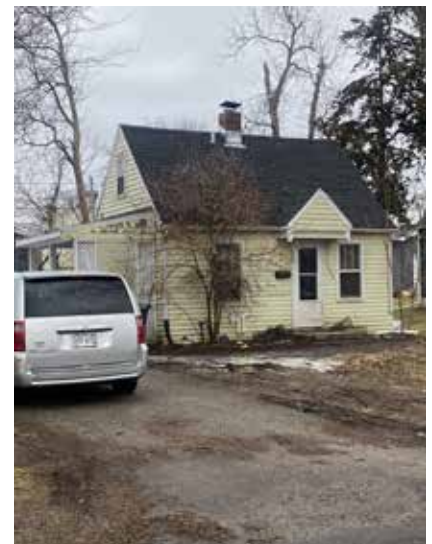
PARCEL NO. 104 (1617 Schmedeman Ave)
Score: 44.5

Accessory Structures: plywood covering garage door opening; faded and peeling paint on fascia board, Drives/Parking/Walks: unpaved; piled up trash, Erosion and Stormwater: evidence of water pooling, Exterior Doors & Entranceways: Entrance door: faded; damaging, Gutters & Downspouts: gutter: discolored and peeling paint; growing weeds, Major Maintenance: piled up trash, Roof: discolored, peeling paint, and chipping fascia board, Storage & Screening: piled up trash; discolored and rotten wooden fence.

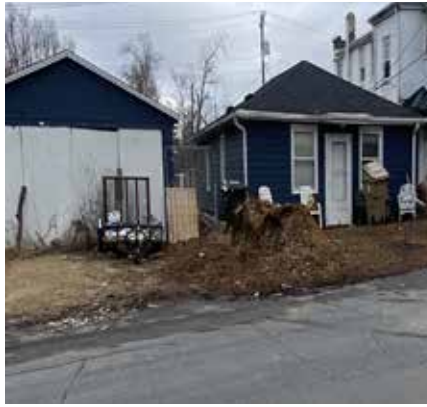
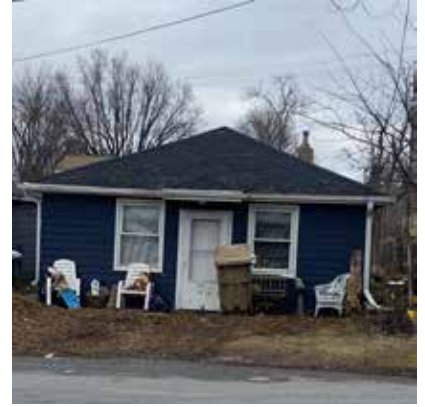
PARCEL NO. 108 (3177 E Washington Ave)
Score: 56.8

Chimneys & Vents: rust and dent on the chimneys and HVAC equipment, Drives/Parking/Walks: cracking, deterioration, Exterior Doors & Entranceways: faded door at the rear, Major Maintenance: Trash and junk at different locations, retaining walls failing, large tree branches in landscaping, Roof: main roof not visible; slight opening and sagging on the roof fascia cladding at the rear and side, Storage & Screening: no screening for dumpster, Walls & Cladding: brick is stained, water damaged, Windows & Awnings: chipping and discolored window frame at the rear.

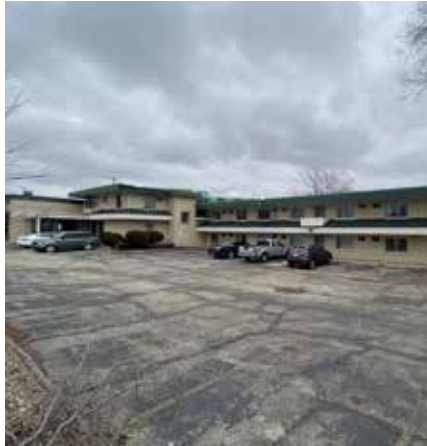
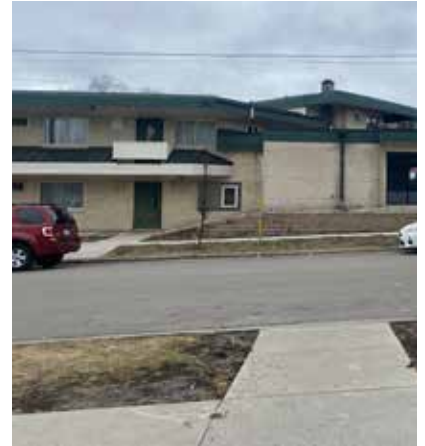
PARCEL NO. 115 (3229 Ridgeway Ave)
Score: 45

Minor Maintenance: weedy, overgrown, Public Sidewalk: none.

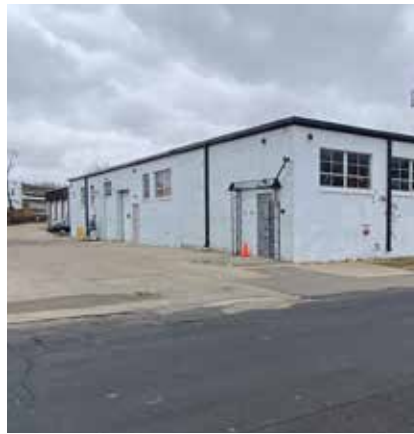
PARCEL NO. 121 (3501 E Washington Ave)

Score: 59.8

Chimneys & Vents: discolored and rust, Drives/Parking/Walks: significant cracking, Erosion and Stormwater: water pooling, Exterior Doors & Entranceways: rear door: faded, peeling paint, and rusted door panel, Exterior Stairs/Stoops/Ramps: Ramp: discolored, cracked and chipping concrete, Porches & Overhangs: rusted porch pole, Signage & Lighting: faded signage at the front, Storage & Screening: rusted pole and chain fence, Walls & Cladding: Cladding: faded; peeling paint; rust; and folded panel and edges.

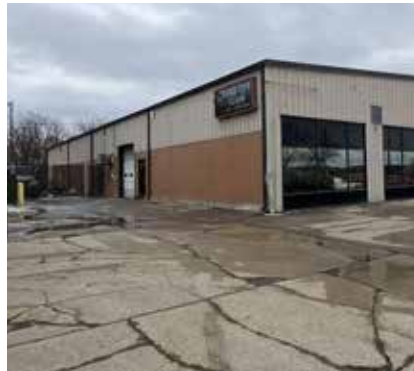
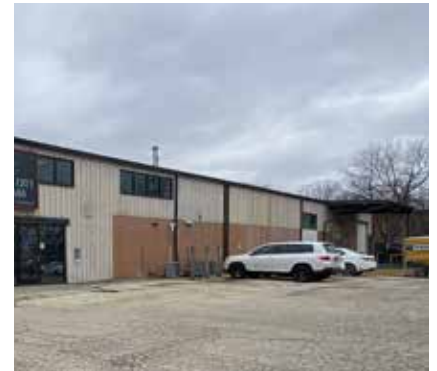
PARCEL NO. 130 (3370 E Washington Ave)

Score: 57.4

Accessory Structures: Garage: leaning, faded roof, peeling fascia board paint, missing or broken garage door, junk around the garage, Building not Handicap Accessible: true, Chimneys & Vents: discolored, Drives/Parking/Walks: discolored, major cracking, Erosion and Stormwater: evidence of water pooling, Exterior Stairs/Stoops/Ramps: discolored, cracked and chipping entrance stairs, Foundation: discolored concrete foundation, Major Maintenance: piled up trash, Porches & Overhangs: discolored porch wall and chipping concrete cover at the front, and rotten wooden rail at the rear terrace, Roof: faded roof covering and peeling paint on the fascia board, Storage & Screening: junk on site, Walls & Cladding: discolored brick wall and cladding.

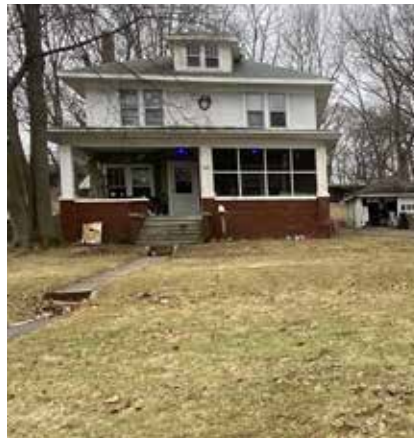
PARCEL NO. 133 (3602 E Washington Ave)
Score: 21.5

Drives/Parking/Walks: pavement failing, crumbling, Erosion and Stormwater: soil and pavement eroding onto sidewalk, Exterior Doors & Entranceways: rotten wooden door frame at the side, Exterior Stairs/Stoops/Ramps: discolored and cracked entrance ramp, Major Maintenance: trash all over site, Minor Maintenance: grown weeds around the building and parking lot, Occupancy: Appears empty, Storage & Screening: not properly aligned concrete screening, Walls & Cladding: discolored, varied painting, and little cracking on the wall, Windows & Awnings: poorly sealed up windows.

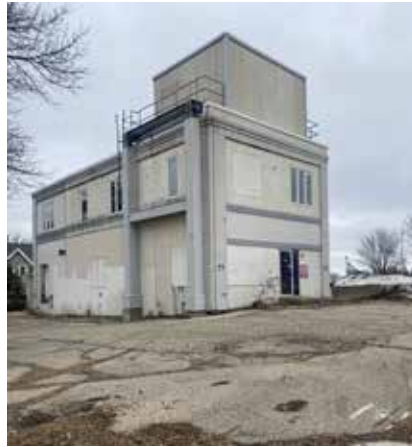
PARCEL NO. 68 (3562 E Washington Ave)
Score: 43.6

Drives/Parking/Walks: cracking and potholes, Exterior Doors & Entranceways: door: deteriorating frame; Foundation: discolored, chipping brick, Gutters & Downspouts: sagging gutter, Major Maintenance: trash around building, Roof: dented, discolored, Storage & Screening: discolored and deteriorating wooden fence, Walls & Cladding: discolored, irregular painting, opening on cladding at the side.

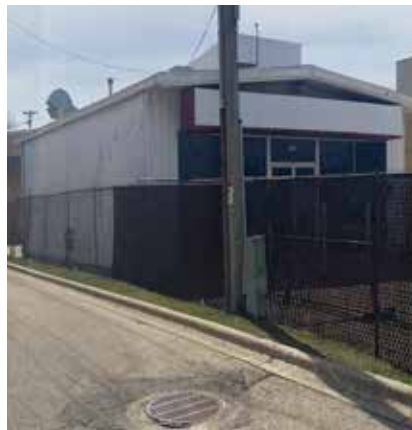
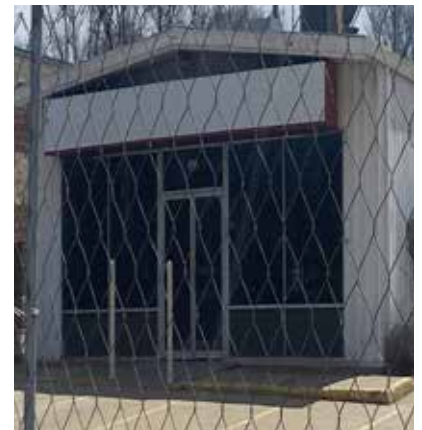
PARCEL NO. 120 (3433 E Washington Ave)
Score: 56.3

Drives/Parking/Walks: cracking, some deterioration, Exterior Doors & Entranceways: entranceways: discolored, Storage & Screening: fence: rust on the base of the post, Walls & Cladding: stained and discolored, peeling paint.

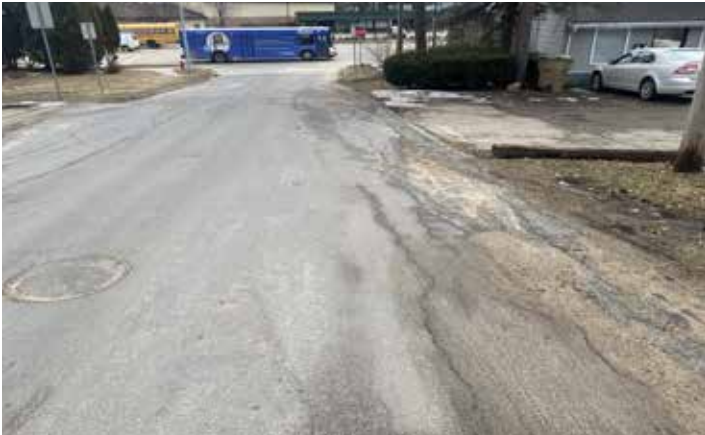
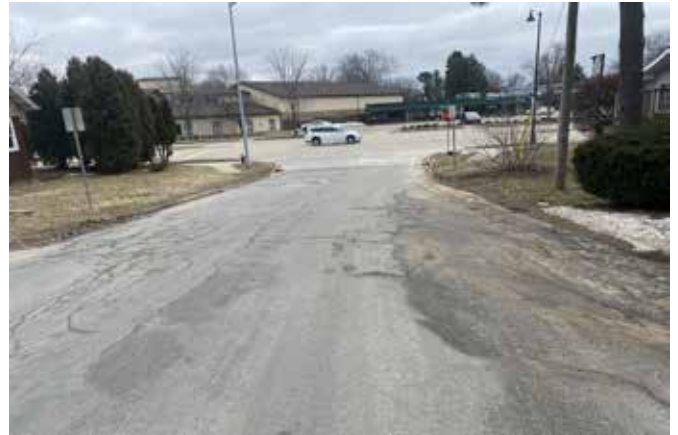
Carpenter Str, off E Washington Ave. (fair to poor condition, crack, uneven surfaces)

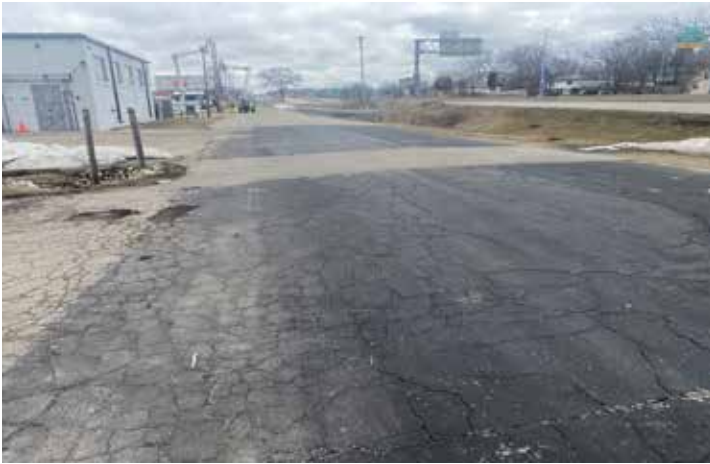
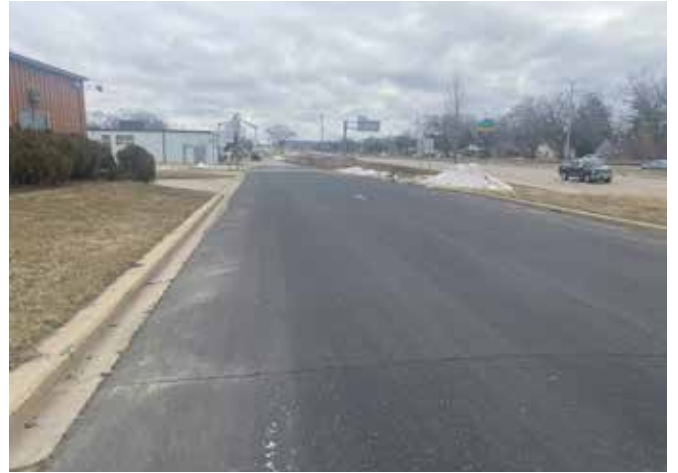
Commercial Av., near I-39 ALT (fair to good condition, crack, potholes, uneven surfaces)

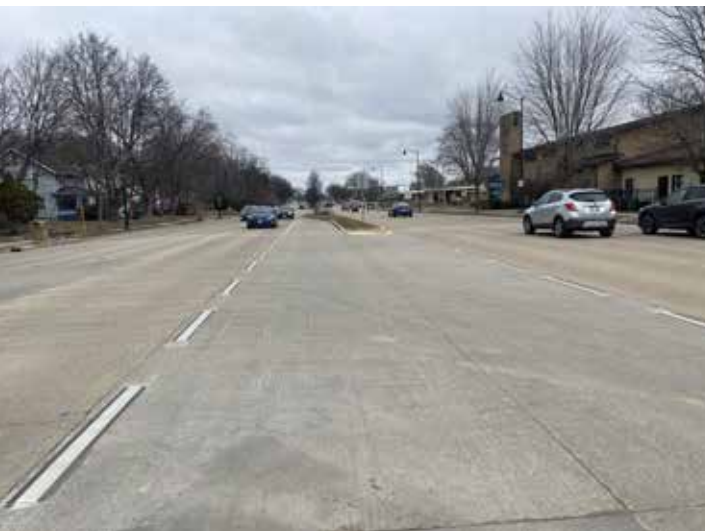
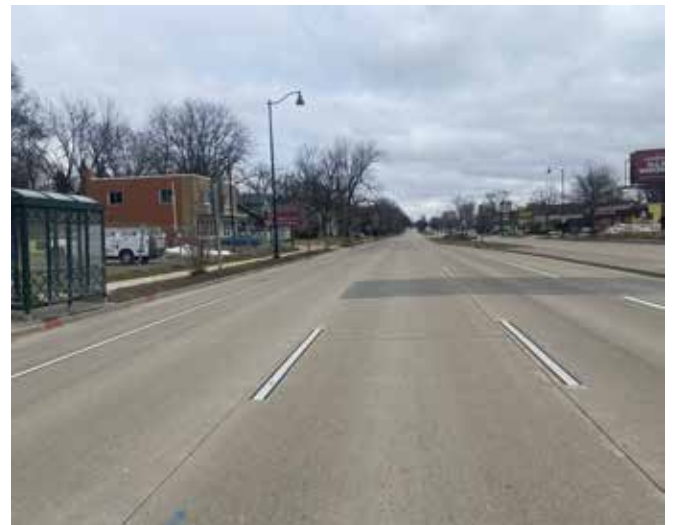
E Washington Av.,(good condition)

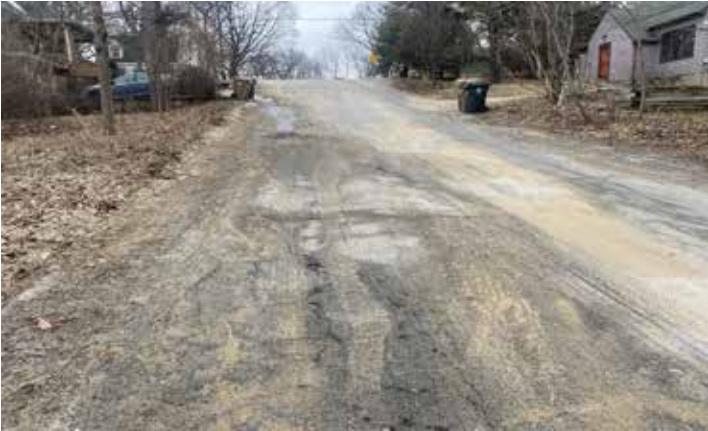
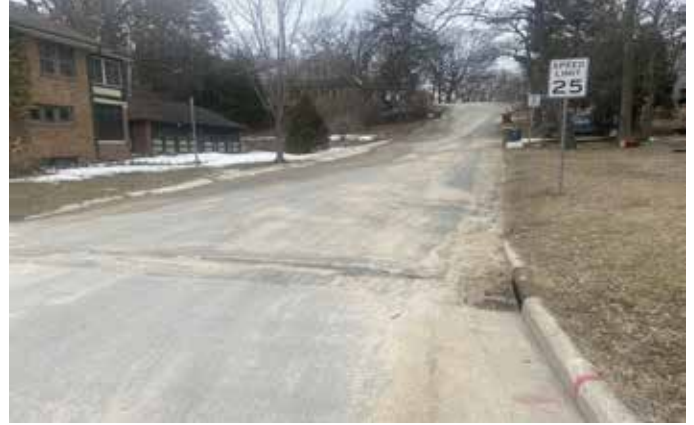
Grover St., near E Washington and Wright St. Junction (fair condition, some cracking and uneven surfaces)

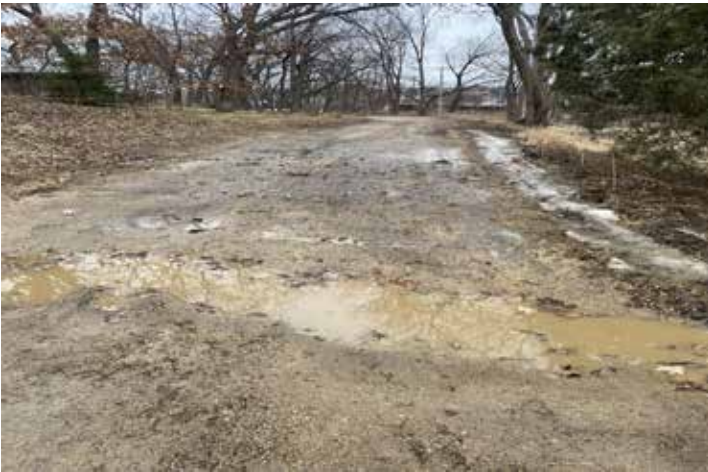
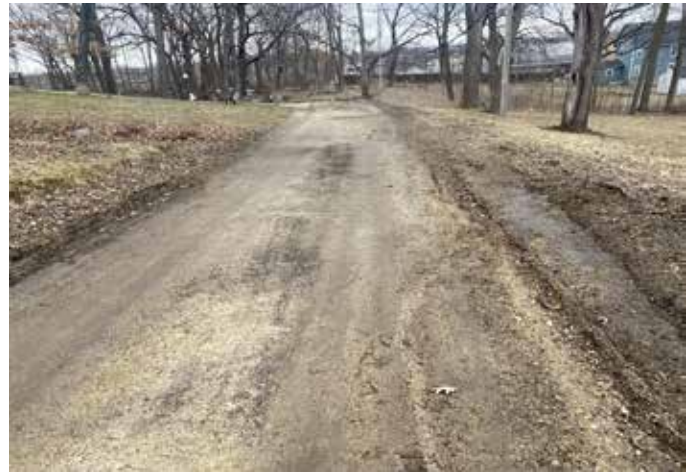
Ridgeway Ave, North of Grover Ave, (poor condition, untarred, water pooling surfaces)

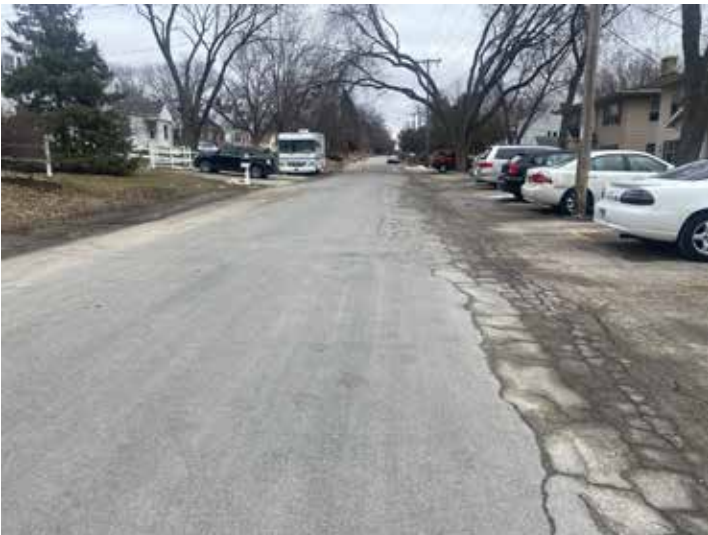
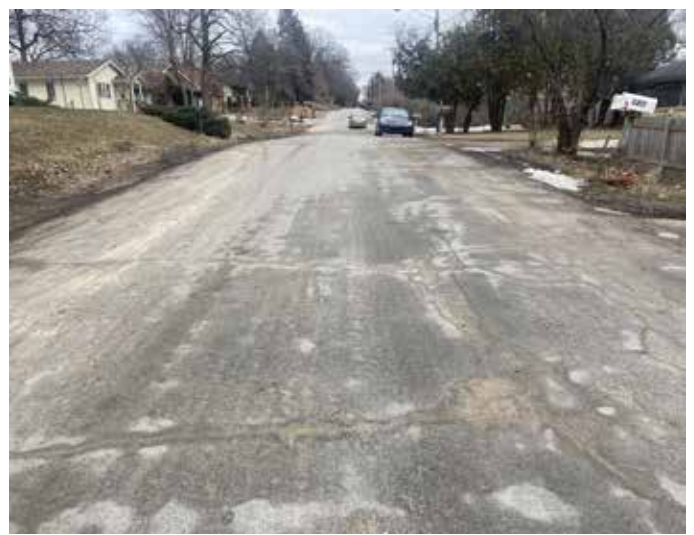
Ridgeway Ave, near E Washington Ave and Wright St, junction (fair condition, crack, no curb and drainage, uneven surfaces)

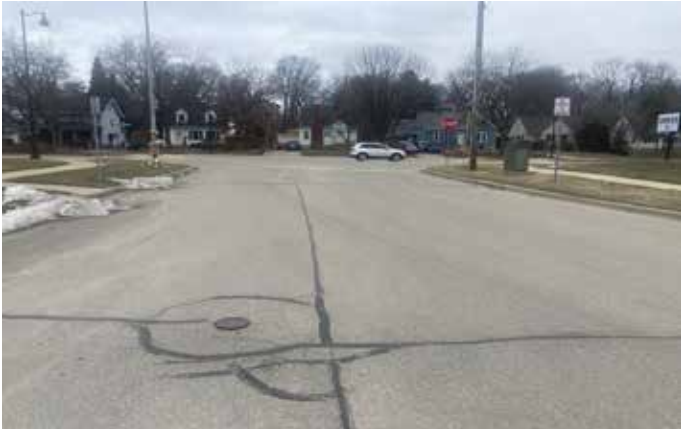
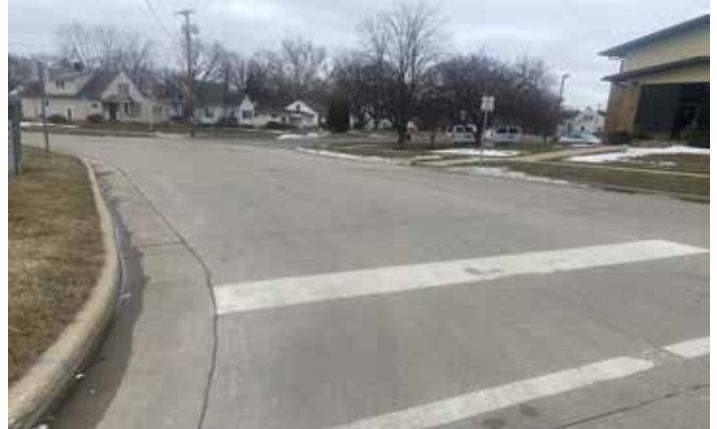
Lexington Ave, off E Washington Ave (good condition)

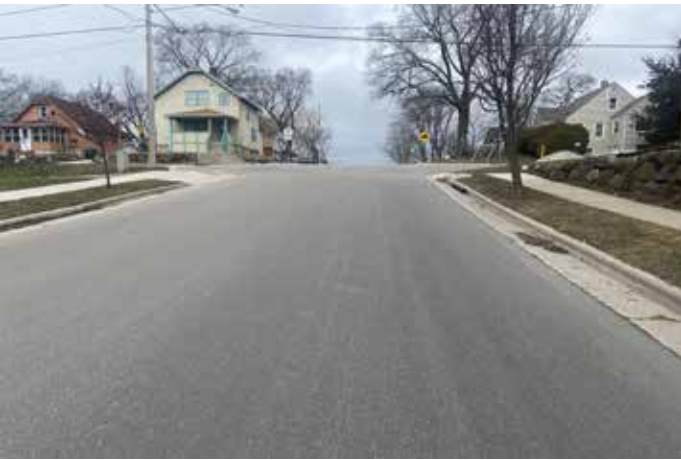
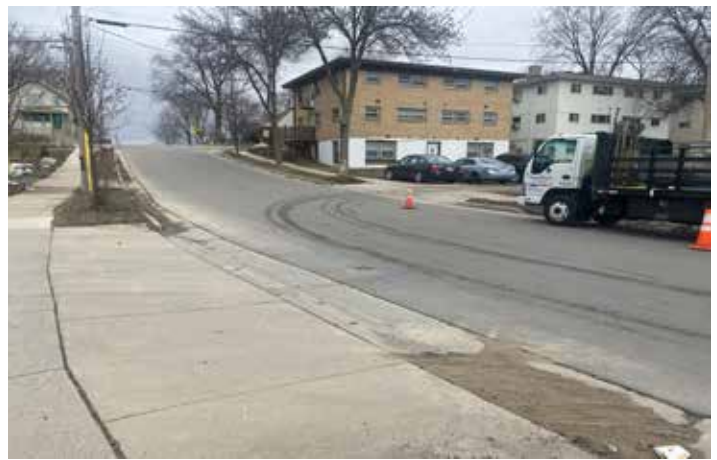
Melvn Ct, off E Washington Ave, (good condition)

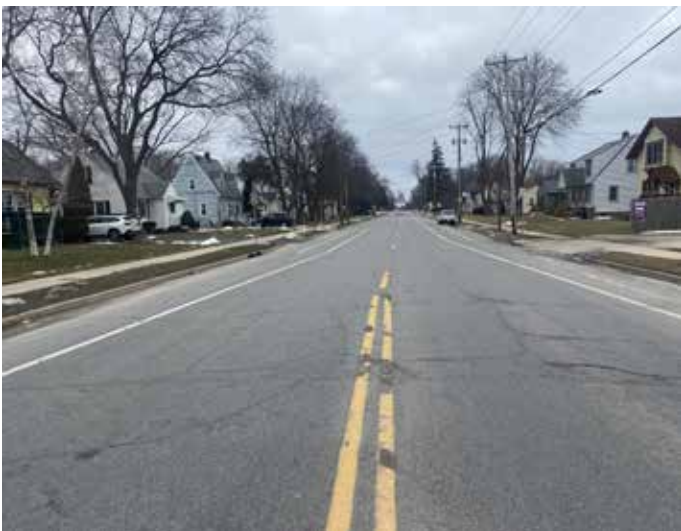
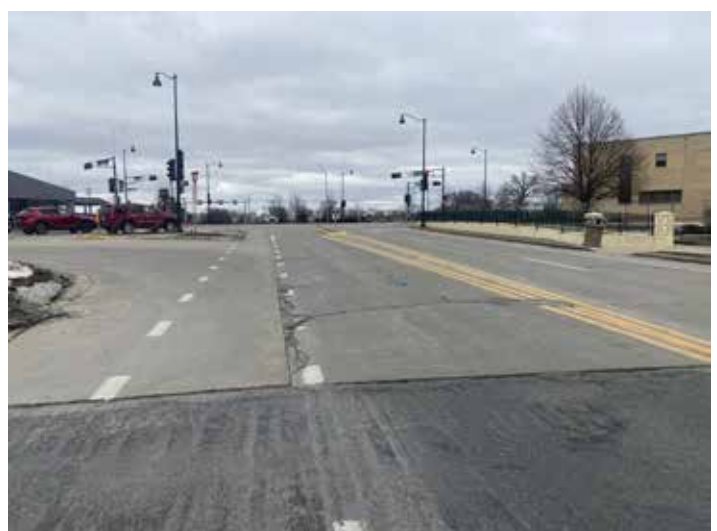
N Fair Oaks Ave, near E Washington junction (fair to good condition, minor crack)

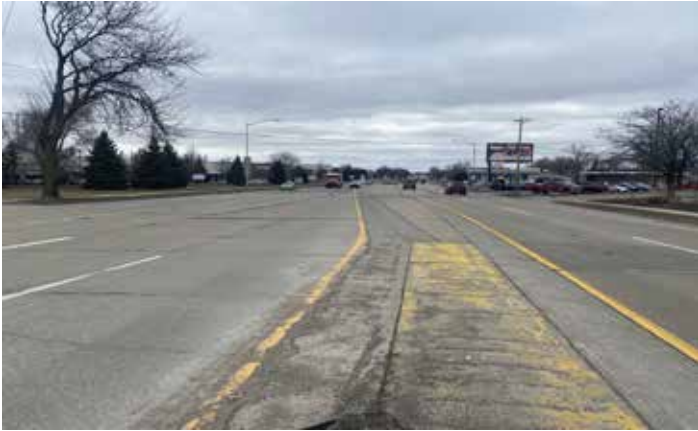
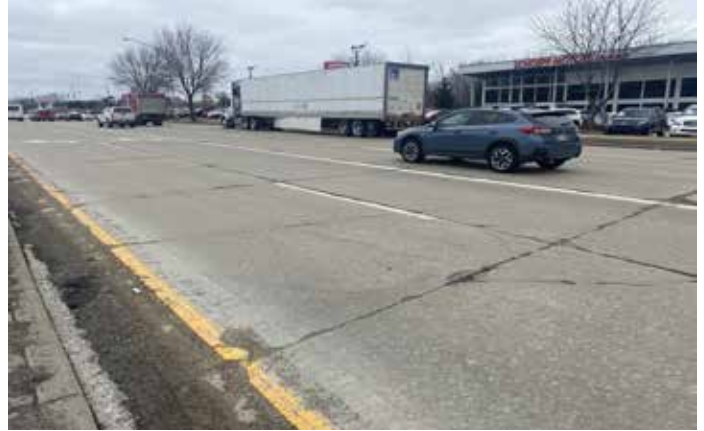
N Stoughton Rd, (fair to good condition, some cracking)

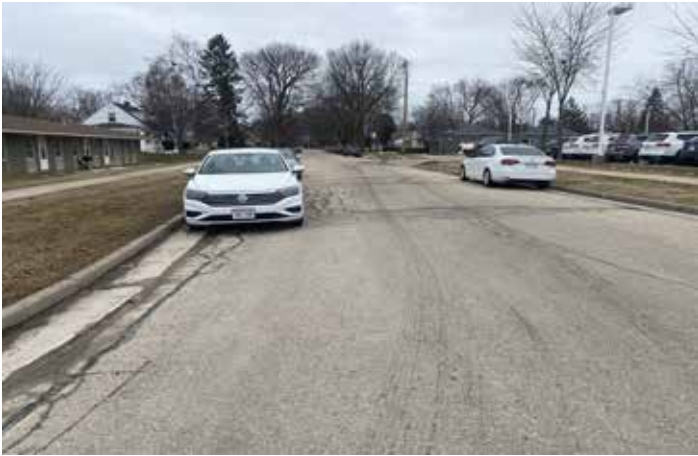
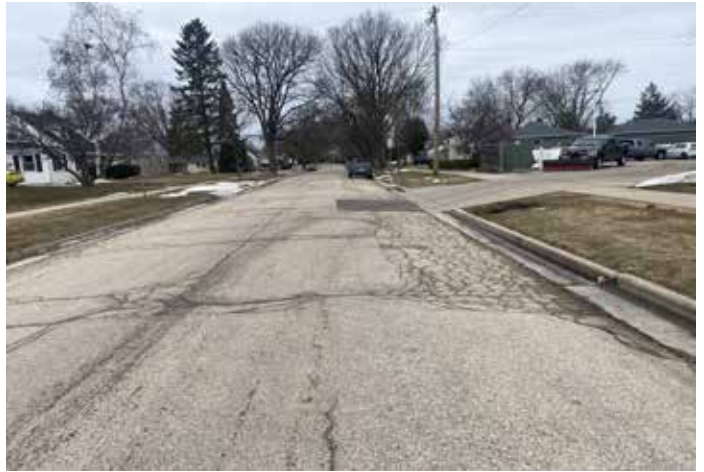
Concord Rd, near N Stoughton Rd (fair condition, crack)
