2023 E Washington Avenue (TID 52) Blight Study

Madison, WI

Prepared by MSA Professional Services, Inc.
April 14, 2023

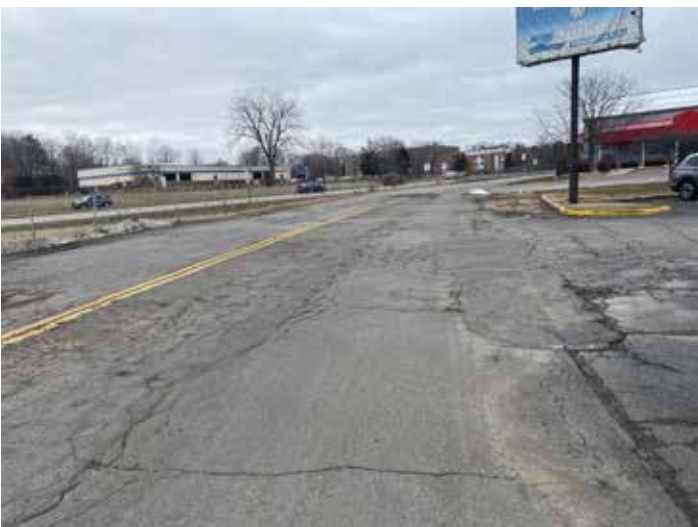
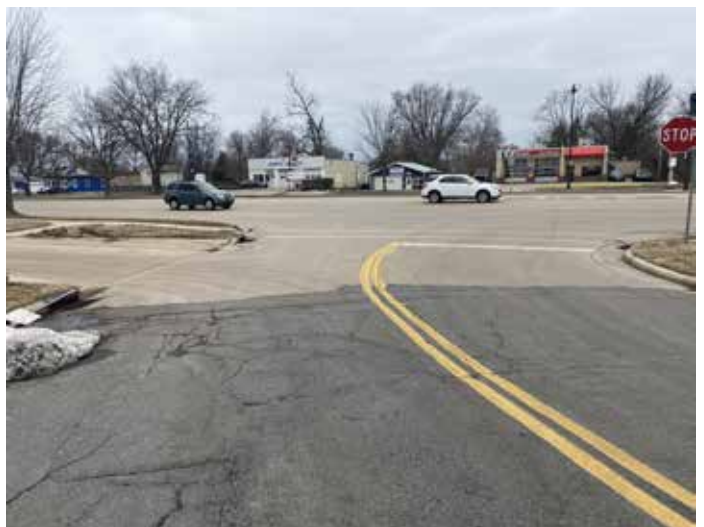
N Stoughton Rd, Service Rd, (fair condition, crack, uneven surfaces)

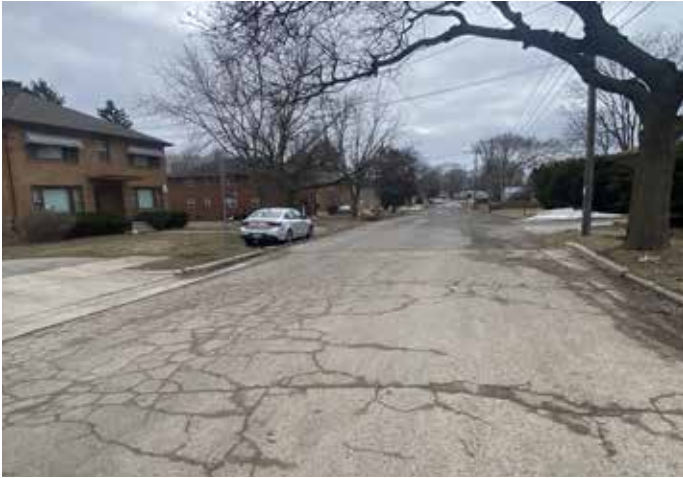
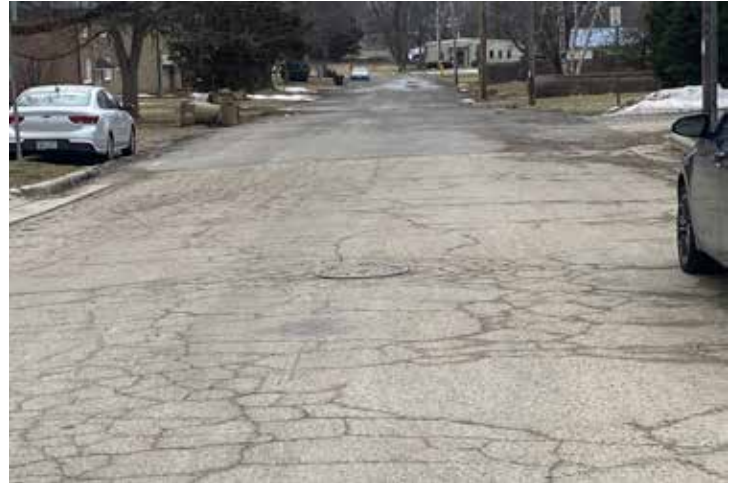
Pinecrest Dr, Near E Washington Ave, (fair condition, cracking, no gutter)

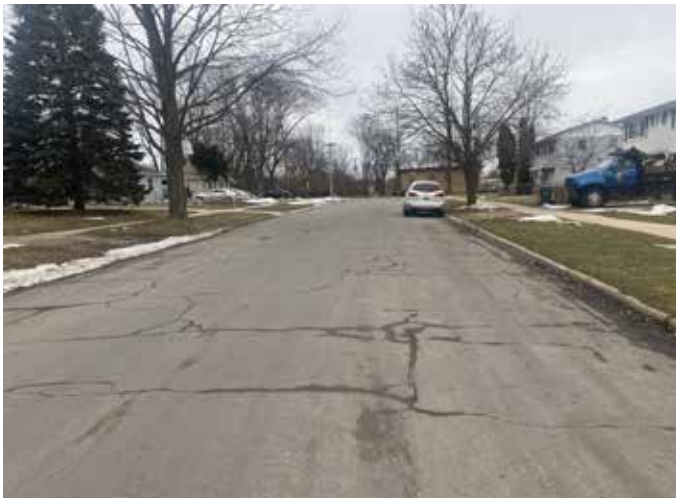
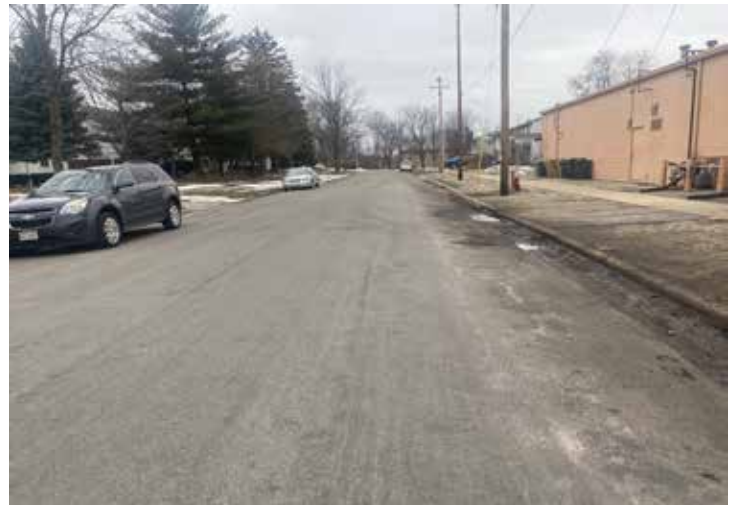
Prairie Av, near N Stoughton Rd, (good condition, but minor cracking)

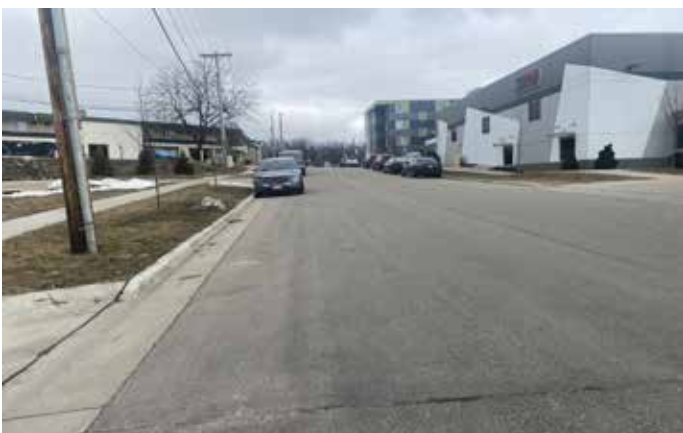
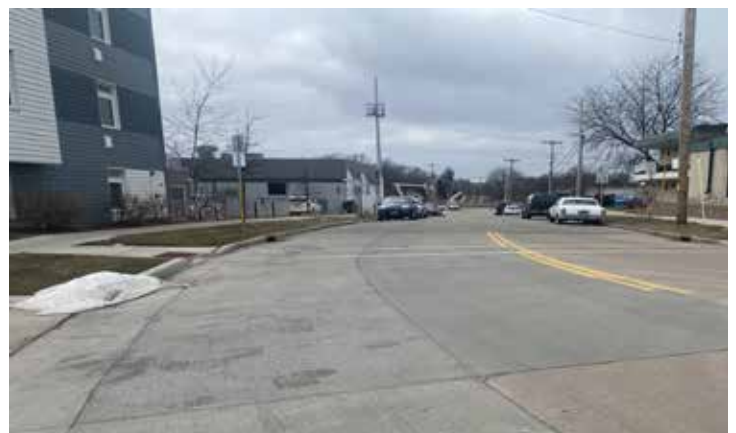
Rethke Ave (good condition)

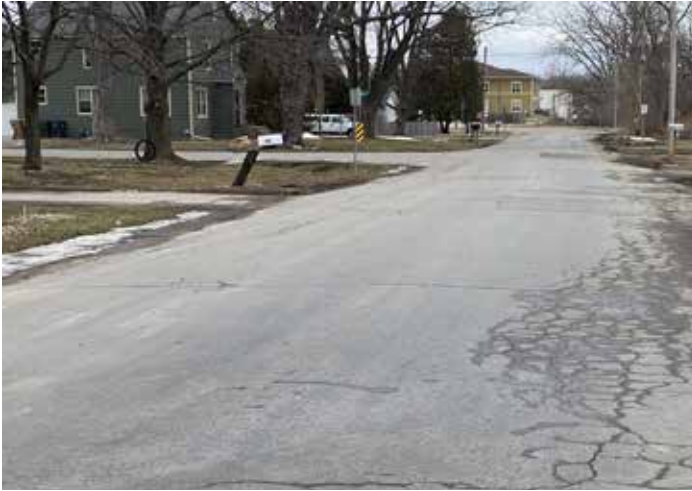
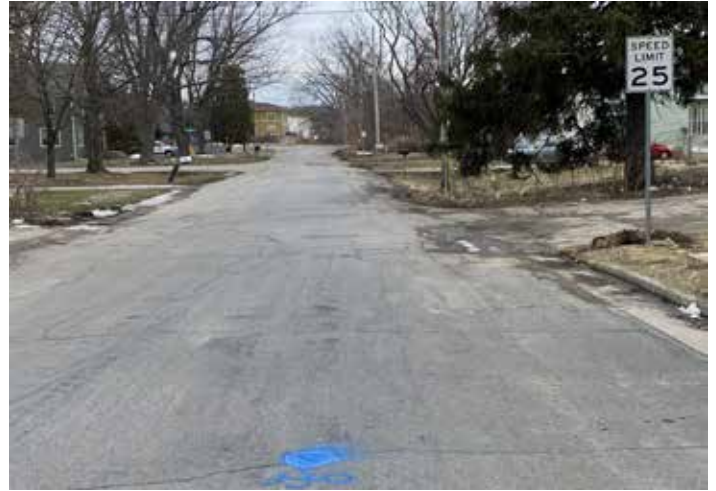
Rowland Ave (fair condition, crack, pothole)

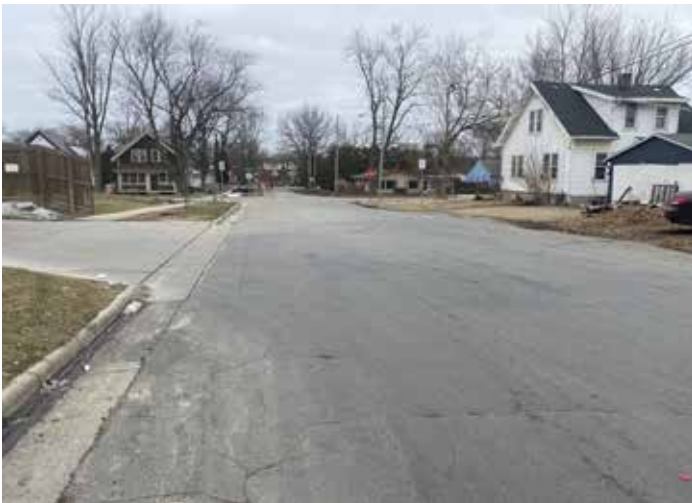
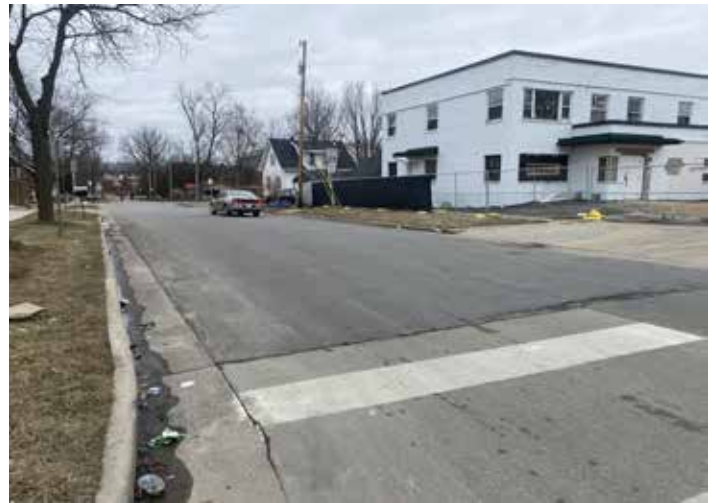
Schmedeman Ave off E Washington Ave (fair condition, crack, uneven surfaces)
