2023 E Washington Avenue (TID 52) Blight Study

Madison, WI

Prepared by MSA Professional Services, Inc.
April 14, 2023

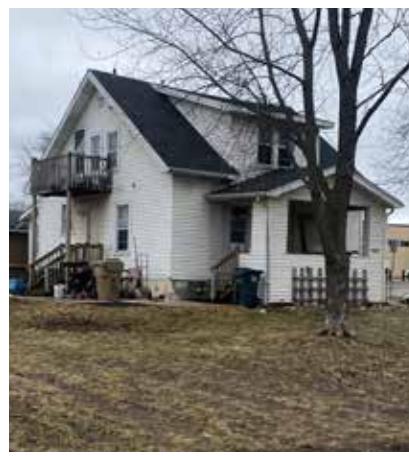
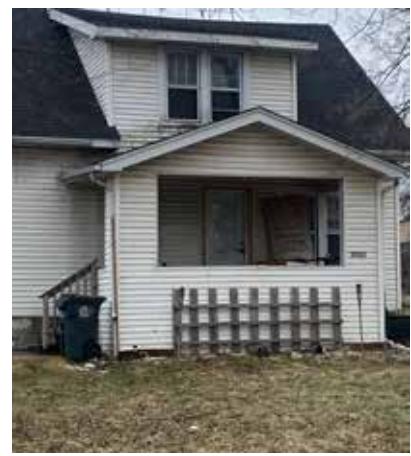
Accessory Structures: garage: missing door and unsightly temporary entrance covering; paint peeling; sagging gutter and missing downspouts, Building not Handicap Accessible: true, Chimneys & Vents: rust on vent, Drives/Parking/Walks: unpaved and flooded, Erosion and Stormwater: water pooling, Exterior Doors & Entranceways: door: faded; entranceways: flooded, Exterior Stairs/Stoops/Ramps: discolored, rotten and worn wooden stairs, Foundation: discolored, chipping concrete, and peeling paint, Major Maintenance: piled up trash, Porches & Overhangs: porches: discolored and rotten wood; Public Sidewalk: none, Roof: missing fascia covering, Storage & Screening: storage: piled up trash; screening: discolored and missing element on wooden fence.

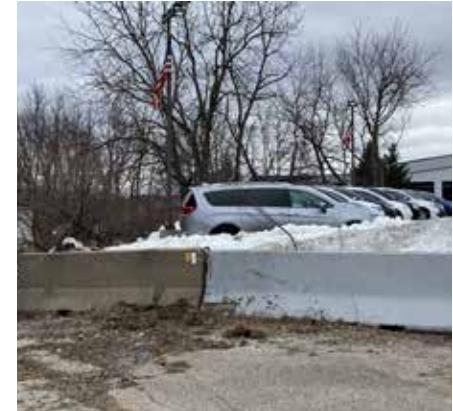
PARCEL NO. 21 (3608 E Washington Ave)

Score: 48

Drives/Parking/Walks: cracks, Erosion and Stormwater: water pooling, Major Maintenance: trash; unsightly concrete barriers, Occupancy: small, irregularly-shaped lot.

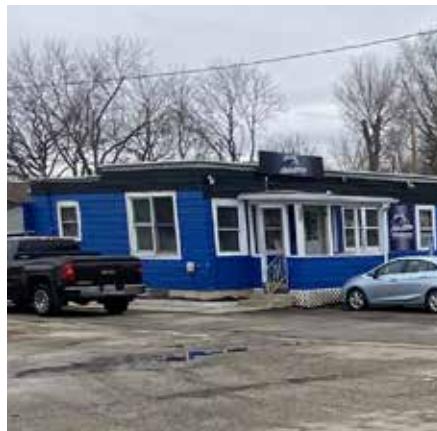
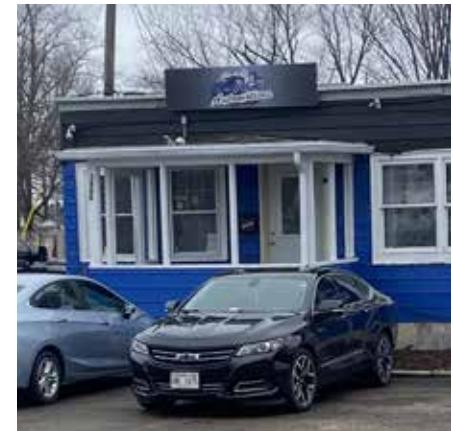
PARCEL NO. 23 (3566 E Washington Ave)

Score: 51.6

Building not Handicap Accessible: true, Drives/Parking/Walks: cracking and deterioration throughout, Erosion and Stormwater: evidence of water pooling, Exterior Stairs/Stoops/Ramps: rust on stairs handrail, Foundation: discolored and unmatched painting, Major Maintenance: large tree stump, Signage & Lighting: rust and missing element on sign post, Storage & Screening: discolored and missing element on wooden fence, Walls & Cladding: cladding: dented, Windows & Awnings: front window frame rotted.

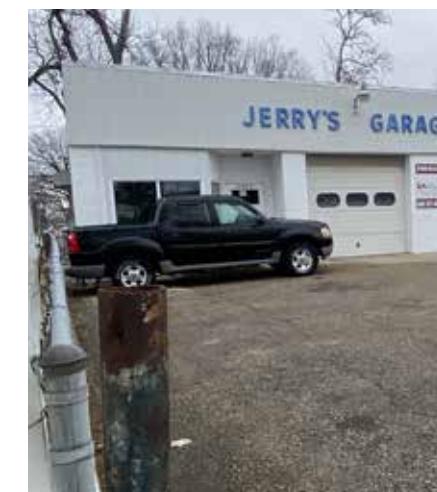
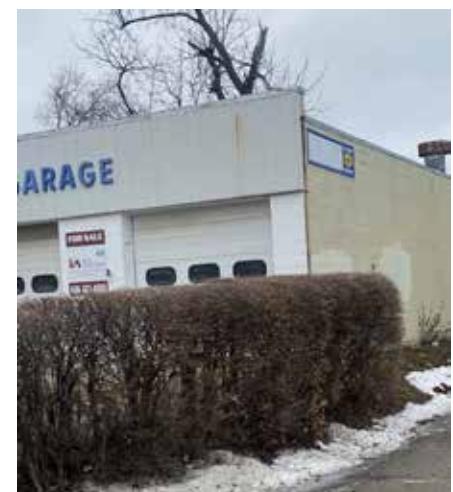
PARCEL NO. 25 (3582 E Washington Ave)

Score: 54.7

Chimneys & Vents: discolored and rust on vent, Drives/Parking/Walks: minor cracking, Exterior Doors & Entranceways: faded; and dent and opening on the garage door, Foundation: discolored, paint peeling, and minor crack, Minor Maintenance: rusty guard rail, Occupancy: does not appear to be in use as a garage, Storage & Screening: rust on post and chain fence, Walls & Cladding: wall: faded, crack, mismatched painting and missing mortar, rusty.

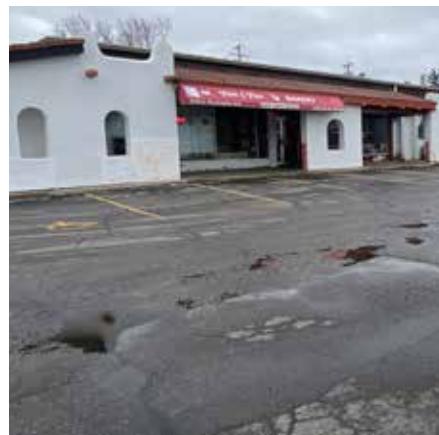
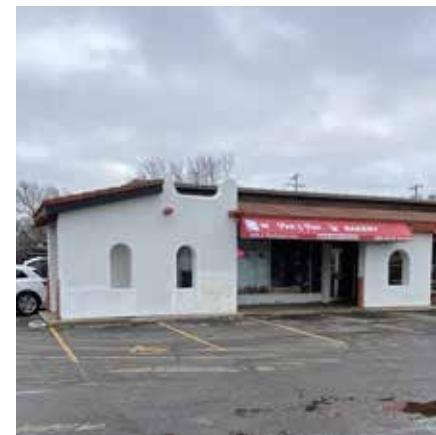
**PARCEL NO. 37 (3539 E Washington Ave)****Score: 51.2**

Drives/Parking/Walks: pavement cracked and deteriorating, Erosion and Stormwater: water pooling in parking lot, Porches & Overhangs: discolored roof and canopy; chipping on exposed wood joist; Walls & Cladding: discolored, paint peeling, water damage.

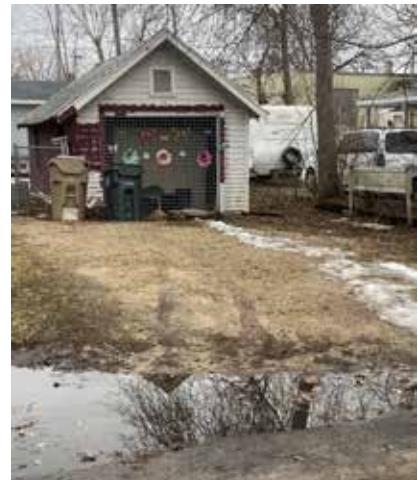
Score: 35.9

Accessory Structures: Garage: missing fascia board; missing door; falling off window; and mismatched siding color, Building not Handicap Accessible: true, Drives/Parking/Walks: unpaved driveway and parking, Erosion and Stormwater: water pooling, Exterior Doors & Entranceways: door: discolored; graffiti on door glass; deteriorating wooden frame; entranceways: discolored; crack, Exterior Stairs/Stoops/Ramps: stair: discolored; missing rail; and deteriorating wooden stairs, Foundation: discolored and chipping concrete at the front edge, Major Maintenance: piled up trash, Porches & Overhangs: rear porch roof: discolored, Public Sidewalk: none, Storage & Screening: piled up trash; rust on post and wire fence, Walls & Cladding: Cladding: discolored and peeling paint, Windows & Awnings: Window: discolored and deteriorated wooden frame; and graffiti on exterior glass.

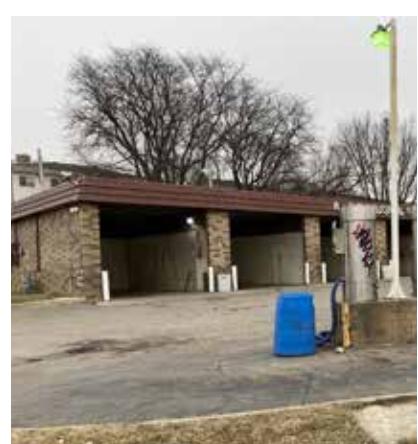
PARCEL NO. 48 (3206 E Washington Ave)

Score: 52

Accessory Structures: car vacuum stand: graffiti on vacuum machine; discolored brick, chipping concrete, and rust on angle support at the base; Drives/Parking/Walks: significant cracks, decay, potholes, Erosion and Stormwater: evidence of water pooling, Major Maintenance: graffiti on the wall and the vacuum machine, Minor Maintenance: overflowing trash cans, trash across parking lot, Signage & Lighting: lighting: rust on the iron pole; deteriorating electric pole; and rust on exposed electric board, Storage & Screening: dumpster unscreened; missing bricks on the fence; rust and missing components on the fence gate; Walls & Cladding: wall: discolored, missing mortar, and chipping brick; graffiti on wall.

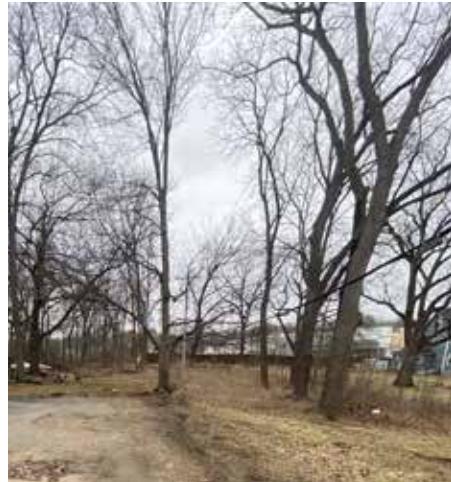
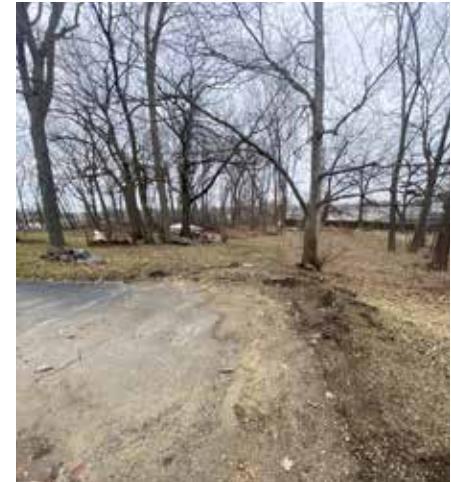
**PARCEL NO. 42 (3396 Ridgeway Ave)****Score: 53**

No public sidewalk.

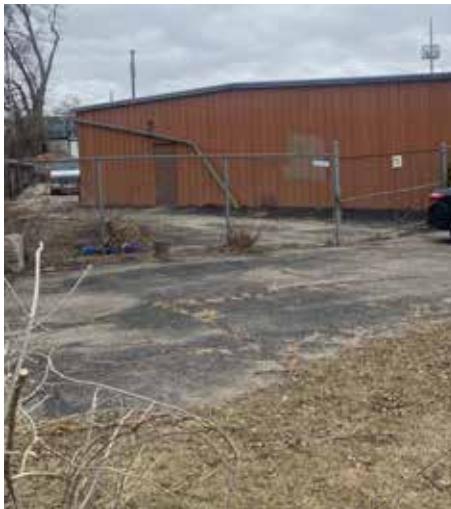
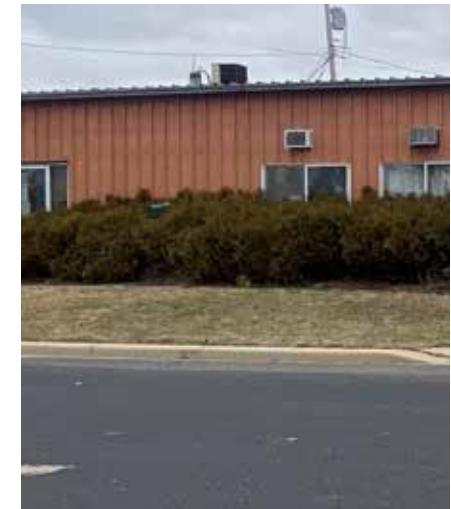
**PARCEL NO. 51 (3102 Commercial Ave)****Score: 48.6**

Accessory Structures: Rear storage structure: In extremely poor condition, Drives/Parking/Walks: Parking pavement: discolored and minor cracks, Exterior Doors & Entranceways: Doors: discolored, interior glass has a ripped plastic over it, Exterior Stairs/Stoops/Ramps: none, Gutters & Downspouts: gutters: Missing and falling gutters; downspouts: stained, Minor Maintenance: Overgrown shrubs, Public Sidewalk: No public sidewalk, Signage & Lighting: Side signage area: missing sign remnant support in poor condition with a sagging wall lighting; Address sign rusted, Storage & Screening: Faded pole fence, collapsing and rusting iron pipe gate, and discolored wall fence, Walls & Cladding: siding: faded, mismatch paint treatment on the side and bent siding at the base.

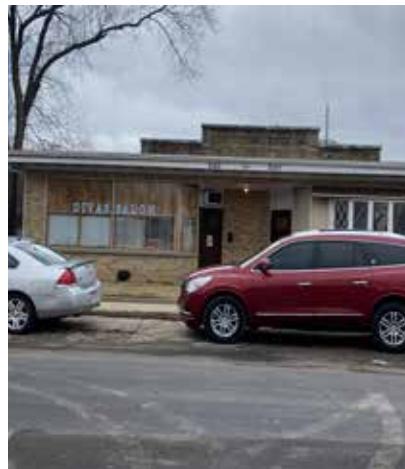
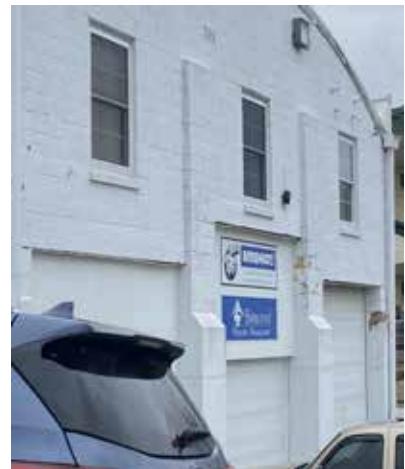
PARCEL NO. 53 (3165 E Washington Ave)

Score: 58.8

Accessory Structures: none, Drives/Parking/ Walks: minor cracking all through the parking and driveway; chipping along curb, Foundation: Rear side: minor cracking, stain and paint chipping off, Gutters & Downspouts: slight displacement of the downspout cap at the rear, Major Maintenance: graffiti on curbing, Minor Maintenance: overgrown shrubs, Public Sidewalk: No public sidewalk, Signage & Lighting: crooked sign post, Storage & Screening: fence: bent, Walls & Cladding: Block wall: cracked, stained, and paint peeling at the side and rear; Brick: discolored ; parapet wall: discolored, missing mortar, chipping and discolored cap, Windows & Awnings: Front Window: wooden plastic behind window ; concrete seal chipping and discolored; window frame deteriorating ; bent awnings support.

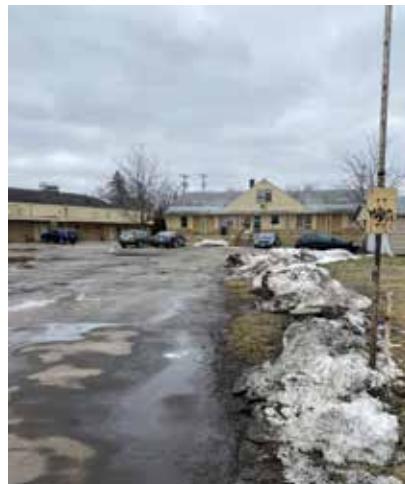
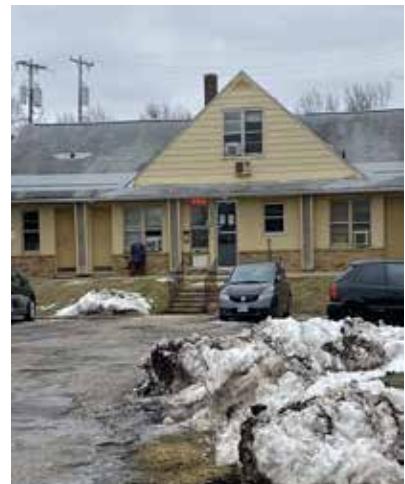
PARCEL NO. 62 (3575 E Washington Ave)

Score: 29

Accessory Structures: faded; peeling paint; rust at the base of the cladding; chipping and discolored fascia, Building not Handicap Accessible: true, Chimneys & Vents: rust on chimney, Drives/ Parking/Walks: major cracks and potholes, Erosion and Stormwater: water pooling, Exterior Doors & Entranceways: doors: faded, Exterior Stairs/ Stoops/Ramps: stairs: discolored, chipping concrete, and rust on hand rails, Gutters & Downspouts: discolored, Major Maintenance: piled up trash, Roof: discolored, mismatched shingles, Signage & Lighting: signage: rust on pole and frame; missing component and faded board, Storage & Screening: piled up trash; rusty and discolored post and chain fence, Walls & Cladding: wall: faded and peeling paint; crack; and missing mortar; cladding: faded, Windows & Awnings: deteriorating window frame, unsightly reflecting plastic cover behind glass; missing glass at the gable window.

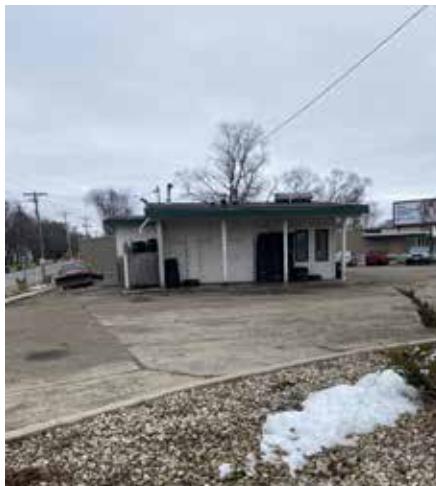
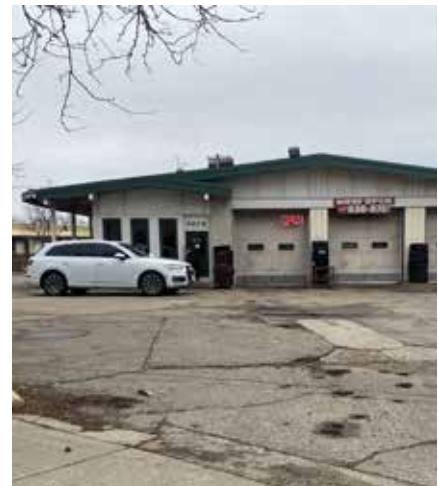
Score: 45.9

Accessory Structures: discolored and rotten wood storage, Chimneys & Vents: rust on chimneys and vents, Drives/Parking/Walks: major cracks, deterioration, Erosion and Stormwater: water pooling, Exterior Doors & Entrances: Door: faded, peeling paint, and deteriorating wood frame, Gutters & Downspouts: missing downspout, Major Maintenance: used tires piled in view, Porches & Overhangs: porch: discolored and rust on the iron pole, Roof: discolored, damaged fascia cover at the front edge, Walls & Cladding: wall: faded paint, crack, missing mortar, and stain; cladding: stain; faded; and mismatched plywood and aluminum material, Windows & Awnings: paint peeling on the aluminum window frame.

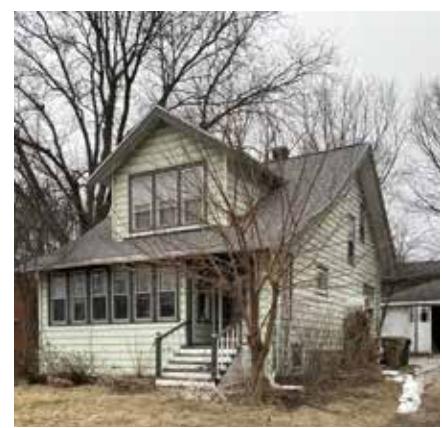
Score: 44.9

Accessory Structures: garage: missing component on roof and door; paint peeling and falling door, Building not Handicap Accessible: true, Chimneys & Vents: chimney: discolored and missing mortar, Drives/Parking/Walks: driveway unpaved and rutted; no front walk, Erosion and Stormwater: evidence of water pooling, Exterior Stairs/Stoops/Ramps: stairs: peeling paint; rotten wooden; and faded paint on rail, Gutters & Downspouts: gutter sagging, Major Maintenance: vehicles parked throughout rear yard, trash in sideyard, Minor Maintenance: overgrown tress and bushes around house, Walls & Cladding: faded cladding.

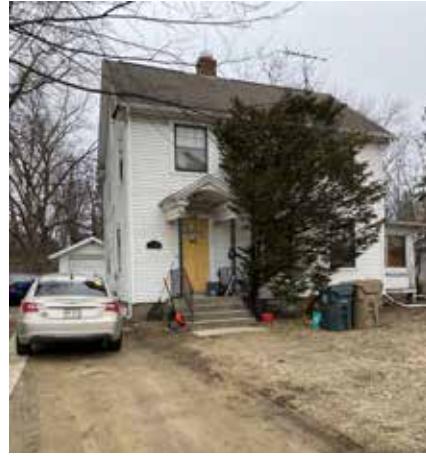
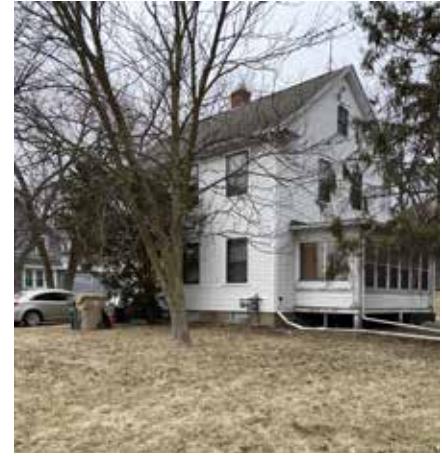
PARCEL NO. 87 (3230 E Washington Ave)

Score: 56.4

Building not Handicap Accessible: true, Drives/Parking/Walks: driveway unpaved, rutted, Exterior Doors & Entranceways: entranceways not paved, Exterior Stairs/Stoops/Ramps: stair: rust on handrail and concrete chipping at the base, Foundation: peeling paint; and chipping concrete, Porches & Overhangs: peeling paint and discolored on front porch, Roof: discolored; missing component and peeling paint on the fascia, Walls & Cladding: faded, peeling paint, and chipping wooden wall frame at the rear, Windows & Awnings: window: chipping wooden frame at the rear.

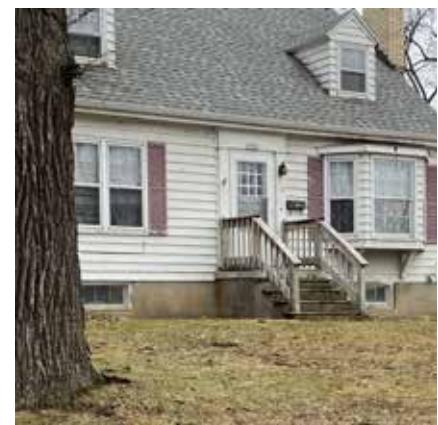
**PARCEL NO. 100 (3382 E Washington Ave)****Score: 55**

Building not Handicap Accessible: true, Chimneys & Vents: Chimney: discolored; missing mortar and cracking, Drives/ Parking/Walks: minor cracking in driveway; front walk missing, Exterior Doors & Entranceways: door: chipping and paint peeling on frame, Exterior Stairs/Stoops/ Ramps: stairs: discolored, faded wooden handrail, Foundation: discolored; chipping concrete and minor crack, Roof: chipping and paint peeling on the eaves, Walls & Cladding: Cladding: faded and peeling paint; Brick: discolored, cracked, and missing mortar, Windows & Awnings: chipping wooden frame; peeling paint; and faded awnings.

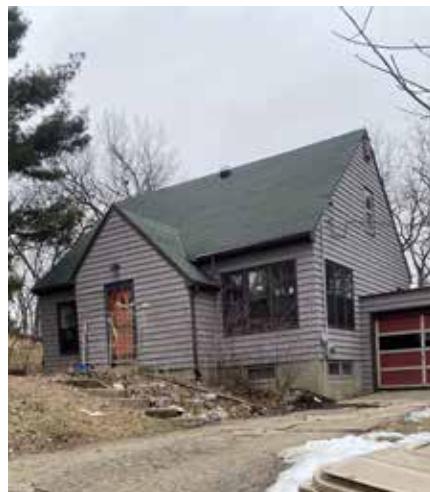
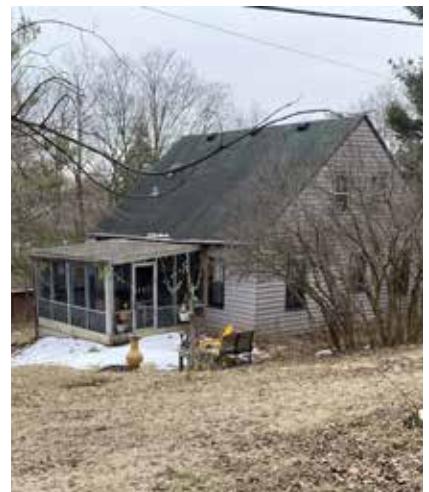
PARCEL NO. 101 (1013 Grover St)

Score: 56.3

Building not Handicap Accessible: true, Drives/Parking/Walks: pavement: cracked and deteriorating, debris accumulating, Exterior Doors & Entranceways: entrance way: piled up trash; door: missing panel on garage door; screen porch door screening ripped open, Exterior Stairs/Stoops/Ramps: discolored and cracked concrete stairs, Minor Maintenance: toys in yard, Porches & Overhangs: faded and unstained wooden porch, Public Sidewalk: no sidewalk, Roof: peeling paint on garage fascia, Storage & Screening: wooden retaining wall: discolored, rotten, and collapsing, Walls & Cladding: cladding: stained and paint peeling.

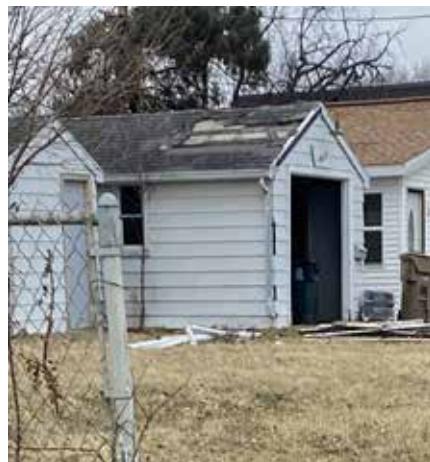
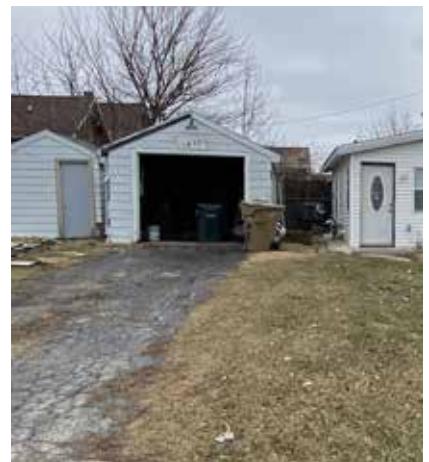
PARCEL NO. 102 (1413 Reindahl Ave)

Score: 55.5

Accessory Structures: Garage: damage roof; missing fascia cover and garage door; fallen cladding at the front edge; Store: discolored door frame and rust on cladding at the base, Drives/Parking/Walks: no walkways to house; driveway pavement breaking down, growing grass, Erosion and Stormwater: water pooling, Exterior Doors & Entranceways: door: discolored, unpainted wooden frame, Exterior Stairs/Stoops/Ramps: ramp: discolored and chipping concrete, Major Maintenance: trash in yard, Roof: fascia discolored, Signage & Lighting: trash container in front of house, Storage & Screening: piled up trash; fence rusty and crooked.

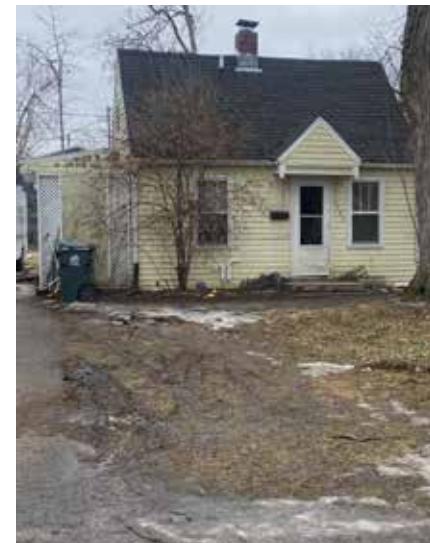
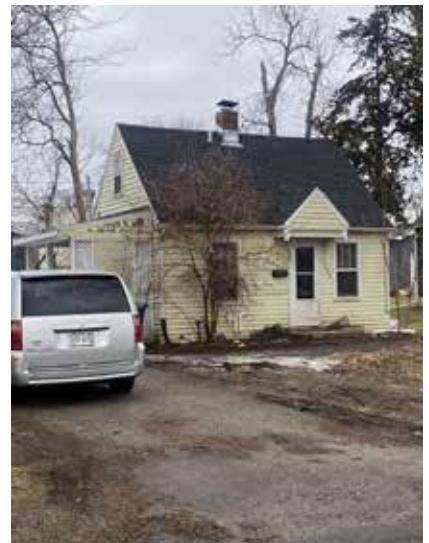
PARCEL NO. 103 (3585 Ridgeway Ave)

Score: 49.6

Building not Handicap Accessible: true, Drives/Parking/Walks: minor crack, Exterior Doors & Entranceways: Door: discolored, rotten wooden frame, and stained panel, Exterior Stairs/Stoops/Ramps: Stair: discolored and chipping concrete, Gutters & Downspouts: dirt in the gutters and broken downspout at the side, Major Maintenance: piled up trash, lawn damaged by vehicle parking, Porches & Overhangs: porch: peeling paint on eaves; stain and faded wooden frame, Roof: rotten fascia board, Storage & Screening: piled up trash; rust on fence, Walls & Cladding: Cladding: discolored, stained, and peeling paint, Windows & Awnings: discolored and chipping window frame.

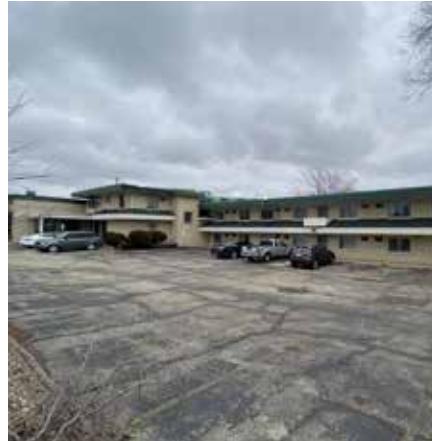
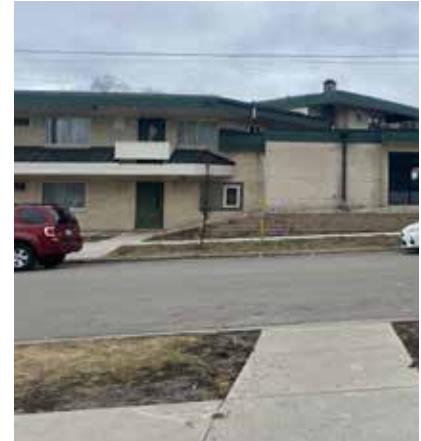
**PARCEL NO. 108 (3177 E Washington Ave)****Score: 56.8**

Chimneys & Vents: rust and dent on the chimneys and HVAC equipment, Drives/Parking/Walks: cracking, deterioration, Exterior Doors & Entranceways: faded door at the rear, Major Maintenance: Trash and junk at different locations, retaining walls failing, large tree branches in landscaping, Roof: main roof not visible; slight opening and sagging on the roof fascia cladding at the rear and side, Storage & Screening: no screening for dumpster, Walls & Cladding: brick is stained, water damaged, Windows & Awnings: chipping and discolored window frame at the rear.

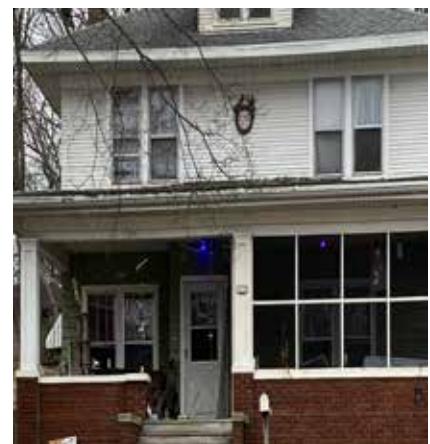
Score: 57.4

Accessory Structures: Garage: leaning, faded roof, peeling fascia board paint, misding or broken garage door, junk around the garage, Building not Handicap Accessible: true, Chimneys & Vents: discolored, Drives/Parking/Walks: discolored, major cracking, Erosion and Stormwater: evidence of water pooling, Exterior Stairs/Stoops/Ramps: discolored, cracked and chipping entrance stairs, Foundation: discolored concrete foundation, Major Maintenance: piled up trash, Porches & Overhangs: discolored porch wall and chipping concrete cover at the front, and rotten wooden rail at the rear terrace, Roof: faded roof covering and peeling paint on the fascia board, Storage & Screening: junk on site, Walls & Cladding: discolored brick wall and cladding.

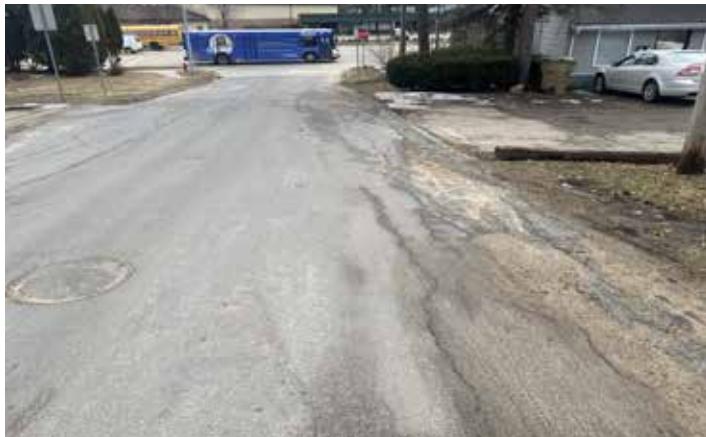
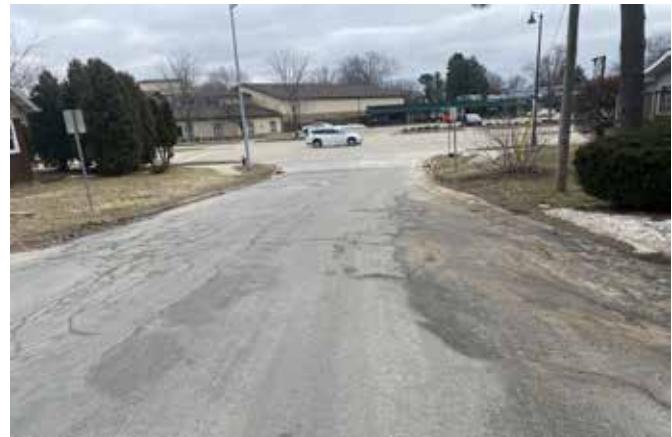
Carpenter Str, off E Washington Ave. (fair to poor condition, crack, uneven surfaces)

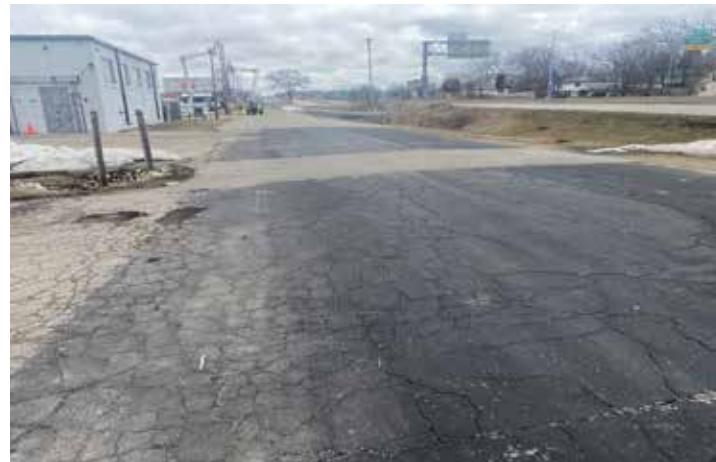
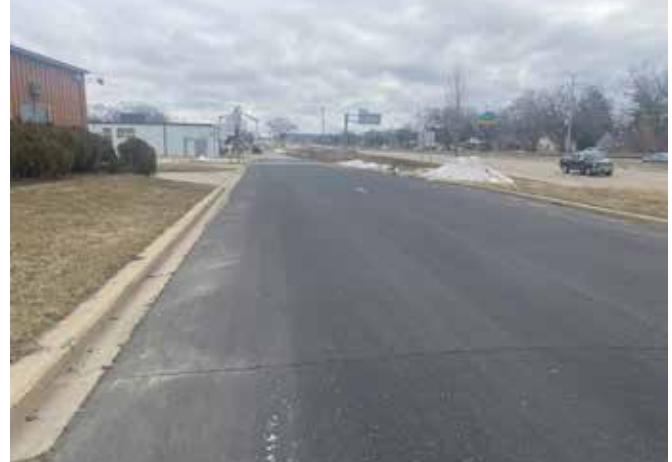
Commercial Av., near I-39 ALT (fair to good condition, crack, potholes, uneven surfaces)

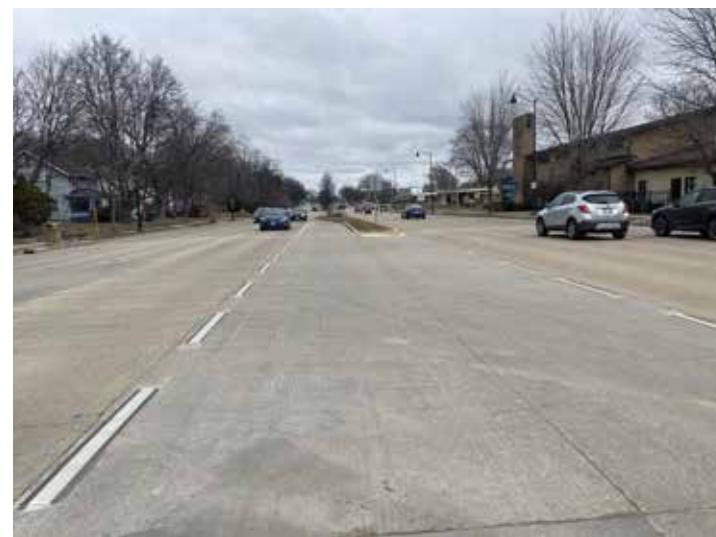
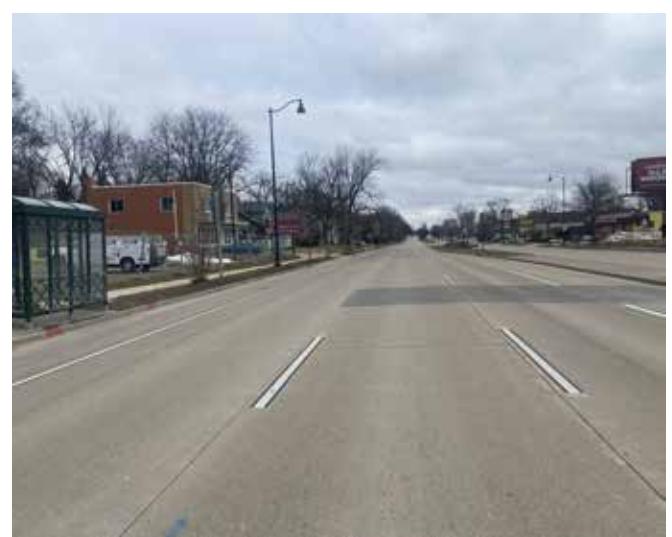
E Washington Av.,(good condition)

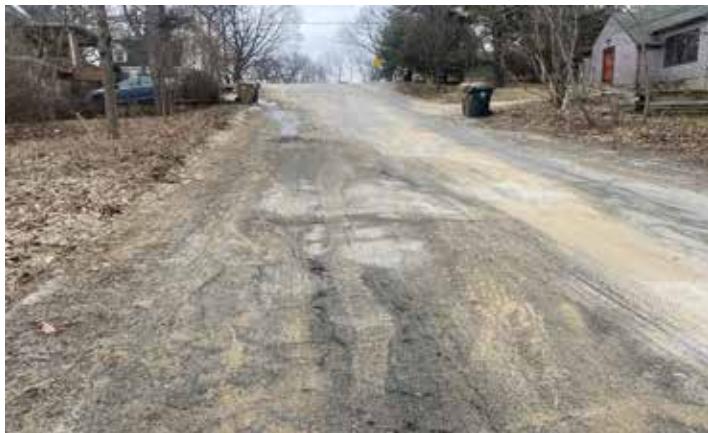
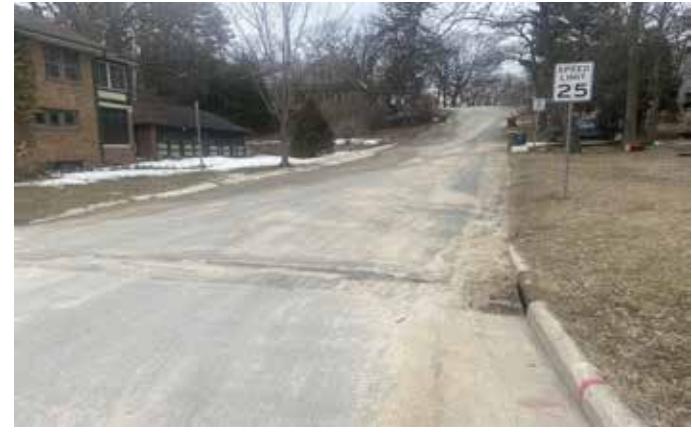
Grover St., near E washington and Wright St. Junction (fair condition, some cracking and uneven surfaces)

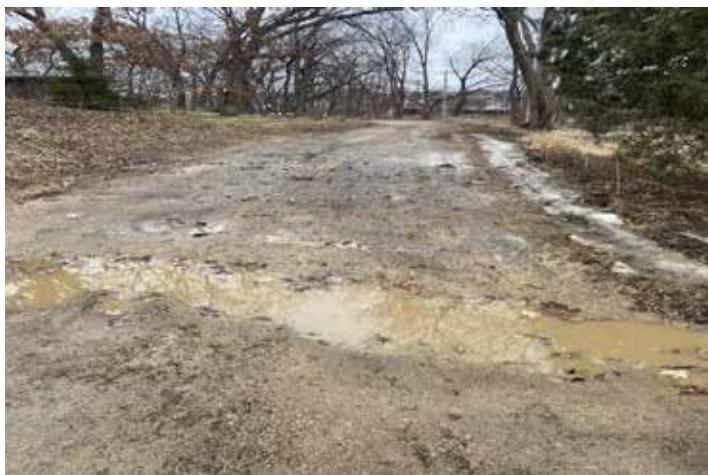
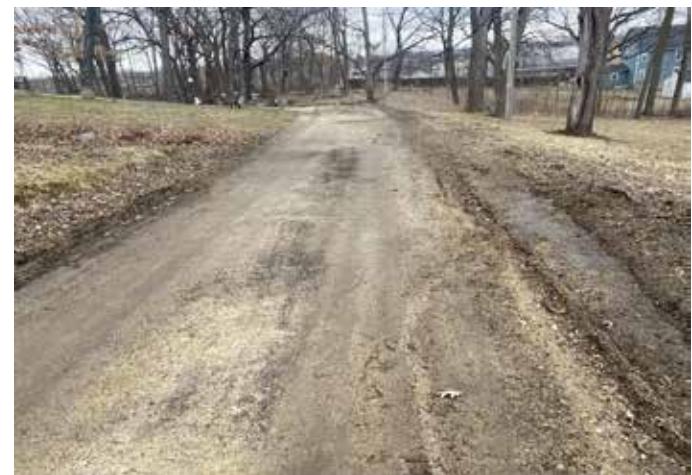
Ridgeway Ave, North of Grover Ave, (poor condition, untarred, water pooling surfaces)

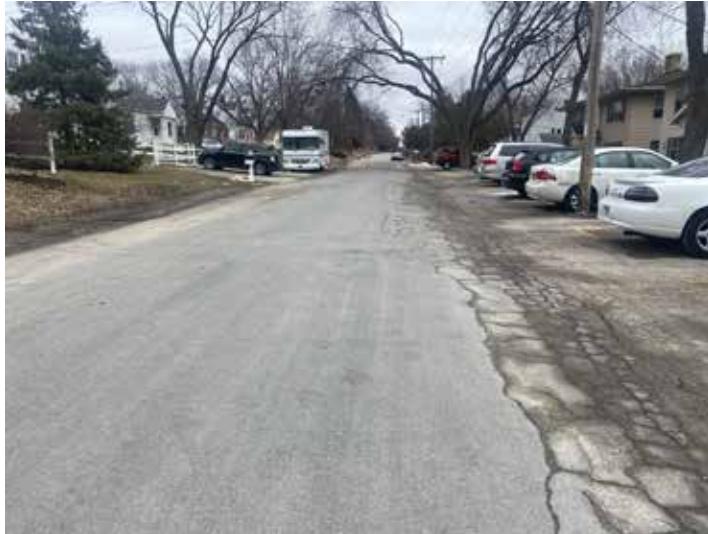
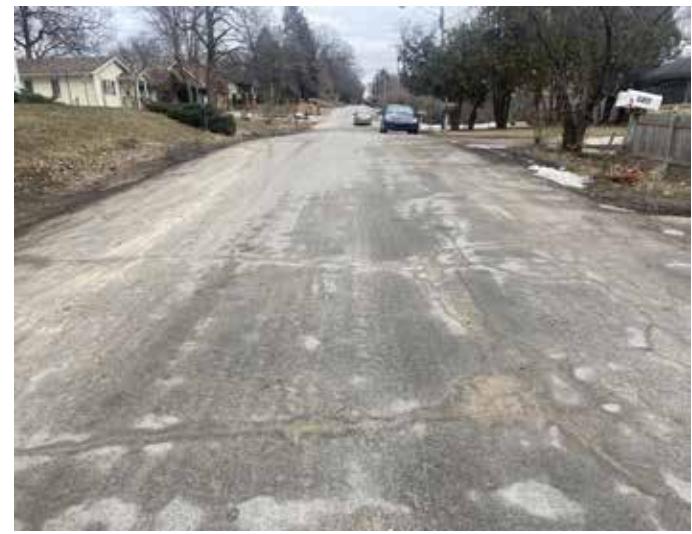
Ridgeway Ave, near E Washington Ave and Wright St, junction (fair condition, crack, no curb and drainage, uneven surfaces)

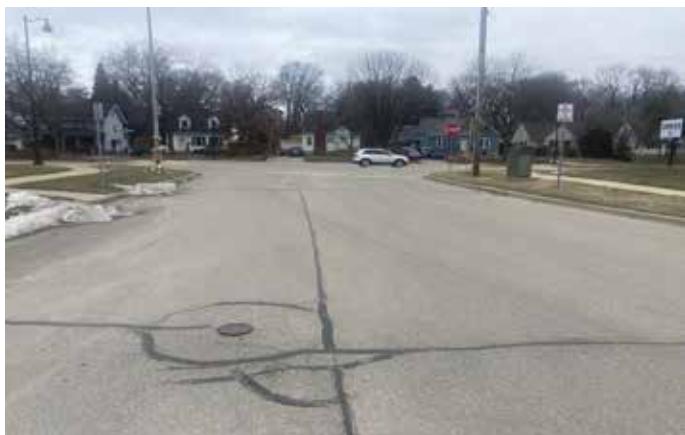
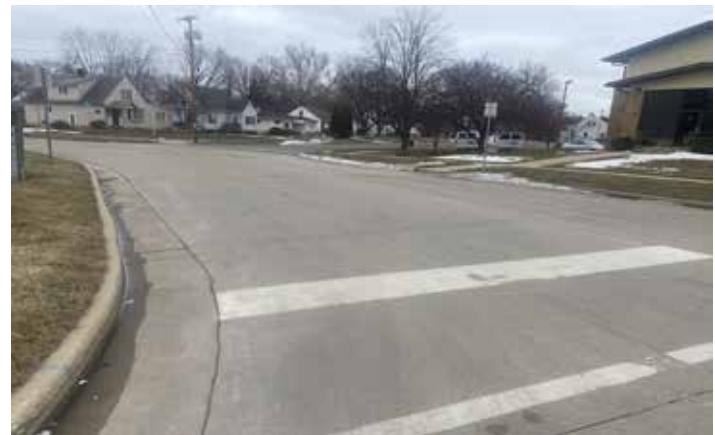
Lexington Ave, off E Washington Ave (good condition)

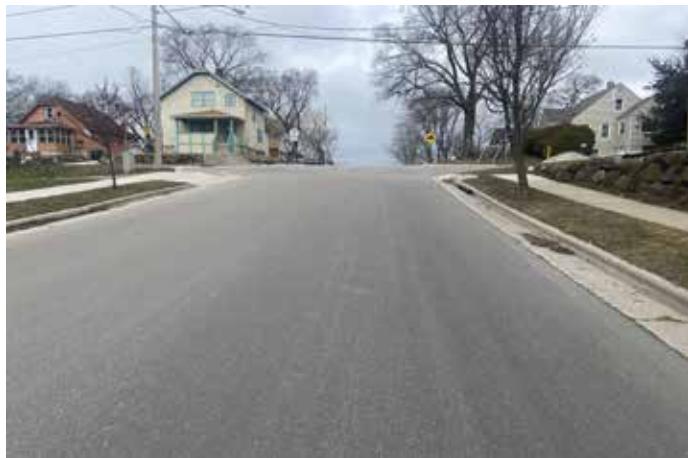
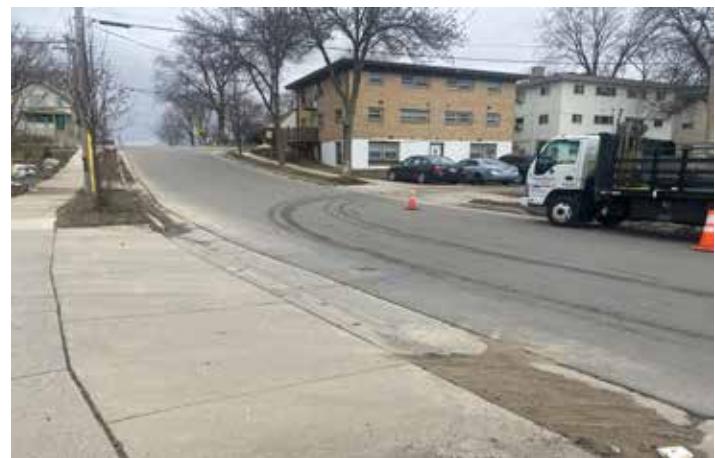
Melvn Ct, off E Washington Ave, (good condition)

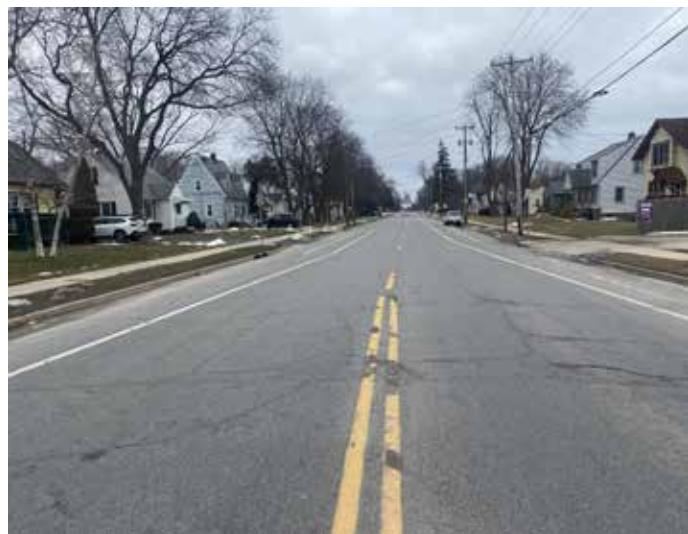
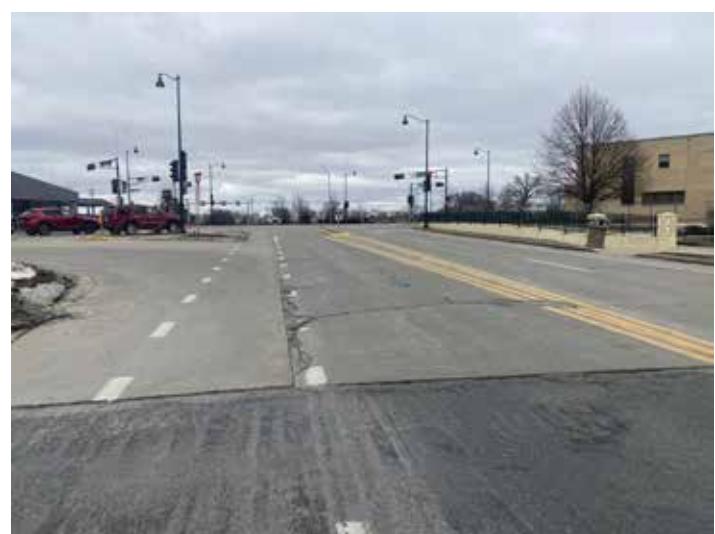
N Fair Oaks Ave, near E Washington junction (fair to good condition, minor crack)

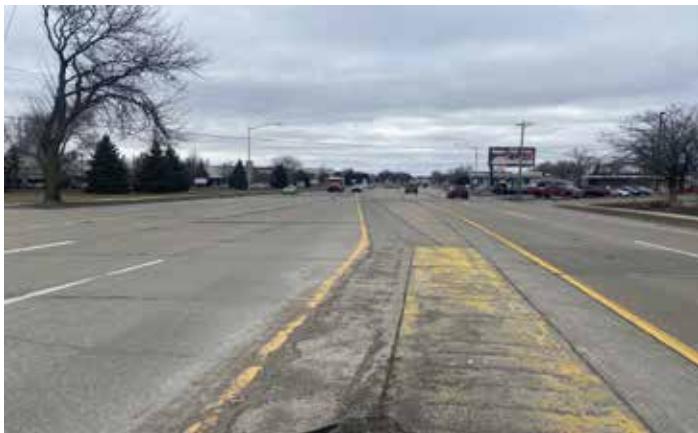
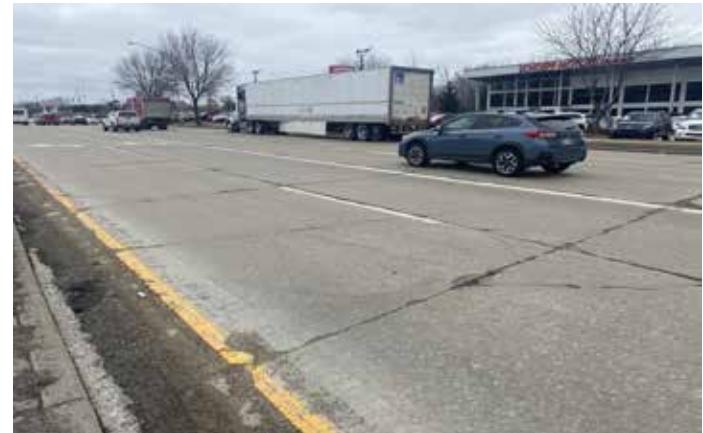
N Stoughton Rd, (fair to good condition, some cracking)

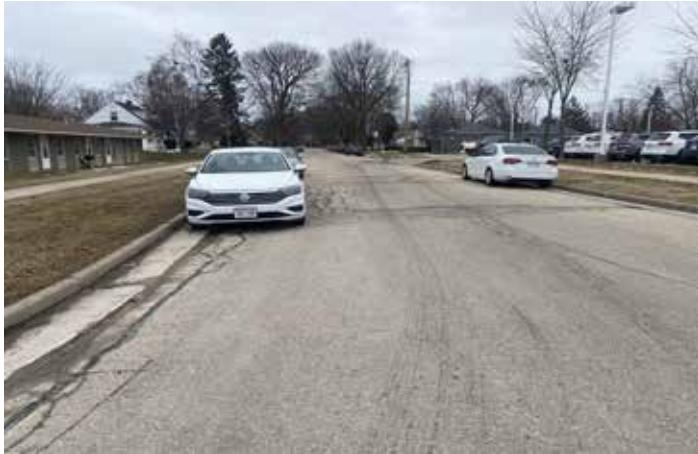
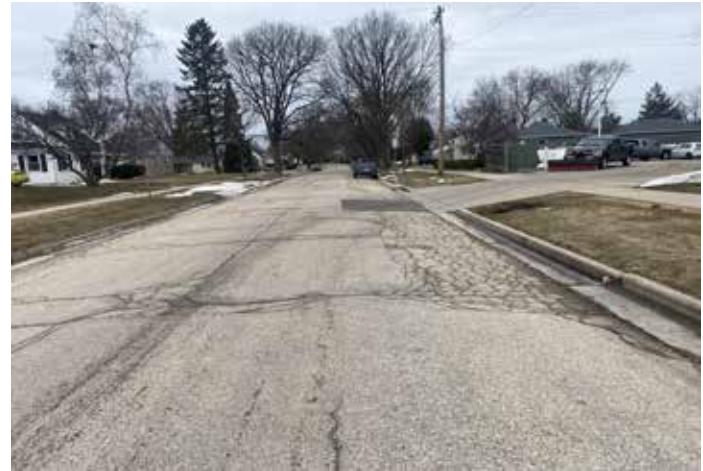
Concord Rd, near N Stoughton Rd (fair condition, crack)

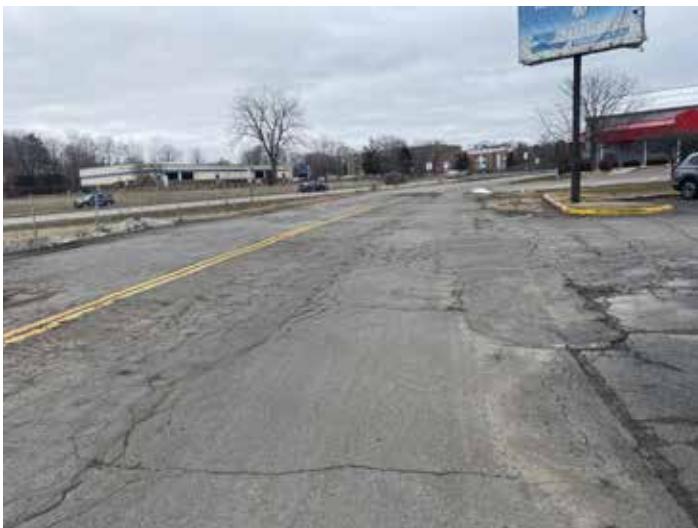
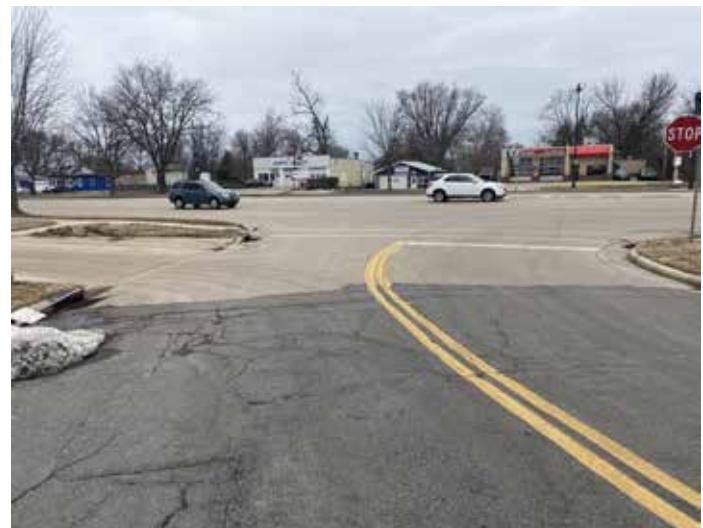
N Stoughton Rd, Service Rd, (fair condition, crack, uneven surfaces)

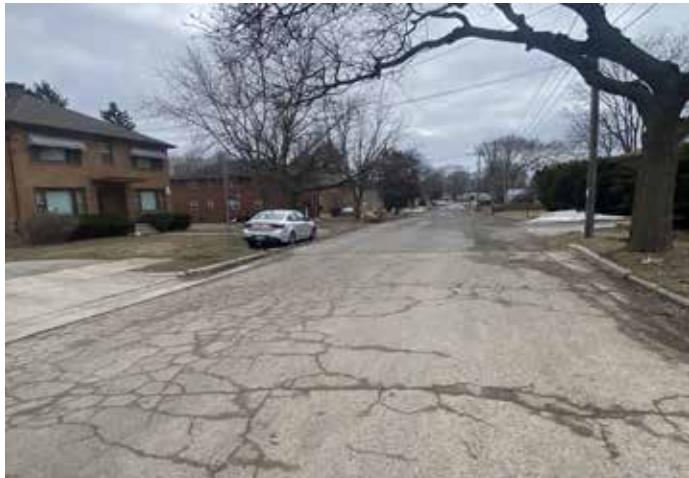
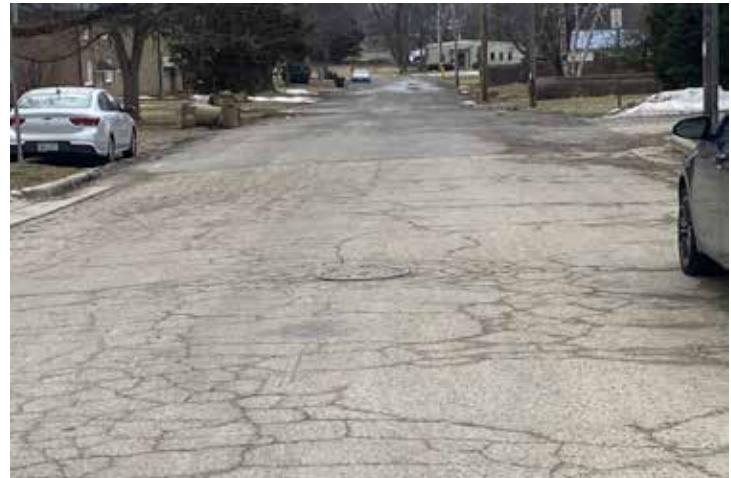
Pinecrest Dr, Near E Washington Ave, (fair condition, cracking, no gutter)

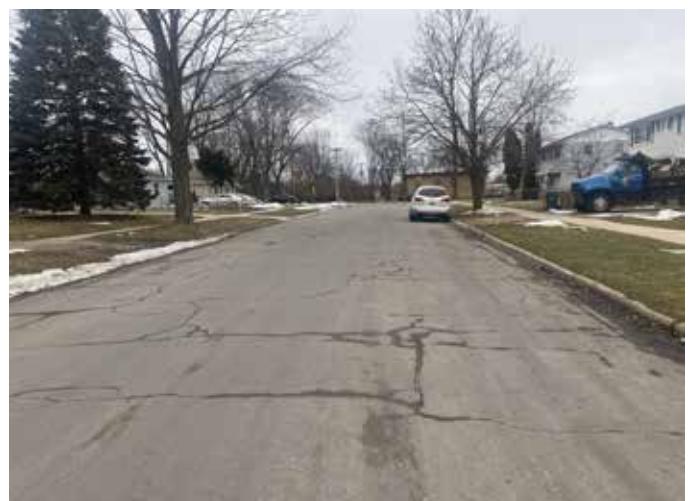
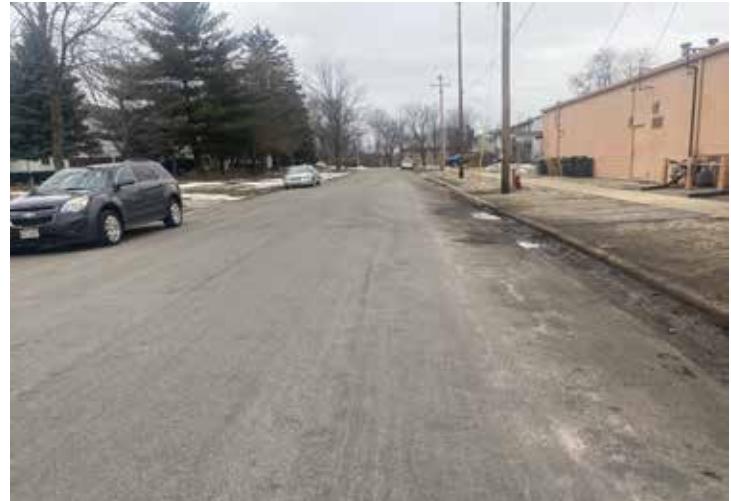
Prairie Av, near N Stoughton Rd, (good condition, but minor cracking)

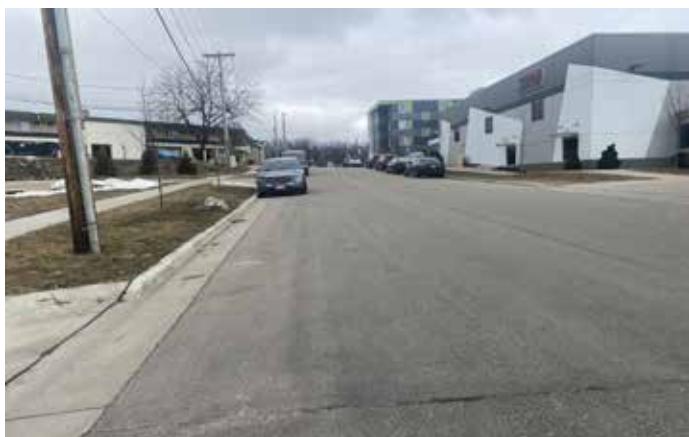
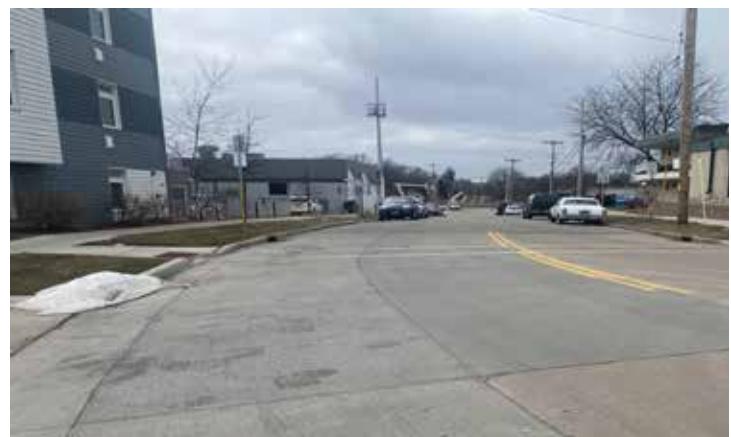
Rethke Ave (good condition)

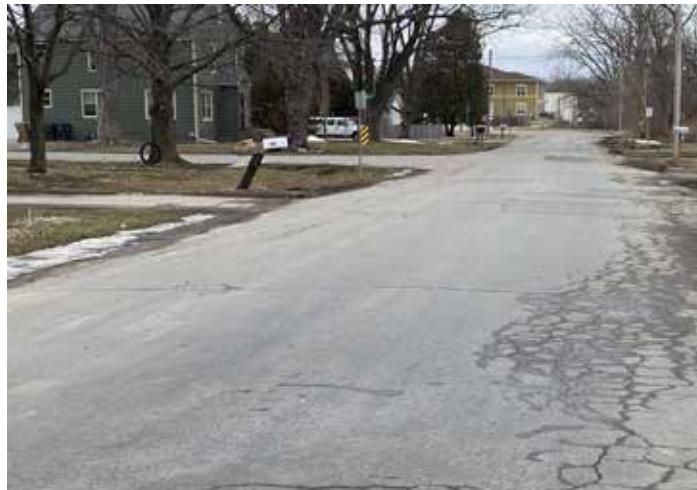
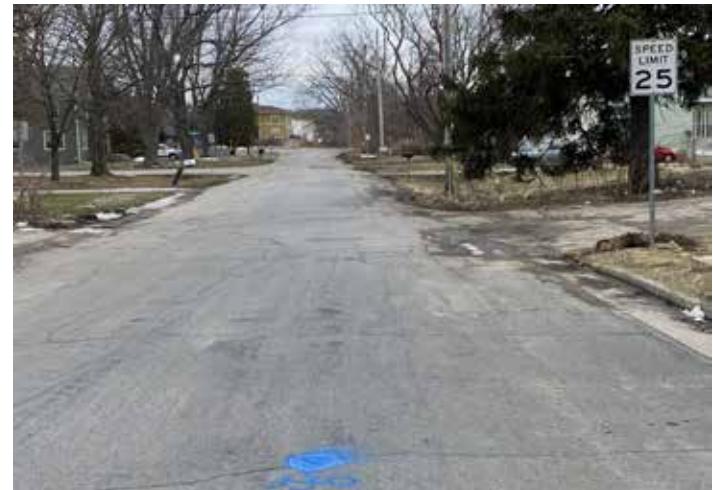
Rowland Ave (fair condition, crack, pothole)

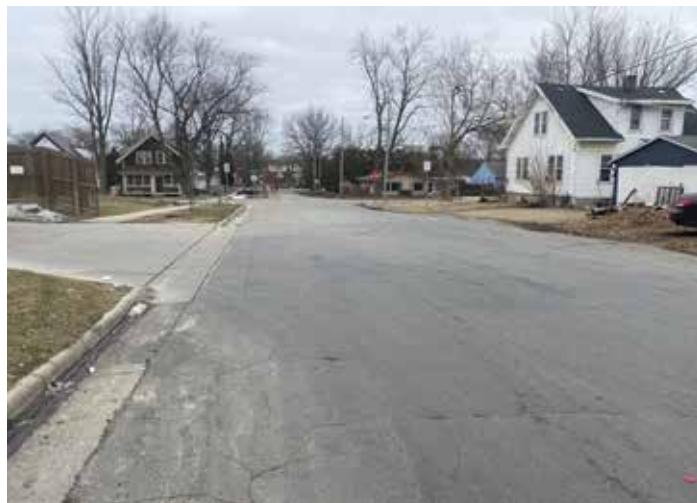
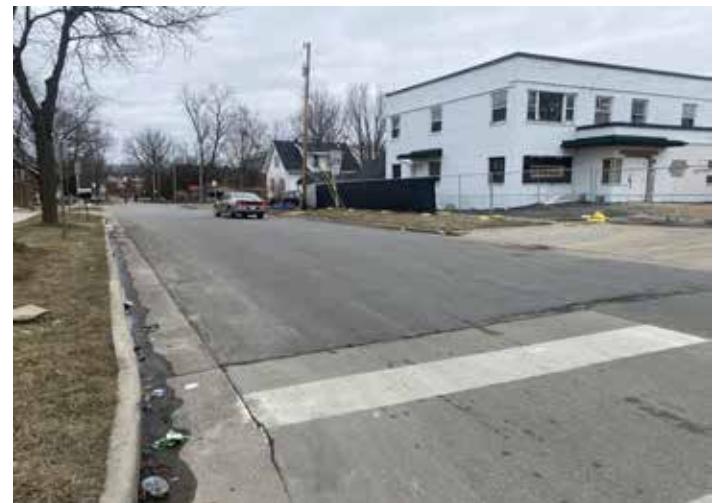
Schmedeman Ave off E Washington Ave (fair condition, crack, uneven surfaces)
