Capital Assessment Equipment

Golf Enterprise Program

Capital Assessment Courses

Yahara Hills Golf Course Capital Needs Assessment

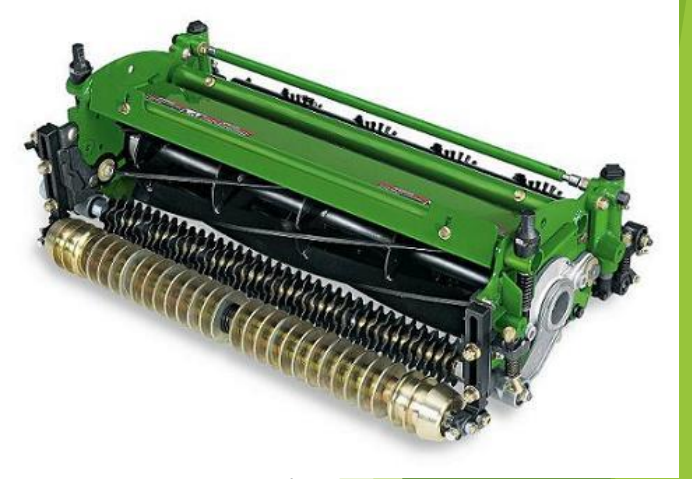
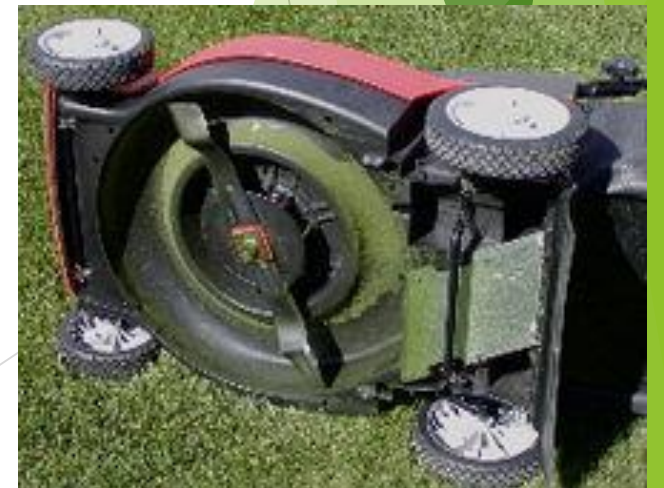
- ▶ Reel Cutting Units -

- ▶ Units provide high quality finish cut of turf at low heights. Allowing for better playing conditions and faster green pace.
- ▶ Cutting heads on machines used to cut tees, fairways and greens.

- ▶ Rotary Cutting Units -

- ▶ Similar to residential grade
- ▶ Units used one - two times weekly for cutting the “rough” or higher cuts.

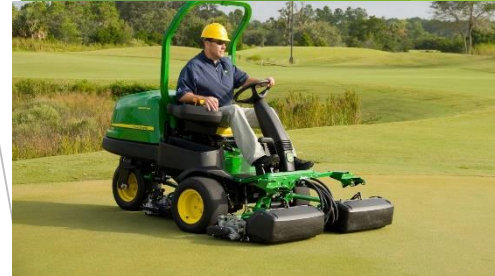
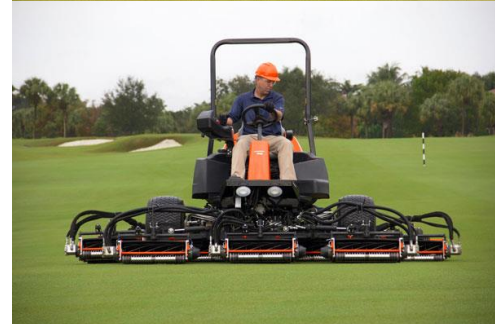
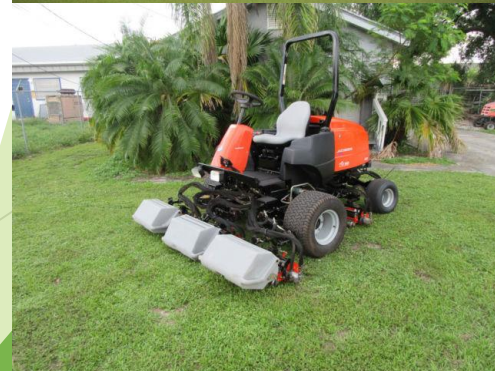
▶ Greens mower or Tri Plex -

- ▶ Maneuverable, lightweight machine equipped with three reel cutting units to provide a close cut.
 - ▶ Types: Toro 3150, Jacobsen Eclipse (hybrid), Jacobsen Greens King

▶ Fairway Mower -

- ▶ Machines containing 5 -7 reel cutting units on each machine. The larger size and width provide for efficiencies of operations.
 - ▶ Types: Jacobsen LF-3400, Jacobsen LF557, Toro 5210

▶ Tees and Collars -

- ▶ Machines with 5 reel lightweight mowers allow for faster turn around when mowing collars and approaches to greens. Provide higher height of cut than greens, but lower than fairways.
 - ▶ Types: Jacobsen 1880

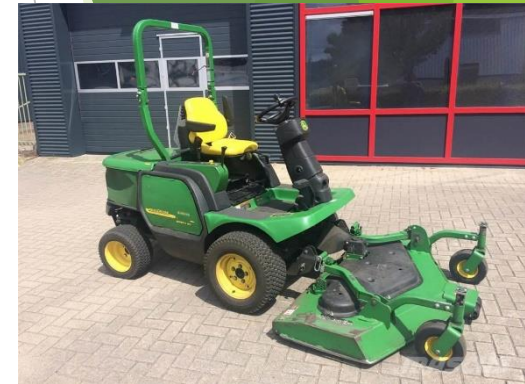
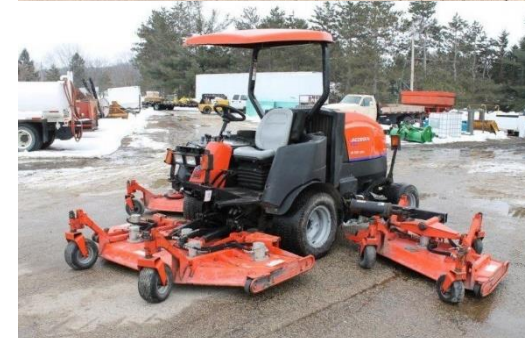
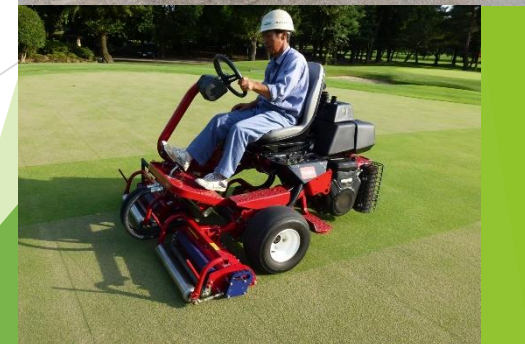
▶ Small Area or Trim Cut Area Mower

- ▶ These mowers are rotary cutting units with smaller cutting decks than the large area mowers. They are used to cut around trees or intricate areas for easier maneuverability.

- ▶ John Deere 1435, Toro 3500D

▶ Tri Plex Rollers

- ▶ Same machine as Tri Plex greens mowers containing heads with weighted roller bar instead of reel cutting units. Rolling greens reduces turf stress and disease pressure and provides a smoother green surface.

- ▶ Jacobsen Greens King

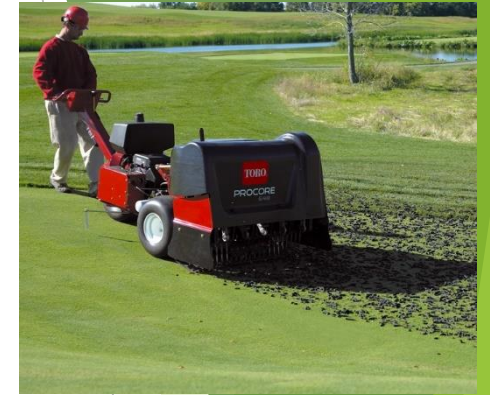
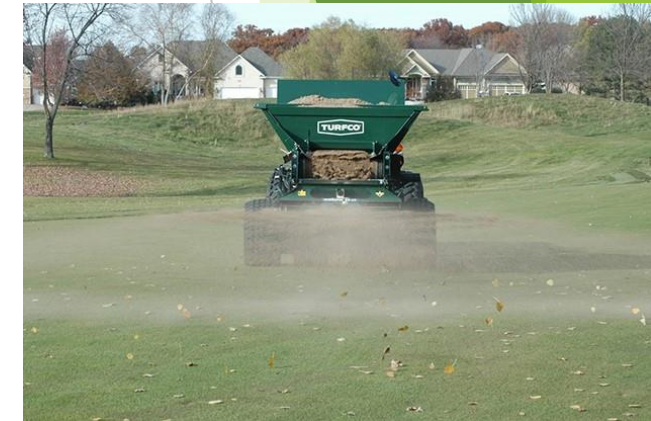
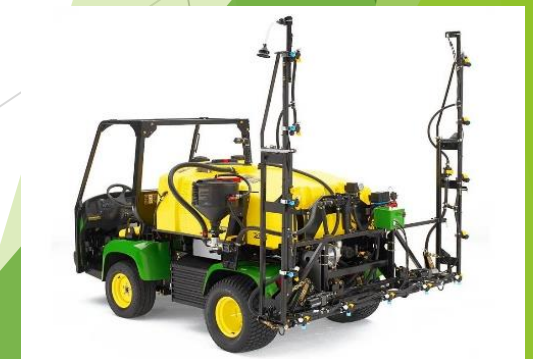
▶ Aerifier -

- ▶ Aeration is essential to keeping playing surfaces healthy and in good condition by relieving soil compaction, increasing air flow, stimulating root growth and improving drainage.
- ▶ Used in spring and fall to “punch” holes into the turf grass, through the thatch/organic layer and soil.
- ▶ Type: Ryan GA30 & 60, Toro ProCore 648, Wiedenmann 72

- ▶ Topdressing improves playing conditions, thatch dilution, turf recovery, firmness, and improves root zone for healthier sub-surface.
- ▶ Used to apply small layers of materials (specialized sand, compost) to the turf.
- ▶ Type: Turfco Widespread Topdresser, Toro Dropdresser

▶ Sprayer -

- ▶ Machine equipped with GPS and foam indicators, used to apply herbicides, insecticides, and fertilizers directly to turf areas, providing for precise and efficient applications.
- ▶ Used Spring, Summer, Fall according to needs of course
- ▶ Type: John Deere HD300

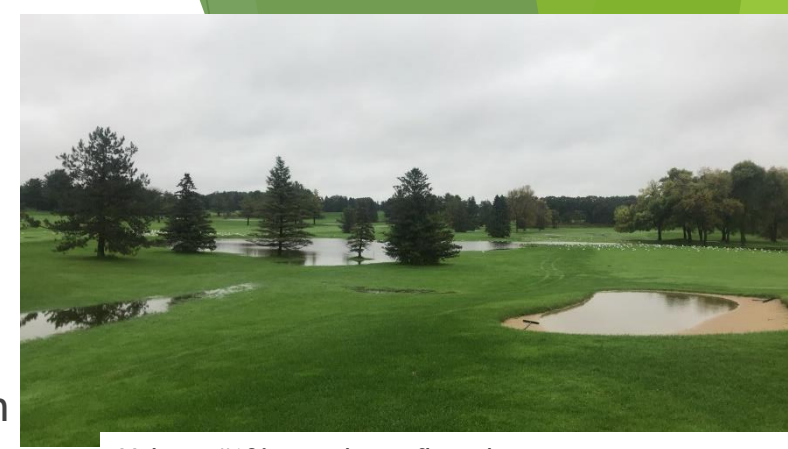
Yahara #18's pond overflow due to max capacity 10/2/2019

- ▶ Concern: Course cannot handle amount of water it is receiving during large rain events, causing significant course closures.
- ▶ Solution: Enlarge existing retention ponds and create new basins to aid in stormwater management. Use available fill to increase low problematic areas.

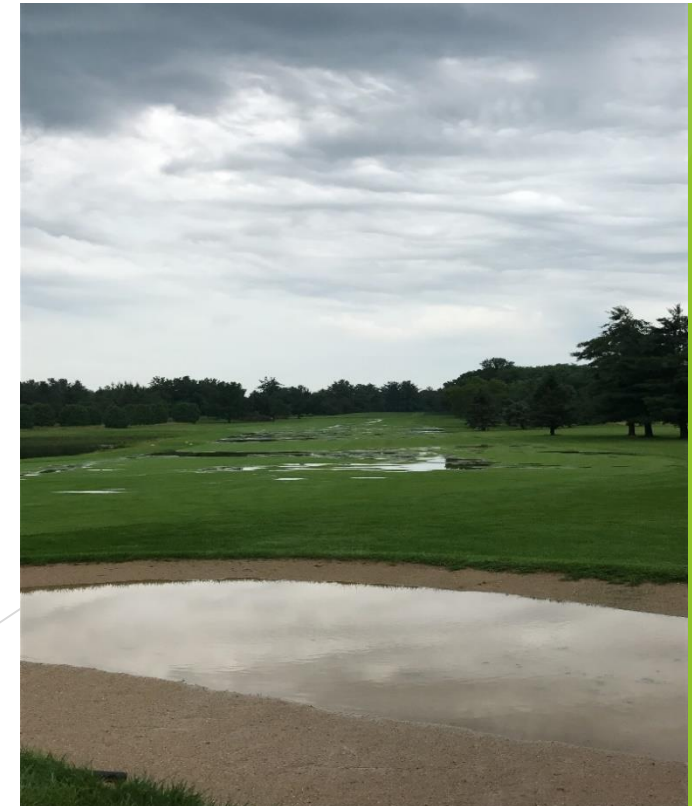
Yahara East #5 standing water due to lack of drainage 7/26/17

Picture #1 - East 12. Water is flowing on site from Eastern properties. Water must travel across entire course to exit

Picture #2 - East 12, 11, 9, 18. West 18 & 9. Water from offsite continues across all six holes creating a blockage of all holes to the clubhouse

Picture #3 - West 10 pond at max capacity and overflowing onto holes West 10 and East 1

- ▶ Concern: Low lying areas of course are frequently saturated for extended periods of time following rain events. Excessive water is the driving factor in course closures. Large culvert running across course is failing and undersized for current flow. Disrupts flow of stormwater and contributes to course closures.
- ▶ Solution: Raise and re-grade fairways of 6 lowest holes and add drainage tile to improve drainage. West: 1 & 18. East: 1,5,6,18. Replace 24" culvert with 36" plastic pipe and restore connections as necessary.

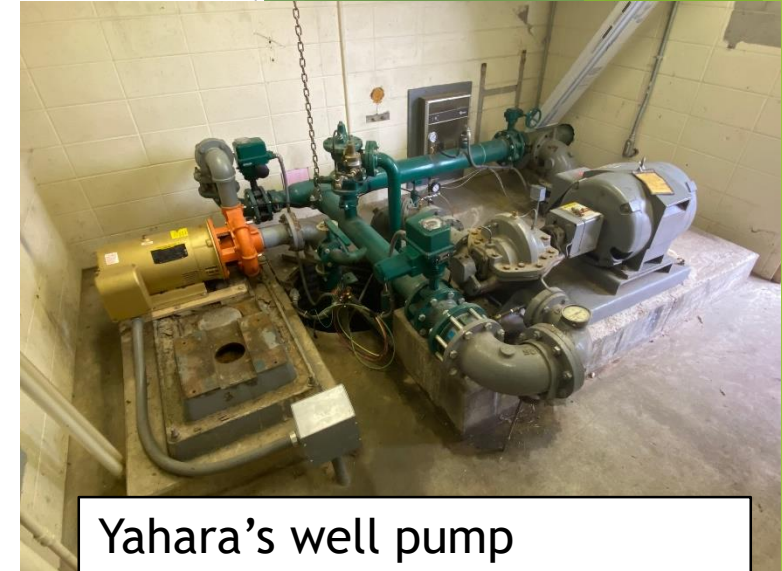
- ▶ Concern: Two pump stations are original to course (50 years old) and experiencing growing issues/reliability, computer control system experiencing shutdowns. Irrigation system was last renovated 20 years ago and is approaching end of useful life.
- ▶ Solution: Rebuild pumphouse; replace control unit, 2 Pump stations and Control Satellite Units and rebuild in-ground irrigation system.

Yahara's well pump
Deteriorating pumphouse

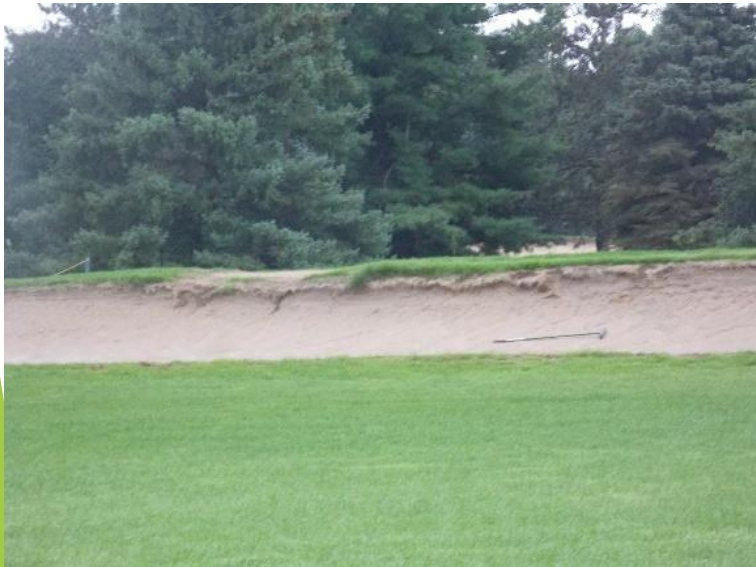
- ▶ Concern: With 90 bunkers total on the course, there are too many oversized bunkers, which are costly to maintain, and many are experiencing failing drainage, causing them to retain water, impacting playability of course and customer satisfaction.
- ▶ Solution: Reduce size of bunkers and reshape throughout entire course, using Better Billy Bunker system to rebuild to provide consistency and reduce maintenance requirements and increase longevity of system.

East #6 bunker collapse from overtime failure

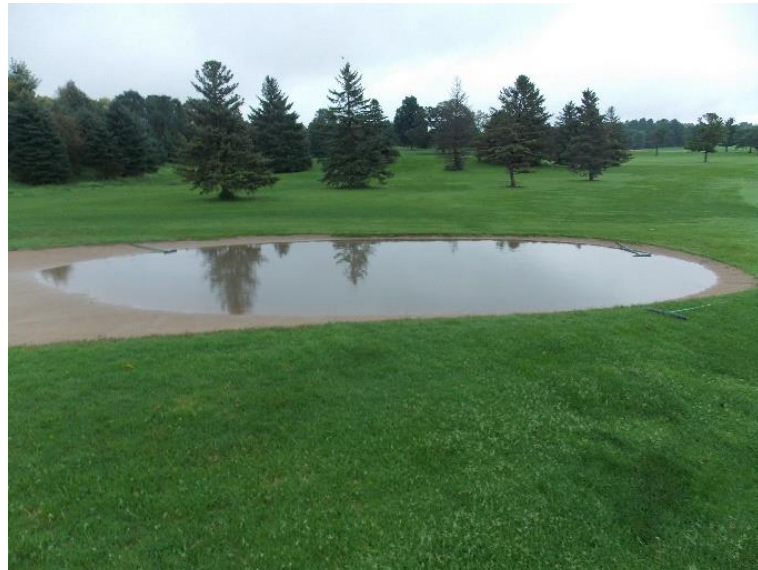
Yahara #18's bunker following overnight rains 9/23/16

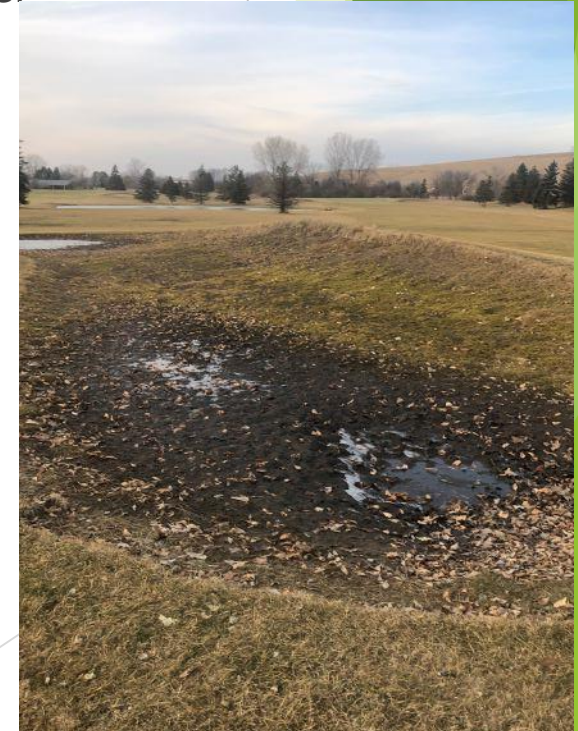
West #12 bunker drainage collapse, resulting in compaction, poor drainage and excessive weed growth.

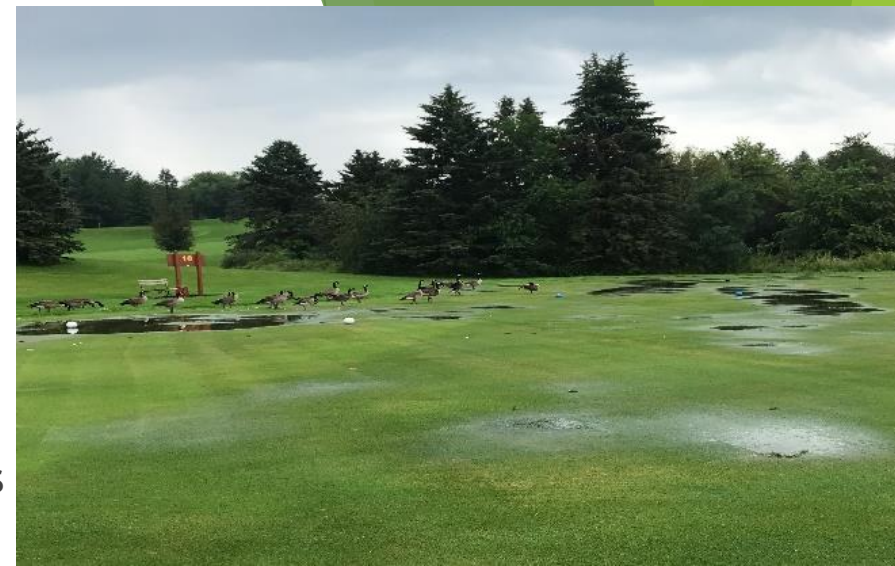
- ▶ Concern: Course has many long holes. Existing tees result in longer play, and can be too challenging for novice players and others, which can deter play.
- ▶ Solution: Install new, shorter tee boxes to longer holes in order to enhance golfer experience and generate new clientele.

Tee box at Yahara post-rain event.

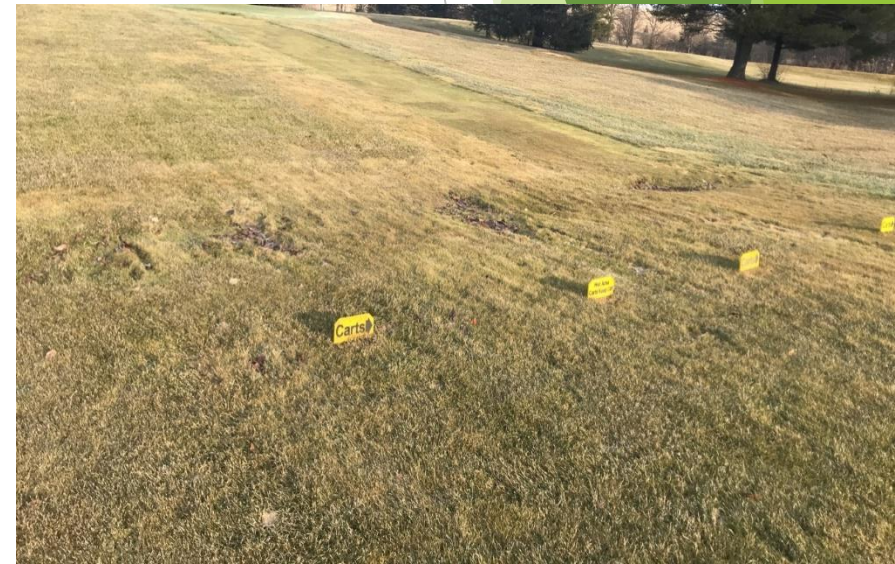
- ▶ Concern: Drainage issues and highly organic soil result in wet conditions that prevent use of carts and impact amount of play.
- ▶ Solution: Install asphalt cart path system throughout the course, which will allow for cart use at all times, resulting in less downtime due to weather related events.

Regular cart traffic causing wear on course. East #11.

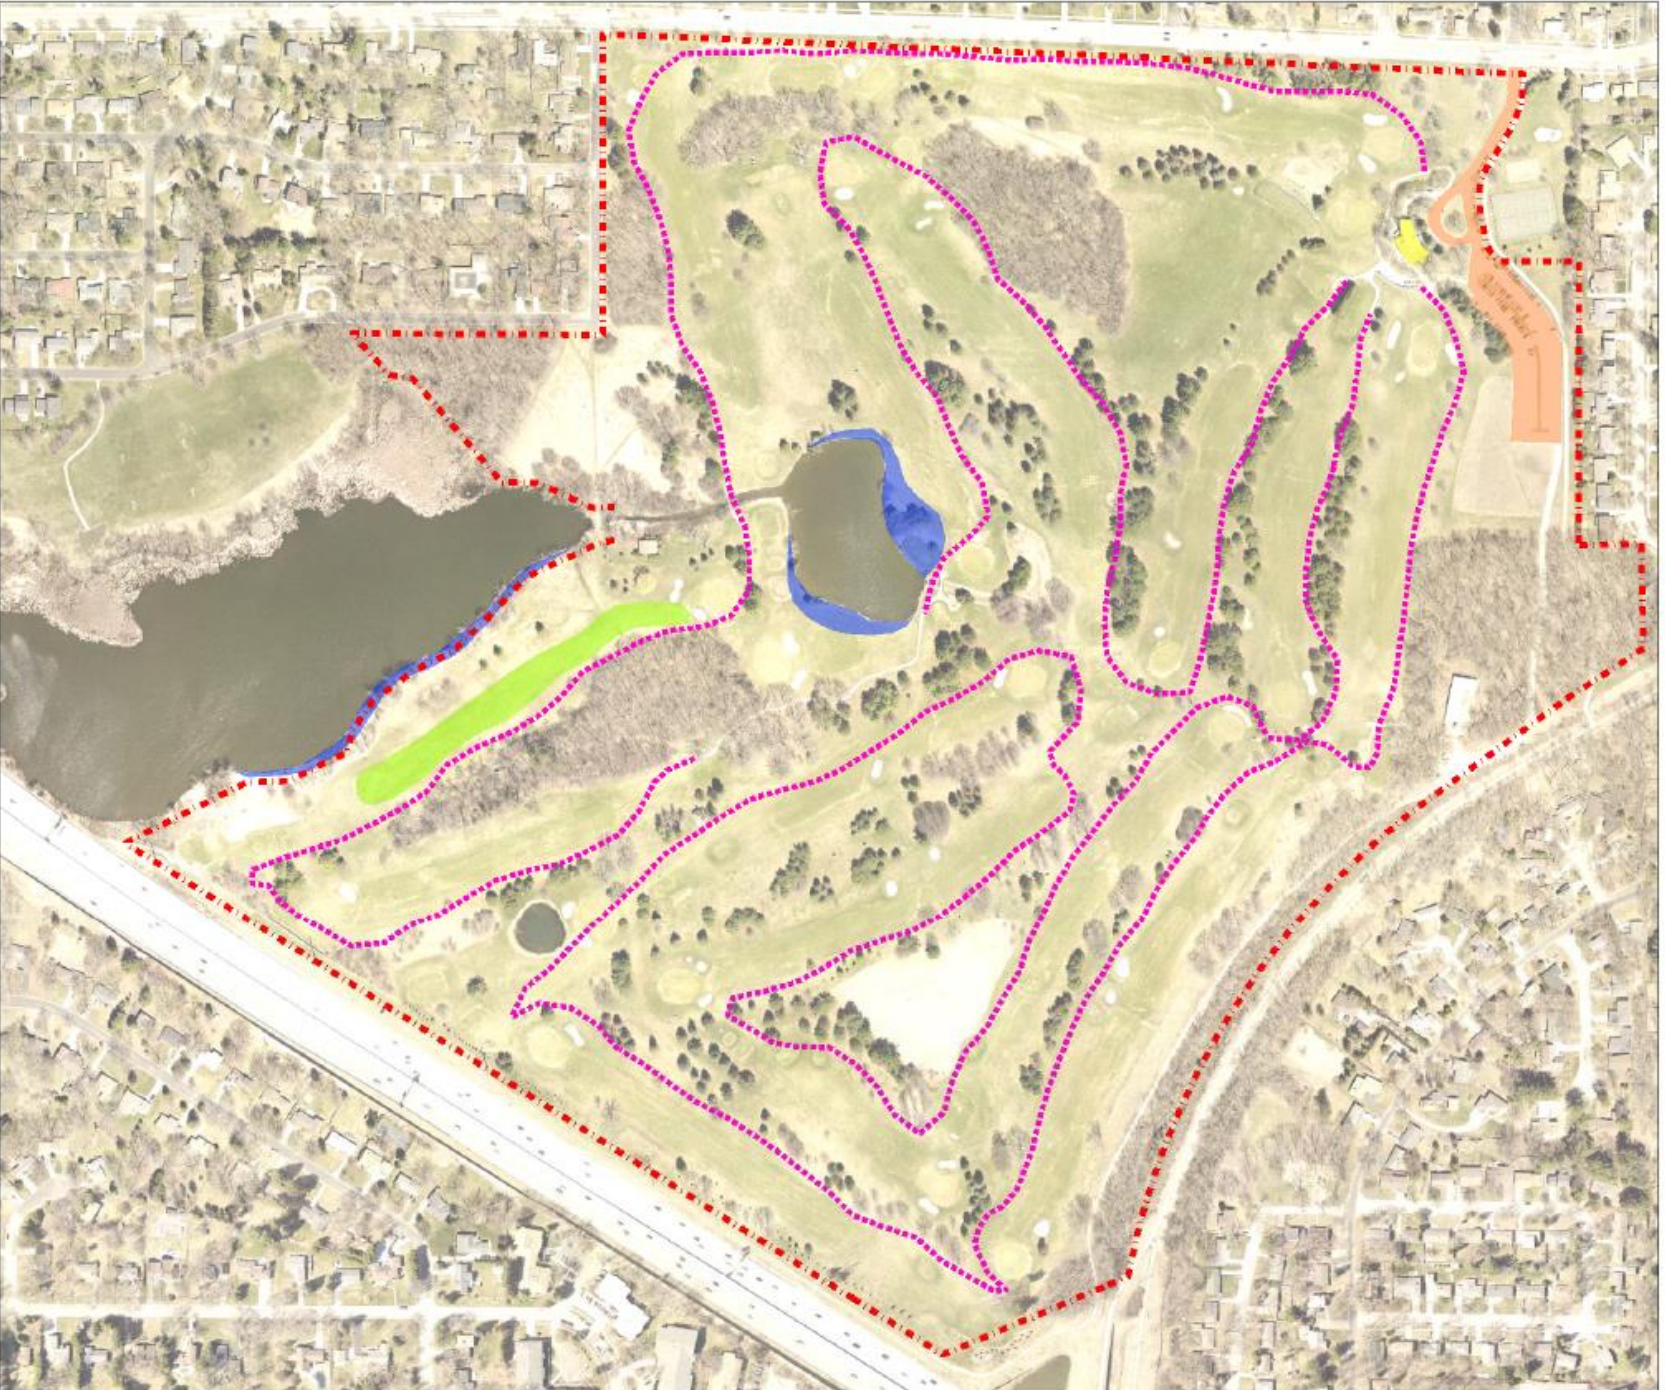
Odana Hills Golf Course Capital Needs Assessment

Priority	Need
1	Fairway Restoration Hole #15
2	Pond Improvements
3	New Well and Pumphouse, Irrigation Updates
4	Improve Drainage
5	Clubhouse Replacement and Parking Lot Renovation
6	Green Renovation
7	Install New Tees and Expand Driving Range Tee
8	Cart Path Installation
9	Covered Storage for Bulk Materials

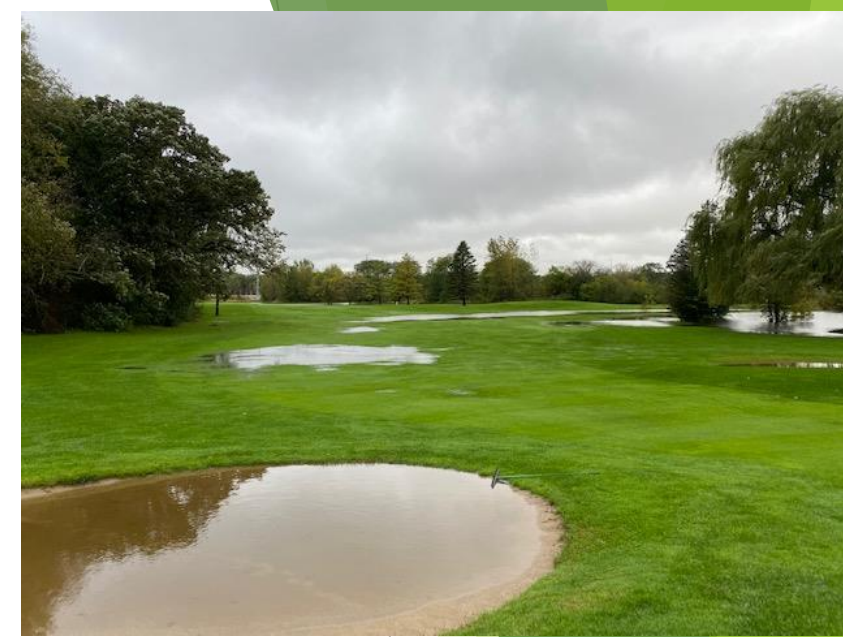
- ▶ Concern: Hole #15 floods after every rainfall and is unable to recover. The hole is now lower than the existing retention pond running along the hole, not allowing for the area to drain.
- ▶ Solution: Raise the entire hole out of flood zone with fill and increase drainage of entire area.

#15 rainwater remains in fairway and in bunker.

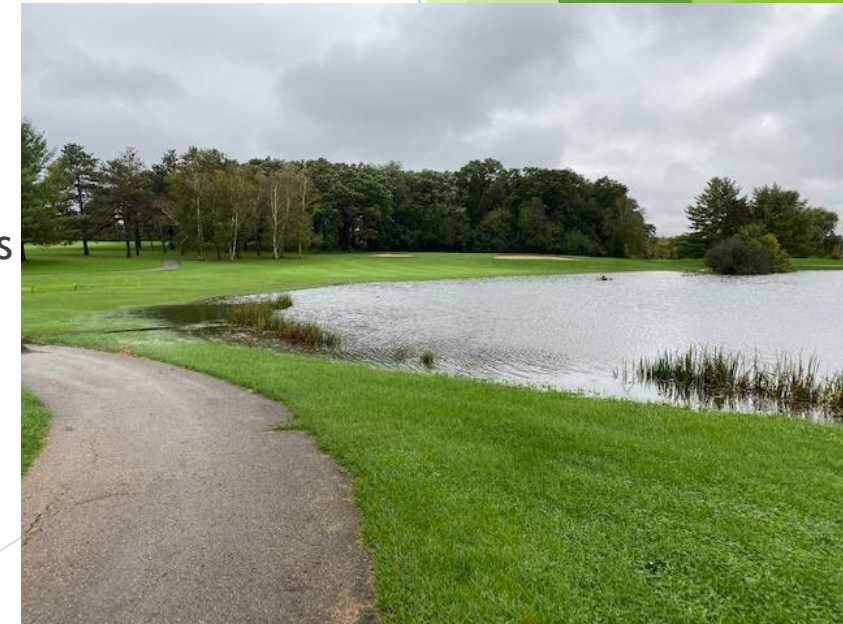
Odana pond on #13 overflow.

- ▶ Concern: Course cannot handle amount of water it is receiving during large rain events, causing significant course closures.
- ▶ Solution: Increase stormwater capacity, by enlarging existing retention ponds and creating new basins to aid in stormwater management. Use available fill to increase low problematic areas. Study is underway and there is potential for cost sharing/collaboration with Stormwater Engineering.

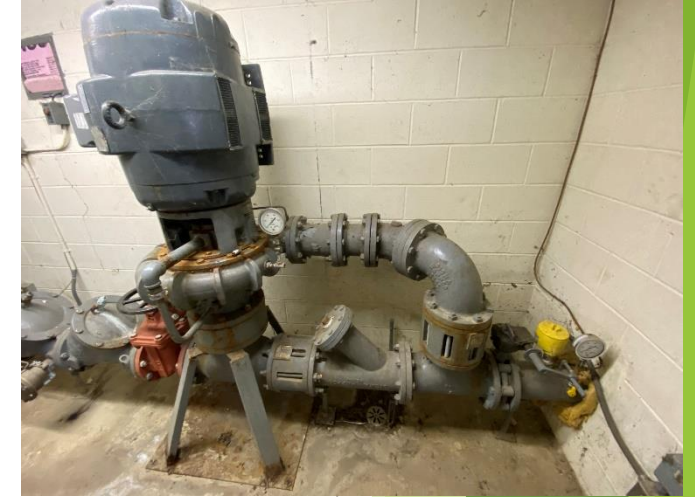
- ▶ Concern: Treated City water is used to irrigate the course. The water costs to irrigate the golf course are rising yearly. The pump station has outlived its useful life and needs to be replaced and relocated.
- ▶ Solution: Install well to increase sustainability and reduce water costs. A new pump station is necessary for reliability and to move water from well.

Odana irrigation pump

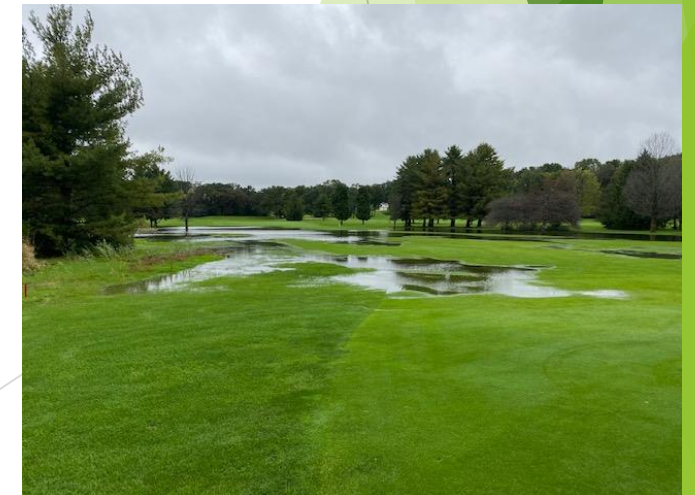
Drainage issues on hole #12 (view from green toward tee box)

- ▶ Concern: Low lying areas of course are frequently saturated for extended periods of time following rain events. Contributing to course closures.
- ▶ Solution: Install new drainage in areas of holes 8,11,12,15,& 16 to allow for faster turn around after rain events.

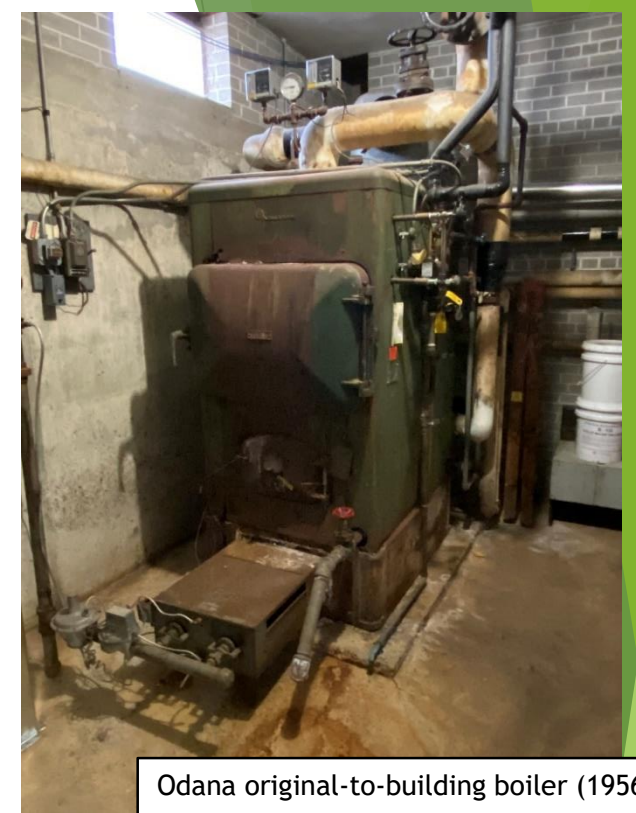
- ▶ Concern: Current clubhouse is not ADA accessible, is extremely outdated and running on original (1956) boiler. Small size restricts size/number of events. Parking lot does not meet current code requirements and is in need of overall replacement.
- ▶ Solution: Build a multi-use facility that will allow for added revenue streams for the Golf Enterprise Program, community space for various uses and user group needs on the West Side. Rebuild parking lot to meet code.

Odana original-to-building boiler (1956)

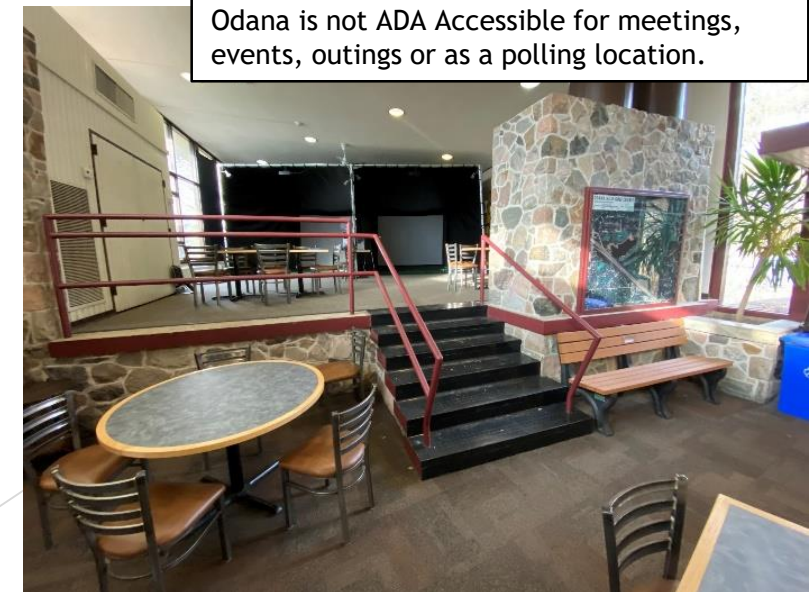
Odana is not ADA Accessible for meetings, events, outings or as a polling location.

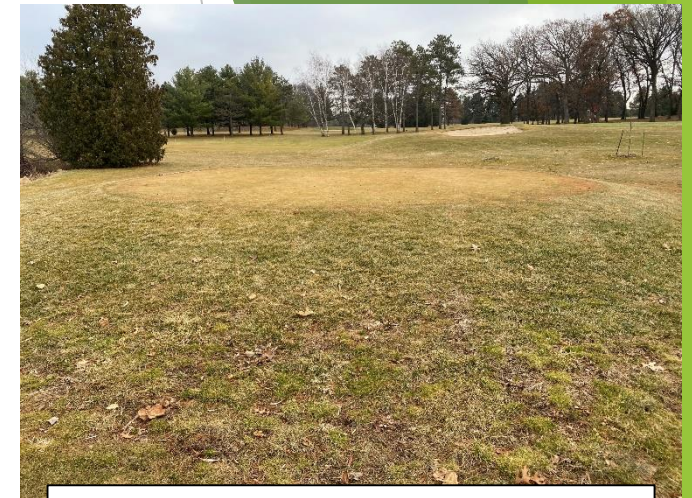
New tee box on hole #16. Built in 2018 to diversify level of play.

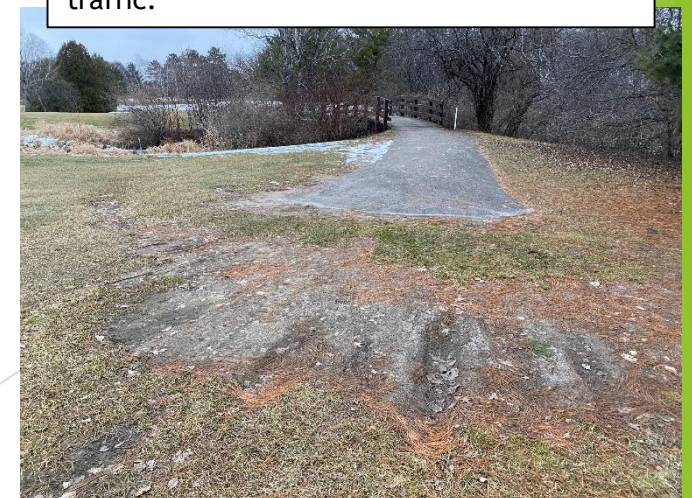
- ▶ Concern: Drainage issues and highly organic soil result in wet conditions that prevent use of carts and impact amount of play.
- ▶ Solution: Install cart path system throughout the course, which will allow for cart use at all times, resulting in less downtime due to weather related events.

Deteriorating foot bridge and cart path - hole #16 Odana. Wear due to high cart traffic.

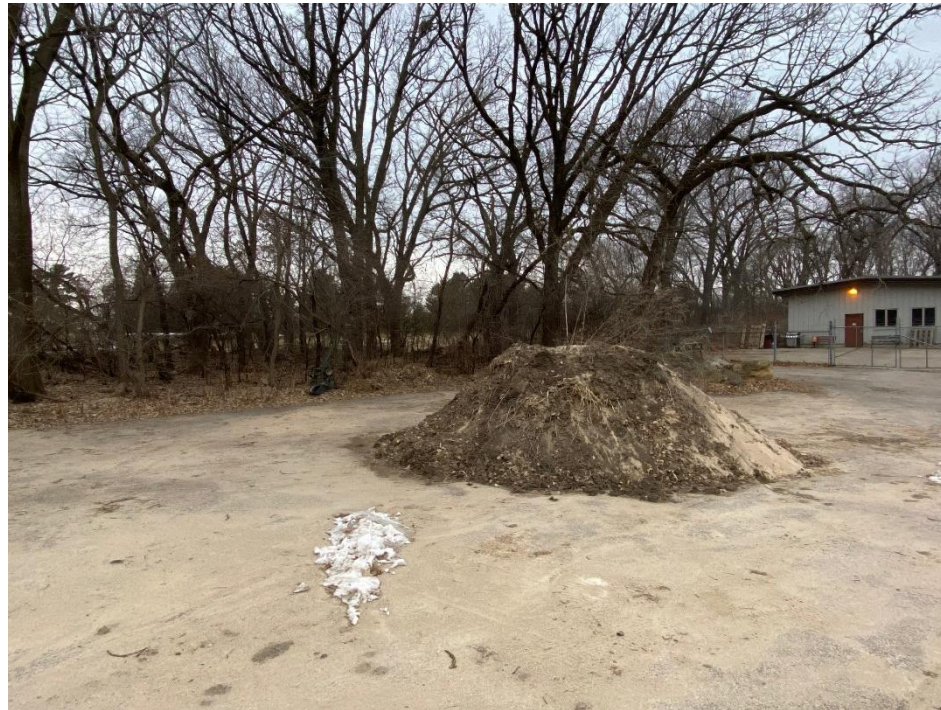
- ▶ Concern: Currently no storage for bulk products, such as soil, sand and topdressing. Material is stored on pavement and tarped. Material can be damaged, washed or blown away by rain and wind.
- ▶ Solution: Build a structure to contain these soils and sands to avoid loss and keep items in correct working order.

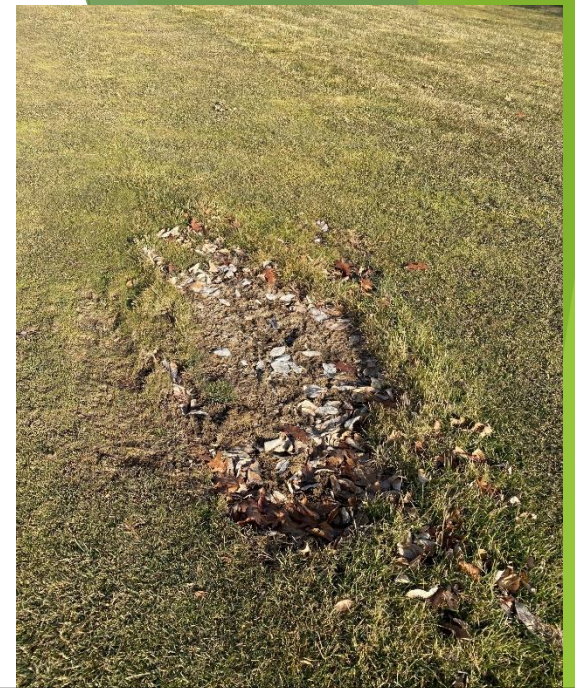
- ▶ Concern: System and pump dates back to the 1960's and operates on outdated controls. Experiencing growing issues/reliability, computer control system experiencing shutdowns. Glue joints failing near sprinkler heads will need to be addressed. Treated City water is used to irrigate the course. The water costs to irrigate the Golf Course are rising yearly.
- ▶ Solution: Replacement of control unit, pump station, and Control Satellite Units. Install well to increase sustainability and reduce water costs.

Monona irrigation head leak area visible in many areas of course.

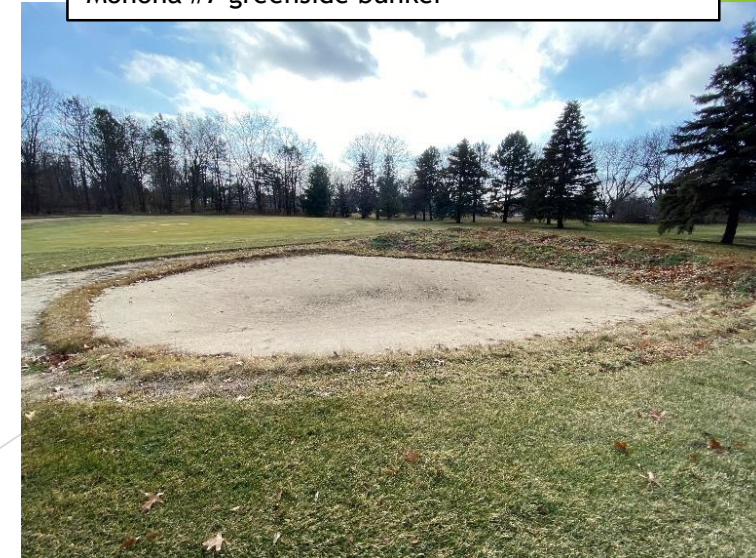
- ▶ Concern: There are too many oversized bunkers (18 Total), which are costly to maintain with failing drainage and water retention impacting playability of course and customer satisfaction.
- ▶ Solution: Reduction of bunker size and reshaping throughout entire course, using Better Billy Bunker system to rebuild will provide consistency and reduce maintenance requirements and increase longevity of system.

Monona #7 greenside bunker

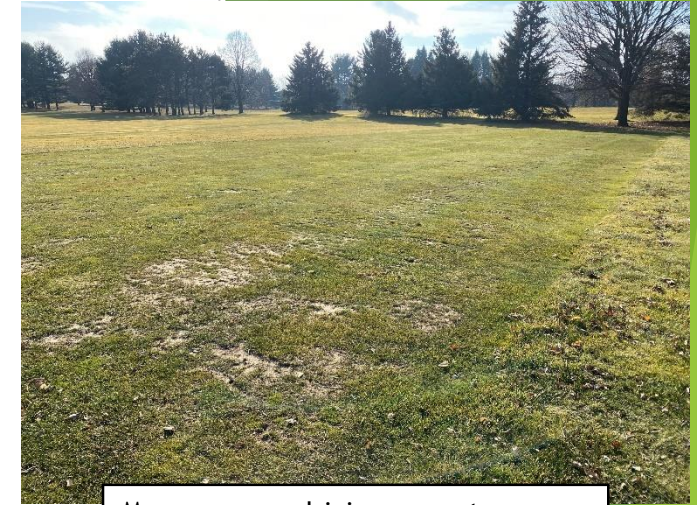
- ▶ Concern: Current driving range tee box has reached end of useful life and has sustained damage due to significant amount of use.
- ▶ Solution: Rebuild driving range tee box using existing soil and adding new soil where needed to create a level playing surface, reestablish area. Install new all-season mats on existing concrete slab.

Monona grass driving range tee area.

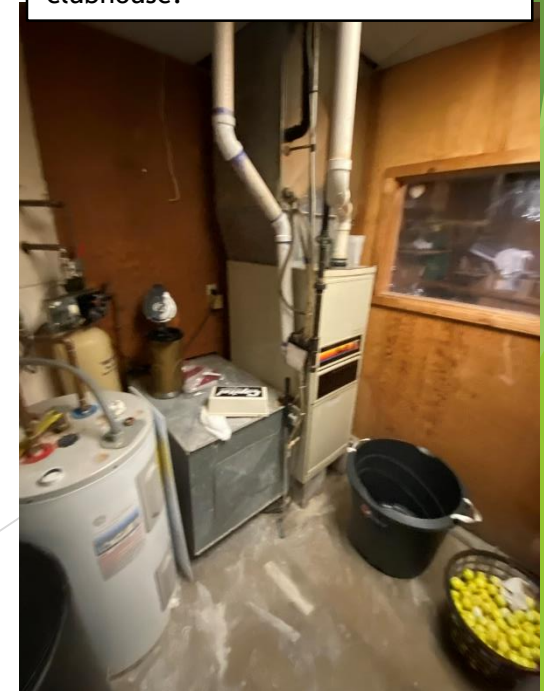
Monona HVAC system is outdated and does not work in half of the clubhouse.

- ▶ Concern: HVAC system does not work on half of the clubhouse, thus cannot keep the building cool in the summer months when needed for staff and customer satisfaction and comfort. Current building is aging and inefficient, HVAC system is in need of replacement. Parking lot is failing and must be brought to code with building replacement.
- ▶ Solution: Replace clubhouse and mechanicals, renovate parking lot to meet current code.

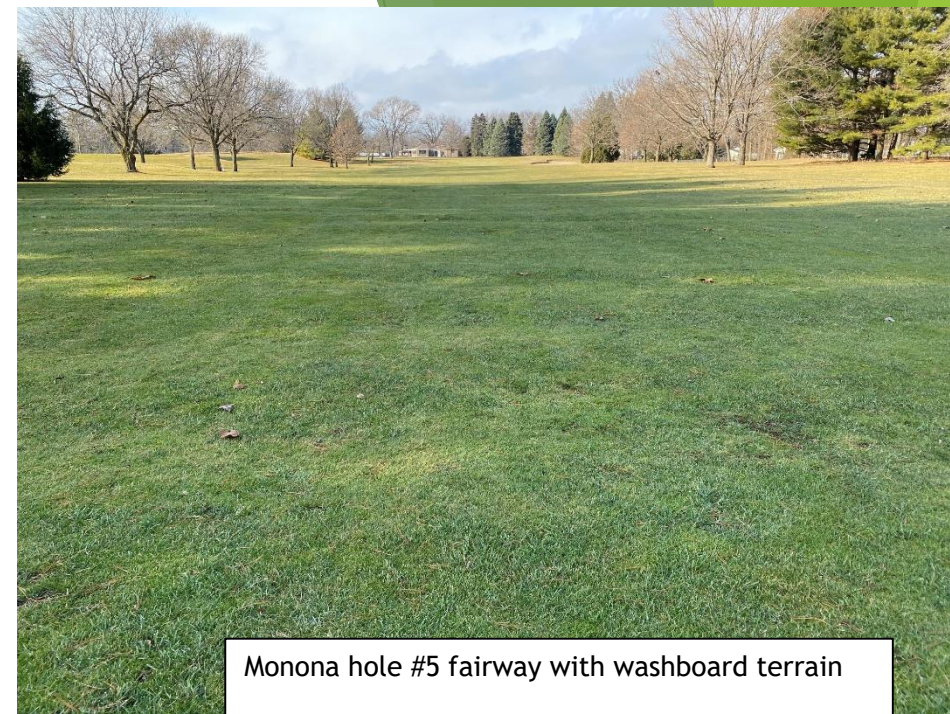
- ▶ Concern: Fairways on many holes have a washboard-like terrain, causing issues with playability and ability to mow fairways at a low height of cut.
- ▶ Solution: Re-grade, fill and reestablish fairways.

Monona hole #5 fairway with washboard terrain

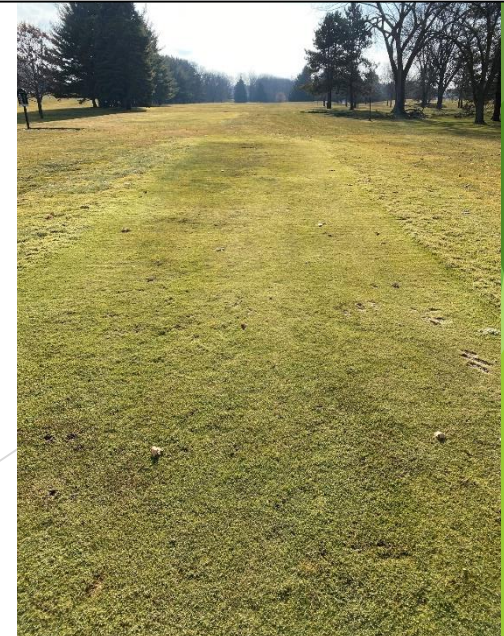
- ▶ Concern: Tees and fairways can only be cut at current height of cut due to turf species, which is higher than other courses and requires more frequent mowing. Height can interfere with playability of course and can result in increased stress to turf and increased insect and disease pressure.
- ▶ Solution: Using a slit seeder reseed all areas as necessary with new blend of turf seed.

Monona hole #6 tee box. Small, narrow tee boxes add to wear of the course.

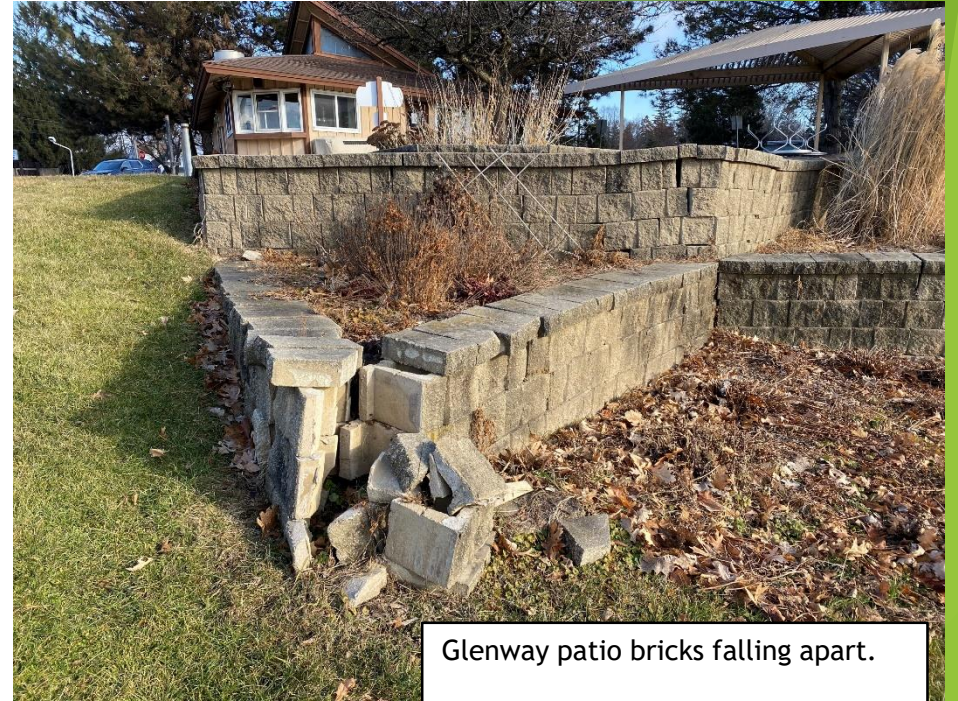
- ▶ Concern: Patio at Glenway is paved with bricks, but is currently sinking and falling apart, posing serious safety concern and may result in closure of patio. Failure could damage the 9th hole's playing surface and will impact the user experience.
- ▶ Solution: Remove and rebuild existing patio.

Glenway patio bricks falling apart.

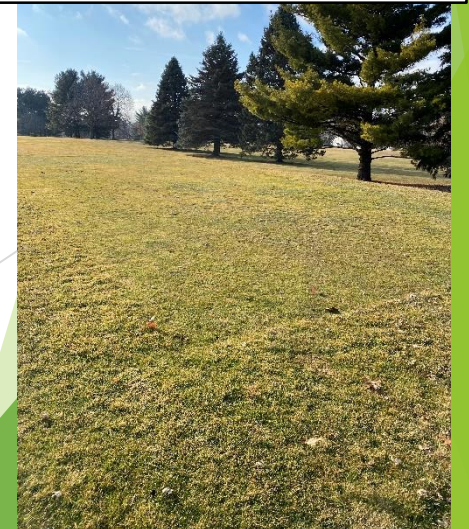
- ▶ Concern: Tee boxes can only be cut at its current height of cut and have recovery issues due to over use and small size. Quality impacts play and user experience as well as makes turf susceptible to weed and pest pressure.
- ▶ Solution: Repair and renovate existing tees.

Small, narrow tee boxes add to wear of the course.

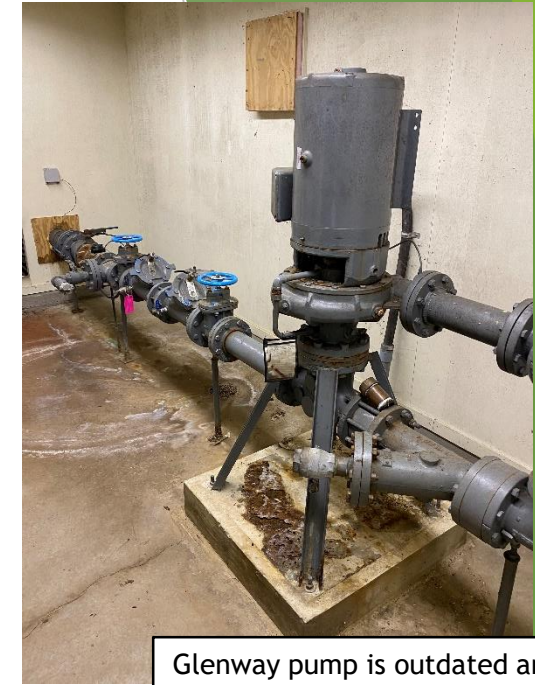
- ▶ Concern: Water costs to irrigate the golf course have risen at a high rate making expense inflation difficult. Along with this is an outdated pump station that has outlived its useful life and needs to be relocated with well addition.
- ▶ Solution: Install well to increase sustainability and reduce water costs. A new pump station is necessary for reliability and to move water from well.

Glenway pump is outdated and would need relocating if on well.

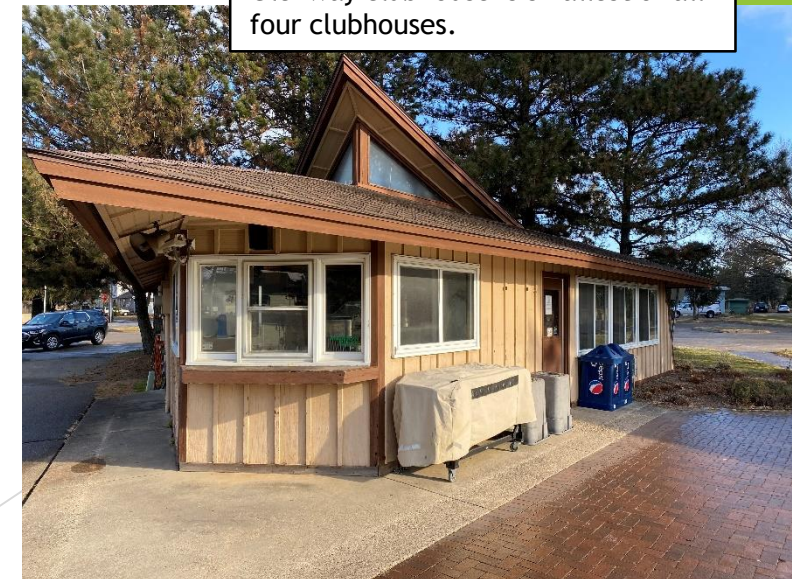
Glenway clubhouse is smallest of all four clubhouses.

- ▶ Concern: Current clubhouse is extremely outdated and beginning to have rot and water damage throughout. In addition, it is undersized for amount of use and size limits retail offerings to customers. Parking lot is failing and must be brought to code with building replacement.
- ▶ Solution: Replace clubhouse and mechanicals, renovate parking lot to meet current code.
