Problematic Right Turn from Northbound Groveland Terrace onto Eastbound Pflaum Rd

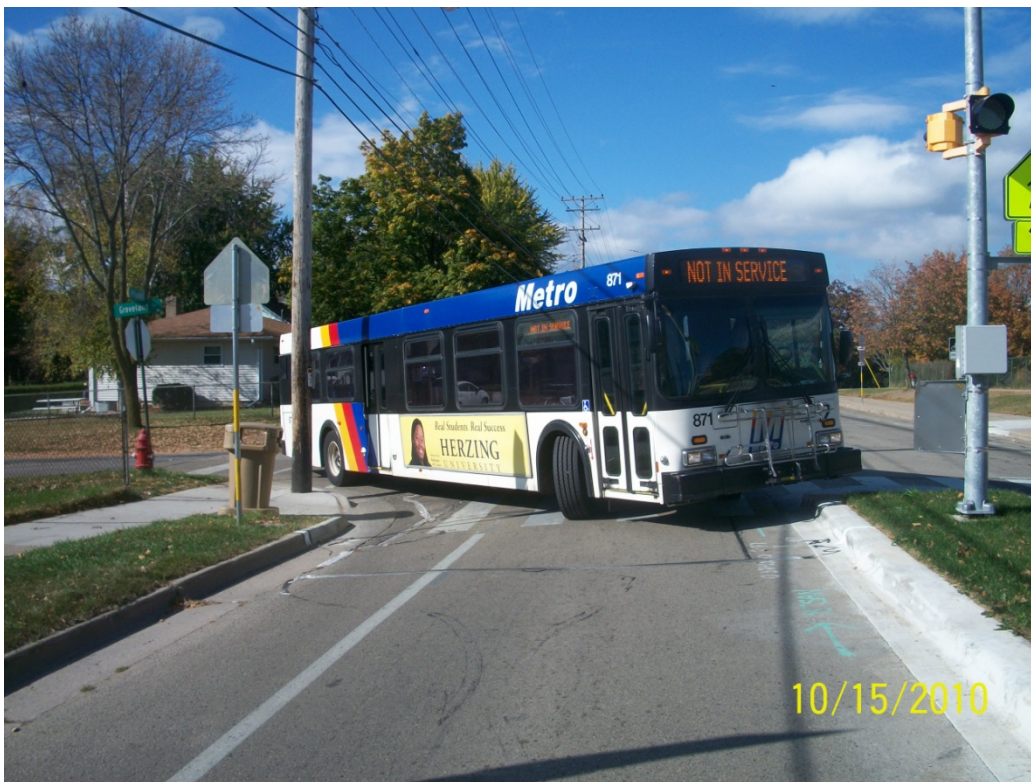
Even with an adequate “set up” for the turn, the front bumper of the bus still sweeps out over the center island. There have been occasions when buses have backed up in the intersection to avoid either the utility pole in the S.E. corner, or the light pole mounted in the island.

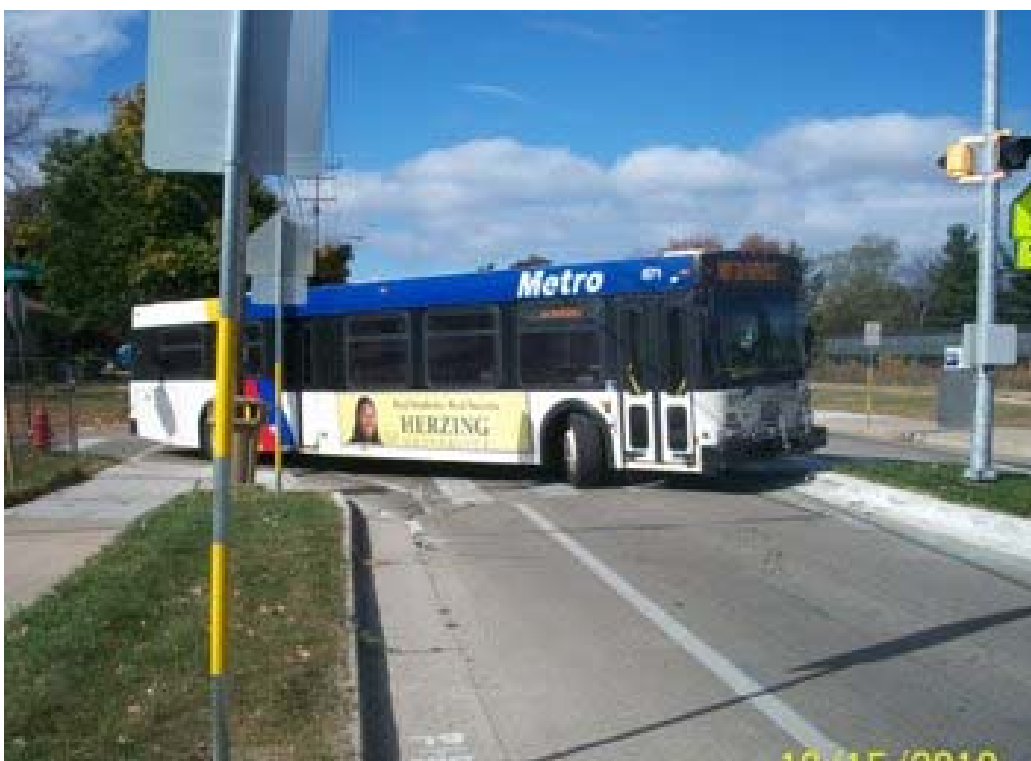
When snow gets piled to the sides of the street, this will have the effect of further narrowing Groveland Terrace and making the turn even more difficult.
