Pumpkin Hollow- North

Professionally Assured Wetland Delineation Report

Project Number: DAN21-011-01

Property Address: 4404 Hoepker Road, City of Madison, Dane County, Wisconsin

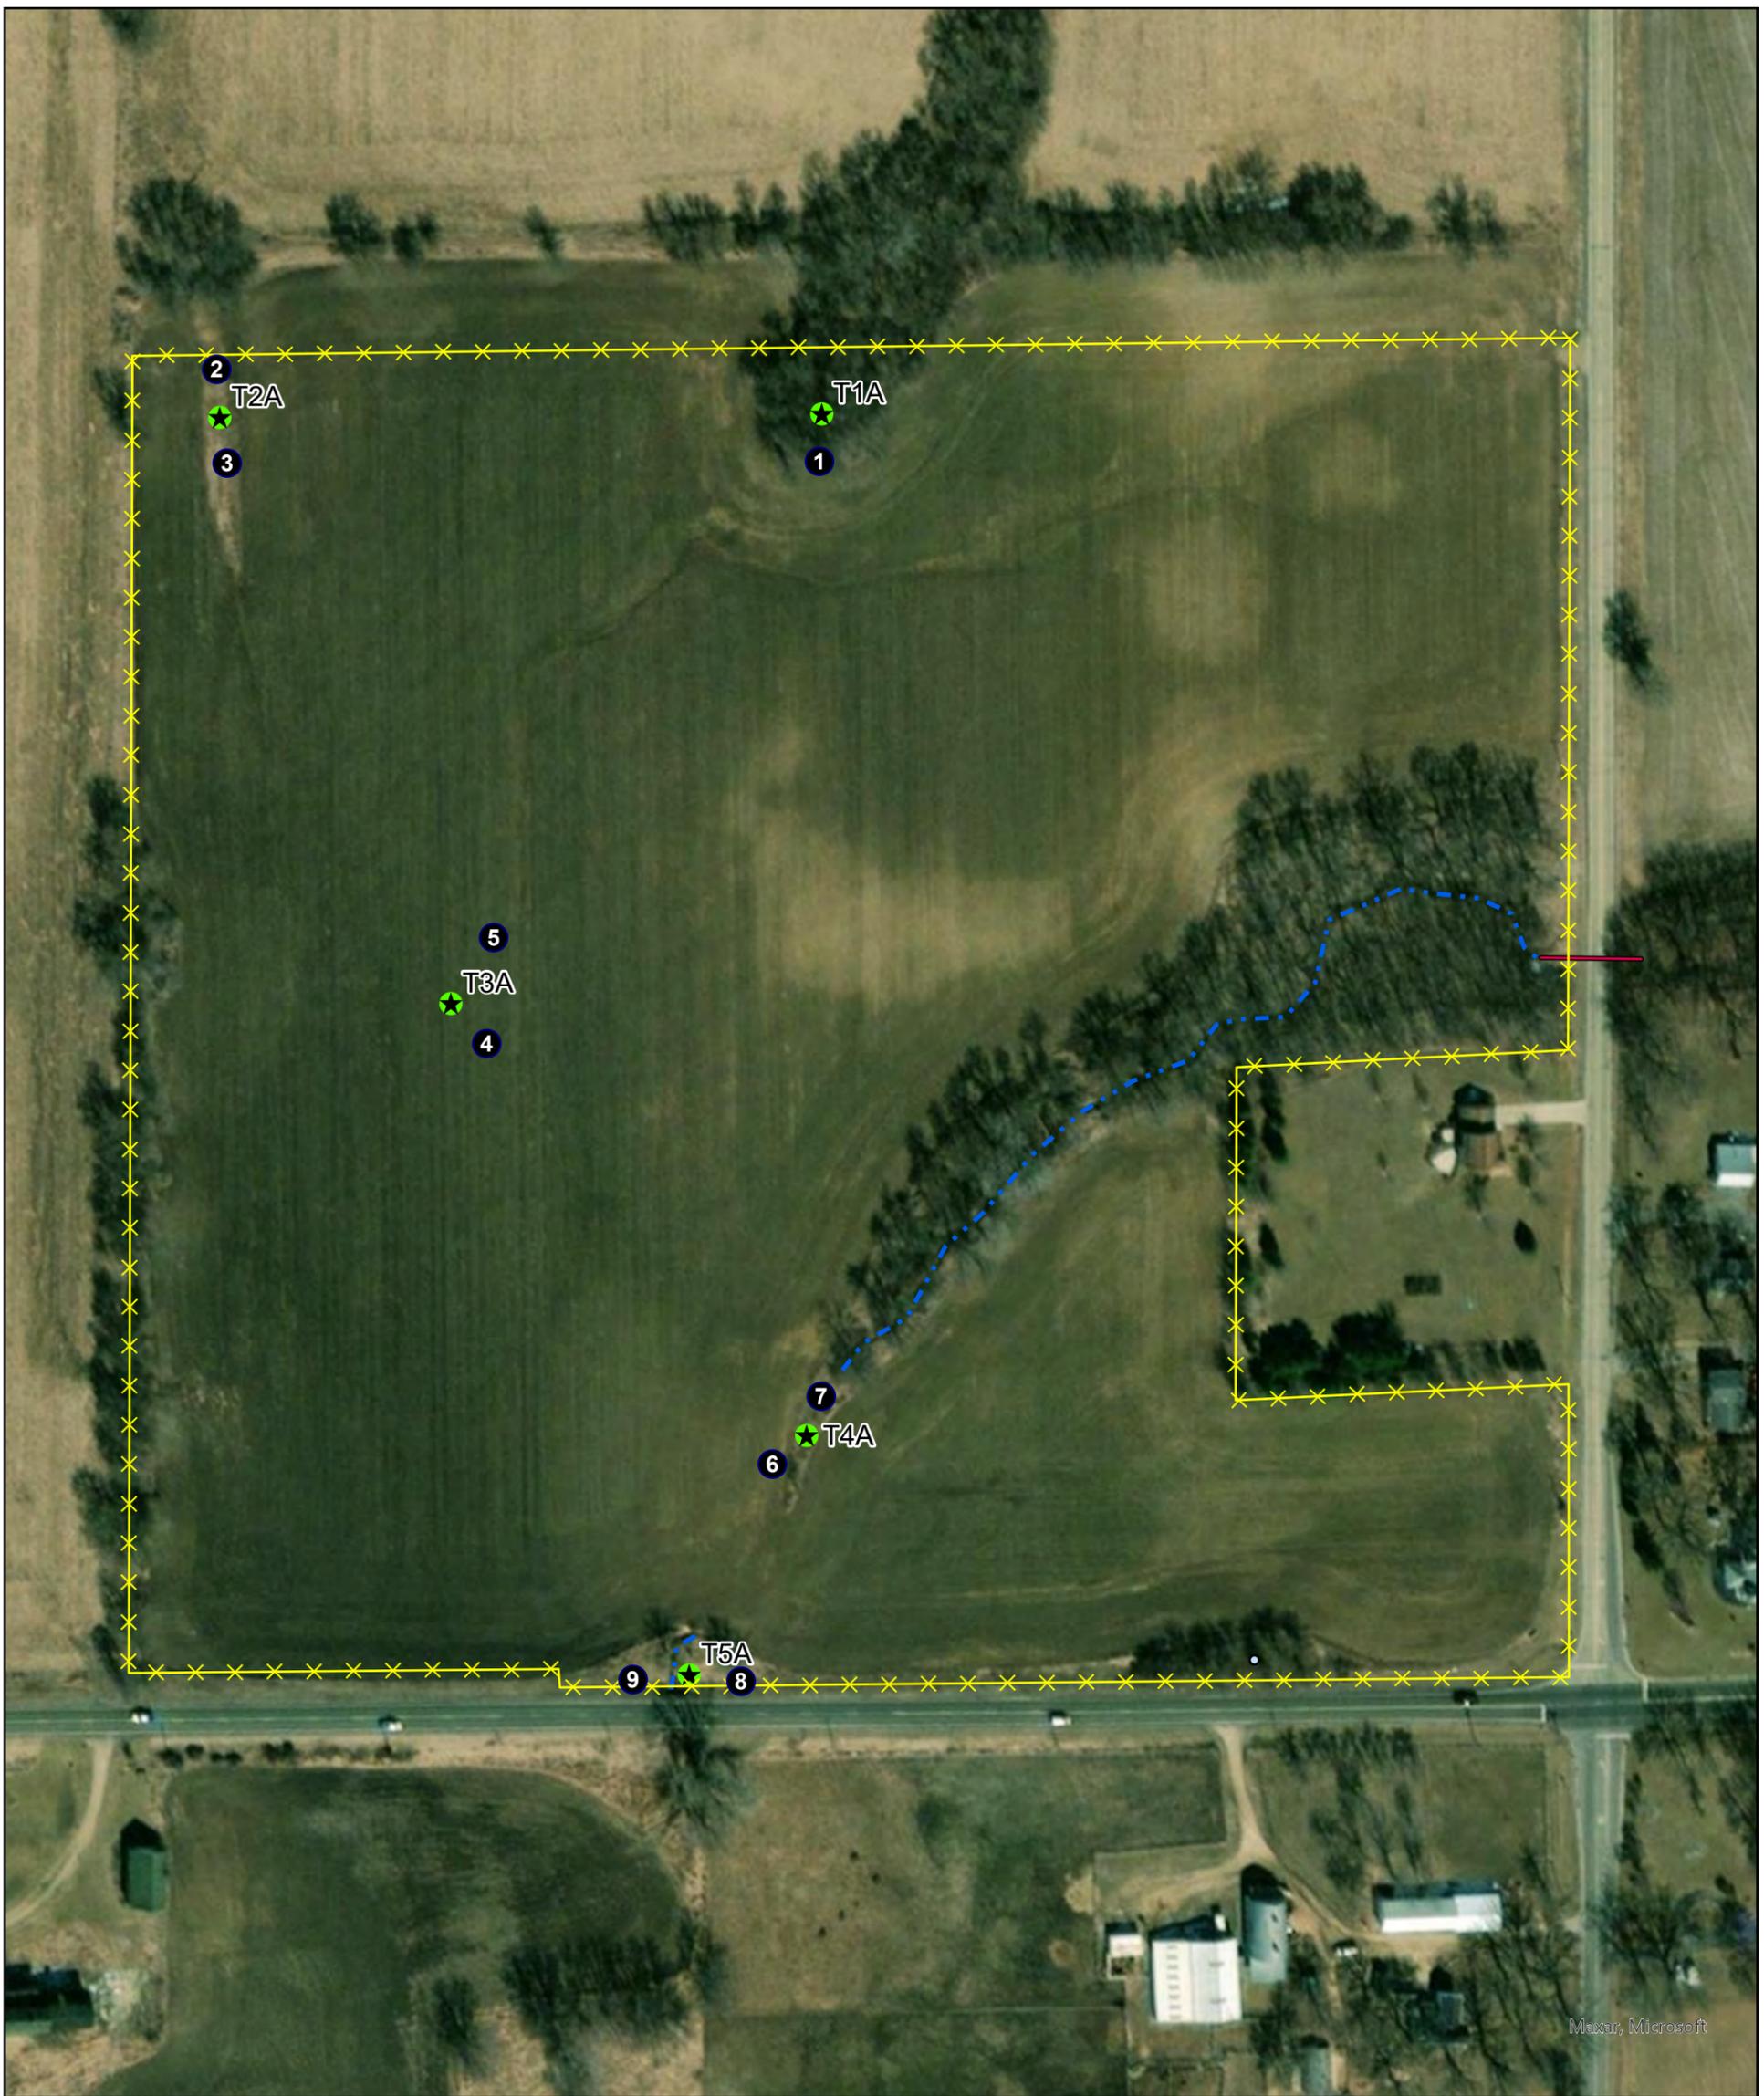
Wetland Delineation was conducted by
Chad Fradette, EP, Chem,
WDNR Professionally Assured Wetland Delineator
with assistance from
Shyann Banker, Environmental Specialist

No wetlands were observed on the Site. The test pit locations are shown on the Wetland Determination map located in Appendix A, Site Maps.

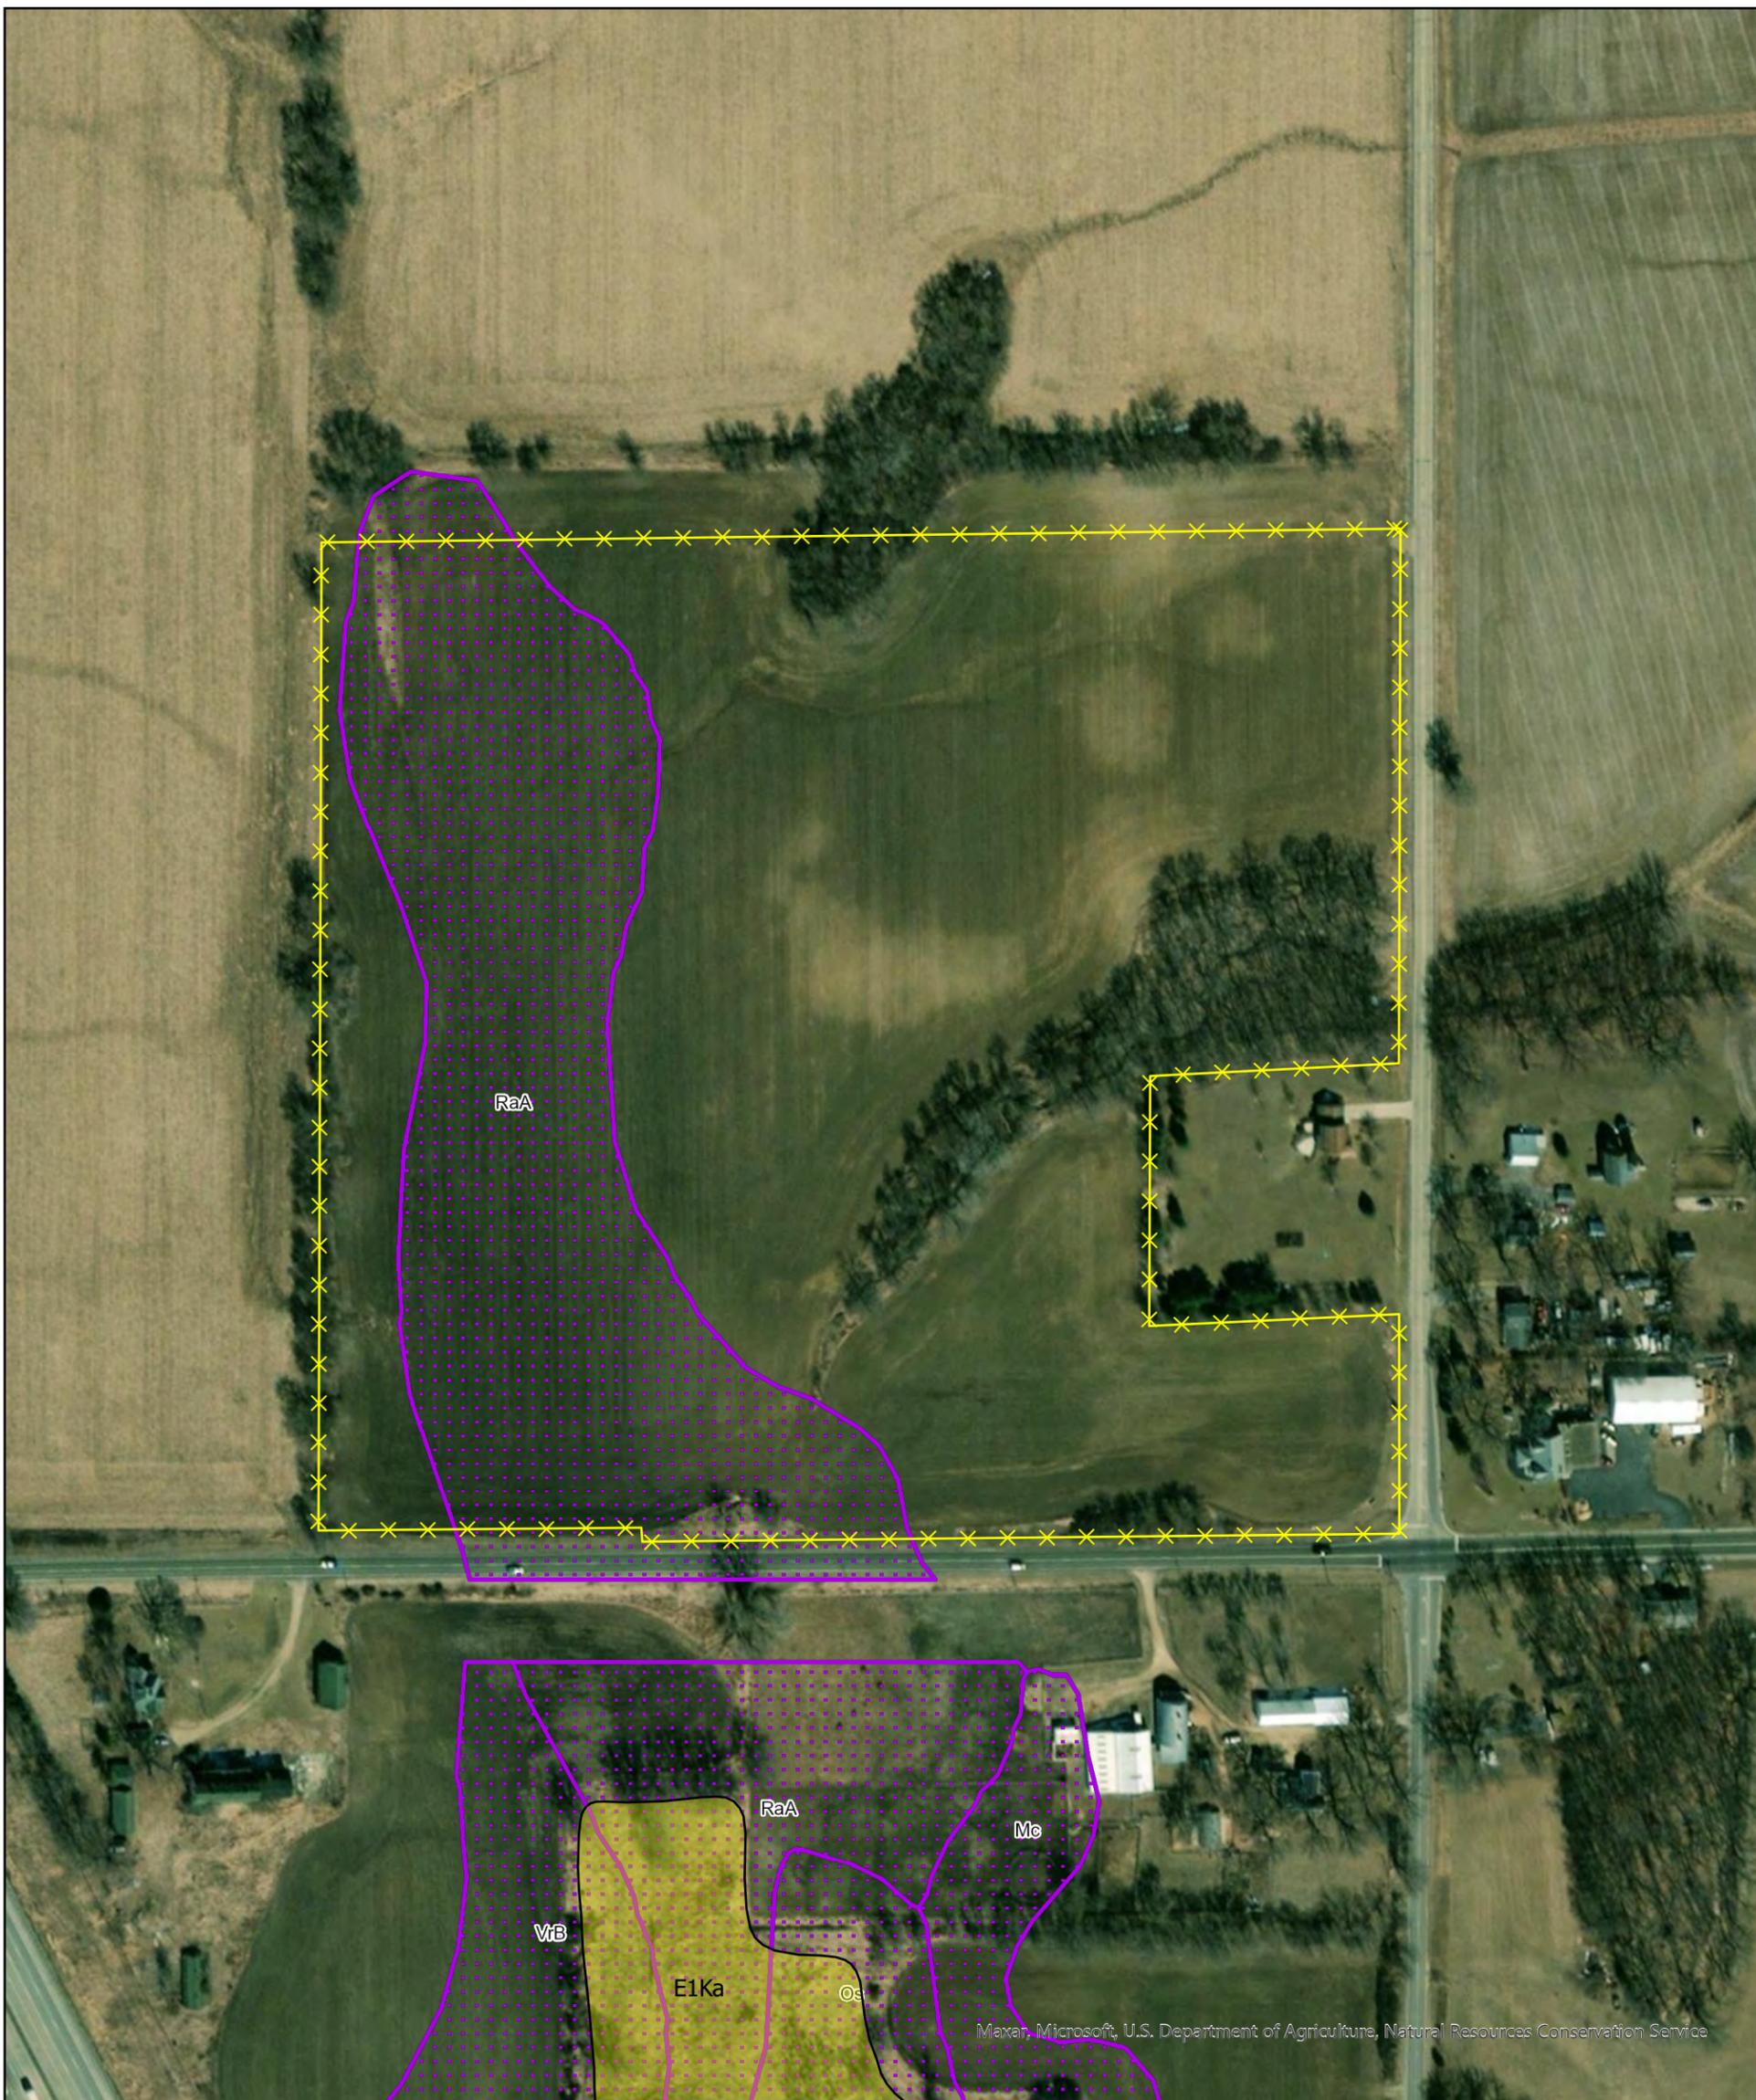
Pumpkin Hollow Properties Wisconsin Wetland Inventory Map 4404 Hoepker Road City of Madison Dane County, WI

The WDNR Wisconsin Wetland Inventory (WWI) Map was reviewed and indicates the absence of wetlands in the study area. The WWI wetland indicator soils layer was also reviewed and indicates the presence of indicator soils in the western half of the study area. The study area is mapped as having Nonhydric and Predominantly Nonhydric soil within the study area. Indicator soils are soils which are commonly found in wetlands or have inclusions of soils that are commonly found in wetlands. The WDNR Surface Water Data Viewer (SWDV) was also reviewed and indicates the presence of an unnamed stream throughout the study area, the stream is mapped on the Wetland Delineation Map in Appendix A as a ditch.

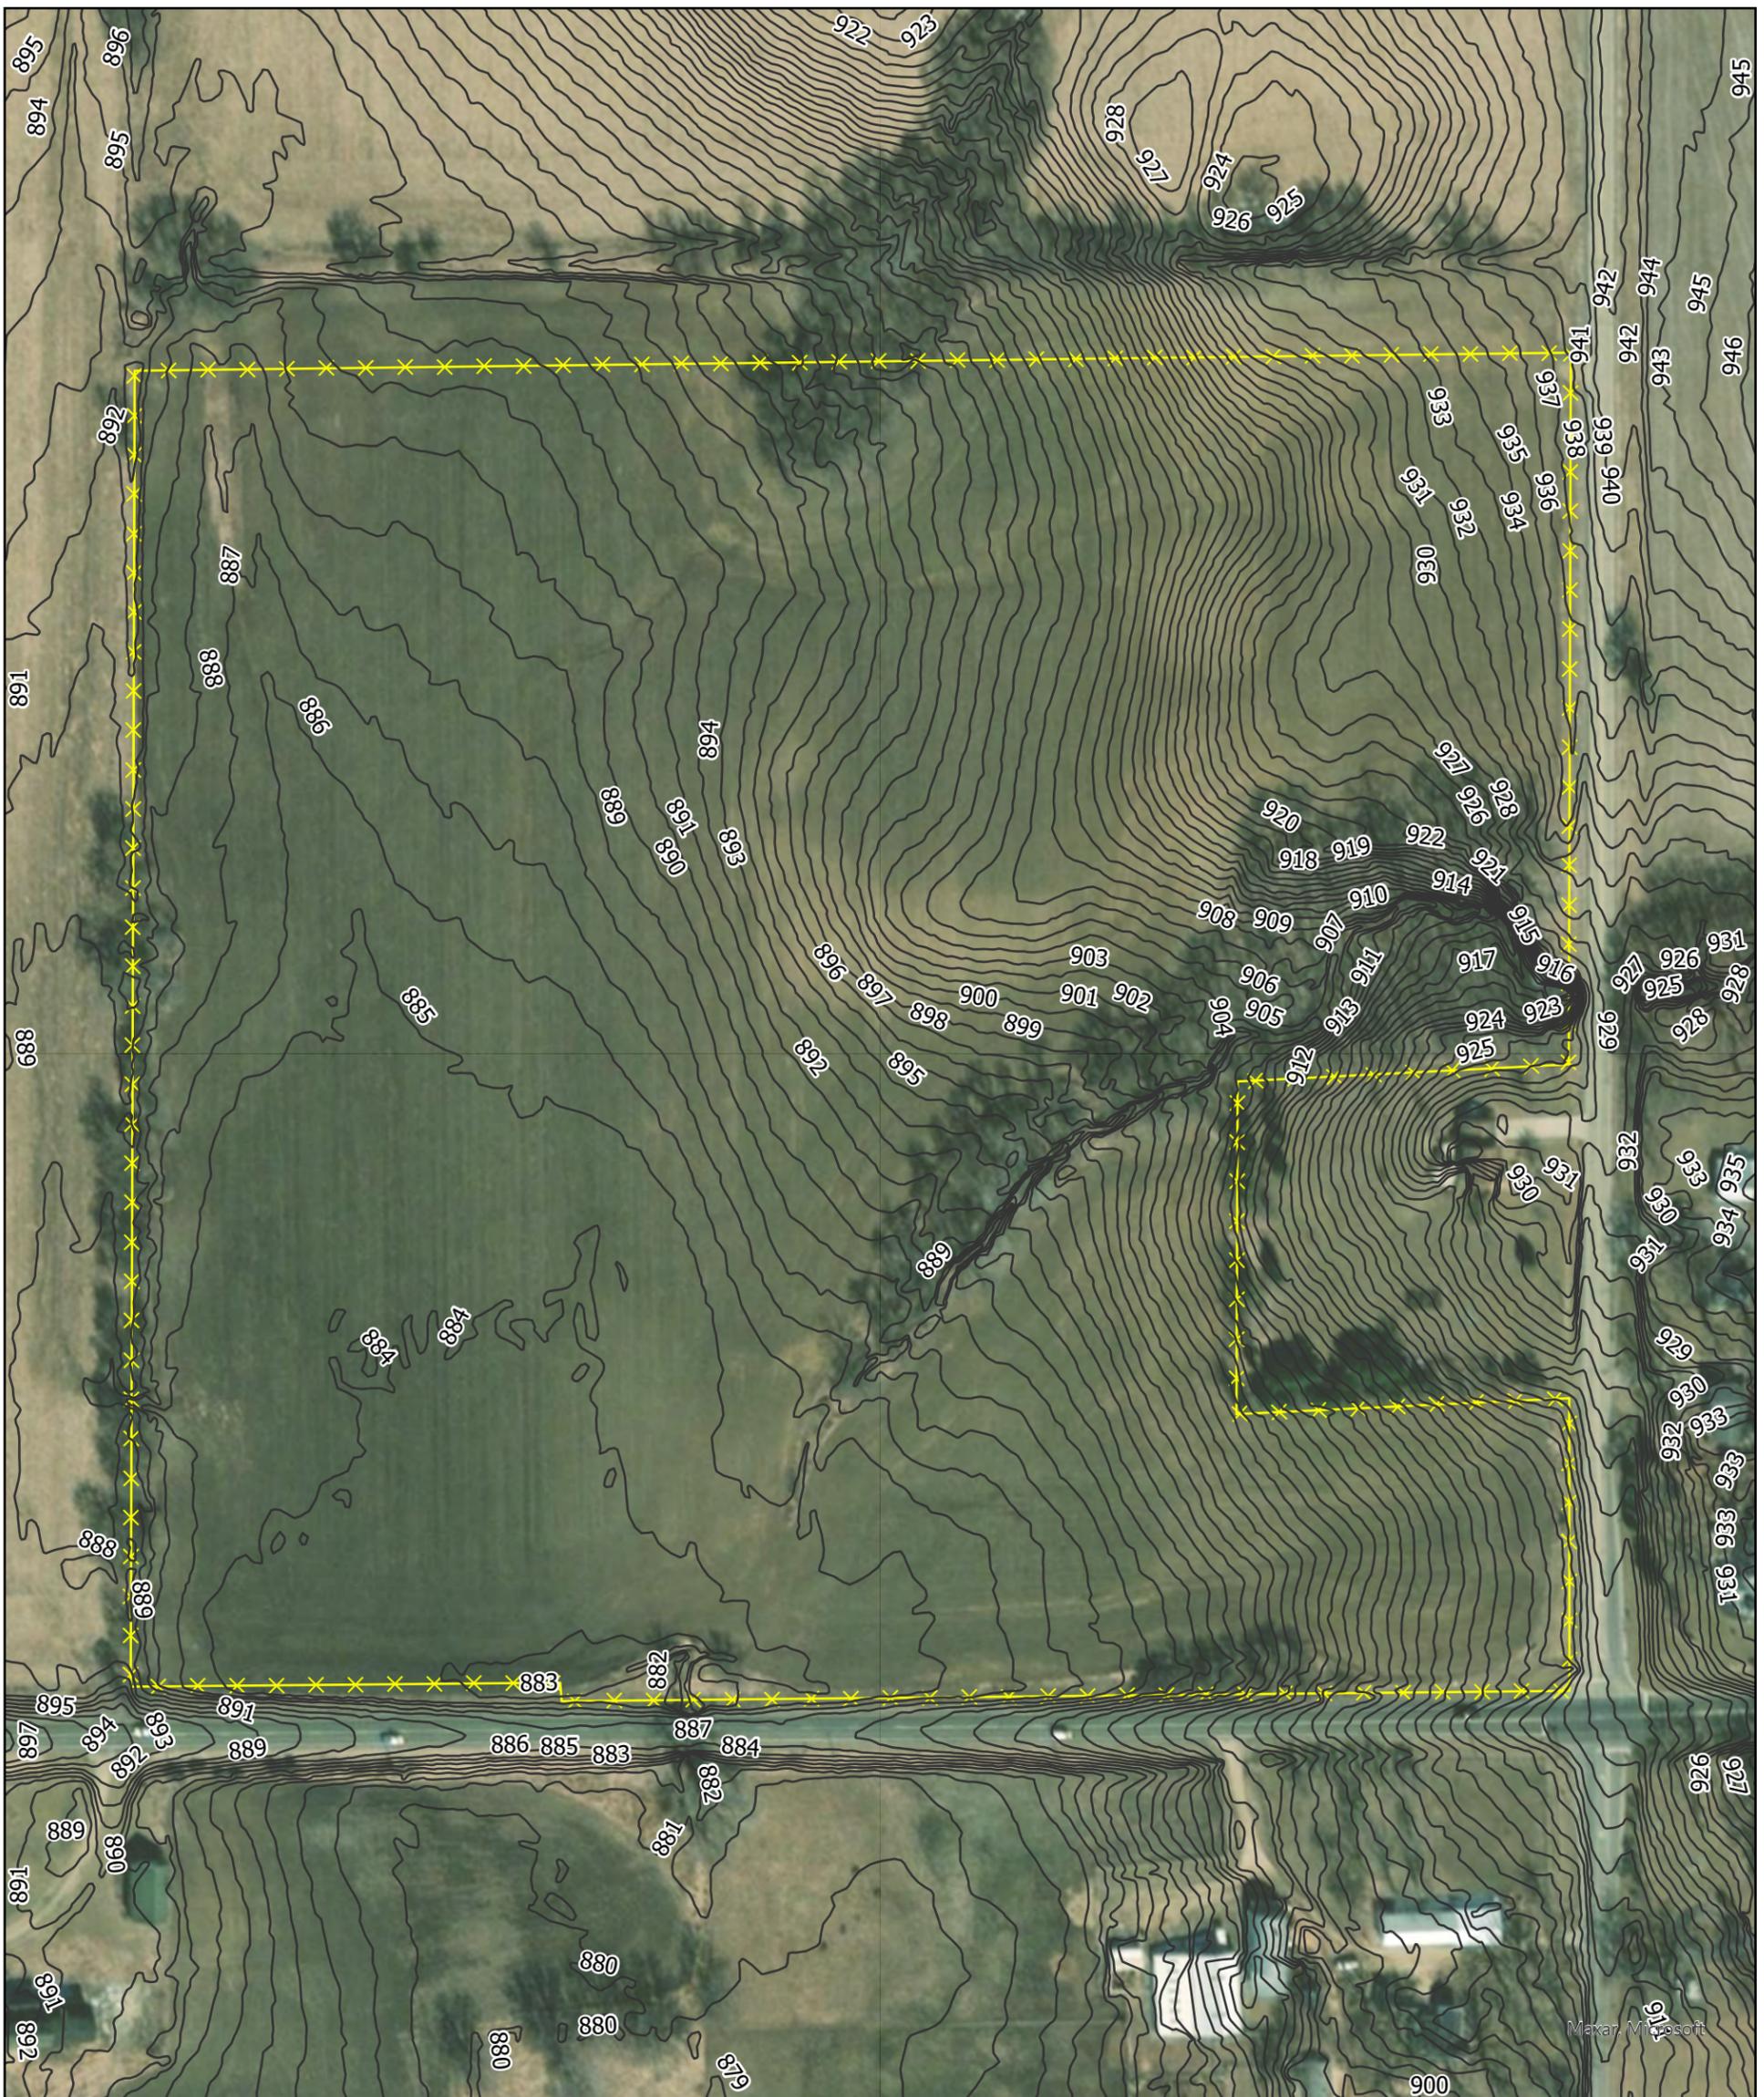
Pumpkin Hollow Properties
 Topographic Map
 4404 Hoepker Road
 City of Madison
 Dane County, WI

- Site Boundary
- Contours 1ft

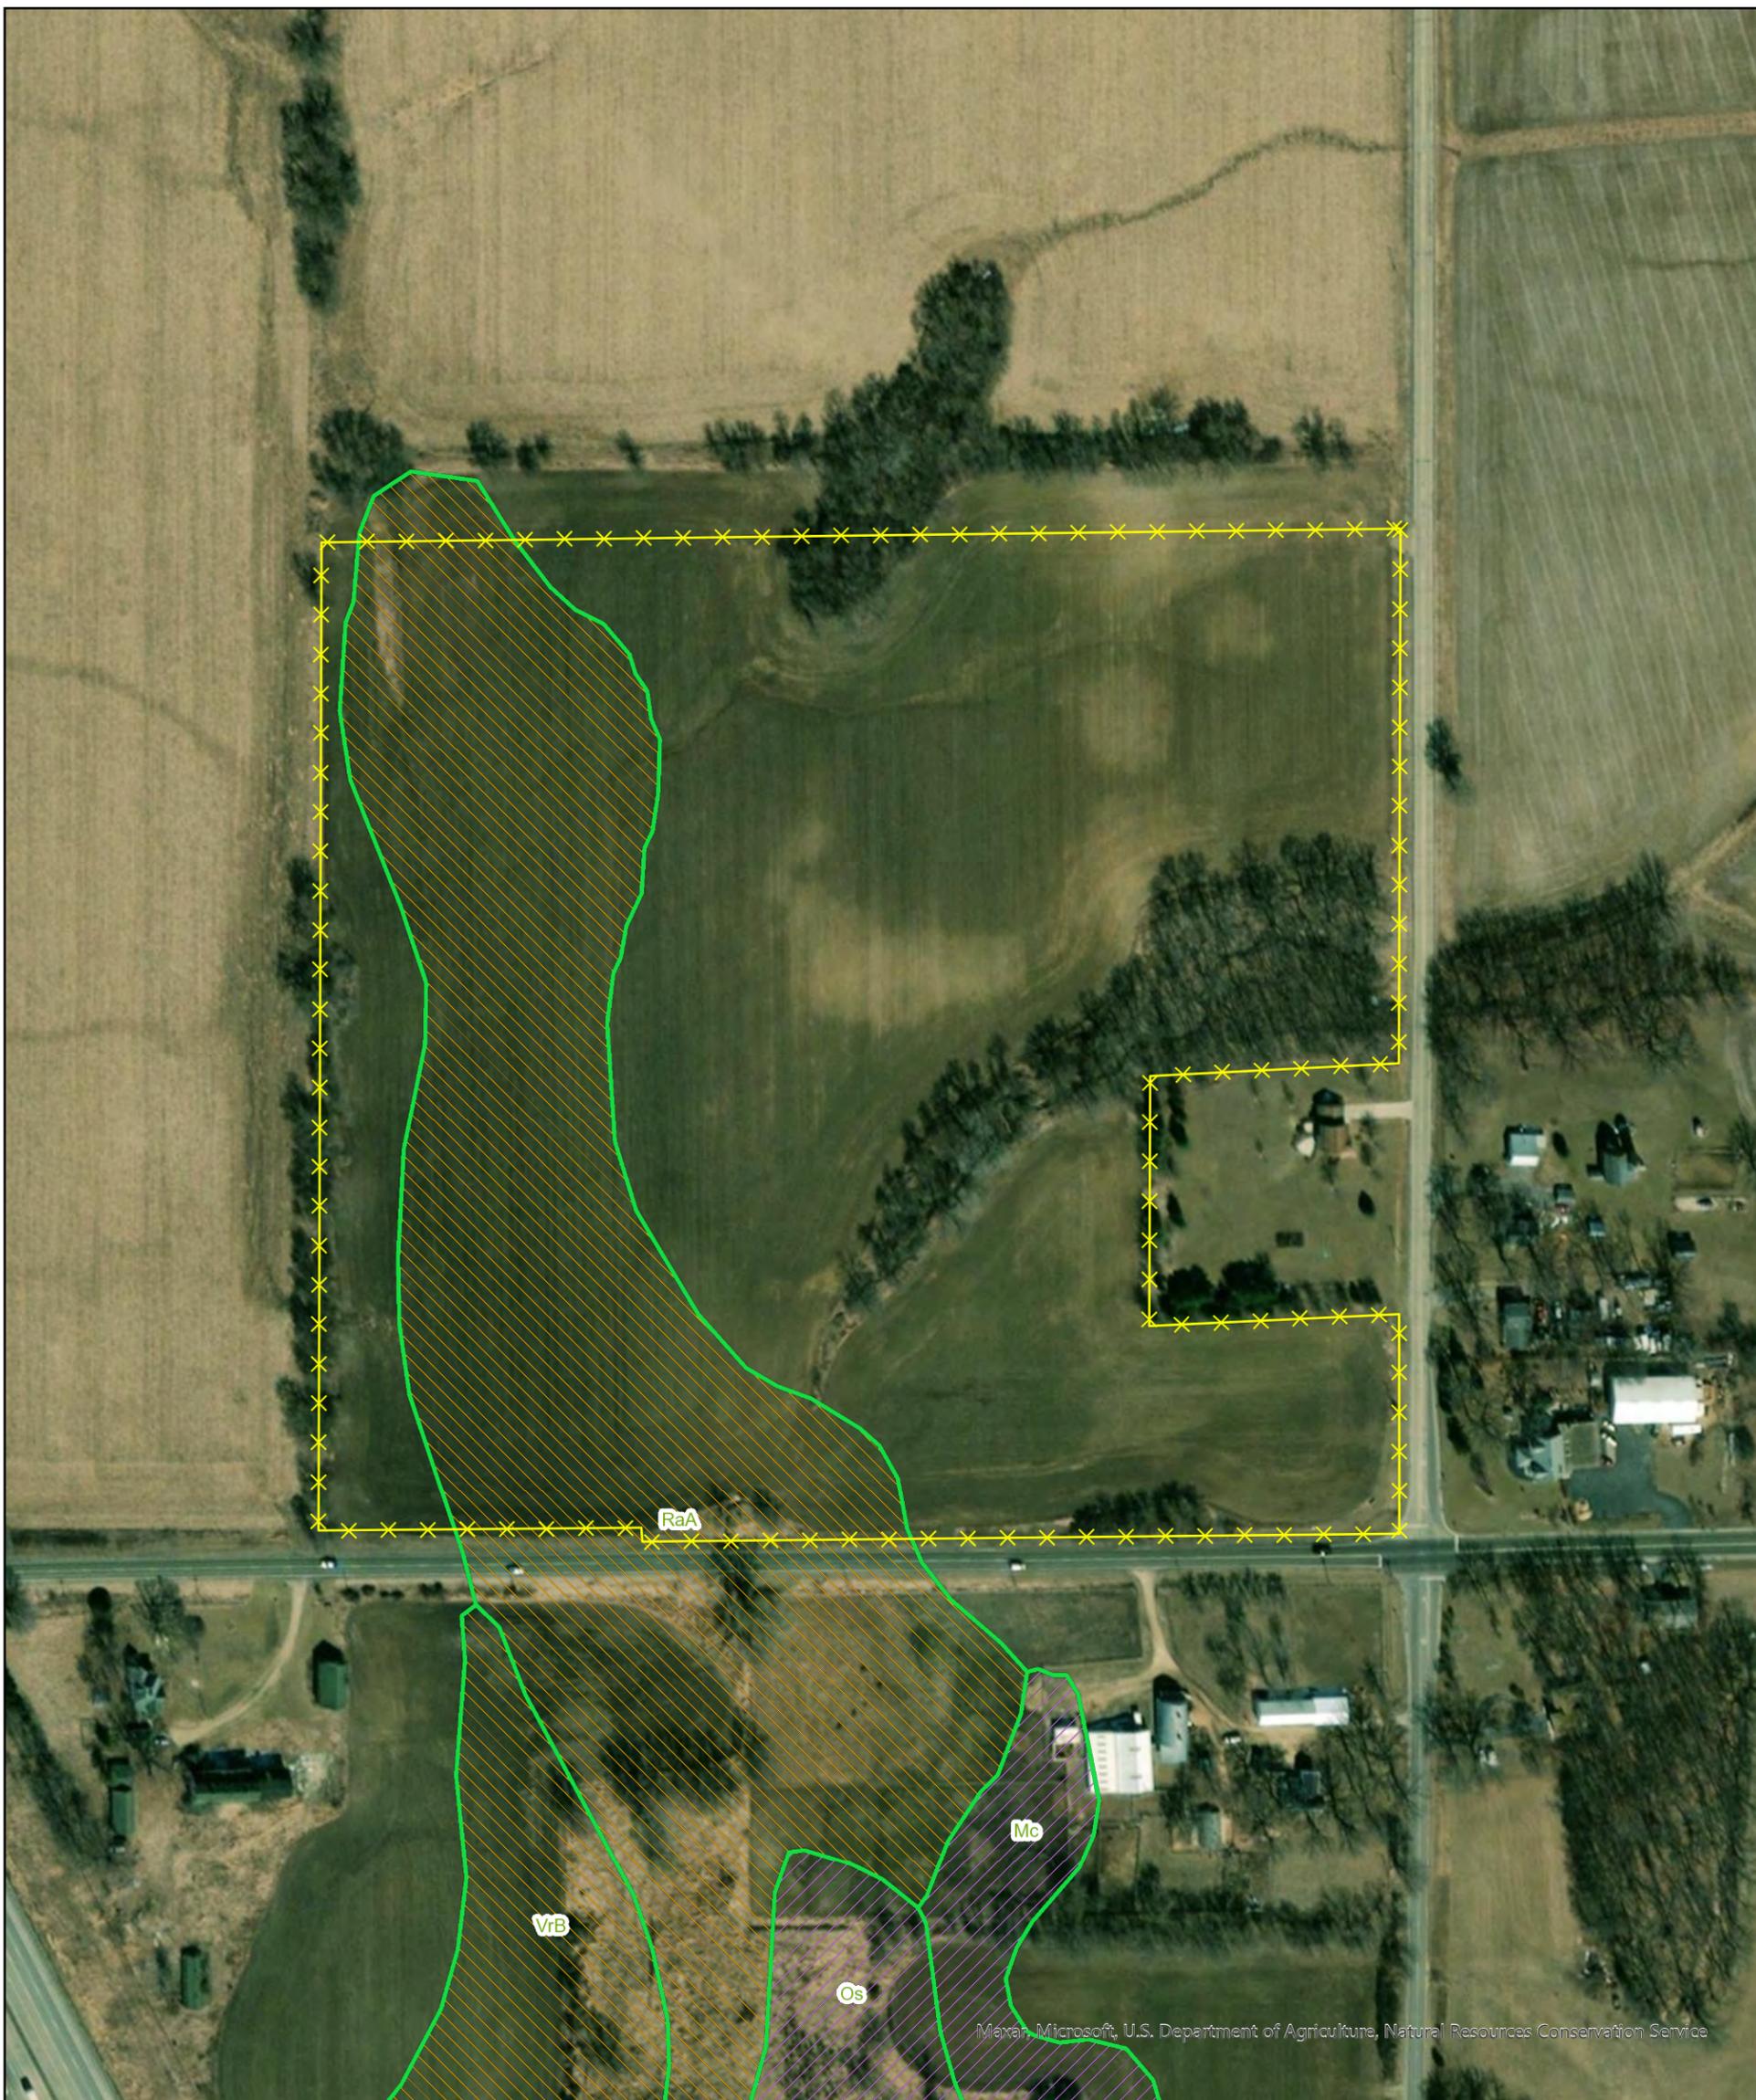
Pumpkin Hollow Properties NRCS Soil Hydric Ratings Map 4404 Hoepker Road City of Madison Dane County, WI

Predominantly Non-Hydric

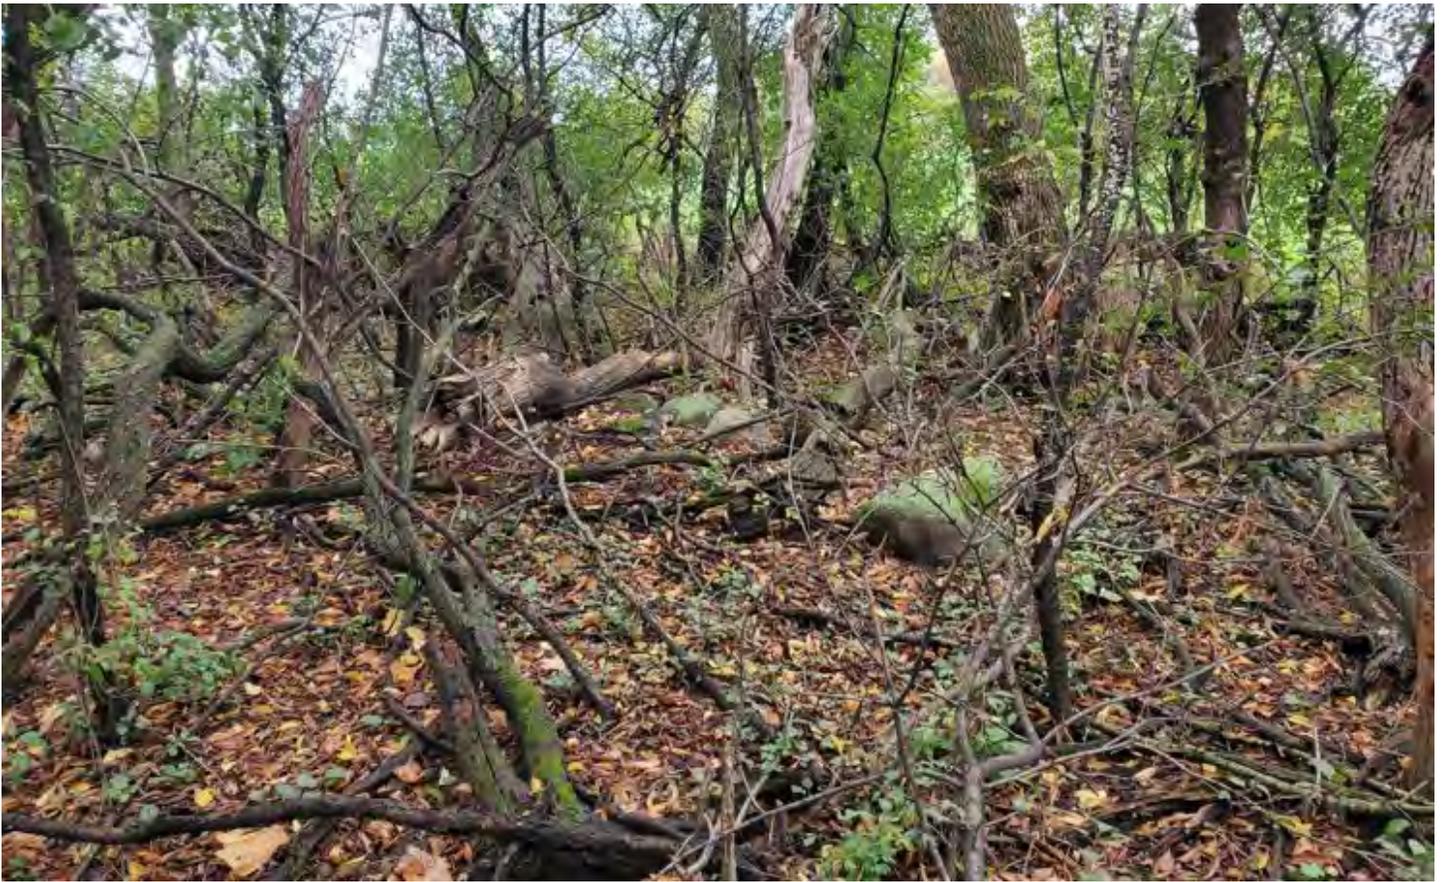
T1A was placed on a rocky forested hillslope. The soil was observed to a depth of 24 inches. Wetland hydrology and hydric soils were not present at this sample point; therefore, this sample point does not meet wetland criteria.

1- Standing near T1A.

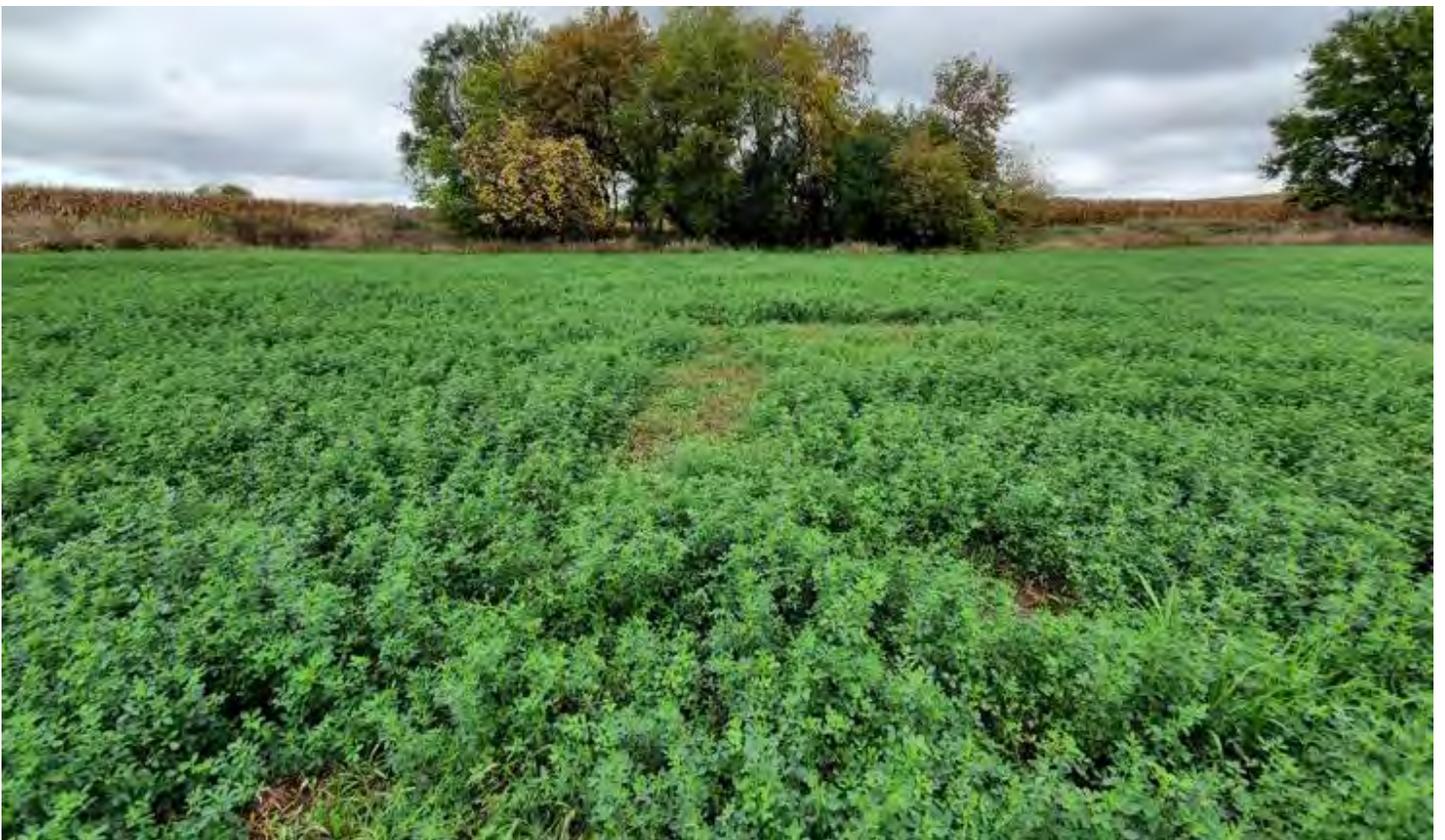
T2A was placed on a shallow hillslope within an alfalfa field. This area has been a historic grassed swale constructed for erosion control. The soil was observed to a depth of 24 inches. Wetland hydrology, hydrophytic vegetation, and hydric soils were not present at this sample point, therefore this sample point does not meet wetland criteria.

2- Standing near T2A facing north.

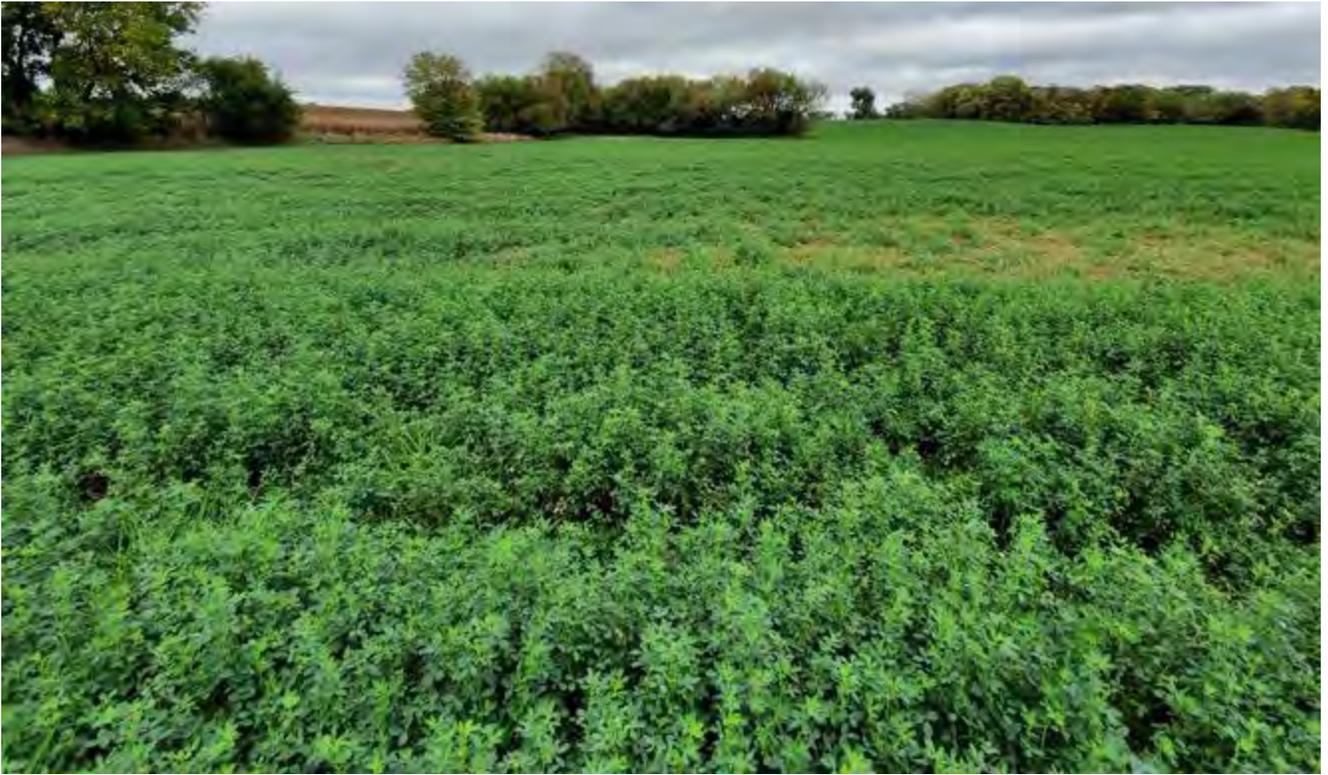
Dominant vegetation observed in T2A included common crabgrass (*Digitaria sanguinalis*, FACU) and barnyard grass (*Echinochloa crus-galli*, FAC). The adjacent vegetation at the field edge just off-site upslope is brome grass and boxelder. Due to lack of hydric soil and hydrology indicators, one would expect upland vegetation to dominate under normal circumstances.

3- Standing near T2A.

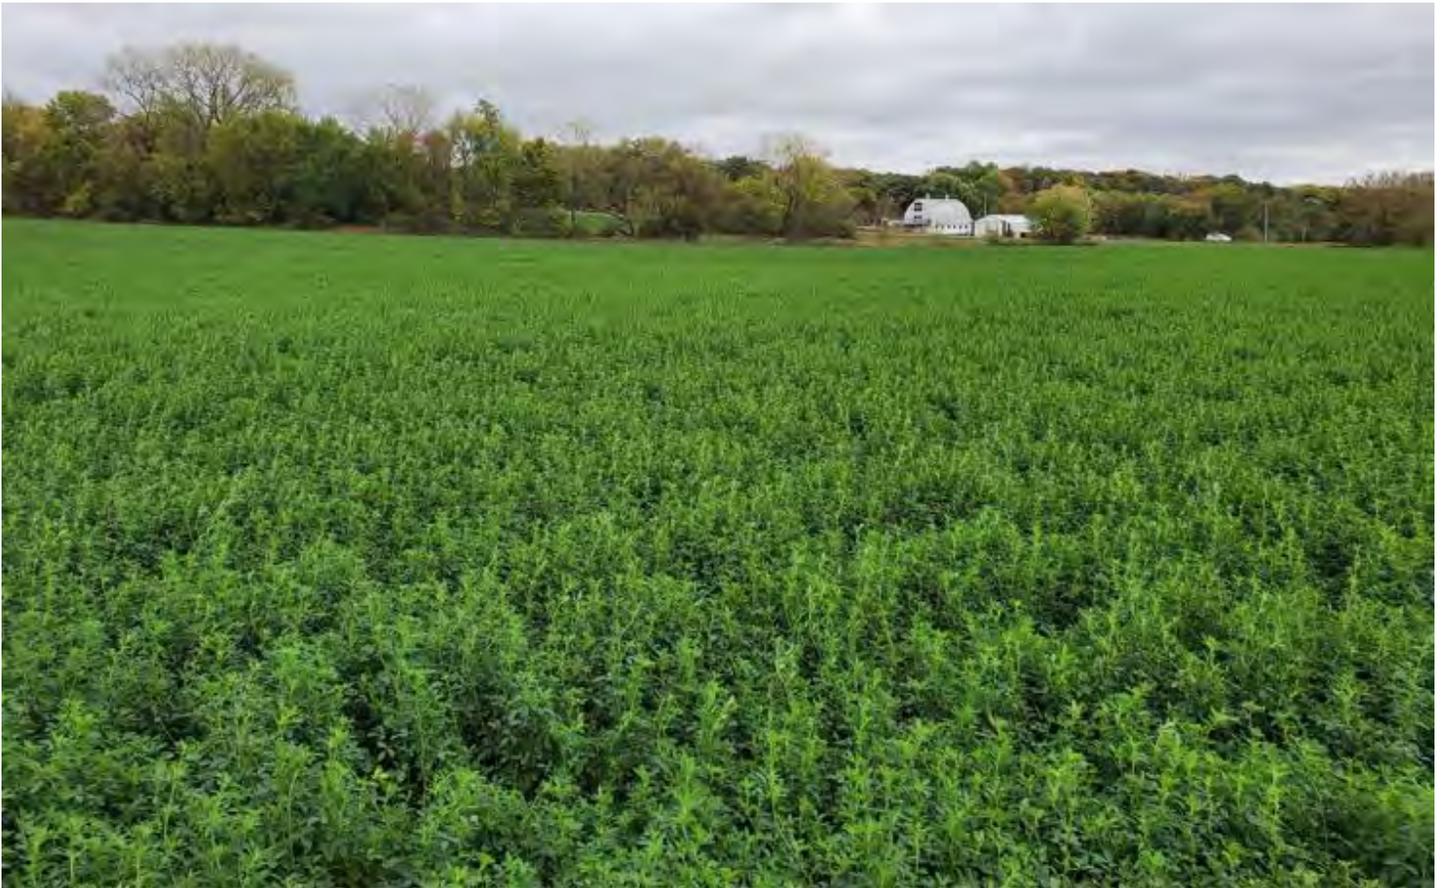
T3A was placed on a hillslope within an alfalfa field. The soil was observed to a depth of 24 inches. Wetland hydrology, hydrophytic vegetation, and hydric soils were not present at this sample point, therefore this sample point does not meet wetland criteria.

4- Standing near T3A facing southeast.

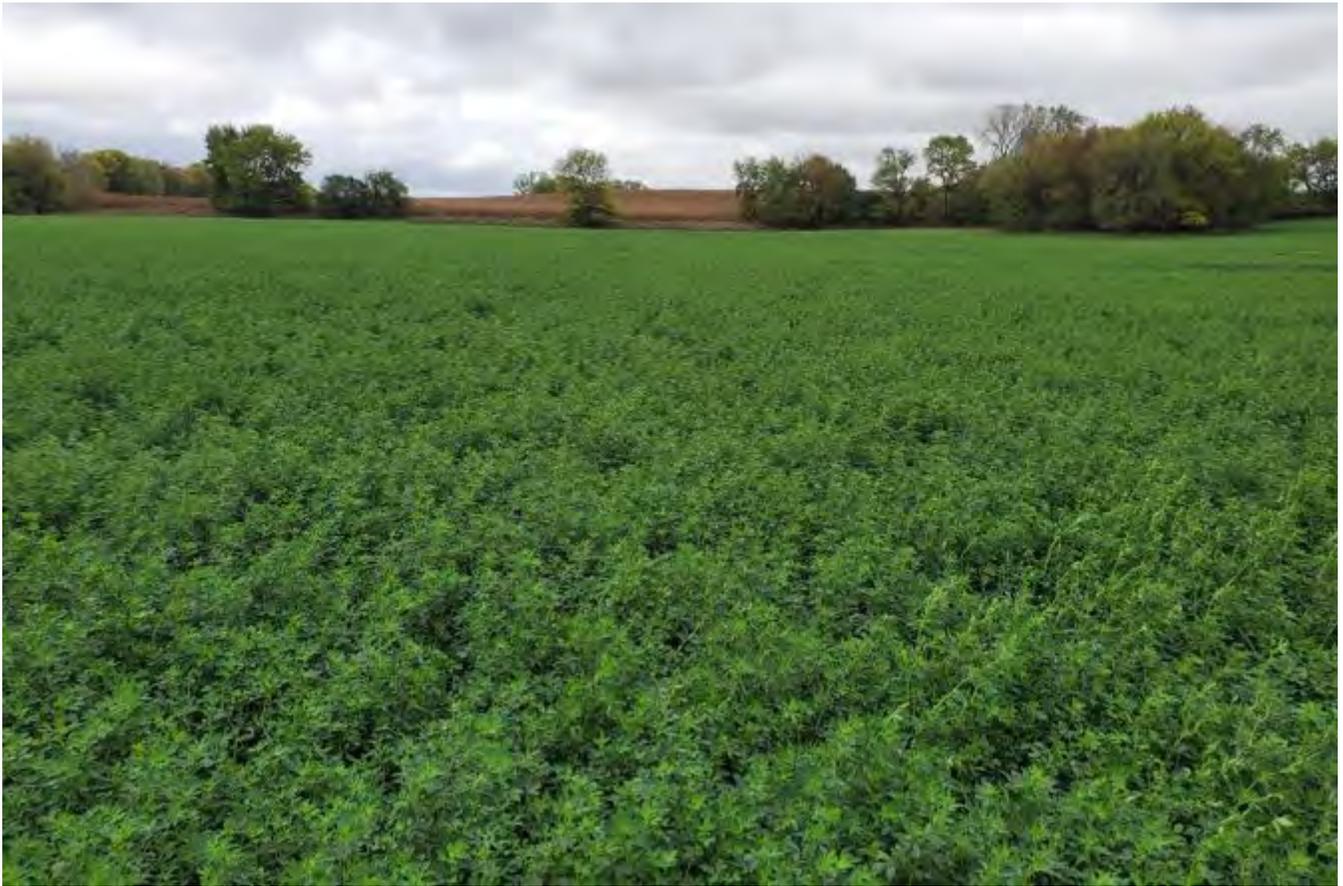
5- Standing near T3A.

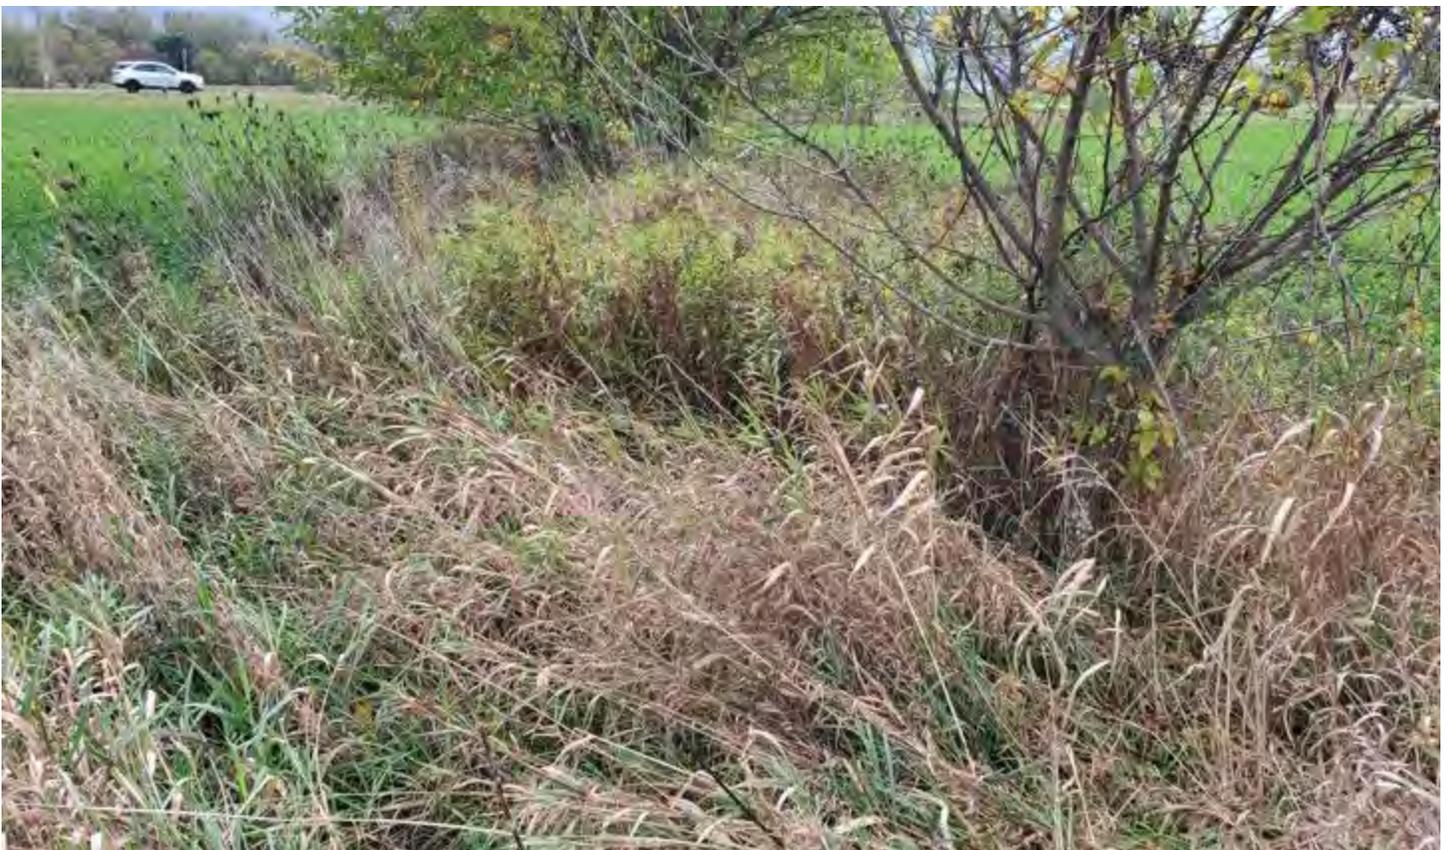
T4A was placed in a wide grassed swale within a hillslope that is flanked by an alfalfa field. The soil was observed to a depth of 24 inches. Wetland hydrology, hydrophytic vegetation, and hydric soils were not present at this sample point, therefore this sample point does not meet wetland criteria.

6- Standing near T4A facing south.
