Pumpkin Hollow- North

Professionally Assured Wetland Delineation Report

Project Number: DAN21-011-01

Property Address: 4404 Hoepker Road, City of Madison, Dane County, Wisconsin

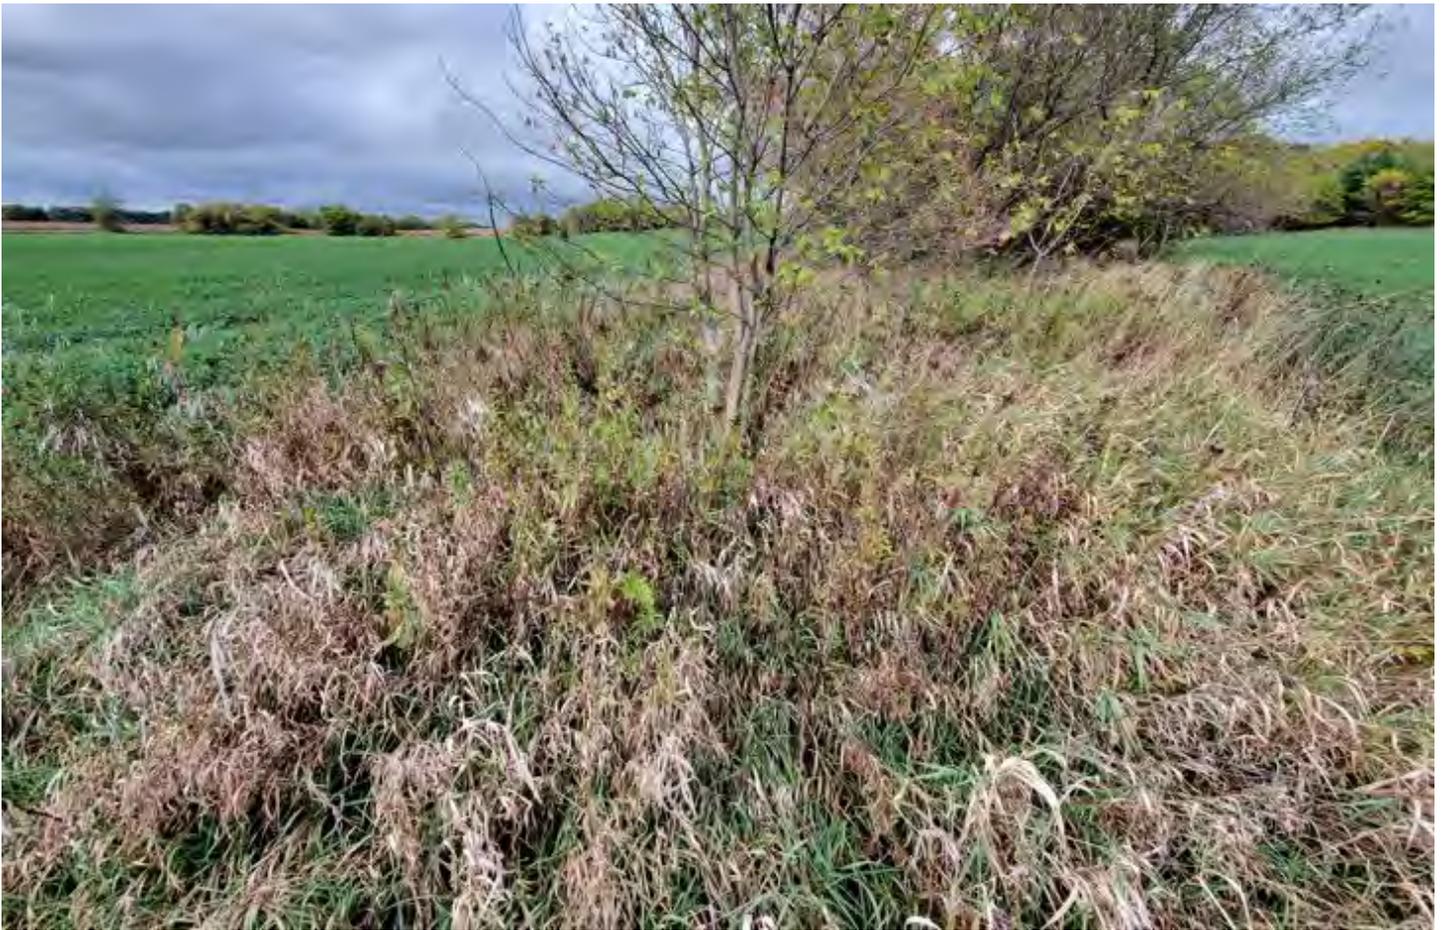
Dominant vegetation observed in T4A included boxelder maple (*Acer negundo*, FAC) and smooth brome grass (*Bromus inermis*, FAC).

7- Standing near T4A facing north.

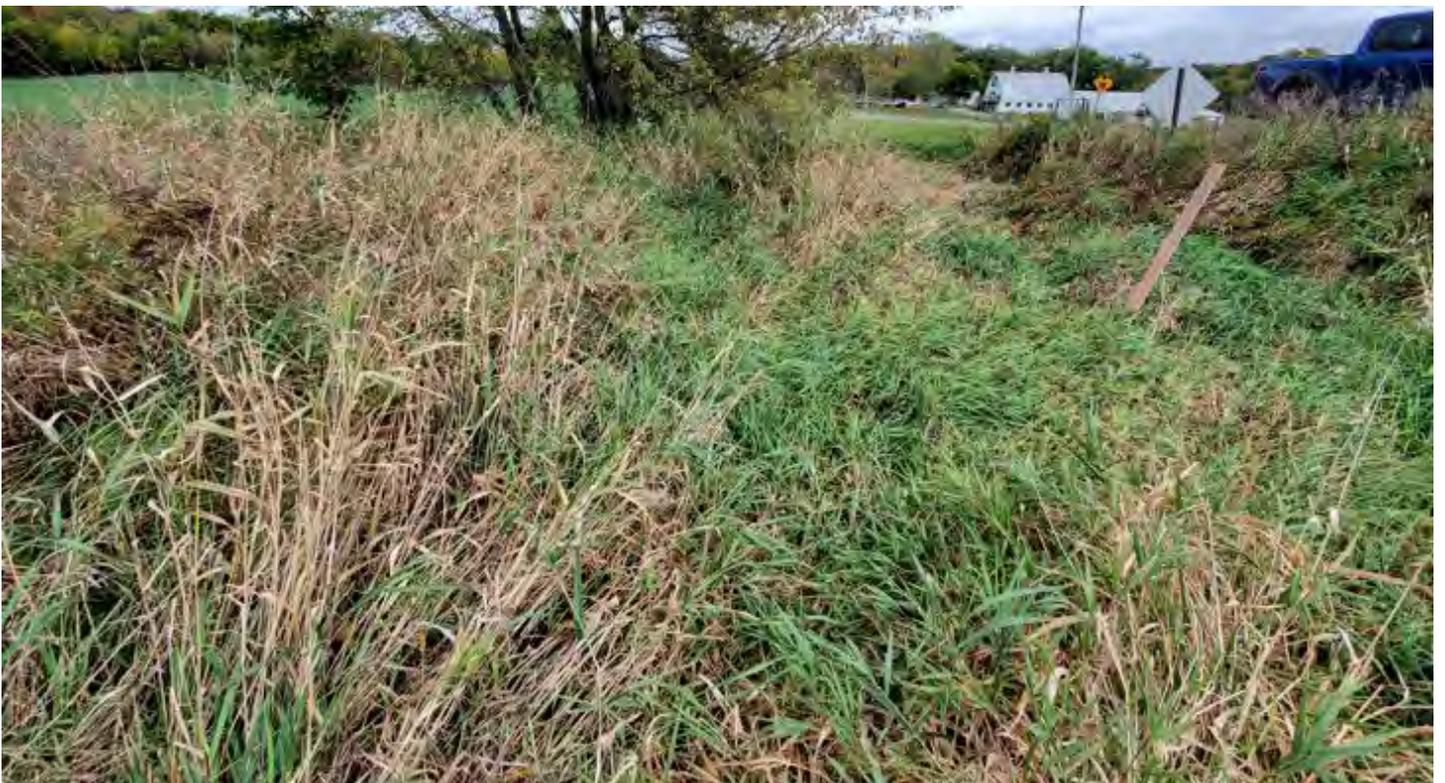
8- Standing near T4A facing east.

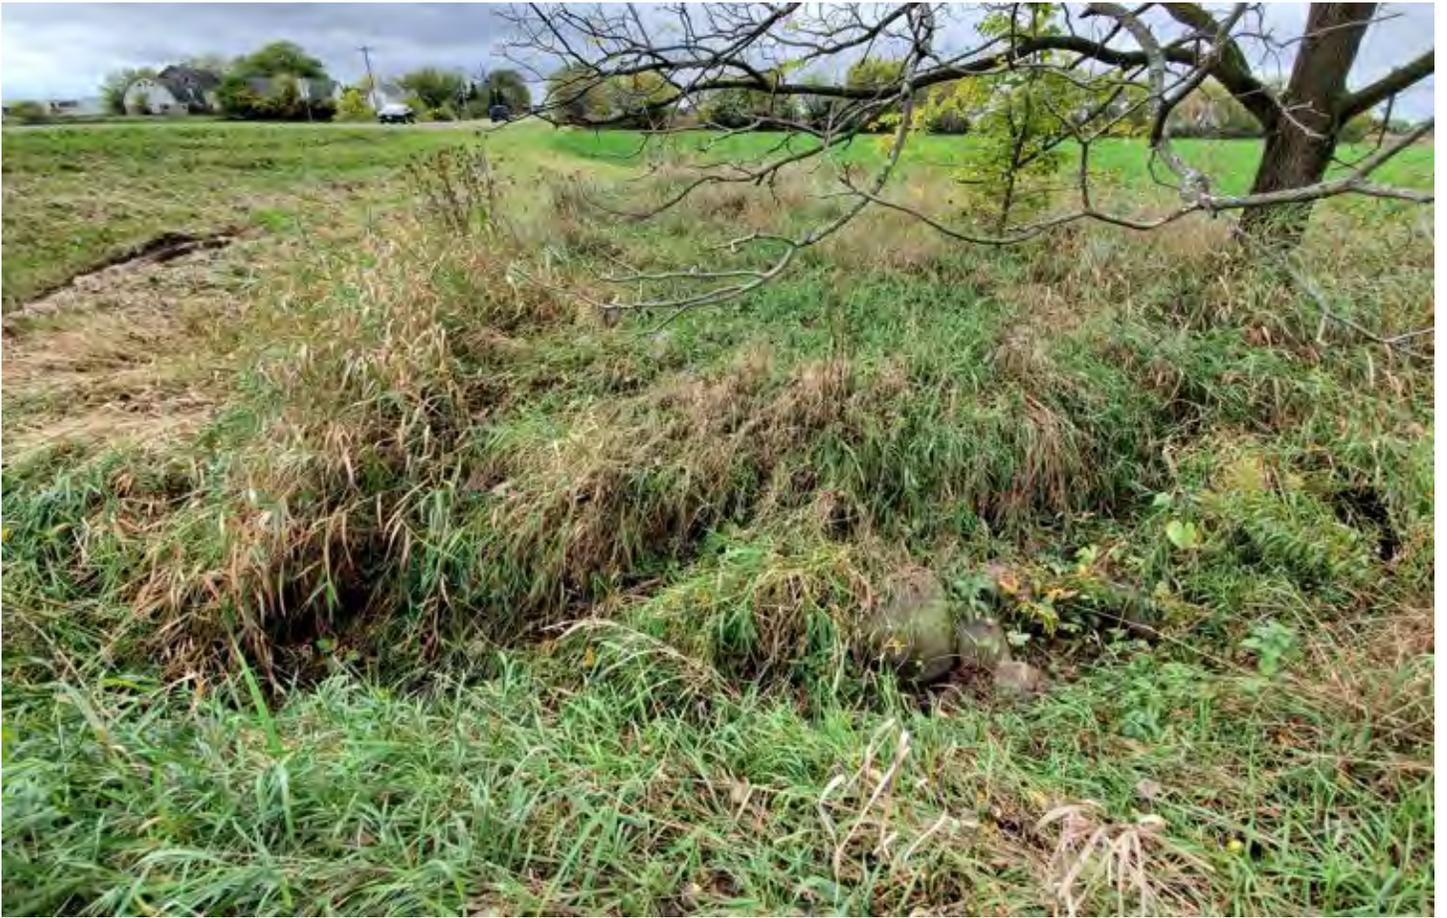
T5A was placed in a depression adjacent to the road and a narrow ditch that runs throughout the study area. The soil was observed to a depth of 24 inches. The area is drained by the adjacent narrow ditch, the ditch started a few feet away from the test point, dry and rocky. Wetland hydrology, hydrophytic vegetation, and hydric soils were not present at this sample point, therefore this sample point does not meet wetland criteria.

9- Standing near T5A facing west.

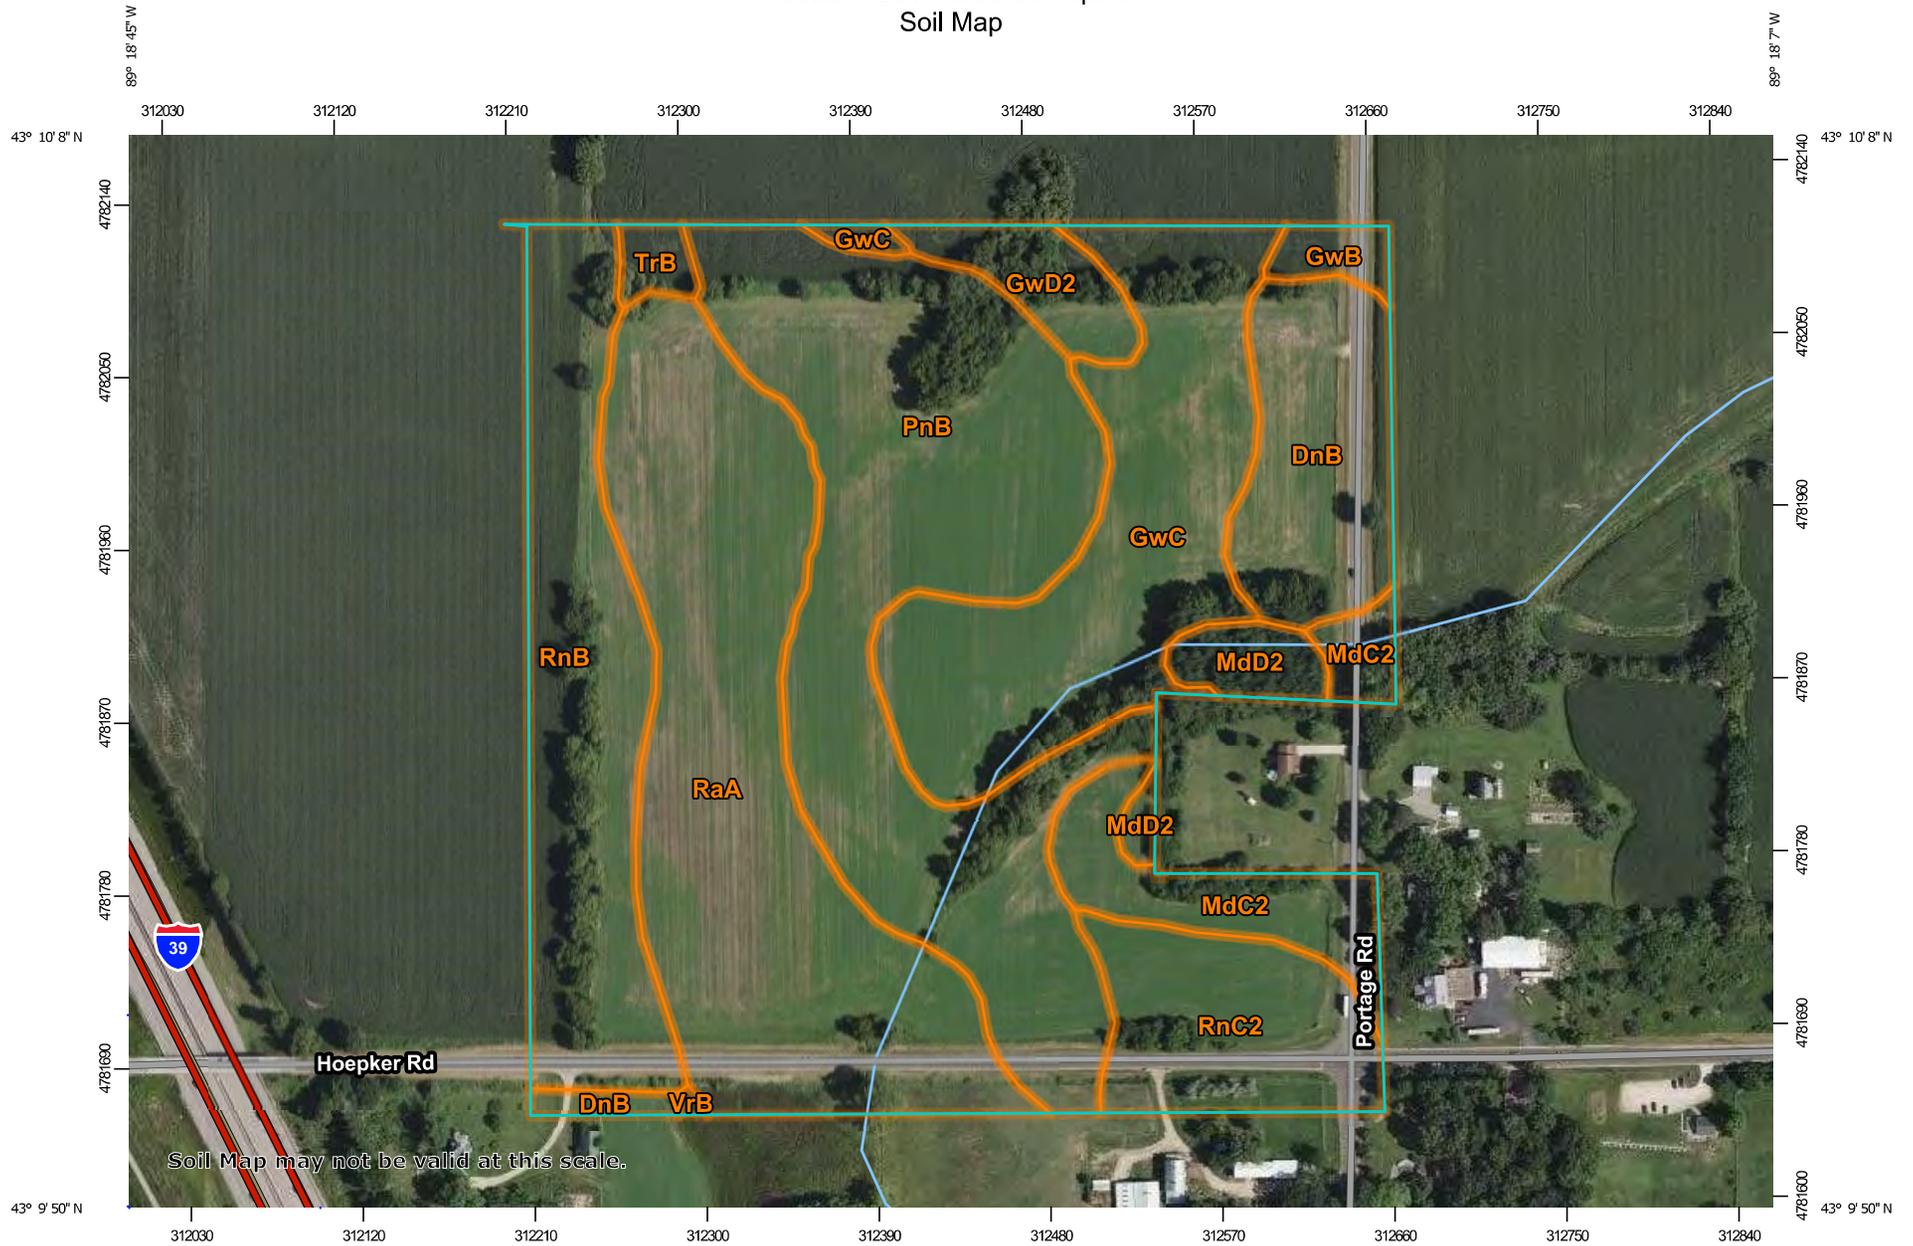
Custom Soil Resource Report Soil Map

Soil Map may not be valid at this scale.

Map Scale: 1:3,930 if printed on A landscape (11" x 8.5") sheet.

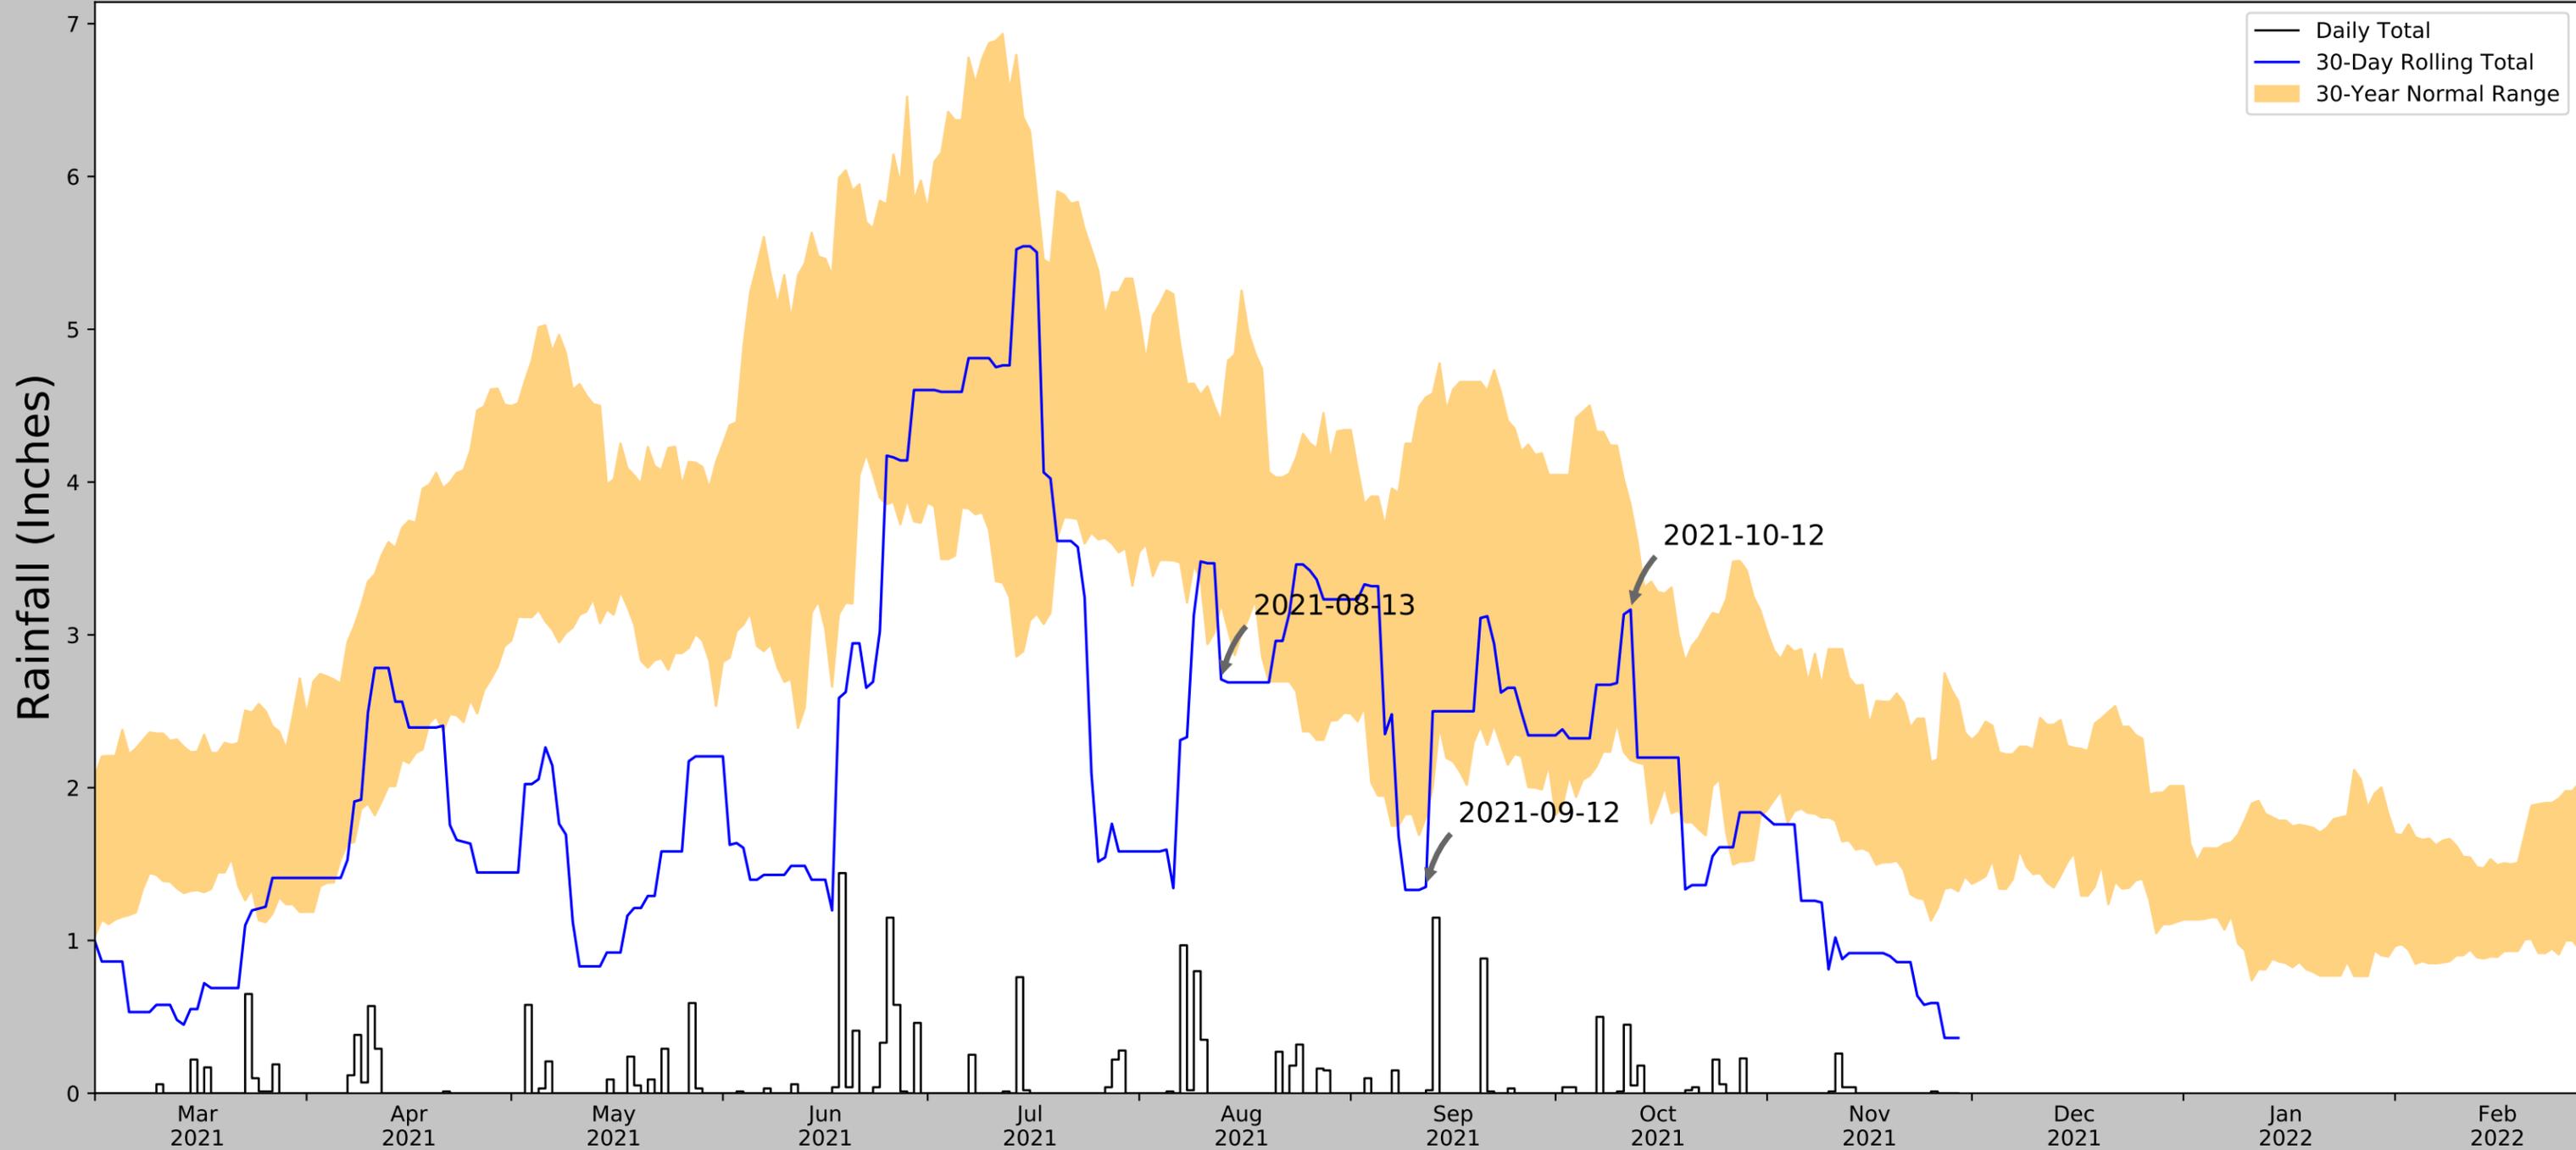
Antecedent Precipitation vs Normal Range based on NOAA's Daily Global Historical Climatology Network

An antecedent precipitation evaluation was conducted for the three months prior the site visit. Precipitation data from the Madison Dane Regional Airport, WI WETS station indicates climatic conditions were drier than normal at the time of the site visit. The Palmer Drought Index also indicates conditions were drier than normal (Moderate Drought, -2.00 to -2.99) for this location at the time of the site visit. Based on evaluation of both sources of data, it was determined climatic conditions were drier than normal at the time of the site visit. The antecedent precipitation evaluation, WETS data and Palmer Drought Index reports for the area at the time of the site visit are included in Appendix F.

Coordinates	43.1678468, -89.3074025
Observation Date	2021-10-12
Elevation (ft)	896.8
Drought Index (PDSI)	Moderate drought
WebWIMP H ₂ O Balance	Wet Season

30 Days Ending	30 th %ile (in)	70 th %ile (in)	Observed (in)	Wetness Condition	Condition Value	Month Weight	Product
2021-10-12	2.180709	3.849213	3.165354	Normal	2	3	6
2021-09-12	1.805512	4.555118	1.350394	Dry	1	2	2
2021-08-13	3.208268	4.397638	2.708662	Dry	1	1	1
Result							Drier than Normal - 9
