JOSEPH AND EMILY REINARDY 408 WESTMORLAND LBVD. MADISON, WI. 53713

1980'S (?) ERA ADDITON TO BE REMOVED - INCLUDES GARAGE AND MASTER SUITE

Version/Date:
LAND USE PHOTOS
180316
04.09.18

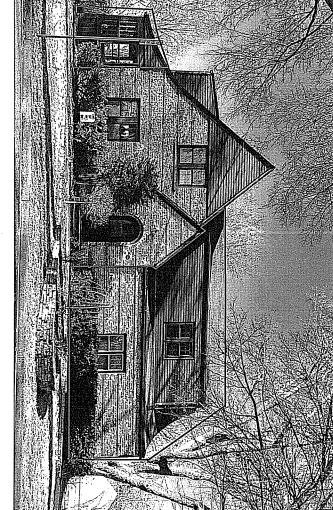
TINY ENCLOSED PORCH & CHIMNEY TO BE REMOVED

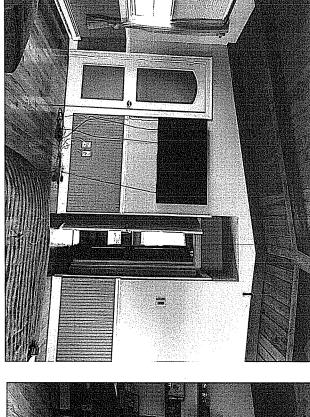
MAGTER SUITE INTERIOR (electric baseboard heat, no AC, insufficient insulation to garage below, awkward and unsafe transition off staircase winder treads)

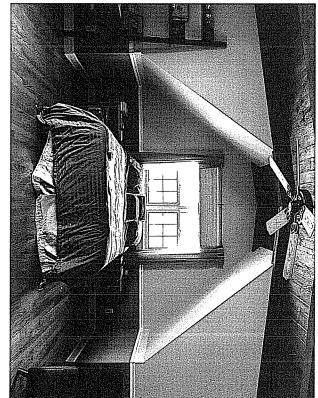
THE WAY IN WHICH THE 1980'S ERA ADDITON WAS ADDED TO THE HOUSE CREATED AN UNSAFF CONDITION AT THE EXISTING WINDER OF THE STAIRCASE
