Royster Clark Proposed TID Blight Study

Madison, WI

May 10th, 2013

Prepared by MSA Professional Services, Inc.

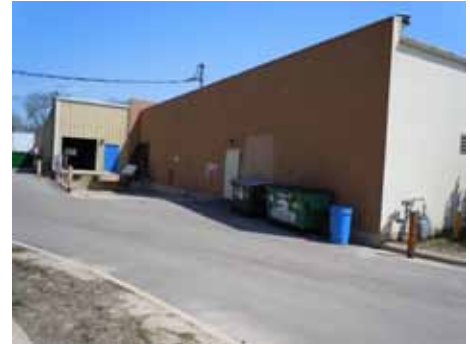
Parcel 6

Score: 59.4

Lower intensity use than preferred per comp plan; cladding dirty in places, mismatched patching; wall blocks crumbling at edges; worn paint on curbs; rusted stairs in back; asphalt faded, cracked and poorly patched, parking curbs deteriorating; litter in landscaping

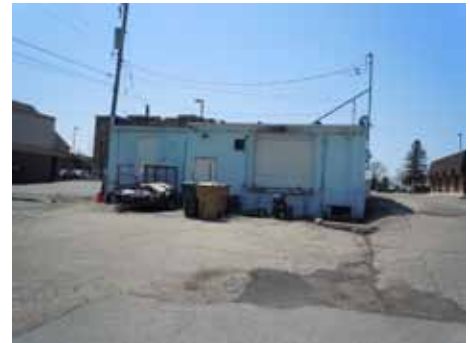
Parcel 16

Score: 56.5

Lower intensity use than preferred per comp plan; rust streaks and chipping paint on walls and cladding, mortar missing in places, broken pieces on corner; portions of parapet are missing; paint peeling on chimney; rear steps crooked, missing handrail, wood is worn and warped; piles of debris in back; asphalt drive deteriorated; gravel and litter in parking lot

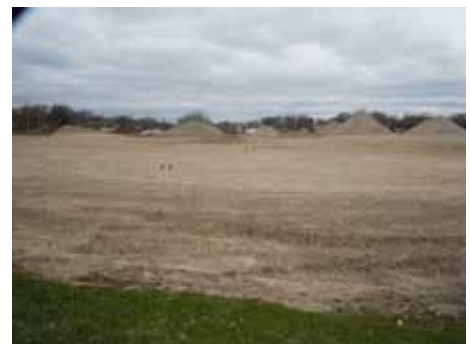
Parcel 19

Score: 55.5

A rezone is pending for this property but has not yet been approved - site is evaluated "as-is". Fences rusted and bent; overgrown with weeds; overgrown shrubs; graffiti, piles of railroad ties; known soil contamination (remediation started but not completed); most of site soil exposed, relying on silt fence to contain ongoing erosion

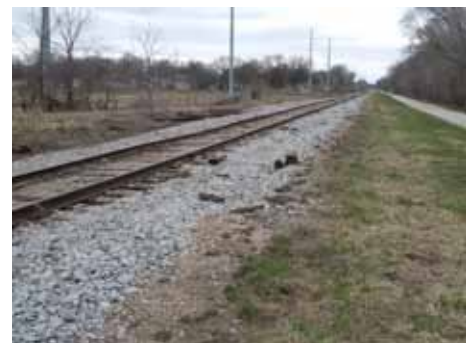
Parcel 28

Score: 51.5

Chain link fence, twisted and rusting; overgrown weeds; debris scattered; dead weeds and other vegetation; abandoned, broken rail road ties

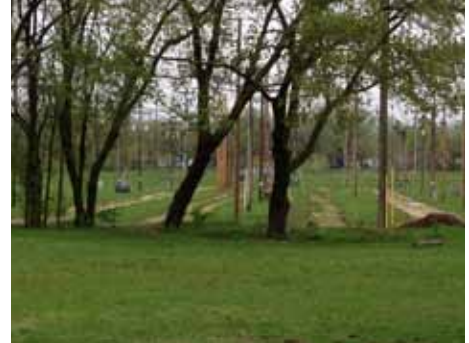
Parcel 39

Score: 48.2

Mostly unused and vacant; rusty fence bisects parcel; gravel drives in poor condition; loose pile of wood poles; scrub trees growing along fence; dead branches on ground; unprotected stockpile of dirt

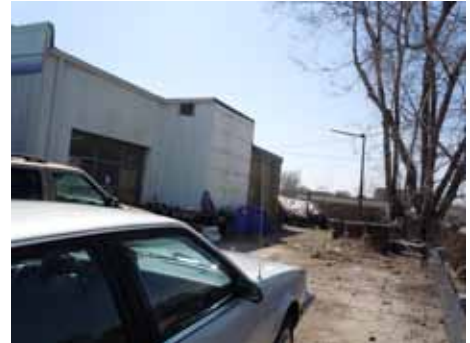
Parcel 40

Score: 55.7

Lower intensity use than preferred per comp plan; dirty walls with some of the building discolored and faded; rear windows dirty; rusted vents; dirty and dented doors; shed is weathered; cement and asphalt discolored and stained; backyard has piles of junk, weedy, overgrown

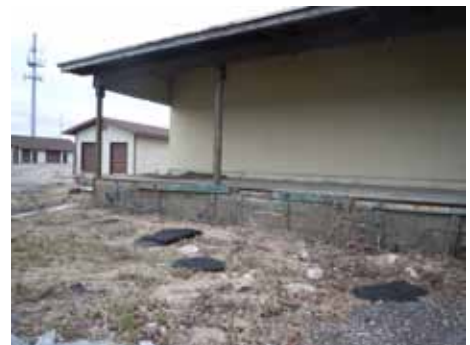
Parcel 42

Score: 20.6

Warehouse use is not recommended in employment district in comp plan; vacant; bulging foundation; rusted gutters filled with debris, falling apart; rusted vents; rust marks on stairs from railing; no screening for dumpsters; gravel drive and parking lot; weeds everywhere; substantial amounts of litter and garbage

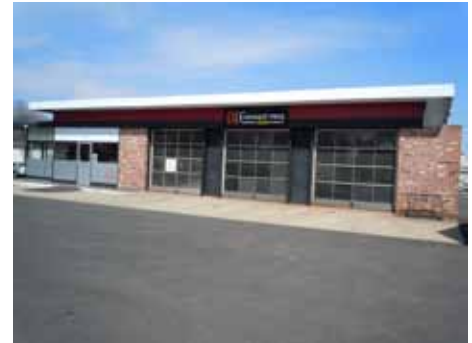
Parcel 3

Score: 58.2

Lower intensity use than preferred in Plan; walls paint peeling, rear and side cladding damaged and warped, rusted; windows broken and boarded up; missing downspouts; vents dented; garage doors cracked and rusted; stained concrete in front of garage; rusted barrier on the right side of lot

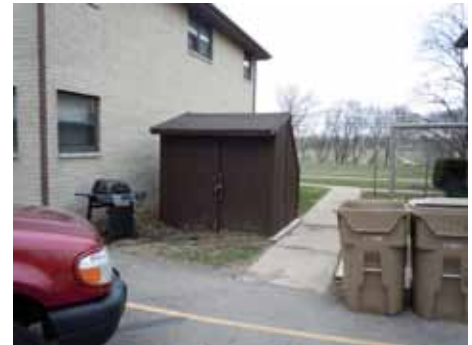
Parcel 14

Score: 50.5

Residential not appropriate or recommended use for Employment District; vacancy; brick is dirty, rust stains; shingles beginning to curl; rear balconies rusted; rear stoop, exposed aggregate/chunks missing at edges; shed door chipping near base; retaining wall shifted; concrete deteriorated at joints; asphalt faded and cracked; litter; rusted railings; leaves and debris

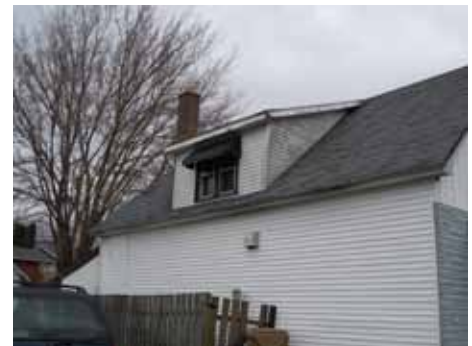
Parcel 24

Score: 48.1

Not recommended use per comp plan; walls very dirty; shingles warped, some patchwork, sagging roof; canopies filthy and falling apart, missing gutters; dumpster not screened, fencing on east side of building falling over; asphalt crumbling, weeds, gravel debris, litter; bare spots in lawn; piles of dirt

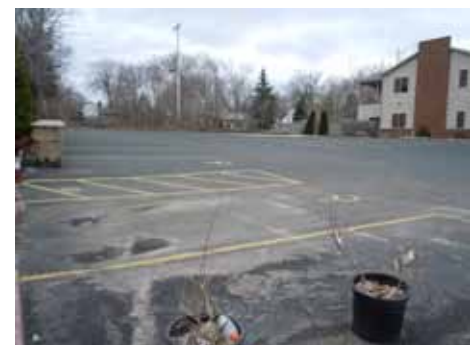
Parcel 25

Score: 56.0

Parking is just a support use in an Employment District; asphalt is fading and oddly seal coated (worked around painted markings, didn't finish), cracked, public walks are stained; litter, weeds, planting beds a mix of wood and stone mulch, piles of brush at back of lot

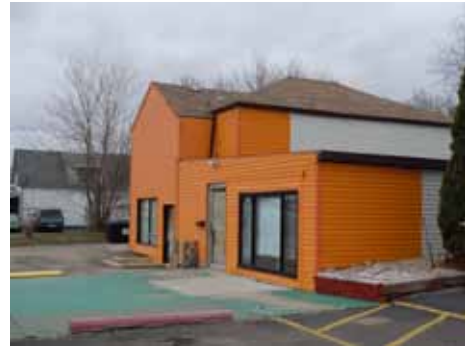
Parcel 27

Score: 33.6

Not a recommended use per comp plan; vacant with Surco coming soon sign; cladding worn out, patchy paint; missing cladding and gutters; paint peeling on windows; asphalt faded and cracked; sign post rusted, bulk of sign entirely missing; litter, debris, wood timber retaining wall chipping paint, misc. debris in planter

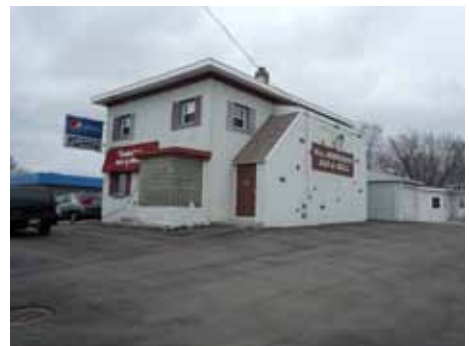
Parcel 50

Score: 50.7

Not recommended use per comp plan; walls dirty, cement block beginning to crack, asphalt splatter on bottom; eaves dirty; shingle color fading; chimney poorly patched; glass blocks dirty; all stoops discolored, pieces of cement coming off on stoop; chunks missing out of fence post; dirty signage; litter, trash bags along side of building

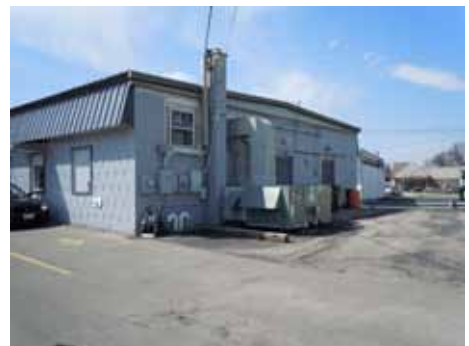
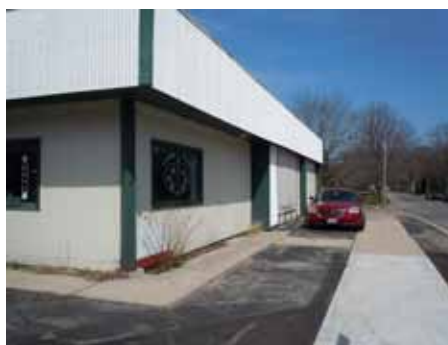
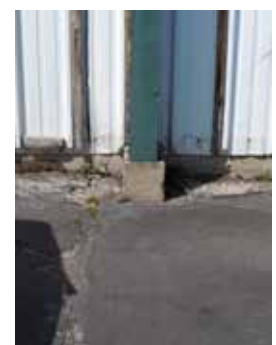
Parcel 54

Score: 54.1

Lower intensity use than preferred in Plan; half of Java Cat(JC) not occupied; JC: damage to metal cladding, holes in cinder blocks; faded porch canopy; heavily damaged drive-thru; vents in back need to be repainted; concrete walk in front dirty/stained, chunks missing and poorly patched; rear door frames chipping paint; no screening of dumpster of HVAC; side sign fading; walks dirty/stained;

Crowns of Glory: heavy peeling and deterioration of wood; base and upper cladding needs to be repaired; concrete cracked, chunks missing; weeds and litter, trash behind building; worn asphalt

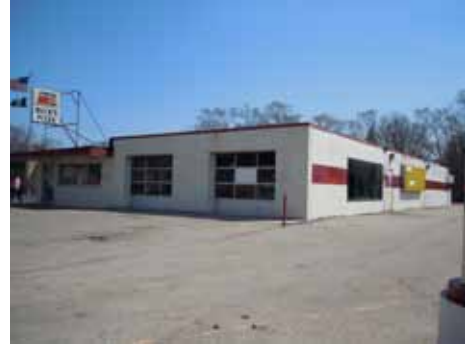
Parcel 56

Score: 55.8

Lower intensity use than preferred in Plan; paint peeling along the side; dirty, evidence of water damage; paint on windows; some windows covered; window cracked and duct taped, window loose dirty overhang; trash cans not screened; litter and weeds

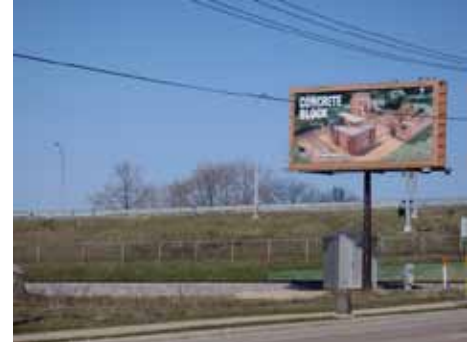
Parcel 12

Score: 53.0

Lot is too small for industrial use; lot is vacant; billboard is peeling paint; a lot of weeds and debris; large tree stump

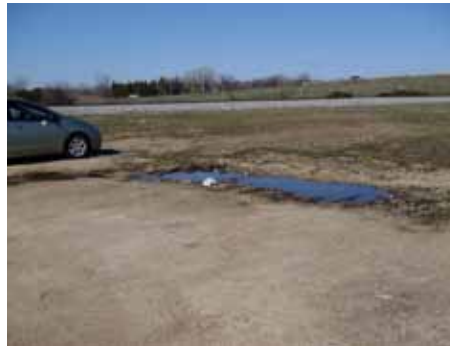
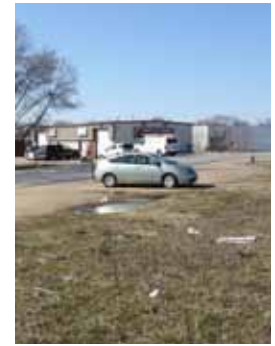
Parcel 49

Score: 51.0

Lot is too small for industrial use; gravel parking has a large pot hole and standing water; weedy; a lot of debris and garbage on land

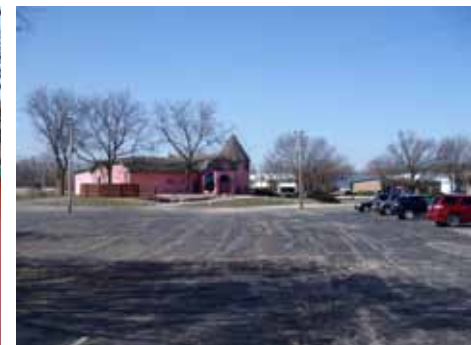
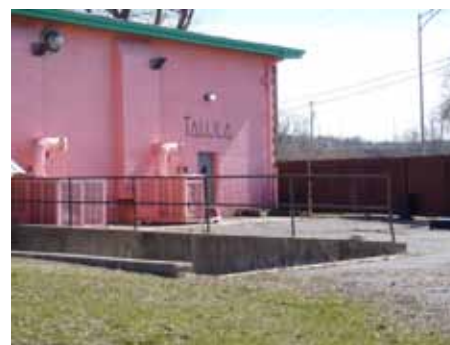
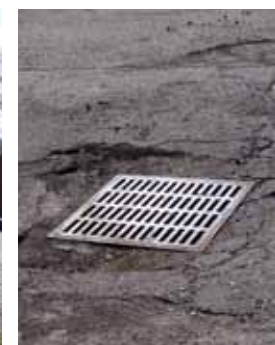
Parcel 60

Score: 53.5

Vacant; concrete walls dirty; chipping paint near front entry; awning is very dirty/molding; bent green gutters; back air conditioner dented and smashed; paint worn on screened fence; street sign worn, paint chipping on TULULA sign; parking lot very worn in most places with crumbling; rear lot has small pond forming in pot hole; site is littered; gravel backfilled hole in lawn; light base left in front with exposed wires; railing in rear is bent; bare spots in lawn; branch debris in parking lot

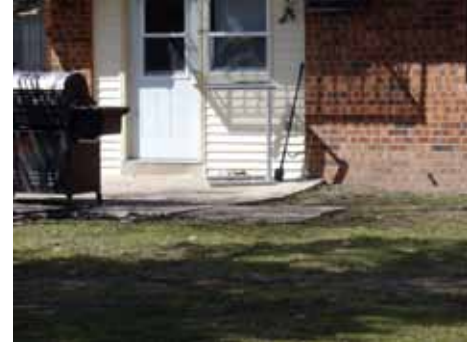
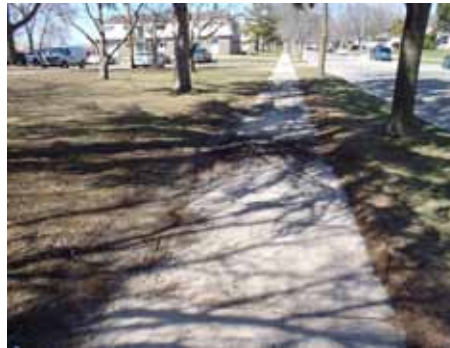
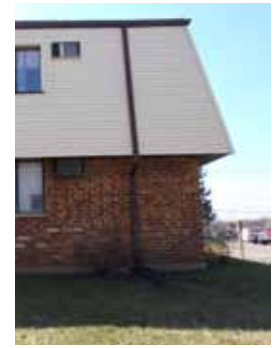
Parcel 26

Score: 42.7

Brick is very dirty, rust stained; fascia on roof is rusting; broken window screens and deteriorating window frames; window wells unlevel, rusted, mismatch or missing entirely; missing dumpster enclosure; lawn in poor condition; dirt washed onto sidewalks; junk around entries; bent and rusted gutters; doors dirty and mismatched; broken light fixtures on building that fronts Cottage Grove Rd.

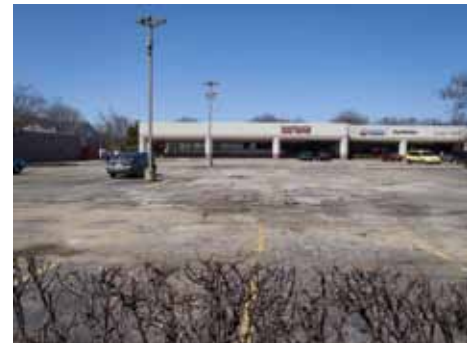
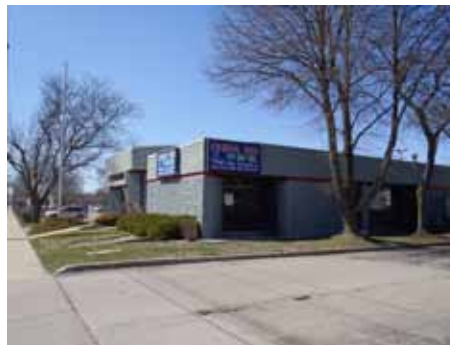
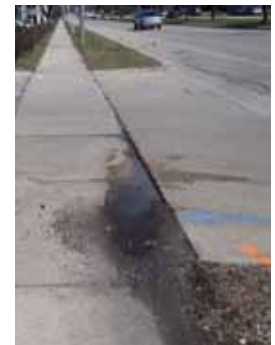
Parcel 51

Score: 45.8

Single story development; three vacant stores; discoloration on brick; chipping paint on restaurant; overhangs on mall stained, missing signs; cracked concrete stoop; planter brick damaged; dumpster fence chipping paint; debris visible around dumpster and in front yard and terrace; bare spots and weeds in lawn terrace; sediment and water pooling on sidewalk and in driveway areas

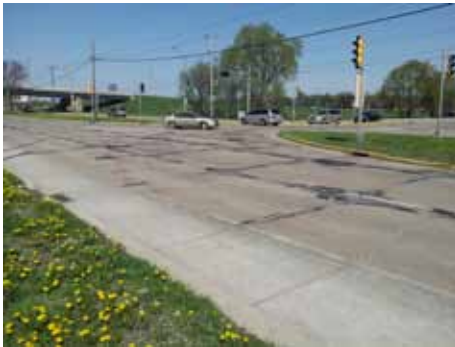
Cottage Grove Rd. at US 51 looking NW (cracks, large patched voids)

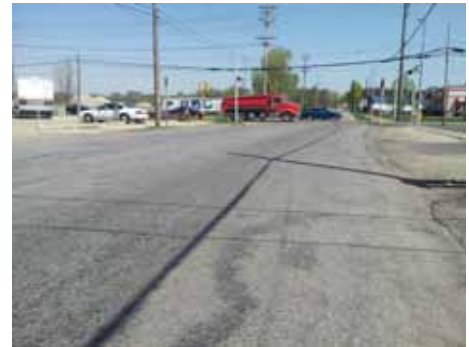
Dempsey Rd. Looking N (fading asphalt)
