# East Washington Proposed Redevelopment District Blight Study

December 14, 2011  
Madison, WI

PREPARED BY MSA PROFESSIONAL SERVICES, INC.

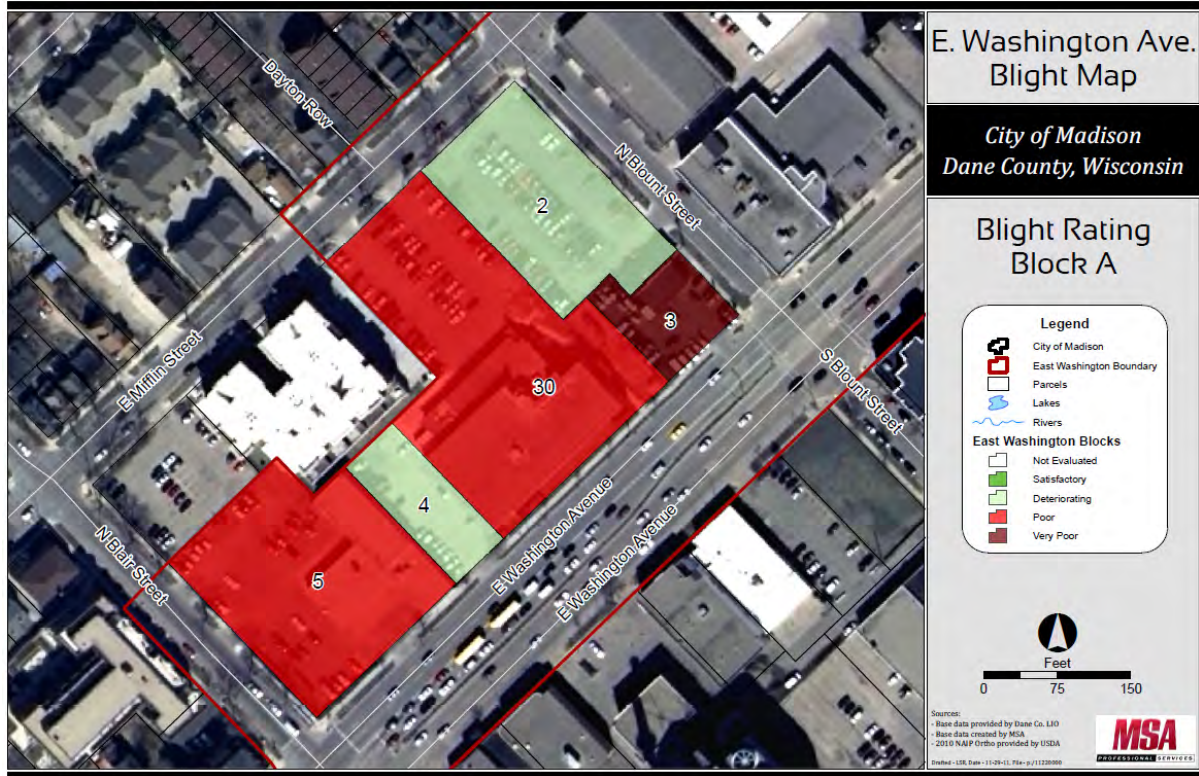
This block includes five parcels ranging in size from 0.23 to 1.34 acres. All the parcels are designated for Community Mixed Use in the Comprehensive Plan and are currently zoned C3. Of the five parcels, two have commercial/service uses (3 and 5), two are parking lots (2 and 4), and one is social services (30).

**Three parcels were found to be blighted (Poor or Very Poor condition), representing 72.95% of the block, by area.** Detailed notes and photos of the two blighted parcels follow. Every parcel in this subsection lost points due to site improvement conditions and other blighting influences. In addition, parcels with structures lost points in primary structure exterior condition. Four of the five parcels also lost points in utilization.

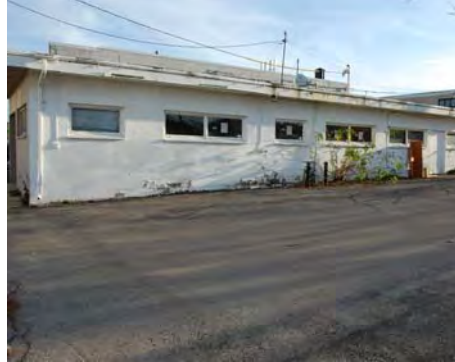
Paint peeling from walls and cladding, window and door frames, and fascia; elements of roof rusted, broken, bent; garage doors dented; sign face missing; paint peeling from existing sign and poles; parking lot cracked and overgrown; walk heaving; litter; landscaping not maintained; junk behind building

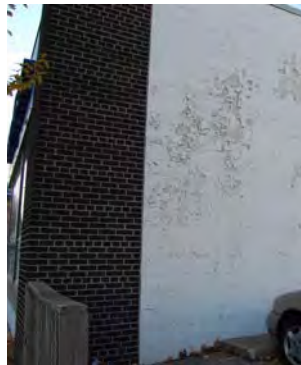
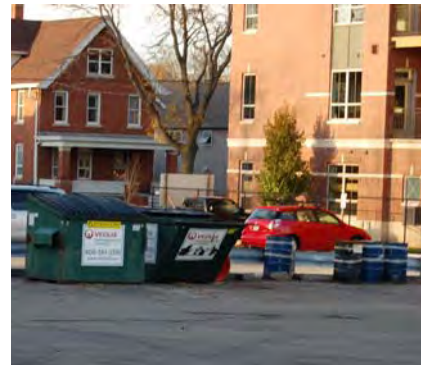
#### **Parcel 5**

**Score: 59.8**

Paint peeling from walls, stair railings, foundation and overhang; foundation cracked; window sills cracked; garage doors dented and rusted; rear door heavily rusted; dumpster and fluid drums not screened; asphalt lot cracked and pitted; litter

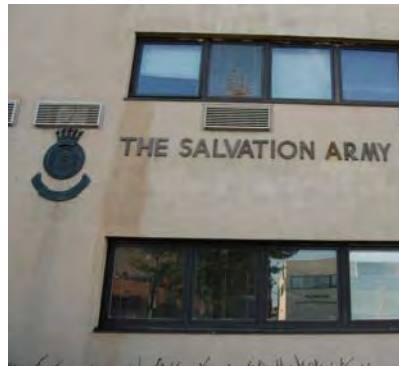
#### **Parcel 30**

**Score: 43.2**

Cladding dirty, stained and paint mismatched; overhang on front entrance damaged- fascia bent, lights falling, pieces of soffit missing; front stairs crumbling; vents rusted; litter; signage missing; graffiti; screening not protected by paint or stain; extensive litter in parking lot; walks and ramp cracked

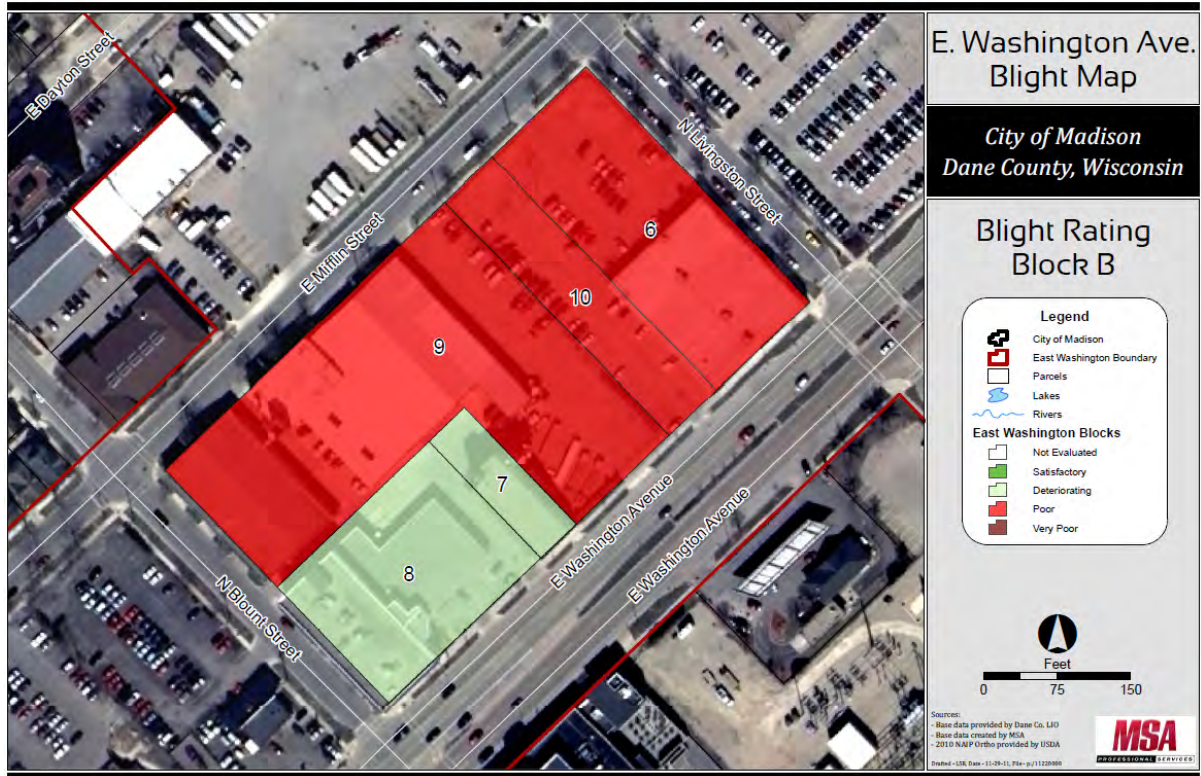
This block includes five parcels ranging in size from 0.22 to 1.96 acres. All the parcels are designated for Community Mixed Use in the Comprehensive Plan and are currently zoned C3. Of the five parcels, two have warehouse/trucking uses (7 and 9), one is employment services/post office (8), one is auto sales and repair (6), and one is a parking lot (10). Two parcels are vacant (6 and 10).

Three of the parcels were found to be blighted (Poor condition), representing 77.07% of the block, by area. Detailed notes and photos of the three blighted parcels follow. Every parcel in this subsection lost points due to site improvement conditions and other blighting influences. In addition, parcels with structures lost points in primary structure exterior condition. Four of the five parcels also lost points in utilization.

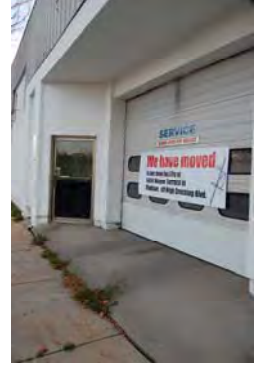
Cracks and holes in cladding; windows graffitied, broken, boarded, dirty and scratched; paint peeling from frames; vents rusted; garage doors dented/rusted; screening rusted and leaning; signage missing; parking lot cracked, overgrown; sidewalk cracked, aggregate beginning to show; litter; overgrown/dead vegetation in lot; vacant

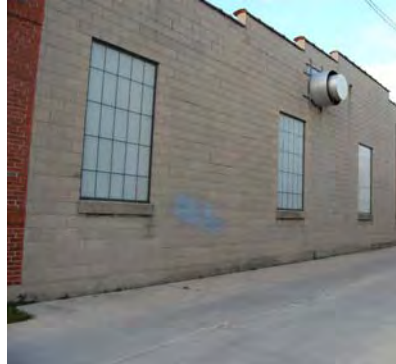
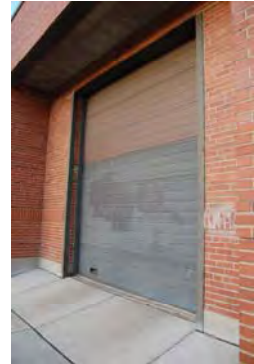
#### **Parcel 9**

**Score: 46.4**

Paint mismatched/peeling; walls on interior buildings heavily cracked; graffiti; gutters rusted; window sills crumbling; concrete wear on garage overhangs; chain-link not providing adequate screening; cracked and worn asphalt drives; litter; some water pooling in drive

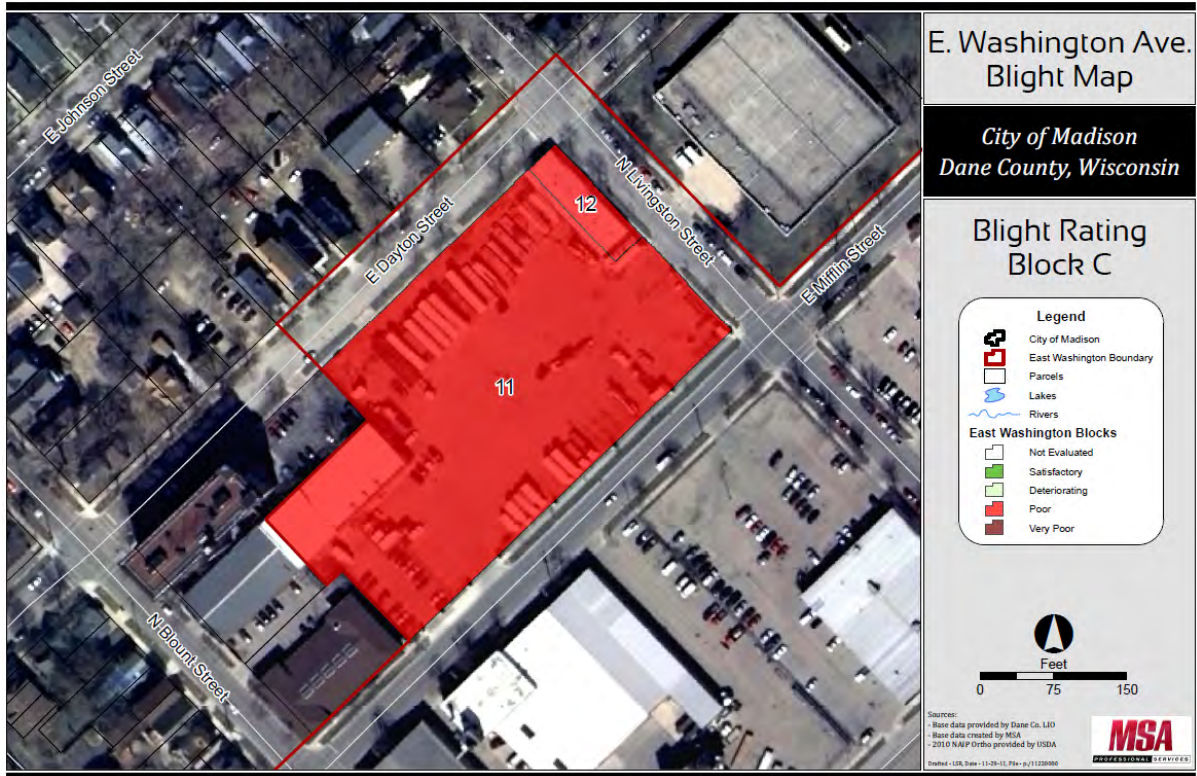
This block includes two parcels ranging in size from 0.12 to 2.48 acres. All the parcels are designated for High Density Residential in the Comprehensive Plan and are currently zoned C3 and PUD. Both parcels are used for storage/trucking.

Both parcels were found to be blighted (Poor condition), representing 100% of the subsection, by area. Detailed notes and photos of the blighted parcels follow. Both parcels in this subsection lost points due to site improvement conditions and other blighting influences. Both parcels also lost points in utilization.

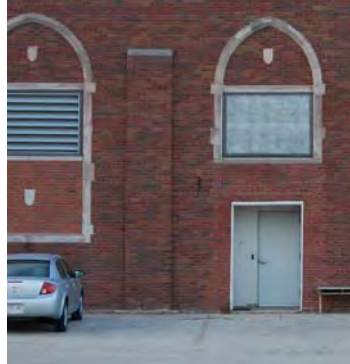
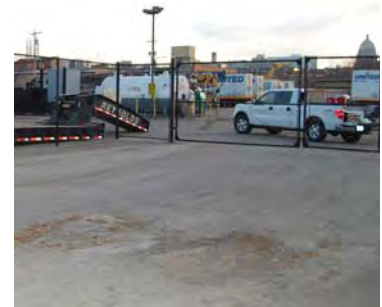
Some brick discoloration and mortar wear on structure; minor rust staining on doors; chain-link not providing adequate screening; drives and lot cracked and pitted; sidewalk cracked, aggregate starting to show; not compatible with adjacent HDR; low lot utilization compared to preferred future land use

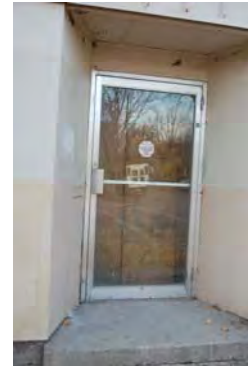
#### ***Parcel 12***

**Score: 41.2**

Foundation is crumbling/discolored; walls heavily graffitied; mismatched paint; metal siding curling-sharp pieces; rust stains; gutters full of debris, rusted, sections missing; overhang dirty, paint peeling; door dirty, boarded from the inside; junk on side of building not screened by chain-link fence

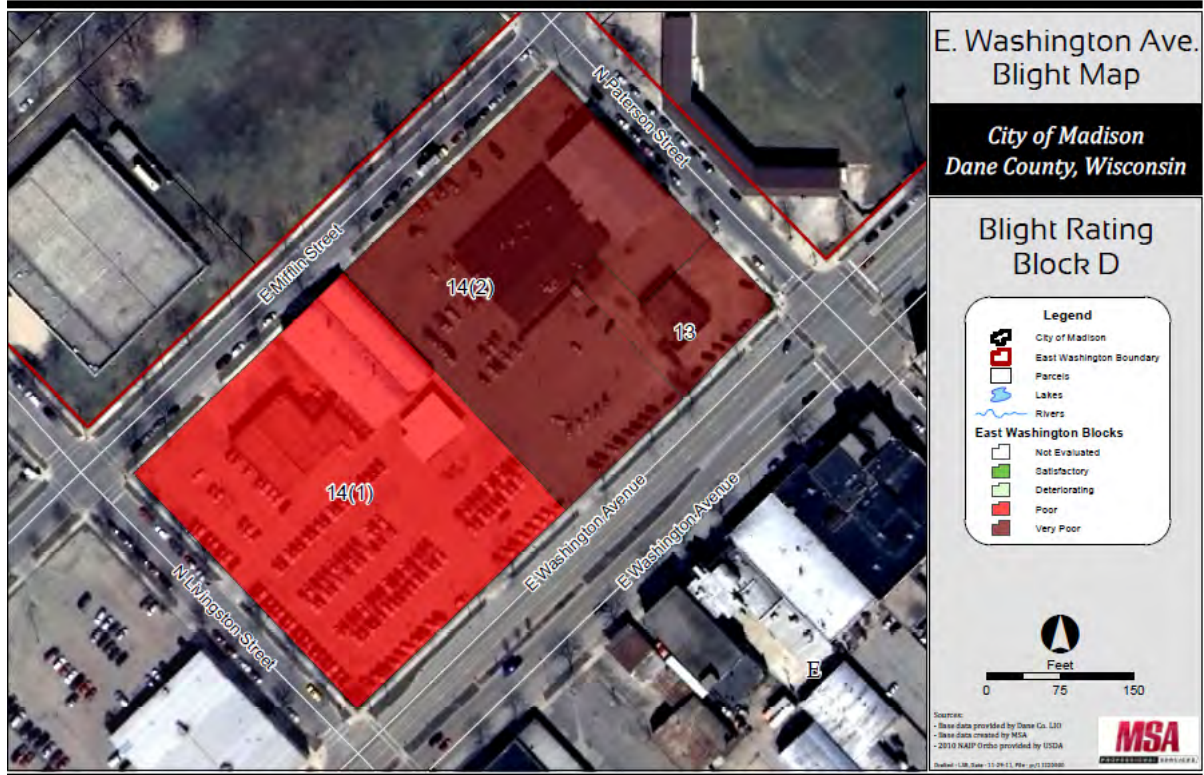
This block includes two parcels ranging in size from 0.35 to 4.15 acres. Both parcels are designated for Community Mixed Use in the Comprehensive Plan and are currently zoned C3 and PUD. Both parcels have auto sales and service uses. Parcel 13 is vacant. Parcel 14 was divided into two parcels (14 (1) and 14 (2)) for blight evaluation purposes to correspond with existing conditions and structures.

All parcels were found to be blighted (Poor or Very Poor condition), representing 100% of the subsection, by area. Detailed notes and photos of the blighted parcels follow. Every parcel in this subsection lost points due to primary structure exterior conditions, site improvement conditions and other blighting influences. Both parcels also lost points in utilization.

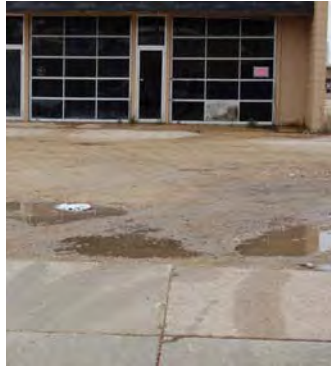
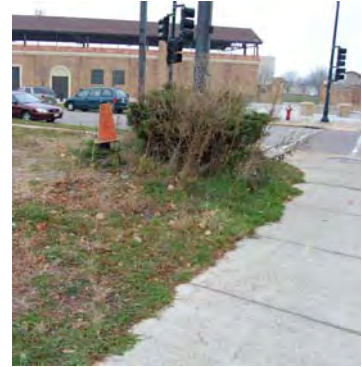
Foundation cracked; paint peeling; walls cracked; siding curling; windows broken, boarded, and scratched; shingles discolored; vents rusted; door glass heavily scratched, weeds growing from frame; lighting rusted; gravel driveway in poor condition; walks cracked; landscape unmaintained, litter; piles of trash; stormwater issues in parking lot; vacant

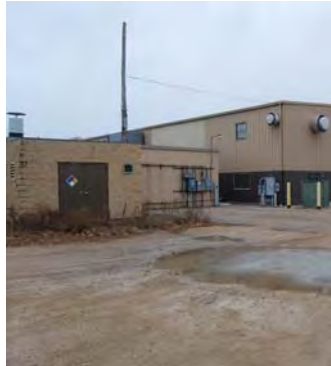
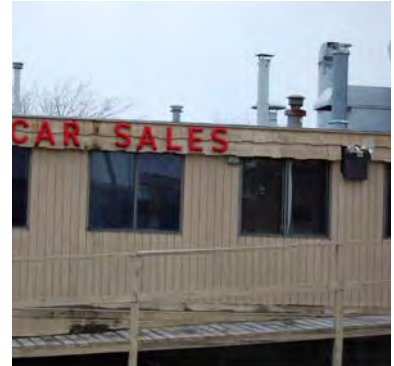
#### **Parcel 14 (1)**

**Score: 53.3**

Wood siding deteriorating at base; metal siding bent and rusted; minor rust on vents; minor discoloration on doors; accessory structures in poor conditions; fencing bent and rusted; no screening around dumpsters; pole sign rusted; asphalt parking worn; pooling in unpaved areas

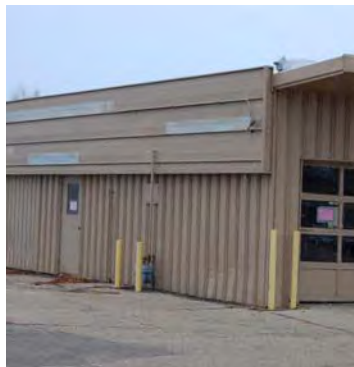
#### **Parcel 14 (2)**

**Score: 28.9**

Metal siding bent and patched; paint wearing; brick discolored; major cracks in concrete blocks; shed buildings very rusted; broken windows; graffiti; no screening around dumpsters; major cracks and weathering in paved areas; piles of trash; graffiti; open wires; some pooling and washed out gravel

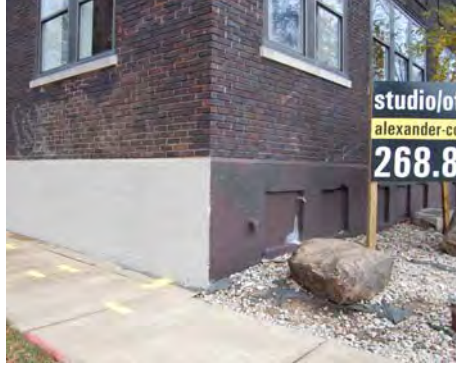
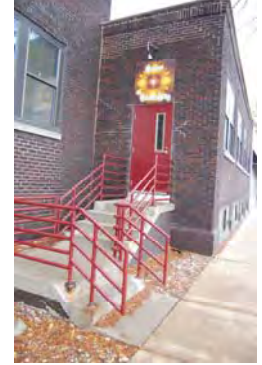
Foundation cracked; some brick discoloration; graffiti; concrete damage, rust on roof; window sills stained, paint peeling from frames; porch screens damaged, paint peeling; vents rusted; railings rusted; handicap ramp rusted, crumbling; some units vacant

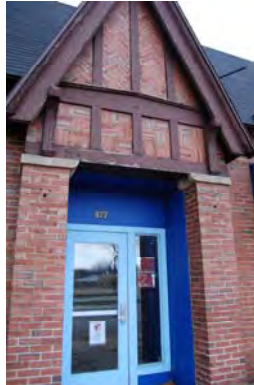
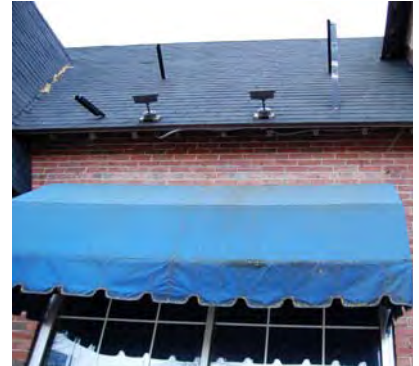
#### **Parcel 26**

**Score: 56.1**

Brick discolored; minor graffiti; paint peeling from fascia and decorative elements of roof; some shingles curling; canopies dirty; gate rusted; signage missing; sidewalk-minor heaving; minor graffiti; for sale, partial occupancy

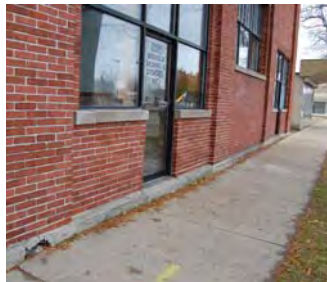
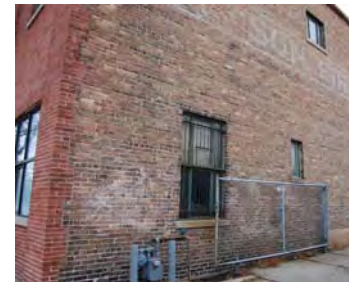
#### **Parcel 27**

**Score: 59.3**

Bricks discolored; poorly covered graffiti; window frames rusted, paint peeling; crack in door frame; sign dirty, faded; asphalt drive cracked, pooling water;

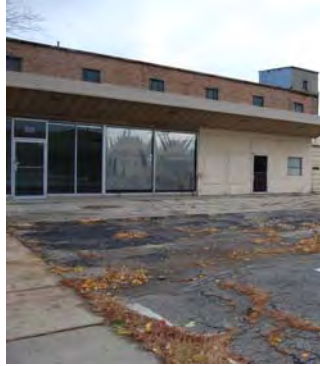
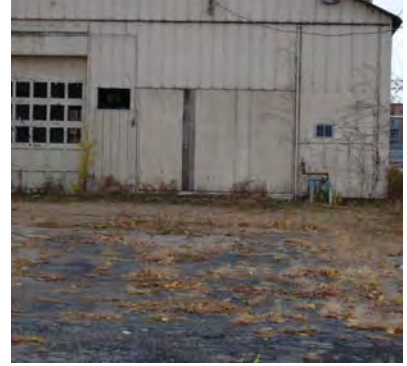
**Parcel 28**

**Score: 34.5**

Paint peeling, mismatched; some siding missing; windows covered with plastic on outside; paint peeling from window frames; overhang faded, rusted, warped; garage door and frame sagging; parts of address missing; Drive cracked, potholes, gravel, debris; overgrown; minor stormwater issues; vacant

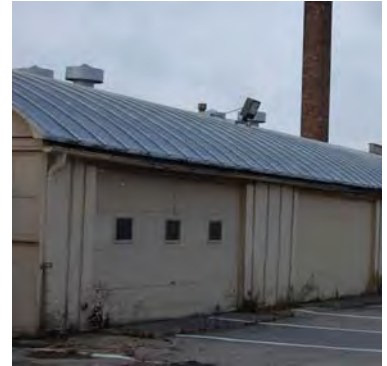
**Parcel 29**

**Score: 33.7**

Foundation cracked; siding dirty, rust stained and dented; some windows boarded up; stoop discolored; paint peeling from garage doors; side door in poor shape; overall condition of garage poor; dirty parking light fixtures; weeds overgrown; asphalt cracked and weathered; major heaving; vacant

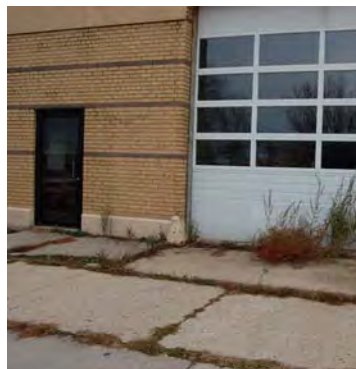
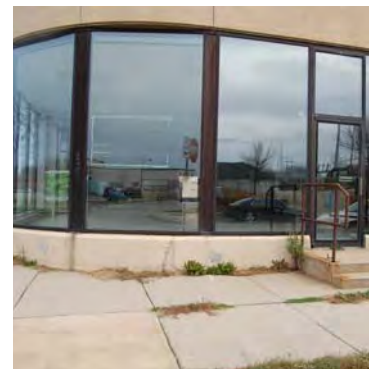
**Parcel 31**

**Score: 31.3**

Cracks in foundation; holes and discolored brick and mortar; graffiti; window frames rusted; rusted railings; concrete cracked and aggregate showing; weeds in joints of public sidewalks; vacant

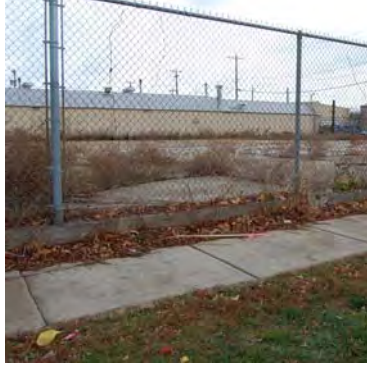
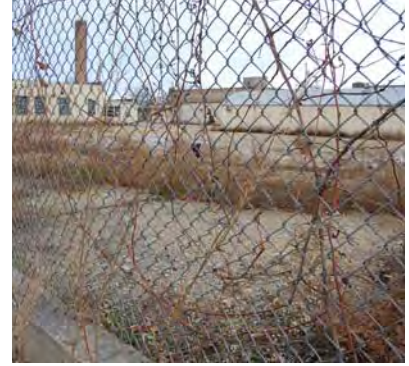
**Parcel 32**

**Score: 39.7**

Fence rusted; asphalt lot deteriorating; loose gravel; concrete base along fence line discolored; weeds throughout; debris; vacant

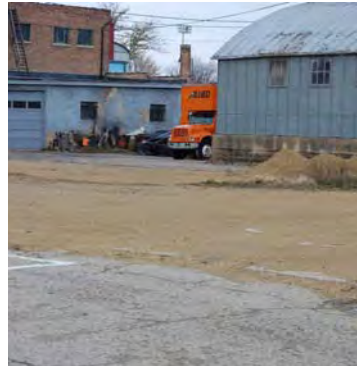
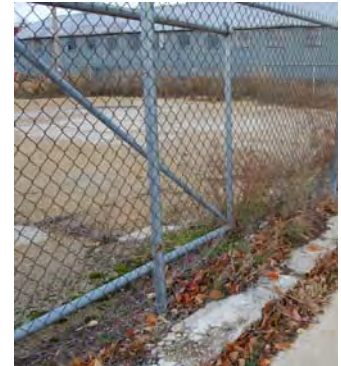
**Parcel 33**

**Score: 28.6**

Fence rusted with holes; concrete crumbling; lot partially covered with sand, major cracks, asphalt disintegration; litter; overgrown; piles of trash; stormwater issues; vacant

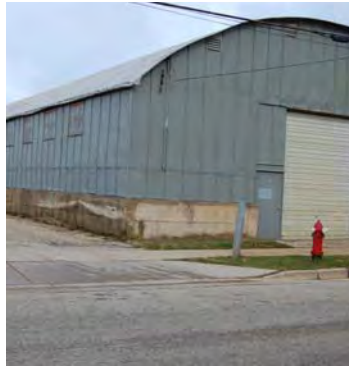
**Parcel 34**

**Score: 43.7**

Cracks in foundation; cladding dented; roof warped, rusted, edges sagging; windows painted over; garage door paint mismatched; drive cracked, pot holes; vents rusted;

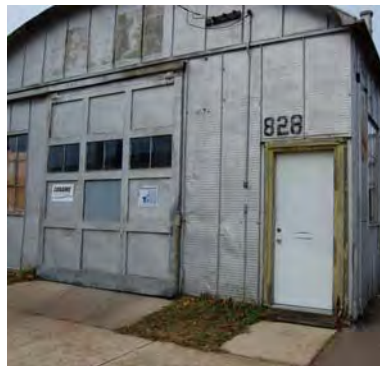
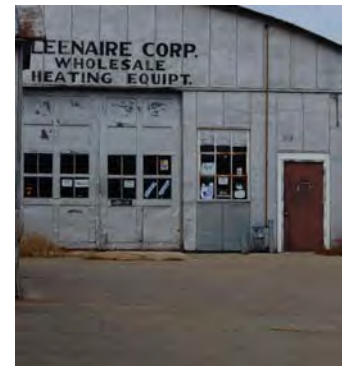
**Parcel 35**

**Score: 43.5**

Cladding rusted, dented, curling; roof rusted, metal missing; window frames rusted; some windows painted over/covered with cardboard from the inside; drive cracked, overgrown; vacant

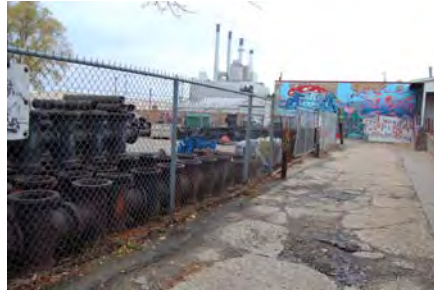
**Parcel 36**

**Score: 55.1**

Chain-link rusted, bent; graffiti on signs; asphalt drive in need of repair; stormwater issues

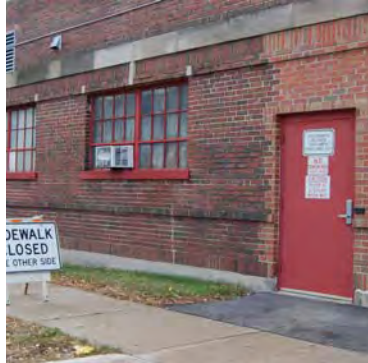
**Parcel 37**

**Score: 58.8**

Bricks discolored; poorly covered graffiti; paint peeling from window frames; some vents rusted; garage doors dented; door on roof rusted; lot screening missing slats; dumpster not screened; some cracks in parking lot

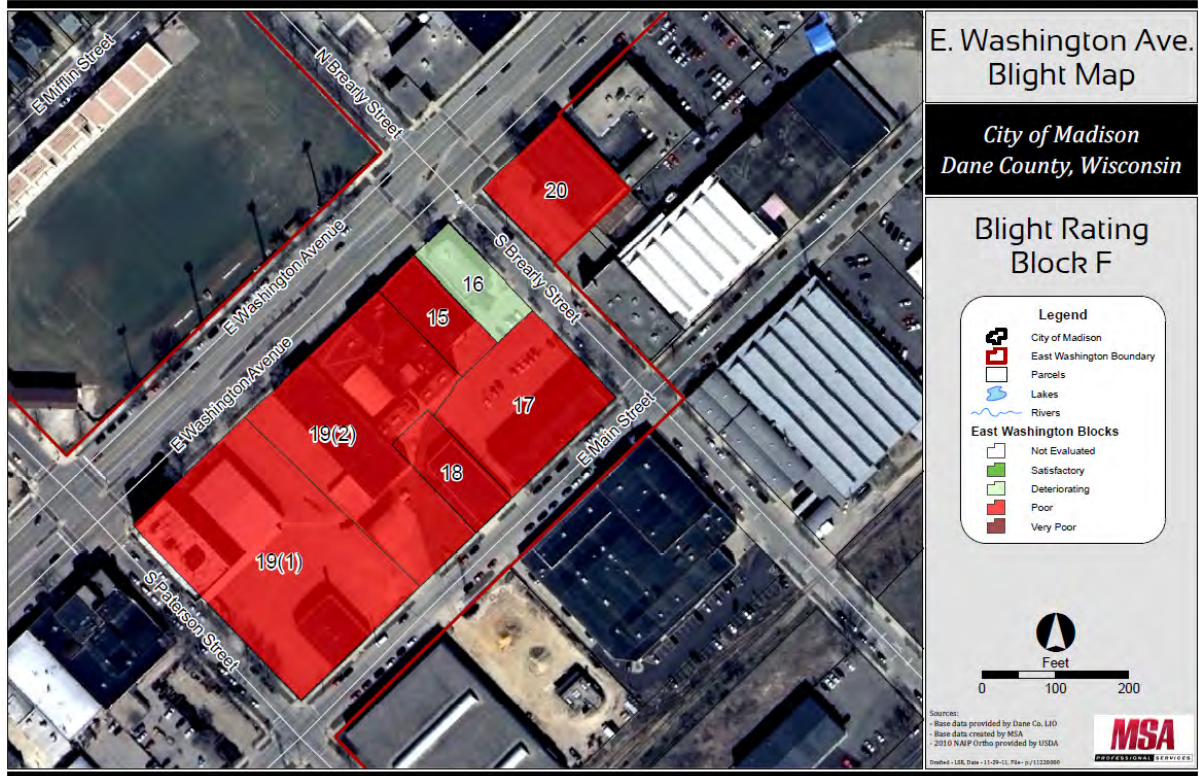
This block includes six parcels ranging in size from 0.25 to 3.01 acres. All the parcels are designated for Employment in the Comprehensive Plan and are currently zoned M1 (except Parcel 16 zoned C3). Of the six parcels, two have commercial/office uses (15 and 17), one is a credit union (16), one is manufacturing (19), and two are general storage (18 and 20). Parcel 19 was divided into two parcels (19 (1) and 19 (2)) for blight evaluation purposes to correspond with existing conditions and structures. Parcel 17 is vacant and Parcels 19(1), 19(2) and 20 are partially vacant.

Six of the seven parcels were found to be blighted (Poor or Very Poor condition), representing 94.96% of the block, by area. Detailed notes and photos of the six blighted parcels follow. Every parcel in this block lost points due to site improvement conditions and primary structure exterior conditions. A majority of the parcels also lost points in utilization.

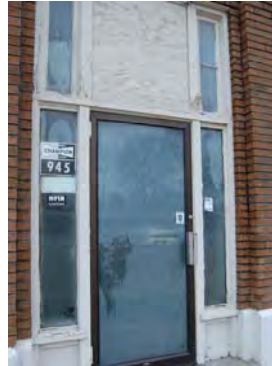
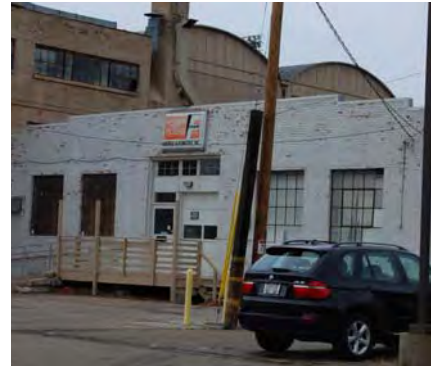
Paint peeling from walls; some windows boarded; paint peeling from window frames and doors; signage missing; cracks in asphalt lot; vacant

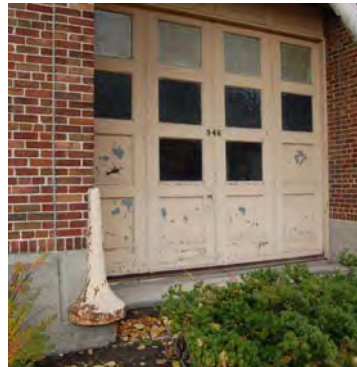
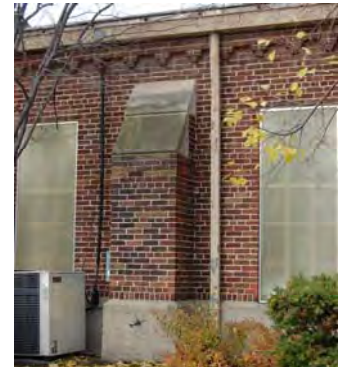
**Parcel 17**

**Score: 35.3**

Graffiti; walls-concrete stained, bricks discolored; cracks in foundation; gutter rusted, debris-filled; windows dirty and rusted, covered from inside; door frame rusted, paint peeling; graffiti on drive; vacant

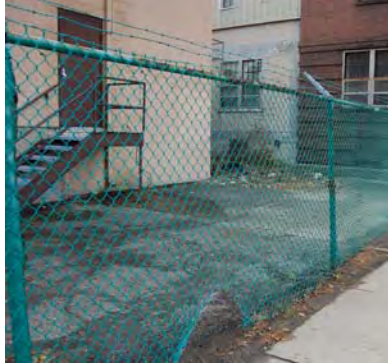
**Parcel 19(1)**

**Score: 33.2**

Foundation of main building worn, discolored, cracked and crumbling; graffiti; discolored and mismatched brick; metal siding graffitied; paint wearing; broken window panes; rusted framing; dock doors dirty; minor cracks and cosmetic damage to 910 building; chainlink rusted and bent; access drive in poor shape; many buildings vacant/unused

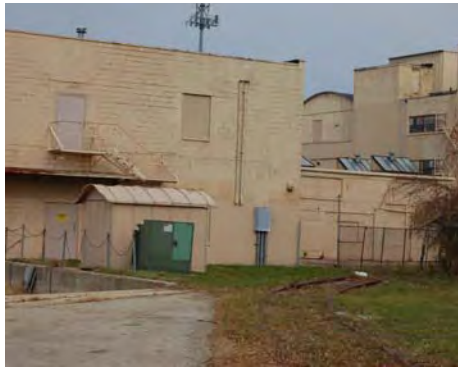
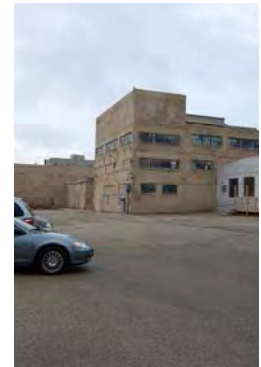
**Parcel 19(2)**

Mortar issues on side and brick; broken windows; paint peeling; rusted mullions; exterior doors worn, dirty; loading dock in poor shape; signage rusted; asphalt cracked/potholes; lawn and landscaping not maintained in back; graffiti; many buildings appear vacant/unused

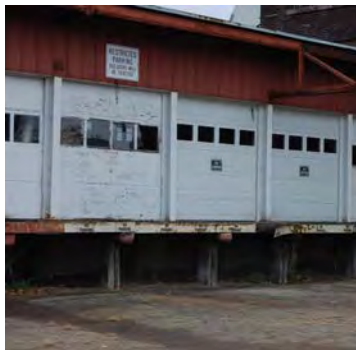
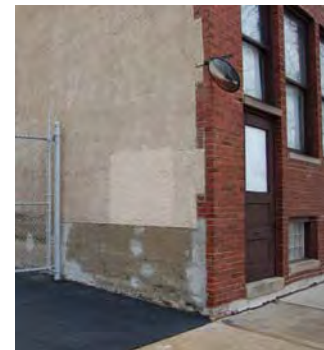
**Parcel 20**

Foundation cracked, crumbling; wood siding broken; mismatched wall paint; some windows broken; dock doors curling; dock rusted; screening missing; parking lot cracked; graffiti; litter/debris; partially vacant

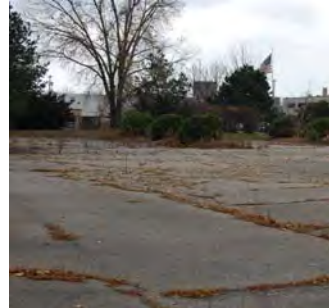
Fence rusted, bent; lot overgrown; pavement significantly deteriorated; graffiti; litter; vacant

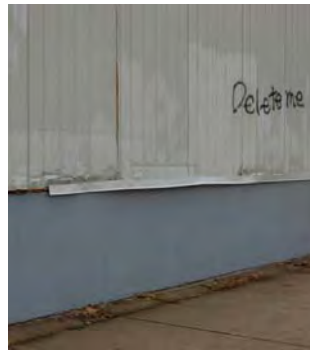
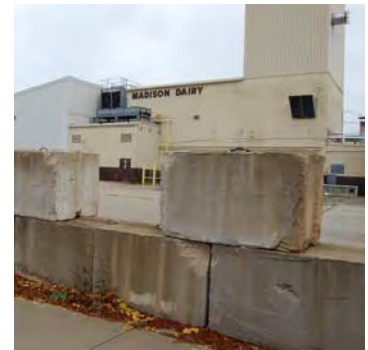
#### ***Parcel 24***

Paint peeling from walls, cracks in concrete; siding missing; graffiti; vents and dock doors rusted; slats missing from fence; asphalt lot cracked, pot holes; rusted and crumbling concrete blocks blocking drive; weeds around base of building

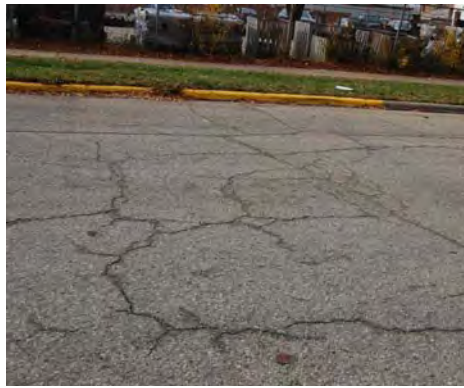
Paterson St at Main St (Fair condition)

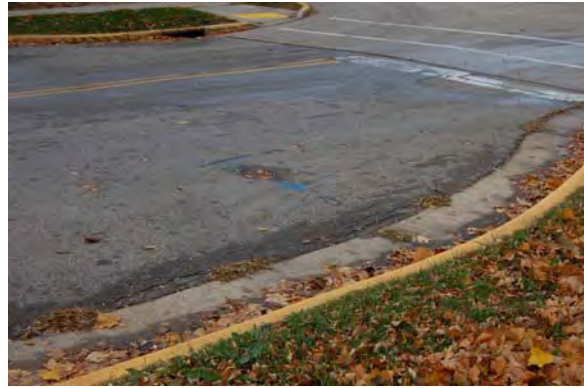
Brearly at E Washington (Good condition)

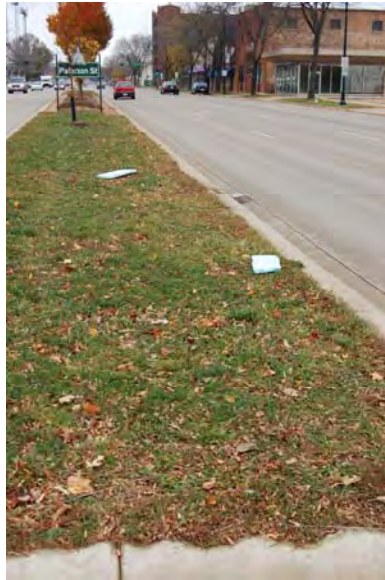
E Washington looking NE (litter)

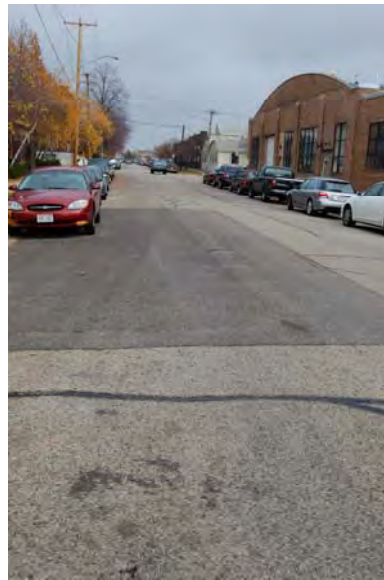
Main looking NE (Good condition)
