### Reasons To Deny Landmarks Commission Approval Of 7/10/17 Submission For 801 Williamson

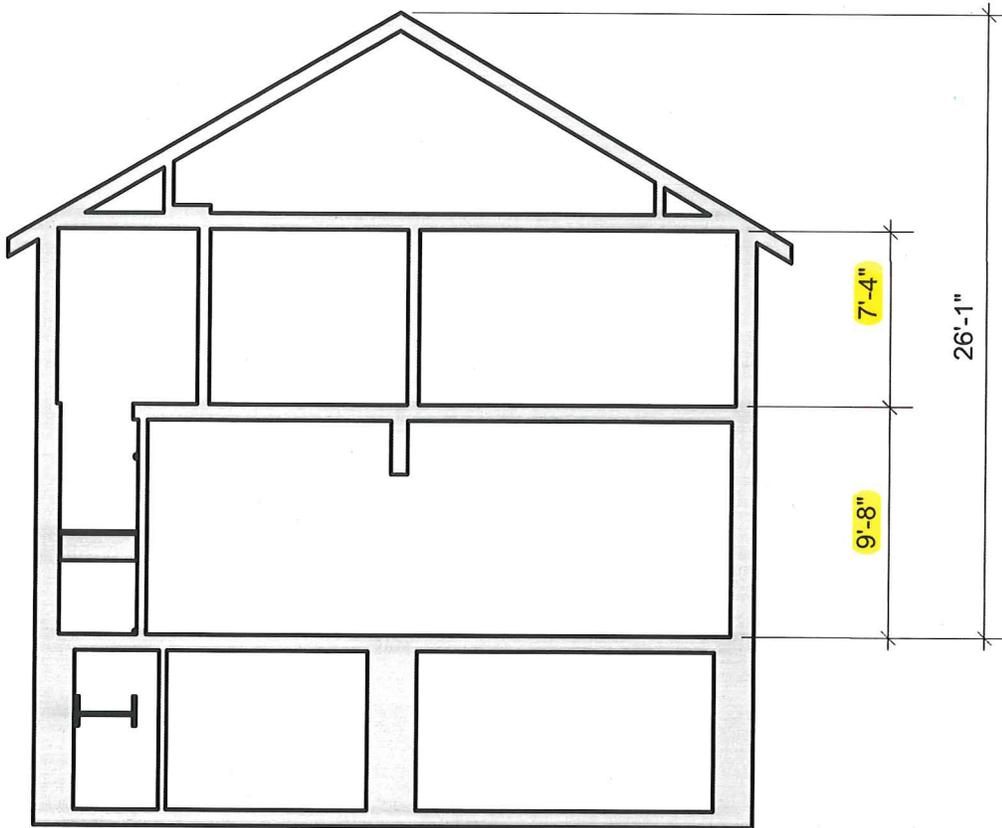
1 Floor Heights 805 Williamson (811 similar)  
801b Scale: 1/8" = 1'-0"

Floor-to-floor heights can be easily lowered to a more historical standard. Adjacent properties (805, 809) have commercial first floor heights of 9'-8" floor-to-floor. Second floor residential ceiling heights is 7'-4" (805, 811). **A minimum of 1'-0" should be removed from each or the floors, reducing 801 building height from 33'-4½" to 30'-4½", still over 4 feet higher than the next two streetfront buildings.**

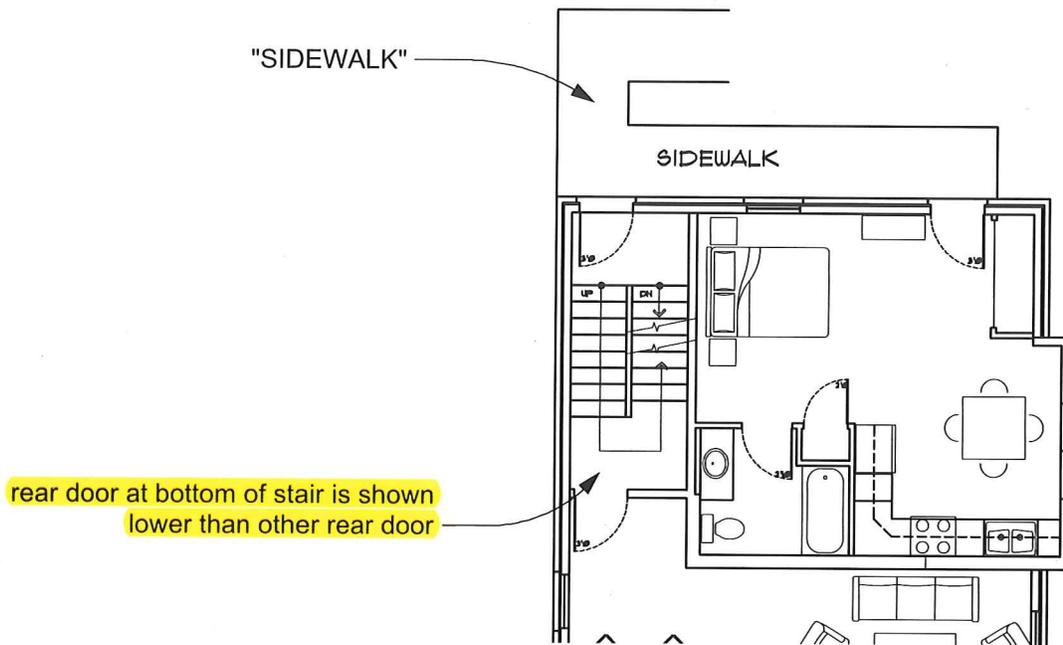
1 Submission Page 5  
801c

Plans submitted are contradictory, incomplete, and lack critical exterior dimensions. The fifth page shows a "sidewalk" that may in actuality be a ramp or stair with guardrails or a fire escape, and two doors appear to be at different levels. The fourth page does not show the "sidewalk"/ramp and shows the two doors at the same level. **A significant architectural element, the rear sidewalk/ramp/guardrail/fire exit is not shown clearly in any of the drawings.**

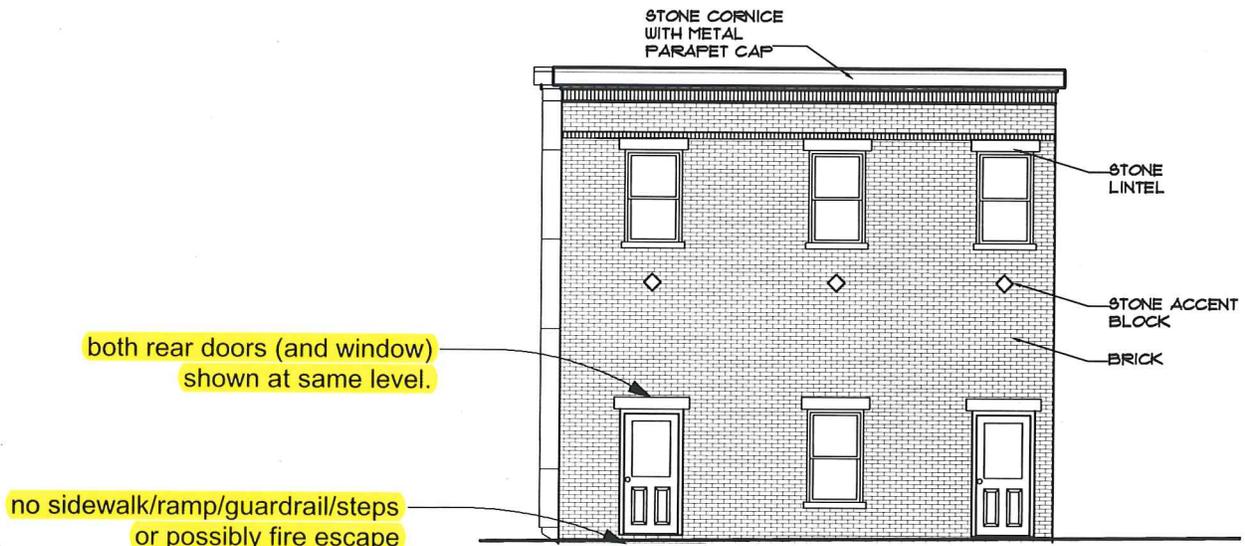
2 Submission Page 4  
801c

REAR (SOUTHEAST) ELEVATION
