Certificate of Appropriateness for 2127 Regent St

August 12, 2019

Proposed Work

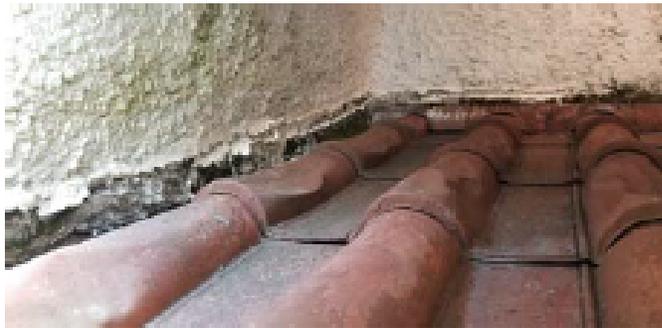
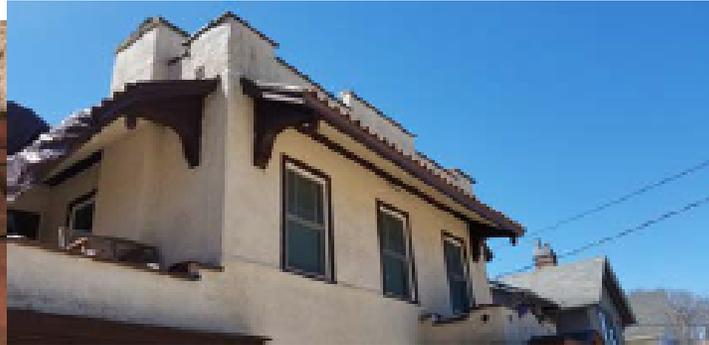
Figure 1. Our current roof, 2127 Regent Street, Madison WI 53726. Left is a zoomed in view of the region of our home that is leaking. At right, a street view of the overhangs on our home where the new roof will go.

- Replace existing tile roofing with another tile roofing product

- Constructed in 1923
- Mediterranean style
- Existing tile roofing is metal to replicate clay tile appearance

Staff believes that the standards for granting a Certificate of Appropriateness could be met and recommends that the Landmarks Commission approve the project with the following conditions:

1. Explore repairing areas of failed roofing with limited replacement of failed tiles
2. Replace roofing with a tile that replicates the original design, to be approved by staff

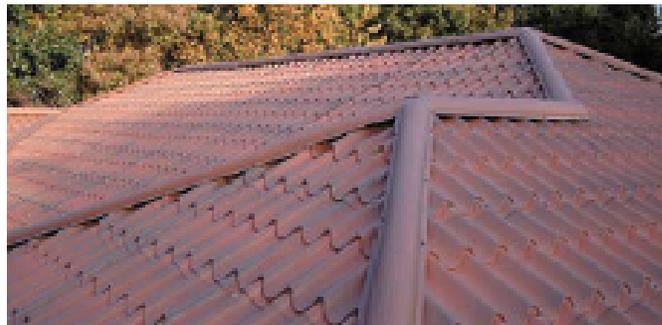
Figure 2. The roofing product we have contracted Metal Roofing Systems to install (sample home from vendor website). It is made by “Classic Metal Roofing Systems”
