Park Drake Blight Study - Proposed Redevelopment District

February 14, 2013

City of Madison,
Wisconsin

PREPARED BY MSA PROFESSIONAL SERVICES, INC.

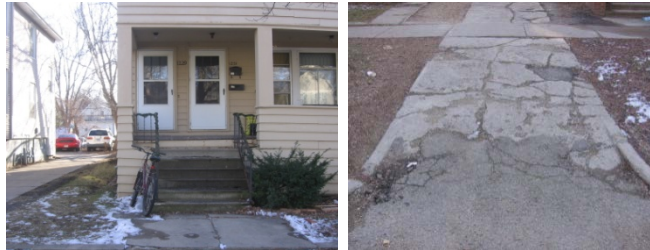
Dirty and stained siding, damaged shingles, chipped paint on fascia, two story porch not level with unfinished wood, poorly patched chimney, front steps cracked and pieces missing, column on garage leaning, and driveway is severely cracked, heaving and poorly patched.

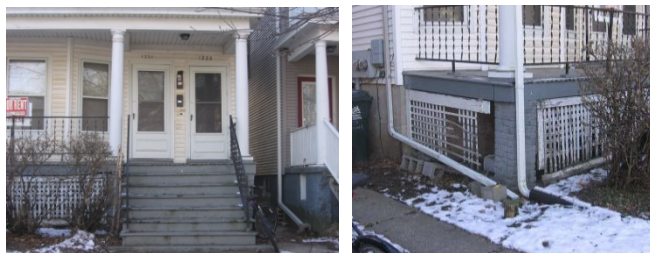
Parcel 45

Chipped paint on fascia, front porch boards decaying, broken lattice, rear porch missing lattice, mold on front stairs, garage doors have gap, walk is cracked and heaving enough to create a trip hazard.

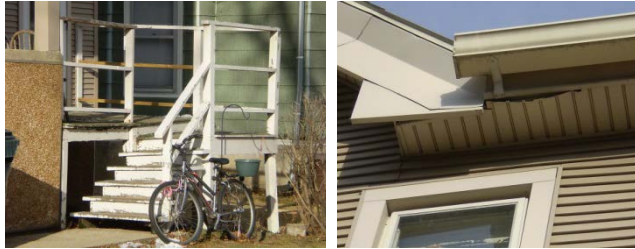
Score: 57.4

Soffits separated in places, vinyl fascia is ripped exposing wood; front overhang poorly installed; back porch sagging and leaning with chipping paint and unfinished wood; garage roof damaged and moldy and missing doors; driveway is uneven and asphalt is faded; rusting mailboxes; debris scattered around garage

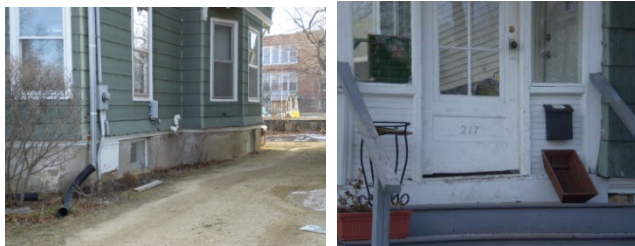
Parcel 115

Score: 46.7

Foundation resurfaced with poor patch work; chunks missing from siding; floor sloping in sun porch; gutters separating from fascia; wood stairs worn and dirty; concrete stairs missing pieces; driveway has large ruts and potholes; debris scattered around house

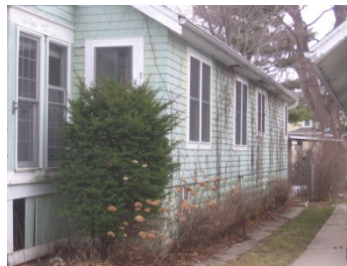
Score: 53.2

Fascia paint chipping, flashing above gutters rusted; piece missing at base of window trim; porch skirt broken, missing pieces, and signs of rot; porch roof sloping; front stairs stained; rusted poles in car port; chipping paint on garage doors; missing window in garage; sidewalk is dirty and heaving; vines covering sides of house

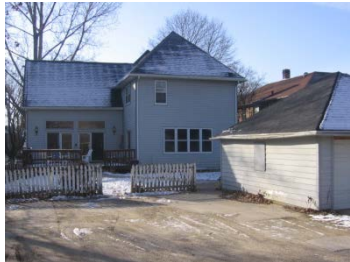
Parcel 170

Score: 59.9

Left side foundation cracked and flaking; window frames chipped paint; stain on porch is wearing off; gutters stained, twisted and dented; chimney brick is separating and missing mortar; vent damaged; wood stairs sagging; garage sagging roof, chipping paint, gutters falling off; ruts in gravel driveway; debris

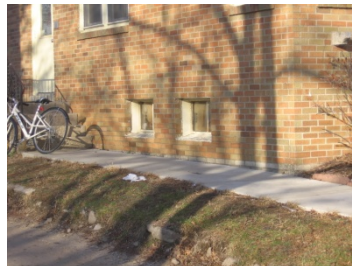
Parcel 274

Score: 42.2

Brick is stained near chimney; roof is discolored; windows chipped paint and paint on glass; basement windows have rust stains and sills have chipping paint; front overhang discolored; side balcony floor flashing peeling up; concrete stairs have chunks missing and exposed aggregate; garbage cans in front yard; garage roof damaged and heavy patchwork; gravel ruts forming; duct taped "For Rent" sign

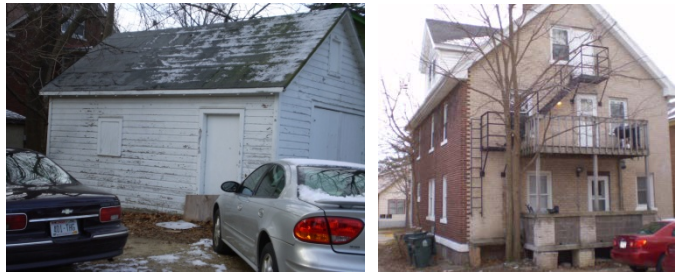
Parcel 176

Score: 42.9

Foundation is dirty and has minor cracking; brick siding has some mismatched colors, efflorescence, mortar patchwork; roof shingles faded, flashing paint chipped; porches have chipping paint; back porch columns have loose/broken bricks, leaning, balcony has unfinished wood; concrete steps have cracks; cheek walls have separating brick; garage has chipping paint, roof damaged, mold

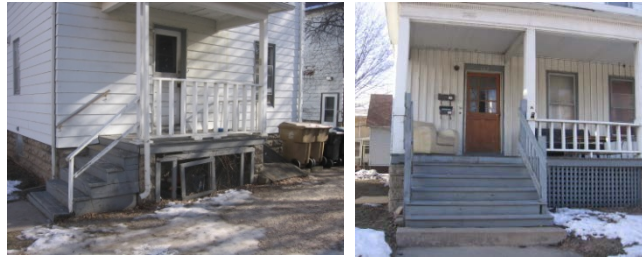
Score: 58.9

Foundation is discolored with aggregate showing; siding has areas that are quite dirty; roof eave fascia is missing on side; eave soffit panels are dirty and some loose; paint worn on windows trim and frames; sections of screening missing; floor boards worn, chipping paint; chipping paint on stairs and railings; dirt lawn areas, shrub stumps along foundation; indoor furniture on porch

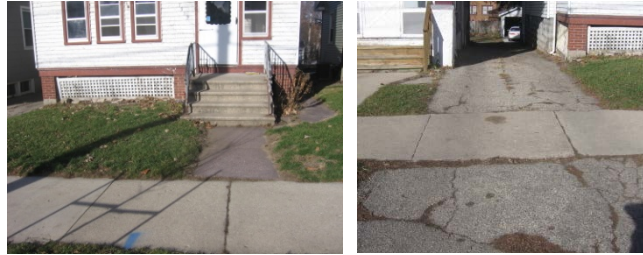
Score: 56.7

Foundation is dirty and moldy, siding is dirty; lower roof is sagging, faded with a few peeling shingles; window trim is faded; basement windows dirty; porch lattice skirt is broken, chipping paint; chimney is dirty with some mortar patchwork and dented flashing; concrete stairs dirty with rust stains; asphalt drive cracked, exposed aggregate; remnant vines on house

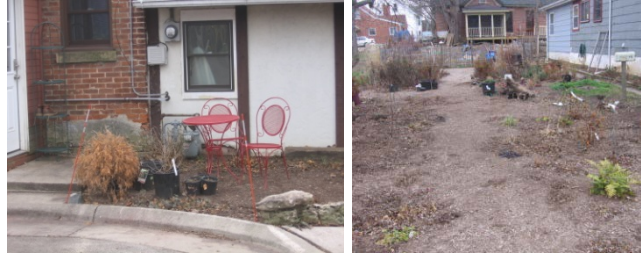
Score: 59.2

Brick is dirty and stained with mortar patchwork, siding is chipping paint; roof shingles mismatched; chimney is molding and stained; fence on side is leaning and unfinished wood; garbage cans in front yard, bare dirt, weeds in planting beds, piles of materials and outside storage

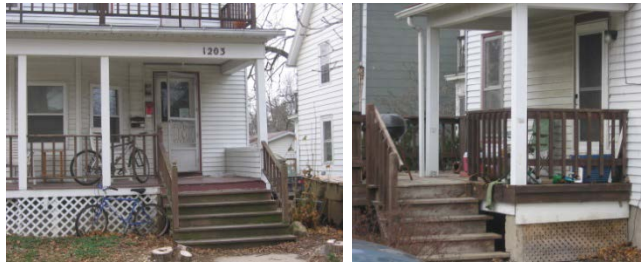
Parcel 265

Score: 57.3

Foundation is dirty and uneven; cladding very dirty; windows dirty with chipping paint on frames; porch and balcony sagging, chipping paint, moldy; gutters sagging in places and dirty; chimney missing chunks; front storm door is missing closer; mismatch mailboxes, debris on roof, weeds and bare spots, remnant tree trunks

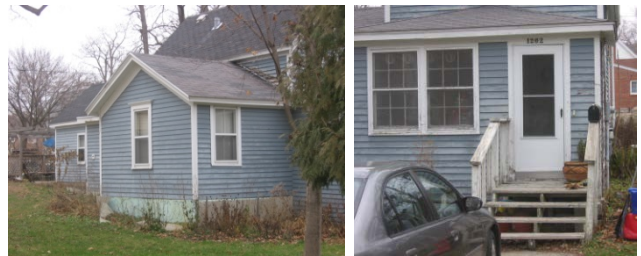
Parcel 282

Score: 54.2

Foundation poorly resurfaced, insulation visible; significant discoloration and chipping paint on siding, signs of rot along roof line; mismatched patchwork on roof; chipping paint on most window trim; stairs have chipping paint; significant cracks in concrete drive; bare spots and weeds in lawn

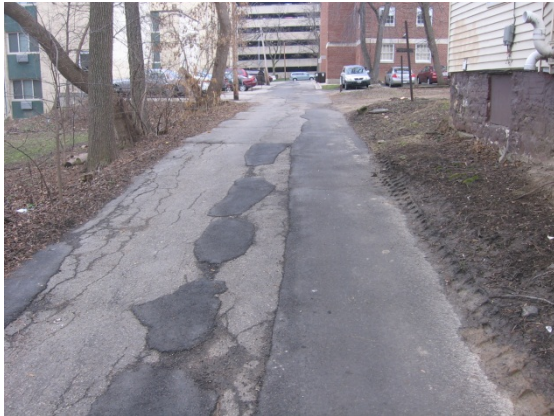
Asphalt problems in Sections B Alley
(poor condition)

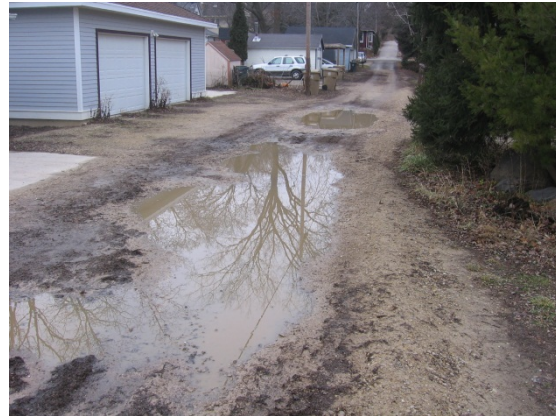
Water pooling issues in Section G Alley
(poor condition)

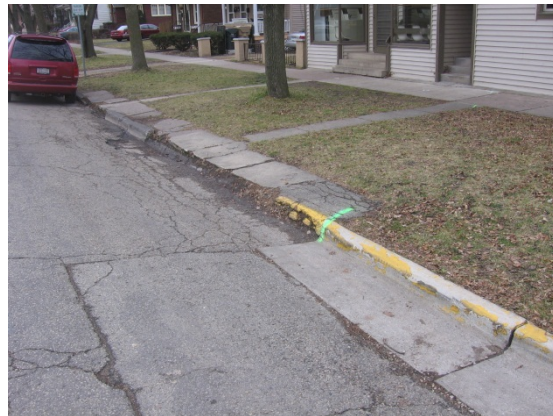
Mound between Orchard and Randall
(curb and road in poor condition)
