Ruhaak-Smead Residence
 150 N. Prospect
 Madison, Wisconsin

Proposed Alterations to Facade Openings
 (See attached elevational sketches for further info.)

ELEVATIONS OF PROPOSED WINDOW ALTERATIONS

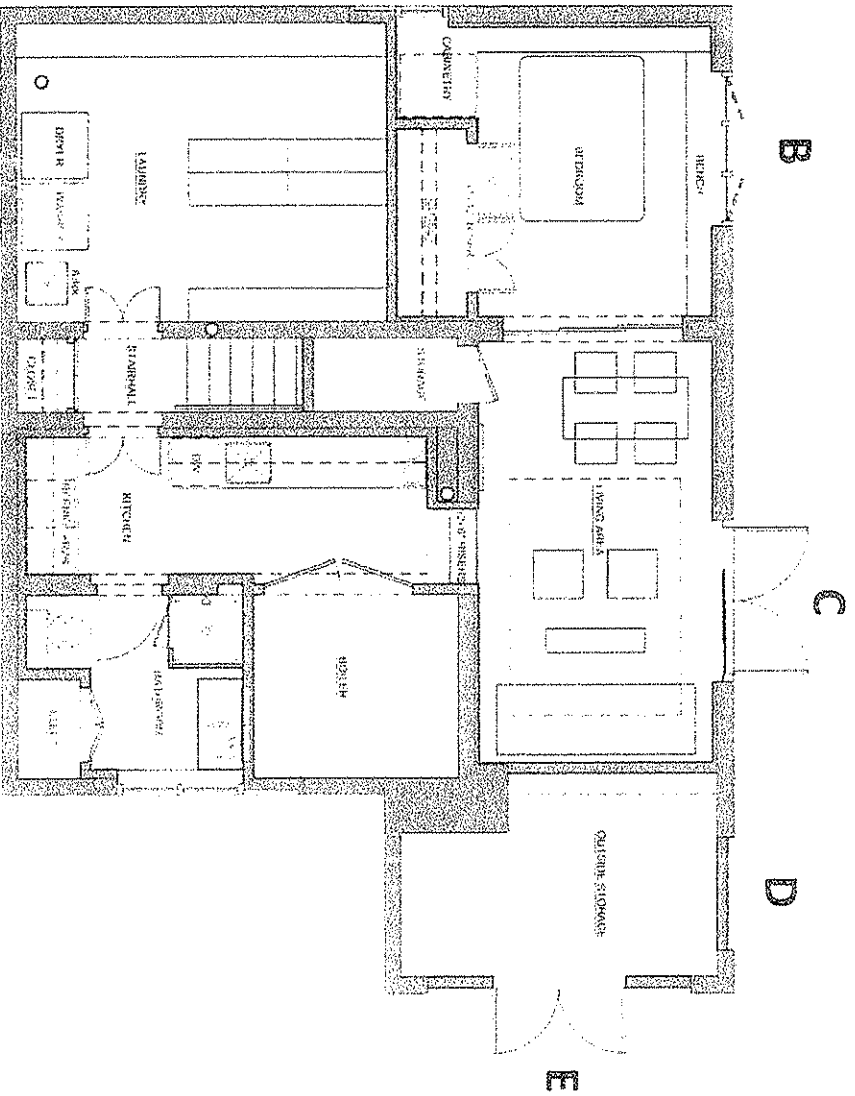
KEY PLAN (north up)
Scale: 1/8" = 1'-0"

- B:** No change to existing brick opening. Existing window/door assembly will be removed and replaced with existing window assembly from Opening "C".
- C:** Brick sill will be lowered to floor level. Existing window assembly will be replaced with new pair of doors incorporating salvaged leaded glass panels from Opening "B".
- D:** No change to existing brick opening. Opening will be infilled with board & batten per sketch.
- E:** No change to existing brick opening. Opening will be infilled with a pair of stile/rail doors and board/batten.

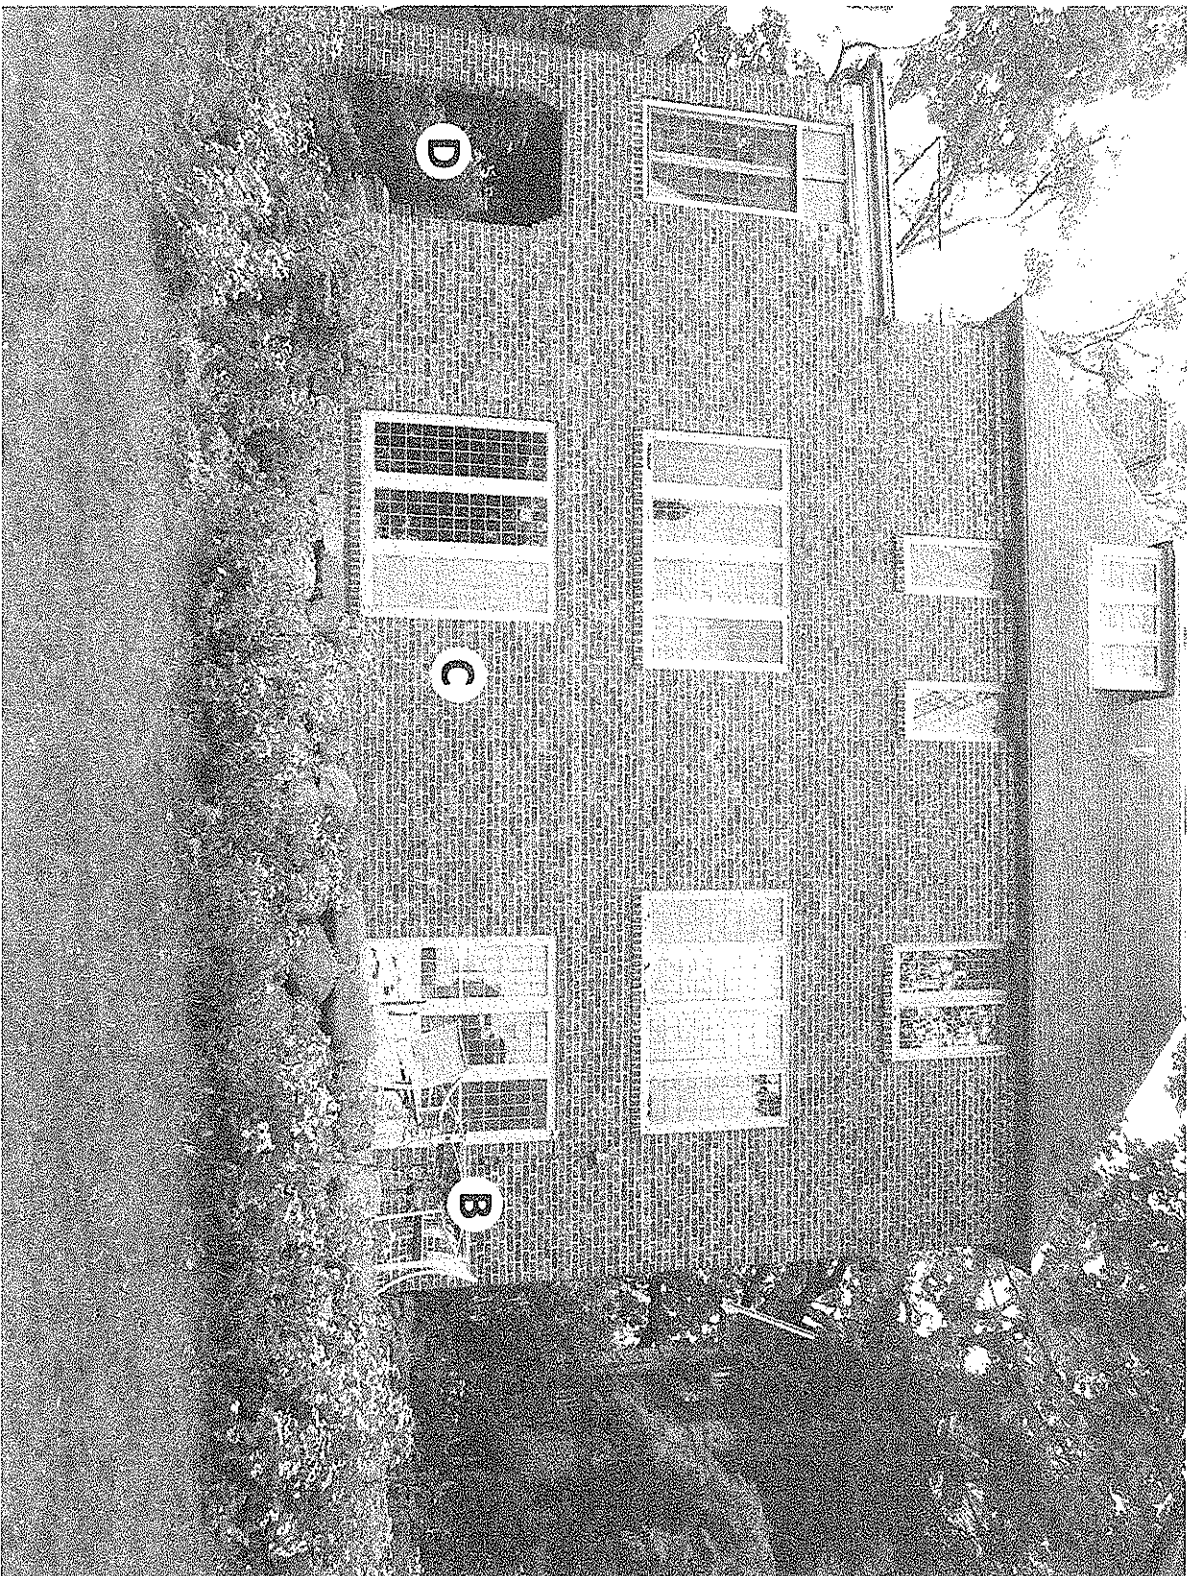
NORTH (REAR) ELEVATION OF HOME

Proposed Alterations to Facade:

Window Opening "B":
Existing window unit to be removed and replaced with relocated window unit from "C". Repair to be operable and install interior insect screens. See attached sketch.

Window Opening "C":
Existing window unit to be removed and replaced with a newly-constructed pair of doors, incorporating salvaged window elements from "B". See attached sketch.

Carport Opening "D":
Infill existing opening with board/batten per attached sketch.

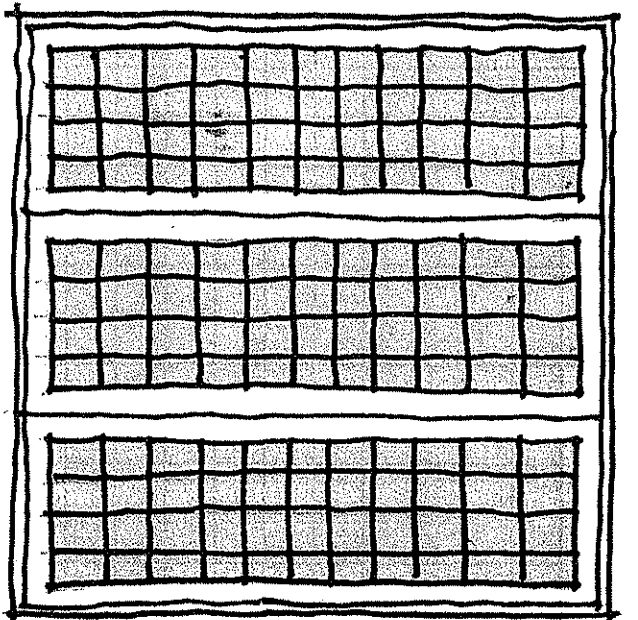
Opening B:

Remove existing door/window assembly.
Relocate existing window assembly from Opening "C".
Repair as needed to make operable.
Install interior insect screens.

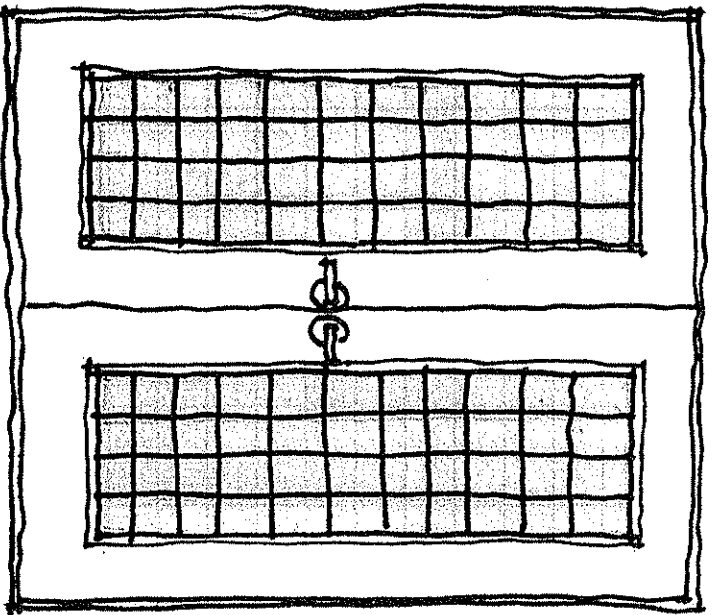
Opening C:

Remove existing window assembly

Replace with two new outswinging doors incorporating two salvaged glass panels from Opening "B".

Install interior sliding insect screens.

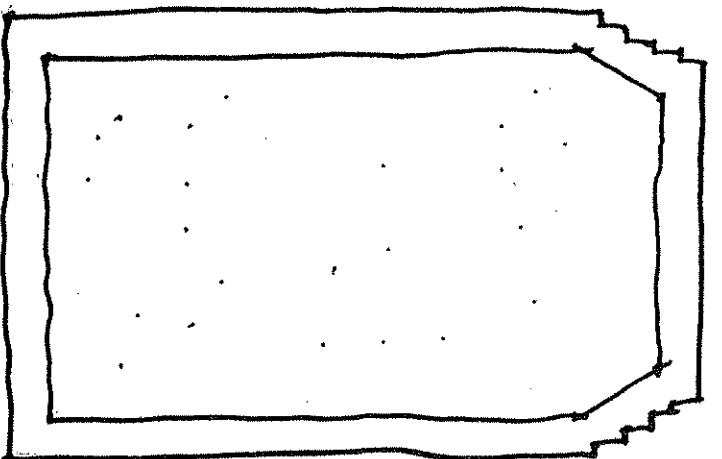
Opening D:

Infill existing opening with 2x4 stud wall.

Insulate cavity and face with smooth-face concrete panel for paint (Hardie-panel or similar). Trim with 1x cedar trim. Paint.

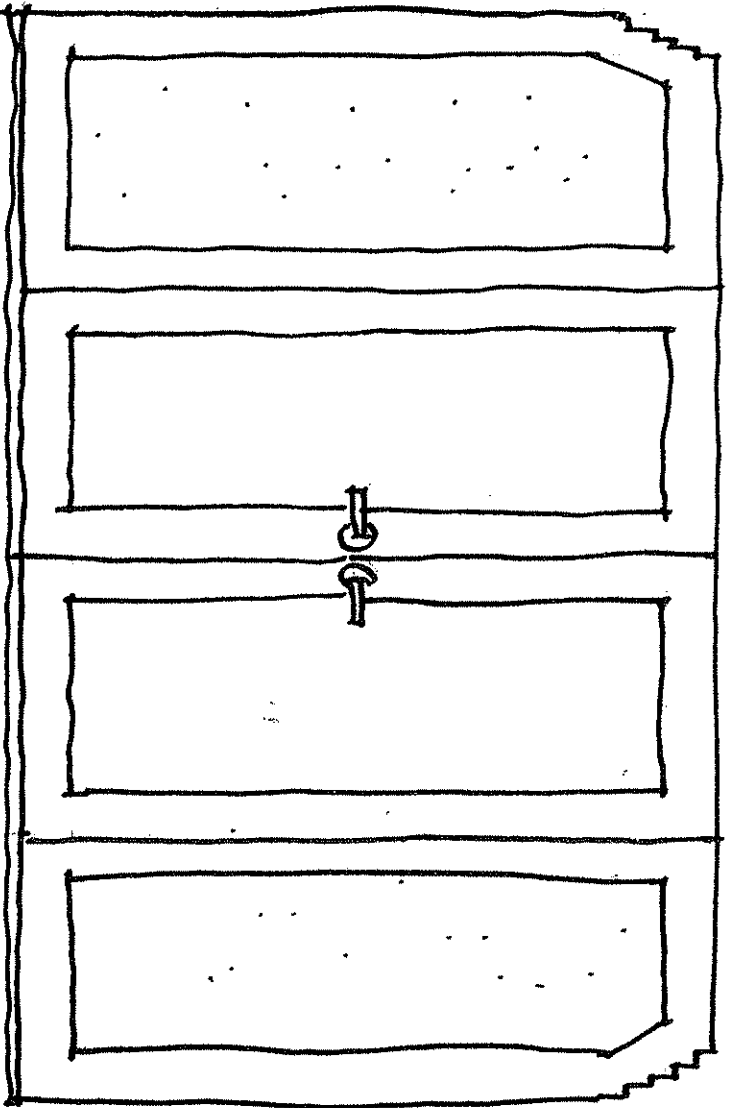
Opening E:

Infill existing opening with 2x4 stud wall, incorporating double outswing stile-and-rail doors. Insulate and face stud wall with smooth-face concrete panel for paint (Hardie-panel or similar). Trim with 1x cedar trim for paint.

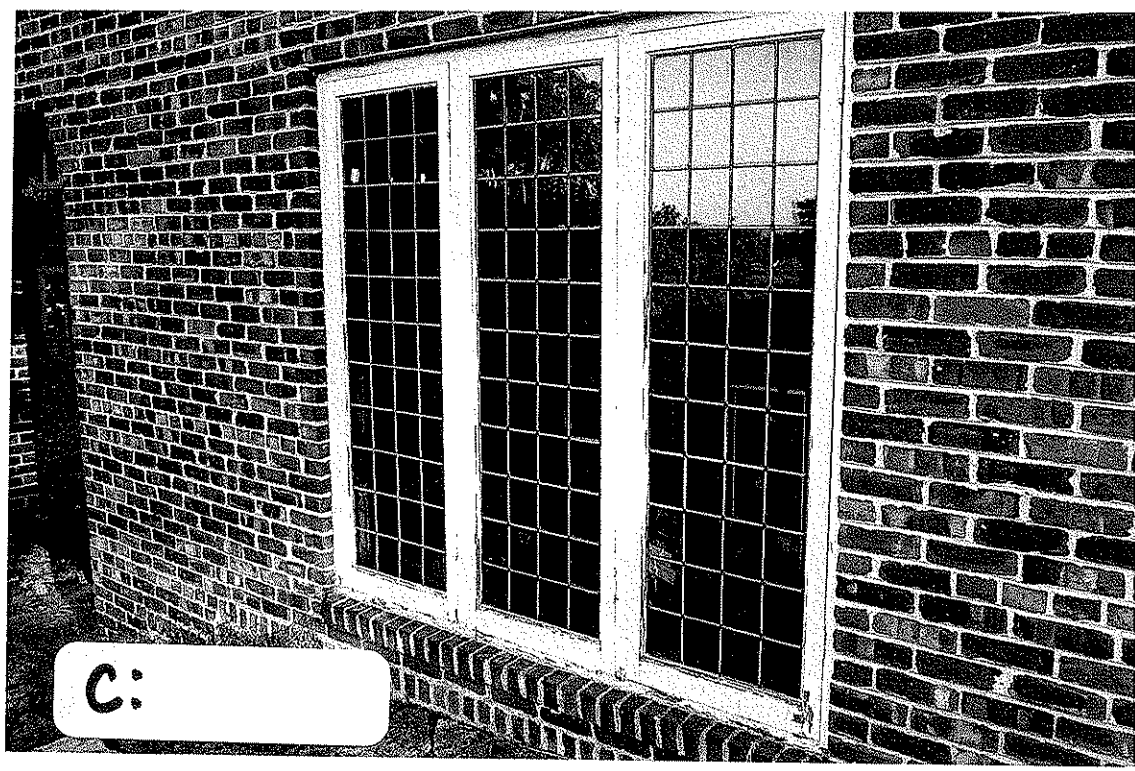
- The current walkout basement and garage are going to be made into a new living area.
- The windows that are on the basement level are original.
- The condition of the windows are as follows:
 - The windows were never made to be opened
 - They have no storms
 - The sills are quite rotted
 - Some of the glass is broken
 - There are many old patches to fill in rotted areas
- Exit door center section of B:
 - The center section of B opens but is not wide enough to be up to code
 - The "lock" is a tiny old latch
 - For security and safety a new door needs to be made

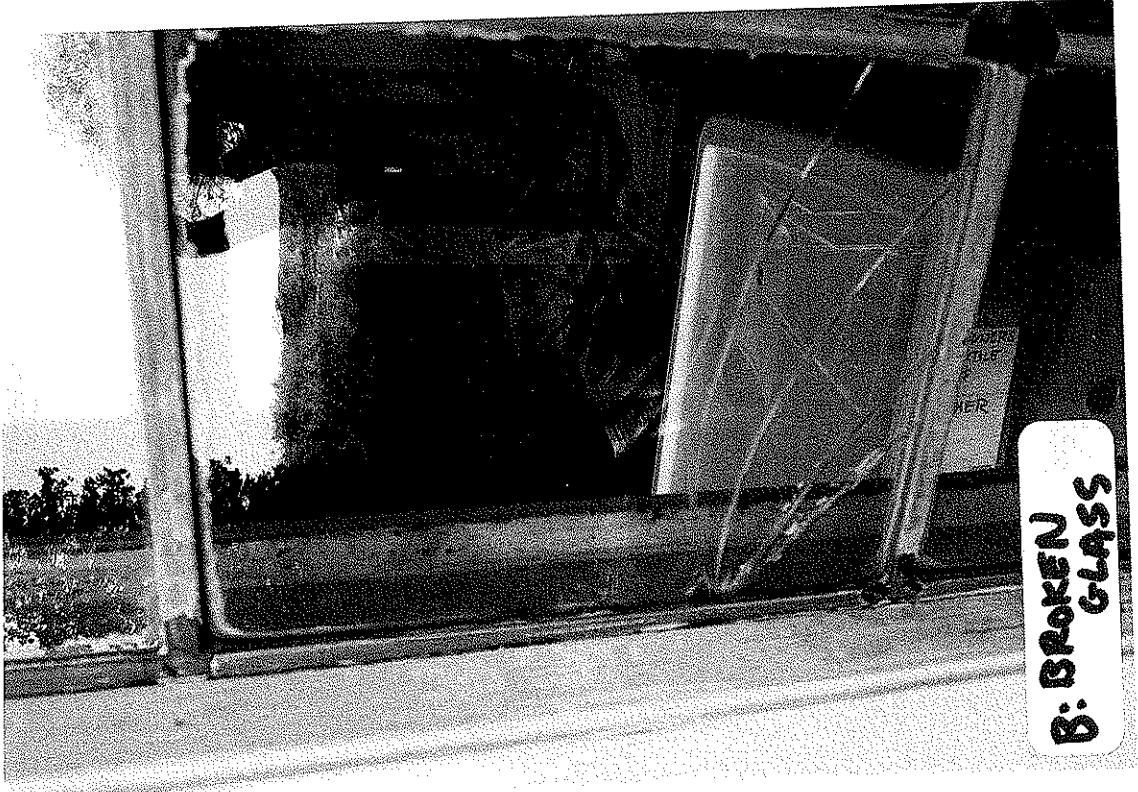
**B: BROKEN
GLASS**

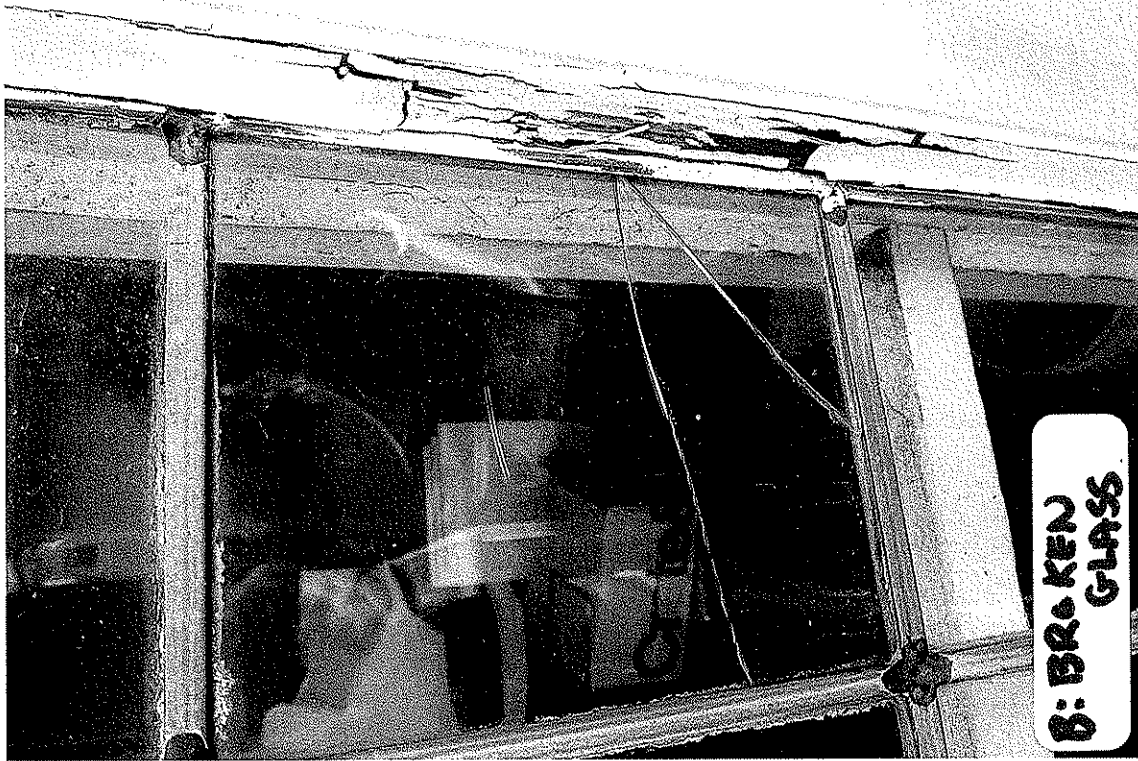
**B: BROKEN
GLASS**

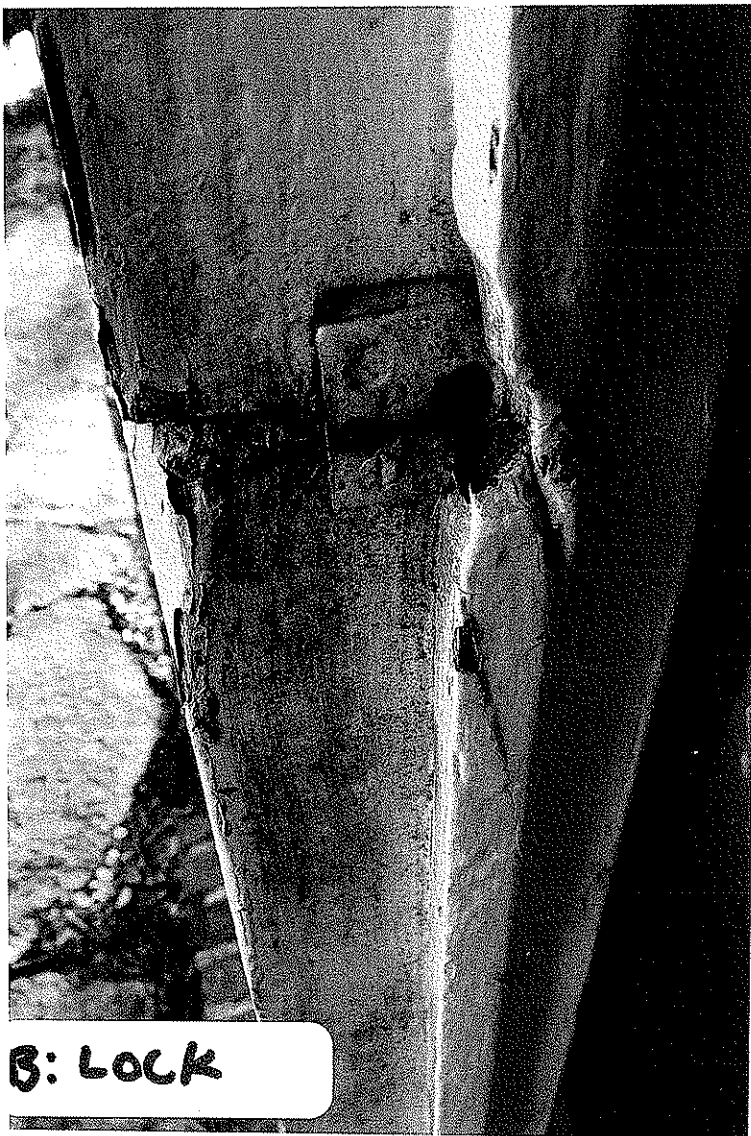
B: LOCK

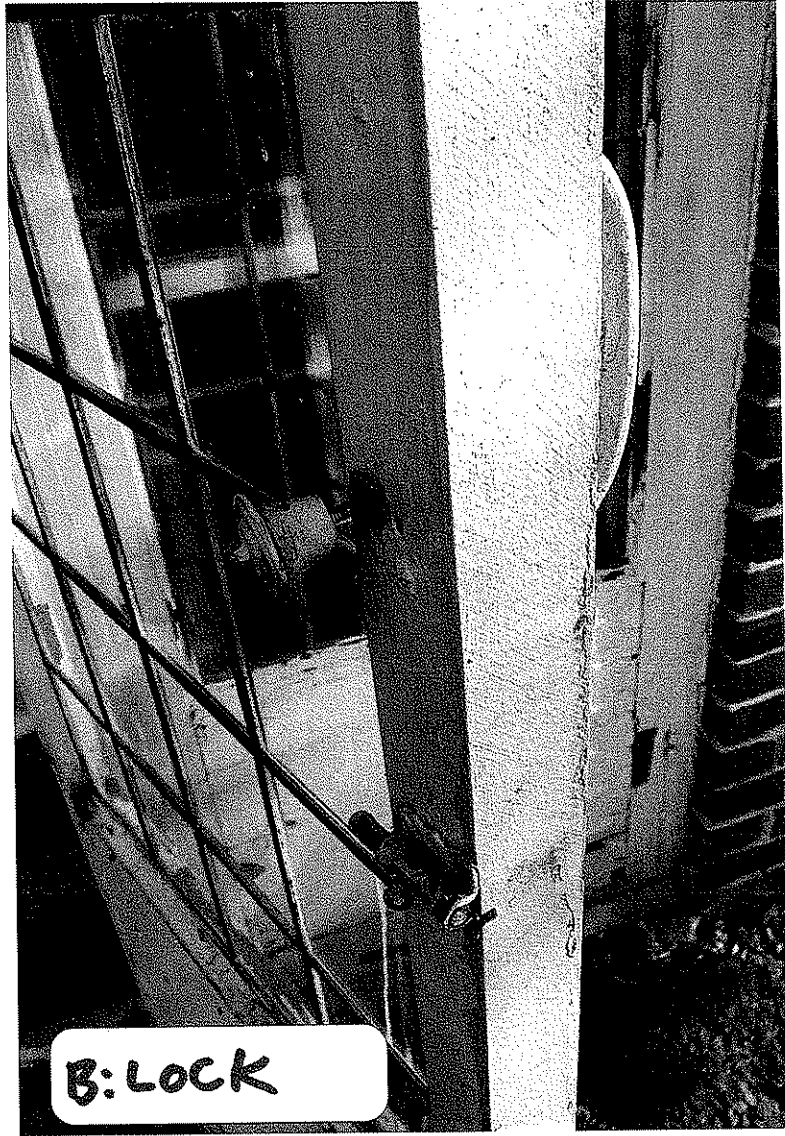
B: LOCK
