2022 Pennsylvania Avenue (TID 53) Blight Study

Madison, WI

Prepared by MSA Professional Services, Inc.
January 23, 2023

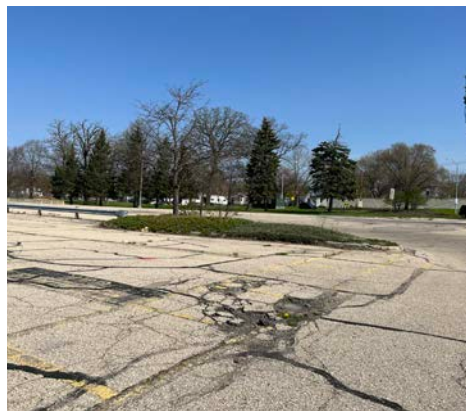
Score: 54.9

Lot is underutilized; chainlink fencing: bent metal sections, barbed wire bent in areas, minor discoloration; light poles: rusted, paint chipping on base; signs: faded, discolored; lot: tarred cracks, settling, crumbling, parking lines faded; weeds; overgrown landscaping; closed ERP site; evidence of water pooling.

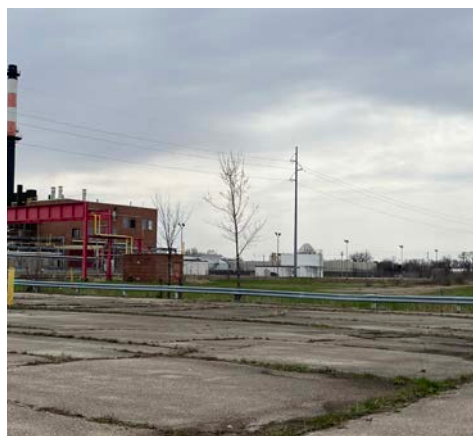
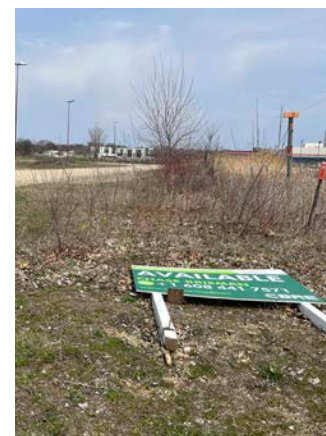
Parcel 4

Score: 15.9

Lot is underutilized; no screening for dumpsters; signage collapsed; lightpoles extremely rusted/discolored; lots: cracked; gravel lot area: low levels of gravel (mostly dirt/weeds); aggregate showing throughout; no maintenance of landscaping/yard; faded parking stalls; parking barriers rusted/bent/missing; gate warped and rusted; trash in lots; graffiti on accessory structure; dead landscaping; 2 Open ERP and 1 Conditionally Closed LUST sites; evidence of pooling water.

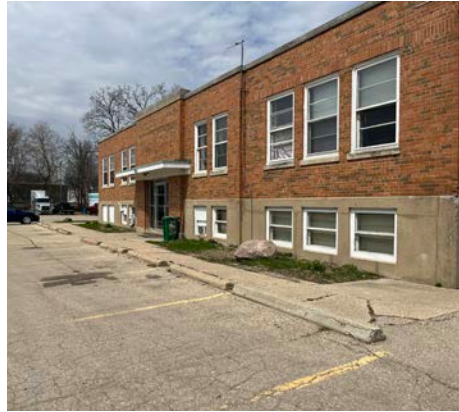
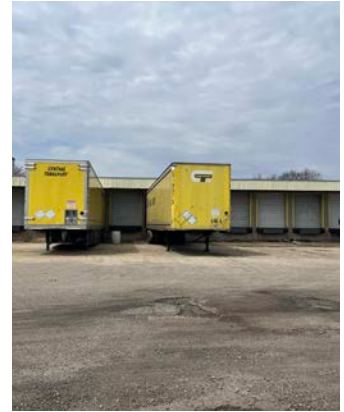
Parcel 16

Score: 44.4

Discoloration of bricks and parapit caps; minor crumbling on corner; windows: boarded up, sills discoloration; front overhang bent; side overhang missing flashing; chimney poor condition (cap discolored, paint wearing); garage door discolored/dirty; southern structure: discolored walls, cracks/crumbling in concrete block, discolored roof coping; dumpsters not screened,; southern structure: storage unit rusted, collapsed; lightpoles: worn/discolored; shop sign worn/fallen; lot: cracked, crumbling, patchwork, worn; curbing: worn/chipped; walk: cracked, aggregate showing.

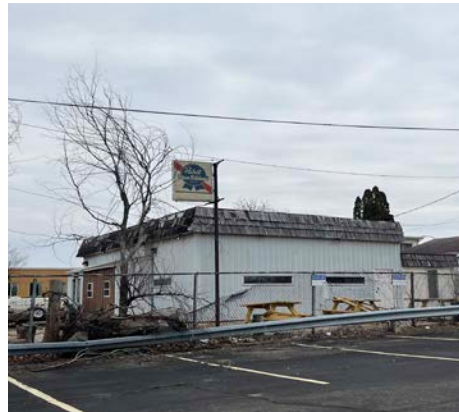
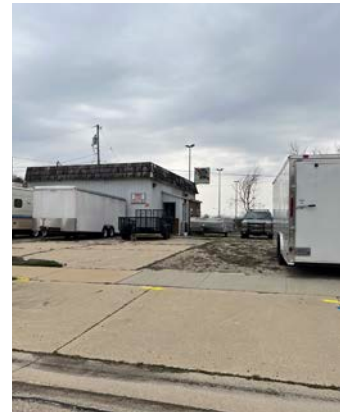
Parcel 20

Score: 34.6

Not preferred land use or size; vacant; siding: stained, cracked; shingles: worn, dirty, missing; roof sagging; gutters: rusted, missing downspout; chimney rusted; fence: rusted, sagging, broken; trash/recycling carts unscreened; sign faded; lighting: discolored, missing; asphalt: cracked/crumbling, uneven settling; curbing crumbling.

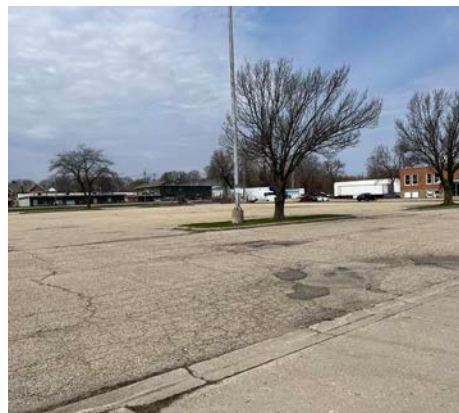
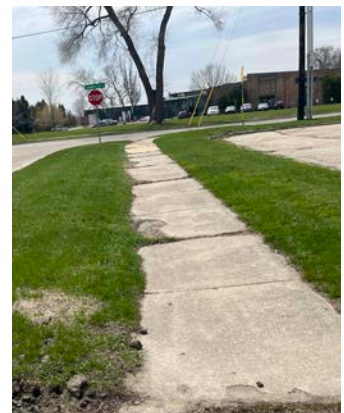
Parcel 24

Score: 59.7

Light pole: discolored and rusted sections; cracking/crumbling throughout parking lot, curbing crumbling; sidewalk aggregate showing (but not all sections); weeds growing in cracked sidewalk expansion joints; debris in parking lot gutters, evidence of water pooling.

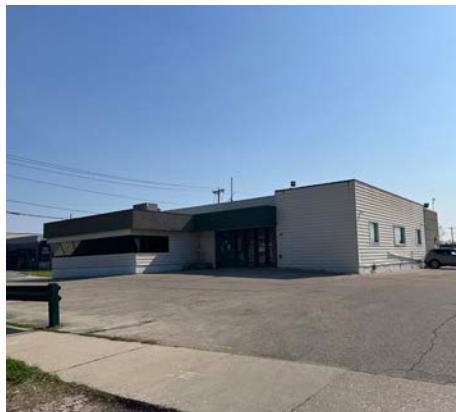
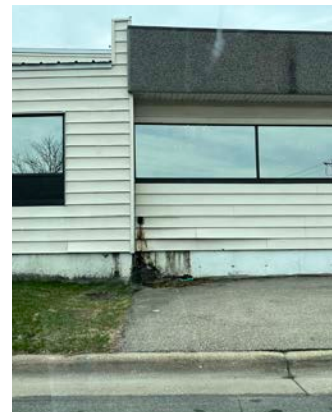
Parcel 25

Score: 54.1

Not preferred land use; foundation: small cracks and paint wearing off, discoloration/staining; crumbling; siding: dirty, discoloration, rust, bent/wavy along base on side; metal coping: rusting (south side); overhang dented; downspout missing north side of building; stairs: stained concrete from rusted railing, crack running along base of ramp; door: rusted, discoloration on rear door; dumpsters unscreened; drive cracking; aggregate showing throughout sidewalk.

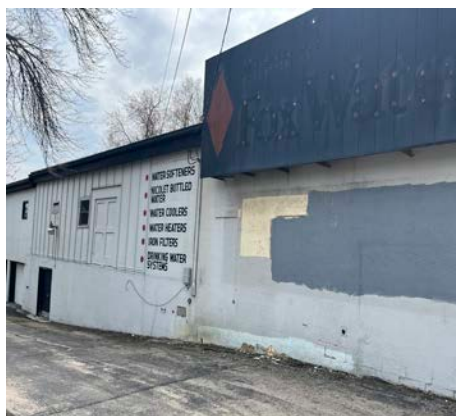
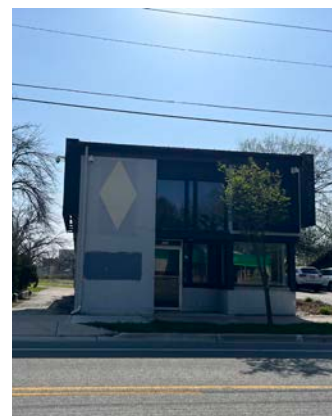
Parcel 28

Score: 44.7

Vacant; siding: discolored, peeling, cracked, chipped, worn; side door: frame bent/broken, paint chipping; side garage door: paint chipping, bent; shed: door broken, wood is worn; screening for dumpsters missing; signing: removed, worn and chipped/not repaired; parking lot: crumbling, cracks, worn.

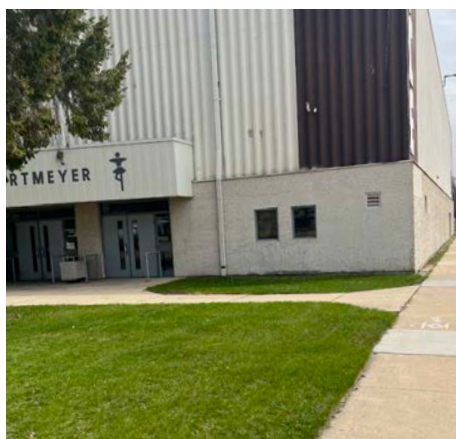
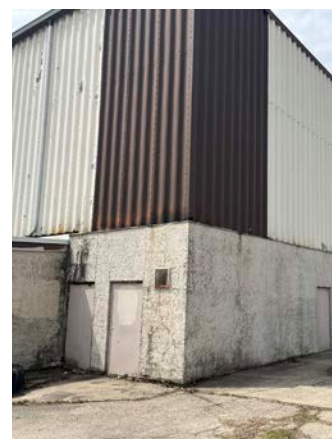
Parcel 29

Score: 59.7

Not preferred land use; siding: discolored, paint chipping, rust; rear garage missing cladding; stucco damaged in many places; rear doors/side doors: discolored, painted over, paint chipping, poor material for infill of doors; fencing in back bent/rusted; dumpsters unscreened; no parking sign on side door: faded, off-centered sign posts; parking lot: aggregate showing, curb crumbling; rear parking: cracks; walkway: discolored, cracks, dirt.

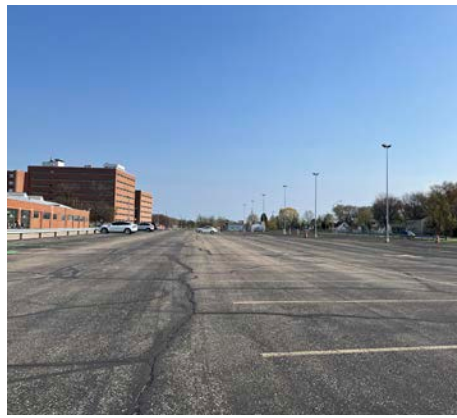
Parcel 39

Score: 54.7

Lot is underutilized; light poles: rusting; lot: tarred cracks, faded parking lines, some settling; missing sidewalk sections; weeds in cracks of lot; safety barrier bent/broken in places.

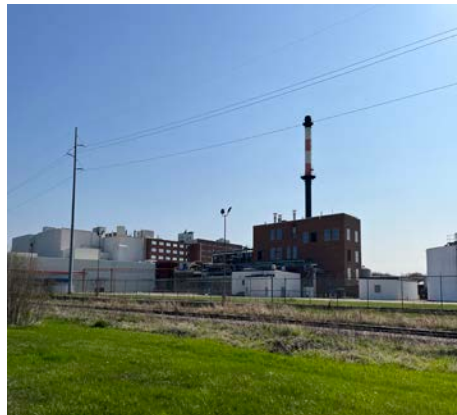
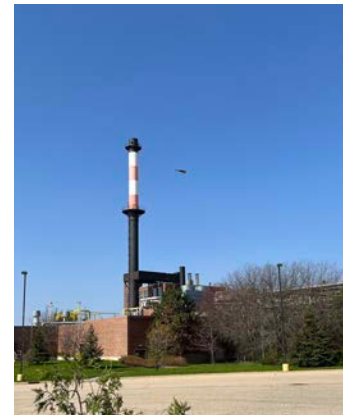
Parcel 47

Score: 50.5

Vacant; siding: bricks in worn condition, rust, poor patchwork; windows: boarded up, worn, some missing; large chimney: paint chipping, worn; south east structure: bricks worn, paint chipping on tank; entrance sign removed, parking signs crooked, light pole base rusting; tarred cracks, crumbling, rusting, sidewalk: aggregate showing; weeds; fountain not working; overgrown landscaping; debris and pipes lying around; contaminated sites: 3 Open ERP, Close LUST w/ continuing obligations; Closed ERP; evidence of water pooling.

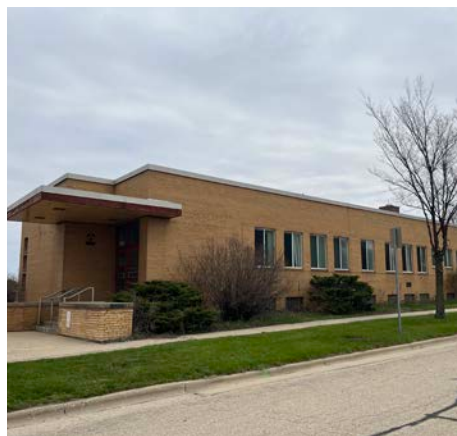
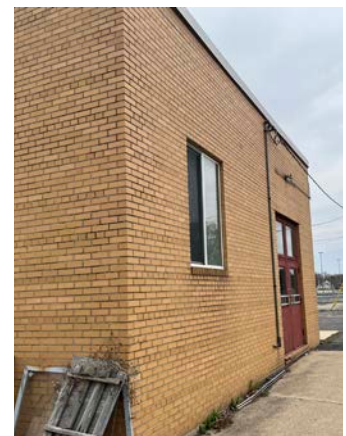
Parcel 53

Score: 38.9

Not preferred land use; vacant; siding: patched, mortar missing, discolored, paint chipping; glass block: stained, dirty; overhang: discoloration; vents: rusted, paint peeling; chimney: eroding bricks, discolored concrete cap; stairs: cracked, minor crumbling, discolored; garbage screening missing; signs faded/word; sign removed; lighting discolored; parking lot: cracked, potholes, back walk: settling, cracked; weeds growing in lot cracks, basement window wells misaligned, overgrown landscaping; brick halfwall: missing mortar, bricks loose, discolored and aggregate showing from concrete cap; trash; not ADA compliant.

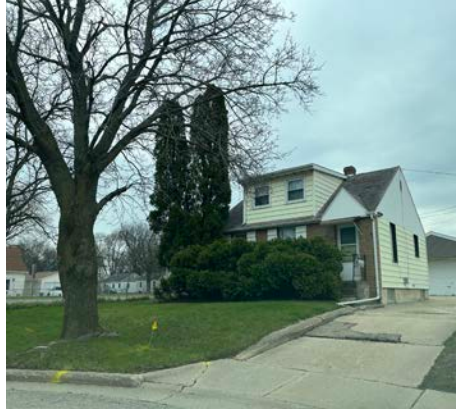
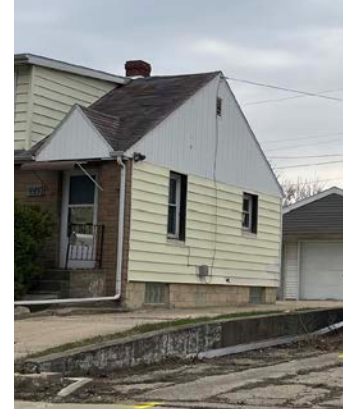
Parcel 59

Score: 53.0

Not preferred land use; foundation: stained, discolored; poor siding matching; roof: worn, discolored, some shingles missing; awning: worn; chimney: discolored; rusted attic vent; stairs: discolored, cracked, railing bent, major settling issues; detached garage: worn shingles, garage door dirty w/ paint chipping at base; chainlink fence: bows with lack of horizontal pole support; driveway: uneven settling, patchwork, pitting, minor chipping; missing sidewalk; overgrown bushes; discolored retaining wall; surrounded by nonresidential uses and a high volume arterial street; surrounded by industrial uses; front steps to door: settling unevenly, obstructed by downspout pipe.

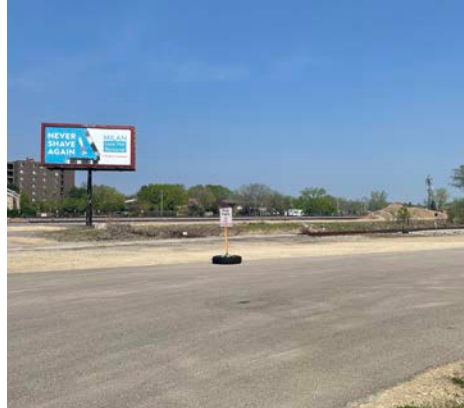
Score: 52.0

Lot underutilized; fencing: bent, sections peeled away; sidewalk: aggregate showing, missing along Fordem Ave; overall lack of maintenance; junk present; piles of dirt; graffiti on signal station; closed LUST site.

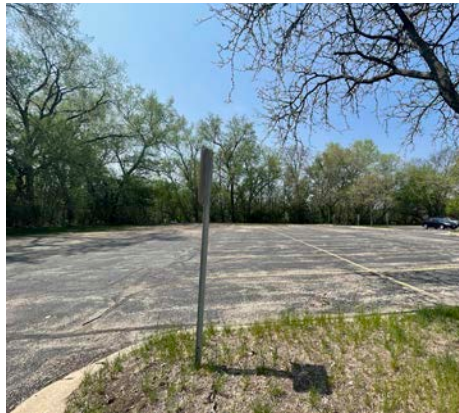
Parcel 7

Score: 49.7

Not preferred land use; lot underutilized; parking lot: tarred cracks, worn, lines faded, crumbling; patches of grass missing.

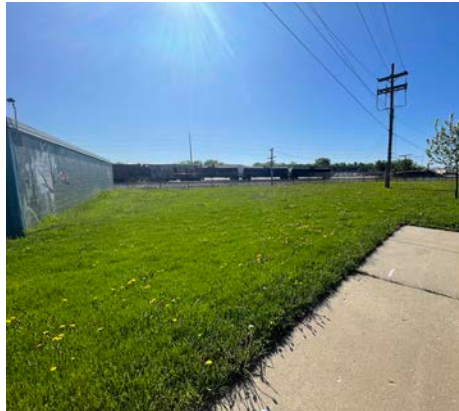
Parcel 38

Score: 39.0

Not preferred land use; limited developable area; missing sidewalk.

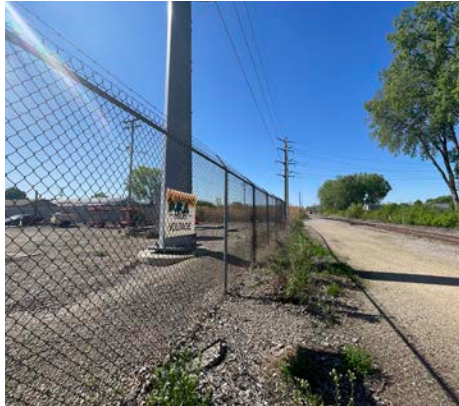
Parcel 42

Score: 49.4

Limited developable area; chain link fence: quite rusted, leaning/bent; parking: irregular levels of gravel; sidewalk discoloration; terrace is in poor condition; unmaintained areas; overgrown landscaping; graffiti; some debris; evidence of water pooling.

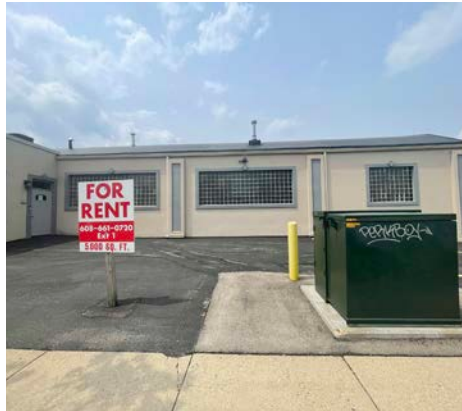
Score: 43.8

Not preferred land use; vacant; siding: dirty, some staining/discoloration in areas, dented; metal fascia: worn, dented, rusted; overhang: paint chipping, concrete crumbling/cracked/discolored; loading dock: rusting, crumbling; garage doors: paint chipping, dented; remnants of sign removal; lot: cracked, patchwork, wheel stoppers crumbling; sidewalk aggregate showing; trash present; graffiti.

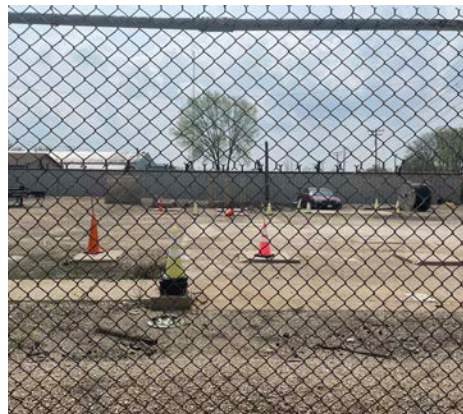
Parcel 6

Score: 54.4

Fencing: bent, rusted; warning sign has graffiti; drive: cracked, discolored, aggregate showing; parking not paved; sidewalk: cracked, aggregate showing throughout; weeds growing in lot; piles of trash in parcel; terrace eroded.

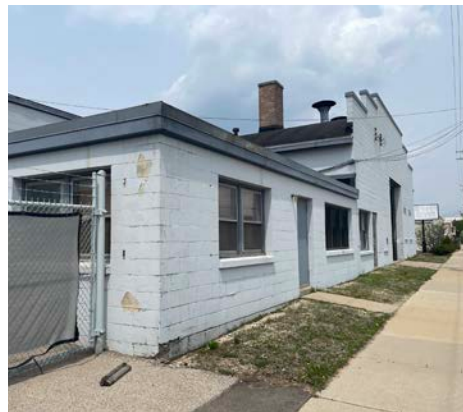
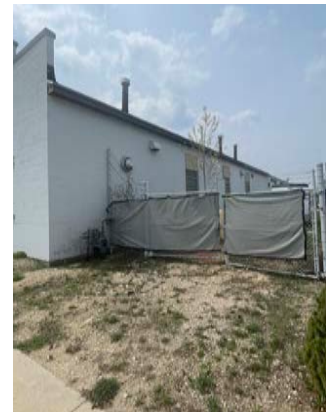
Parcel 8

Score: 55.7

Foundation: discoloration/staining; siding: dirty, some staining/discoloration in areas, paint peeling; metal fascia: dirty/stained, rusted, missing on the side; window frames paint chipping; old window sills chipped (window mostly filled in w/ CMU); main chimney: eroding brick, missing mortar, discolored, crumbling cap; rusted chimneys; dumpster screening worn; chainlink broken at bottom; light: missing shield; drive: cracking; walk: aggregate showing; trash present; no landscaping in terrace; graffiti; only accessible through garage.

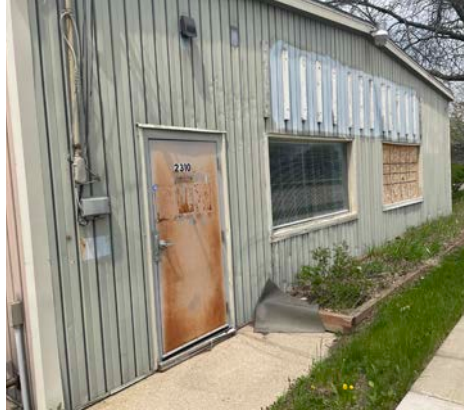
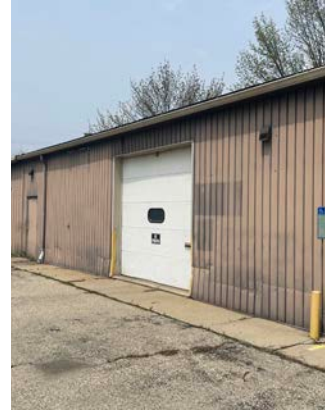
Parcel 9

Score: 34.3

Vacant; stained, rusted, dented, sagging; front window: frames chipping, boarded up; downspouts: rusted, mismatch materials/colors; vents: rusted, painted; garage doors: dented/discolored; front door: worn paint, chipped, discolored; trash bins not screened; former signage poorly painted over; lot: cracked; patchwork, worn; sidewalk aggregate showing; overgrown landscaping, rusted gas line, weeds; downspouts empty into drive; water pools near front door.

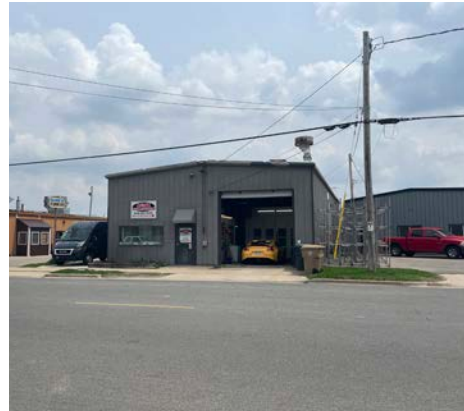
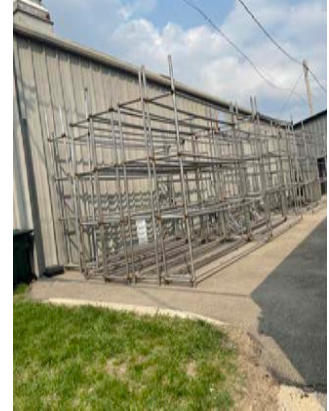
Parcel 12

Score: 55.6

Siding: dirty, some staining/discoloration in areas, portions of wall paneling bent; window frames worn/bent; gutter: flashing along the top bent, discolored; vents and chimneys rusted; front door: discolored, paint worn; garage discoloration/denting near bottom; trash bins not screened; light cracking in lot; front curb: some missing, crumbling; sidewalk aggregate showing and missing; overgrown landscaping; equipment sitting in lot; terrace eroded; evidence of water pooling.

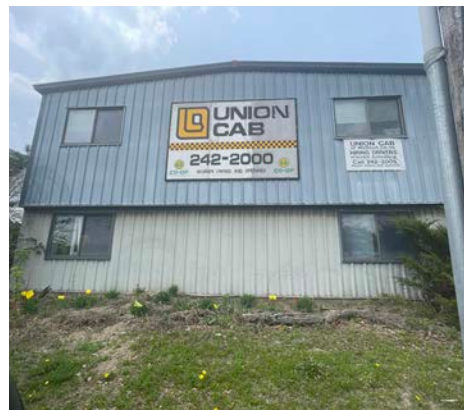
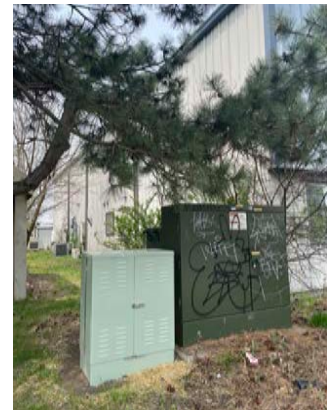
Parcel 26

Score: 53.9

Foundation aggregate showing; siding: dirty, discolored, bent; window: frames worn/bent; fueling canopy posts rusting; downspouts: stained, dented; side door: discolored, dented; garage doors: stained, some dents; dumpster screening missing; signage worn; lot: cracked, aggregate showing, faded parking lines; sidewalk: crumbling, aggregate showing, some missing; bench in poor condition; leaning stop sign; unmaintained landscape; graffiti; Conditionally Closed ERP site.

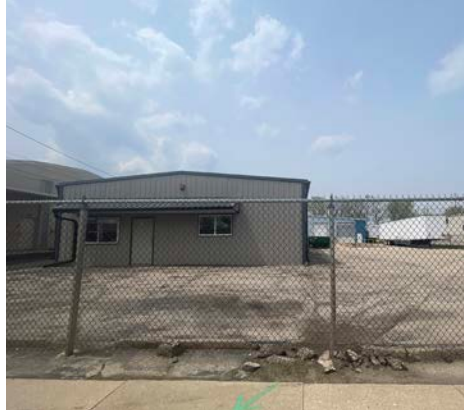
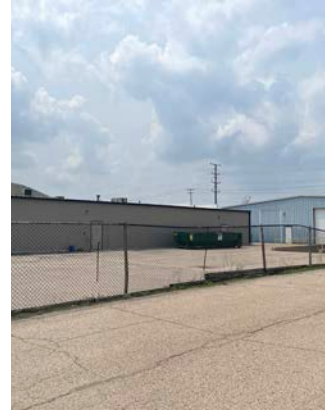
Parcel 34

Score: 55.9

Vacant; vent: rusted; chimney: rusted; side door: discolored, removal of sign; rusted loading dock; fencing: rusted, bent missing horizontal support poles, dumpster not screened; lighting discolored; lot: cracks, worn, crumbling; sidewalk: aggregate showing, discolored; weeds along fence, junk scattered around structure; broken asphalt piled along fence; water pooling in driveway; stormwater runs into sidewalk.

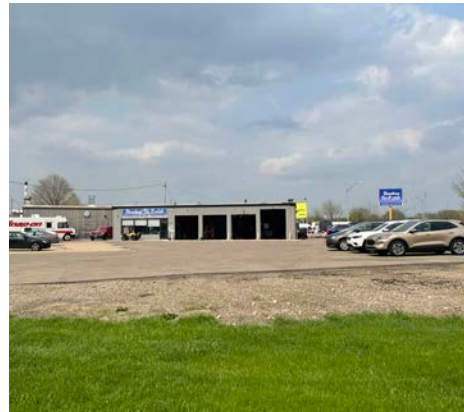
Parcel 40

Score: 56.8

Siding: dirty, some staining/discoloration in areas, dented; roof: some discoloration/staining; most of the vents are rusted; no dumpster screening; lot: crumbling, cracks, gravel lot in south corner; sidewalk: aggregate showing, some sections missing; rusted metal bollards; large areas near pavement just gravel not grass; pile of tires; graffiti; Conditionally Closed ERP site; water pooling in drive/lot; terrace eroded.

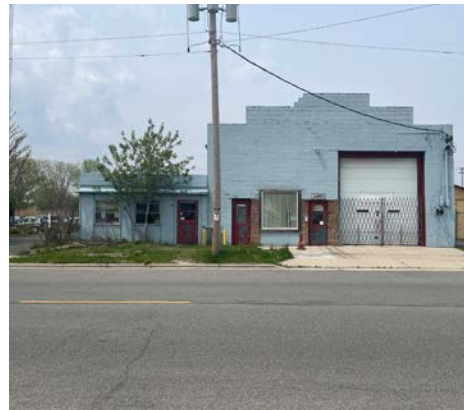
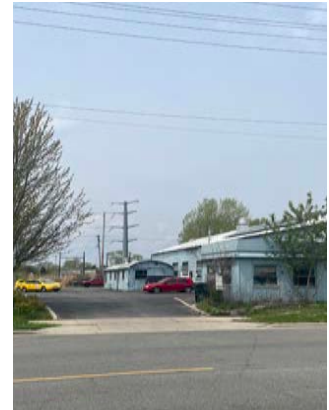
Parcel 45

Score: 26.3

Siding: paint chipping, bricks missing mortar, major cracks and shifting in block wall; roof: discolored, rusting, bent; window frames: rusted, discolored, partially missing; partial gutter collapse; doors: paint chipped, garage door bent; paint peeling, siding bent, windows discolored, roof rusted; trash not screened; signage fading; lot: cracks, curb is crumbling; sidewalk: does not connect, aggregate showing; overgrown landscaping; retaining wall collapse; rusted picnic table.

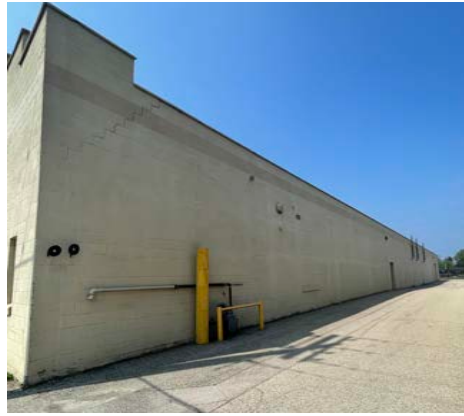
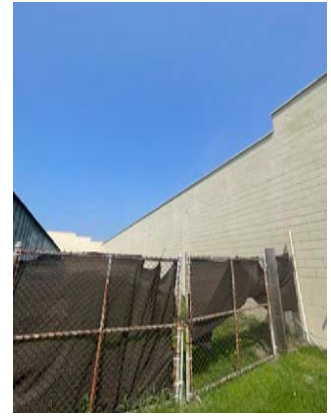
Score: 51.2

Vacant; foundation: minor cracks, discolored; siding: discolored, cracks, paint peeling; vents: rusted; garage doors: dirty, discolored, safety barriers rusting; fence: rusted, bent; dirty light covers; pavement against building: aggregate showing, rusted; sidewalk: aggregate showing, crumbling at edges; roof drain pipe empties right on to public sidewalk.

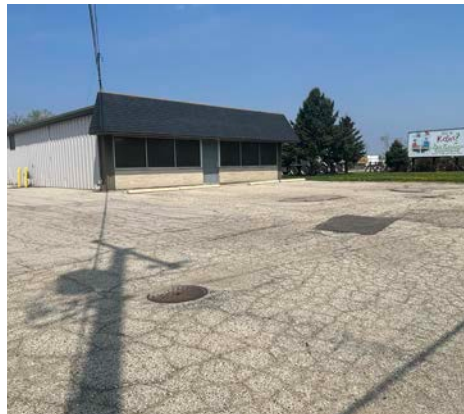
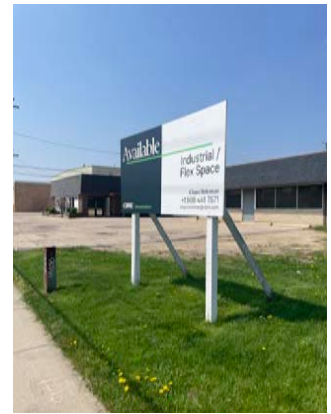
Parcel 27

Score: 50.7

Vacant; foundation concrete chipping; siding: stained, discolored, dented; front windows discolored sills; underside of overhang is discolored; side doors: faded paint, rusted; front door: discolored, dirty; rusted sign pole; missing sign face; parking lot: crumbling sections, cracks, patchwork; paint wearing on wheel stops; bent safety bollards along side of building; patches of grass missing; graffiti.

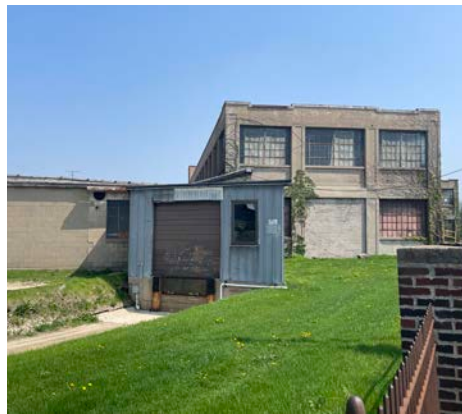
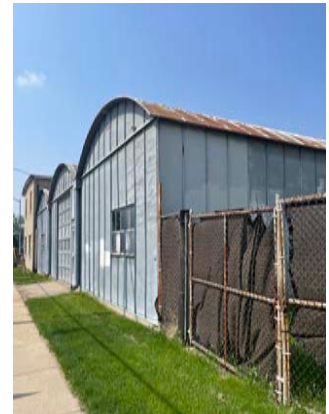
Parcel 33

Score: 22.2

Vacant; foundation: minor chipping and discolored exposed sections; metal clad siding: stained, rusted; concrete walls: discolored, crumbling in sections, exposed rebar; metal garage: rusted; concrete/metal fascia: crumbling, rusted; windows: rusted frames, broken, boarded up; fire escapes rusted; gutters rusted; rusted vents; most doors are in poor shape; metal shed: rusted roof, discolored walls; fencing rusted; brick columns: discolored cap, broken, crumbling; signage: faded; lighting poles rusted; loading dock: cracked, crumbling; gravel driveways: low level of gravel; walk: cracked, settling; sidewalk aggregate showing; weeds present; rusted utility line; graffiti; piles of junk; trailer sitting in grass; conditionally closed ERP site; evidence of water pooling.

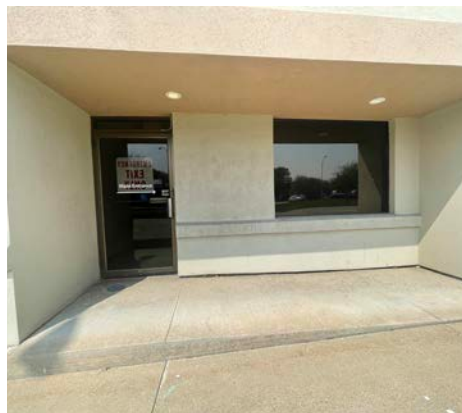
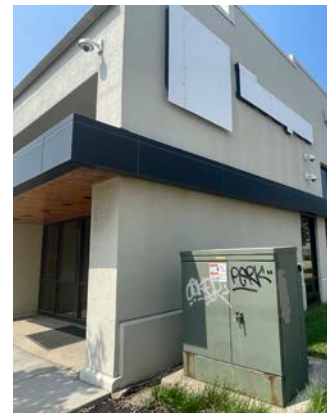
Parcel 52

Score: 55.9

Vacant; foundation: paint peeling; siding: paint patch color not matching, discolored; brick: cracked, minor crumbling; metal roof: paint wearing off; windows: frames peeling, cracks in sill; discolored siding on accessory structure; remnants of sign removal; drive (south): patchwork, aggregate showing; parking lot (north): aggregate showing, minor cracks; sidewalk: aggregate showing, discolored; weeds in grass and landscape beds; graffiti; some trash present.

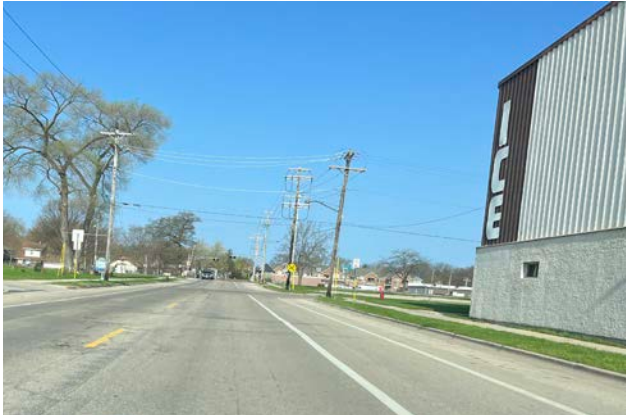
Commercial Ave (cracking, crumbling, some settling)

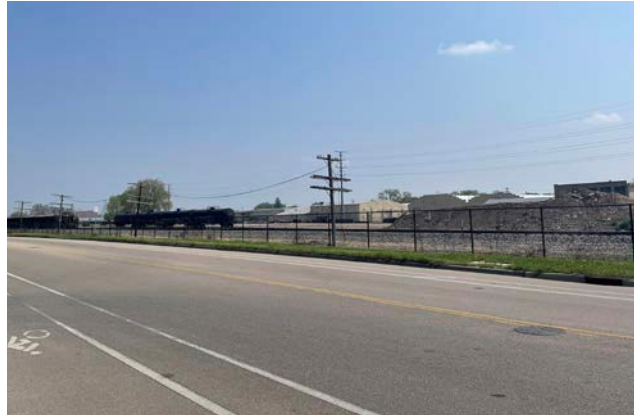
Fordem Avenue paint marks fading, generally good condition)

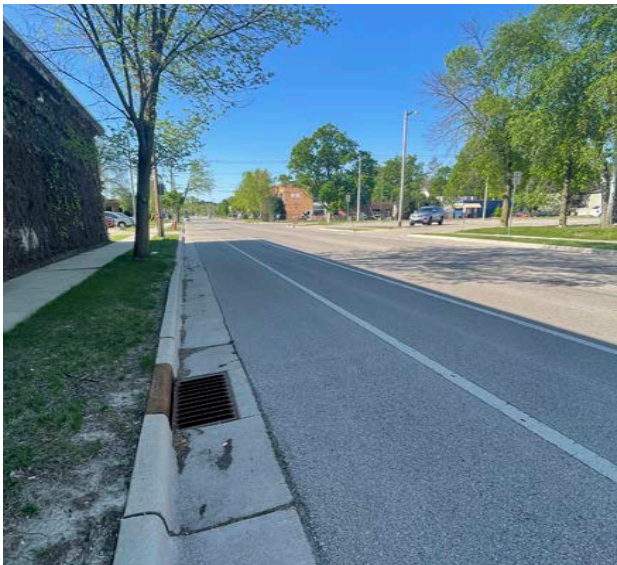
Fordem Avenue (some debris in gutter)

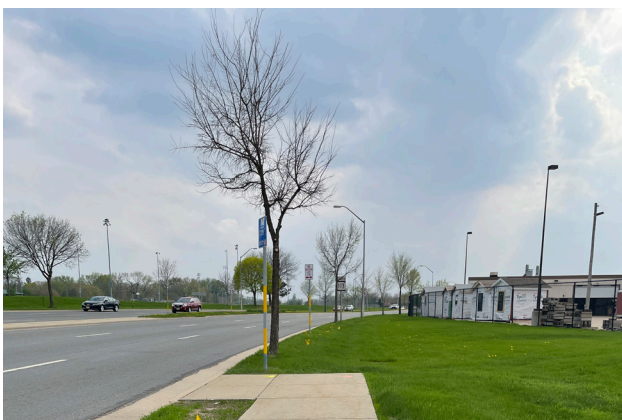
Packers Avenue (some cracking, otherwise good condition)

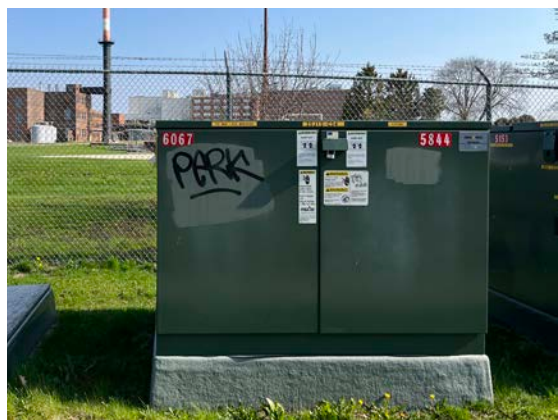
Commercial Avenue (graffiti on electrical box)

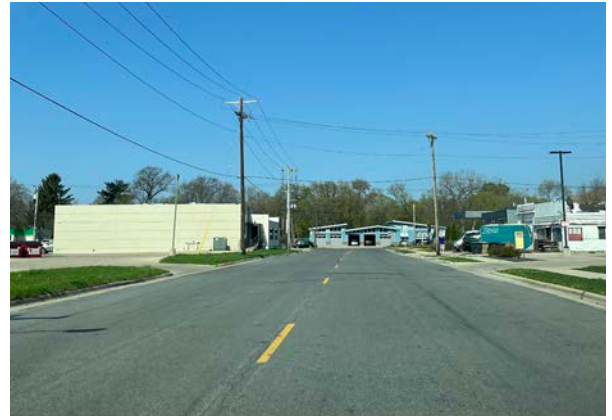
Roth Street (cracking, curb crumbling)

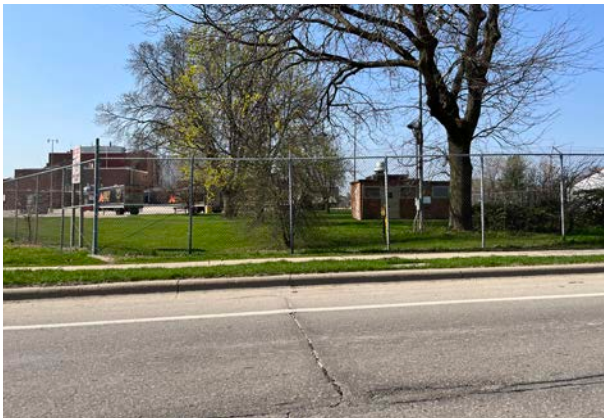
Aberg Avenue (cracking, crumbling, settling)

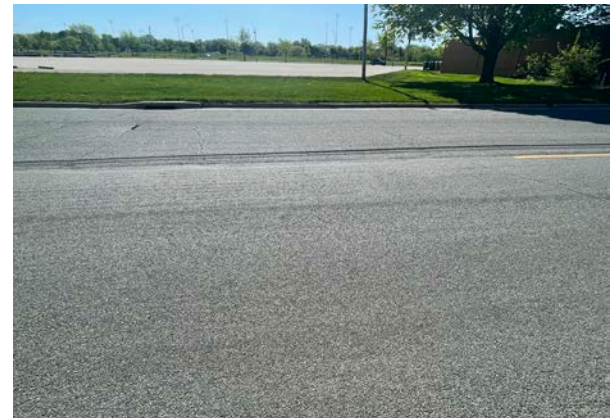
Pennsylvania Avenue (cracking, curb crumbling, some settling)

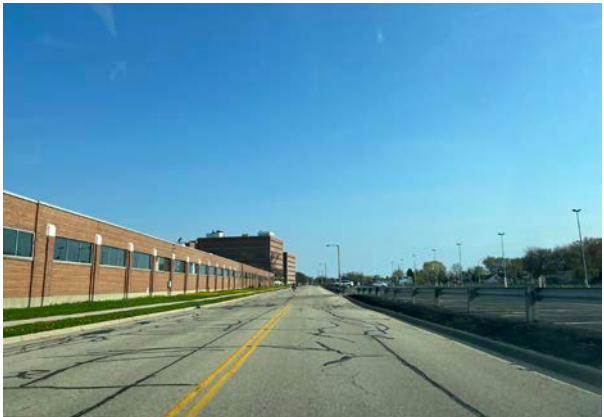
Oscar Avenue (tarred cracks, crumbling along gutters, fading center line paint)

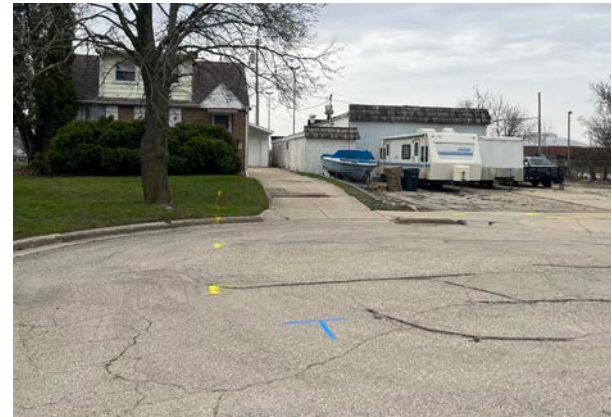
Myrtle Street (cracking, crumbling curb, aggregate showing)
