# BLOCK 100 FOUNDATION

# GENERAL PROJECT INFORMATION

**Location:** 100 block of North Fairchild and State Streets in downtown Madison

**Project Size:** 37,779 gross square feet, in 2 and 4 story buildings

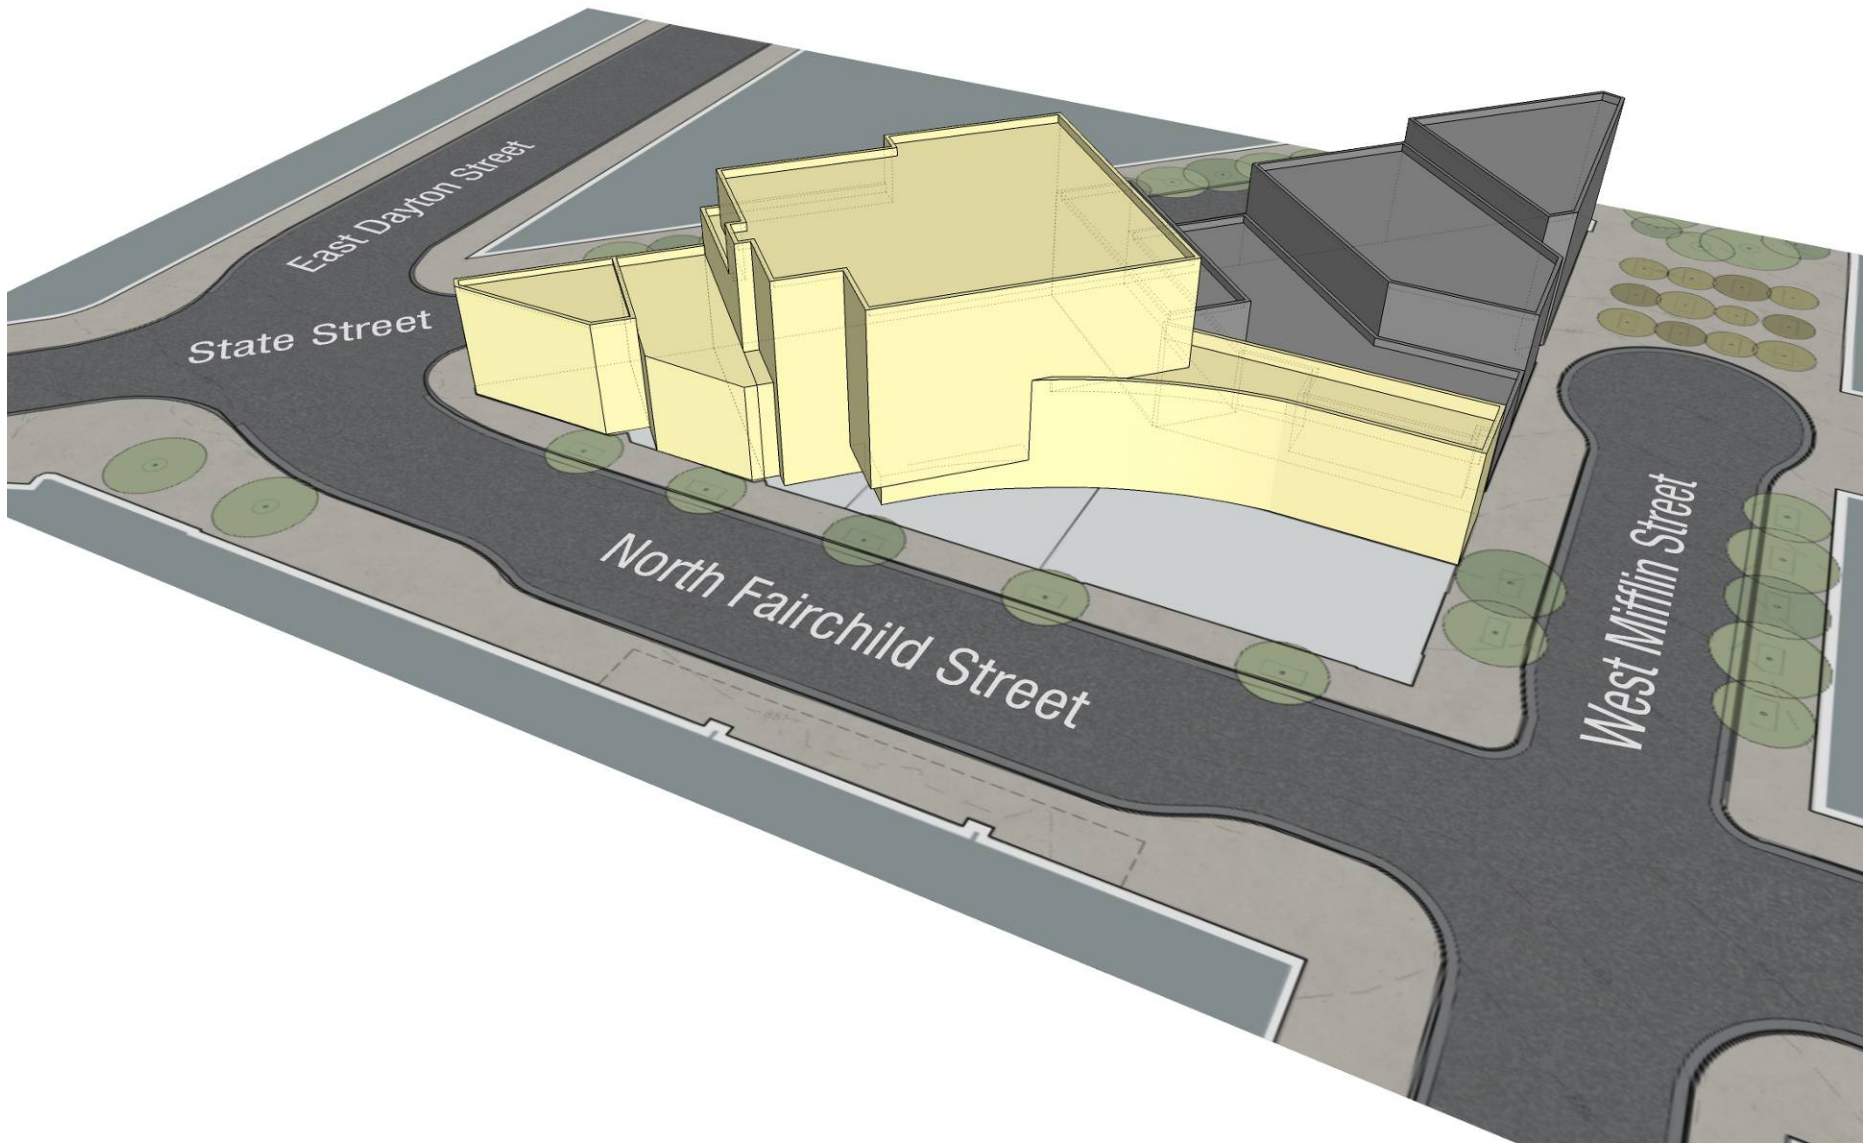
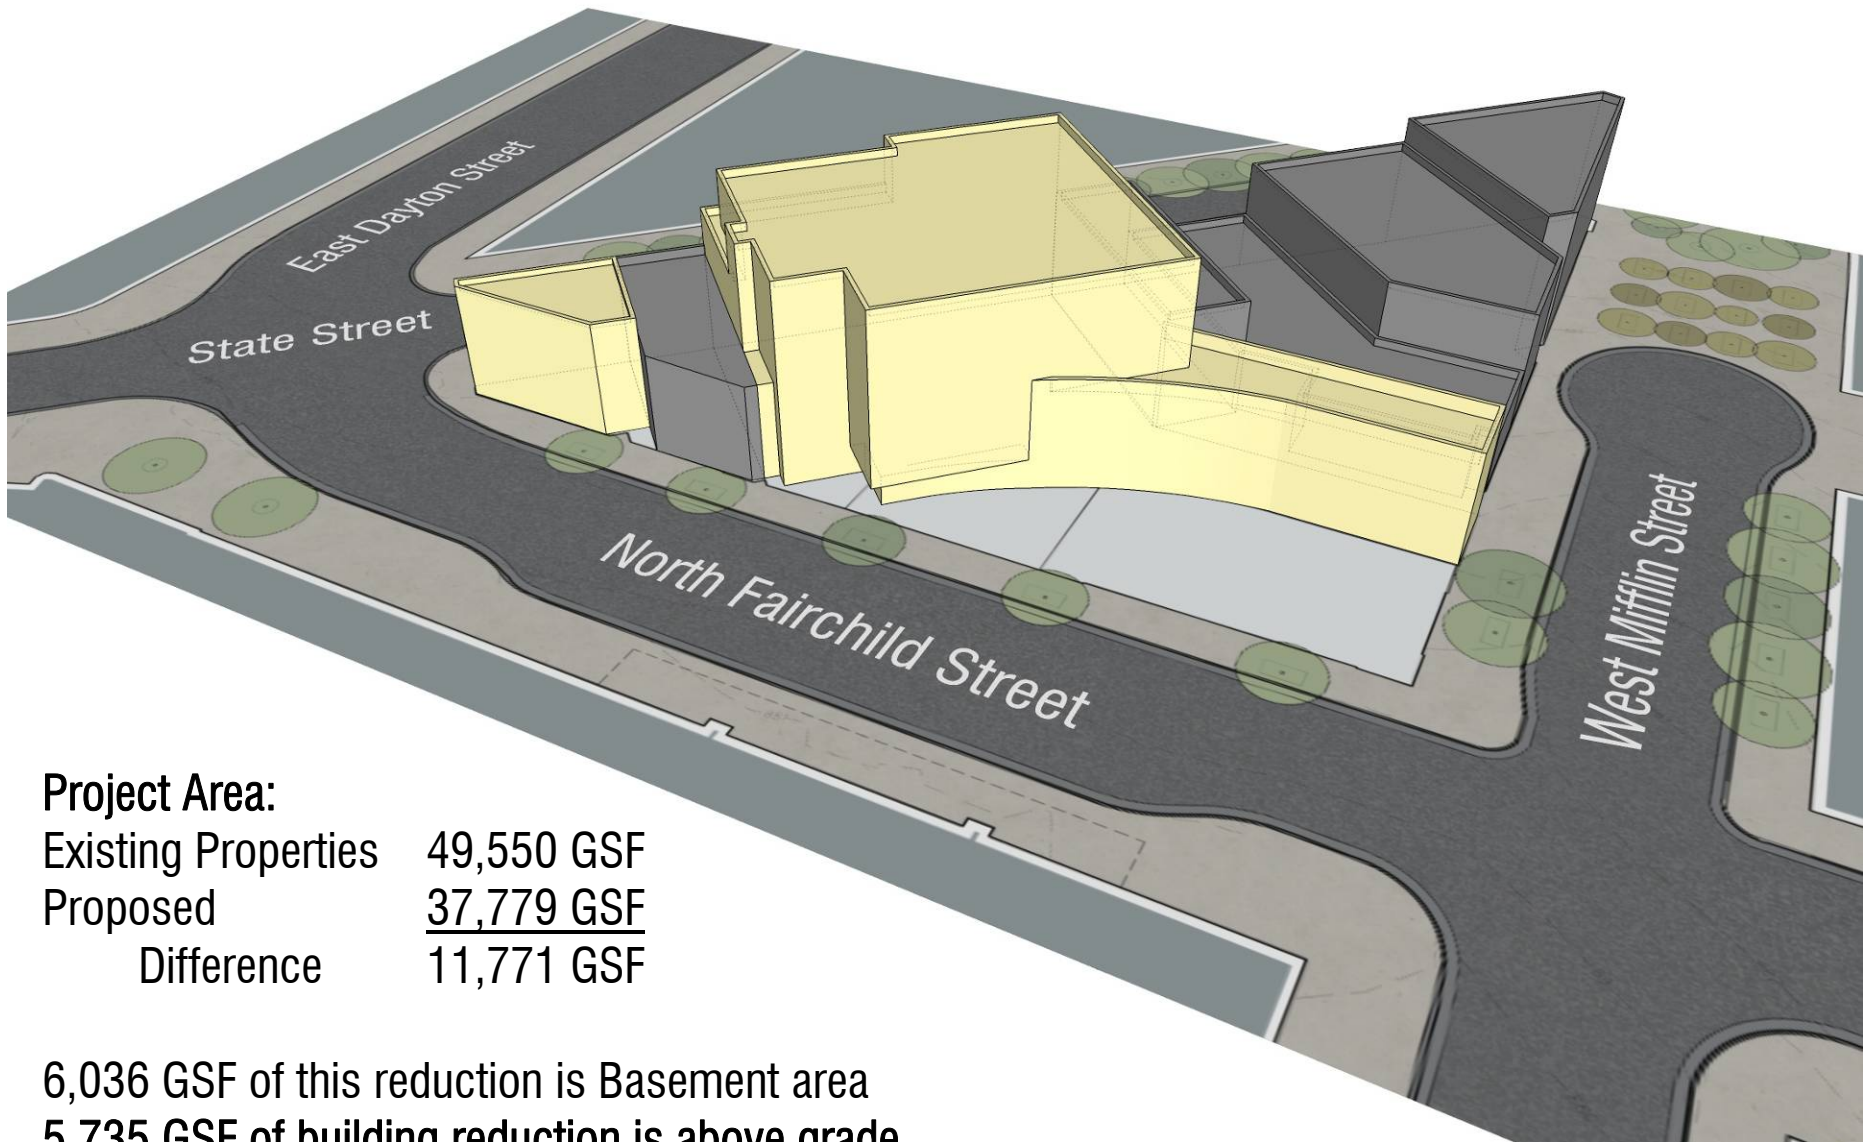
Overlay of Existing & Proposed Building Massing

**Project Area:**

Existing Properties	49,550 GSF
Proposed	<u>37,779 GSF</u>
Difference	11,771 GSF

6,036 GSF of this reduction is Basement area  
5,735 GSF of building reduction is above grade  
Fairchild Building above grade is 5,764 GSF

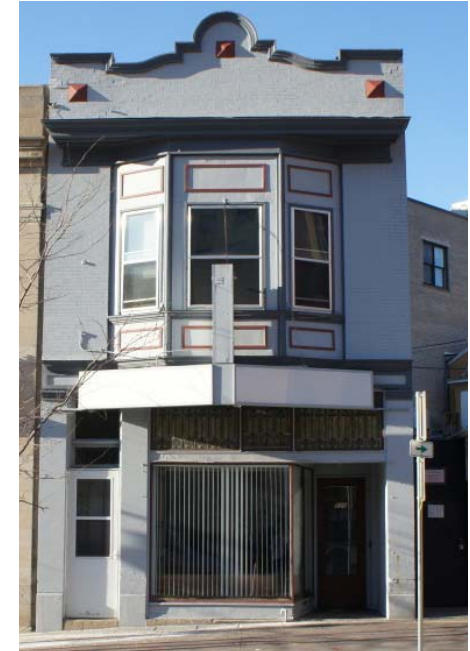
### EXISTING CONDITION – IMPENDING IMPROVEMENTS

- W. Mifflin Street façade
  - Remove the existing coating from all masonry
  - Repoint the brick and stone masonry
  - Dismantle and reconstruct a portion of the parapet wall
  - Inspect and make necessary repairs to the transom window
  - Replace the existing storefront system and entrance door
  - Repair the existing double-hung windows on the second floor
  - Install a new stoop at the entry door
  - Investigate and repair the bay window
  - Replace the apartment entrance door and transom
  - Remove the projecting aluminum and glass marquee/sign and repair the façade

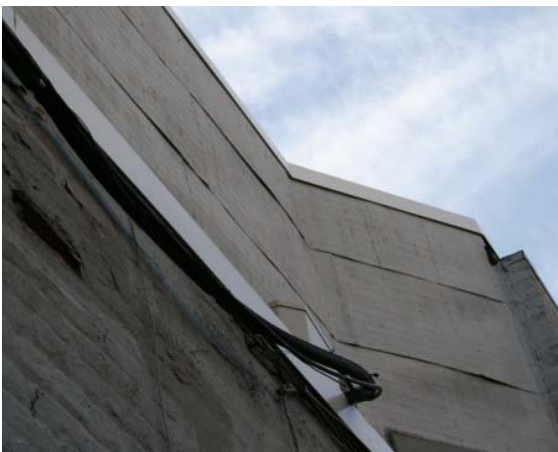
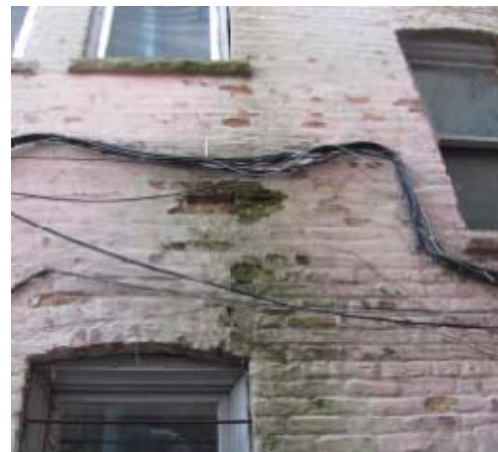
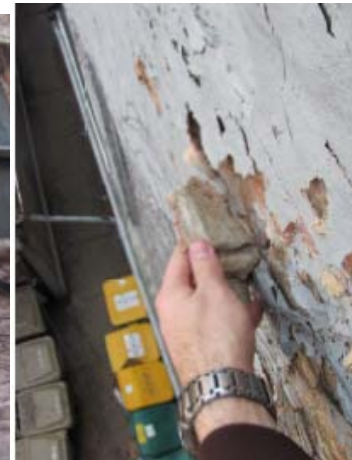
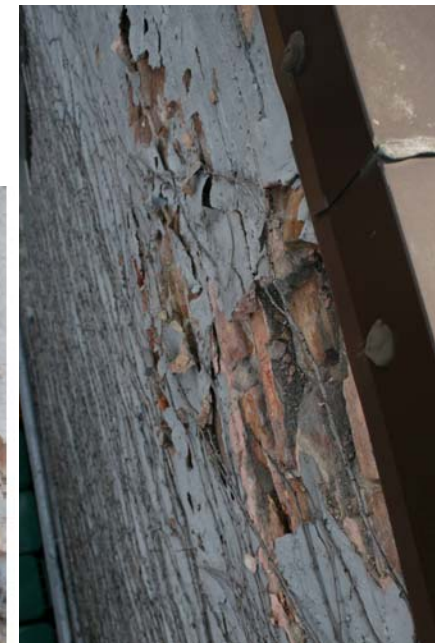
### EXISTING CONDITION – IMPENDING IMPROVEMENTS

#### Alley and rear building facades

- Remove the existing coating and parge materials on the brick
- Extensive replacement of the majority of the brick on both facades – potential replacement of the masonry back-up system may also be required
- Remove and re clad the recessed area on the second floor currently covered in painted sheet metal
- Replace the gutter and downspout system and tie into a new storm water line to the street
- Repair the existing double-hung windows on the second floor
- Replace the first floor windows
- Re clad the roof access penthouse and replace the exterior door to the roof
- Replace the roof on the penthouse roof access structure

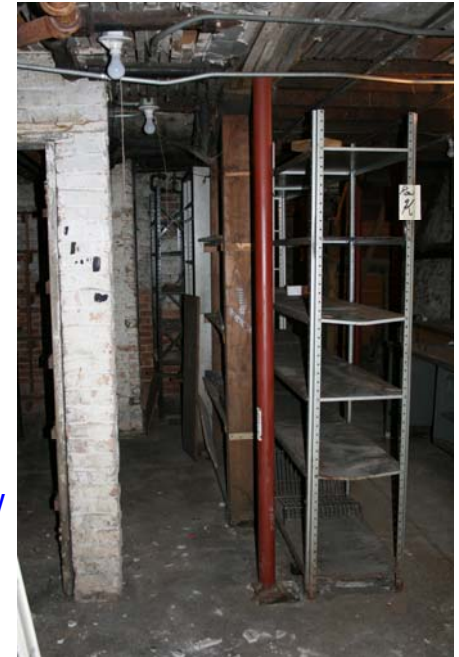
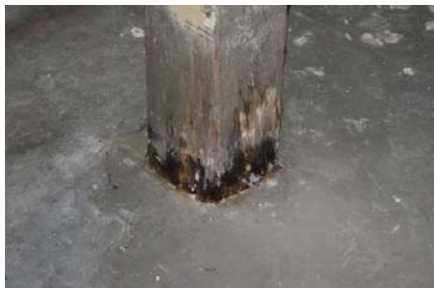
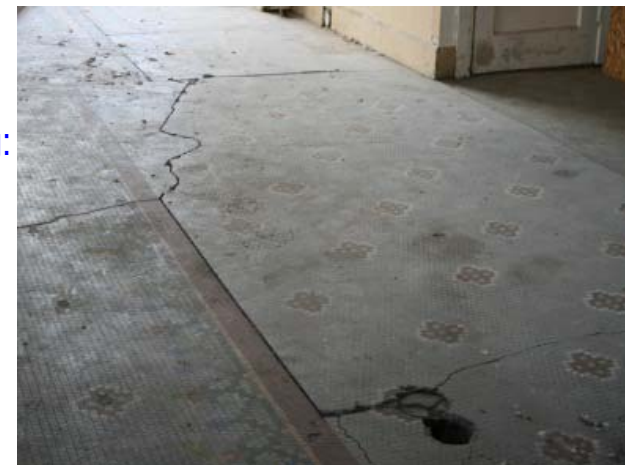
## EXISTING CONDITION – IMPENDING IMPROVEMENTS

- Install new first floor finish
- Where required, repair the rubble foundation walls
- Replace the structure with fire resistive construction pursuant to the Capitol Fire District requirements

- Install a first floor toilet room
- Repair the plaster walls and ceilings on the first and second floors
- For the change in occupancy on the second floor, complete the following:

- Remove the existing second floor walls and re-support the roof structure
  - Remove the existing kitchens
  - Relocate and install a second floor toilet room

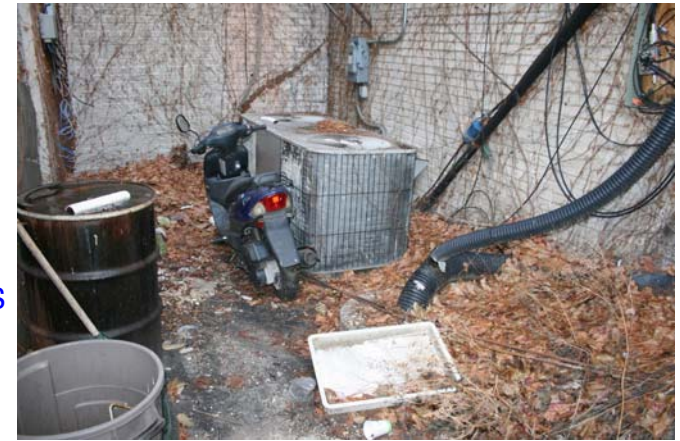
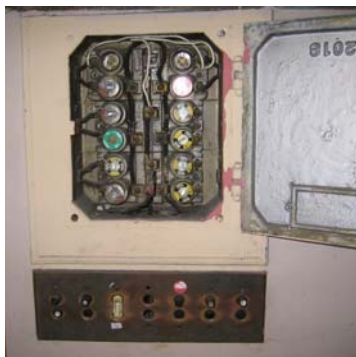
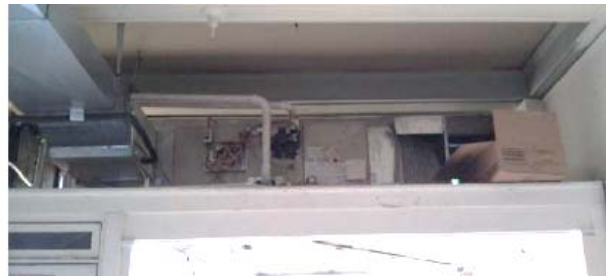
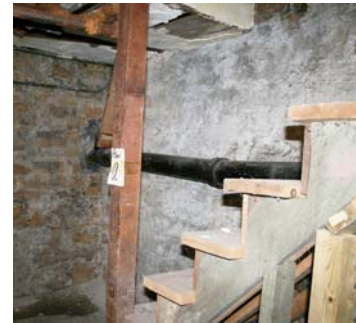
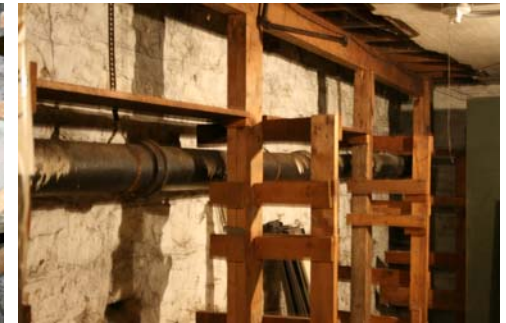
### EXISTING CONDITION – IMPENDING IMPROVEMENTS

#### Mechanical, Electrical and Fire Protection

- Install a fire protection system
- Upgrade the HVAC system
- Remove the existing lead piping and patch floors, walls and ceilings
- Install a first floor toilet room
- Replace the electrical infrastructure
  - Install new branch circuit wiring and fuse panels
  - Install new lighting and electrical outlets
- For the change in second floor occupancy, complete the following:
  - Remove the kitchen fixtures and bathroom fixtures, patch floors, walls and ceilings
- Remove the storm water cistern in the rear of the building and the storm water piping running horizontally through the basement
  - Have adjacent building Owner(s) route storm water to W. Mifflin Street
- Construct a new storm water line to route storm water from the rear of the building to W. Mifflin Street
- Replace the gas piping in the basement

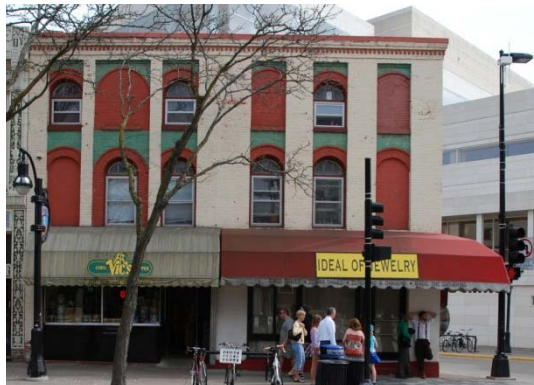
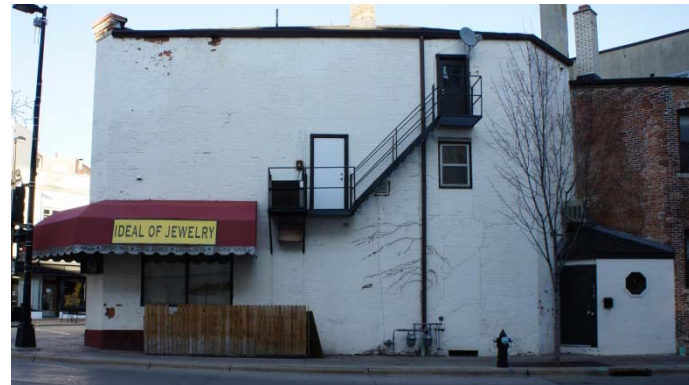
#### EXISTING CONDITION SUMMARY

- Building appearance has been significantly altered since its original construction
- Brick masonry is generally in very poor condition with severe deterioration – 100% replacement should be assumed
- Moisture penetration through the exterior wall assembly
- Existing windows are low-quality wood replacements
- Structure of building has excessive defects
- Exterior wall pulling away from support of the floor/roof joists
- Existing mechanical and electrical systems do not fully comply with existing code requirements
- Fairchild Street façade currently has a metal fire escape and HVAC condensing unit attached to the side of the building
