Losing Ground on Seminole Highway

A recent road 'improvement' project has created a dangerous situation for bicyclists.

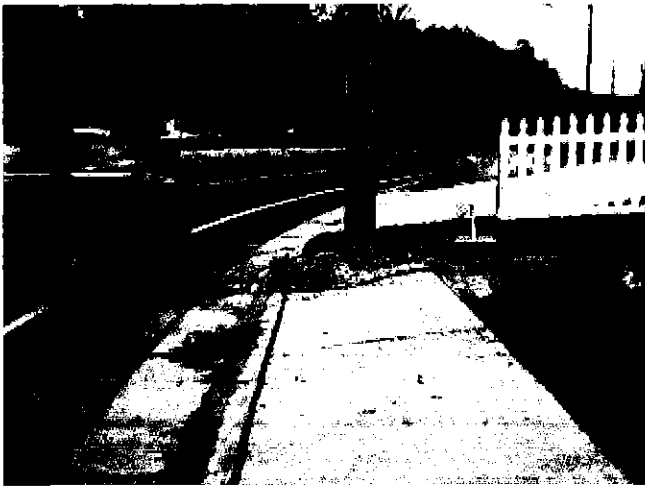
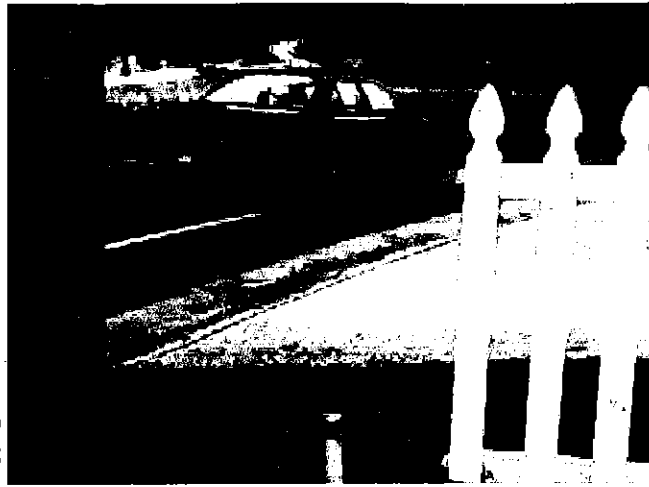
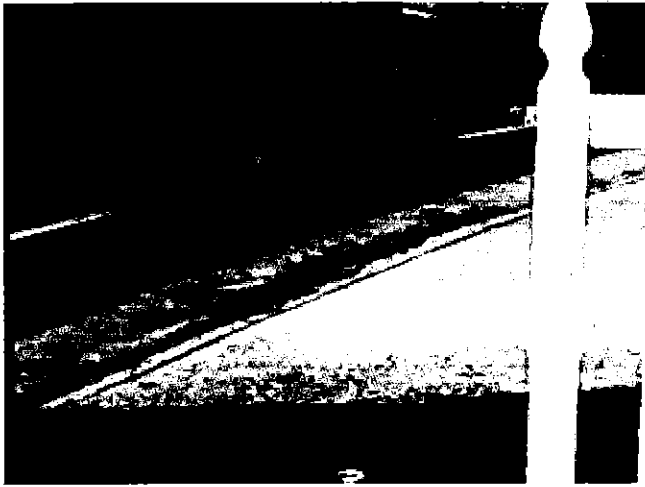
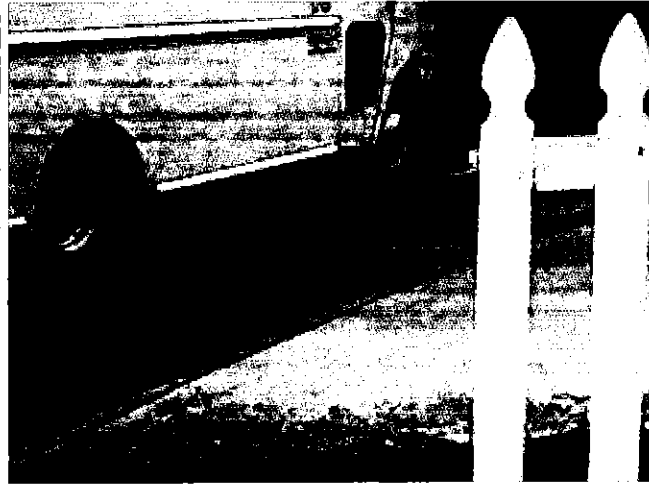
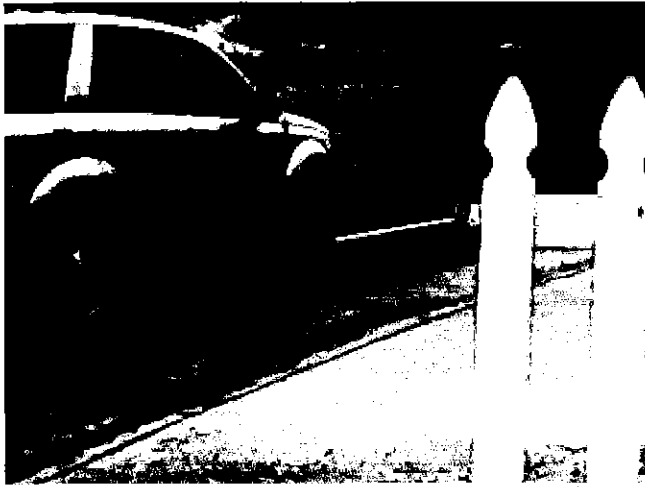
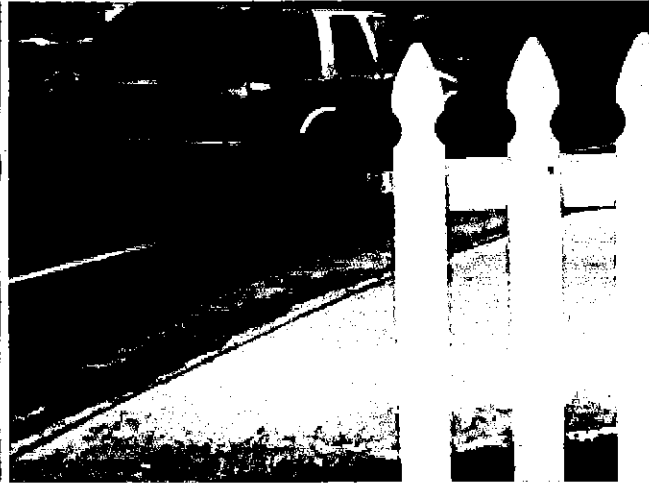
Fig. 3 - Cars crossing into bike lane

The narrower traffic lanes created an especially dangerous situation in the Southbound lane, just South of the intersection, where the road curves to the right. From my observations, most motorists (who are typically exceeding the speed limit) partially or significantly cross into the bike lane as they make the curve. This is clearly verified in [Figure 3](#) below.

Note that this is a fairly representative sample of cars taken in a short (10 minute) period.
