1. EXECUTIVE SUMMARY

The City of Madison is considering creation of a Tax Incremental Financing District (TID) in an area that includes parcels on Johnson St. and Dayton St. This blight study seeks to determine what percentage of the identified parcels, by area, are blighted as defined by Statute 66.1105(2)(ae)1. MSA evaluated 285 parcels, eliminated 2 due to active construction or inadequate access, and scored the remaining 283 parcels using a scoring tool developed to standardize the evaluation process. We visited each parcel in September and October 2012, taking pictures of conditions and recording those conditions in the scoring tool.

2. PARCEL AND STRUCTURE SURVEY METHODOLOGY

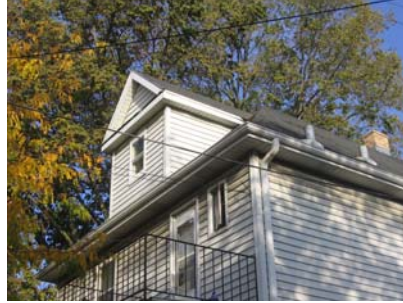
Score: 57.0

Less intensive use than planned land use; foundation discolored, minor crack, chipping off at base; walls and cladding: siding dirty under eaves, damaged in a few places along alley; roof eaves dirty in areas, shingles coming up in a few areas; dormer flashing rusted

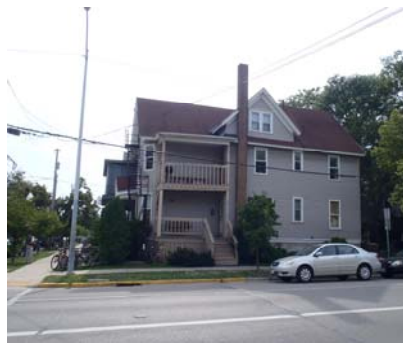
Parcel 44

Foundation discolored, minor cracks, missing stucco, wood cladding warped and discolored; wall shingles paint/stain has worn off, warped, couple spots missing shingles; roof eaves untreated, wood fascia and paint peeling off soffit, discolored metal flashing

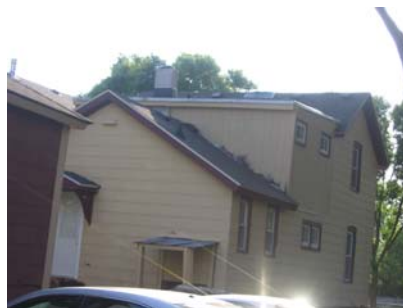
Parcel 219

Foundation patchy, cracked, missing material; walls and cladding: window framing paint color on siding, some areas cracked or missing a piece of siding, signs of rot; large rubber patch on peak of roof; window framing paint wearing off

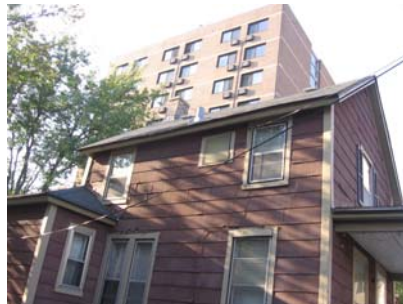
Parcel 255

Score: 45.8

Less intensive use than planned land use; foundation patchy, cracks, discoloration; siding missing pieces, dented, warped, paint wearing; shingles worn and coming up in sections; window framing warped, cracking paint, discoloration; chimney completely covered in patching material

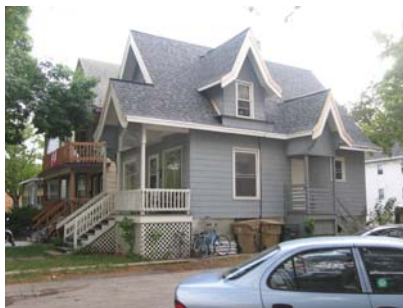
Parcel 273

Score: 437.9

Foundation is patchy and discolored; siding mismatched color, dented, broken pieces; roof eaves paint wearing off, unpainted newer fascia board; basement window covered by wood panel, sill paint wearing off; balcony quite dirty; stair paint cracking and wearing off

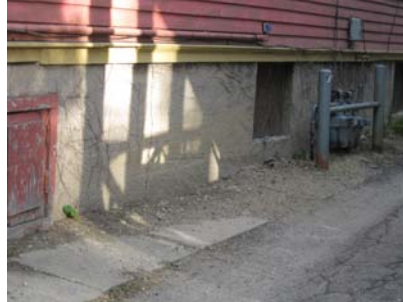
Score: 55.9

16 code violations in the past ten years; foundation discolored; siding paint wearing off, discolored; windows boarded up; stairs have patchy fixes of significant cracks, rust stained, crumbling at base; railing has some rust

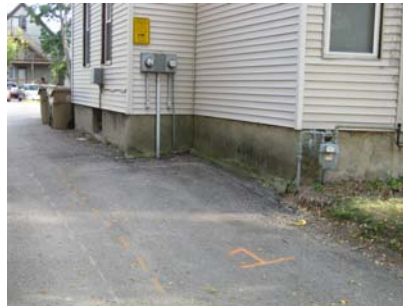
Parcel 82

Score 58.9

Foundation discoloration, surface of exterior insulation chipping away; east façade cladding in poor condition, peeling up, chipping off at base, discolored; aluminum siding dirty; basement window boarded up, some trim white, some brown

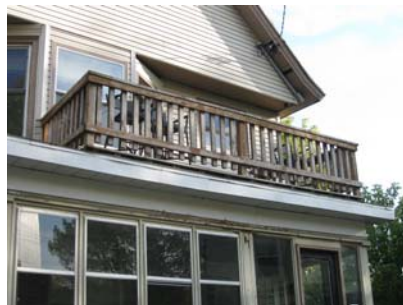
Parcel 114

Score 58.3

Roof shingles worn, eave has cracked boards, missing boards, paint chipping off; window trim paint wearing off; porch has paint wearing off porch lattice & cladding, signs of rot; discolored brick bases; balcony stain wearing off; asphalt driveway is crumbling

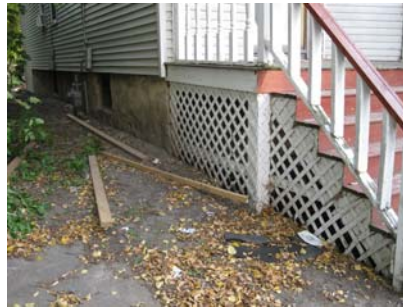
Parcel 144

Score 54.6

Foundation patchy, crumbling, discolored; walls and cladding dirty in areas, stained under porch, missing sections (under front window, on corners); window trim dirty, front window paint wearing off; front architectural character damaged by removal/covering of all but one window

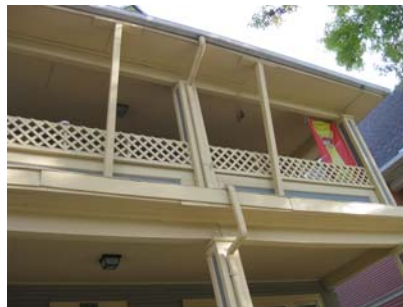
Parcel 151

Score 50.8

Foundation discolored; walls have rusted nails and rust stained siding, paint wearing thin; roof eaves dirty, cracked/broken fascia boards, paint wearing off; porch fascia boards irregularly nailed, ceiling boards warping and splitting in areas, eave collapsing and propped up, screening broken; gutters dirty

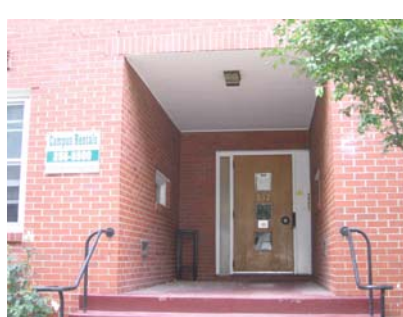
Parcel 171

16 violations in the past ten years; walls have dirty bricks near base and cornice; roof eave paint chipping; window infilled with wood; stair paint wearing thin, railing paint wearing off; front entryway very dirty

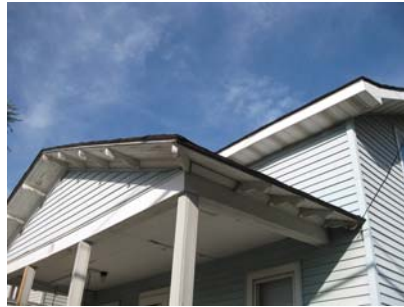
Score 54.5

18 code violations in the past ten years; less intensive use than planned land use; foundation patchy and discolored; roof shingles worn, structure sagging towards the center; flashing rusting; stairs sagging, paint chipping off; railing wood unpainted

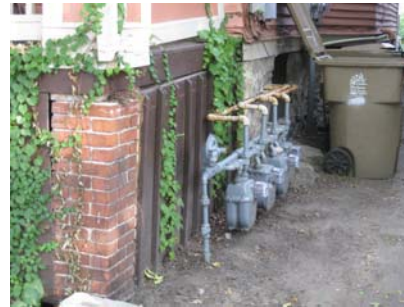
Parcel 183

Score 58.2

20 code violations in the past ten years; foundation patchy; walls and cladding: paint bubbling, loose siding, pieces missing; boarded-up windows – all in basement, one on third floor; stair paint wearing off, missing side boards, cracked rise board; left door paint wearing, trim cracking

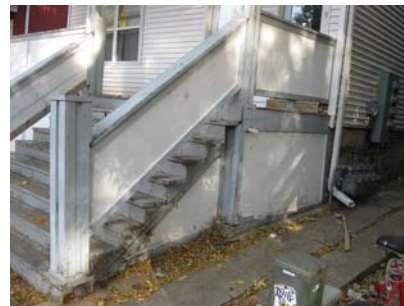
Parcel 199

Score 59.2

28 code violations in the past ten years; foundation quite discolored, insulation oozing out of cracks; windows boarded up, chipping paint; porch wood rotting, discolored, paint wearing off,

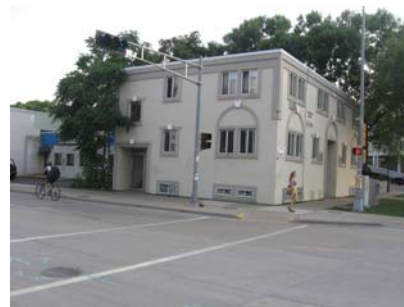
Parcel 207

Score 59.6

Wall paint peeling off, significant dents, small cracks, mismatch paint used to cover up past graffiti; window framing dirty; chimney cladding material is bulging, rusted vents on south façade; driveway cracked, discolored

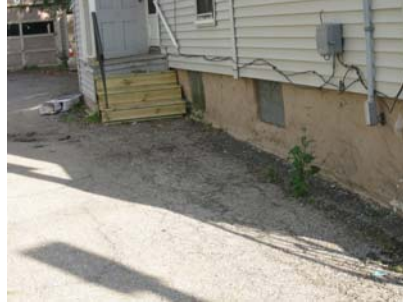
Parcel 226

Score 52.5

Less intensive use than planned land use; foundation cracked, crumbling, discolored; walls and cladding: siding missing near eave; roof eaves fascia board missing on side overhang and one bent piece on upper north corner; front porch paint chipping

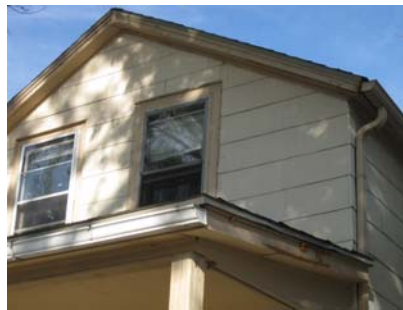
Parcel 252

Less intensive use than planned land use; foundation discolored; siding quite worn, pieces chipped off near foundation; eaves paint chipping off, insulation oozing out of cracks; porch lattice broken missing pieces, paint worn

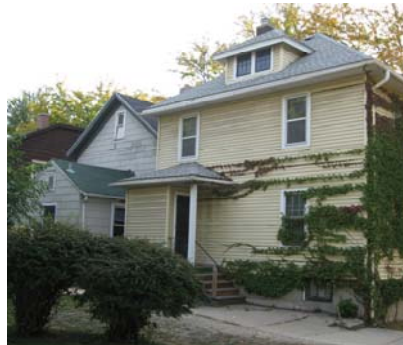
Parcel 267

Less intensive use than planned land use; foundation discolored; siding worn, paint splatters along upper porch; windows boarded; porch lattice paint wearing off, loose boards in eave and ceiling

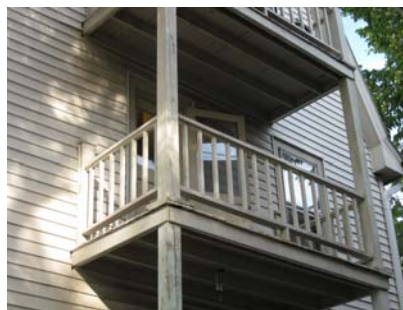
Parcel 285

24 code violations in the past ten years; siding dirty along eaves and back balcony; roof shingles worn and discolored, shingles coming up in areas; back balcony wood cracked, paint wearing off, front porch irregular paint job

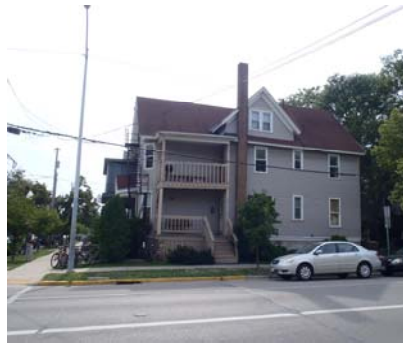
Parcel 45

Siding is dirty; soffit separating from roof; porches weathered and chipping paint; concrete stoop cracked, poorly patched; unpaved parking; trash piles in backyard; overgrown shrubs; bare spots and weeds in lawn

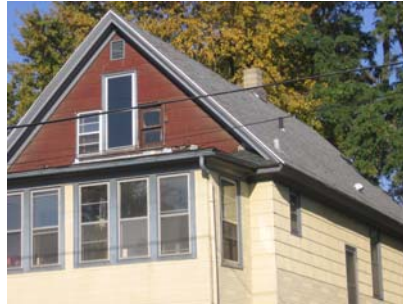
Score: 48.6

16 code violations in the past 10 years; walls and cladding: siding mismatch, broken pieces, dirty, cobwebs; shingles damaged; foundation: flaking pieces, foam insulation exposed; weeds

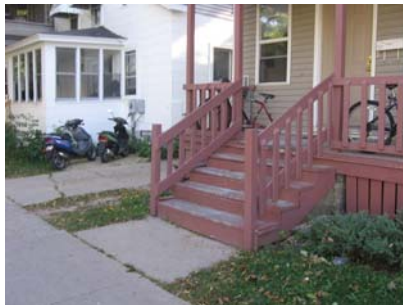
Parcel 46

Score: 54.4

Mismatch siding with cracks and chips missing, graffiti; porch skirt board missing, chipping paint, porch leaning, scattered debris, weeds

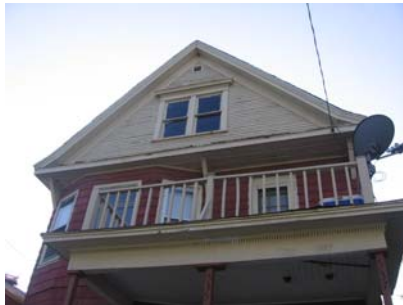
Parcel 51

Score: 55.8

17 code violations in the past 10 years; foundation dirty, cracked and missing chunks; porch has worn floor boards, chipping paint, bent skirt boards; chimney missing chunks; scattered litter; indoor furniture on porch

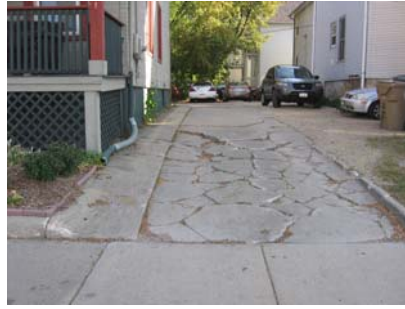
Parcel 69

Less intensive use than planned land use; foundation has a large chunk missing near window; walls and cladding chipped, dented, faux brick siding peeling at edges; rusted gutters; cracked concrete drive with exposed aggregate

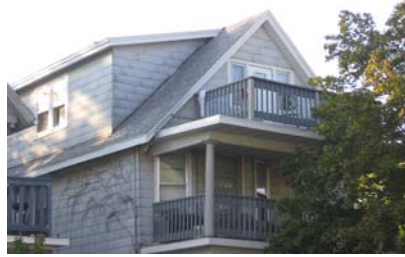
Score: 58.2

21 code violations in the past 10 years; foundation has significant cracks and patchwork; walls and cladding dirty, chipped and fading in color, vine remnants on side of house; porch and stairs; worn wood, chipping paint

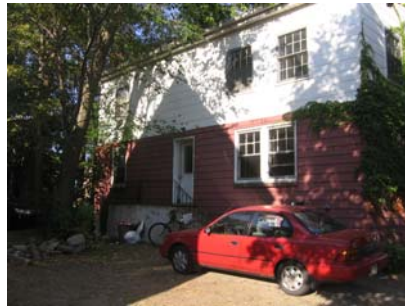
Parcel 74

Score: 49.1

23 code violations in the past 10 years; concrete stoop and stairs dirty/stained, cracked, patched with rusted railing; pile of trash in yard, vines growing over windows, scattered debris

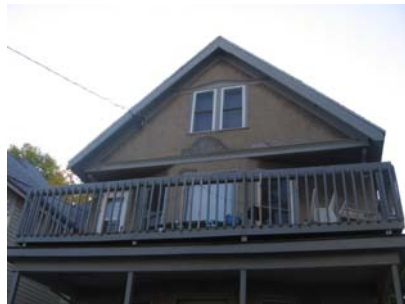
Parcel 123

Score: 53.7

29 code violations in the past 10 years; walls and cladding dirty/stained, mismatch color, fading, mismatch patchwork; porch and balcony chipping paint, untreated wood railings, sagging at center

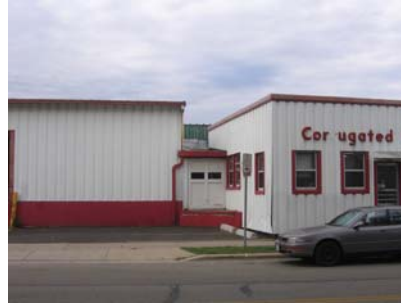
Parcel 141

Score: 39.1

Metal siding severely dented and rusted, mismatched paint to cover graffiti, paint wearing thin; loading area concrete has cracks, crumbling sections, exposed aggregate; cracked, uneven and patchy asphalt

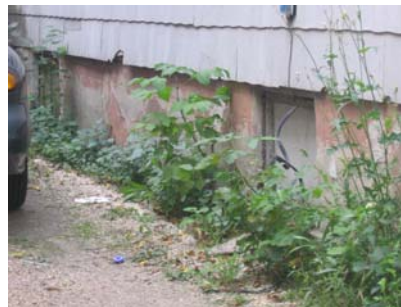
Parcel 154

Score: 55.5

Foundation has chipping paint; walls and cladding dirty, chipped siding pieces, chipping paint; porch floor boards rotting, chipping paint; stair treads worn, chipping paint; balcony leaning left

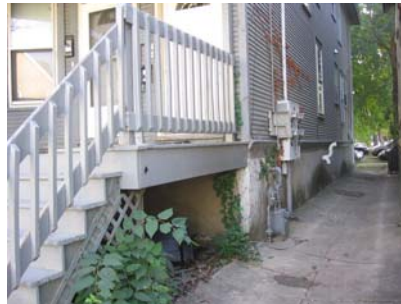
Parcel 181

Score: 58.0

19 code violations in the past 10 years; porch has missing and broken lattice skirts, balcony trim chipping paint; stair treads worn, railings chipping paint; mismatch doors; cracked concrete walk; vines on house

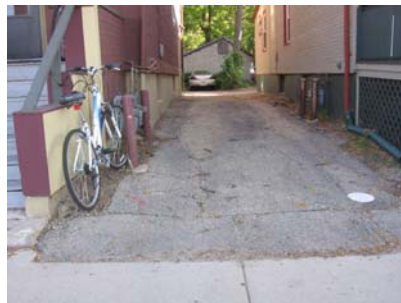
Parcel 185

Score: 52.8

21 code violations in the past 10 years; walls and cladding have some chipped siding pieces, paint cover up in spots, exposed seems on faux brick siding; stairs sagging in center, loose on ends, chipping paint; concrete step cracked; asphalt drive is fading and cracked

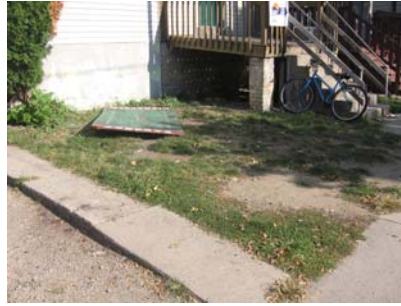
Parcel 213

Score: 48.8

25 code violations in the past 10 years; shingles hanging over edge of roof in places; flashing rusted ; front porch unlevel, weathered untreated wood; concrete stoop and stairs; cracks, chunks missing, exposed aggregate

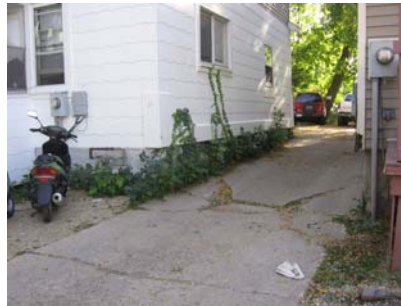
Parcel 241

Score: 55.3

19 code violations in the past 10 years; less intensive use than planned land use; windows are dirty, there is a missing window in front; stairs and door dirty; concrete drive cracked and sunken; weeds, bare dirt, bare spots in lawn terrace

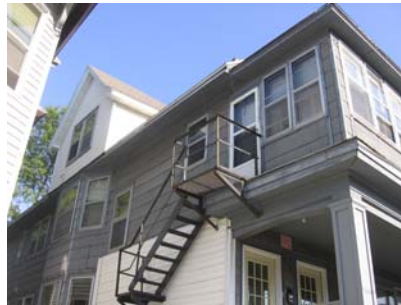
Parcel 251

Score: 50.3

Foundation has cracks, flaking pieces, chunks missing and poor patchwork; large pieces of siding missing; cornice cracked at peak, rusted flashing, trim hanging; weathered/wavy floor boards on porch; stair treads worn, chipping paint, loose skirt boards

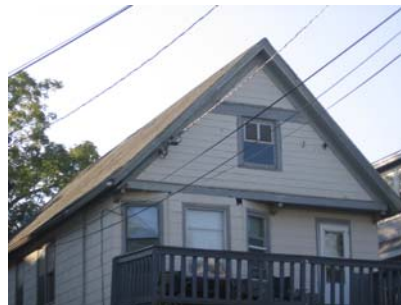
Parcel 259

Score: 46.0

Foundation has significant patchwork, mismatched paint; siding has a few holes, chunks missing; porch chipping paint; balcony sagging at center; gutters loose and chipping paint; stairs worn with sagging treads, chipping paint

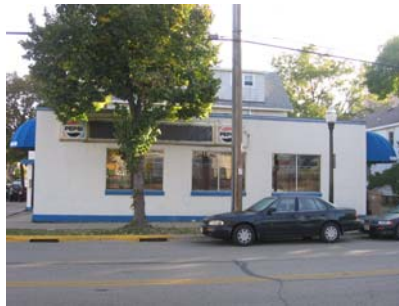
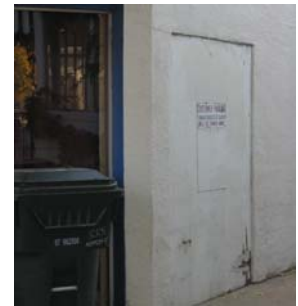
Parcel 274

Score: 42.6

19 code violations in the past 10 years; less intensive use than planned land use; walls and cladding paint chipping, cracks and holes; awning dirty; plywood door cracked, chipping paint; remnant Pepsi sign blacked out

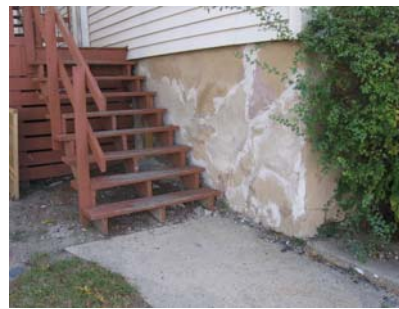
Parcel 280

Score 51.3

Foundation has significant patchwork, flaking and discoloration; roof is dirty, fading color, rust stains, damaged shingles, flashing peeling off; concrete pad cracked; stair treads worn with chipping paint, emergency exit rusted

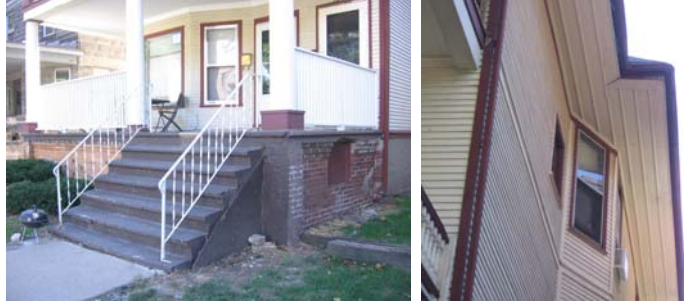
Parcel 72

Foundation brick needs tuck pointing, poorly patched mortar; siding dirty; roof worn, budging shingles in places, stained, soffit decaying, chipping paint; porch and balconies have chipping paint on railings, columns and floors

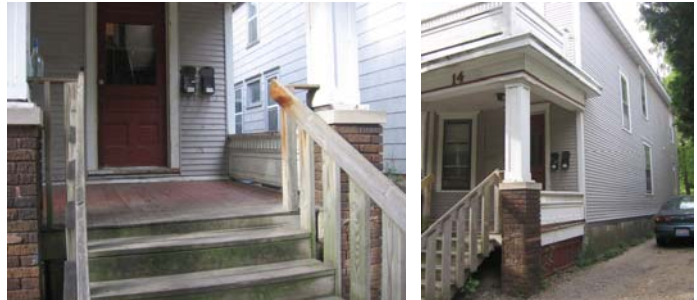
Parcel 80

Foundation is dirty, cracked, gouged, poorly patched; siding is dirty, chipping paint, has small holes near doors; roof damaged, loose shingles, soffit pieces lose, bent and dented; porch boards worn, chipping paint, untreated wood, broken off wood

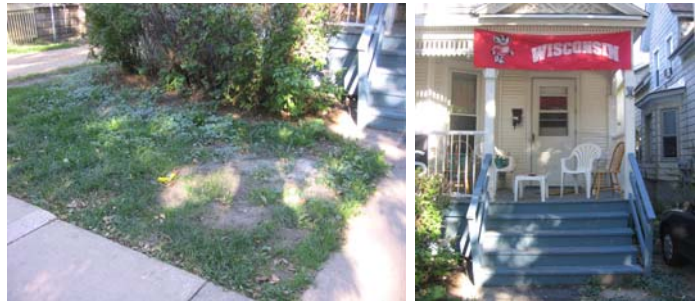
Parcel 93

19 code violations in the past ten years; foundation is dirty/stained; siding is dirty; front porch has chipping paint, rear porch warped boards; missing light cover; cracked concrete; many weeds in beds, drive, lawn, bare spots and weeds in terrace

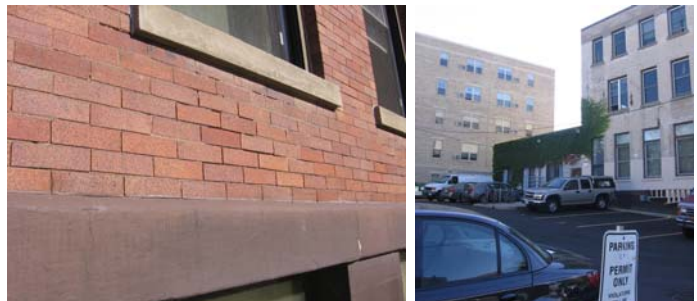
Parcel 96

Brickwork cracks, missing mortar; windows dirty, windows sills are chipping paint; stoop along W. Washington cracked, chunks missing; no dumpster enclosure; parking sign bent and crooked; rust stained concrete, some cracks; bares spots and weeds in lawn terrace

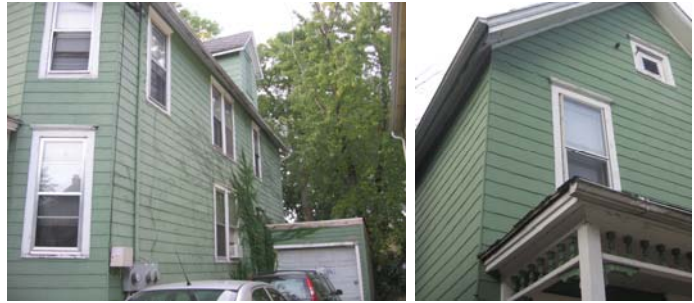
Parcel 101

32 code violations in the past ten years; foundation is dirty/stained, paint splattered, exposed foam insulation; some chipping paint and pieces missing from siding; roof has mismatch patchwork, shingles in poor condition; chipping paint on window trim

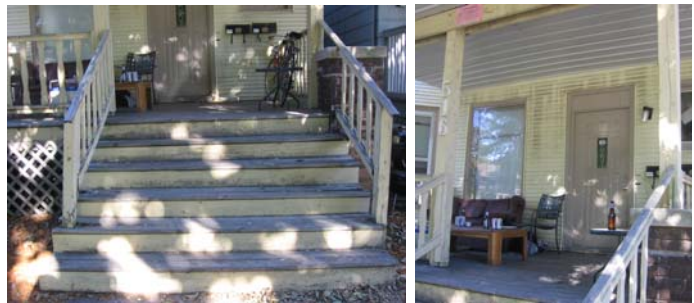
Parcel 106

Mismatch siding, siding is very dirty, remnant vine debris, siding in back is in poor condition; windows are dirty, window frames dirty/stained, front porch dirty, worn, untreated wood floor, chipping paint, ceiling sagging, weathered treads, dirty, chipping paint

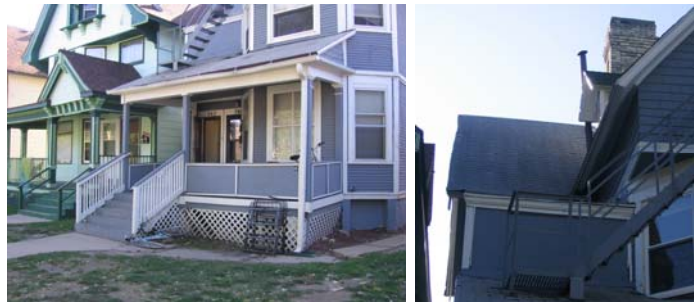
Parcel 118

Foundation has chipping paint, some pieces of wood siding are damaged, hanging off; one section is missing, replaced with plywood? Roof weathered/worn, stained, poorly patched, bulging shingles; porch ceiling sagging, stairs dirty, rust stains from fasteners

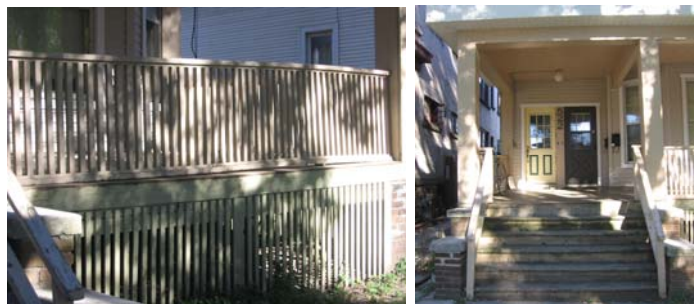
Parcel 134

19 code violations in the past ten years; mismatched siding, west side siding dirty and different size; windows have some chipping paint; porch worn with molding wood, poor brick patchwork, sagging floor and railings; uneven walks, cracked concrete

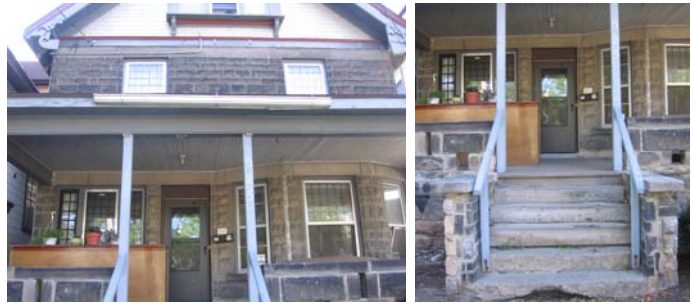
Parcel 142

Wall block dirty/stained black, pieces chipping near ground, beam above door cracked; soffit is faded, worn paint, dirty; porch brick dirty/stained black, wood ceiling separating, face paint on stone; concrete stairs have substantial chunks missing, wood worn

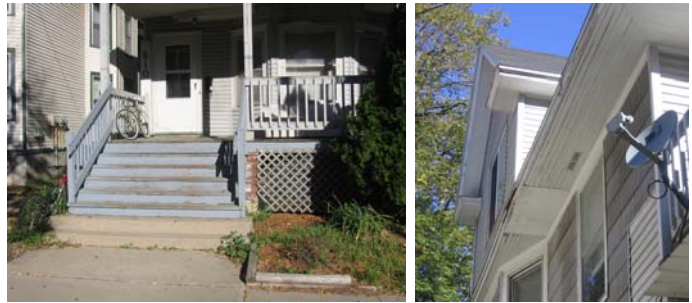
Parcel 210

Siding is dirty and has cobwebs, mismatched siding types; soffit has chipping paint, peeling pieces, rust stains, damaged on south side; window trim dirty, bent, chipping paint; porch bricks missing, overhang separating wood, chipping paint, poorly patched

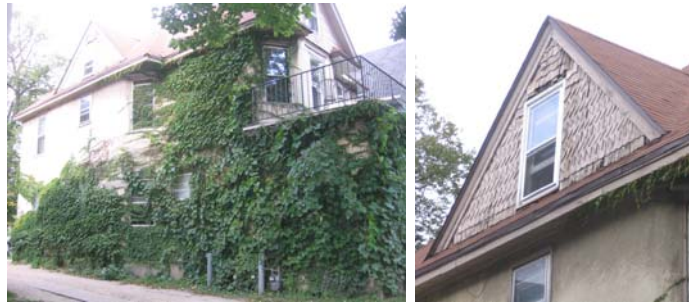
Parcel 220

Foundation has many patches; siding is dirty/stained; wood broken/chipped pieces, signs of significant rot on east wall near roof; loose shingles; ripped window screens; windows covered in vines; broken window

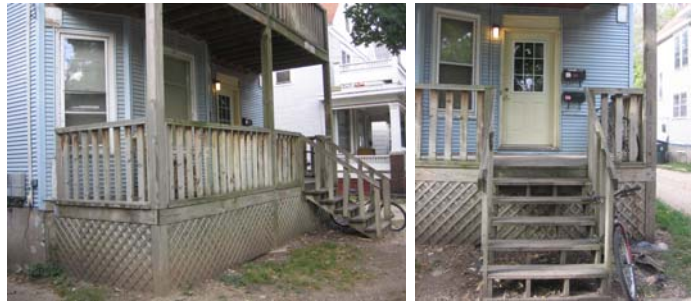
Parcel 225

Foundation has many patches, gouges and cracks; siding dirty/stained, poorly patched where porch meets house; soffit cracked and chipping paint; signs of rot in window trim; porches and overhangs weathered, molding, unpainted

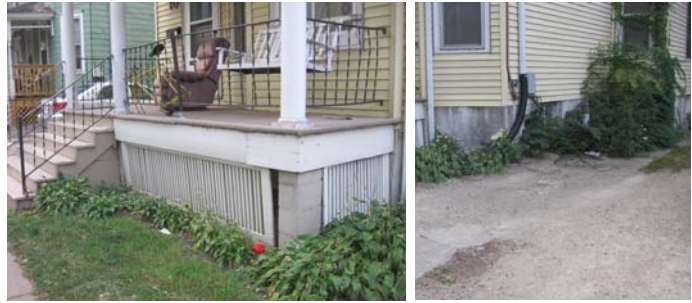
Parcel 256

Foundation has some cracks, dirty, poorly patched; siding very dirty/stained; window trim dirty, some chipping paint; porch and balcony chipping paint on railings, porch railings rusted, tilted wood panels, warped wood fascia

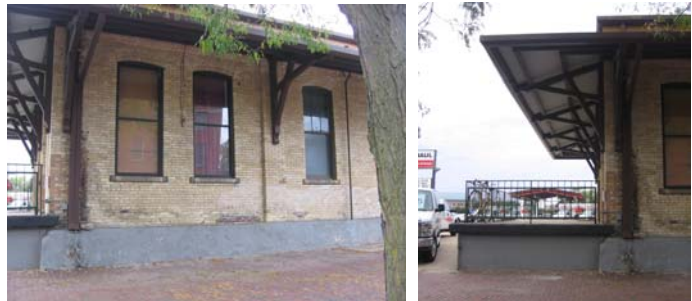
20 code violations in the past ten years; foundation cracking, chips missing, chipping paint; mismatched brick colors, mortar patchwork, red paint on brick, efflorescence, dirty; stone window sills dirt, mismatch paint on gutters; chipping paint on front steps

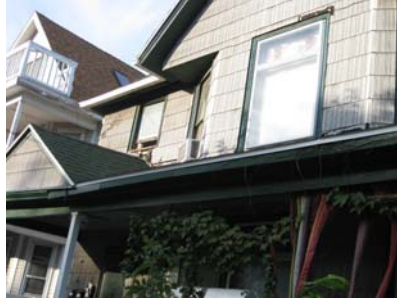
Score: 51.5

Foundation is patchy and discolored; walls and cladding are worn, have paint splatters, eroding sections along porch roof and near foundation; roof eave paint wearing off, some nail holes; porch lattice paint worn off and stained, flooring worn; gutters dirty, rusted nails

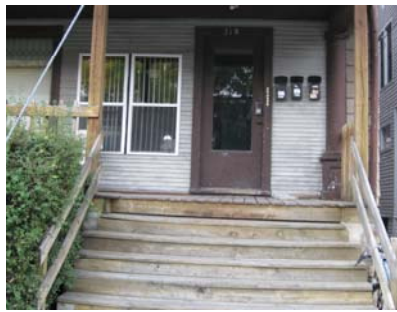
Parcel 15

Score: 56.7

Less intensive use than planned land use; foundation is dirty/stained and has significant patchwork; siding is dirt/stained with chipped pieces and mismatch siding; roof dirty/stained, some loose/damaged shingles, some patchwork; porch is unpainted, worn, broken lattice on left side

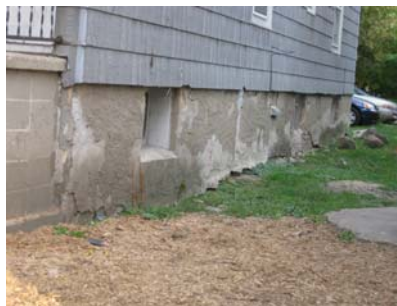
25 code violations in the past ten years; foundation front façade is discolored, pieces cracking off at base, side façade patchy, missing pieces at base; cladding worn missing pieces, missing corner strip; concrete steps crumbling, chipped

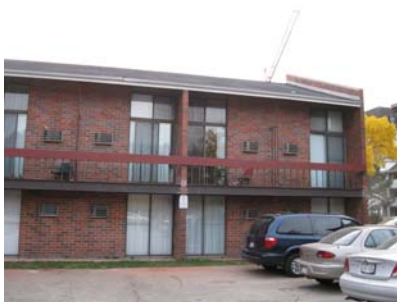
Parcel 27

26 code violations in the past ten years; walls dirty, poor mortar patchwork, loose bricks; balconies: where I-beam connects to brick; brick is patched, railings, chipping paint; gutters bent

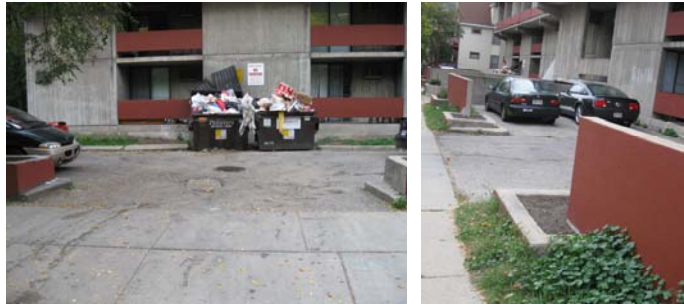
Parcel 42

29 code violations in the past ten years; concrete walls are dirty/stained, other wood surface have chipping paint, some concrete painted white, rust stains over garage area; balcony concrete cracked/chunks missing, some patchwork; concrete stairs cracked, rust stains, dumpsters overflowing and unscreened

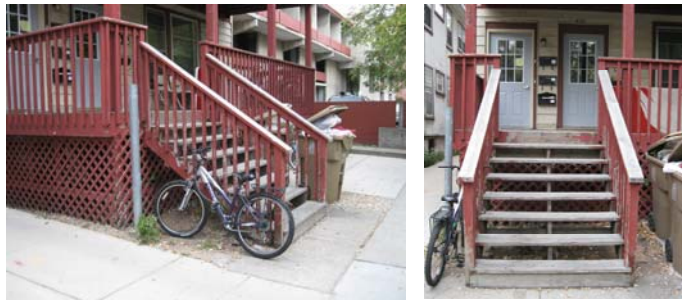
Parcel 54

31 code violations in the past ten years; foundation is dirty, many cobwebs; siding is dirty/stained, series of holes on lower right side, dents on left; porch does not match architecture of building, broken lattice skirt, untreated boards, chipping paint

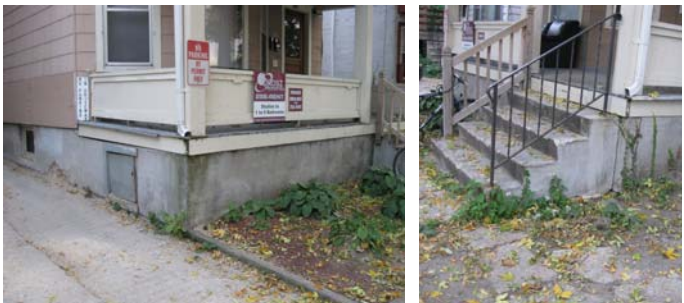
Parcel 63

Less intensive use than planned land use; foundation is dirty/stained, huge chunk missing on driveway side; walls and cladding dirty/stained, pieces missing at porch connection; porch and balcony worn and untreated floor boards, chipping paint; bare spots and weeds in lawn

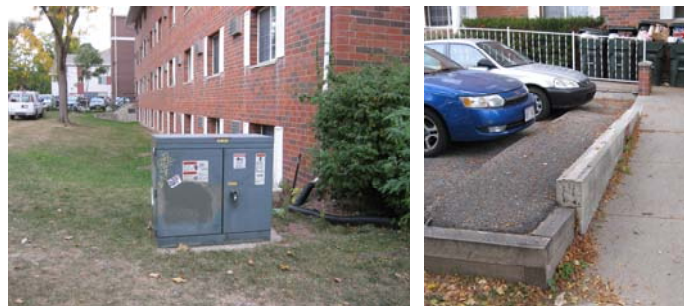
Parcel 70

21 violations in the past ten years; brick siding is dirty, some efflorescence, some eroding brick; shingles are wearing out, peeling up; some shutters are missing, others have rusty screws, some cracking caulk; concrete stairs cracked

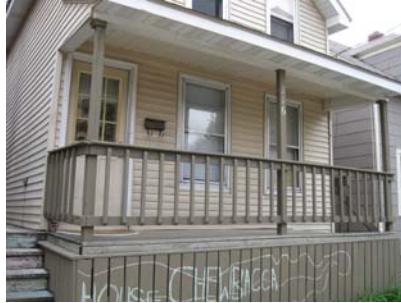
Foundation is discolored; siding is dirty in areas, roof noticeably sagging; front porch has extra blocks added to columns to keep beam level, worn flooring, porch stairs are quite worn; side door has small marks, trim dirty, door awning quite worn and dirt; chalk graffiti

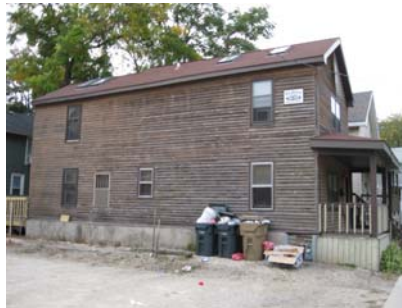
Parcel 107

Less intensive use than planned land use; foundation has minor discoloration; siding is stained, wearing off; fascia hanging loose; shingles showing wear, peeling up; paint on stairs is wearing off; front door paint wearing thin, trim wearing off

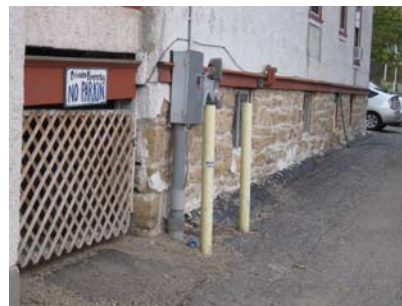
Foundation has significant patchwork, dirty/stained, cladding is dirty/stained, water damage on right side under windows; porch has unpainted floor boards, chipping paint, side lattice door unlevel; stairs untreated wood, chipping paint on railings, door is dirty

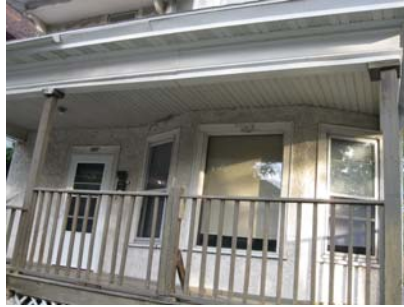
Parcel 126

Foundation paint is chipping off; walls and cladding stucco are discolored and patchy; boarded up basement windows, paint wearing off; porch beam sagging, lattice missing pieces, paint wearing off

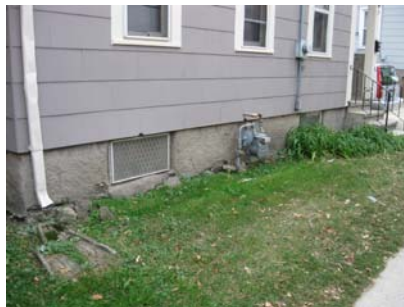
Parcel 145

Less intensive use than planned land use; foundation stucco is breaking off or missing at base, patched cracks on side; walls and cladding siding few places with dents and chipped off sections; roof shingles worn apparent water damage

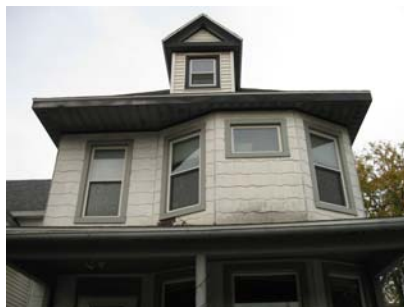
Parcel 147

Less intensive use than planned land use; foundation is dirty/stained, chipping cracks, chunks missing, some patchwork; walls and cladding dirty/stained, some pieces patched with mismatch siding; porch wood floor boards worn bare

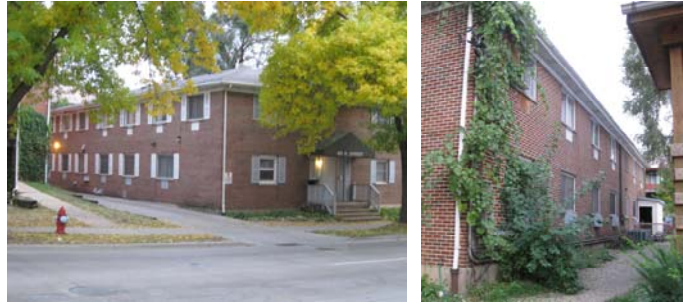
Parcel 164

Foundation is dirty/stained; brick walls are dirty/stained, former A/C unit holes under windows are boarded up, some not painted, some chipping paint; roof fading near edges, soffit pieces missing on left side of building

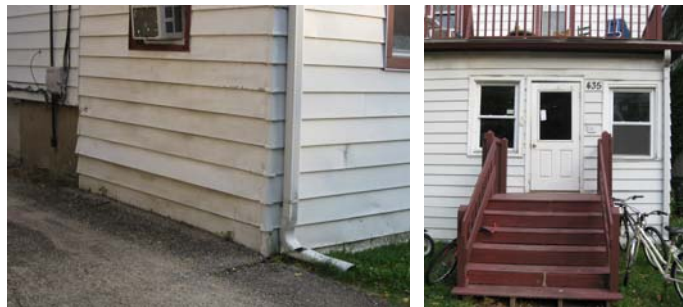
Parcel 192

Foundation is discolored, patchy; cladding dirty, rust stains, small dents; eaves minor chipping paint; basement windows are boarded, bay window paint chipping; gutters bent in sections; wood stairs wearing off, missing bottom riser, boarded up doorway on side

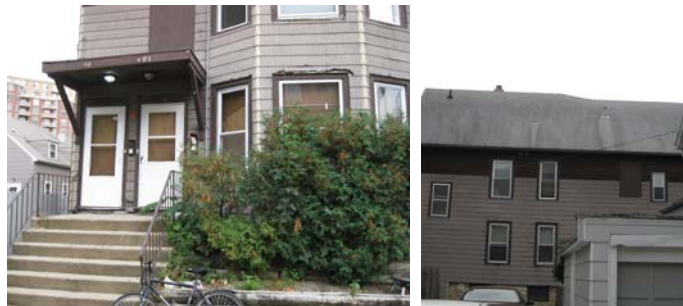
Parcel 231

Foundation concrete has irregular patching cover, missing in areas; siding is quite worn, missing material, missing all corner edging; shingles quite worn; window framing paint wearing off; door overhang boards separating

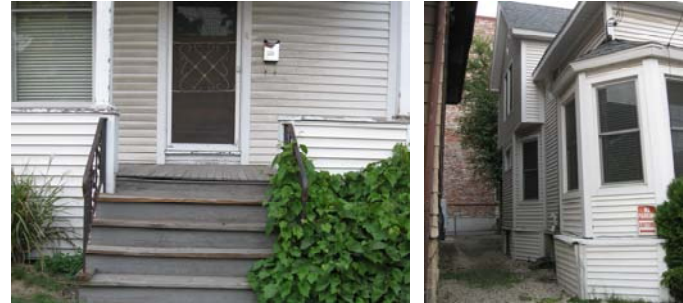
Parcel 244

Less intensive use than planned land use; siding is dirty/stained, siding connections at base of house loose, bent and damaged; porch worn sagging floor boards, chipping paint on supports and cap pieces; stairs worn treads, chipping paint, rusted railings; dirty door

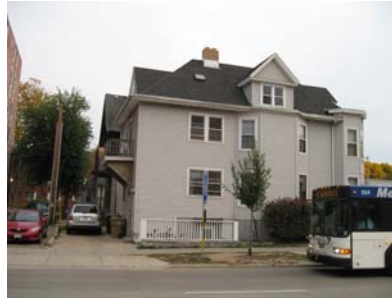
Foundation is dirty/stained, mismatched patchwork under back door, cracked and patched with expanding foam; rear balcony has untreated wood, chipping paint on railing, flashing separating/sagging; overhang has rusted flashing; front concrete stairs have chunks missing

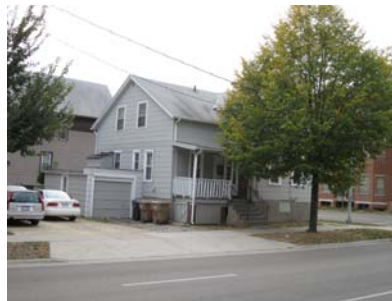
Parcel 265

18 code violations in the past ten years; less intensive use than planned land use; foundation: minor cracks; siding chipped off pieces; attached garage roof splatters, discolored, shingles worn

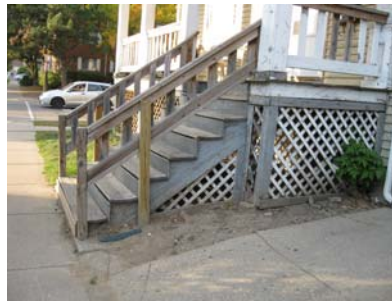
Parcel 272

Foundation on east façade is in poor condition (bulging, cracked, and chunks missing), west façade has some bulging and discoloration; siding bent and pulling up at base, corroded on most facades; window trim and cladding edging dirty

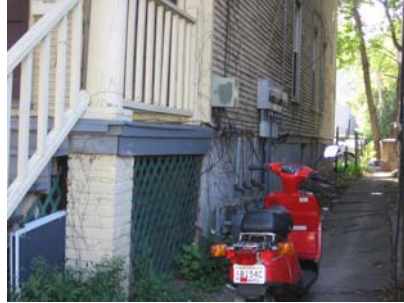
Foundation is dirty/stained, has cracks and chunks missing along driveway, poor patchwork; walls and cladding are dirty/stained; roof is faded, window trim: chipping paint, some screens on ground; porches have worn wood floor boards, chipping paint, stairs dirty

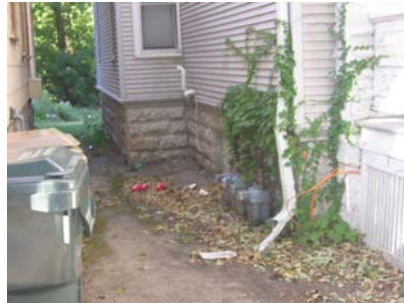
Parcel 77

Underutilized double lot; foundation on left side is chipping/flaking paint; most of foundation is not visible due to vine growth; siding stained/dirty, porch boards and railings worn, chipping paint, brick chipping paint, lattice on side bent; stairs chipping; garage doors sagging, worn roof shingles

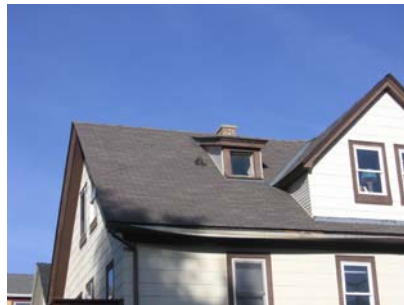
Parcel 84

Foundation has cracks, chipping paint, significant patchwork, inconsistent texture; walls and cladding dirty, rust stained, chipped siding; cornice and soffit chipping paint; porches chipping paint/stain, inconsistent lattice spacing, missing lattice

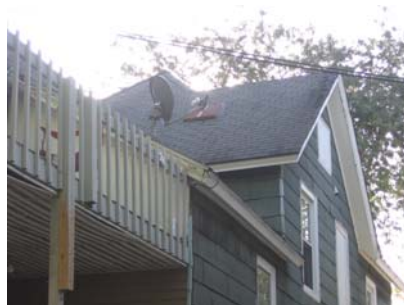
Parcel 97

28 code violations in the past ten years; siding is dirty, stained, mismatched; roof dirty, worn shingles on rights side, chunks and rows of shingles missing; two windows boarded up

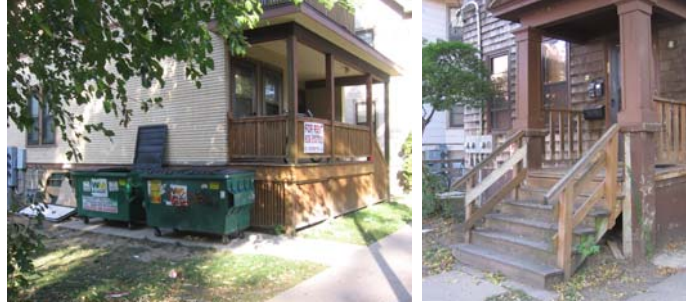
Parcel 116

26 code violations in the past ten years; walls and cladding are dirty, missing siding, mismatch paint patchwork; porch stain is fading; broken lattice skirt, gutters on side loose, some bent and stained; unscreened dumpsters

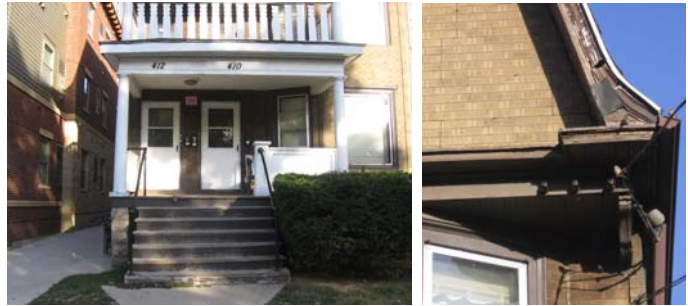
Parcel 143

Foundation is dirty/stained; faux brick siding is very dirty, has exposed seams, chipped pieces, is eroding around window frames, roof shingles fading, cornice significant patchwork, broken pieces, rotting wood; walks have significant cracks

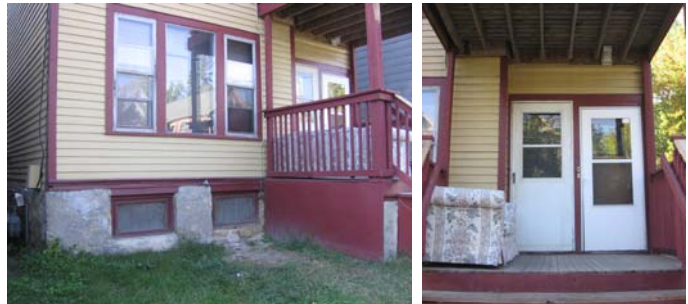
Parcel 178

Foundation is cracked, has significant patchwork; siding has chipping paint; window frames caulked, rusting; front porch floor boards without paint; balconies sagging railings; indoor furniture on porch; bare spots in lawn; rusted bike rack; scattered litter

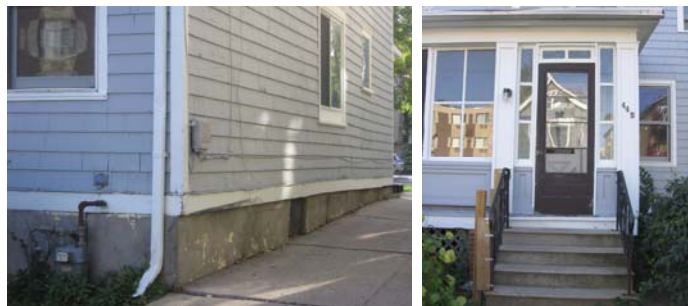
Parcel 193

Foundation is dirty, chipping paint; roof dirty with black streaks; window trim chipping paint; sun porch sagging/leaning, flashing bent and twisted; dented gutters; concrete stairs dirty, rust stains, railing is broken and oddly repaired

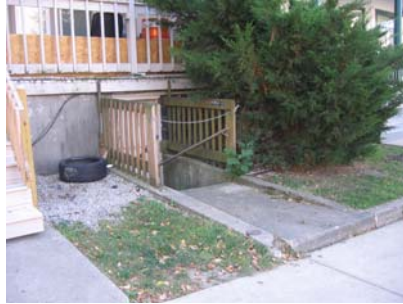
Foundation is dirty, has some patchwork, cracking and chipping; porch has worn floor boarding, molding, chipping paint, unpainted parts; balcony sagging, peeling paint on flashing; doors mismatched, basement door: dirty/molding, chipping paint; debris in stairwell

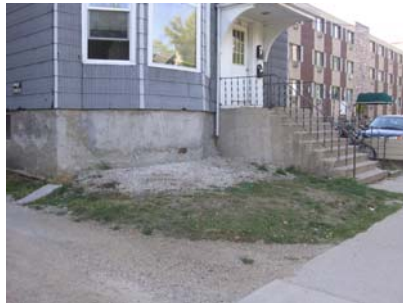
Parcel 194

Foundation is dirty/stained, has significant patchwork, budging outwards; siding dirty/stained, exposed seams, chipped pieces, poor patchwork; roof dirty, worn shingles; cornice and soffit; chipping paint, separating wood; chimney completely covered in mortar

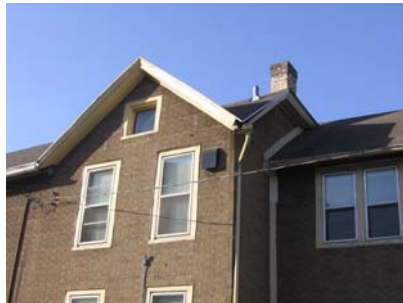
Parcel 228

19 code violations in the past ten years; cladding is faux brick siding and is dirty, has exposed seams, chipped pieces, poor patchwork; shingles are faded in spots, cornice and soffit chipping paint, unevenness in valley; porch weathered, chipping paint

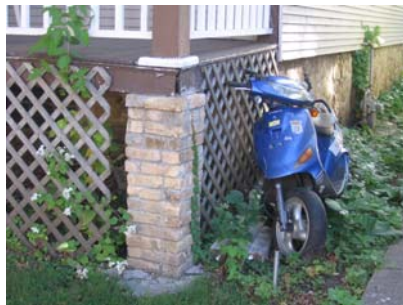
Parcel 248

18 code violations in the past ten years; foundation has significant number of cracks and chunks missing; porch has separating wood skirting, structure is separating at corner, lattice is dirty and does not fit porch dimensions; stairs worn, dirty, risers dirty, chipping paint

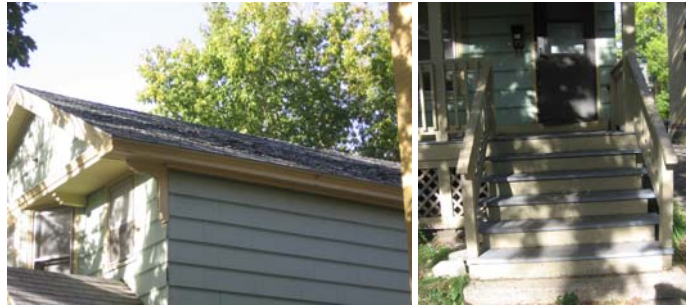
Parcel 275

Less intensive use than planned land use; foundation cracked, chipping paint, some patchwork; siding is dirty/stained, pieces broken off, shifting siding panels; windows dirty, trim chipping paint; chimney mortar missing; stairs dirty, chipping paint

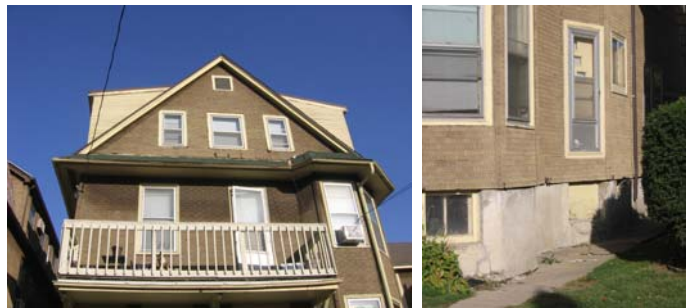
Foundation is dirty/stained, cracks, poor patchwork; faux brick siding is very dirty, has exposed seams, chipped pieces, wood siding chipping paint; main roof ok, overhang missing valley shingles, cornice and soffit chipping paint; bare spots and weeds in lawn

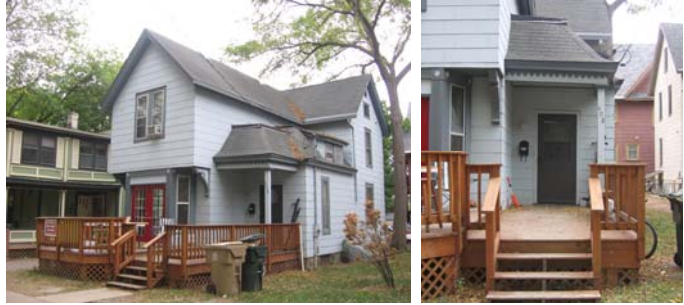
Parcel 85

Siding is dirty, weathered, missing pieces, dents; roof has bulges in places; screening missing in window with A/C unit; porch weathered/worn, no stain in one portion, porch doesn't fit architecture of building; overhang sagging

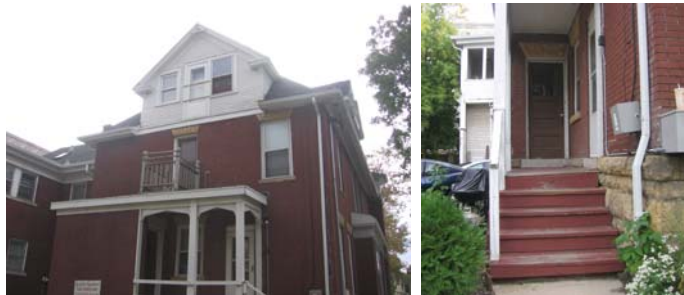
Parcel 100

30 code violations in the past ten years; brick is dirty with some efflorescence, missing mortar; wood is chipping on gables; front porch warped, worn, chipping paint, rear porch sagging, weathered, chipping paint; front doors mismatch, back balcony door boarded shut

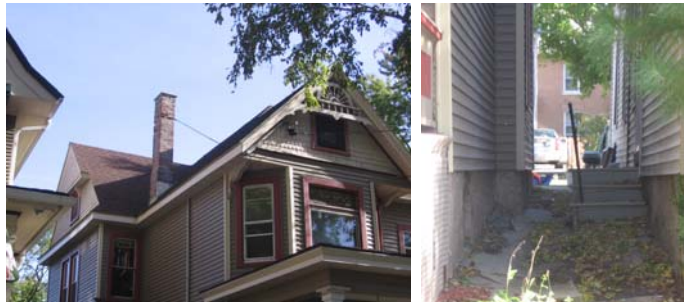
Parcel 105

Foundation has cracks and is missing chunks; siding is dirty and has cobwebs; porches have worn wood, chipping paint; chimney tethered to roof, missing large pieces of brick, flashing needs repair; stairs have chipping paint

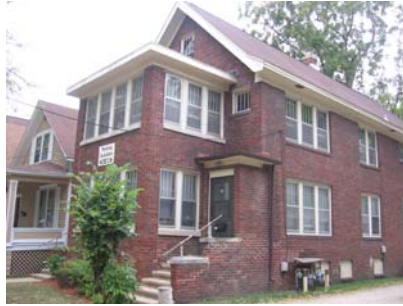
Brick is dirty, efflorescence, poorly patched mortar, brick needs tuck pointing and paint splashes on brick; roof is dirty, flashing bent and chipping paint, cornice is cracked; concrete steps have cracks, chunks missing, cheek walls have brick needing tuck pointing

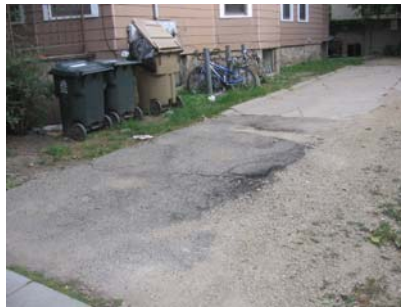
Parcel 149

Foundation has significant chunks missing, cracks, patchwork, insulation pieces wedged in between concrete and foundation; porch has untreated wood, molding; overhang chipping paint; stairs are worn/weathered treads and risers; bare spots and weeds in lawn

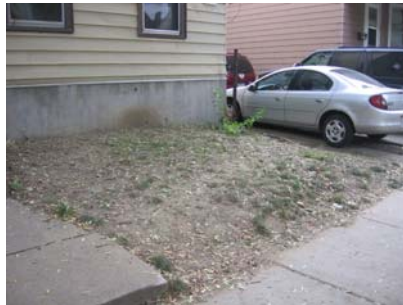
Parcel 163

Foundation is dirty/stained, has some cracks, hole in front; walls and cladding dirty/stained, fading color, vine remnants; roof patched with mismatch shingles; bay window on right side dented cornice; bare spots and weeds in lawn; rusted mailboxes

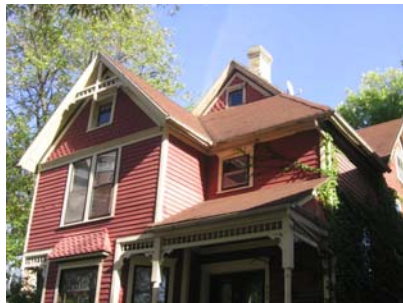
Parcel 168

Foundation has a significant crack; siding chipping paint; roof dirty and stained; cornice and soffit: chipping paint, bent flashing in places, eroding of shingles in valleys, loose shingles; retaining walls falling apart

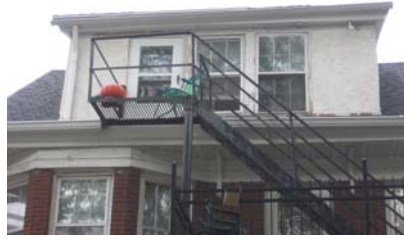
Parcel 177

Brick needs tuck pointing, has some efflorescence, has spots of poorly patched mortar, dirty, vine remnants, block and wall siding chipping paint; window screen broken, chipping paint; brick on porch separating; chimney significant patchwork, eroding cap

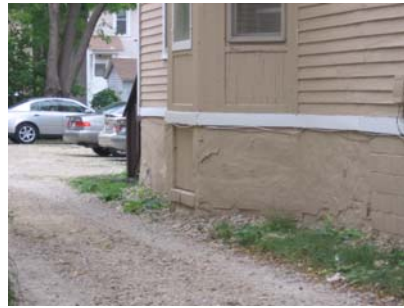
Parcel 236

Foundation has chunks and pieces flaking off, chipping paint; siding is weathered, chunks missing; roof shingles missing at edge, are folded over; windows dirty, chipping paint and paint splatter; porch panels not level, sagging

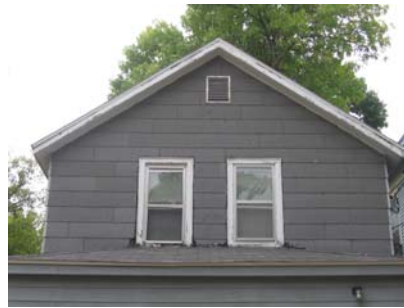
Less intensive use than planned land use; foundation has cracks; siding is dirty, has chunks missing, paint splatter; cornice has chipping paint, enclosed porch roof sagging; rusty vent on side of house; stairs cracked, chunks missing

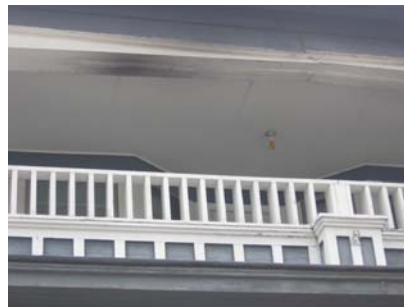
Parcel 263

Foundation is dirty/stained; siding is dirty/stained, chipping paint; window paint has chipping paint; porch brick has efflorescence, poorly patched mortar, bricks need tuck pointing, chipping paint on all wood, sagging porch; stairs dirty, cheek wall has cracks, chunks missing, poor patchwork, rust stains

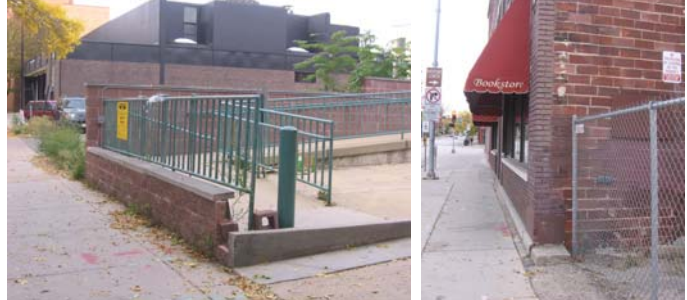
19 code violations in the past ten years; brick walls are dirty in places, brick needs tuck pointing, mismatched paint colors, patched; ramp on Mifflin concrete block broken, loose caps; garbage in parking lot area; “volunteer” trees along building edge

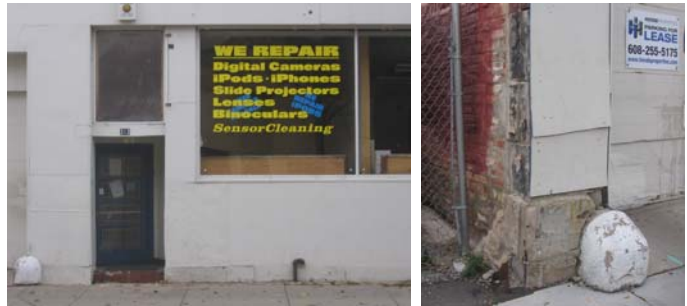
Parcel 115

26 code violations in the past ten years; partial occupancy; less intensive use than planned land use; walls and cladding are dirty/stained, painted red on side; mismatch paint on both buildings; some patchwork in rear; rusty emergency exit; cracked asphalt parking lot
