1. EXECUTIVE SUMMARY

The City of Madison is considering creation of a Tax Incremental Financing District (TID) in an area that includes parcels on Johnson St. and Dayton St. This blight study seeks to determine what percentage of the identified parcels, by area, are blighted as defined by Statute 66.1105(2)(ae)1. MSA evaluated 285 parcels, eliminated 2 due to active construction or inadequate access, and scored the remaining 283 parcels using a scoring tool developed to standardize the evaluation process. We visited each parcel in September and October 2012, taking pictures of conditions and recording those conditions in the scoring tool.

2. PARCEL AND STRUCTURE SURVEY METHODOLOGY

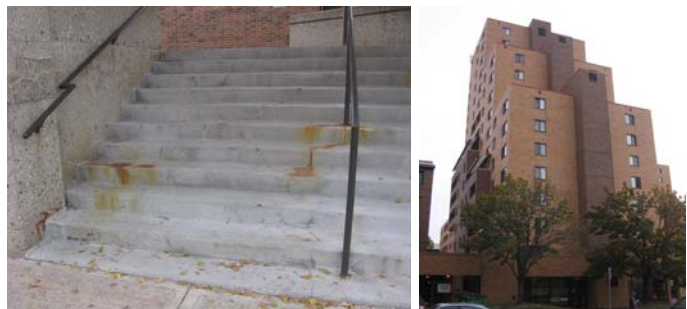
Parcel 264

Brick walls are dirty/stained in places; roof on Broom and Johnson fading metal; awnings dirty; vents dirty and rusting; stairs have rust stains; concrete curbs cracked, exposed aggregate; dumpsters in drive; dead/missing shrubs

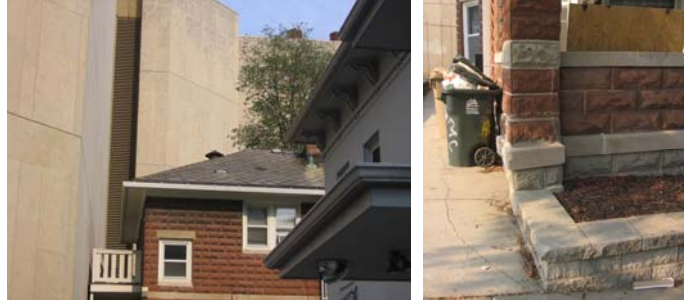
Less intensive use than planned land use; walls and cladding are dirty/stained, moldy, has poor caulk repairs; roof is faded, discolored/stained and poorly patched; poorly patched chimney; cheek wall of stairs cracking and separating from steps; buildings out of scale to surroundings

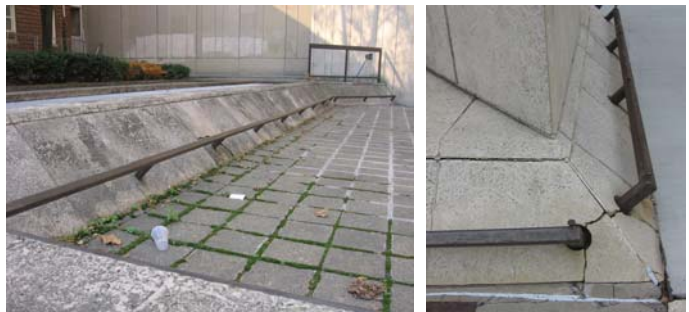
Parcel 211

19 code violations in the past 10 years; walls and cladding are dirty/stained, there is missing grout; stairs and retaining walls are fenced off due to significant decay, chipping, loose and broken pieces, rusty railings; pavers are loose and broken

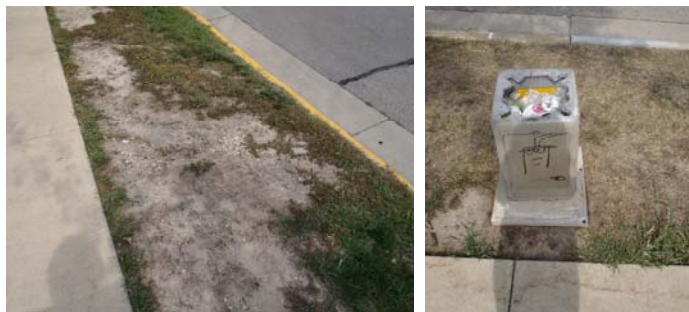
Parcel 283

Vacant and undeveloped parcel; graffiti on light pole; grass is long and weedy; former sign foundation with exposed and rusty rebar; missing street light and pole sleeve used as a trash can, open rusty pipe; erosion in bare areas in terrace

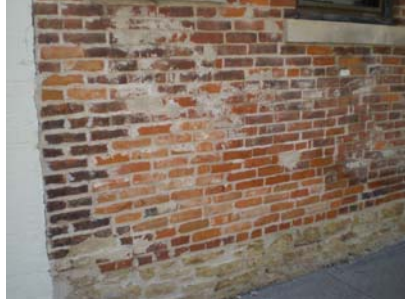
Vacant property; walls and cladding are dirty/stained, some bricks need tuck pointing, cornice looks rough, chipping paint; awning discolored and stained; windows dirty, trim chipping paint; balcony rusted

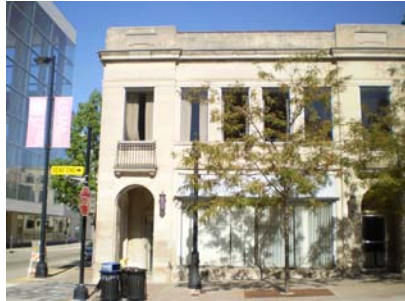
Parcel 98

Appears at least half vacant, no signs of use; walls and cladding are dirty/stained; window broken with duct tape, rusted frames, poorly patched window frame; missing vent covers, stoop missing tiles; litter in doorway

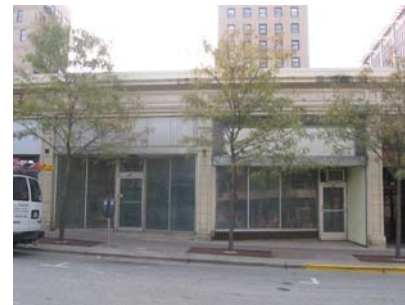
Parcel 111

Vacant, single story building; walls and cladding are very dirty; windows dirty; faded metal, poor patch spots, board used to patch ceiling on overhang; doors dirty, rust at base of door

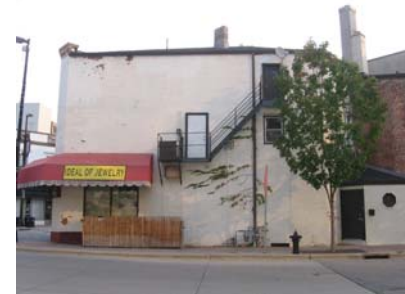
Parcel 140

Ideal Jewelry is vacant; walls and cladding are dirty, with chipping paint, significant cracks and patchwork; chimney brick needs tuck pointing, missing mortar; vents sealed with expanding foam and are rusted

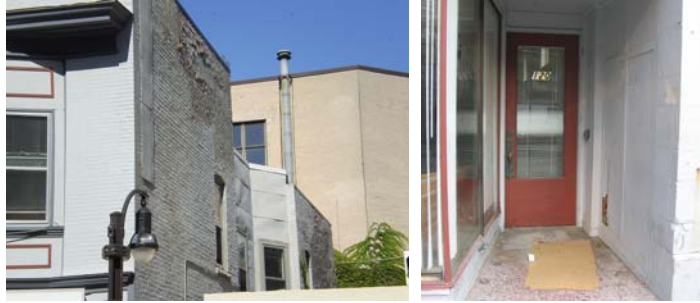
Score 57.5

Vacant; walls and cladding have some chipping paint on front, side has significant chipping paint patchwork and crumbling brick; vent stack in rear is rusted; stoop cracked, discolored; cardboard in entry way

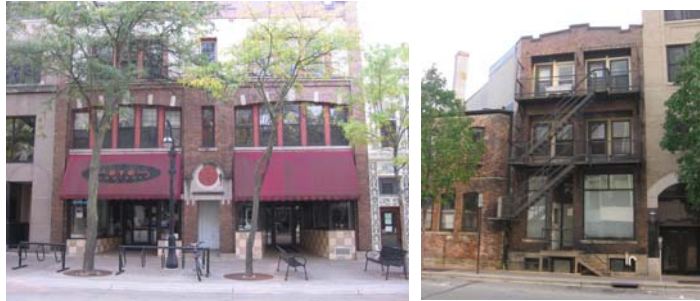
Parcel 195

Score 59.7

Walls and cladding are dirty/stained; windows are dirty, have chipping paint, awnings are very dirty and are fading colors; chimney chunks missing, poor patchwork; fire escape rusted, stairs warped and missing boards, chipping paint

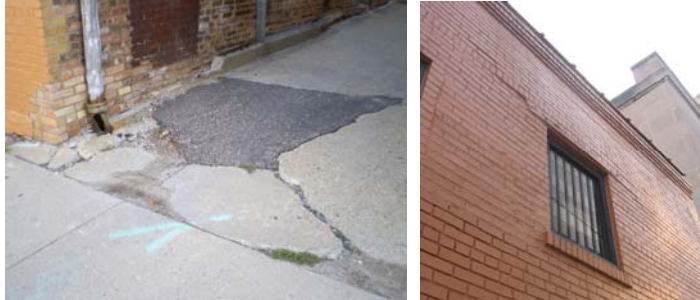
Parcel 198

Score 38.9

Vacant; single story; walls and cladding are dirty/stained, bricks need tuck pointing, some bricks are bulging, mismatch paint, peeling/chipping paint; rusted gutters with holes; concrete drive cracked, patched with asphalt

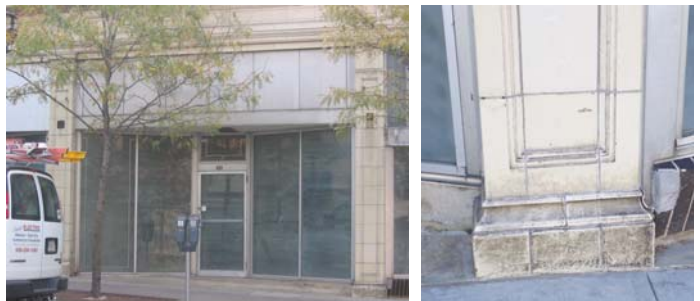
Parcel 240

Score 51.2

Vacant; single story; walls and cladding are dirty/stained, vent above door rusted; windows and trim dirty; drives eroded walkway, cracks, poor patchwork, red spray paint on side wall

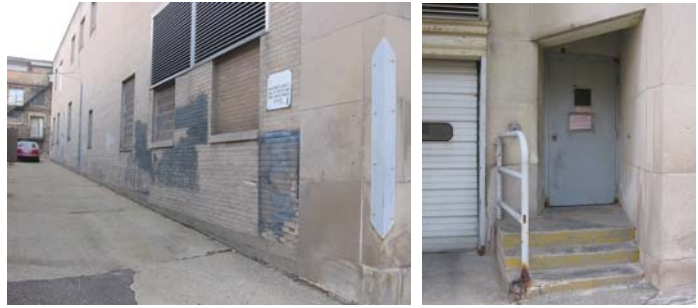
Parcel 245

Score 41.9

At least partially vacant; walls and cladding have significant dirt and stains, brick in rear has splattered paint, mismatch brick, some cracks in mortar; alley windows filled with mismatch materials; concrete stairs have missing chunks, exposed aggregate

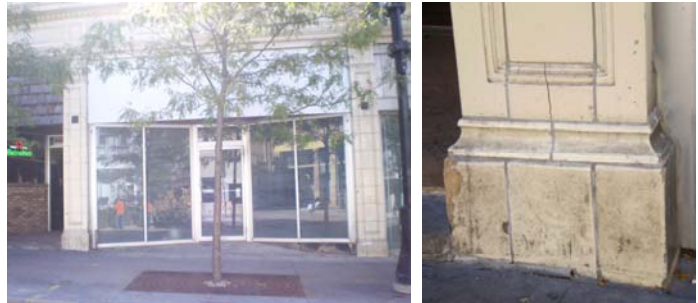
Parcel 249

Score 57.7

Vacant; single story; walls and cladding: dirty/stained; chipping paint on right side; vent above door rusted, windows dirty

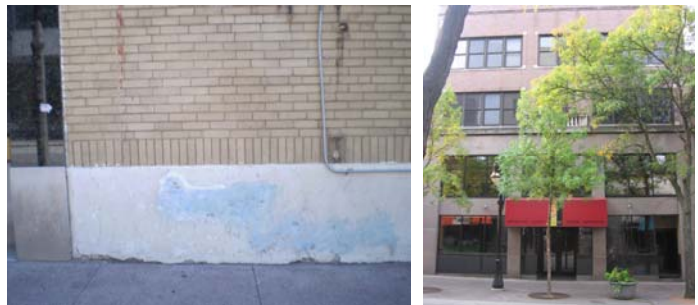
Parcel 268

Score 46.9

Vacant; front brick and stone dirty/stained, rear walls have graffiti remnants; windows are missing screens; rear window well chipping paint, boarded and patched poorly; rear awning is dirty/stained; main entry is dirty and has cobwebs

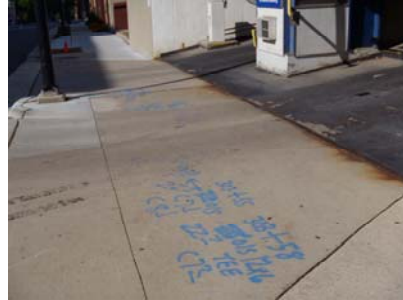
Score 53.8

Parking ramp is not a preferred use; walls and cladding have exposed aggregate, cracks, missing chunks, significant patchwork, exposed rebar; drives have rusted expansion joint, writing on concrete, stained/dirty, chipping surface coat

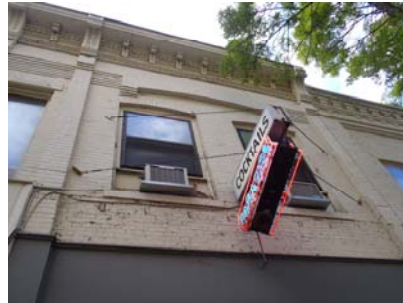
Parcel 20

Score 58.7

Foundation has cracked base stone, poor patchwork; walls and cladding have chipping paint, brick needs tuck pointing; windows dirty, chipping paint on trim, boards to fill windows; rusted vent in concrete walk

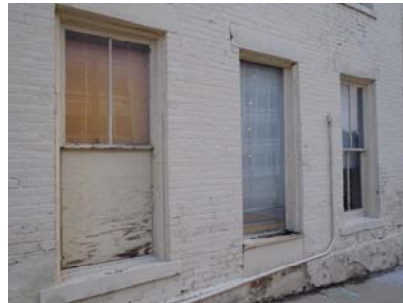
Parcel 64

Score 49.6

Foundation is chipping, chunks missing, chipping paint, significant patches; walls and cladding have bricks that need tuck pointing; staircase on side chipping paint, mismatch rusty railings

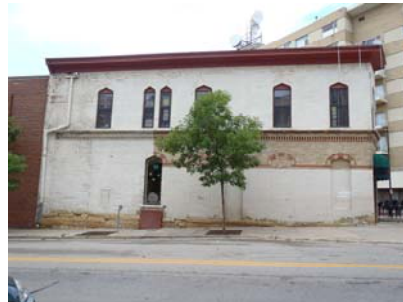
Parcel 152

Score 55.0

Foundation blocks are crumbling and exposed, chipping paint and cracking; walls and cladding bricks need tuck pointing, chipping paint; all window trim paint wearing thin; rusted gutters, chipping paint; rusted cigarette container

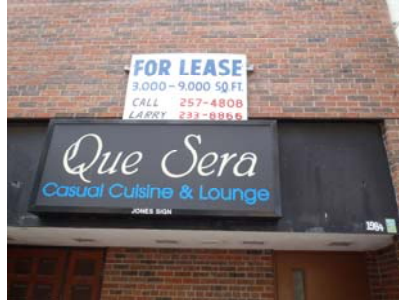
Parcel 216

Score 41.1

For lease sign posted, no signs of occupancy; walls and cladding near rear door have cracked brick; sidewalk is missing concrete and is patched with asphalt; missing street trees, scattered trash and debris

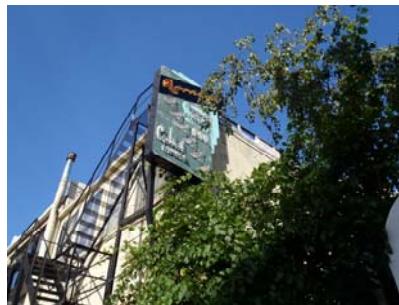
Parcel 232

Score 57.0

17 code violations in the past 10 years; stone is patched with concrete, mortar patched poorly, rear wall by door crumbling wall; main entry chipping paint, rusted iron; overgrown vines

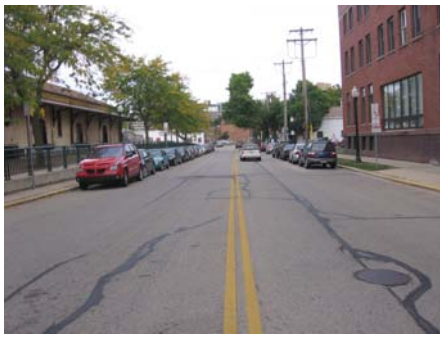
Bedford Looking NW
(cracks, tarred cracks)

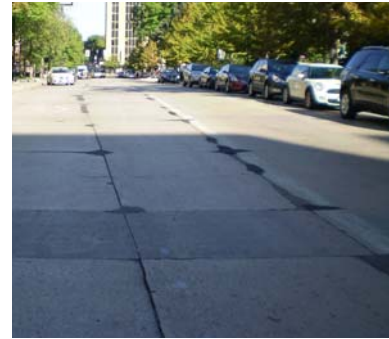
Carroll looking NW
(asphalt patching)
