TID 32 Amendment – Blight Study

April 16, 2010

City of
Madison,
Wisconsin

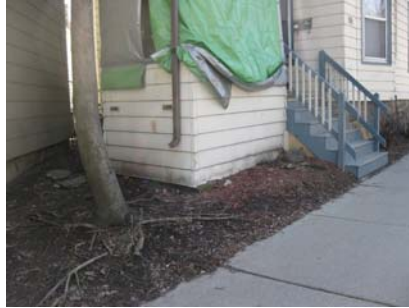
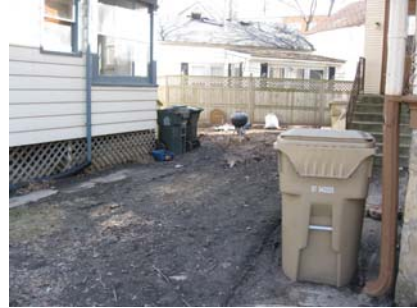
Parcel 123

Score: 58.6

Foundation has cracks and is bulging in areas; Cladding is dirty and mildew is present; insulation coming out of siding; roof flashing is very rusted; boarded up basement windows; chimney missing bricks; walkway has cracks and is heaving; piles of trash present

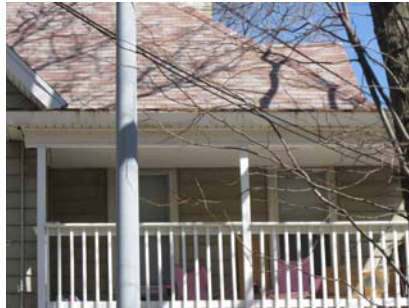
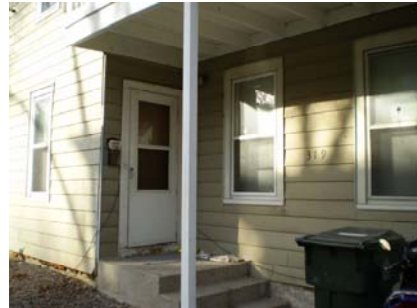
Parcel 124

Score: 59.1

Discolored foundation; Paint peeling and mismatch of paint color; missing mortar in brickwork; paint peeling from window and door frames; stairs missing material and eroding in other areas; piles of trash present

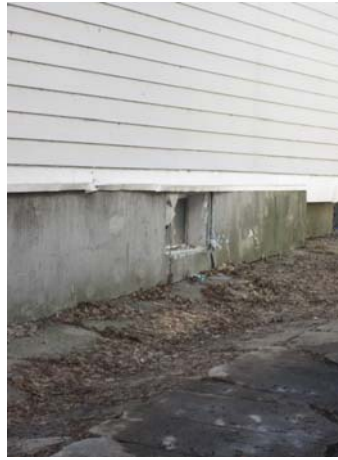
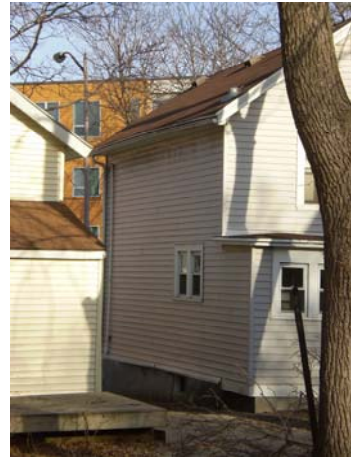
Parcel 126

Foundation is cracked, missing material, discolored and stained; cladding is very dirty and portions are bent and dented; lattice work around porch in poor condition; paint wearing on steps; cracked driveway; graffiti present

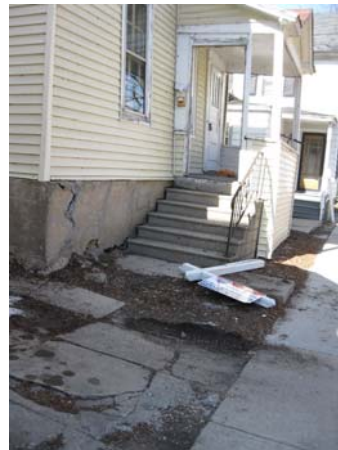
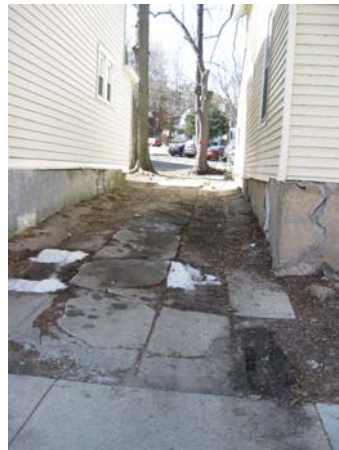
Parcel 127

Bulging foundation (house is leaning); cladding is very dirty; roof has a water leak, is missing gutters and flashing is heavily rusted; paint peeling off window frames; steps are leaning; driveway is cracked and heaving; piles of trash present; 14 code violations in last 5 years

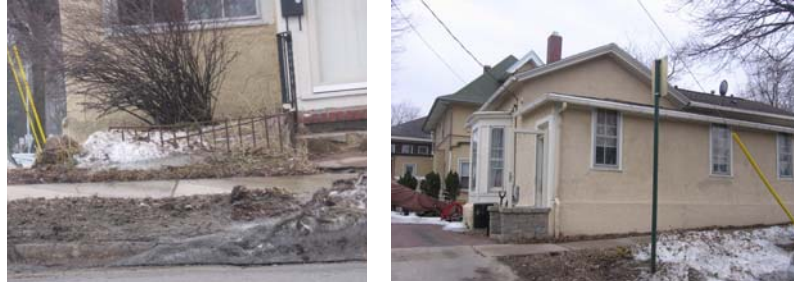
Score: 59.2

Some discoloration on walls; some paint chipping off window sills; uneven porch foundation; steps are cracked and missing concrete; iron fence is broken, rusted, and bent; missing cover over light fixture; some discoloration on driveway; 6 code violations in last 5 years

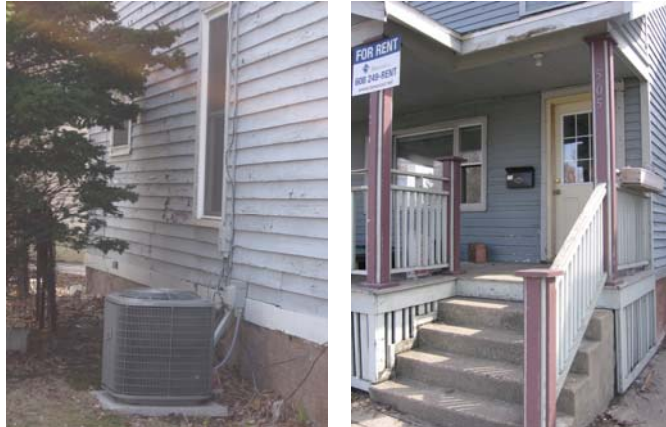
Parcel 131

Score: 57.5

Foundation discolored; cladding paint is wearing thin (very bad on side); window frames' paint wearing/worn off; boarded up window; paint wearing/worn off roof eaves; canopy deteriorating (railing posts broken/missing, woodwork paint is cracking and wearing off, etc.); steps are discolored; door frame in poor condition and base of door marked up; driveway deteriorating; no cover over light fixture

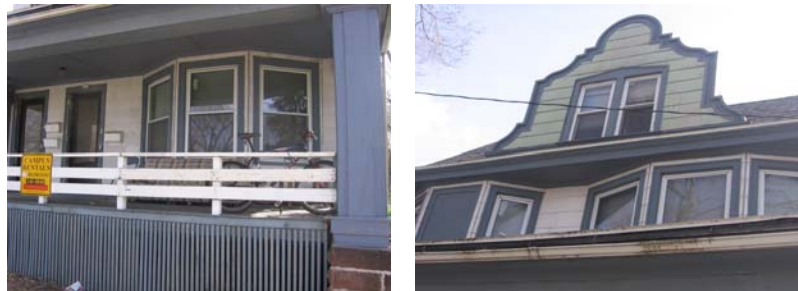
Parcel 132

Score: 53.2

Discolored foundation; Cladding in poor condition (dirty, sagging, stained, and worn); roof shingles buckling and worn; porch lattice is dirty and paint is wearing off; paint wearing thin on the porch woodwork (cracking in areas); rusted vents; boarded up upper-story doorway unsightly; paint wearing thin on door frames; doors are discolored and are marked up

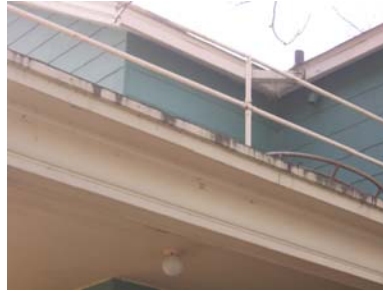
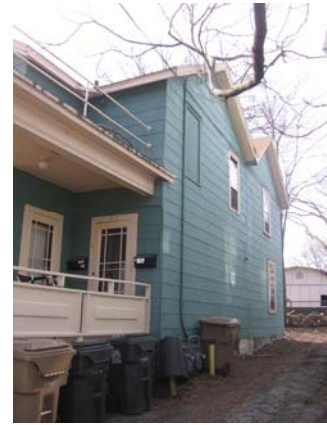
Parcel 138

Score: 46.0

Patchy foundation; cladding is dirty, paint is wearing thin, and dented in sections; shingles are worn and some gutters are damaged; window framing dirty and boarded up window on side is unsightly; canopy in poor condition (ceiling panels warping, discolored column brickwork, cracked woodwork); driveway is deteriorating; the walkway has cracks and is uneven

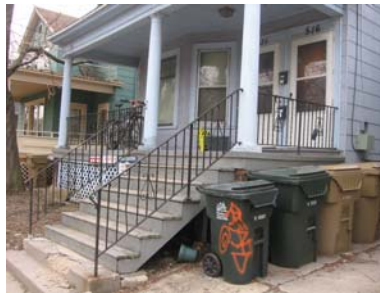
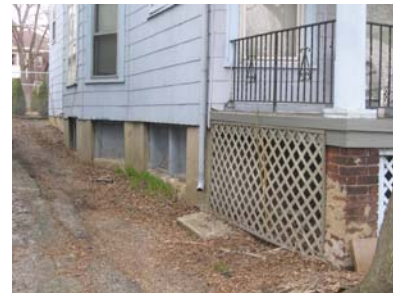
Parcel 139

Score: 48.6

Patchy foundation; Cladding is very dirty, paint is worn/wearing thin, and in areas missing/broken siding; window frames are dirty and paint is cracking and wearing thin; porch columns has rust staining, paint cracking, and mismatch of paint color; lattice work very dirty and paint is wearing off; steps are discolored, (rust) stained, and missing material; unscreened garbage containers in front setback with graffiti on one of them; driveway deteriorating;

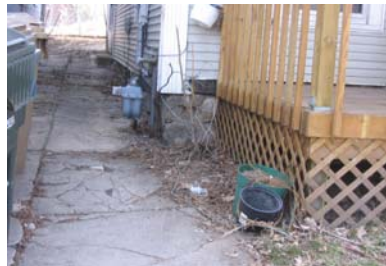
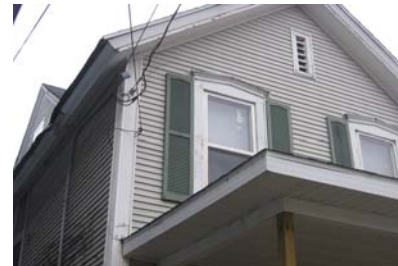
Parcel 140

Score: 54.1

Discolored foundation; paint wearing off vents; paint wearing off roof eaves and fascia board warping (hanging off); window framing in poor condition (paint wearing off, cracking, rust staining); walkway has cracks and missing concrete; junk present in lawn and on porch

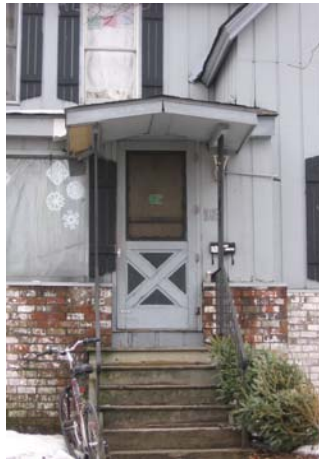
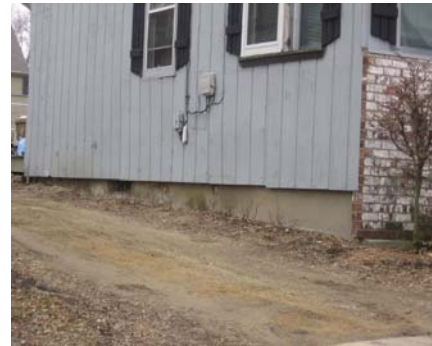
Parcel 142

Score: 54.0

Foundation discolored; cladding is dirty, paint is wearing thin, and mismatched blue paint on front; paint wearing thin on roof eaves; flashing along roofline is rusted; canopy missing section in middle and metal supports are rusted; stairs has major discoloration; paint on door and framing is peeling and cracked; gravel driveway is uneven

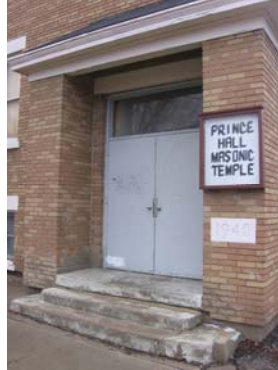
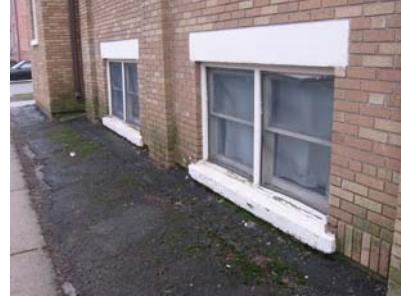
Score: 53.6

Brickwork is discolored (possible water damage) and moss is growing in mortar joints; paint on roof eaves wearing/worn off; window framing is dirty and paint is wearing thin; lower window concrete sills in bad shape and side windows boarded up; stairs are cracked and paint is wearing/worn off; rusted and dented doors and paint wearing off frames; paved area along building is cracked, uneven and patchy

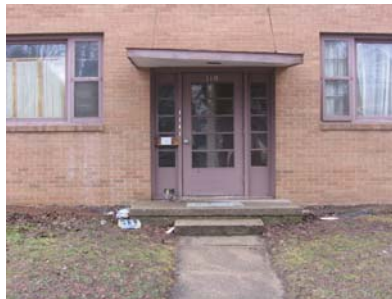
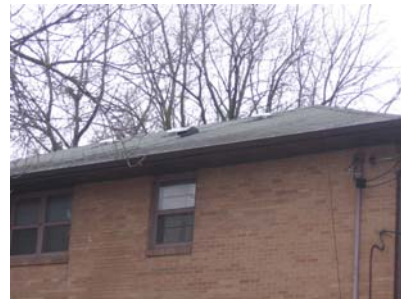
Parcel 147

Score: 57.5

Roof shingles worn; window frames are stained, has cracks, and paint is wearing off; canopy is warped and cracked at corners; stairs are discolored; fence is bent in sections; parking is cracked, uneven, and discolored; piles of trash are present

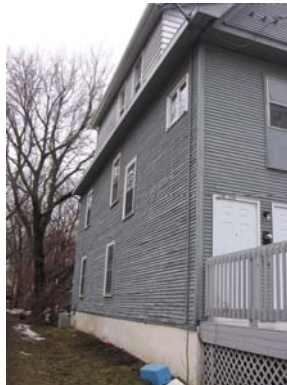
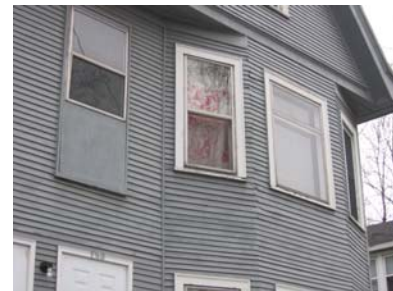
Parcel 148

Score: 51.5

Some staining along foundation; cladding in poor condition (warped, cracked, missing, and water damage along side); cracks in roof eaves and paint is wearing off; window sills warping and paint is wearing/worn off; poorly converted doorways to windows; cracks in driveway; trash along side of building

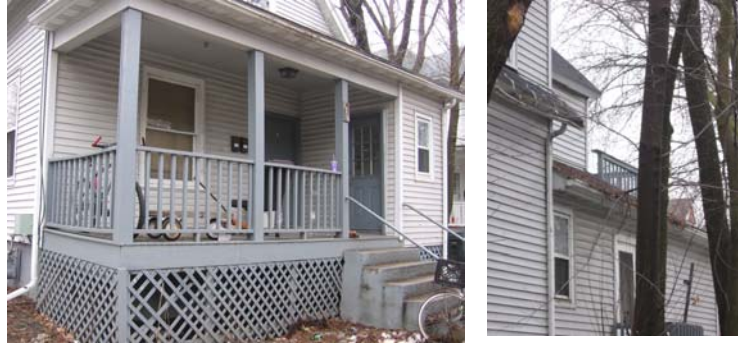
Parcel 150

Cladding is dirty, and bent/broken in couple spots; worn shingles (possible water damage); bent and dirty gutters; chimney in poor condition; discolored and poorly maintained stairs; door is dented and dirty; broken lattice screening; side fence bent and rusted; uneven drive access; missing concrete near expansion joint

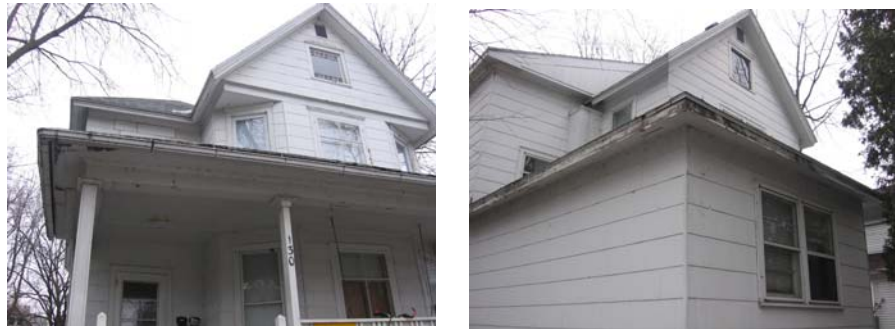
Parcel 151

Cladding dirty and discolored; paint wearing/worn off roof eaves; rusted gutters; very worn window framing and poorly closed off window (upper left); porch woodwork dirty and paint wearing off; stairs are very dirty and rust stained; fence is bent and broken; discolored driveway and cracked/uneven walkway

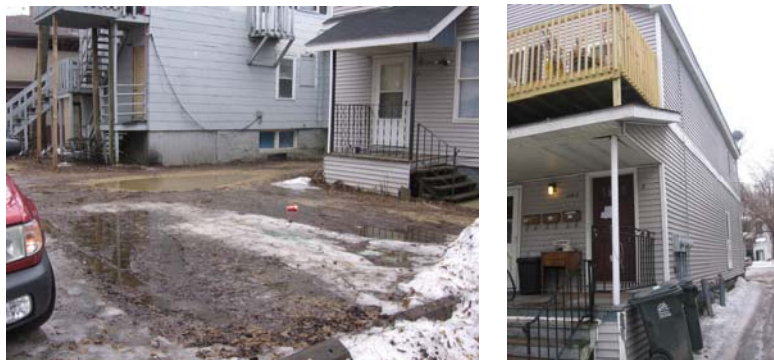
Parcel 152

Foundation has cracks, discoloration, and moss growing; cladding is dirty, dented, and missing metal siding in sections; shingles are worn; porch has metal ceiling coming off and dirty/stained metal columns; side doorway missing stairs; stairs have cracks, discoloration, and paint coming off; uneven gravel driveway/parking area

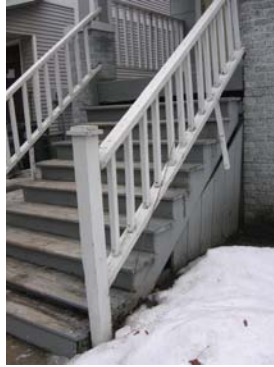
Score: 45.1

Mold (water damage), discoloration, and missing pieces along foundation; cladding is dirty, discolored, dented, cracked, and warped; boarded up windows; roof shingles are very worn and missing in areas; cracked fascia board; stairs has cracks, warped boards, and missing posts in the railing; door frames are dirty and worn; uneven gravel driveway

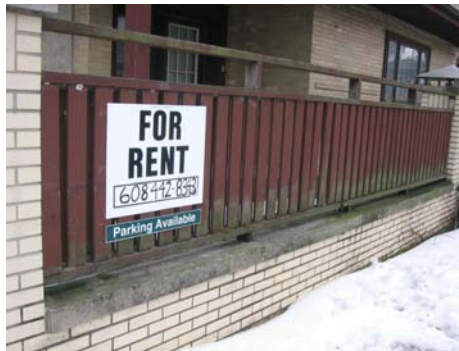
Parcel 154

Brickwork worn and some small holes in brick; roof eaves are worn (cracking, paint wearing off, etc.); porch screening has water damage, and porch column's paint is wearing off and rotted at the bottom; some discoloration on steps; front door is worn and sealant at brick edge is an eyesore

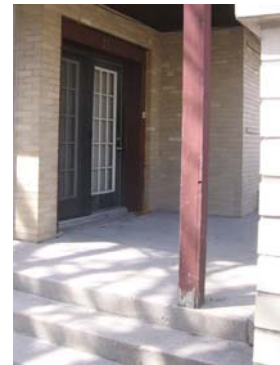
Parcel 153

Score: 58.1

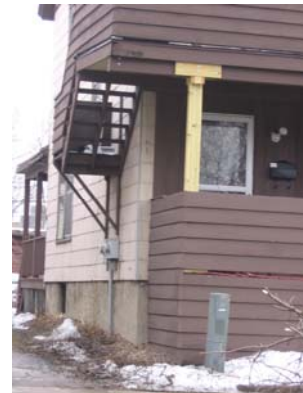
Score: 54.0

Discolored foundation; front cladding has minor cracking, a mismatch paint job, and areas of worn paint; side cladding has apparent water damage (mold growing), some worn fascia boards; window sills has cracks and are missing paint; porch in poor condition (warped flooring, no effort mask repaired column, missing wood section, & paint wearing); driveway is uneven, patchy, and has cracks; walkway is discolored

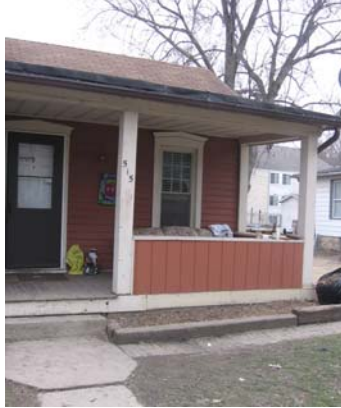
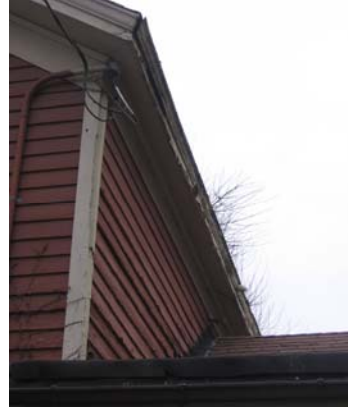
Parcel 158

Score: 49.8

Second floor cladding is cracking and paint peeling/wearing off; roof shingles very worn and coming up; tarred area along roofline unsightly; roof eaves in bad shape; porch in poor condition (dirty and cracking column, flooring dirty and paint wearing off, exposed roof membrane, etc.); fence along side very weathered

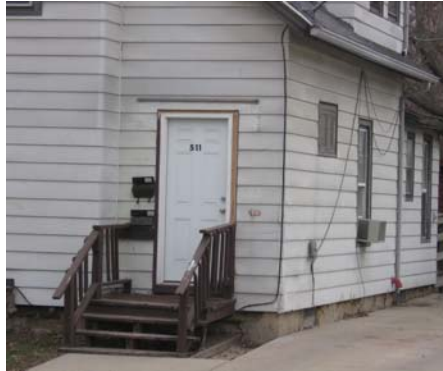
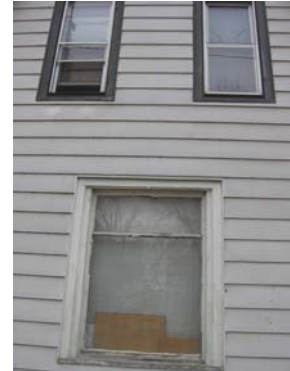
Parcel 159

Score: 57.0

Patch cracks in foundation; cladding is very dirty with dents and holes in areas; tarred joint between dormer/roof unsightly; roof eave along side in poor condition; paint wearing/worn of window framing; resemblance of past awning over front door; paint wearing/worn off stairs and railing

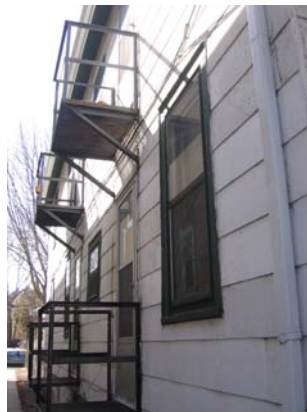
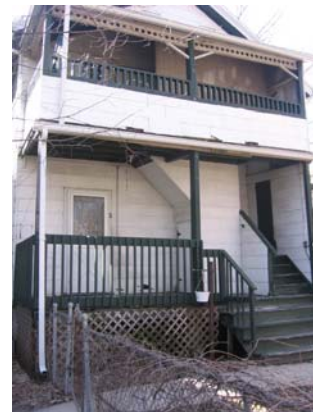
Parcel 164

Score: 48.3

Foundation is discolored with patches of paint; cladding is very dirty with areas of rust staining, dents, and missing siding; roof shingles worn and paint is wearing off roof eaves; back deck is poorly maintained (dirty, paint wearing off, patches of random paint, and discolored trellis); paint on stairs wearing/worn off and railing is quite rusted; unscreened garbage containers in front lawn; 14 code violations in last 10 years (8 in last 5 years)

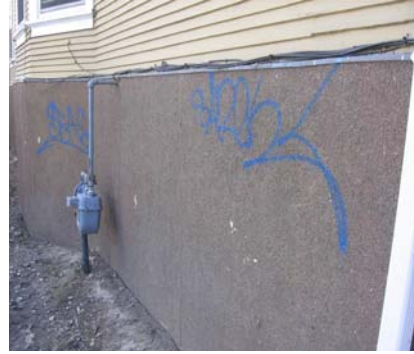
Parcel 165

Score: 44.7

Foundation is dirty, bulging, and marked by graffiti; dormer's siding is worn and has water damage; roof eaves paint is wearing/worn off; window frames are dirty and have cracks; upper story porch very dirty ceiling and paint peeling on woodwork; paint is cracking and wearing off staircase; retaining wall falling over and no lawn – just mud/dirt

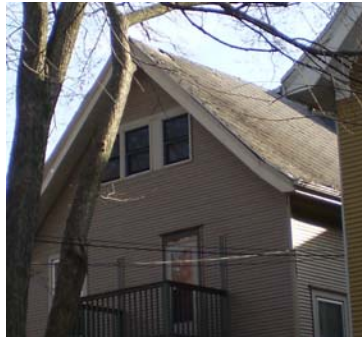
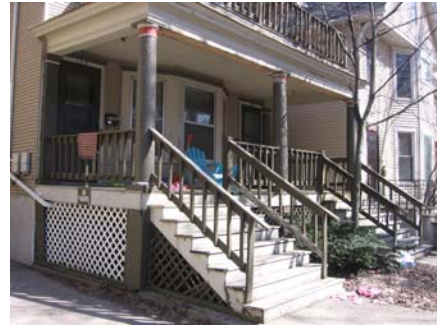
Parcel 166

Score: 56.7

Roof shingles worn and flashing coming up; paint has worn/wearing off boards surrounding windows; porch beam sagging in middle and paint is wearing/worn off woodwork; paint is worn off wood steps and railings, lattice work is broken on side; garage roof won, flashing rusted, and missing garage doors

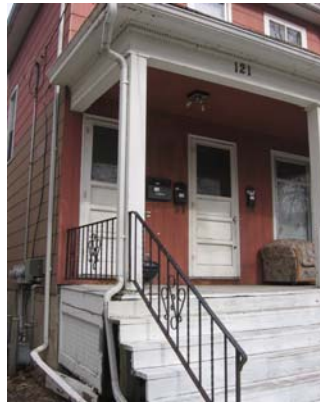
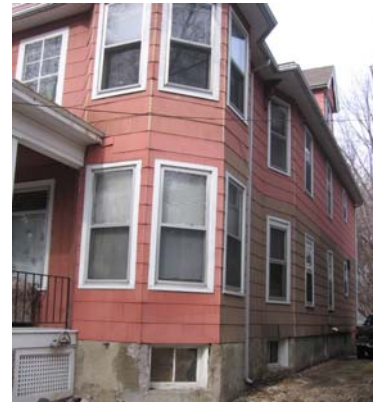
Score: 56.9

Patchy and discolored foundation; cladding dirty, paint wearing off, and mismatch of color on side; porch poorly maintained (floor boards buckling, roof eaves and support beam very dirty and paint wearing off, flashing rusted, and lattice work broke); stairs rusted (from rusted railing) and paint wearing off; light fixture missing cover; discolored driveway

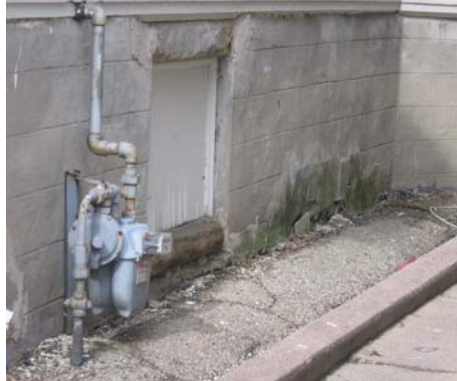
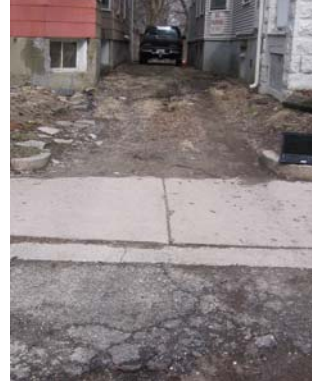
Parcel 169

Score: 58.4

Foundation discoloration and water damage along side (stained and broken blocks); corner fascia board cracking and paint wearing/worn off; dormer window boarded up; porch poorly maintained (gutter broken, column paint cracking, concrete deteriorating from brick base, etc.); door discolored and bottom of frame deteriorating; access drive and driveway in very poor condition (missing material, major cracks, etc.)

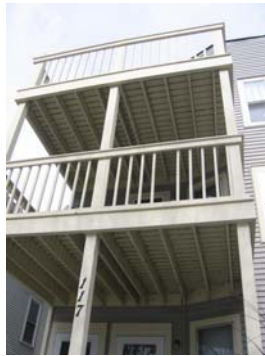
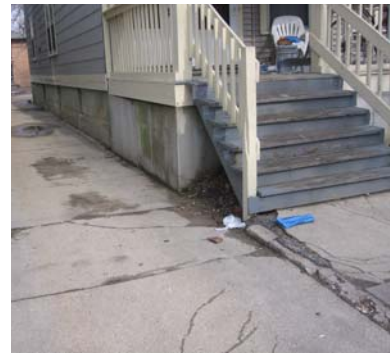
Parcel 170

Score: 55.9

Foundation discolored (moss growing wet areas); cladding is broken, dented, coming up, and worn/dirty; window paint is cracking and wearing thin; porch poorly maintained (flooring is dirty and paint wearing off, railing discolored, decking dirty, etc.); stairs have rust staining and paint is wearing/worn off in areas; driveway has cracks and missing material; walkway is uneven with cracks

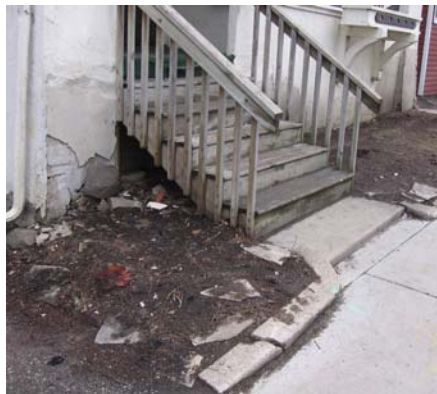
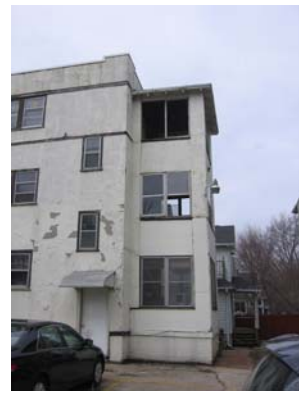
Parcel 173

Score: 37.0

Discolored and cracked foundation; Wall paint is peeling, bubbling up, and is completely gone in areas; cladding is missing in areas; side window frames the paint is wearing/worn off; front window screening broke; back closed in porches in very poor condition; no weather protection or has worn off staircase; poor lawn maintenance - junk in lawn, broken planter curb, no lawn or mulch

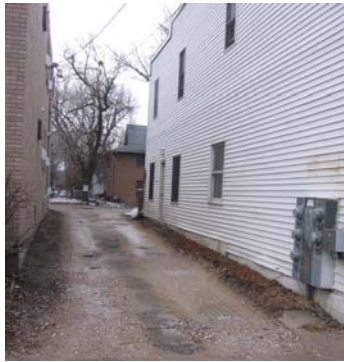
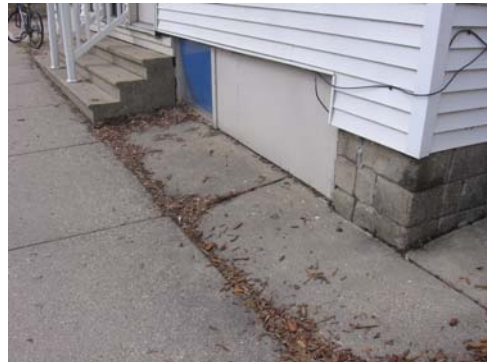
Parcel 176

Score: 58.0

Discolored foundation; siding is very dirty in spots; basement windows boarded up with worn wood and plexiglass; stair railing has some discoloration and past railing has stained steps; driveway has deteriorated to the point that it is mostly gravel; graffiti present in a few locations

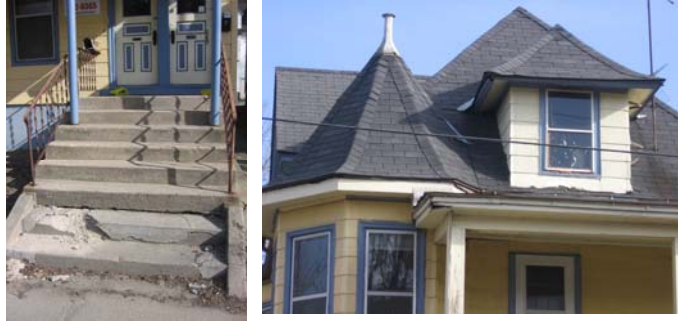
Score: 24.9

Foundation has cracks, patched areas, and is bowing out along side; cladding is discolored, dirty, and missing pieces; roof shingles worn and stained; paint cracking and wearing thin on window frames; upper story back window boarded up; porch columns and beam are rusted; back stair is discolored and has cracks; front stair is missing portions of concrete and has rust staining from rusted railings

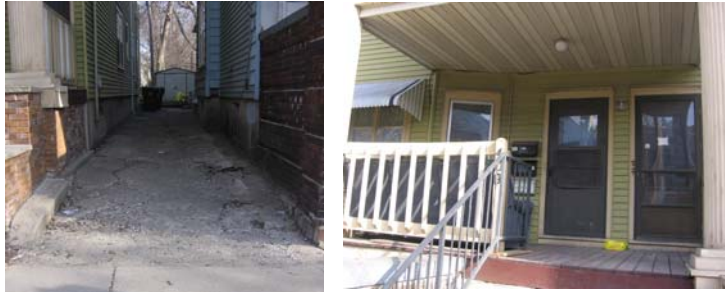
Parcel 39

Score: 47.9

Foundation has discoloration and is missing pieces; roof eaves missing paneling; window frames are dirty and paint is cracking; porch in poor condition (foundation discolored, paint on woodwork wearing thin, metal ceiling dirty, and flooring worn); paint on stairs mostly worn off and is rust stained; driveway is crumbling with cracks and missing concrete

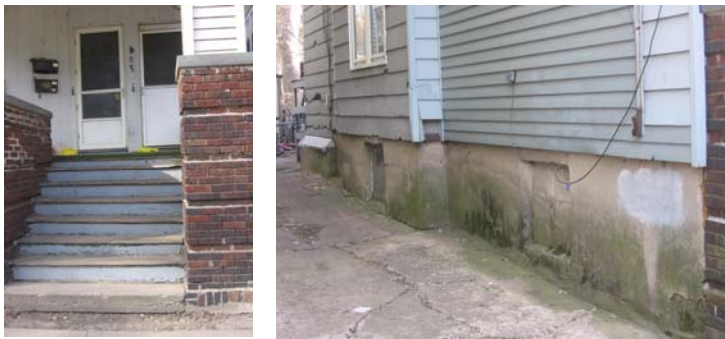
Parcel 40

Score: 49.0

Major water damage along foundation; cladding is worn, dirty, missing pieces, and has rusted nails; mortar poorly patched in sections and has discoloration along the porch brick base; porch roof is sagging in the middle; concrete stair has cracks and wood stairs are very worn; driveway has cracks, patchwork, and missing concrete; covered up graffiti present along foundation and on siding

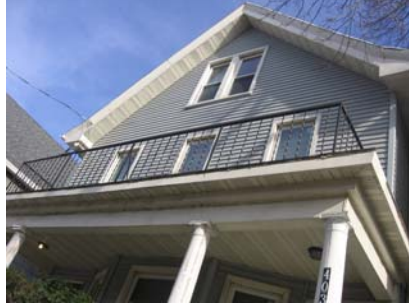
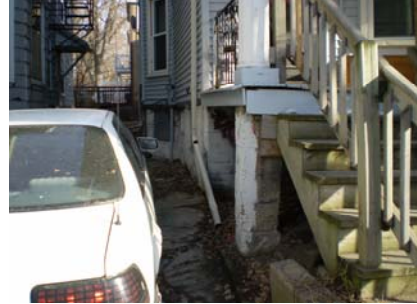
Parcel 41

Score: 58.7

Roof shingles curling up – needing replacement; porch in poor condition (support blocks irregular paint job, columns are dirty and cracked, and eaves are very dirty); wood stair and railing discolored; concrete stair wall cracked with graffiti present; door and frame dirty; half dead shrub and planter supports bulging

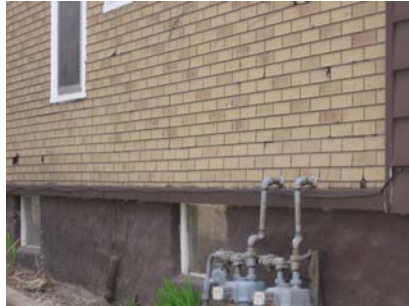
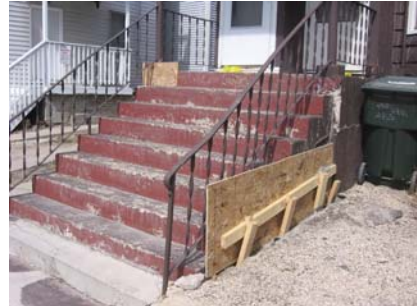
Parcel 43

Score: 49.3

Paint wearing thin on foundation; side cladding worn and pieces missing; front cladding very worn; roof eaves dirty and cracked; stairs are patched, missing material, and paint is wearing/worn off; unscreened garbage containers in front yard; maintenance issues – broken planter curb, wood support along staircase, junk between buildings, graffiti present, etc.

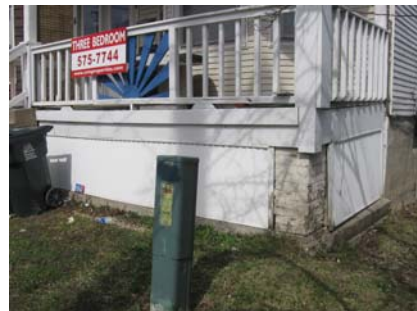
Parcel 44

Score: 42.4

Discolored foundation; dirty cladding and very worn paint on dormer wood shingles; roof shingles and eaves are worn; paint on window frames cracking and wearing thin; porch maintained poorly (foundation settled unevenly, lattice work broken, and woodwork dirty and cracking, etc.)

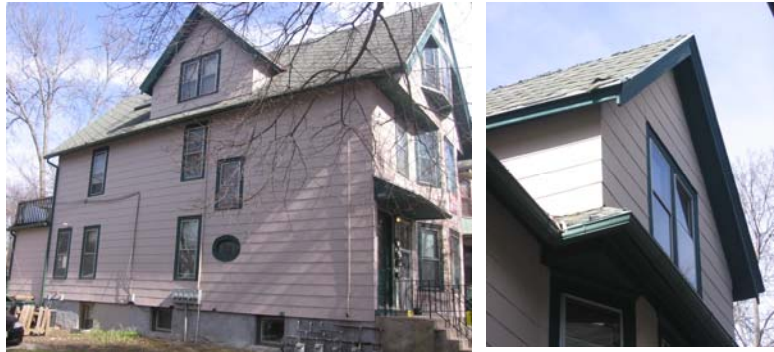
Parcel 52

Score: 57.7

Cladding is worn and pieces are missing; roof shingles are very worn, curling, and missing in areas; paint on window frames is cracking and wearing off; stairs are discolored; paint is wearing thin on both the door and frame, and the bottom of the door is very worn; trash along side of building

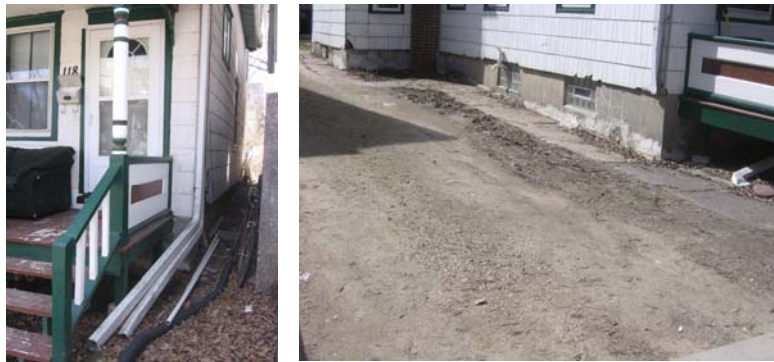
Parcel 57

Score: 59.9

Foundation has discoloration and patchwork; cladding is very worn and missing pieces; window frames are dirty and cracking; some paint wearing off stairs and porch flooring; driveway has deteriorated to just gravel except along building foundation; 7 building code violations in last 5 years

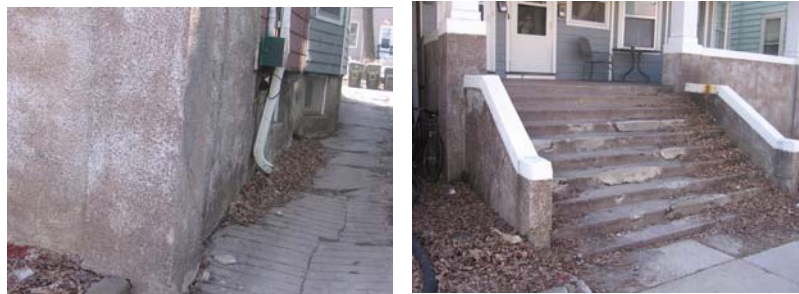
Parcel 58

Score: 50.7

Discolored and very worn foundation; siding is very worn, dirty, and irregular use of color; roof shingles worn; paint wearing/worn off roof eaves; porch poorly maintained (dirty and cracking woodwork, rusted gutter, based discolored worn, etc.); driveway heaving with cracks and missing material; 15 code violations in last 10 years (10 in last 5 years)

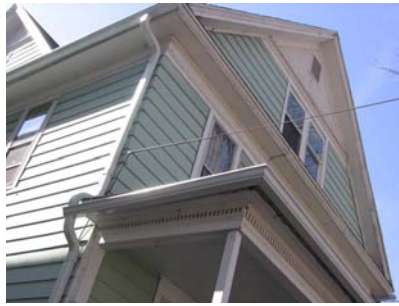
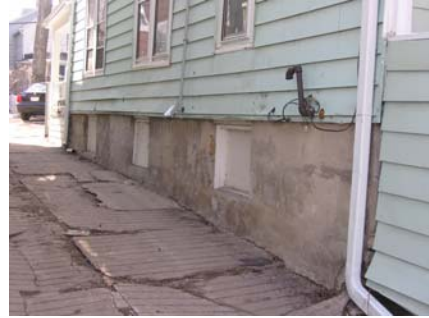
Parcel 59

Score: 58.4

Foundation patchy; cladding is dirty, dented, and bent in areas; paint wearing off of roof eaves; porch woodwork dirty and paint wearing off ceiling; driveway heaving with cracks and missing material; poor lawncare – broken planting bed curb and no mulch/grass (just mud) in front

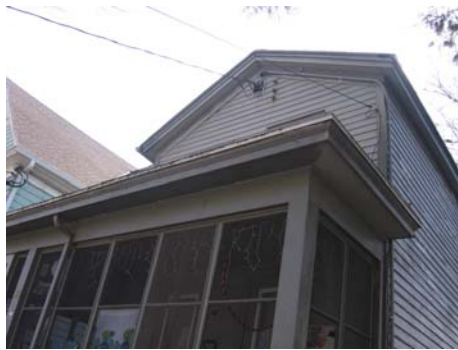
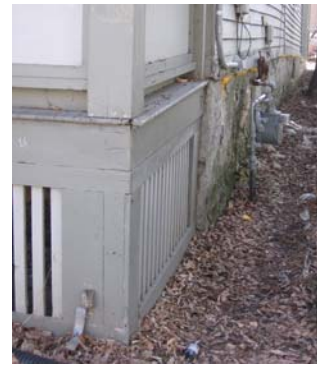
Parcel 60

Score: 52.0

Discolored foundation; siding cracked, paint wearing thin, and insulation oozing out at the base; paint wearing thin on roof eaves and flashing is rusted; unscreened garbage containers in front setback; uneven and discolored walkway and paved area; no grass/mulch (just mud); minor graffiti present

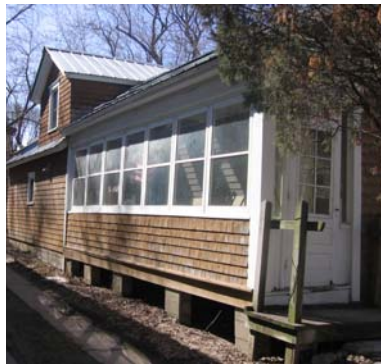
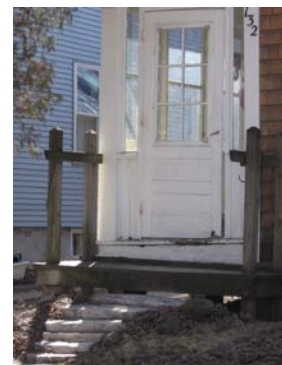
Parcel 62

Score: 46.6

Half of the house is on concrete block columns (no foundation) and cracks along front foundation wall; cladding is very worn and discolored; irregular stoop (possibly slated flooring); irregular stone stairs; access drive cracked and missing material; obvious parking area that is just dirt (no grass/gravel/pavement); landscape unmanaged (dirt, twigs, stumps, lumber/brick piles in side/back, etc.)

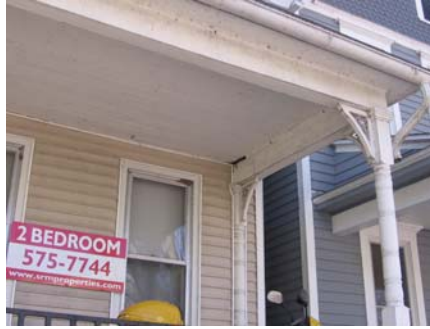
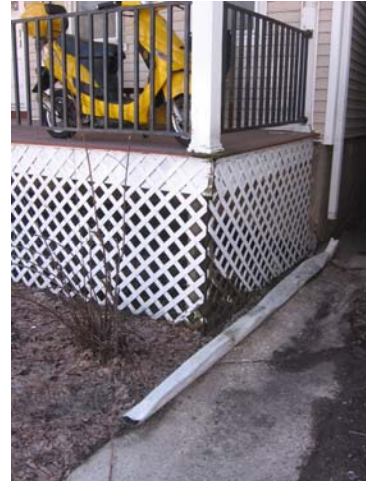
Parcel 63

Score: 56.1

Discolored foundation; dirty siding and window frames; porch woodwork very dirty and broken lattice work with rusted nails; stairs are dirty and paint is wearing thin; rusted railing; chain link fence very rusted (along side); unscreened garbage containers in front yard setback; door is dirty and marked up; gutter and downspout issues – missing, broken, and/or directed right onto sidewalk

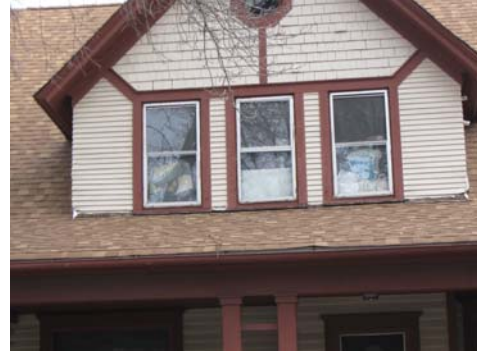
Score: 54.5

Paint peeling from cladding with some water damage on second floor; roof shingles curling and flashing missing between dormer/roof; window framing rotting and paint peeling; porch poorly maintained (paint peeling and second floor porch pulling away from house; lack of gravel on driveway

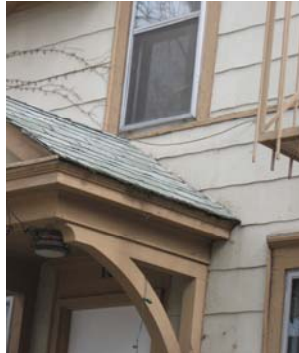
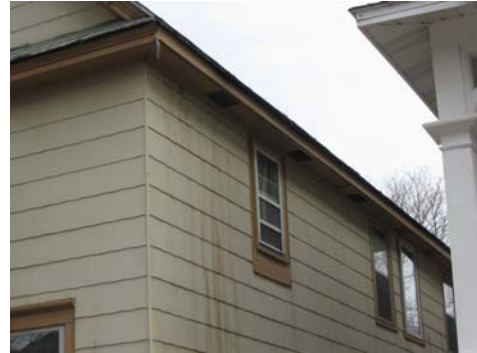
Parcel 71

Score: 59.6

Foundation discolored and apparent damage along side; cladding has rust staining, peeling paint, and is rotting in areas; roof shingles curling and warping; paint peeling on window frames; railing very rusted; door is discolored and paint is peeling; graffiti on garage

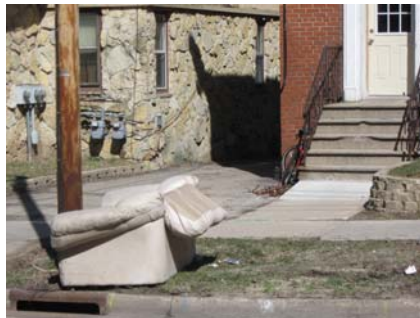
Parcel 77

Score: 58.4

Brick discolored in areas; roof shingles curling; paint peeling from window frames and screen ripped; stairs missing concrete and stained by rusted railing; door is discolored and paint is peeling from the door frame; lack of maintenance on garage; graffiti and piles of trash present

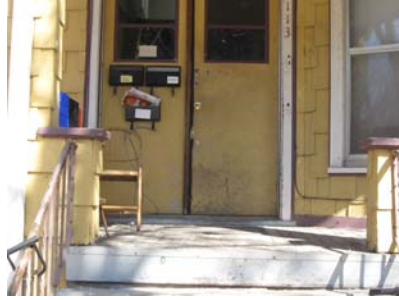
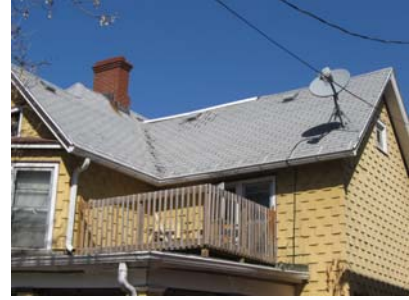
Parcel 80

Score: 55.5

Cladding is dirty and paint is peeling; paint peeling off roof eaves; flashing rusted and corroded; several areas of patchwork and staining on roof; porch poorly maintained (peeling paint, dirty, rotting/missing boards, missing siding); paint peeling off stairs; railing rusted; piles of trash present

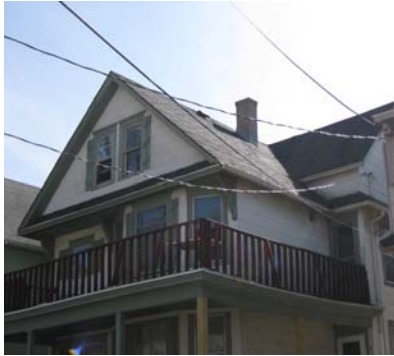
Parcel 99

Score: 58.6

Cladding is dirty; roof shingles patched in many places and missing in others (just tar paper); upper porch is leaning and sagging; lack of paint on porch columns; stairs have significant settling issues; rusted and leaning railing; boarded up garage; walkway is crumbling; piles of trash present; erosion issues

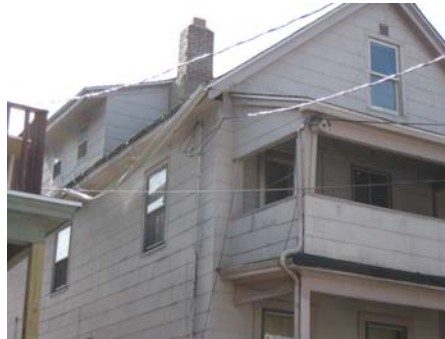
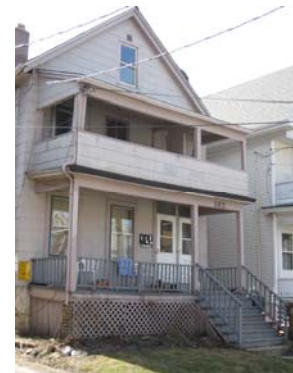
Parcel 100

Score: 58.1

Foundation mildewed; cladding mismatch paint job and missing siding; gutter falling off one side and missing on the other side; porch leaning and sinking; lattice work broken; paint peeling from stairs; unscreened garbage container in front yard; front walkway heaving; piles of trash present

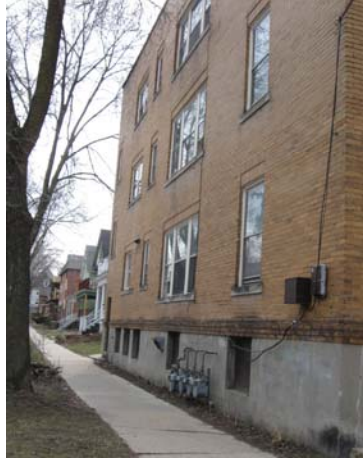
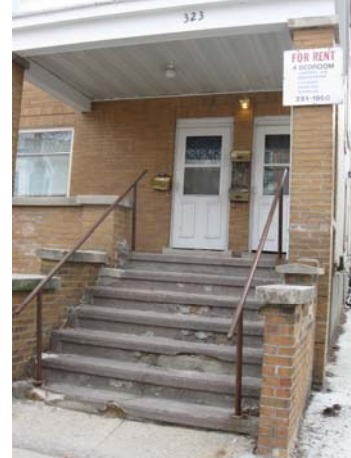
Foundation has some cracking and discoloration; brick very dirty and discolored with some areas needing tuck pointing; window sills discolored; vents rusted and dented; stairs deteriorating – missing material, cracks, patchwork; rusted railing; paint peeling from rear door; piles of trash and graffiti present

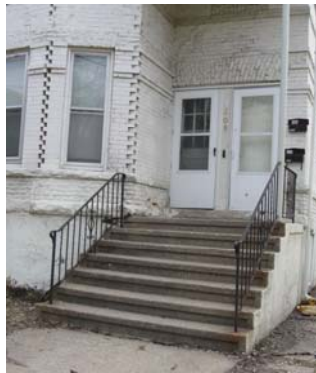
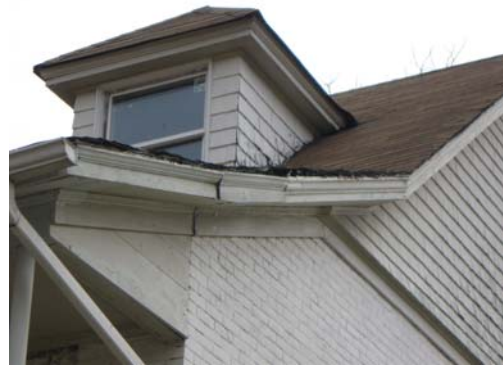
Parcel 106

Score: 58.8

Paint peeling from the foundation with water damage and spalling in the corner (by the steps); paint is peeling from cladding and there is water damage where wall meets the roof; stairs has rust staining from rusted railing; walkway has cracks; 20 code violations in the last ten years (13 in the last five years)

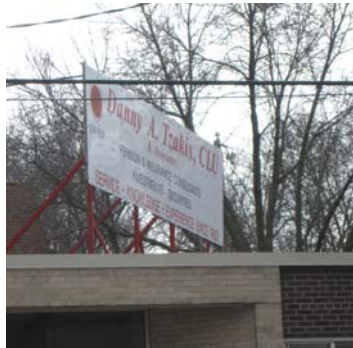
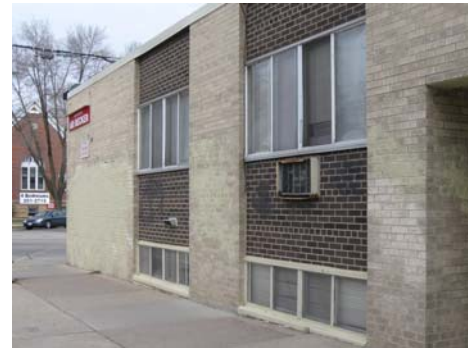
Parcels 107

Score: 47.1

Single story building (not meeting preferred land use description); cladding has severe discoloration and a significant number of poorly painted areas from past graffiti; rusted air conditioning units; rusted vents; 37 code violations in the last ten years (18 in the last five years)

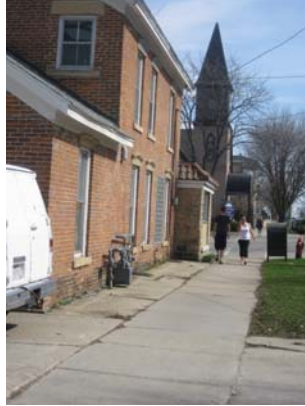
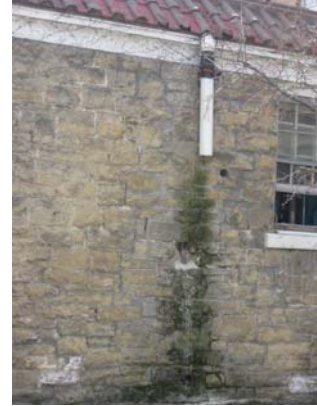
Score: 48.2

Single story building (not meeting preferred land use description); portion vacant; foundation has cracks and is sinking; cladding issues – moss growing, paint peeling, efflorescence of brick, missing mortar, and missing chunks of stone; roof shingles curling and some roof tiles missing; mismatch of brick around chimney; cracks in driveway

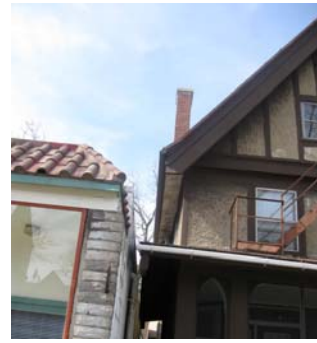
Parcel 29

Score: 58.1

Not a commercial use (as preferred land use suggests for E. Washington); stucco is dirty, patched in areas, and falling off in other areas; roof shingles curling, discolored, and poorly patched in areas; porch poorly maintained (dirty, paint peeling, and roof sagging); stairs spalling and paint peeling; front walk heaving; fire escape rusted

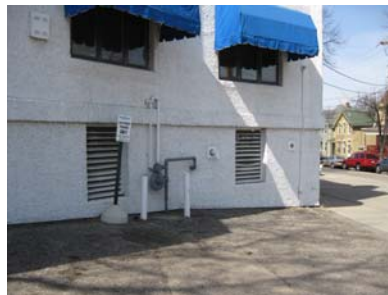
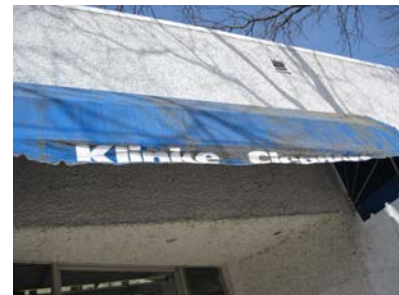
Parcel 30

Score: 52.5

Single story building (not meeting preferred land use description); stucco dirty and chunks are missing; paint peeling off window frames; canopies are old and filthy; vents are rusted and bent; sign in poor condition - sign is faded, paint is peeling around sign, and pole is rusted; pavement is cracked

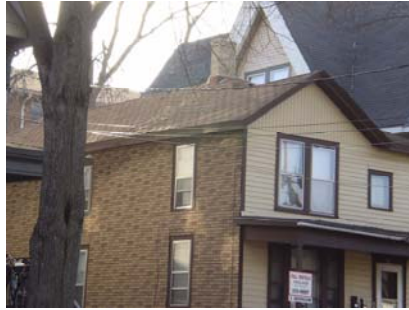
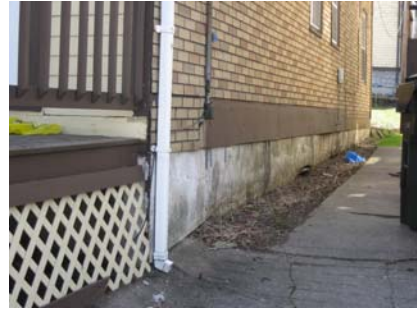
Parcel 32

Score: 56.0

Foundation is discolored and bulging; cladding is dirty, some paint is peeling, and sections have mismatch of paint color; roof shingles curling; paint is peeling from stairs; lattice screening is

broken; poorly managed landscaping; accumulation of junk on front porch

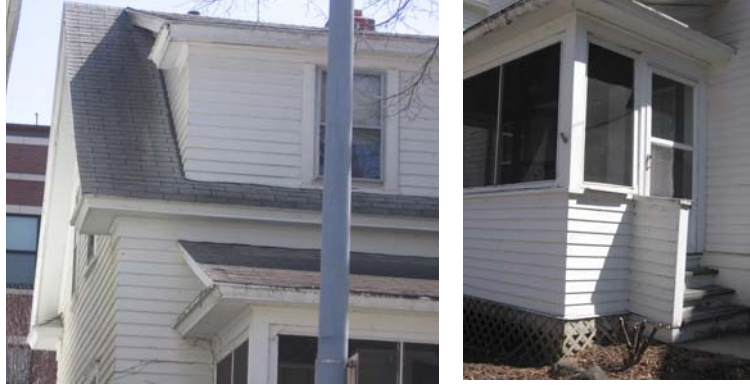
Score: 57.0

Cladding is dirty; roof shingles are very worn and there is no flashing between dormer/roof; porch woodwork very dirty and lattice screening very worn; window frames cracking, dirty and paint is wearing/worn off; stairs are very worn; driveway cracks, uneven, and discolored

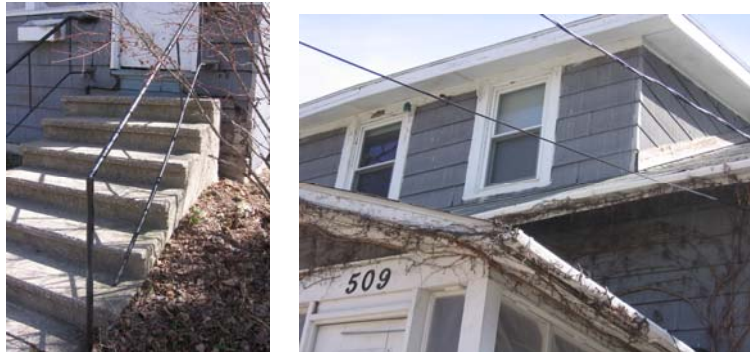
Parcel 8

Score: 45.2

Foundation dirty in areas; cladding in poor condition – very worn, discolored, paint splatters, missing pieces (on side), and missing section (by stair); roof shingles very worn and missing flashing around dormer; paint cracking and wearing off roof eaves; window frames dirty and paint is cracking; stairs are discolored and railing is broken; driveway cracks, uneven, and discolored

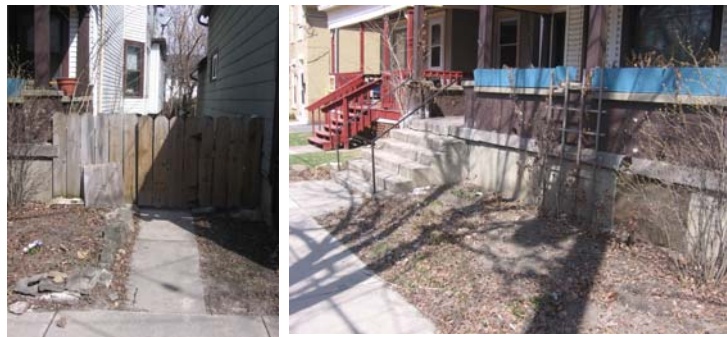
Parcel 14

Score: 57.7

Foundation is discolored and has settling issues; roof eaves rusted, warping, and paint wearing/worn off; paint wearing/worn off second floor window frames; porch poorly maintained (floor discolored, patchy and missing material, support beam warping and rotting, and wall paint is wearing/worn off; stairs discolored and stained by rusted railing; wood fence missing stain/paint and is worn

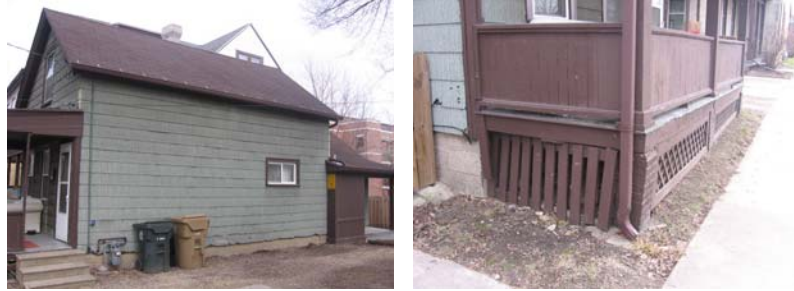
Parcel 15

Score: 59.9

Single story building (not meeting preferred land use description); cladding is very worn, discolored, and missing pieces (near foundation); shingles are worn; paint wearing off window frames; porch poorly maintained (floor is cracked and warped, gutter hanging off, lattice screening broke); pieces missing from the stairs;

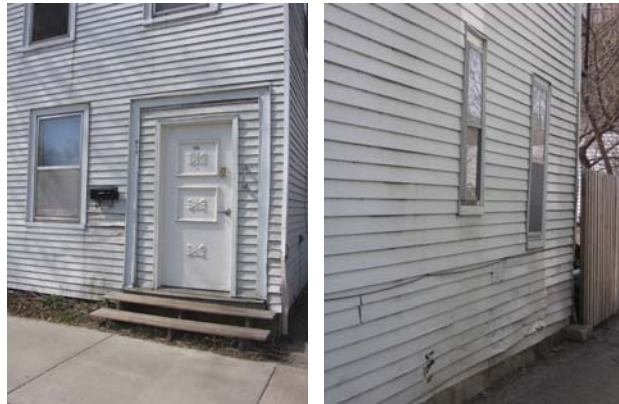
Parcel 17

Score: 51.2

Not a commercial use (as preferred land use suggests for E. Washington); discolored foundation; cladding very dirty, dented, bent, and discolored; roof shingles very worn and curling; stain has worn off stairs; no railing; door is dirty and framing has cracks; walkway has cracks

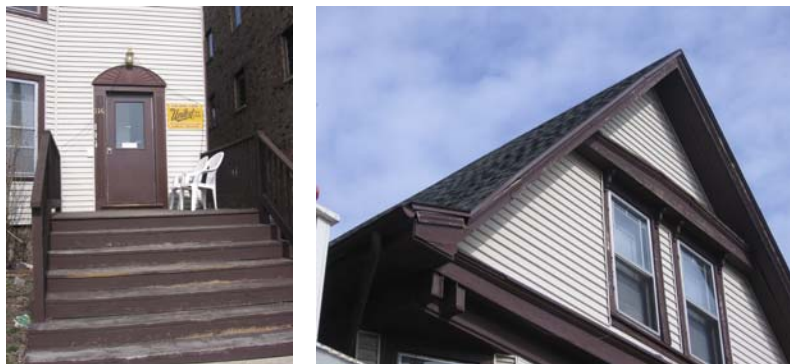
Parcel 20

Score: 49.8

Not a commercial use (as preferred land use suggests for E. Washington); foundation has discoloration and cracks; paint wearing off roof eaves and some sections missing fascia boards; gutter hanging off back side; window frames are warped and paint is wearing off; rusted vents; paint wearing/worn off door and framing; walkway on side has cracks and settling issues

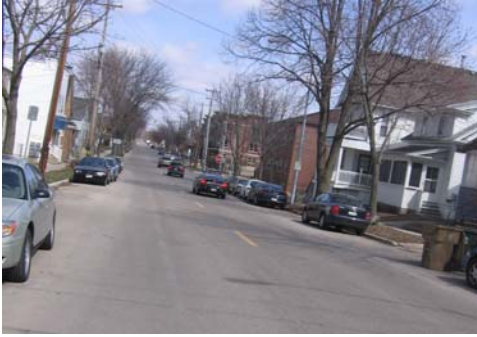
Mifflin and Franklin, looking northwest
(good condition)

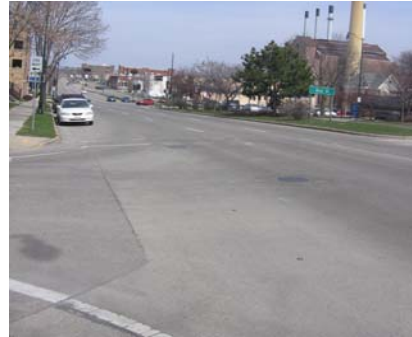
Washington and Hancock, looking northeast
(good condition)

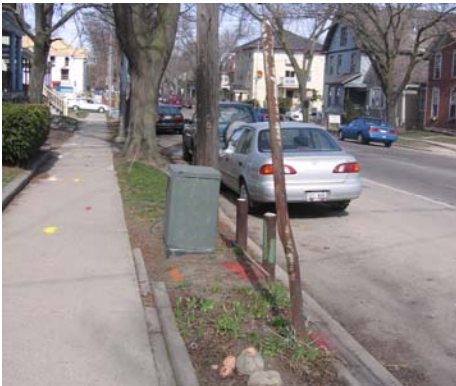
Johnson and Franklin, looking northwest
(rusted pole support and bollards)

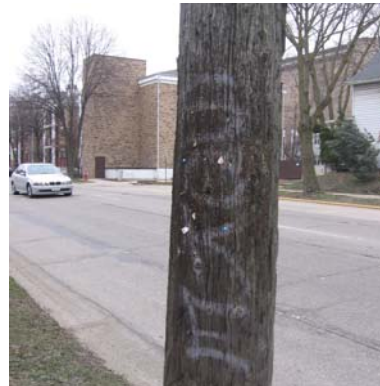
Johnson, looking southeast
(graffiti on pole)

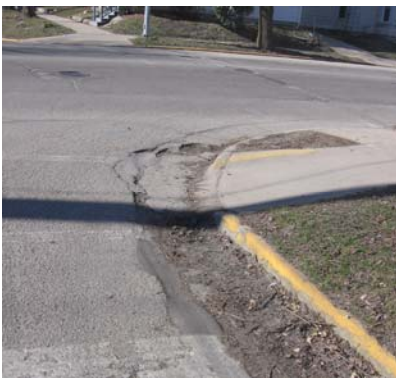
Franklin and Johnson, looking northwest
(debris, patchwork, missing concrete/asphalt)

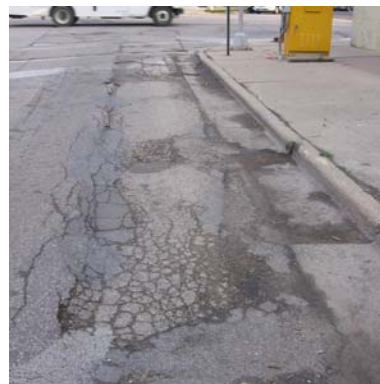
Butler and Johnson, looking northwest
(patchwork, cracks, and missing asphalt)

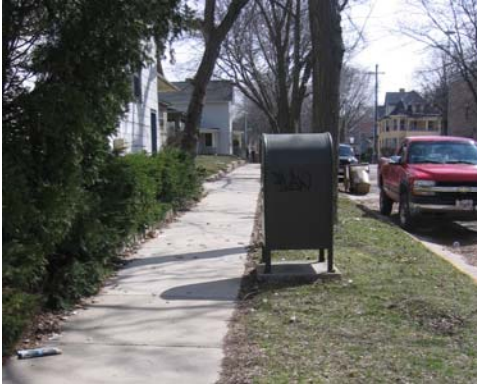
Hancock and Gorham, looking southeast
(graffiti on mailbox)
