TID 32 Amendment – Blight Study

April 16, 2010

City of
Madison,
Wisconsin

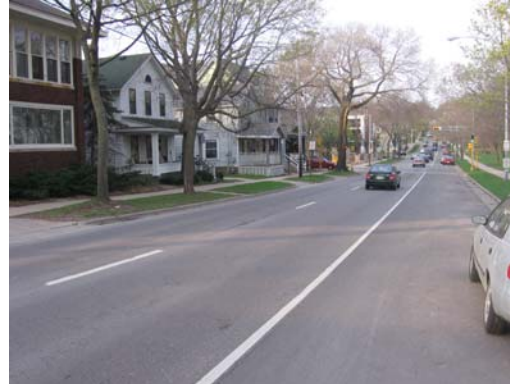
Gorham and Blair, looking southwest
(good condition)

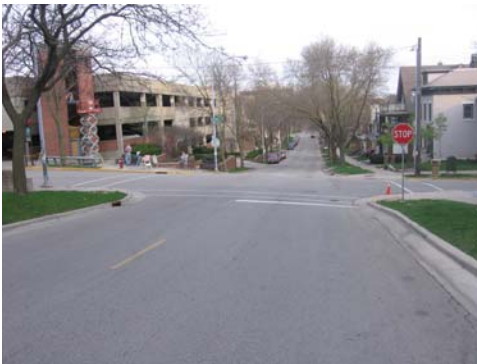
Butler and Mifflin, looking northwest
(good condition)

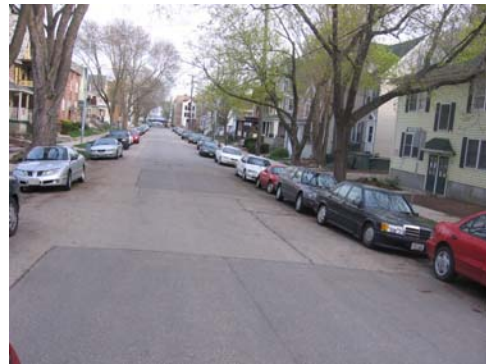
Gorham and Blair, looking southwest
(fairly good condition)

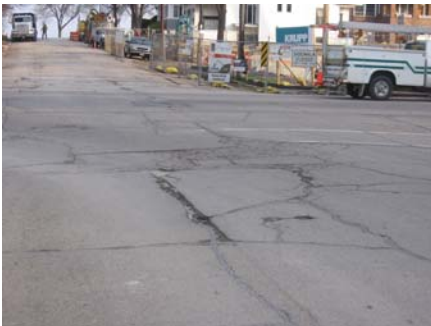
Blair and Johnson, looking northwest
(cracks, patchwork, and missing asphalt)

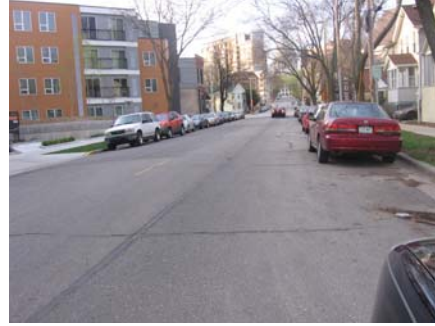
Hamilton and Gorham, looking south
(fairly good condition)
