## Public Health Assessment

### Evaluation of soil, groundwater, and vapor intrusion contamination at open and closed investigations on the Hartmeyer and Oscar Mayer sites in Madison, WI

Hartmeyer & Oscar Mayer Sites  
2007 Roth St & 910 Mayer Ave  
Madison, Wisconsin

November 28, 2022

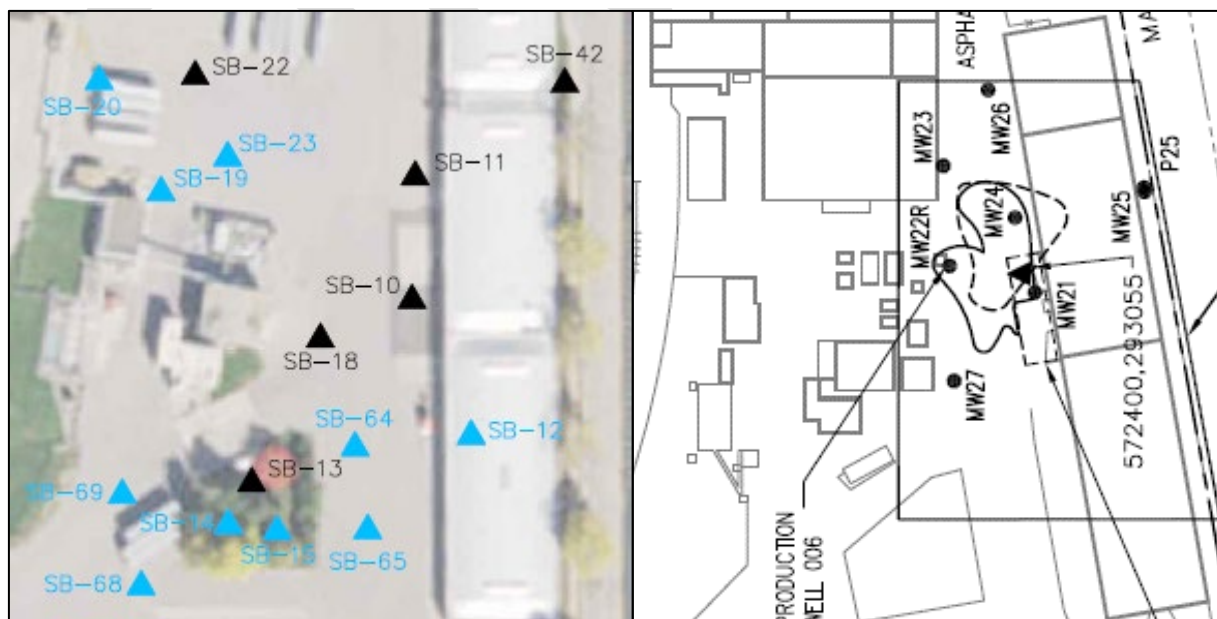
**Figure 4. Closed Site #3 with 2017 data near site (left) and 1996 (right) extent of contamination.**

Closed Site #3 (BRRTS 03-13-114831) is located just west of The Bodgery building on the South side of the Central portion of the Oscar Mayer Property (Figure 4). An underground storage tank (UST), former diesel dispensers, and several former gasoline dispensers were excavated for removal from the site. Following excavation, the site was backfilled with clean fill and a new diesel UST. The former UST excavation for gasoline was also backfilled. Following the original excavation,

soil and groundwater analytical results were taken in 1996 and 1997 from the excavation to determine soil and groundwater contamination at the site. The cap is required to be maintained and inspected annually to determine its integrity. Sampling was also performed on this site as part of the 2017 Oscar Mayer investigation. Additional soil samples and groundwater samples were taken throughout Oscar Mayer property in 2017. The samples were also taken on the former 1,2-DCA tank site and from the area near Closed Site #3 (Figure 4 and Figure 5). Soil samples in the top 5 feet of soil (SB-11, SB-12, SB-18, SB-19, SB-23, SB-42) where the soil is most accessible, and groundwater samples (SB-10, SB-12, SB-18, SB-19, SB-23, SB-42, SB-64) were also taken near the former UST site behind the Bodgery.

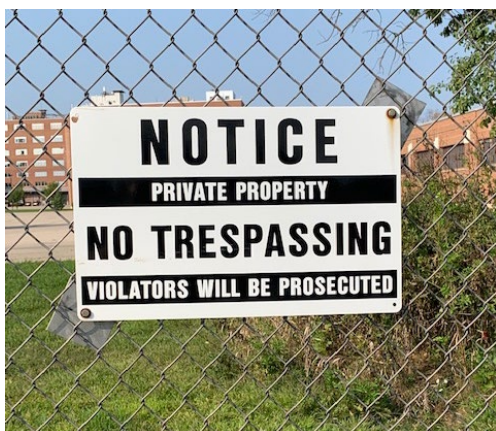
**Figure 7. Trespassing sign on the central Oscar Mayer Property near back of Bodgery building.**

To our knowledge and at the time of our site visit, there was no construction taking place in this area (In December 2020, an excavation to remove contaminated soil was carried out). It was also observed that access to this site appears to be limited due to a fence limiting access to a portion of the site. On the back of the

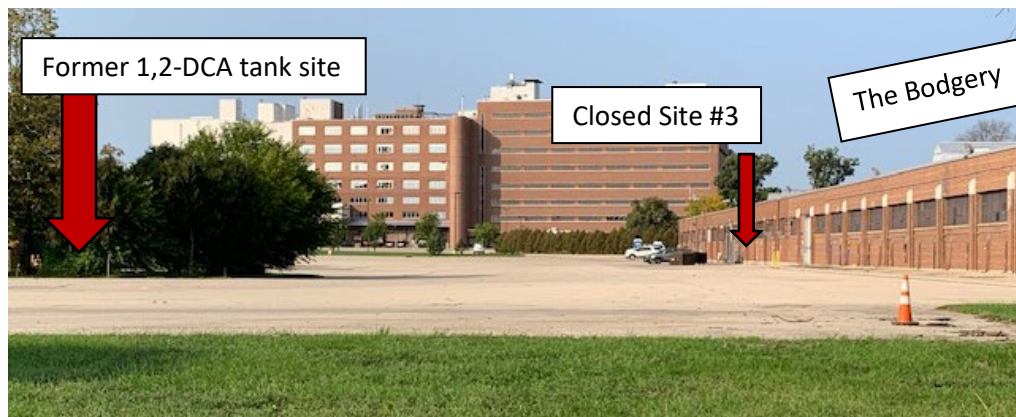
**Figure 6. The former 1,2-DCA Tank location behind the Bodgery, which is a community building used as a makerspace for artists and community members.**

Bodgery, there is a “garage door” type entrance to the building and a side door. Both appeared to not be in use (Figure 6). The fencing right outside this area does have a “No Trespassing” sign (Figure 7). A building at the back of the lot did appear to be in use with cars parked in the parking lot but it appeared to be for the building labeled “Nine-Ten” which is being leased out by a third party company. Upon further

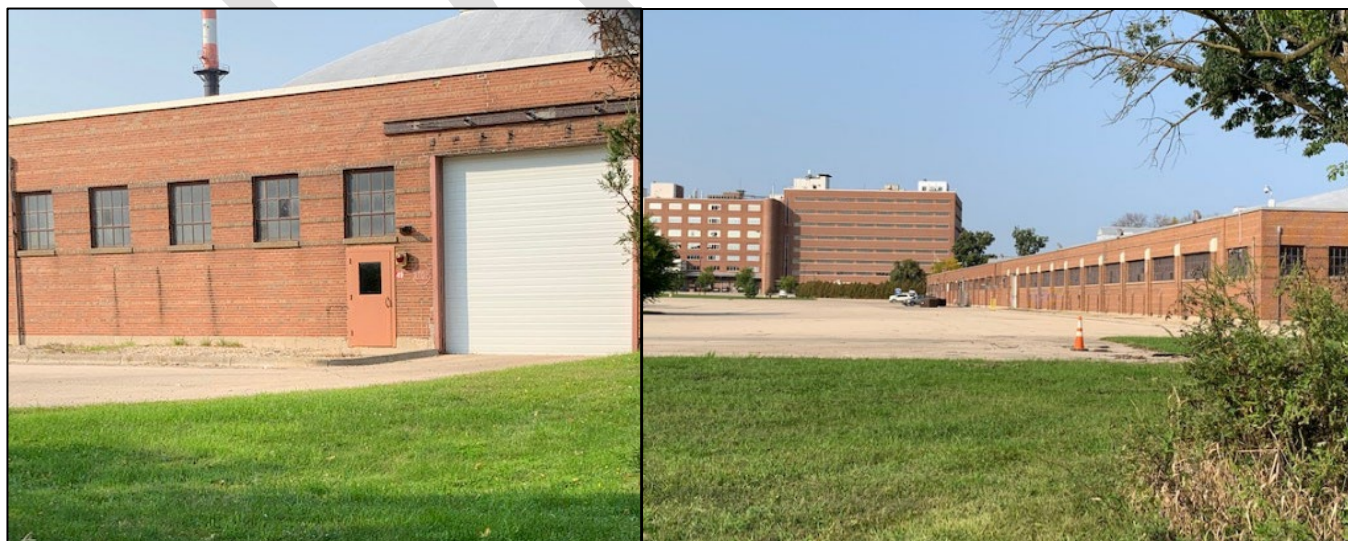
**Figure 8. The south side of the Bodgery building adjacent to the former 1,2-DCA tank site**

- 1) Deed restrictions that require a surface barrier over the remaining soil contamination in order to prevent contamination from impacting human health through direct contact and to prevent contamination from impacting groundwater due to the infiltration of precipitation. The deed restriction also requires the property owner to investigate the degree and extent of residual contamination that is currently inaccessible if and when structural impediments that currently exist on the property are removed.
- 2) If contamination remains, all current and future owners and occupants of the property need to be aware that excavation of the contaminated soil may pose an inhalation or other direct contact

As part of the deed restriction, the pavement barrier is required to be inspected annually and documentation kept noting said annual inspection. **Therefore, these sites have no apparent public health hazard at this time.** Future changes that impact or remove the existing barriers would require DNR approval, which would include an evaluation of potential health hazards by DHS.

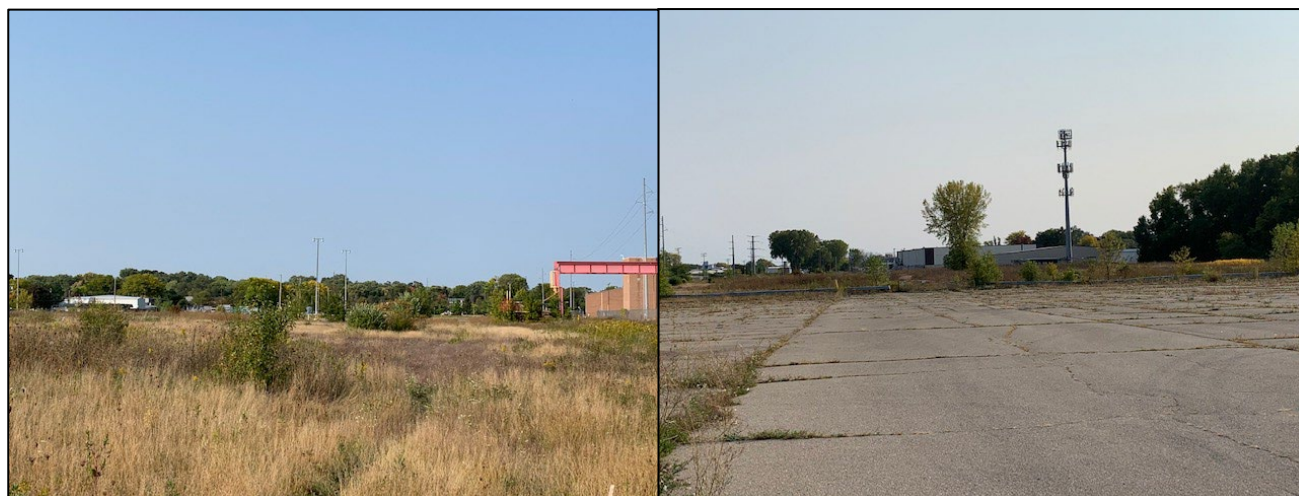
**Figure 10. Hartmeyer site looking South to North (left photo) and looking north to South (right photo).**

Currently, this site is easily accessible to the general public, is not enclosed by a fence, and there is no signage on the property. It also sits adjacent to businesses with parking lots. The northwestern portion of the site is partially capped with pavement. The site is also covered with dense vegetation (Figure 10 and 11) and there are railroad tracks to the east of the site that would limit access in that direction. As long as these features ensure sub-surface soils remain inaccessible, ingestion or dermal exposure to contaminated soil is unlikely and the exposure pathway for contaminated soil at the site is considered to be incomplete
