# Madison Landmarks Commission APPLICATION

Project Address: 906-910 Williamson Street Aldermanic District: 6

Re: Letter of Intent  
906-910 Williamson Street, Madison, WI  
**KBA Project # 1423**

Re: Evaluation of property at 906 Williamson Street, Madison, WI

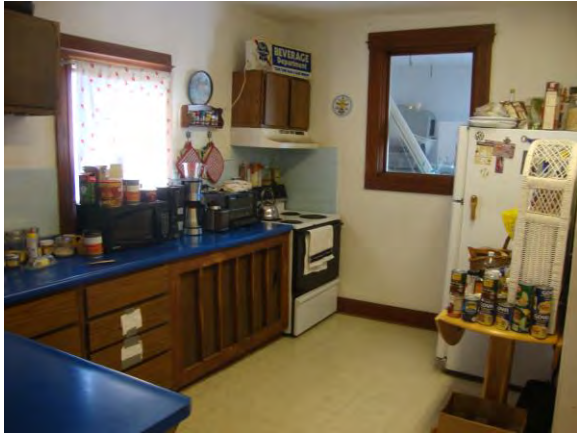
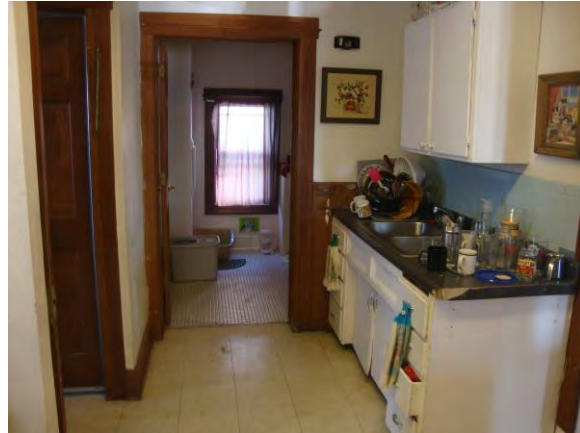
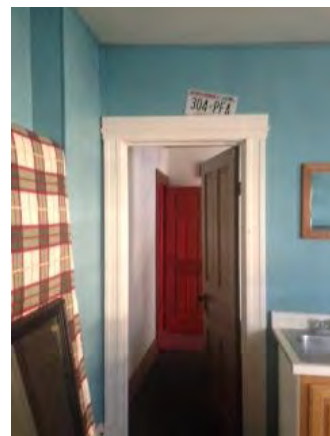
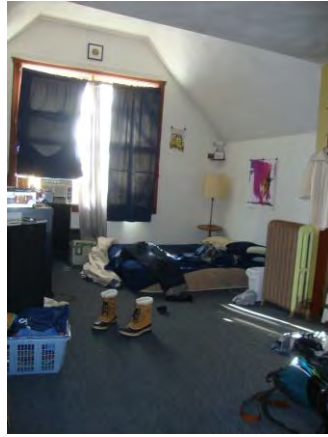
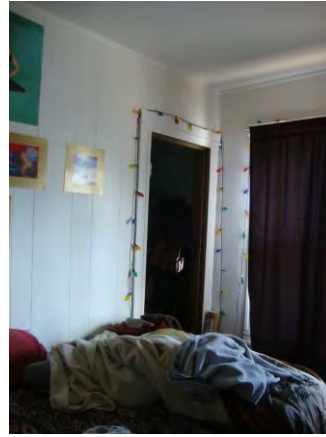
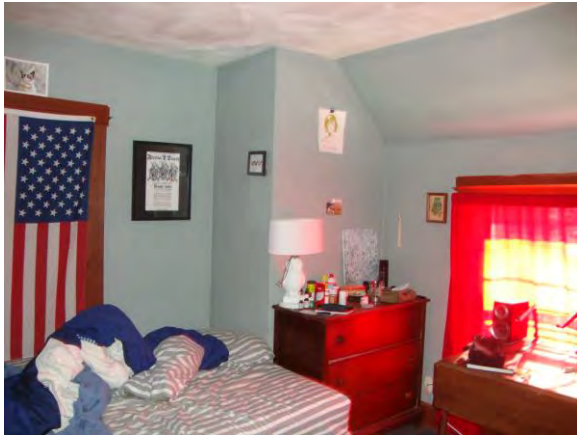
Photos of existing site – building interior.

First and second floors generally undulate and are well out of level. Door openings are generally skewed and not square indicating structural settlement. Overall the interior of the building is in fair condition with serviceable materials and finishes. Some level of repair and rehabilitation work is required.

The limestone foundation walls appear to be in generally poor condition. Extensive efflorescence and moisture infiltration was note on the foundation walls. There are many areas where mortar was eroded and had fallen on the floor. Some older Portland cement patching repair work on the walls was observed. There were a number of cracks in the foundation walls. On the exterior, several areas of missing and deteriorated cementitious coating/parging were observed.

The framing appears to be in fair condition with several significant problems. Sizable deformations were noted in both the first floor and second floor framing consistent with long term weight of walls on floor joist framing. Also likely contributing to deformations of the floors is deterioration in some column supports and a hole cut in the main center beam in the basement.

Typical plaster finish cracking on the upper floors was noted in several areas attesting to the movements. Some bearing walls supporting roof and floor loads did not appear to align from level to level suggesting that the floor joists in some cases are supporting second floor and roof loads. This would also account for some of the deformations noted in the structure.

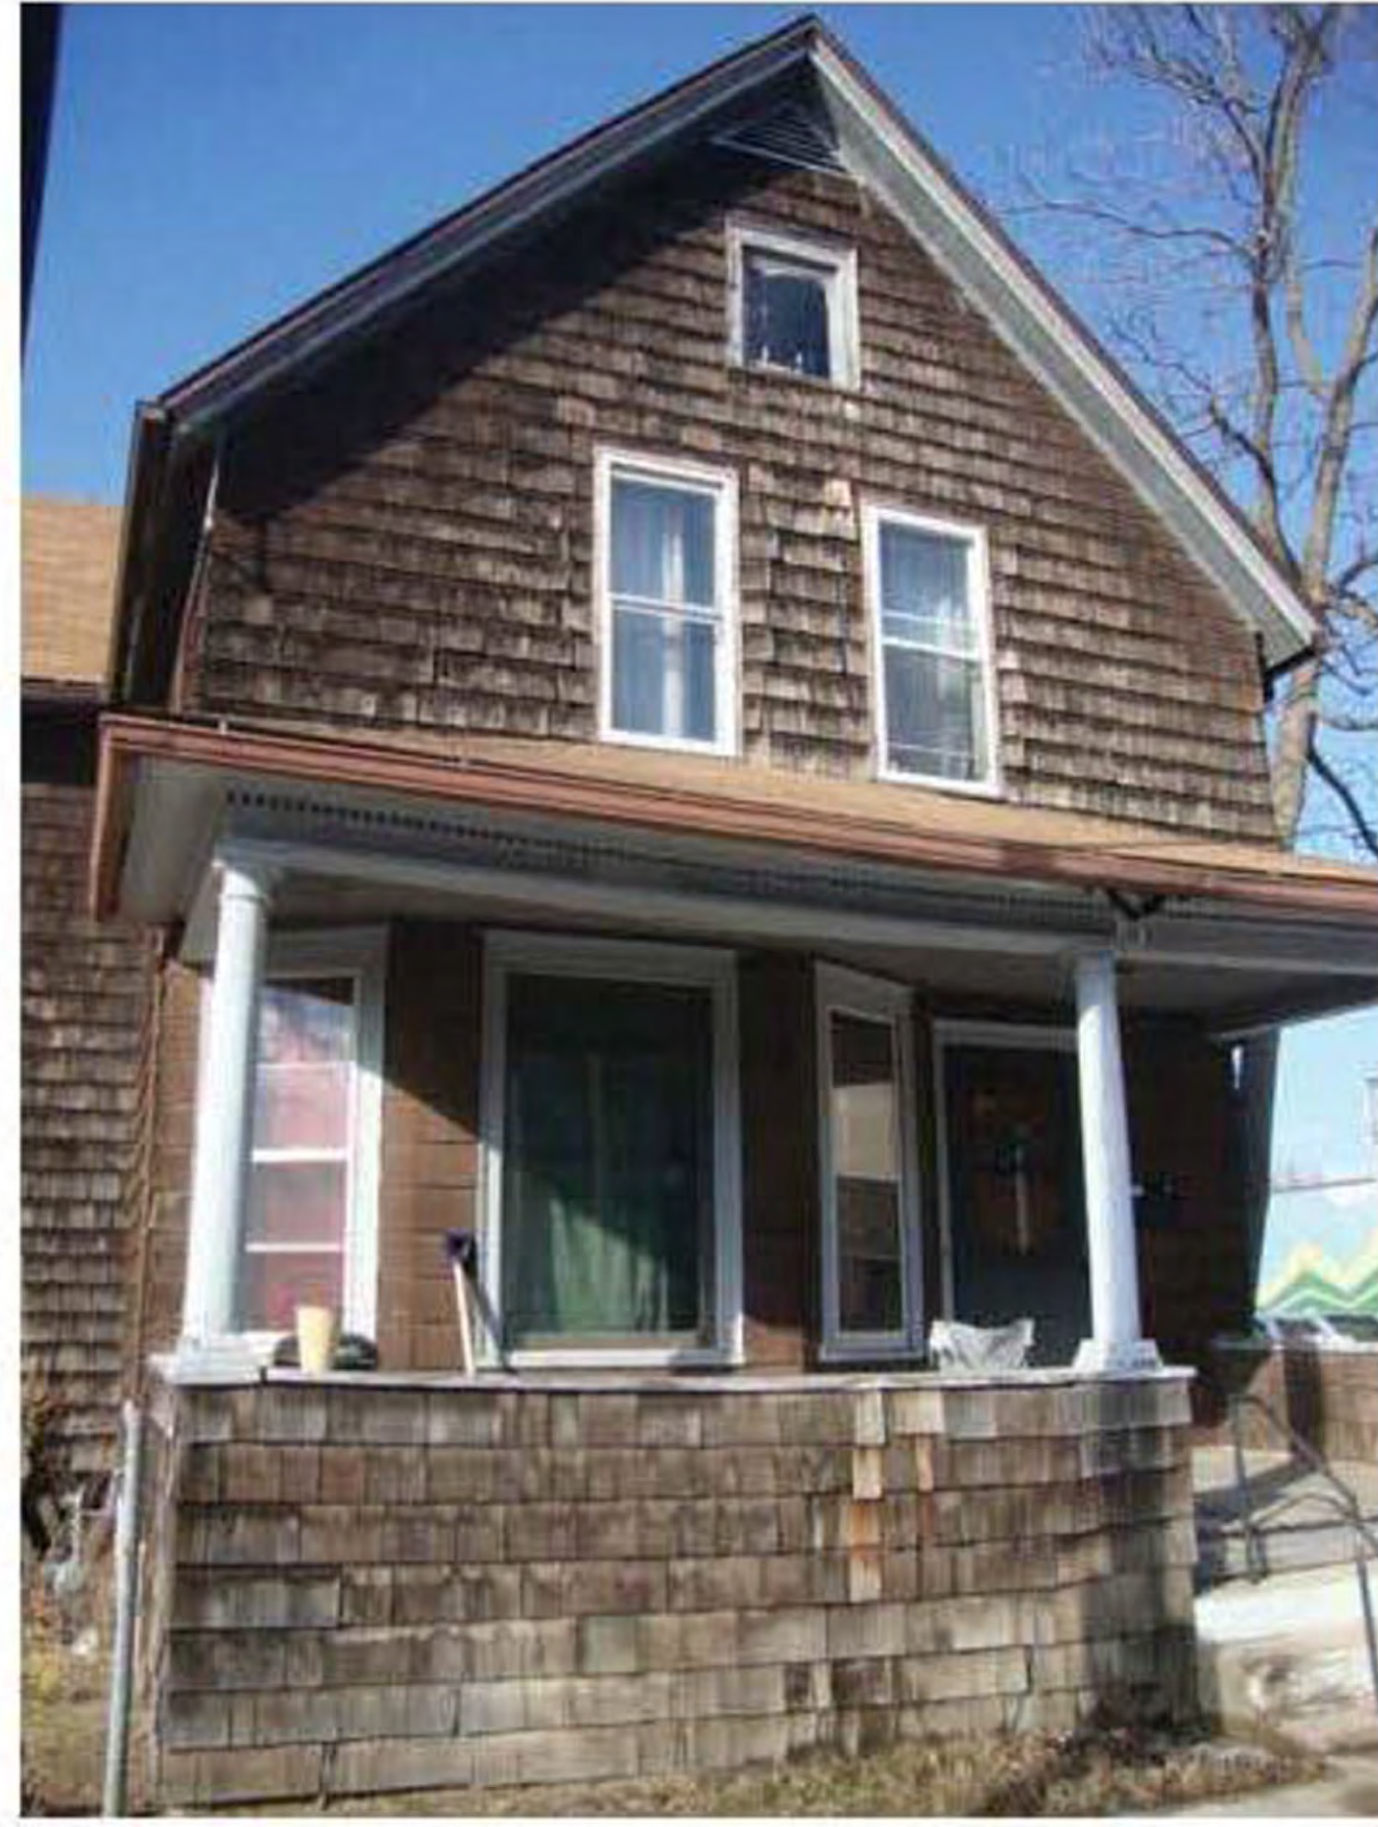
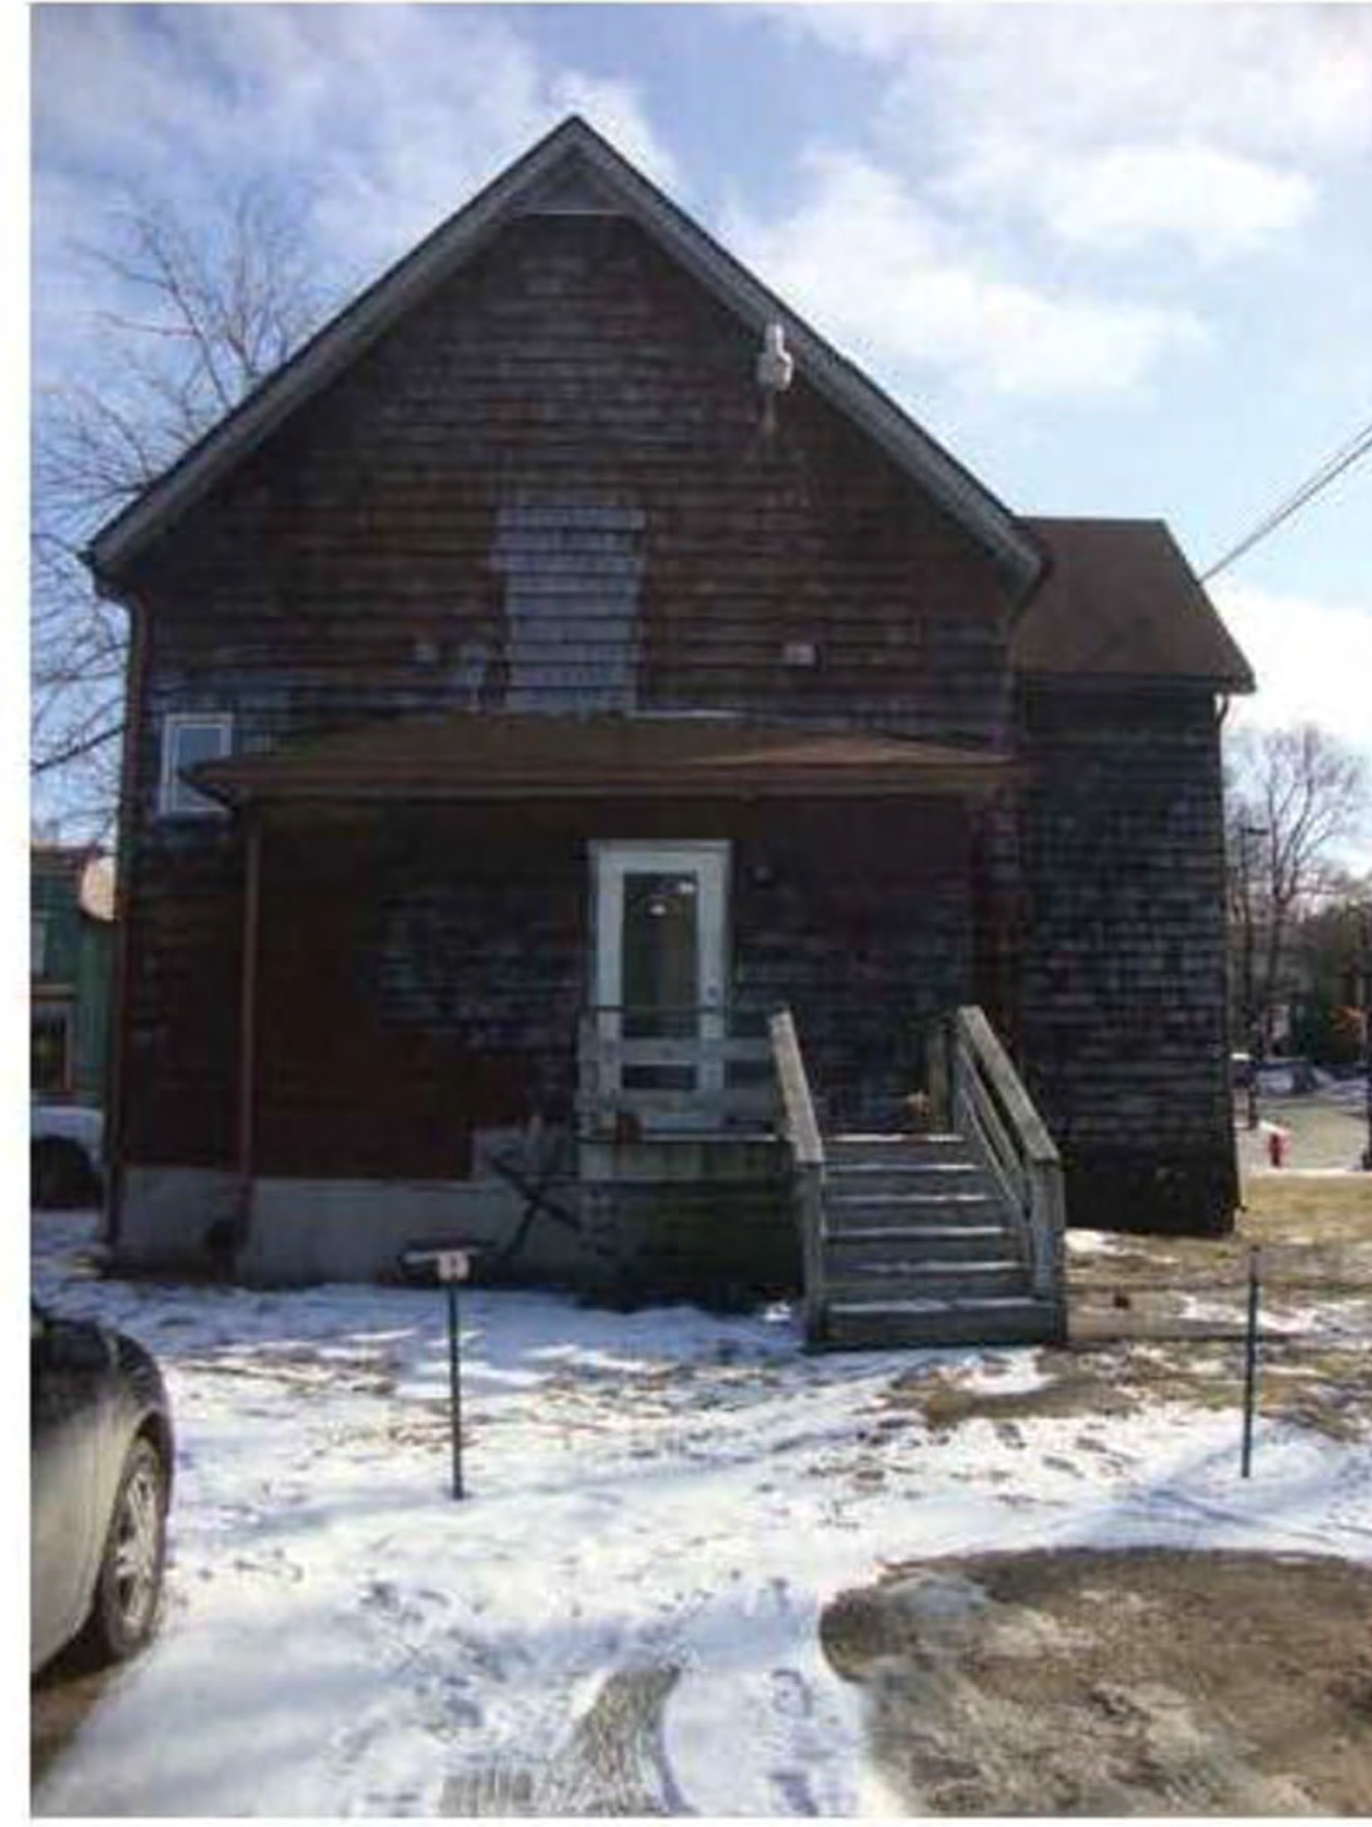
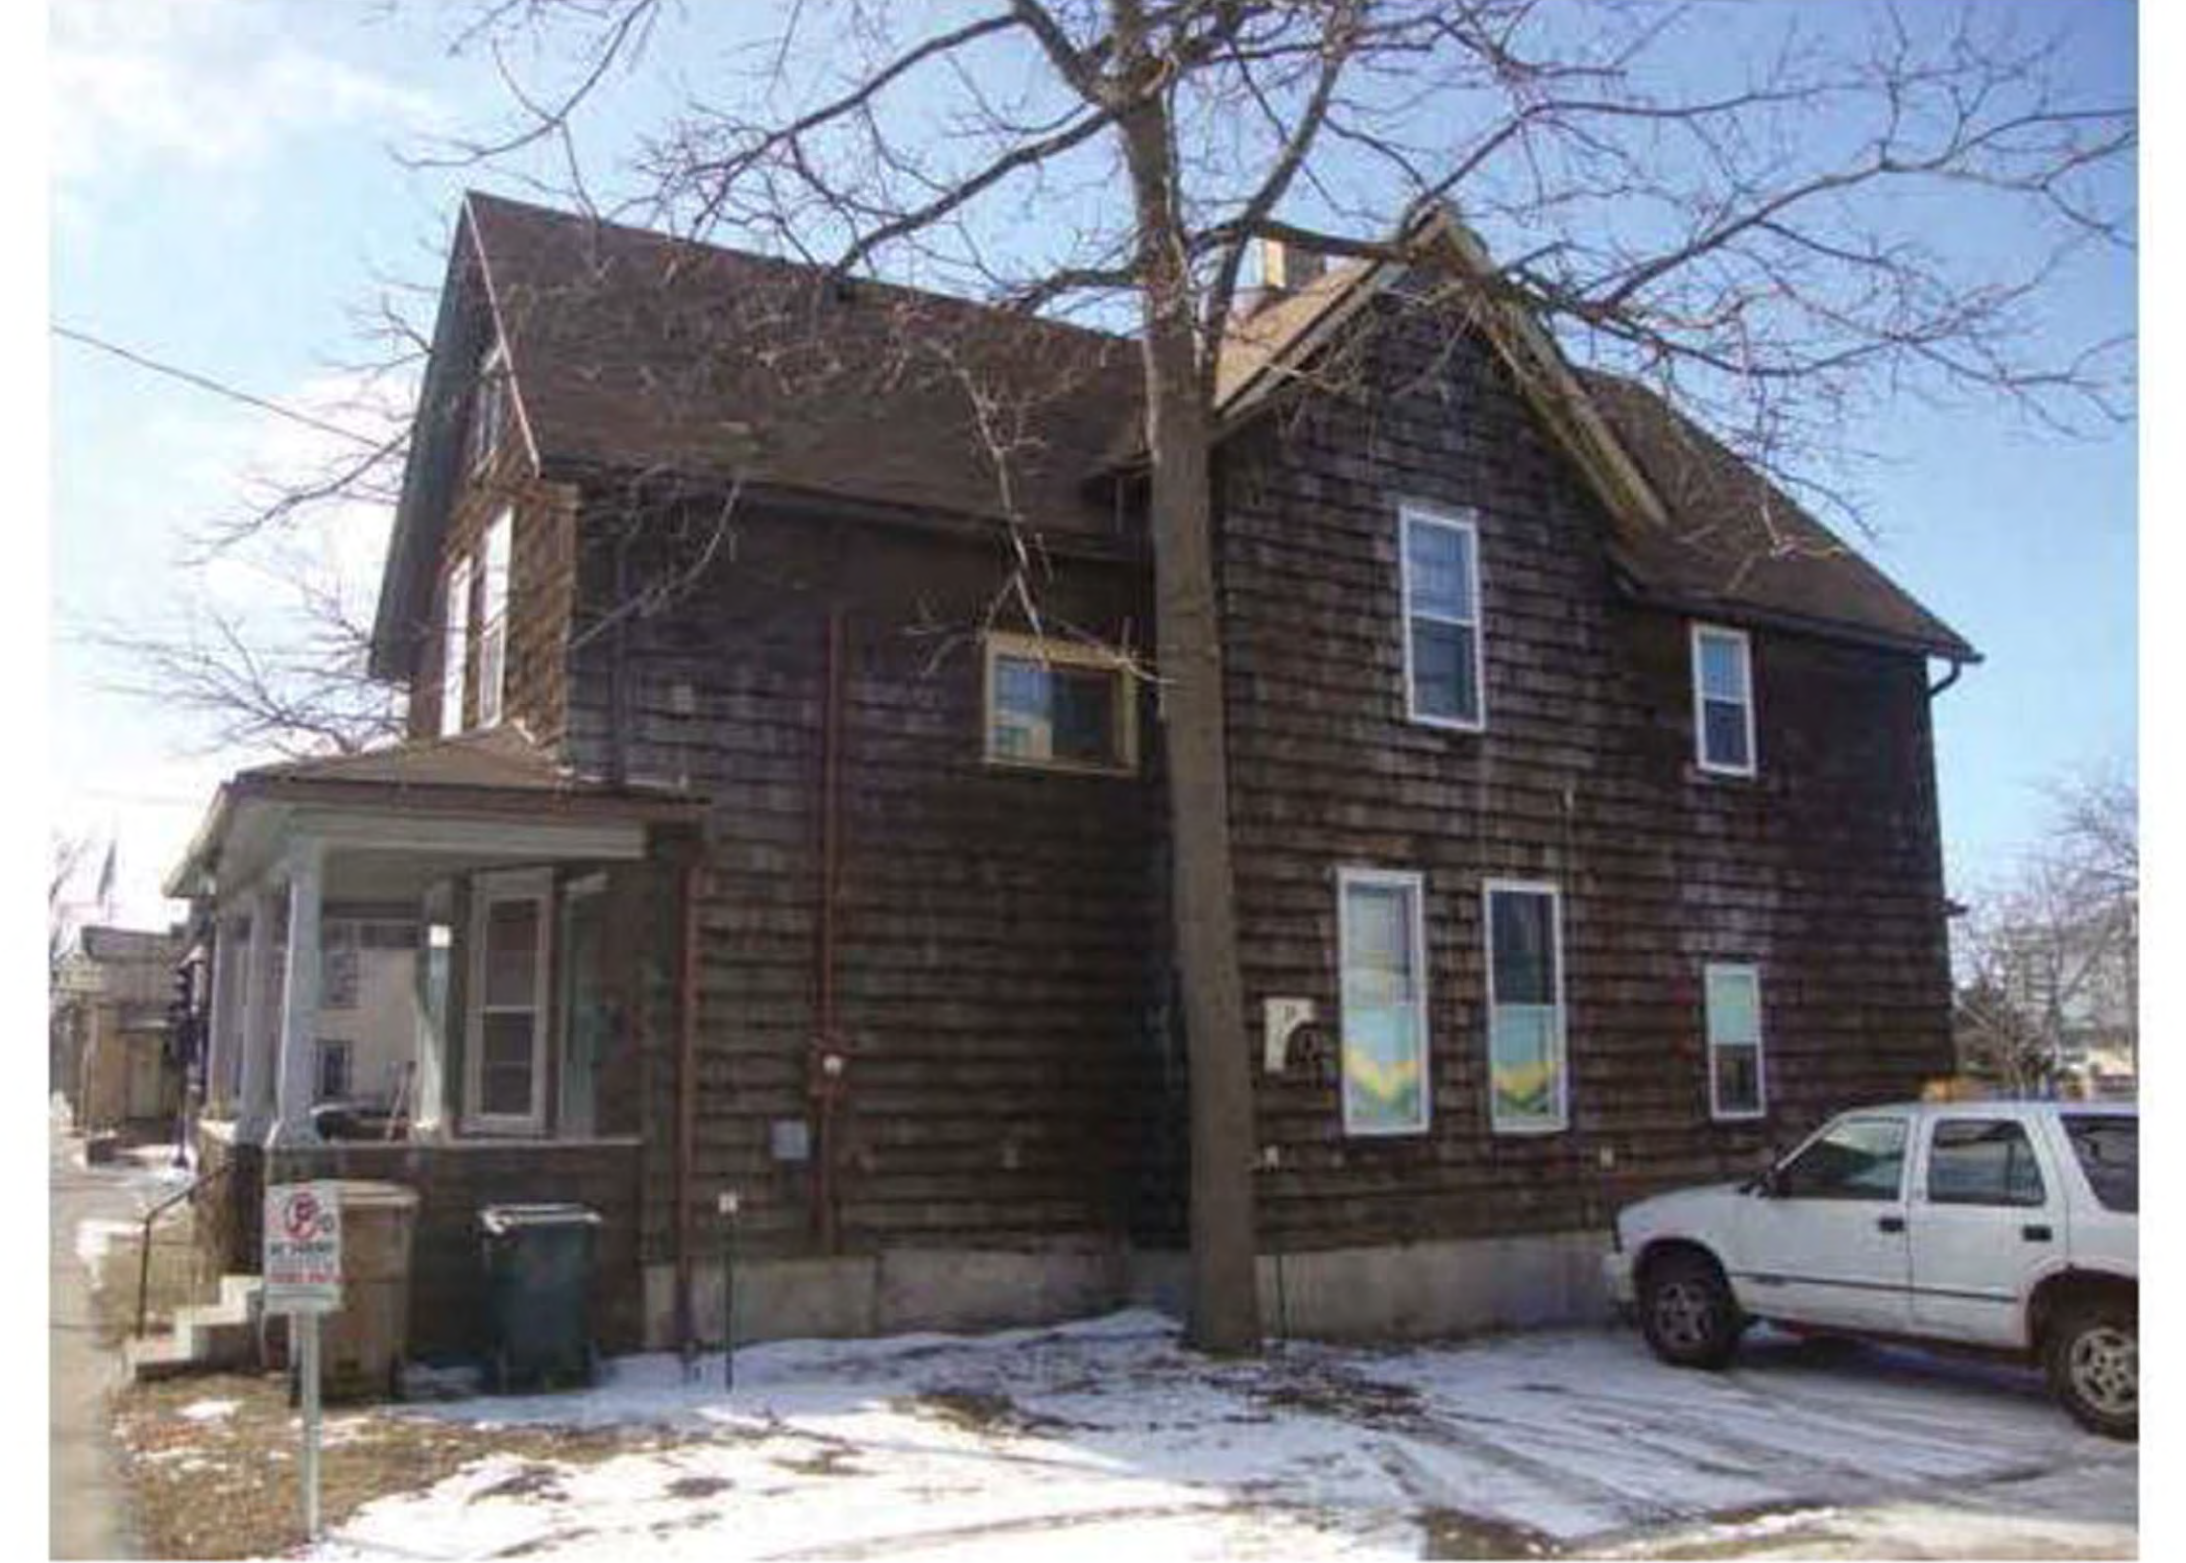
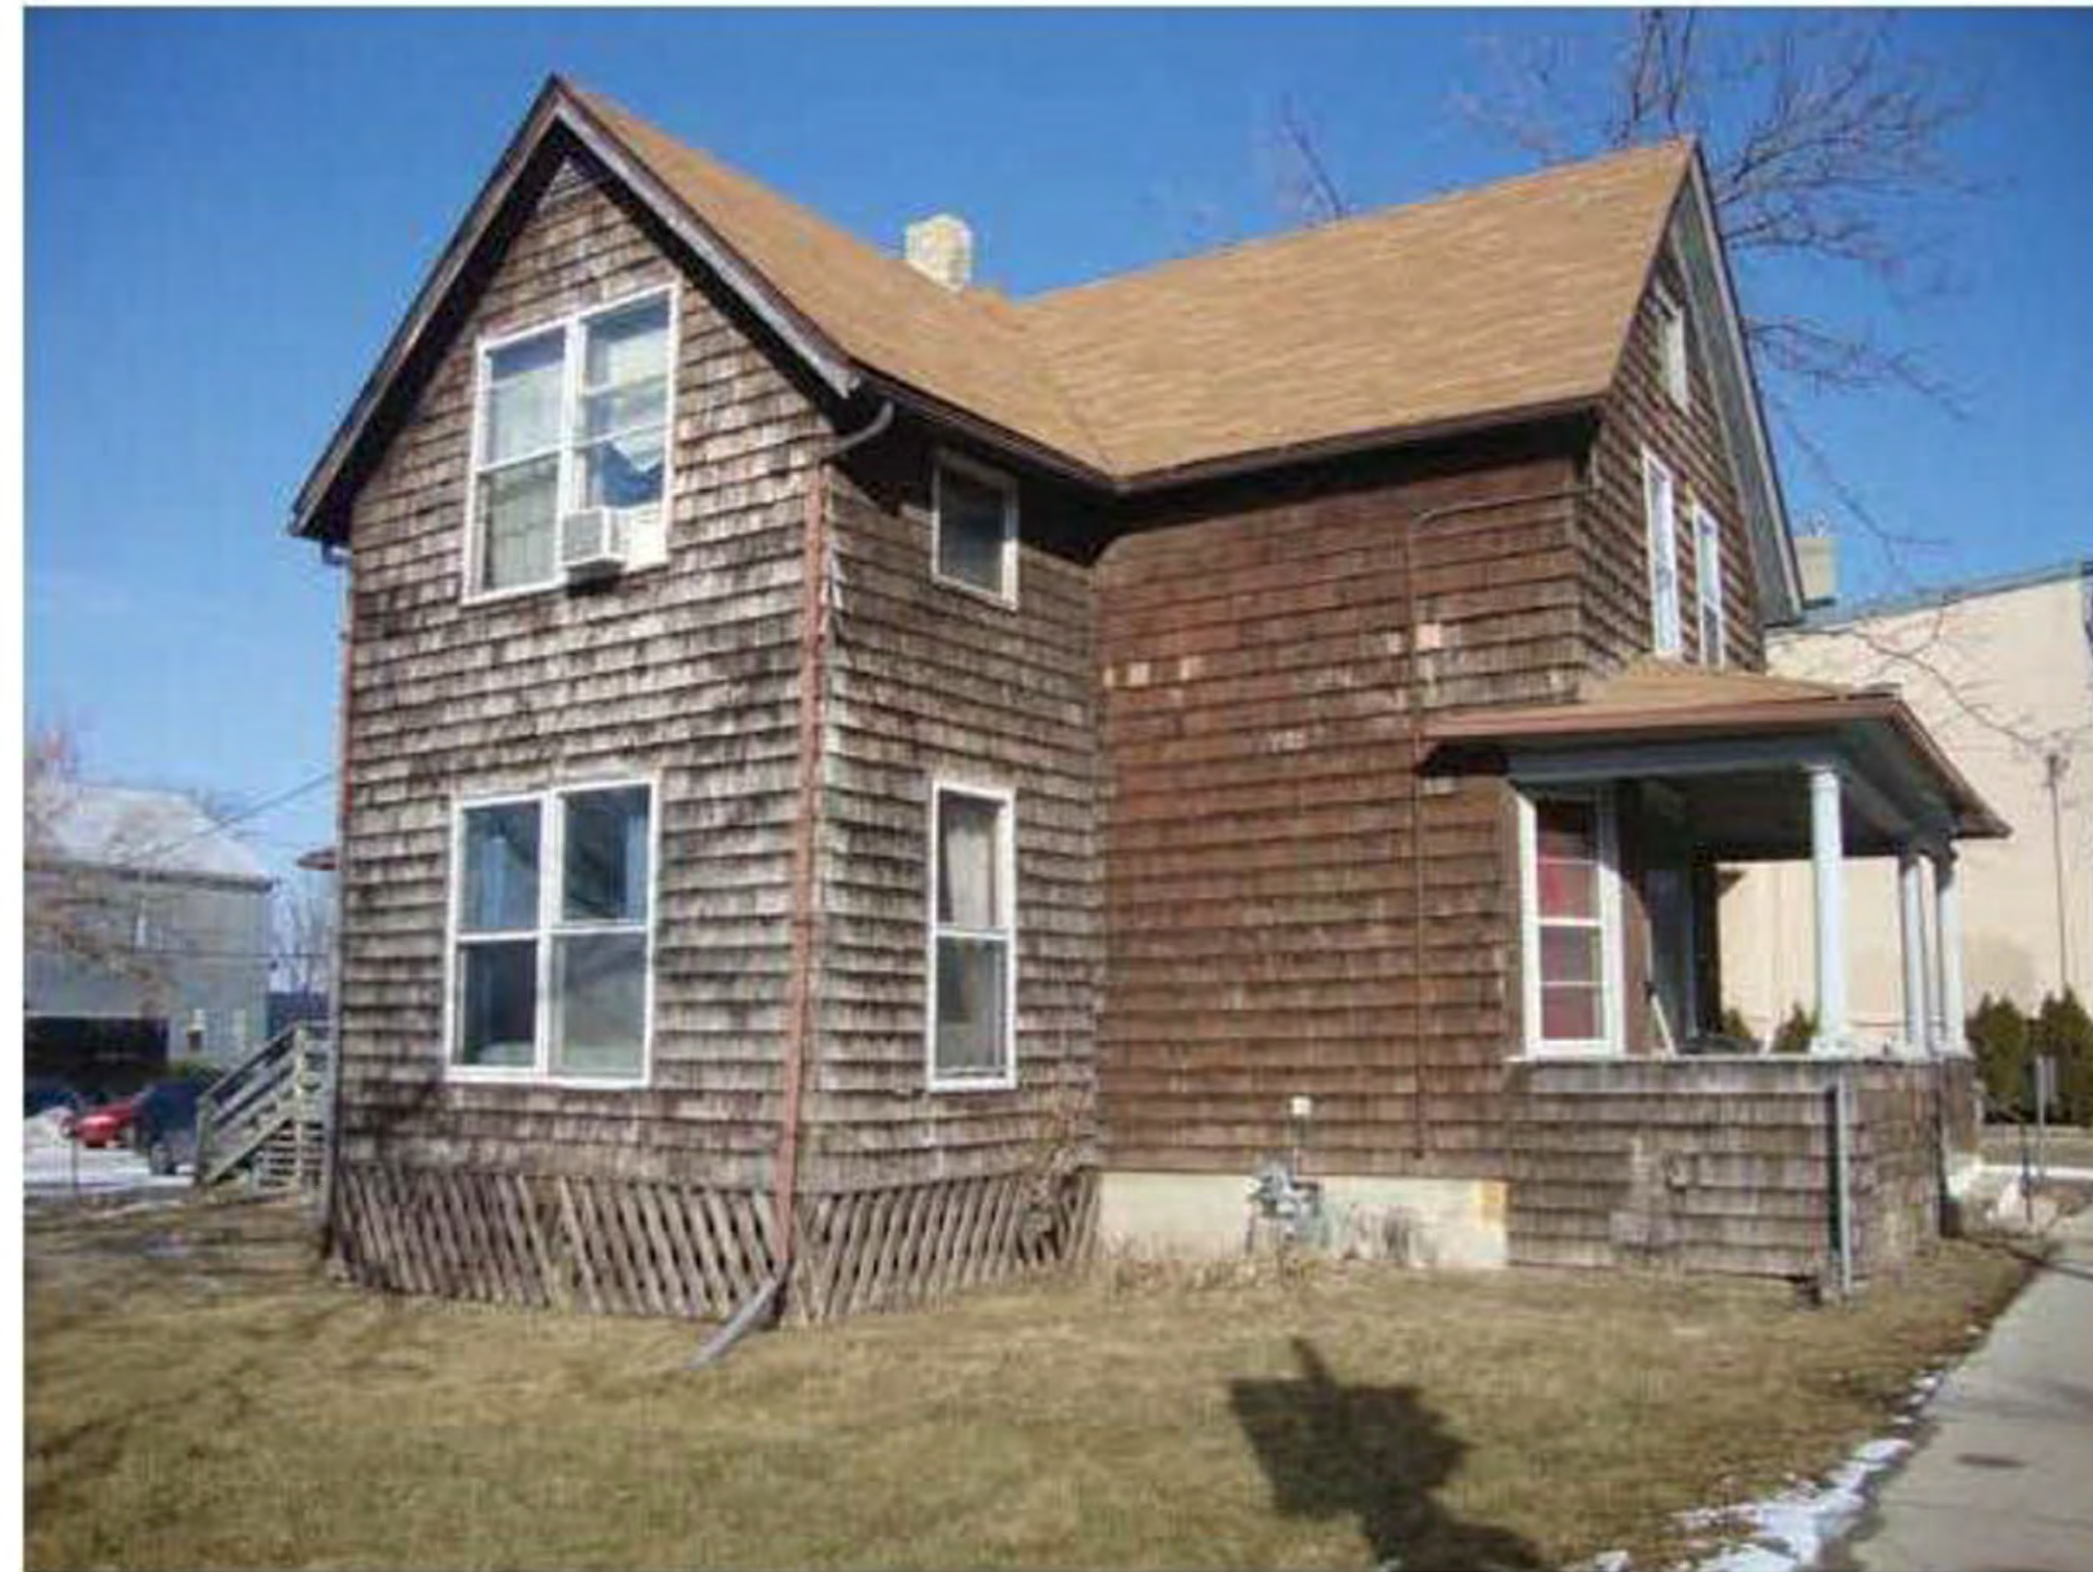
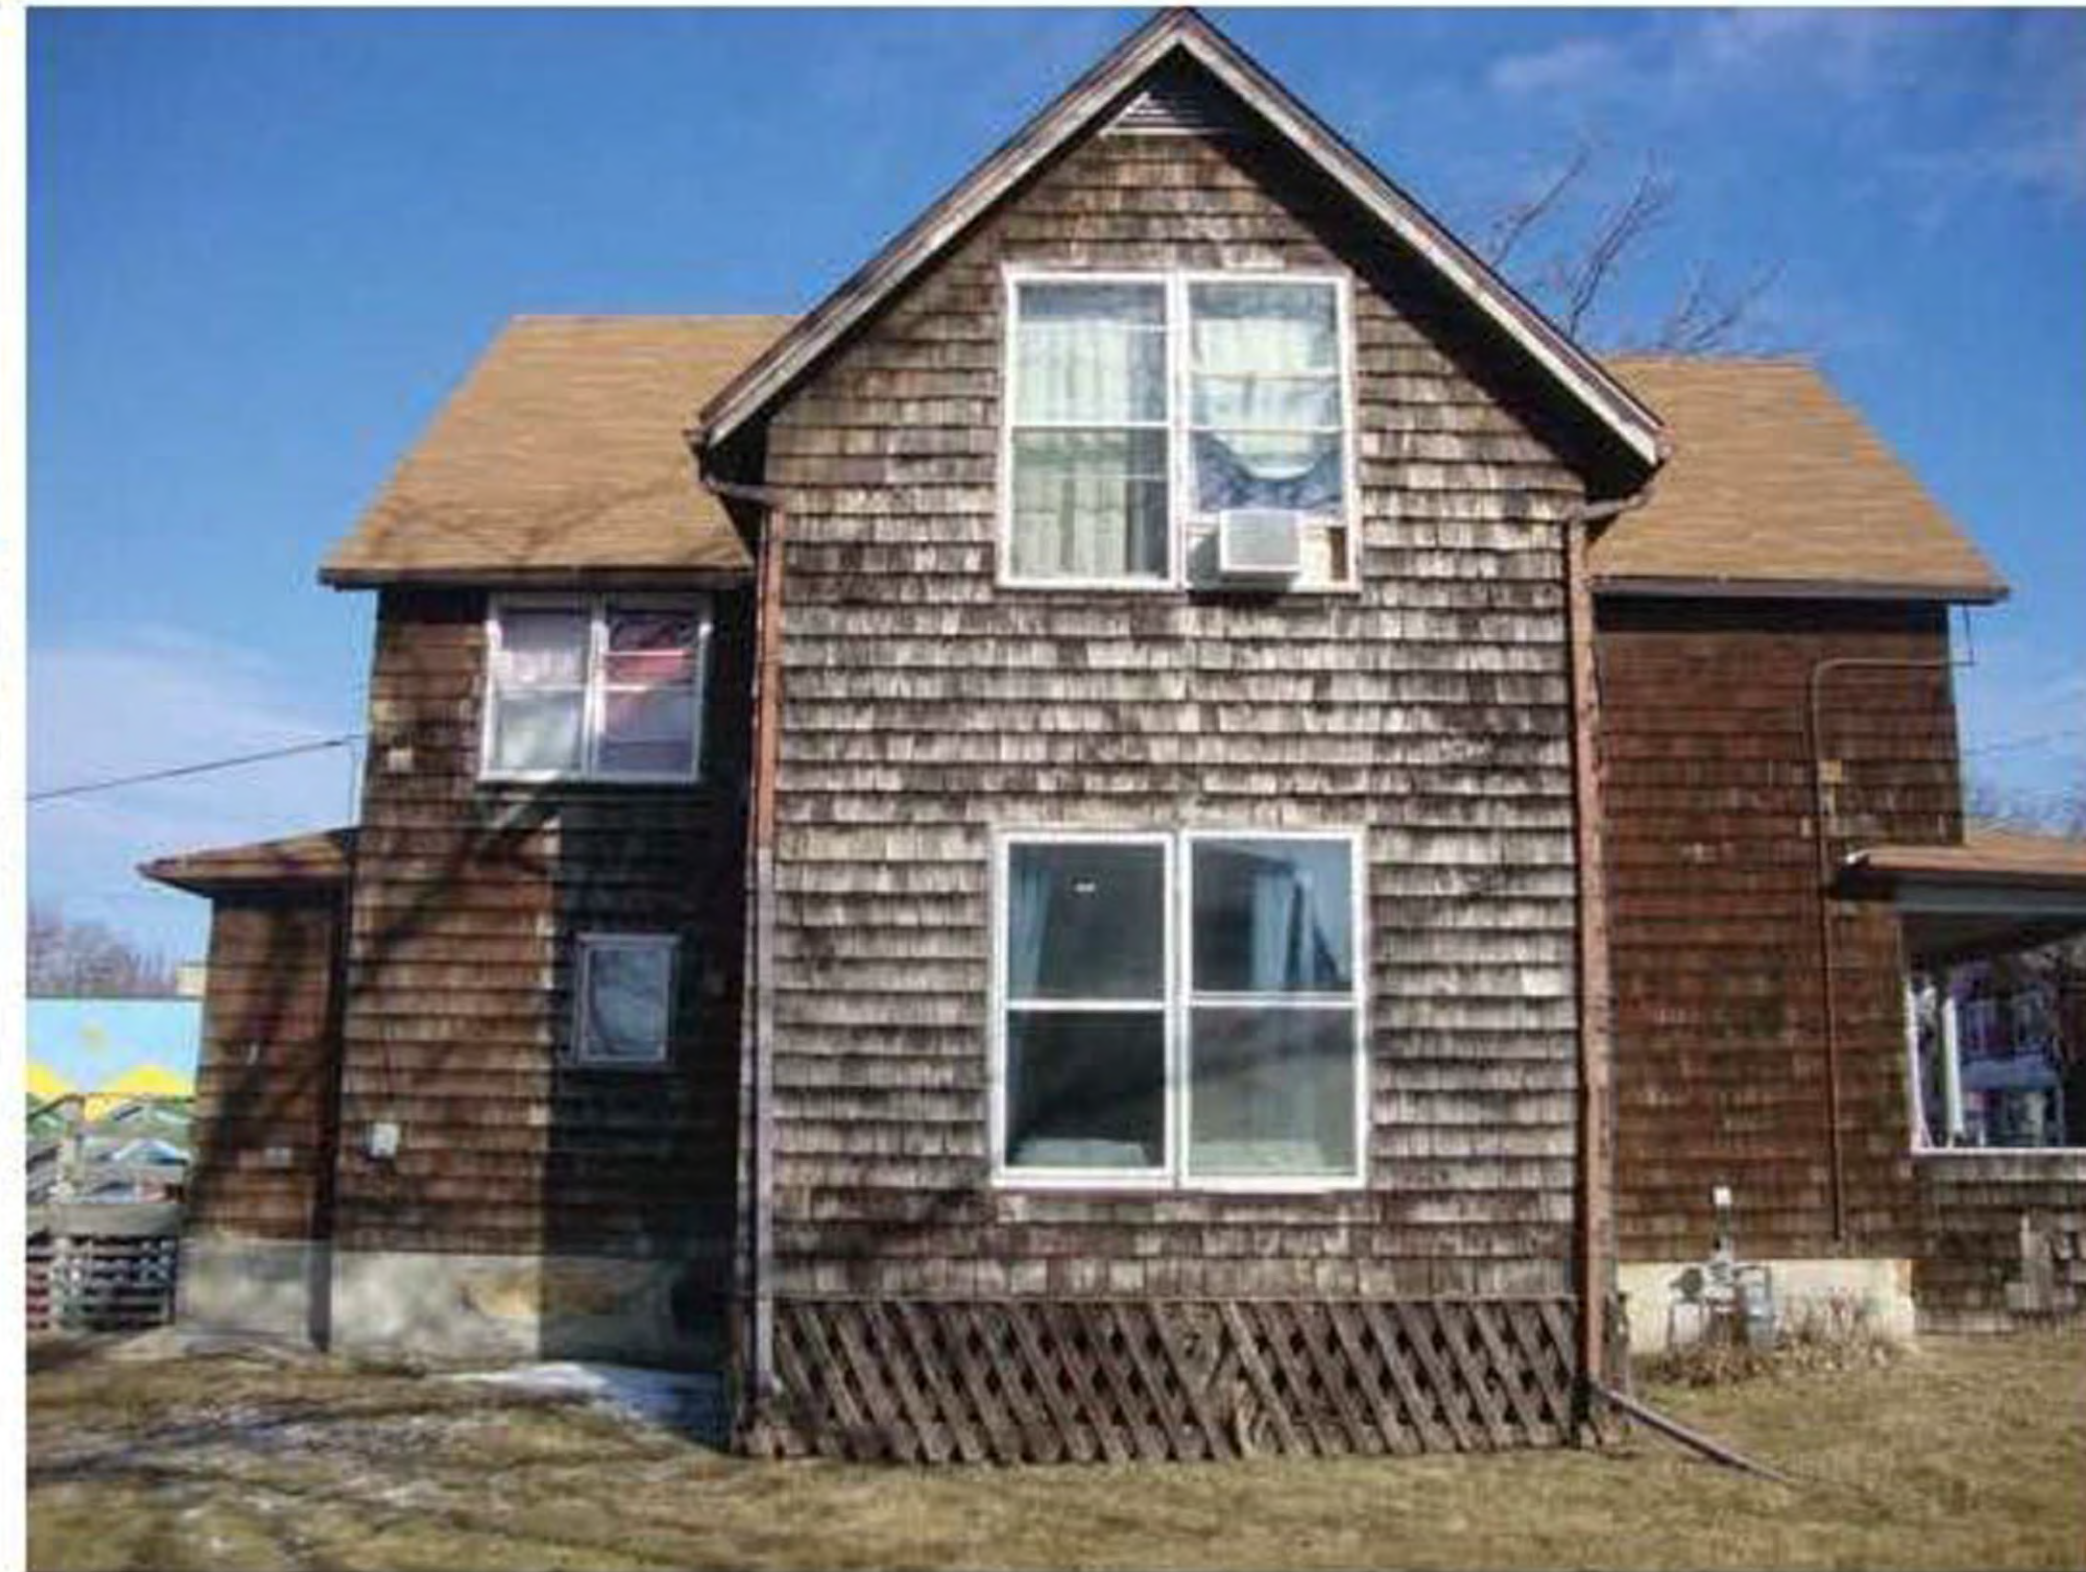
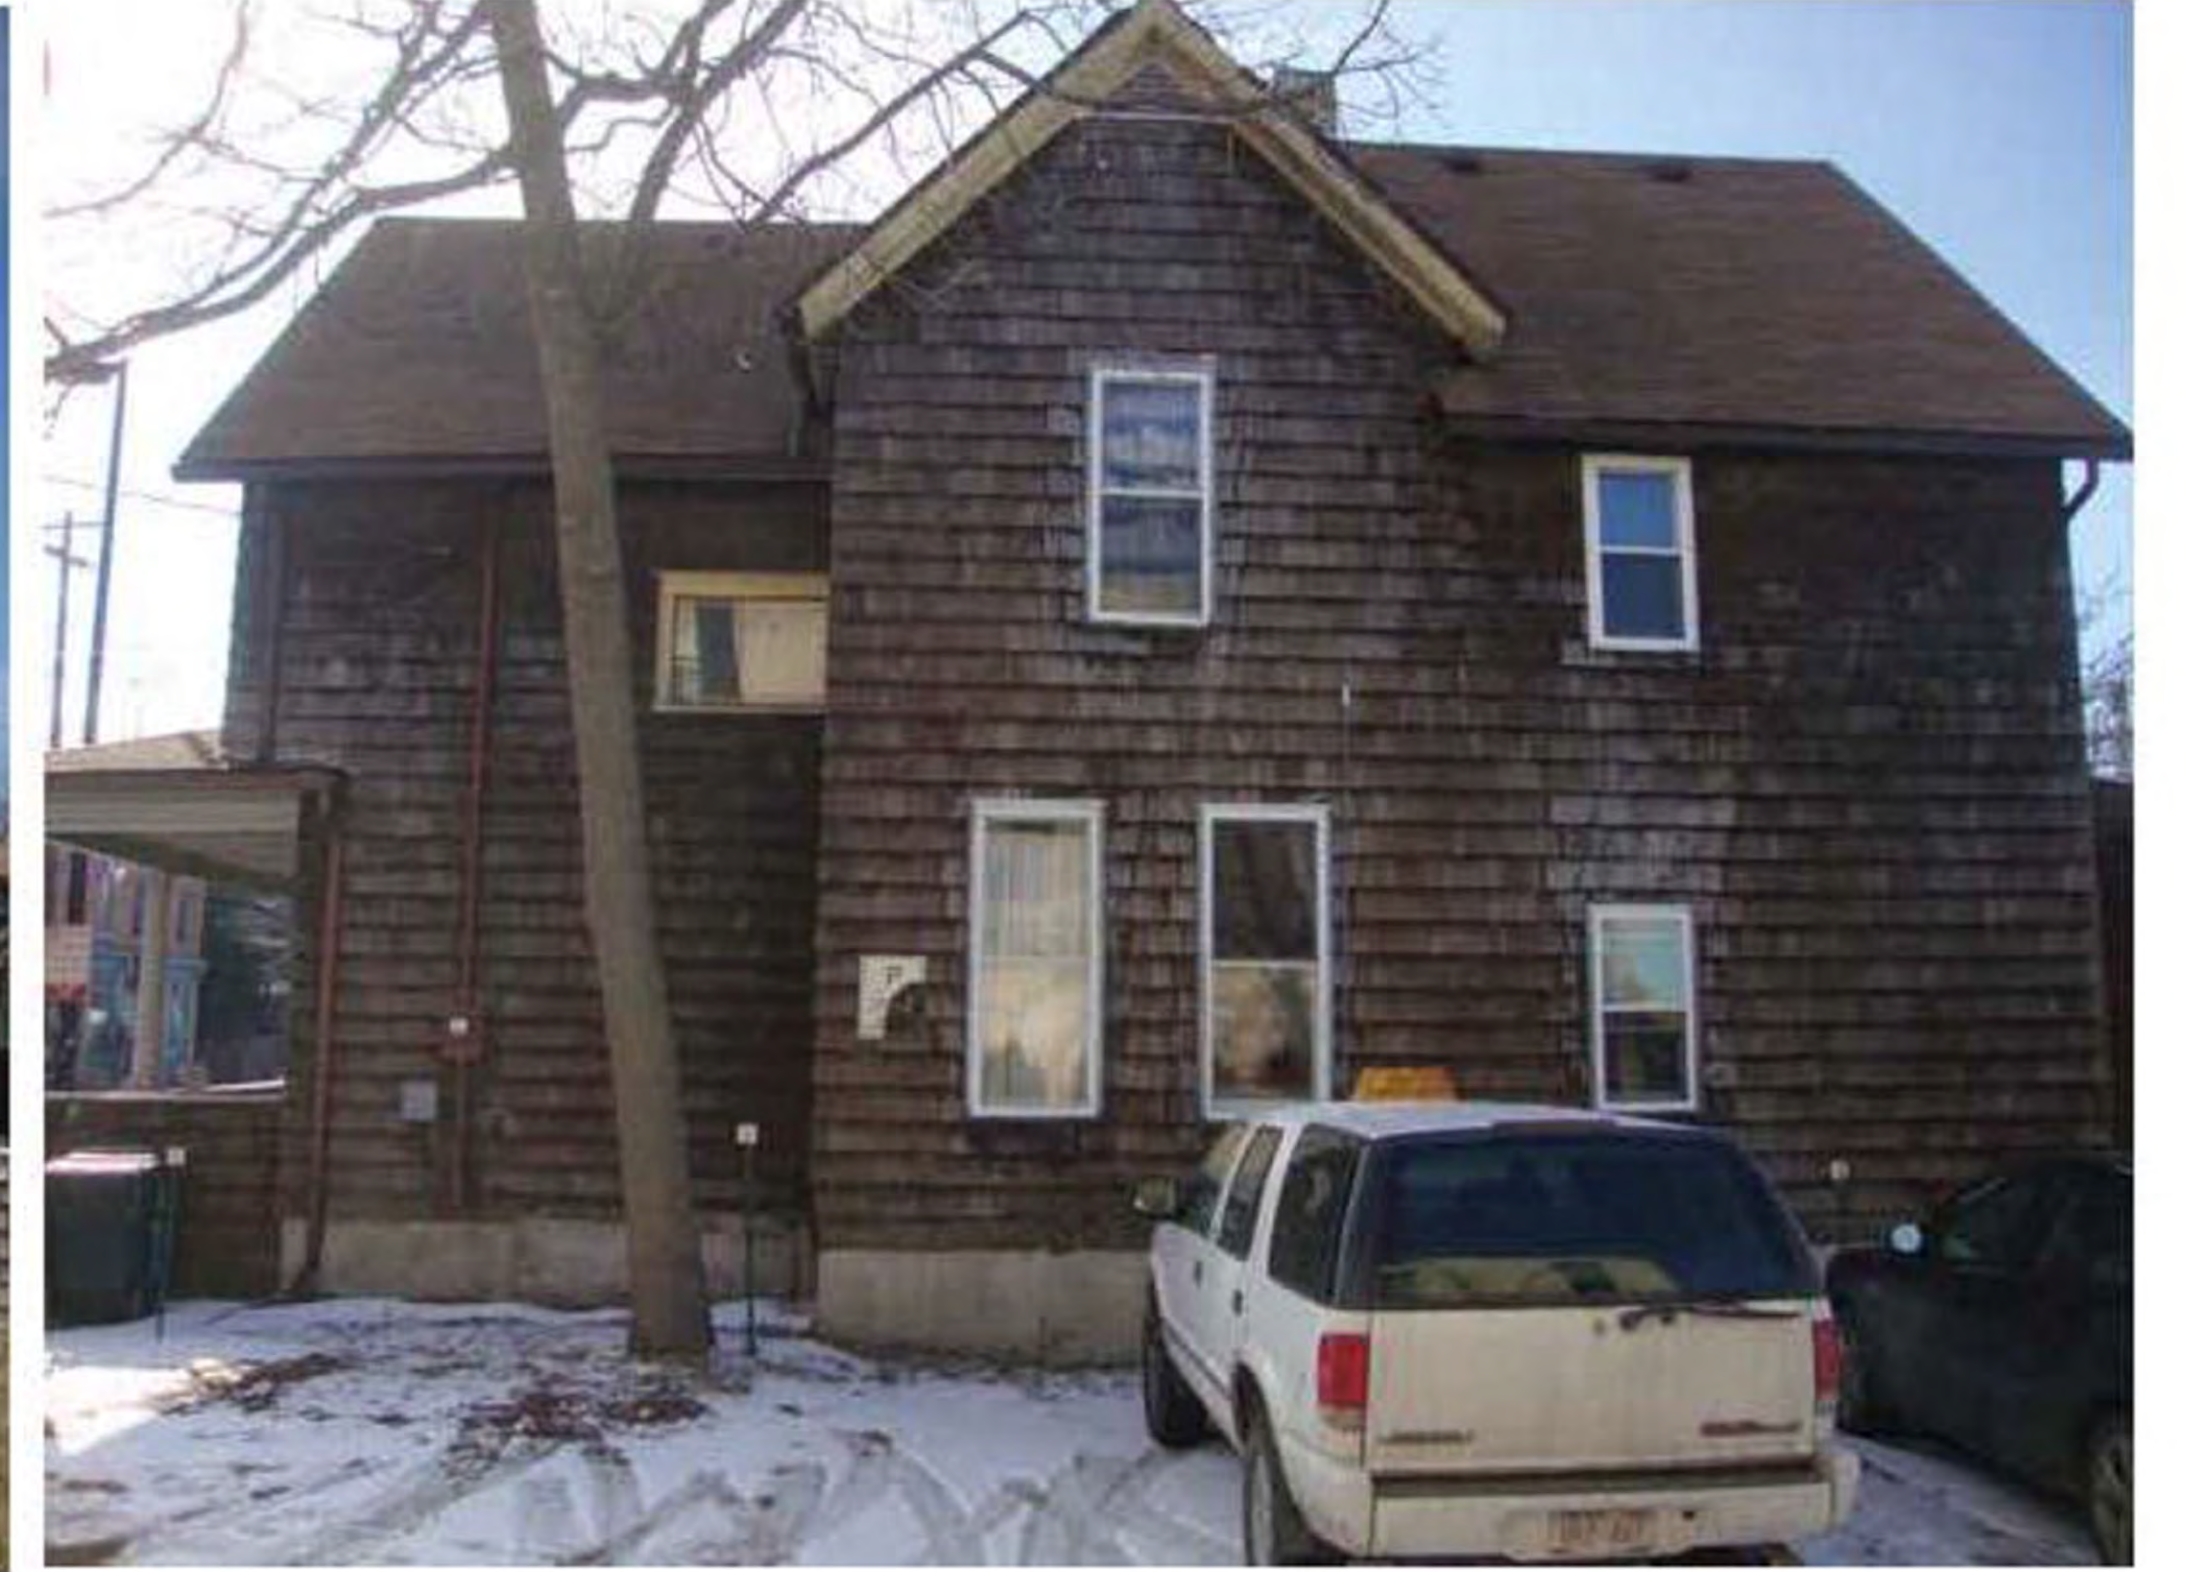
PHOTOS OF EXISTING SITE - BUILDING EXTERIOR

The exterior of the stone foundation walls have been covered with a cementitious stucco material. This material is delaminating, cracking and failing in many areas allowing water penetration into the foundations. Exterior concrete walks are broken and uneven.

The front porch appeared to have several significant issues. Settlement of the front along Williamson Street was noted with some of the framing appeared to be deteriorated and in beginning stages of collapse. The front edge of the porch roof contained deterioration of the finish materials and some likely deterioration of the framing concealed within
