# Madison Landmarks Commission APPLICATION

Project Address: 906-910 Williamson Street Aldermanic District: 6

Re: Letter of Intent  
906-910 Williamson Street, Madison, WI  
**KBA Project # 1423**

Re: Evaluation of property at 906 Williamson Street, Madison, WI

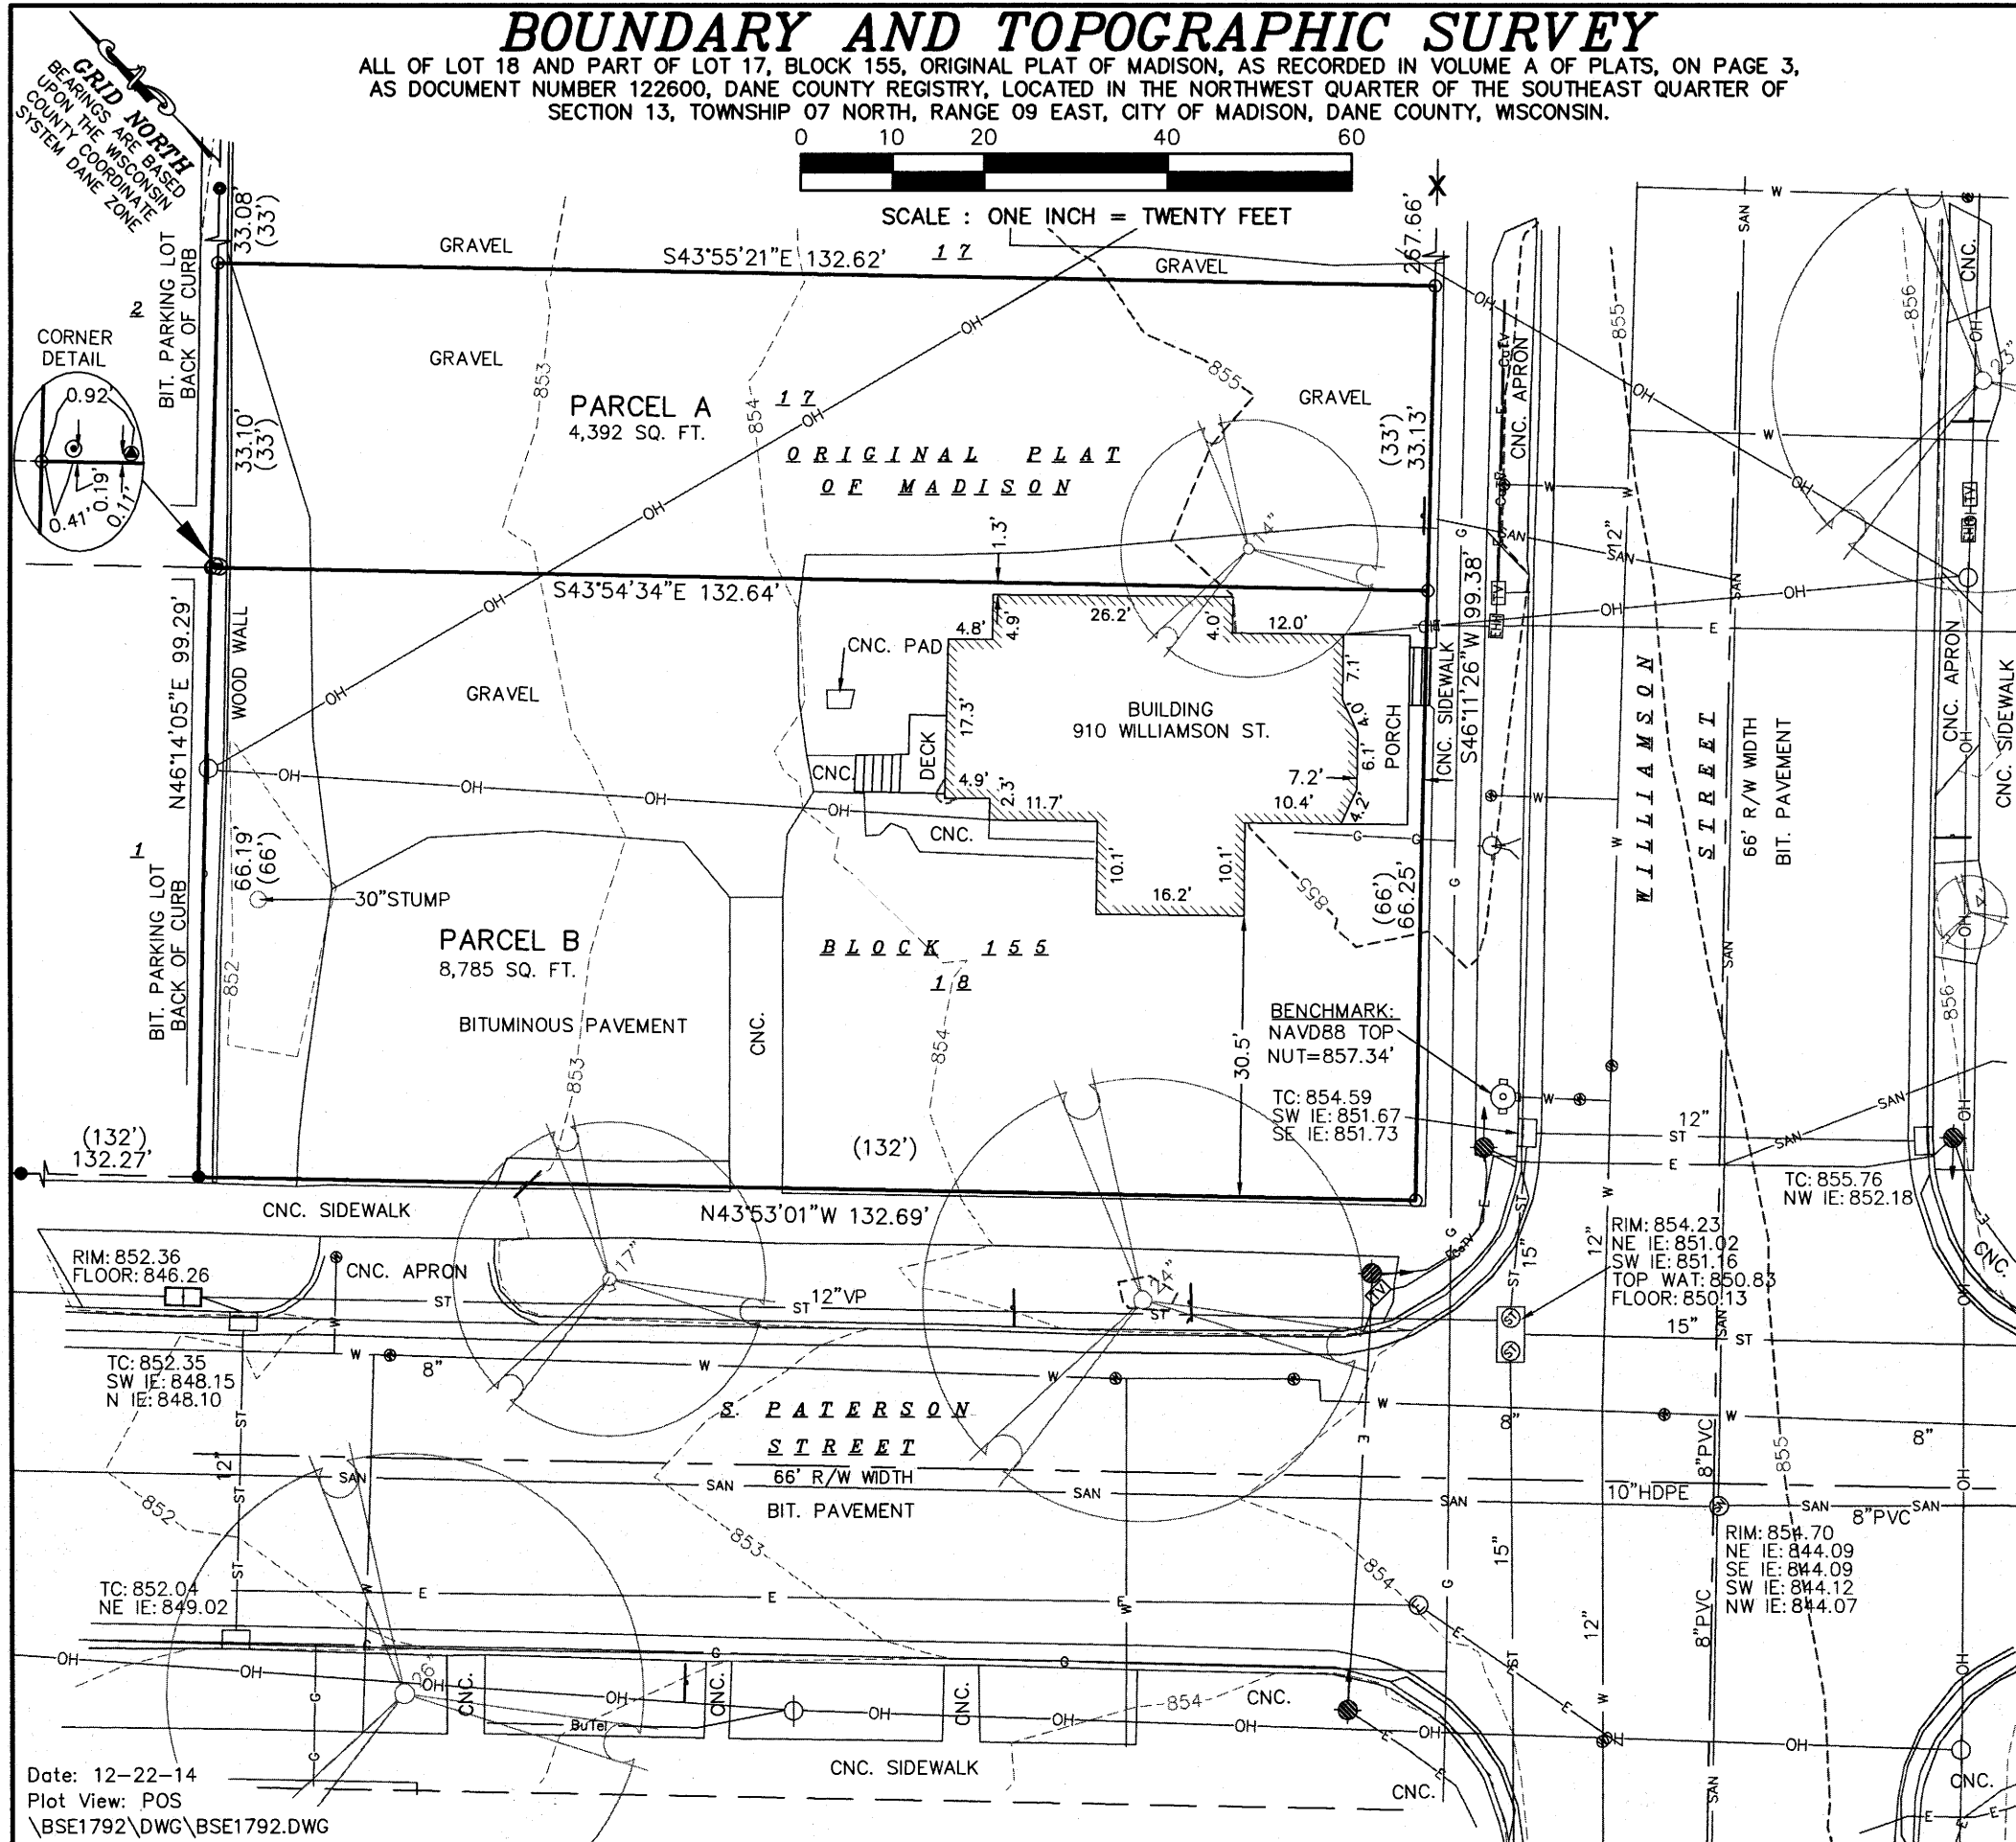
# BOUNDARY AND TOPOGRAPHIC SURVEY

ALL OF LOT 18 AND PART OF LOT 17, BLOCK 155, ORIGINAL PLAT OF MADISON, AS RECORDED IN VOLUME A OF PLATS, ON PAGE 3, AS DOCUMENT NUMBER 122600, DANE COUNTY REGISTRY, LOCATED IN THE NORTHWEST QUARTER OF THE SOUTHEAST QUARTER OF SECTION 13, TOWNSHIP 07 NORTH, RANGE 09 EAST, CITY OF MADISON, DANE COUNTY, WISCONSIN.

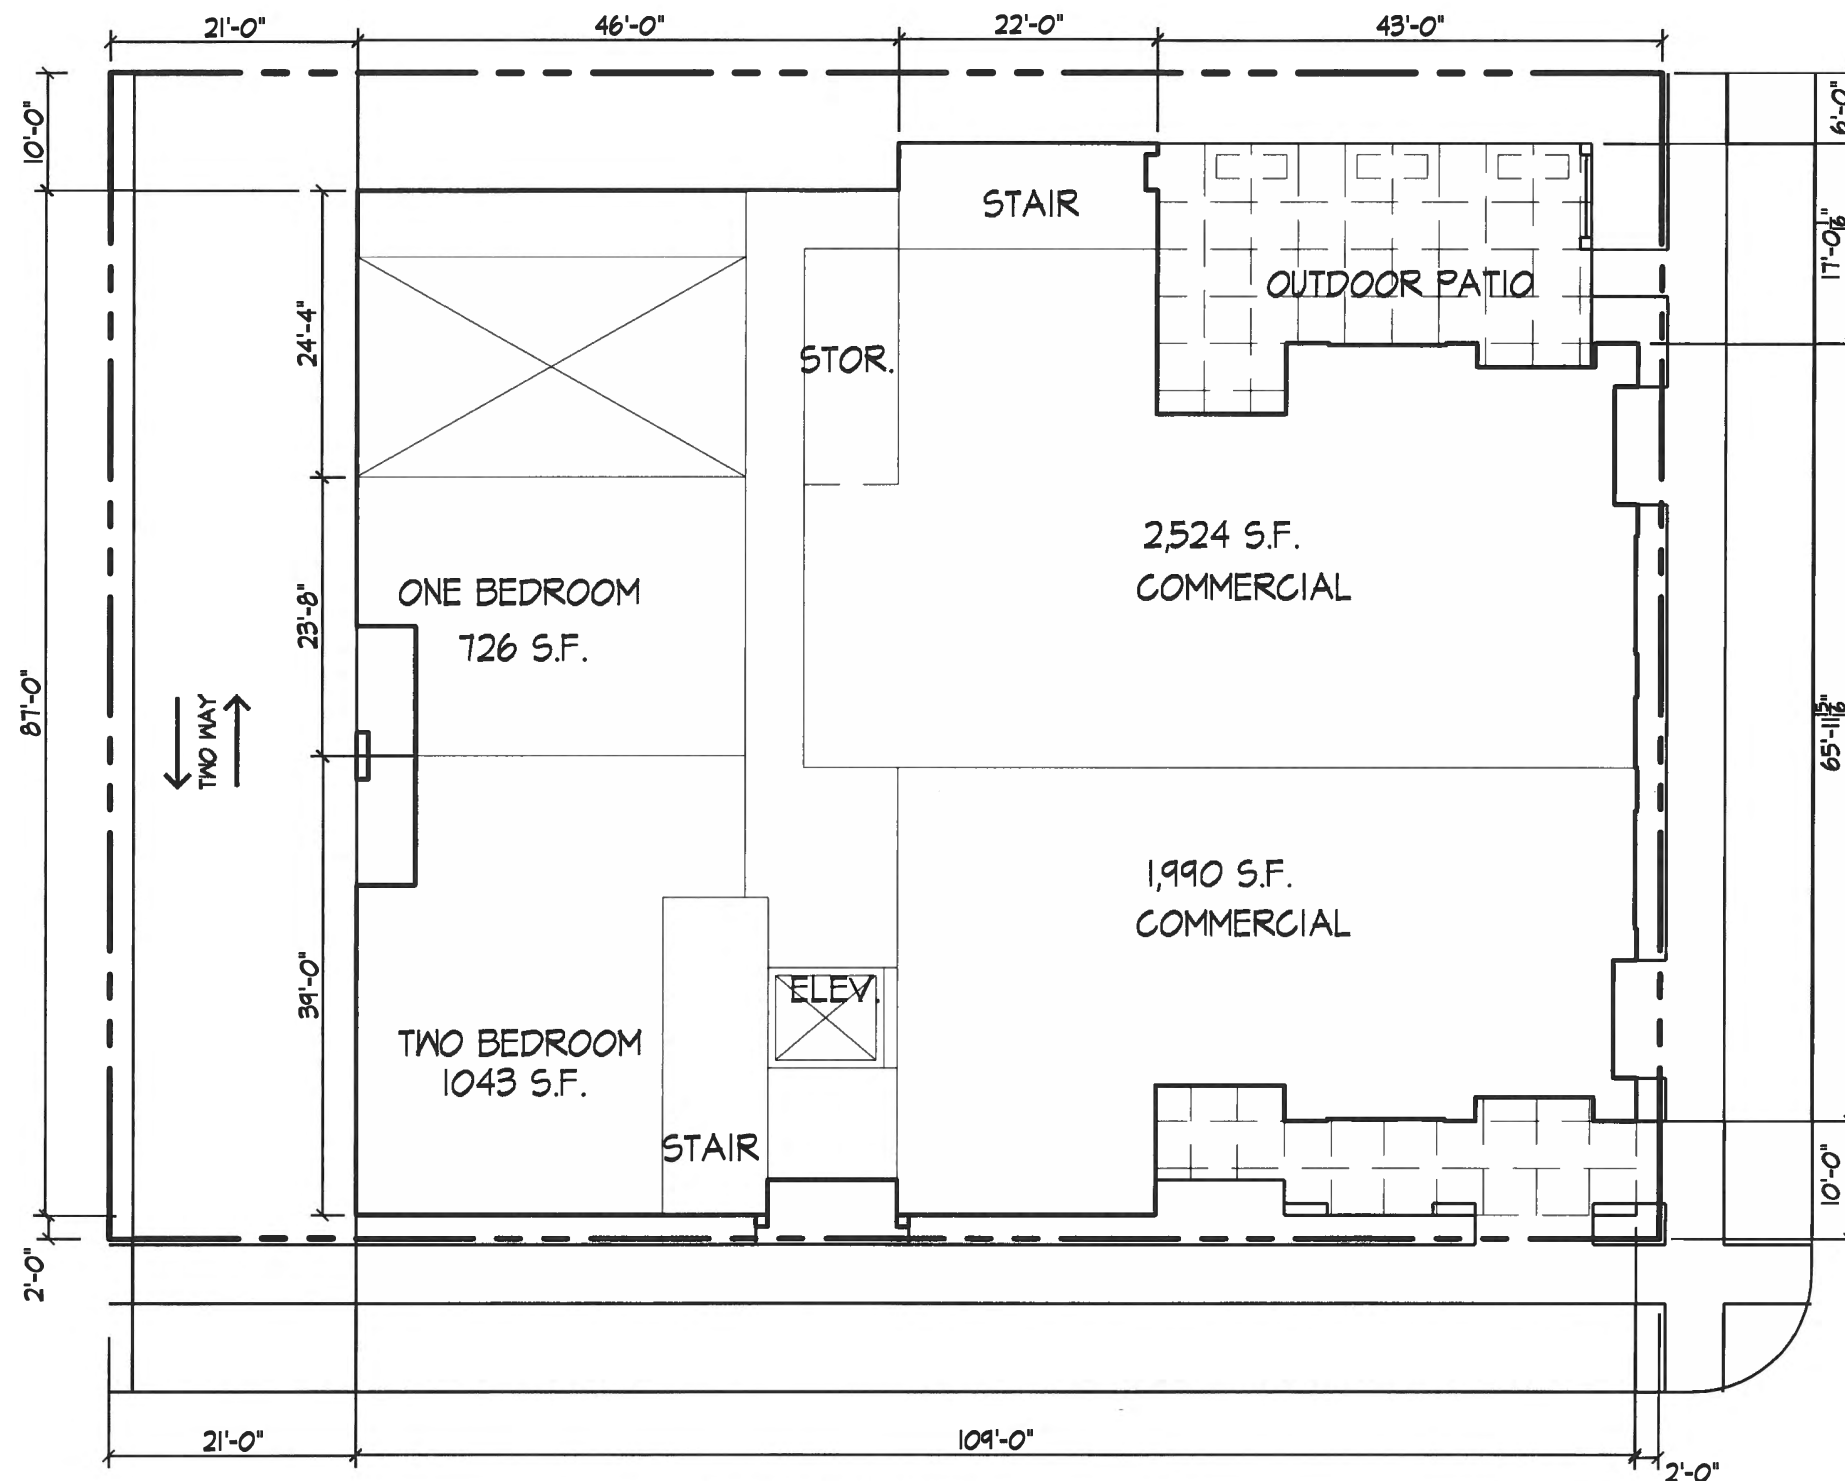
1 SITE PLAN  
A-1.1 1" = 16'

SITE AREA 13,068 S.F.
