Wingra Proposed Redevelopment District Blight Study

March 21, 2012

City of Madison,
Wisconsin

PREPARED BY MSA PROFESSIONAL SERVICES, INC.

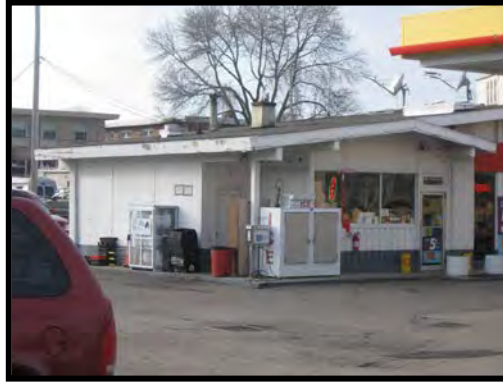
Parcel 46

Walls weathered and dirty; paint peeling from fascia; fascia cracking; paint wearing from window frames; vents rusted and discolored; accessory structure weathered and dirty; no screening around dumpsters; empty sign base; sign rusted; cracks/missing asphalt in lot; landscaping not maintained; trash along side of building

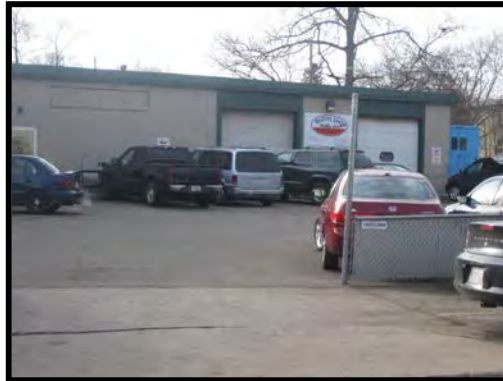
Parcel 49

Foundation cracked/paint wearing; walls rusted/paint peeling; rust around window; awning coming apart; vents rusted; doors dirt/rusted; lot cracked/discholorred; front walk overgrown; excessive litter

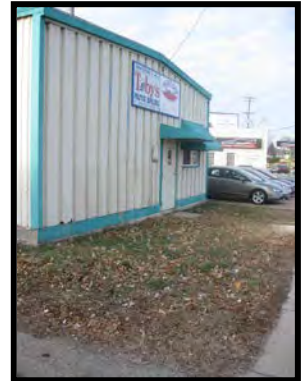
Score: 25.4

Concrete blocks bulging; paint/brick coming off; window framing worn/discholorred; overhang missing parts/rotted/paint wearing; downspout missing; doors not maintained; chain link fence broken; signs rusted/broken; parking lot cracked/patched/missing pieces; sidewalk overgrown; landscaping not maintained; vacant

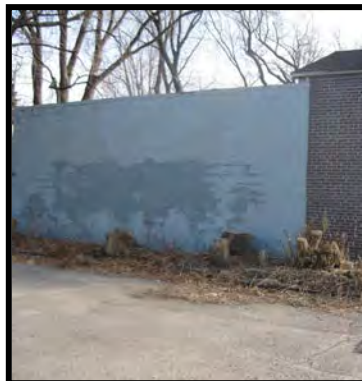
Parcel 51

Score: 27.2

Brick worn; roof missing protection/eaves bent; tires visible on roof from rear; windows weathered; window frames corroded; missing downspouts; vents rusted; doors weathered; mismatched paint on shed; lot cracked/uneven; sidewalk overgrown; landscaping not maintained; vacant

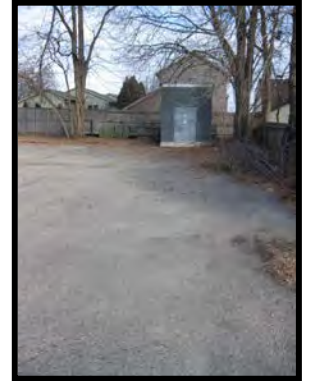
Parcel 55

Score: 53.6

Foundation cracked/missing material; walls cracked/weathered/rust stained; window frames rusted; boarded up window; mortar missing from chimney; stairs weathered/paint worn; back door rusted; fencing weathered; lights and signs weathered; light missing; cracks in lot; no sidewalk along Delaplaine Ct; landscaping not maintained

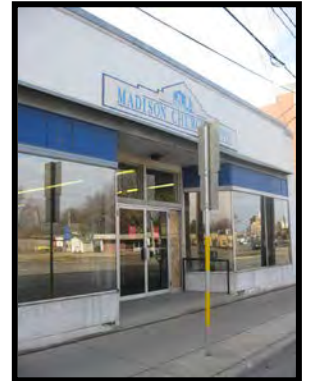
Parcel 58

Score: 59.7

Foundation cracked/weathered; siding detached/dented; staining under dormer; window frames/shutters worn; porch support sagging; stairs weathered/rust stained; doors weathered/paint chipping; accessory structure in poor condition; driveway apron cracked; not compatible with adjacent use

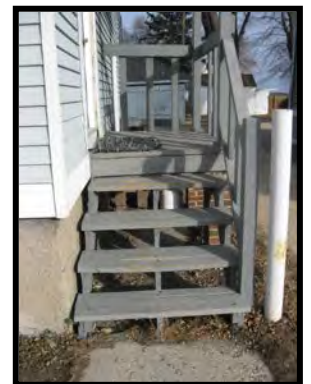
Parcel 104

Score: 43.5

Foundation cracked/missing material; cracks in walls/mortar deficiency; mismatched paint; shingles worn/curling; windows in poor condition; window boarded; gutter hanging/missing downspout; mortar missing from chimney; doors worn; garage door bent; billboard rusted; no screening around dumpster; pole sign rusted; light missing cover; drive cracked/uneven; landscaping not maintained; tires in front of building

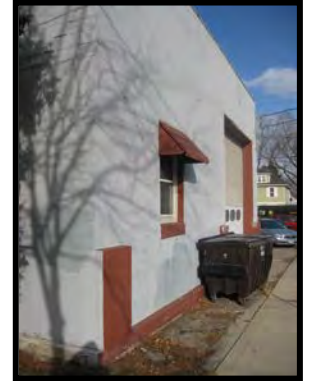
Parcel 106

Score: 58.7

Wall weathered; cornice in poor condition; window sills weathered/cracked; overhang dirty/mismatched paint; chimney brick bulging/cracked mortar joints; front door rusted; sign rusted; lot cracked/missing concrete; electric outlet to sign open/exposed wires

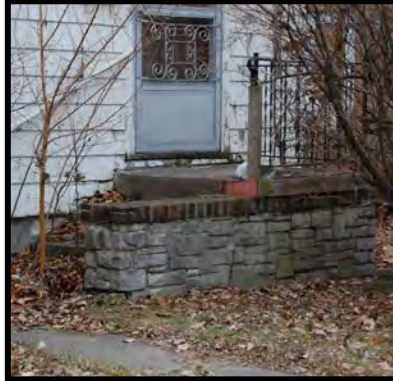
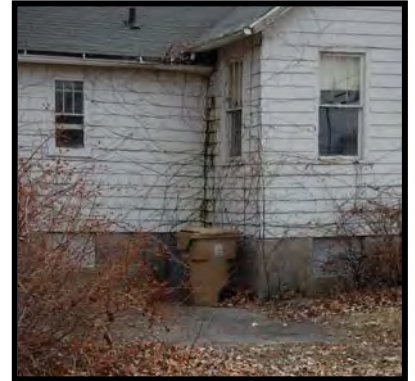
Parcel 21

Score: 13.6

Walls discolored and damaged; docks in poor shape; paint peeling from gutters, sagging; drives & walks overgrown and eroded; vents rusted; excessive litter; graffiti; incompatible with neighborhood; vacant

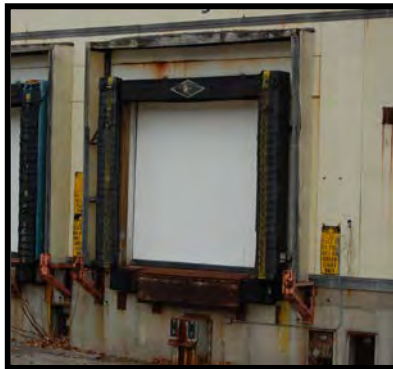
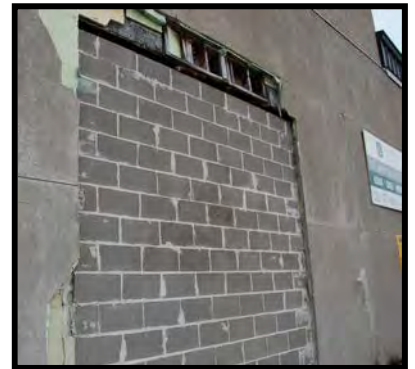
Parcel 27

Score: 54.2

Walls, soffit, windows, back door dirty; balcony weathered and moldy; gutters dented, portions of downspouts missing; garage in poor condition; junk in yard; drive eroded

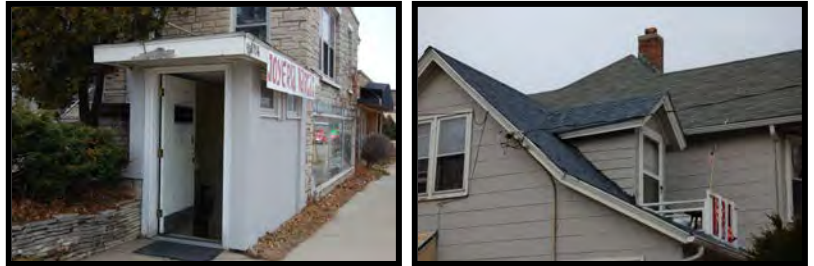
Parcel 110

Walls dirty, discolored, warped, paint mismatched; paint peeling from fascia, soffit, window frames, commercial overhang; gutter rusted; stairs crumbling, uneven; no screening of garbage cans

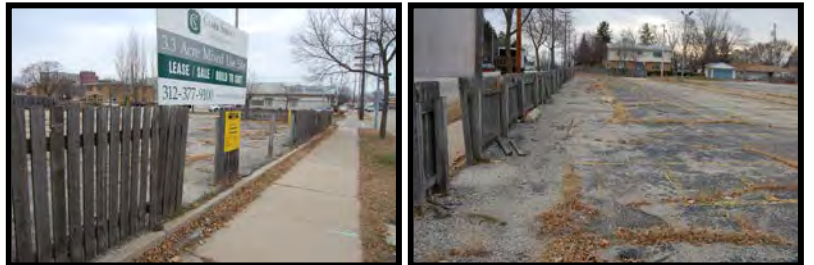
Fence in poor condition; asphalt weathered, cracked, deteriorating; excessive litter; lot overgrown

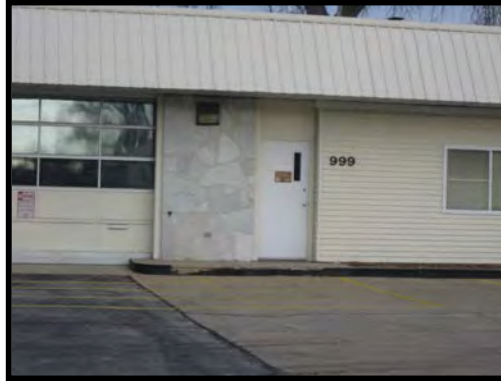
Parcel 38

Walls weathered/some cracks/some rust; stairs weathered/discolored/missing cosmetic trim piece; doors dirty/worn; no screening around dumpster; empty sign/light poles; rusted pole; cracks in lot; walkway eroded; landscaping not maintained

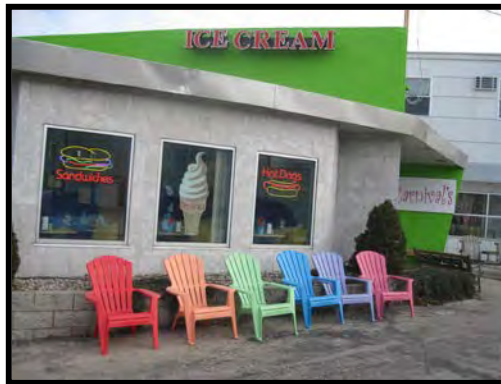
Parcel 41

Walls weathered along sides; mismatched paint; metal roof fascia dented and bent; rusted wire pole; discoloration of stoop; paint worn/staining on side door; no screening around garbage containers; fence worn; drive discolored/ cracked/ stained; sidewalk discolored; landscape edging pavers falling onto sidewalk; graffiti

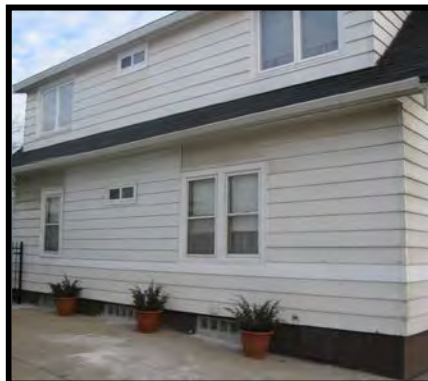
Parcel 61

Foundation weathered/ dirty/ paint peeling & mismatched; walls dirty/weathered/mismatched/ discolored/ dented; roof eaves very dirty; soffit sagging over entrance; window frames dirty; awning dirty/ paint worn; gutters dirty; stairs in poor condition; back fence in poor condition; light rotted/weathered; missing house number; drive weathered; sidewalk rust stained; gas meter exposed & unprotected

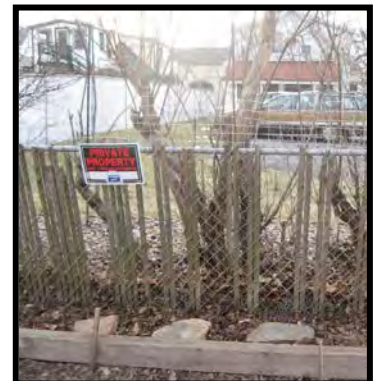
Parcel 69

Score: 47.9

Walls worn/back wall in poor condition; windows dirty; paint wearing off electric pipe; step and curb weathered; side door worn; shed weathered/rusted; fence missing pieces/worn; rusted poles; missing sign face; lot cracked/dischored/missing concrete; garbage containers not maintained; remnants of payphone; cover missing from electrical box

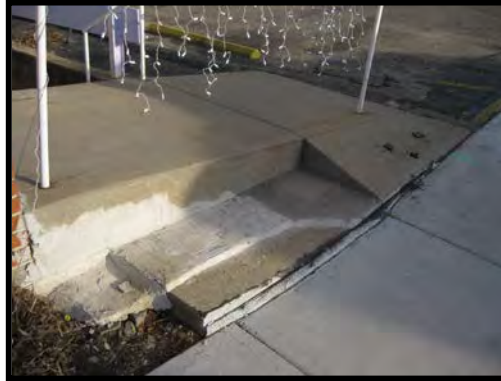
Paint mismatched; missing fascia boards; roof worn; window frame cracked; chimney missing mortar/rusted metal cap; vents rusted; patchwork on stairs/rotted railing pole; side door weathered; wood parking barrier warped/weathered; lot cracked/dischored; site not maintained; poorly covered graffiti

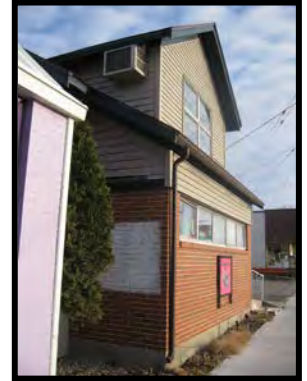
Parcel 78

Score: 53.1

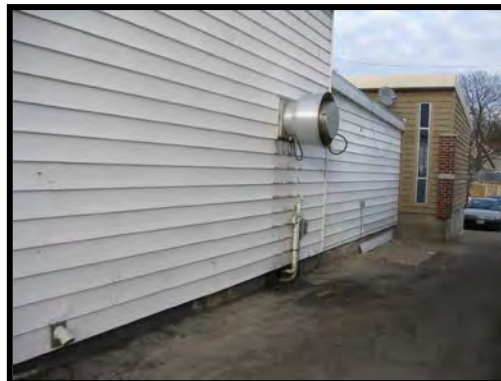
Parcel 81

Back addition of building generally in good condition; Front of building has following deficiencies: foundation weathered/dischored; walls worn/some holes & dents; fascia cracked/weathered; shingles worn; window frames worn; rust on vents; stairs discolored; door frames worn/weathered; signage dirty; lot cracked/dischored; sidewalk discolored

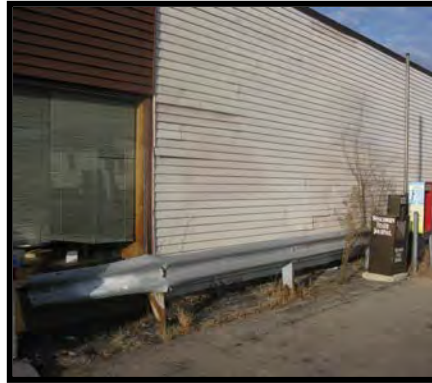
Parcel 108

Siding bent/ dented/ falling off; cladding worn; window sill paint worn; stairs worn; parking weathered; sidewalk in poor condition; rusted seat/pole; weeds along building; interior blinds in poor condition; partially vacant

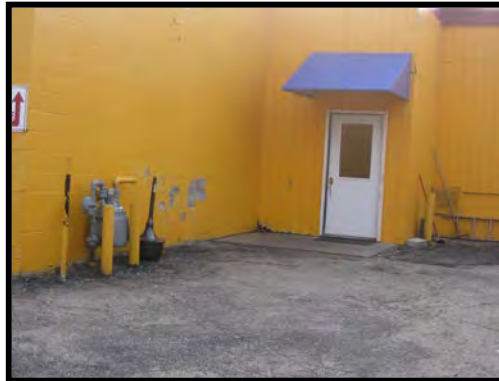
Parcel 111

Inconsistent paint/ paint peeling/ missing boards along cornice; windows worn; vents weathered; doors and frames in poor condition; no screening around dumpsters; chain link fence in poor condition; lighting and signage dirty; walkway cracked/weathered; parking lot cracked/ weathered/ discolored; landscaping not maintained

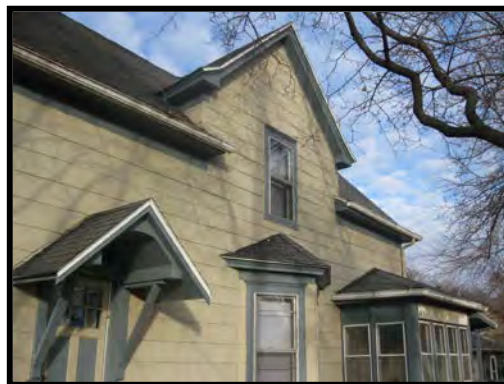
Foundation weathered; wall dirty/damaged/paint wearing/ patched crack around front door; roof worn/rusted metal joint; paint wearing from window frames; portions of gutter missing; stairs weathered/discolored/ missing material; paint wearing from door; garage in poor condition; cracked driveway apron; landscaping not maintained

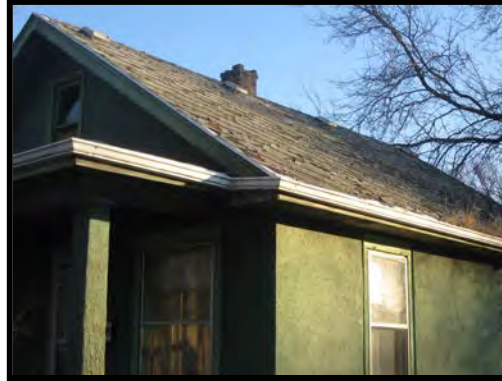
Parcel 92

Foundation weathered/cracked; walls worn/weathered/discolored/missing paint & stucco/missing cladding; missing most shingles/ remaining shingle in poor condition; missing material under roof eaves; window frames weathered; some windows missing; gutters in poor condition; chimney missing bricks; stairs weathered; doors worn and dented; landscaping not maintained; trash around foundation

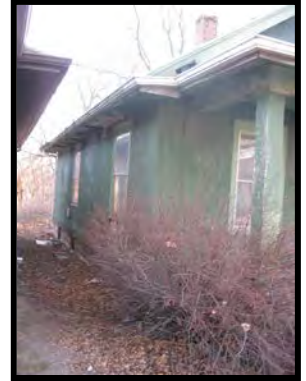
Score: 52.6

Foundation weathered/ discolored/patchwork; walls worn/ weathered /warped/ water damaged; roof worn/ missing flashing/curling; overhang weathered/flashing missing; chimney weathered; door bent; accessory structure in poor condition; garbage containers in front lawn; house number worn; driveway uneven/ cracked/ discolored

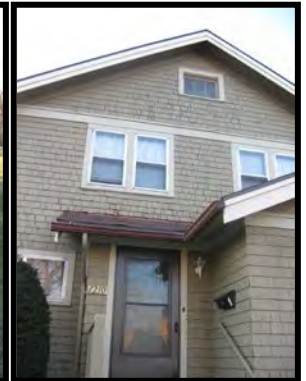
Parcel 119

Score: 55.2

Foundation discolored; walls weathered/ dented/ rust stained; window frames bent; awning in poor shape; back porch lacks adequate foundation; upper porch does not have railings; detached downspout; stairs weathered; concrete chipping; shed in poor condition; garbage containers in front yard; dirt parking; debris in yard

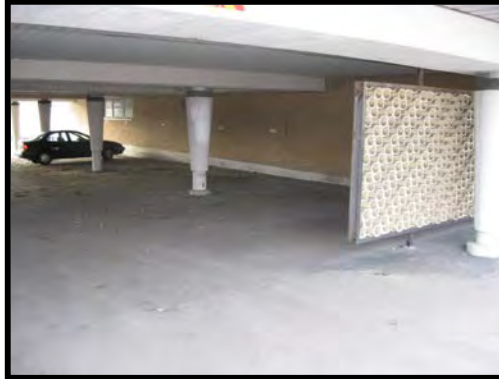
Parcel 13

Foundation discolored; walls discolored/ worn/ rusted metal; windows weathered; gutters rust stained; vents rusted; concrete screening worn; lighting and signage worn; drive is broken up asphalt/ mostly gravel/patchwork; sidewalk cracked/rust stained; graffiti; vacant

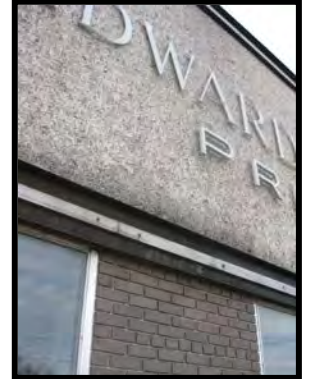
Score: 52.9

Walls worn/weathered/cracked; roof weathered; concrete window sills in poor condition; metal lintel rusted; chimney weathered; door frames and entryways dirty; gate rusted; fence weathered/rotted; rusted sign post; sidewalk discolored; mailbox rusted/worn

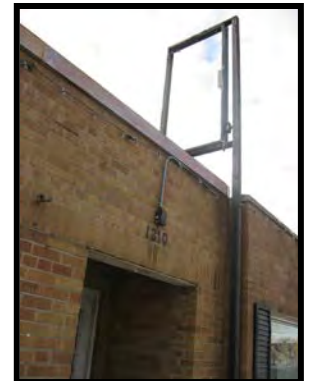
Parcel 26

Score: 55.2

Walls worn/patched holes and cracks; roof weathered; concrete sills cracked; vents rusted; chimney weathered; door frames worn/ irregular paint; no screening around garbage containers; sign and lighting dirty; sidewalk discolored/ uneven/ patchwork

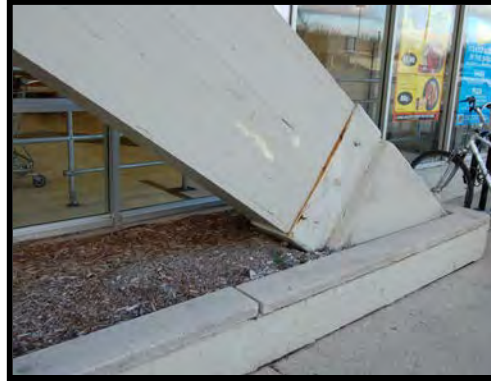
Parcel 19

Foundation cracked/ missing mortar; walls weathered; roof membrane worn; roof overhang missing pieces; supports cracked and rusted; window sills worn; ramp cracked/rusted/railings rusted; doors worn and rusted; sign poles and parking signs rusted; concrete sign base deteriorating; concrete missing from islands; lot cracked/worn/potholes; sidewalk worn/uneven/spalling; cart corrals rusted/damaged; litter

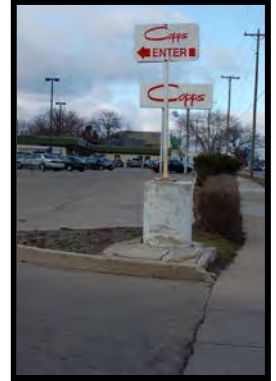
Score: 54.2

Signage weathered/rusted; lot cracked/ weathered/ potholes/ missing asphalt/ markings worn; sidewalk weathered; landscaping not maintained; only partially utilized

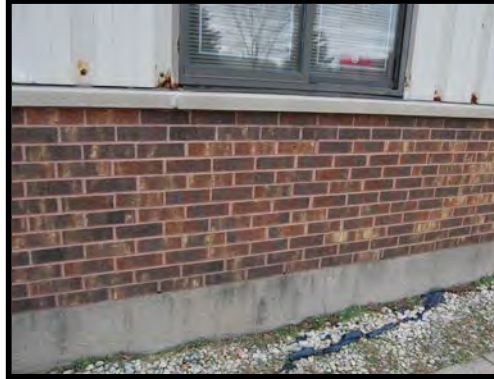
Parcel 18

Foundation weathered/ stained/ cracked; metal siding eroded/rusted; markings from previous signage; metal window frames faded; vents rusted; doors dirty and weathered; no screening around garbage containers; very rusted pole sign; building sign faded; drive worn/ cracked; weeds along building edge

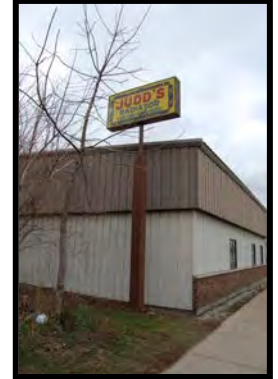
Score: 45.6

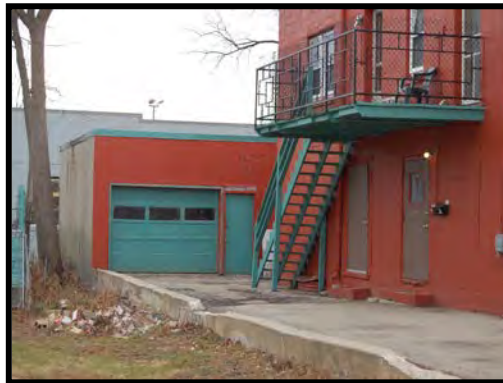
Parcel 24

Walls discolored/ stained/ paint mismatched; siding bent on porch; pieces of downspout missing; paint worn from steps; stairs uneven and crumbling; doors dirty/worn; concrete door frame crumbling; garage paint peeling/rust stained; rotted sign post with no face/dangling wires; drive cracked/ potholes/ asphalt deterioration; graffiti; retaining wall crumbling; partially vacant

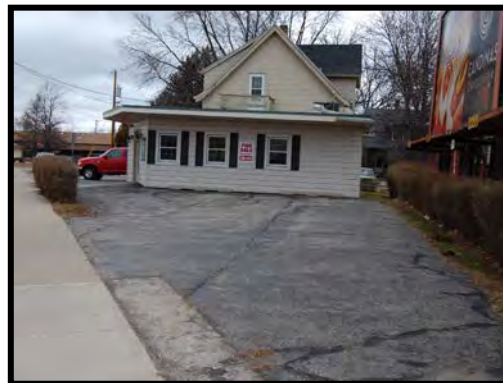
Parcel 25

Foundation mortar deteriorating/ discolored; missing cladding; discolored walls; eaves cracked; paint peeling from fascia; shingles curling; window frames dented; porch weathered/ worn/ cracked foundation/ paint peeling; stairs worn/ moldy/ paint peeling; paint peeling from door frames; accessory structure gutters missing; billboard structure rusting; parking/drive cracked and heaving; sidewalk weathered/spalling; billboard not compatible with residential neighborhood

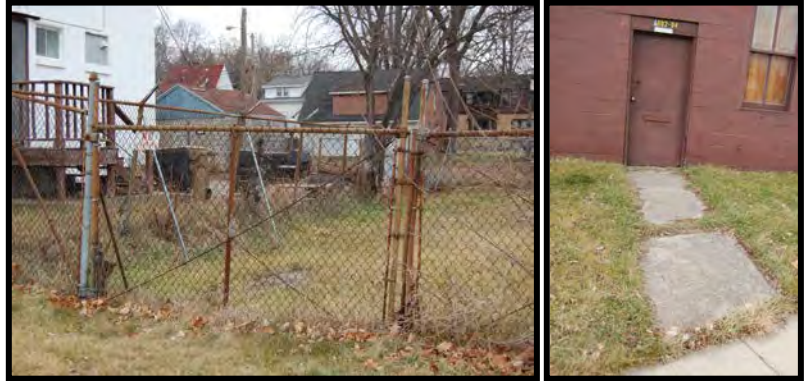
Parcel 53

Paint mismatched; mortar deteriorated; walls crumbling/weathered; majority of windows missing/ boarded up; vents rusted; doors weathered; garage doors rotted; fence rusted/ leaning; drive and walks mostly overgrown; vacant

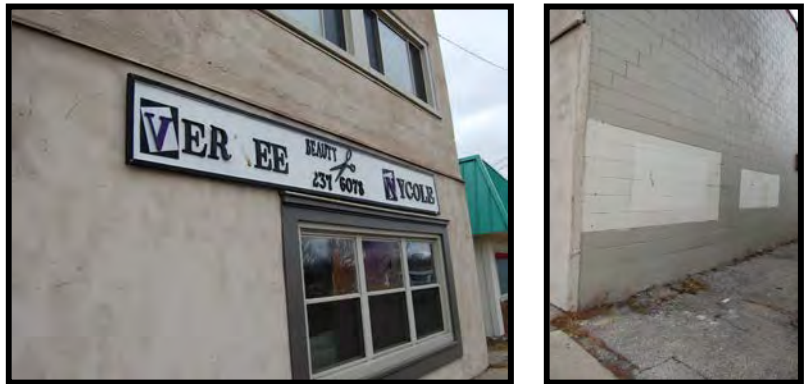
Parcel 66

Walls weathered; cracked; missing material; paint mismatched/ metal drip edge curling; window frames weathered/ missing pieces; gutters discolored; doors worn/ paint peeling/ dented; no screening around garbage containers; letters missing from sign; pavement weathered/ stained; tires in rear

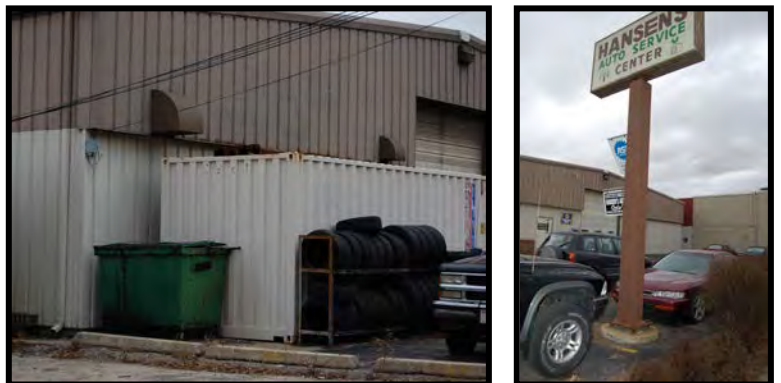
Parcel 67

Cladding bent/ rusted/ dirty/ discolored/ eroded; windows weathered; vents rusted; doors dented/weathered/ rusted; no screening around tires or garbage containers; storage container rusted; signage rusted/faded; guards near rear door rusted; graffiti; oil drums

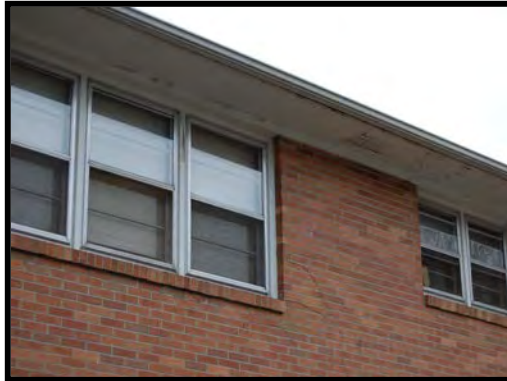
Parcel 71

Walls stained from water damage; paint peeling from roof eaves/soffit; windows weathered; paint peeling from window frames; porches weathered; stairs weathered/ rust stained/ spalling/ railings rusted; fence not protected; sign weathered; missing pole light; dead grass and dirt where drive access would be; bushes overgrown; incompatible with mostly commercial neighborhood; irregular/ crumbling steps pose safety hazards

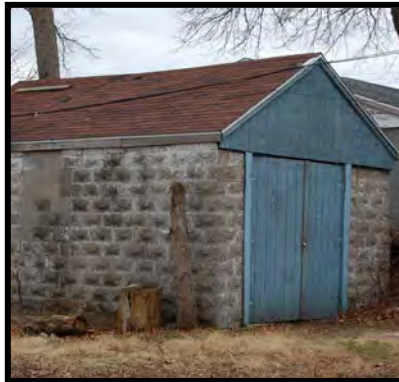
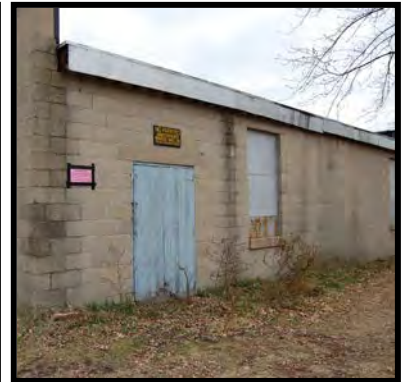
Score: 11.8

Walls cracked/ paint mismatched/ worn; drip edge rusted/rotted; windows boarded; sills stained; overhang components missing/ not painted/ covered by plywood; doors worn/ weathered/ rust stained; small shed in poor condition; signs worn/ rusted; drives/parking deteriorated and overgrown; landscaping not maintained; litter; graffiti; blue plastic on roof; trash in alley

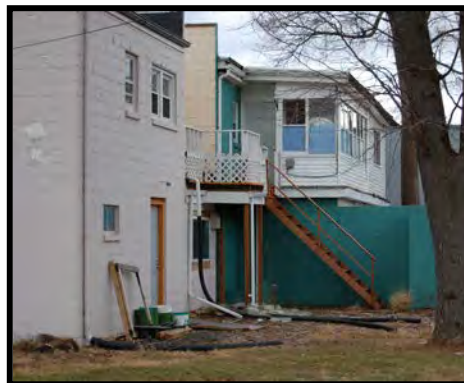
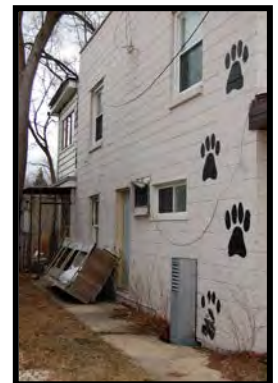
Parcel 87

Score: 37.4

Walls worn/ weathered/mortar deterioration/paint peeling; window frames rusted/ paint peeling/ some missing; back porch in poor condition; front overhang rusted/dented; garage overhang rusted; patchwork on chimney; side vent frame falling; back stairs and side entryway in poor condition; fence is damaged/ missing an entire side; no screening around garbage containers; worn sign; staining/ cracks in drive; landscaping not maintained; building debris along sides of building; partially vacant

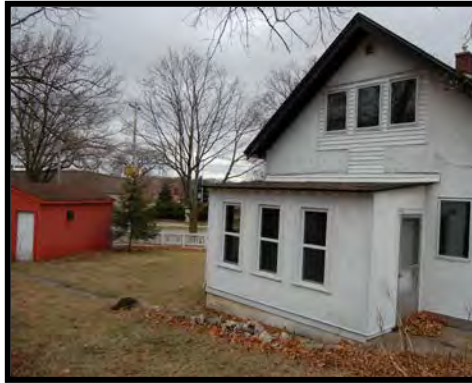
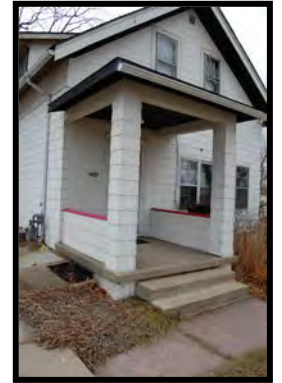
Parcel 88

Score: 51.0

Foundation weathered; wall paint and materials mismatched; pieces of siding broken/ discolored; shingles dirty/ sections of fascia missing/ paint peeling; windows worn/ dirty; porch in poor condition; gutters rusted/ sagging; vent covers rusted; garage door weathered/ shingles discolored; fence is missing pieces; rear walk overgrown; sidewalk discolored

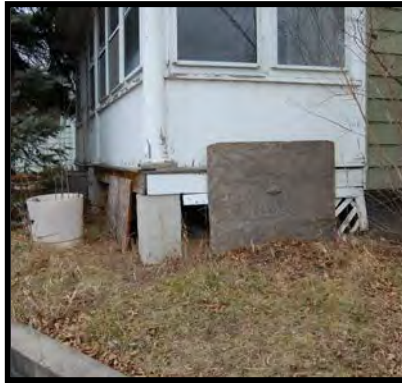
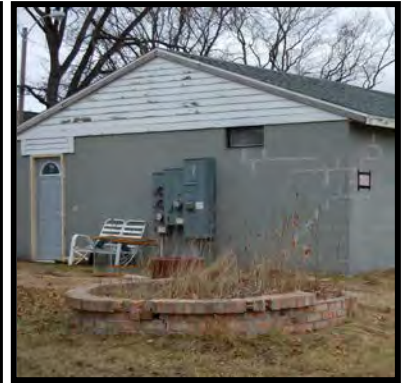
Parcel 95

Score: 30.4

Foundation and walls discolored; mismatched paint; roof weathered; window frames worn; some windows boarded/broken; porches in poor condition; gutters rusted; uneven settling of stairs; chimney weathered; missing door frame; garage in poor condition; drive missing; sidewalk uneven/ spalling; landscape not maintained; retaining wall leaning; junk/ building debris around structure

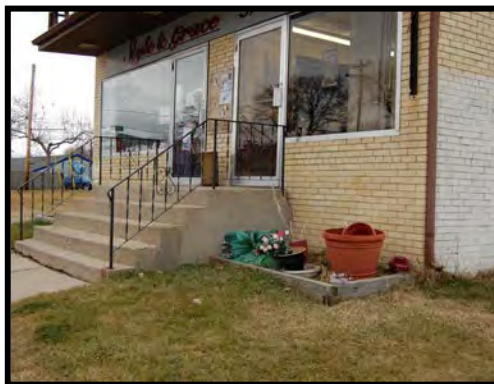
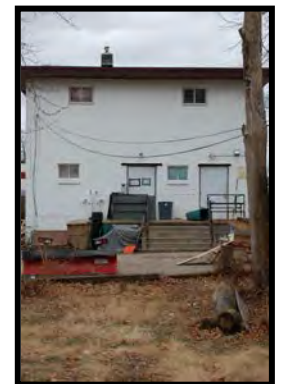
Parcel 100

Score: 43.8

Foundation patchwork; walls cracked/ paint peeling/ mismatched paint/ marks from previous signs; fascia board bent/ worn/ missing/ hanging off/ cracked; some windows boarded; upper porch in poor condition; gutters and downspouts rusted/ vents rusted; chimney patchwork; stairs cracked/ spalling/ rust stained/ railings rusted; upper door rusted; walk discolored; unmaintained lawn ornaments

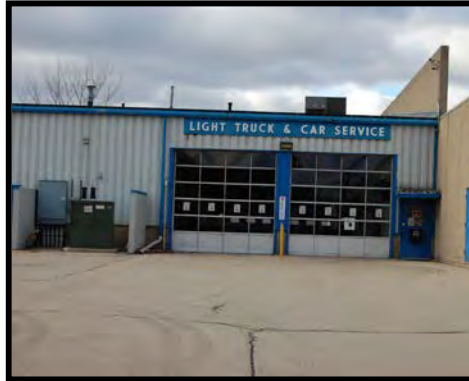
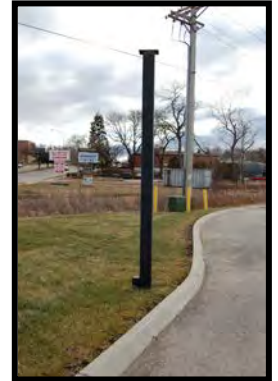
Score: 50.7

Walls discolored/ cracked/ dirty/ worn; window framing weathered; service door overhang weathered/ dirty; paint peeling from gutters; vents rusted; doors weathered/ dirty; lights and signage weathered; empty sign pole; lot cracked/ weathered/ potholes; vacant

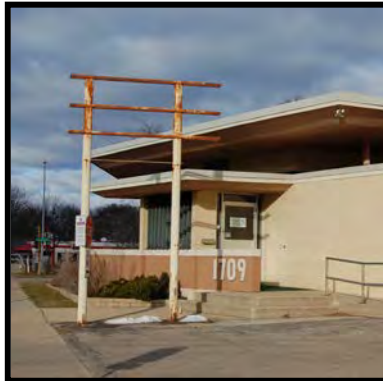
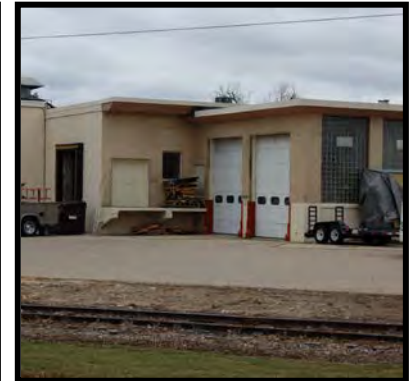
Parcel 89

Score: 47.1

Walls cracked/ discolored/ paint peeling and mismatched; windows weathered/ some broken/ missing panes; supports over rear shed rusted; vents rusted; ramp weathered/ stained; garage doors dented/ stained; no screening around dumpsters; very rusted missing sign face; lot weathered/ discolored/ cracked; weeds in expansion joints of sidewalk; planter box rotted; partially vacant

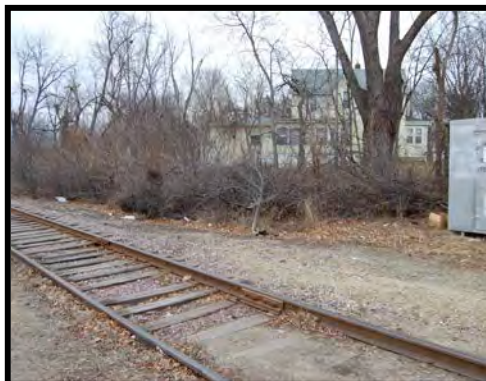
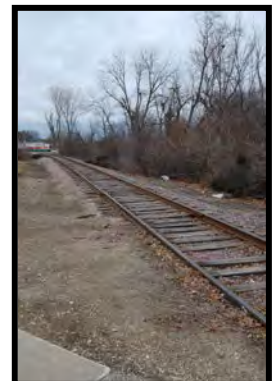
Parcel 114

Score: 51.5

Shed heavily dented; litter; overgrown; debris; trash

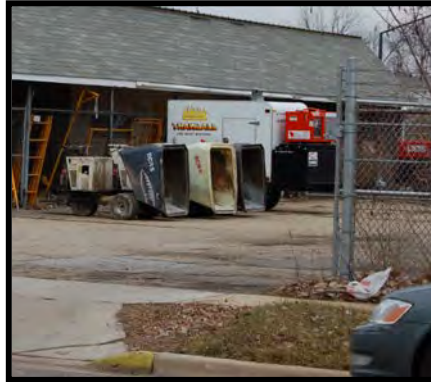
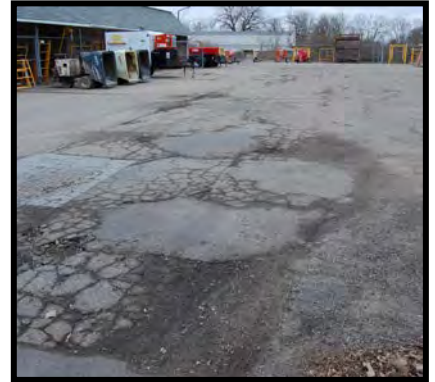
Score: 54.4

Fence bent and rusted; lot cracked/ stained/ missing asphalt; minor cracks in sidewalk; debris along fence; evidence of pooling in lot

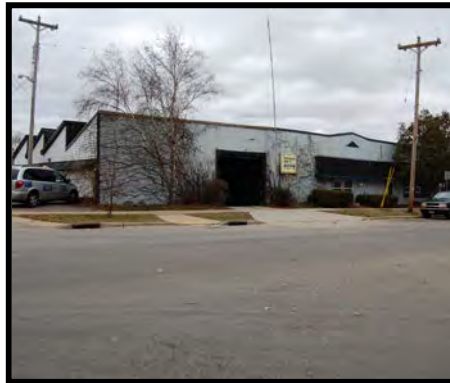
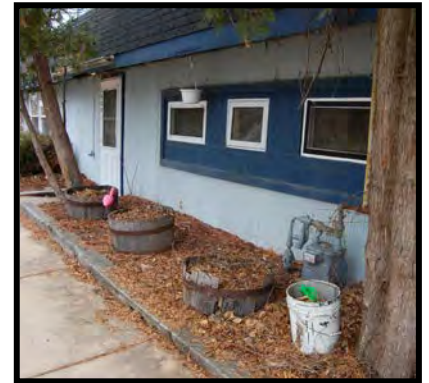
Parcel 28

Score: 54.9

Walls worn/ weathered/ rusted/ missing pieces; missing roofing material; roof eaves rotted; shingles weathered; windows, doors and overhang worn; door frame sagging; signage and lighting dirty; lot crumbling/ pot holes; overgrown shrubs

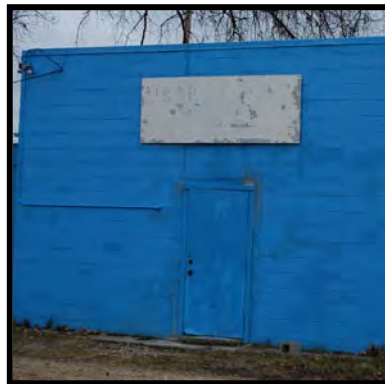
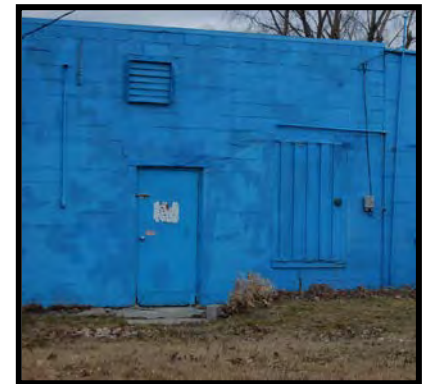
Parcel 40

Score: 30.8

Paint mismatched; mortar deterioration; windows covered by wood; door veneer peeling; signage is blank and weathered; gravel and dirt parking area; no walkway; weeds along building foundation; vacant

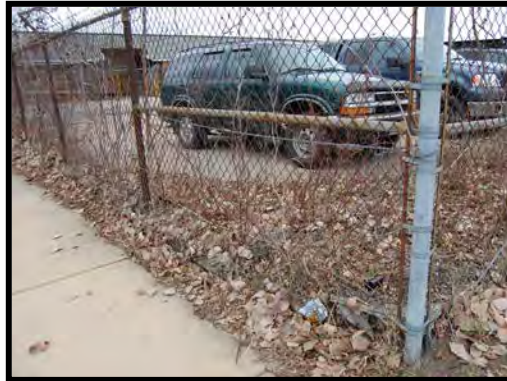
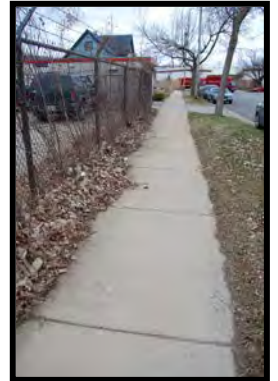
Parcel 57

Score: 53.4

Fence bent and rusted; lot worn/
cracked; debris along fence

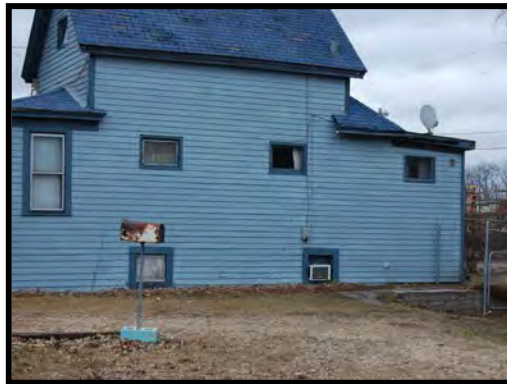
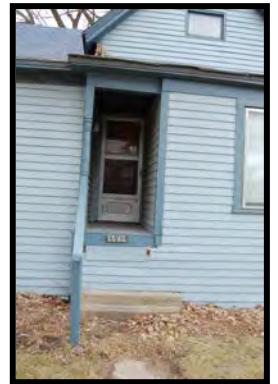
Parcel 62

Score: 38.0

Walls in poor condition; roof weathered;
shingles damaged/ missing; roof material
torn and hanging; paint peeling from
window frames; most sections of gutter
missing; chimney in poor condition;
stairs missing; door worn/ rusted; walk
overgrown; vacant

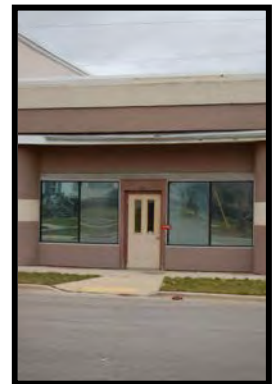
Parcel 79

Score: 59.2

Walls weathered/ rust stained; windows
worn/ dirty; overhang sagging/ rotted/
soffit water damaged; gutter sagging/
missing downspouts; paint peeling from
door frame; drive cracked/ weathered

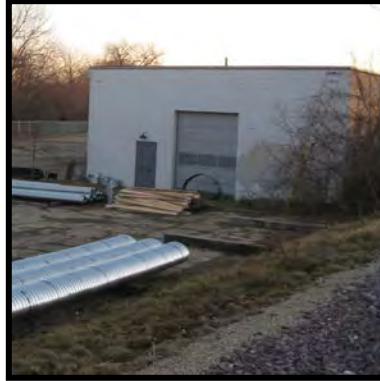
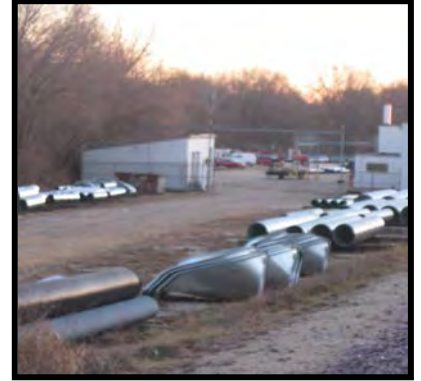
Parcel 115

Score: 54.5

Walls weathered/ paint mismatched/ mortar deterioration; rusted metal screens over windows; vents rusted; accessory structure in poor condition; fence rusted/ leaning; dumpsters not screened; asphalt deterioration; lot severely cracked; exposed sharp edges on culvert pipes; pooling in lot

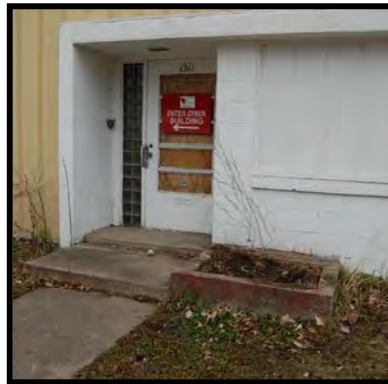
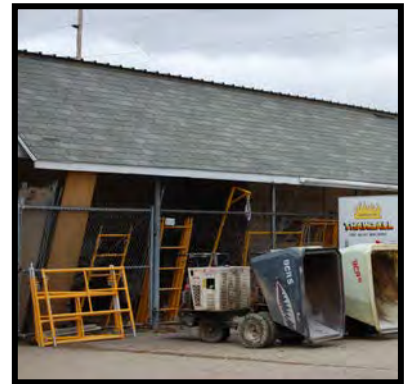
Parcel 117

Score: 44.4

Mortar deterioration; dents in siding; windows weathered; overhang shingles damaged; sections of gutter missing; stairs unevenly settled; door weathered/ boarded; fence rusted/ bent; drive weathered; landscaping not maintained

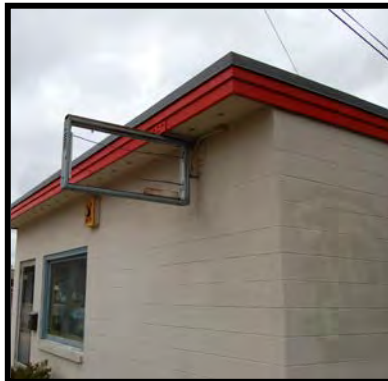
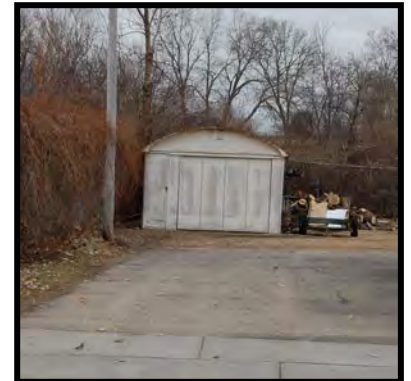
Parcel 120

Score: 52.7

Paint peeling/mismatched; sill paint peeling/ discolored; vent rusted; shed in poor condition; missing sign face; drive cracked/ weathered; graffiti; partially vacant

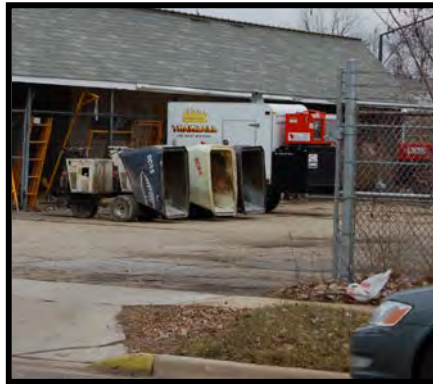
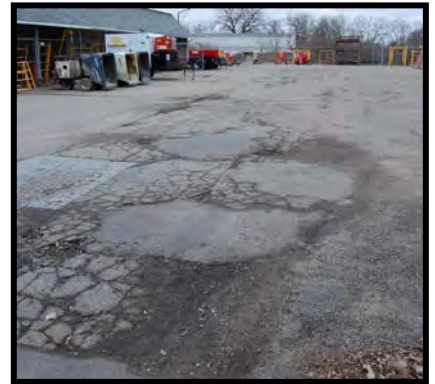
Score: 54.4

Fence bent and rusted; lot cracked/ stained/ missing asphalt; minor cracks in sidewalk; debris along fence; evidence of pooling in lot

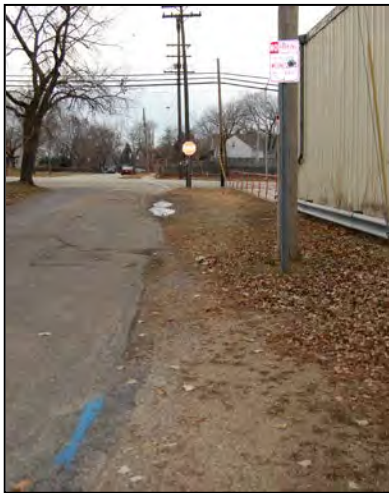
High Street looking west
(poor condition)

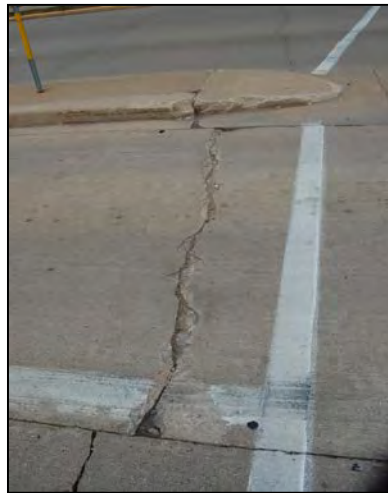
Crosswalk at Park and Emerson
(poor condition)

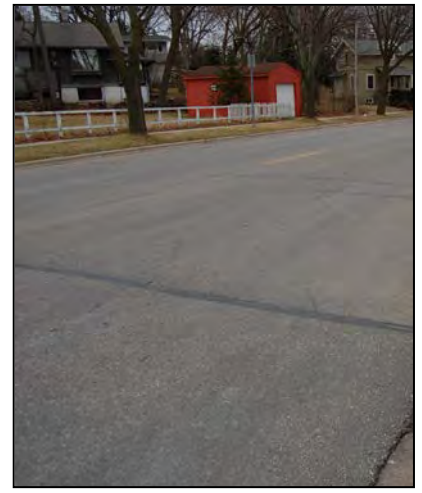
Beld Street looking south
(good condition)

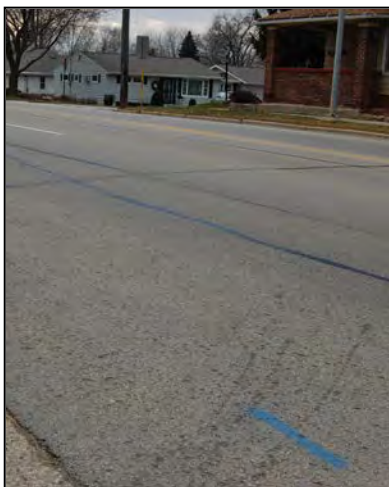
Fish Hatchery Road looking south
(good condition)

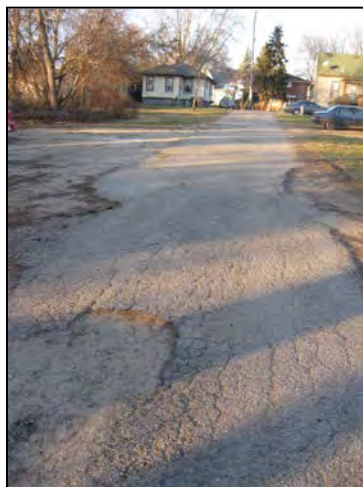
Garden Street
(poor condition)

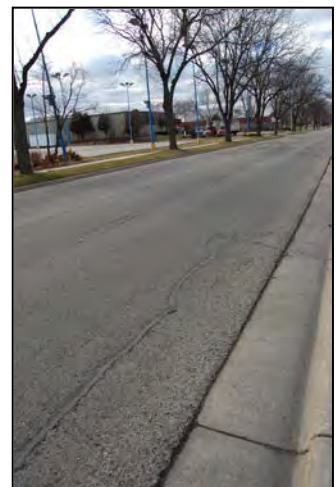
Plaenert Street
(good condition)
