TID 36 Amendment – Blight Study

February 15, 2012
Madison, Wisconsin

PREPARED BY MSA PROFESSIONAL SERVICES, INC.

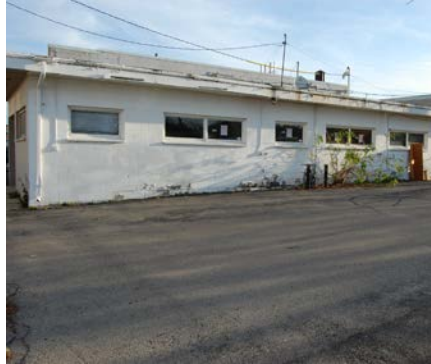
Parcel 16

Foundation cracked; paint peeling and mismatched; fascia peeling, rust stained and broken in places; rain spout bent; paint peeling from doors; garage door bent; storage shed rusted; sign face missing; lighting missing; parking lot cracked and worn; walks heaving; overgrown weeds; trash; broken glass; gutter missing

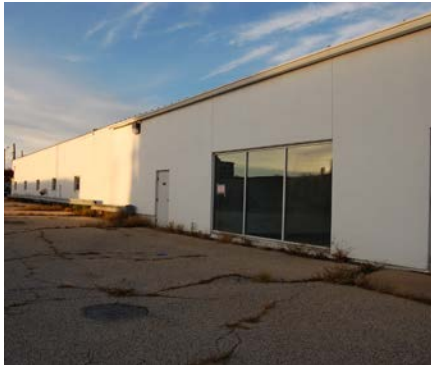
Parcel 24

Cracks, holes in walls; missing and bent gutters; graffiti; windows broken and boarded; garage doors dented/rusted; signage missing; parking lot in poor shape; some heaving in public sidewalks; landscaping not maintained; overgrown parking lot; litter; exposed wiring; vacant

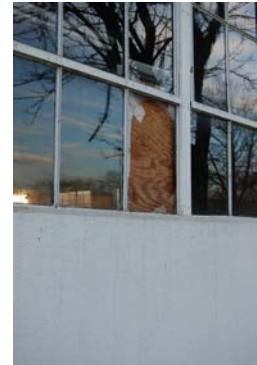
Score: 45.4

Paint mismatched and peeling; walls on interior buildings in poor shape; poorly covered graffiti; gutters rusted; concrete cornice deteriorating; window sills stained; chimney patchworked and weathered; weathered stairs; screening missing around garbage containers; cracking, worn asphalt drives; pooling in drive

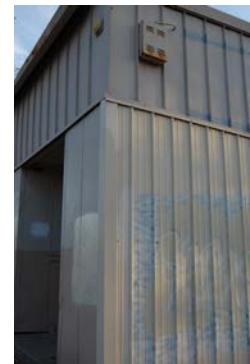
Parcel 177

Score: 42.2

Cladding dirty and stained; overhang on front entrance in poor shape-fascia bent and rusted, pieces of soffit missing; vents rusted; front stairs crumbling; screening not protected with paint or stain; some signage missing from front; paint peeling/rust on other signs; graffiti; parking lot weathered and cracked; heavily littered; landscaping not maintained

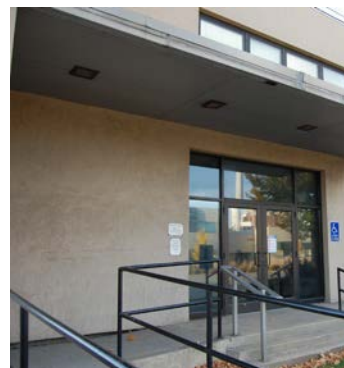
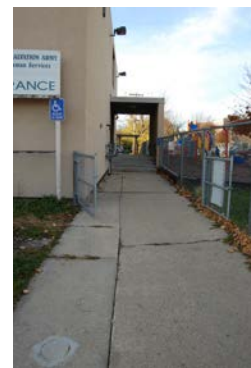
Parcel 198

Score: 55.9

Some brick discoloration, mortar wear; cornice discolored; gutter bent and rusted; minor rust staining on doors; drives and lot cracked and pitted; public sidewalks crumbling, cracked, and aggregate showing

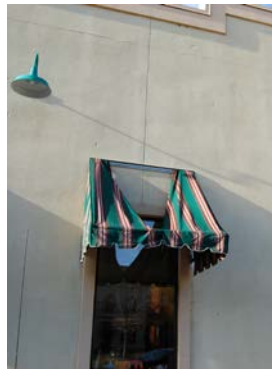
Parcel 188

Score: 52.8

Walls cracking, holes, pieces missing; paint peeling; poorly covered graffiti; canopies torn/dirty, some entirely missing; portico rusted, columns cracking; missing screening; sign paint peeling; asphalt drive/parking in poor condition; litter; some spaces empty

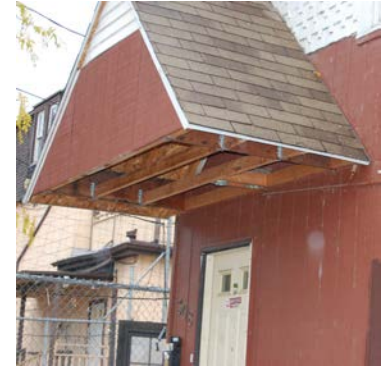
Parcel 154

Paint peeling and mismatched; some cladding broken; shingles curling and discolored; porch soffit missing; piece of porch fascia missing; metal rusting and concrete crumbling on stairs; paint peeling from door frames; poorly covered graffiti on garage; piece of garage roof missing; garbage cans not screened; front light missing; piles of debris in side yard

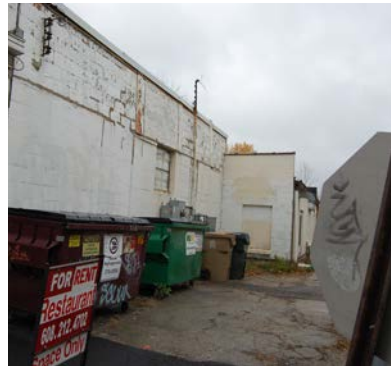
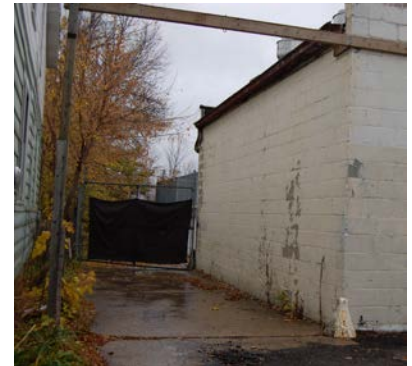
Parcel 167

Foundation cracking and crumbling; extensive paint peeling from walls; graffiti; block damage; fascia not protected with paint/stain; gutter rusted; drip edge curling; window above door boarded; canopy dirty; rust on vents; door rusted; no screening, dumpsters heavily graffitied; asphalt drive in bad shape; space for lease

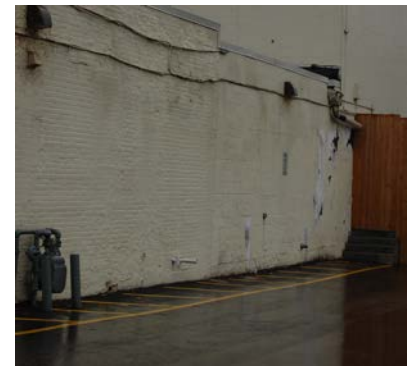
Parcel 170

Brick discolored; cracks in wall; exposed wiring; wall art peeling; paint peeling from window frames; overhang paint peeling; cracks in walk; area between building and sidewalk just dirt; graffiti

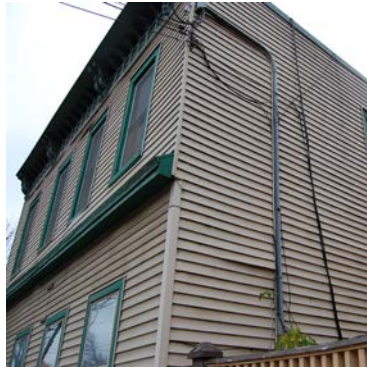
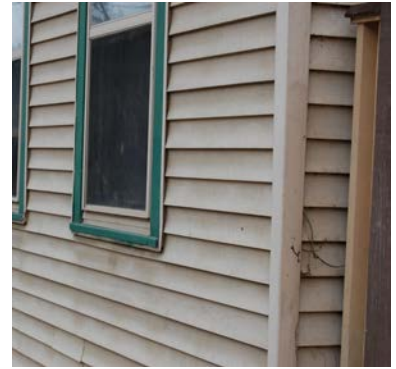
Parcel 183

Foundation cracking and crumbling; walls discolored, paint peeling, cladding warped and dirty; paint peeling from soffit, brackets, and cornice of porch; window bars rusted, screens damaged; rusted brackets from previous signage; broken blinds visible in front windows; pooling in drive

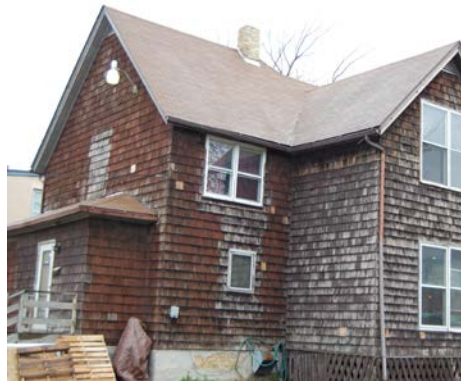
Parcel 195

Foundation stained, crumbling, cracking; shakes discolored, missing, broken, and molding; paint peeling from soffit; debris in gutter; rear gutter bent; paint peeling from window frames; soffit of porch broken and sagging, paint peeling from porch; back porch not painted or stained; rust on vent; stairs leaning; paint peeling from door frame; walk cracked; building debris around structure

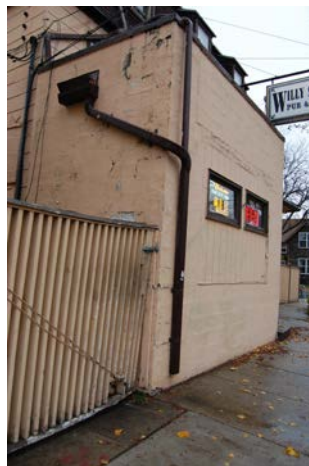
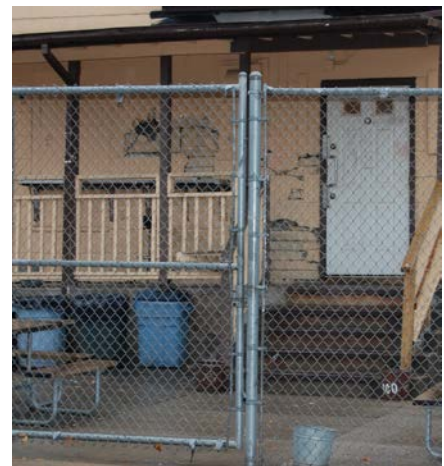
Extensive foundation crumbling; paint peeling from walls; significant holes and siding missing; shingles curling and broken; gutter sagging; paint peeling from window frames; porch shingles damaged; rear porch heavily damaged; back stairs rust stained; doors rusted, dented, paint peeling, slats over windows; screening dirty/sagging; graffiti

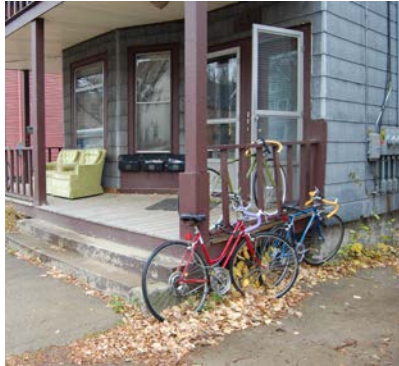
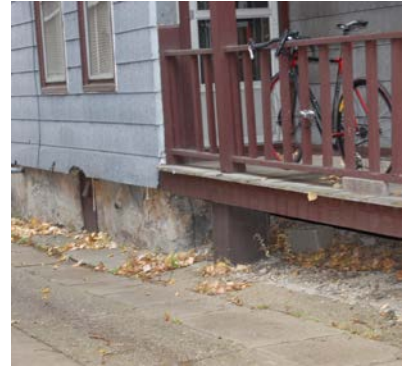
Parcel 28

Some crumbling of foundation; siding broken and discolored; paint peeling from door and window frames; Porch paint peeling, cracks in columns, floor boards not protected; soffit sagging; storm door missing closer; minor cracking in drive; weeds around foundation; indoor furniture on porches

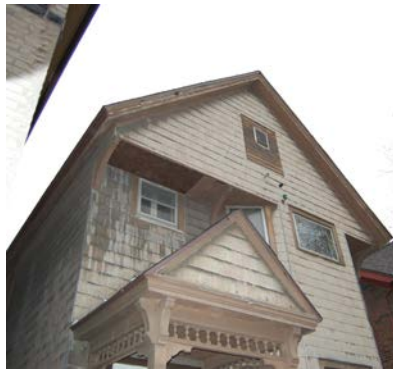
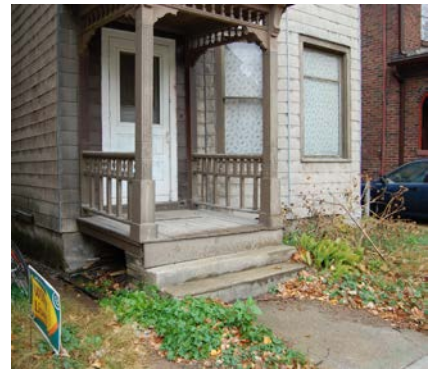
Foundation crumbling; siding missing, discolored, stained, warped; fascia and soffit pieces missing; mismatched material in missing window; porch not protected by paint or stain; drip edge bent, holes in gable; chimney bricks discolored; stairs leaning/crumbling; graffiti; unkempt landscaping; vacant

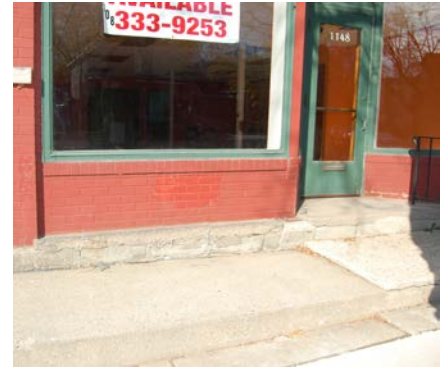
Parcel 102

Some foundation cracking/crumbling; cracks in bricks, paint mismatched and peeling; paint peeling from doors, rust; graffiti; cracks/crumbling in walkway; weeds overgrown around building; puddling in driveway; commercial space and some apartment space vacant

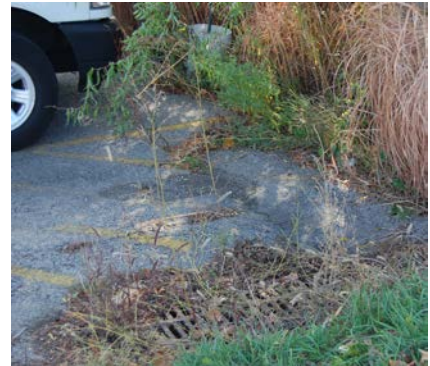
Paint peeling from walls; some windows boarded; paint peeling from chimney, graffiti on vent; paint peeling from door frame; roof and door bent on shed; some pitting in asphalt; weeds in cracks of parking; landscaping overgrown; storm drains covered in debris

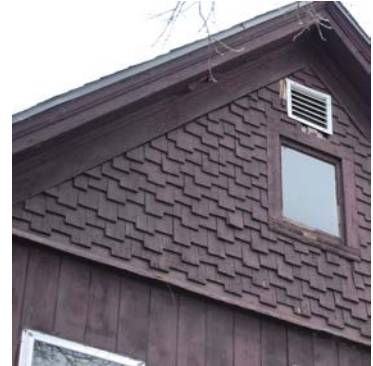
Siding weathered, holes, cladding missing, paint peeling; paint peeling on fascia; window frames missing/broken; paint peeling on balcony/roof overhang; chimney mortar deteriorating; cracks in front cement; broken blinds and improvised curtains in front windows

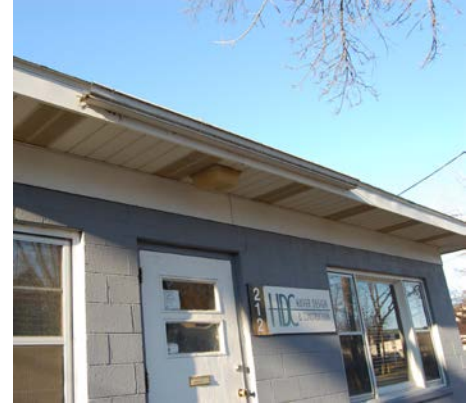
Parcel 66 (modified to include parcel 97)

Foundation cracked/crumbling; siding broken/missing, paint peeling/mismatched, cracks in blocks; drip edge rusted; roof warped; fascia missing/broken; gutters missing/full of debris/rusted; paint peeling from window and door frames; some windows boarded; paint peeling from stairs; drive cracked, heaving, loose gravel; asphalt degraded; aggregate showing on public sidewalk; landscaping not well maintained; trash around building

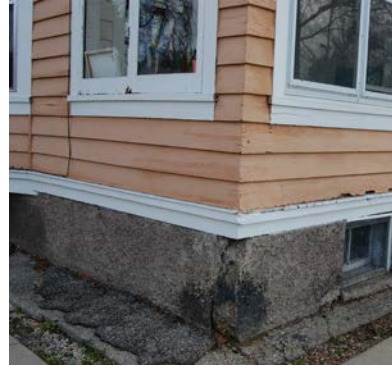
Parcel 114

Foundation crumbling/cracked; remnants of balconies; paint peeling/mismatched; cracking in soffit; fascia warped; paint peeling from window and door frames; gutter rusted; rear wood steps not protected; some crumbling on front stairs; garbage cans not screened; cracks/heaving in walks

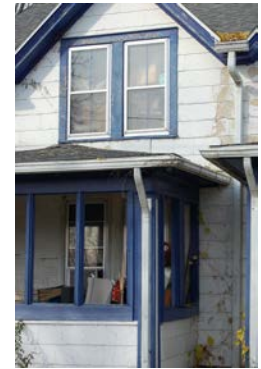
Parcel 131

Score: 40.1

Cladding dirty/paint peeling; debris in gutters; paint peeling from fascia; paint peeling from doors and windows; debris on porch roof; junk on porch; drive/walk crumbling/aggregate showing; shed in poor shape, junk falling out; garbage cans not screened; landscaping not well maintained

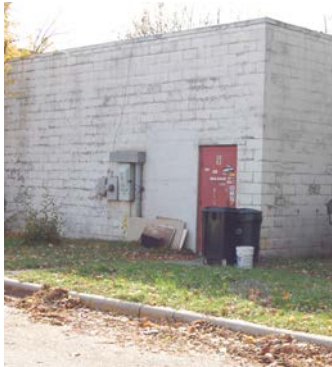
Parcel 11

Score: 49.5

Foundation crumbling; paint peeling from walls, windows and door frames; pieces of soffit broken; fascia peeling; flooring on upper patio warped/pieces broken; stairs cracked and molding; heaving in drive and sidewalk; landscaping not maintained (rotting apples in backyard)

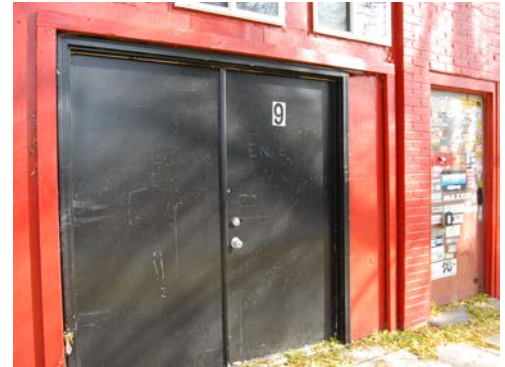
Paint peeling from walls, window frames and door frames; drip edge rusted; doors scratched; graffiti; heaving in public sidewalk; building materials behind structure; partially vacant

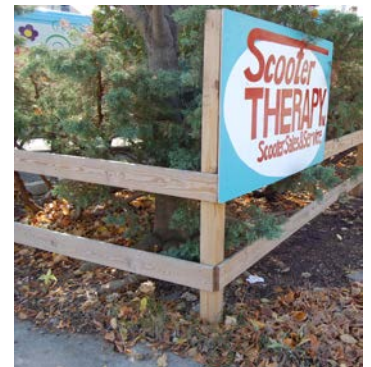
Parcel 36

Cracks in walls; paint peeling from walls, window frames and door frames; garage door dirty/ lintel sagging/failing; screening missing; sign paint peeling; cracks and heaving in drive and sidewalk; painting materials/tarps in drive; some litter; pooling in parking lot

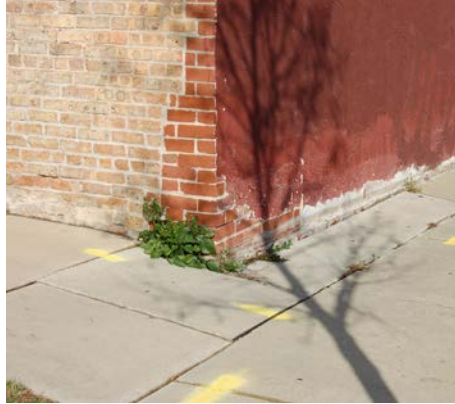
Parcel 87

Weeds growing from base of building; foundation crumbling; paint mismatched, bricks discolored, cracks; poorly covered graffiti; window frames rusted; first floor windows missing/boarded up; paint/stain uneven on porch; vents rusted; paint peeling/mismatched on door frame; cracks in walk

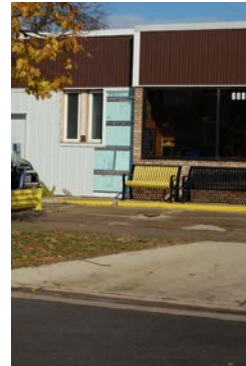
Parcel 178

Score: 57.1

Foundation paint mismatched; rust stains on cladding; metal roof rusted/curling; window frames and doors rusted; vent in front yard rusted; dumpsters not screened; aggregate showing in walk; asphalt lot cracked, weathered, potholes; some pooling in lot

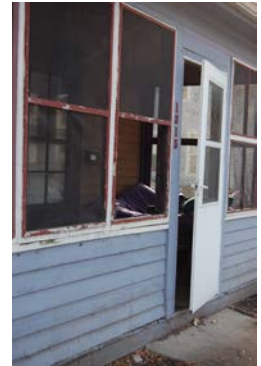
Parcel 6

Score: 47.2

Foundation crumbling, rusted, paint peeling; walls cracked, rust stains; mismatched brick; paint peeling on fascia; underlying brick of roof crumbling; concrete sills crumbling; vent rusted; stairs crumbling, rust stained; ramp crumbling; paint peeling from doors; concrete door ledges crumbling; shed roof rusted, paint peeling; signage/lighting in poor shape; asphalt parking lot cracked/weathered; vacant

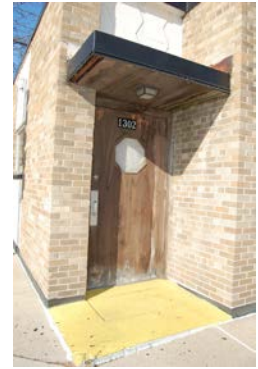
Parcel 99

Score: 57.1

Minor cracks in foundation; paint peeling from window and door frames, fascia and porch; paint mismatched and patchy; some window screens torn; aggregate showing on stairs, railing rusted; garage roof rusted and bent, paint peeling; walks cracked and overgrown; landscaping overgrown

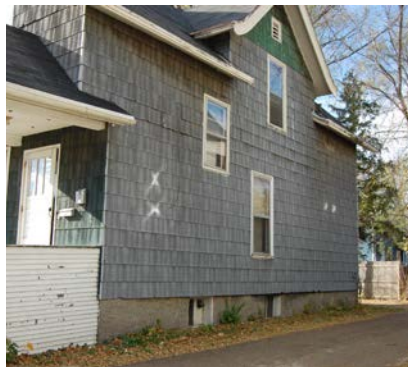
Parcel 116

Foundation crumbling; paint peeling from walls, drip edge, fascia, window and door frames and porch; siding cracked and broken; pieces of soffit and fascia missing; shingle damage; porch carpeting ragged/dirty; vents rusted; stair railings rusted; gravel drive overgrown; partially vacant

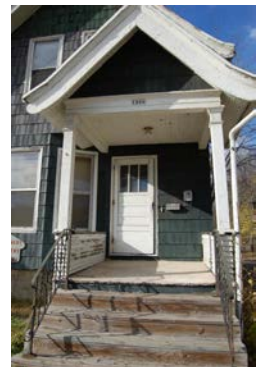
Score: 52.2

Minor foundation cracking/crumbling; siding dirty; paint peeling from decorative roof elements and window and door frames; some basement windows boarded; insulation caulking around windows messy; canopy support rusted; concrete stairs crumbling and rust stained; metal door frame dented; walk cracked and heaving; driveway severely deteriorated; building materials at side of house

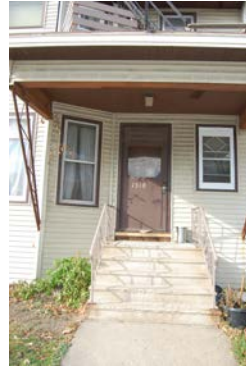
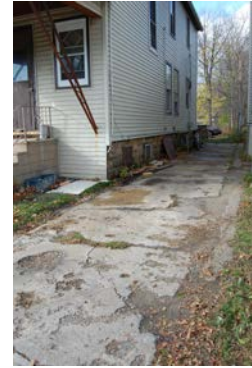
Parcel 120

Score: 38.6

Foundation cracked/crumbling; siding dirty; some shakes on upper story broken; paint peeling from walls and window frames; rust on door frame, door ledge crumbling/leaning; drive cracked/heaving; aggregate beginning to show on public sidewalk; building materials around house; junk visible in back yard

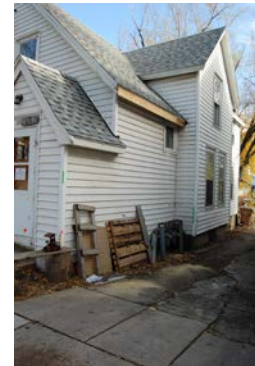
Parcel 127

Score: 47.4

Minor cracks in foundations; paint peeling from walls, window and door frames, and dock; walls stained/discolored and cracked; window frames rusted; overhang roof damaged; dock rusted/ siding dented; fence not protected; minor graffiti; lot weathered and cracked; some heaving in public sidewalk

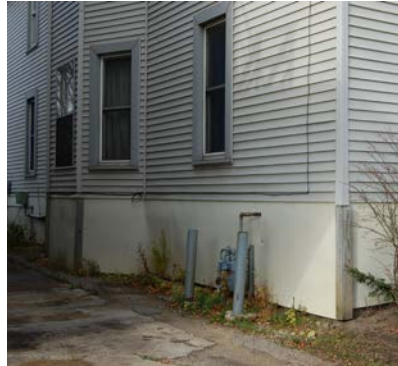
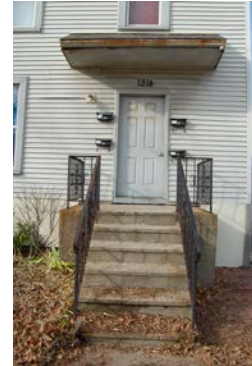
Parcel 139

Score: 54.5

Minor crumbling/cracks in foundation; siding discolored/warped; paint peeling from wood siding, fascia, window and door frames, porch and stairs; chimney crumbling; garbage cans in front yard; walks cracked; gravel drive overgrown

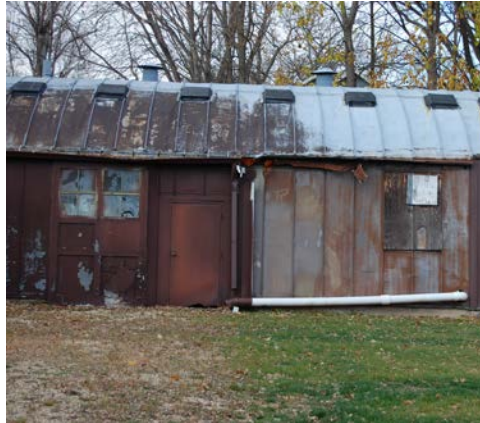
Parcel 46

Score: 7.5

Foundation crumbling; poorly covered graffiti; mismatched paint; metal cladding dented/curling; paint peeling from window and door frames; roof rusted, fascia missing, metal roof warped; some windows boarded; parts of rear dock overhang missing; garage doors dented; drives/walks crumbling and cracked; gravel eroded; piles of sand; pooling in gravel; building materials/rusted equipment; vacant

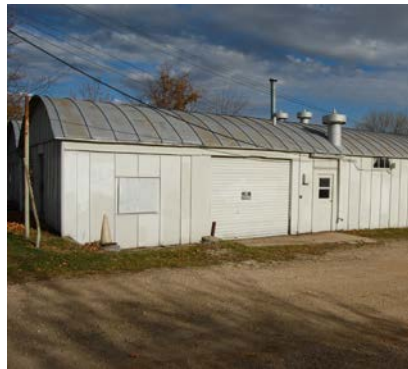
Parcel 61

Score: 24.5

Concrete walls cracked; paint peeling from walls, chimneys, window and door frames, socks, screening and signage; window frames rusted; dock rusted; chimney cracked; pieces of screening missing; signage infrastructure rusted; drive cracked/heaving; trash around dock; some pooling in drive; vacant

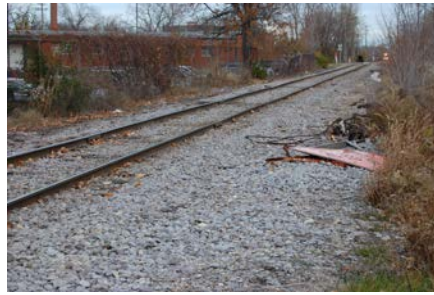
Parcel 75 (modified to include parcel 180)

Score: 53.0

Drive weathered, cracked, weeds and potholes; edges overgrown; pole (orange cone) near island; pooling in parking lot

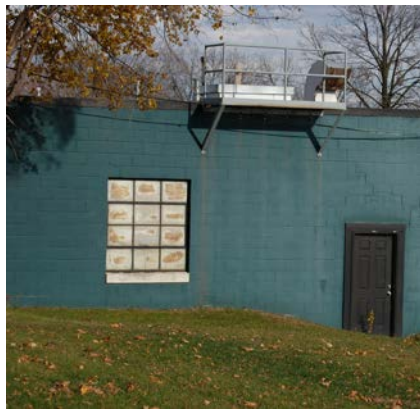
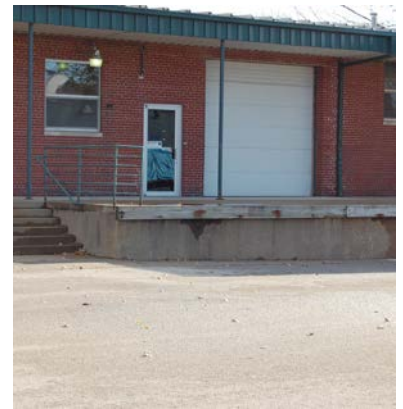
Parcel 140

Score: 57.3

Weeds growing from foundation; paint peeling from walls and window frames; poorly covered graffiti; metal box on wall rusted; overhang soffit dirty, weathered, holes; dumpsters in rear not screened; signage weathered; sign vacant; sign posts rusted; cracks and weeds in parking; some heaving/aggregate showing in sidewalk

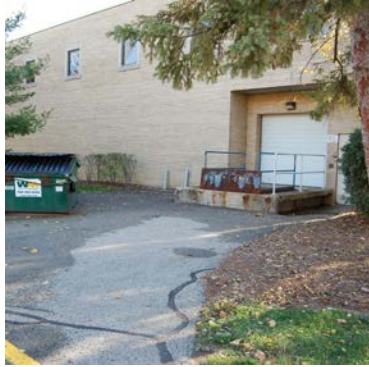
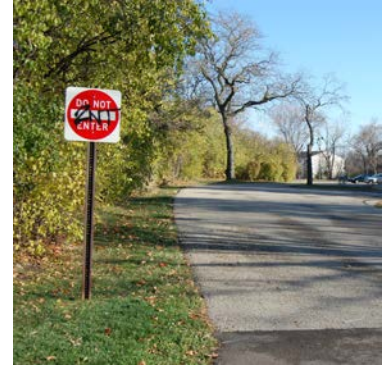
Parcel 25

Score: 56.7

Some signs bent; graffiti underneath bridge; gravel parking eroded; litter; major pooling in parking

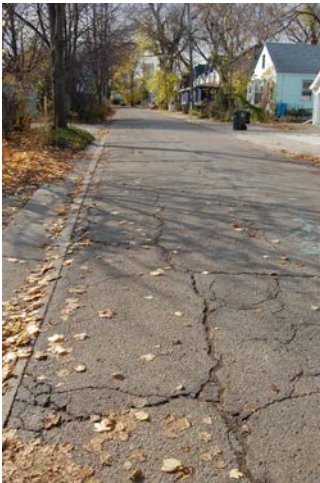
Curtis Ct looking Southwest
(Deteriorating)

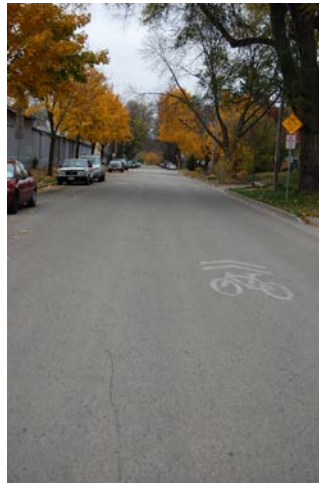
Wilson looking Southwest
(Good)

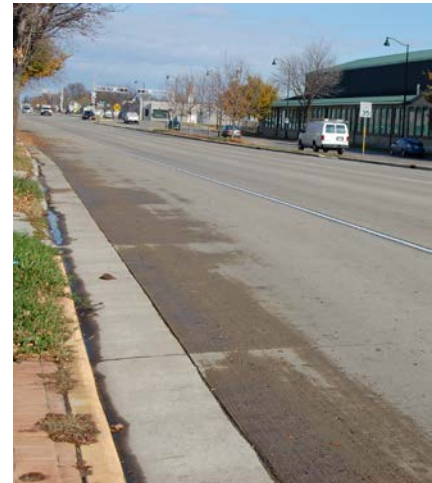
Washington at Baldwin looking Southwest
(Good)

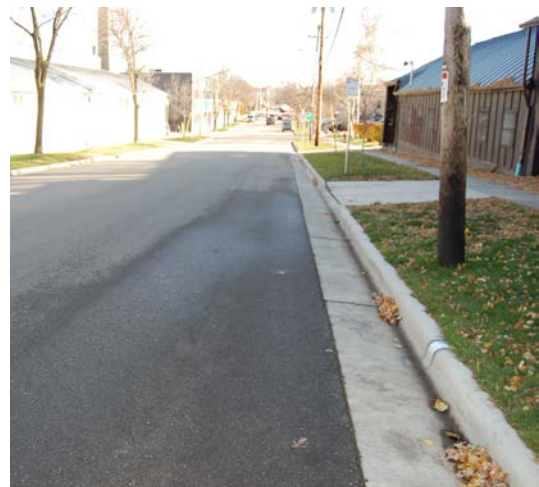
Dickinson at Dayton looking East (Good)
