Garner Masonry Repairs- 2013

Garner Park Masonry Repairs- 2013  
Typical Condition of Masonry Mortar Joints in Designated Repair Areas

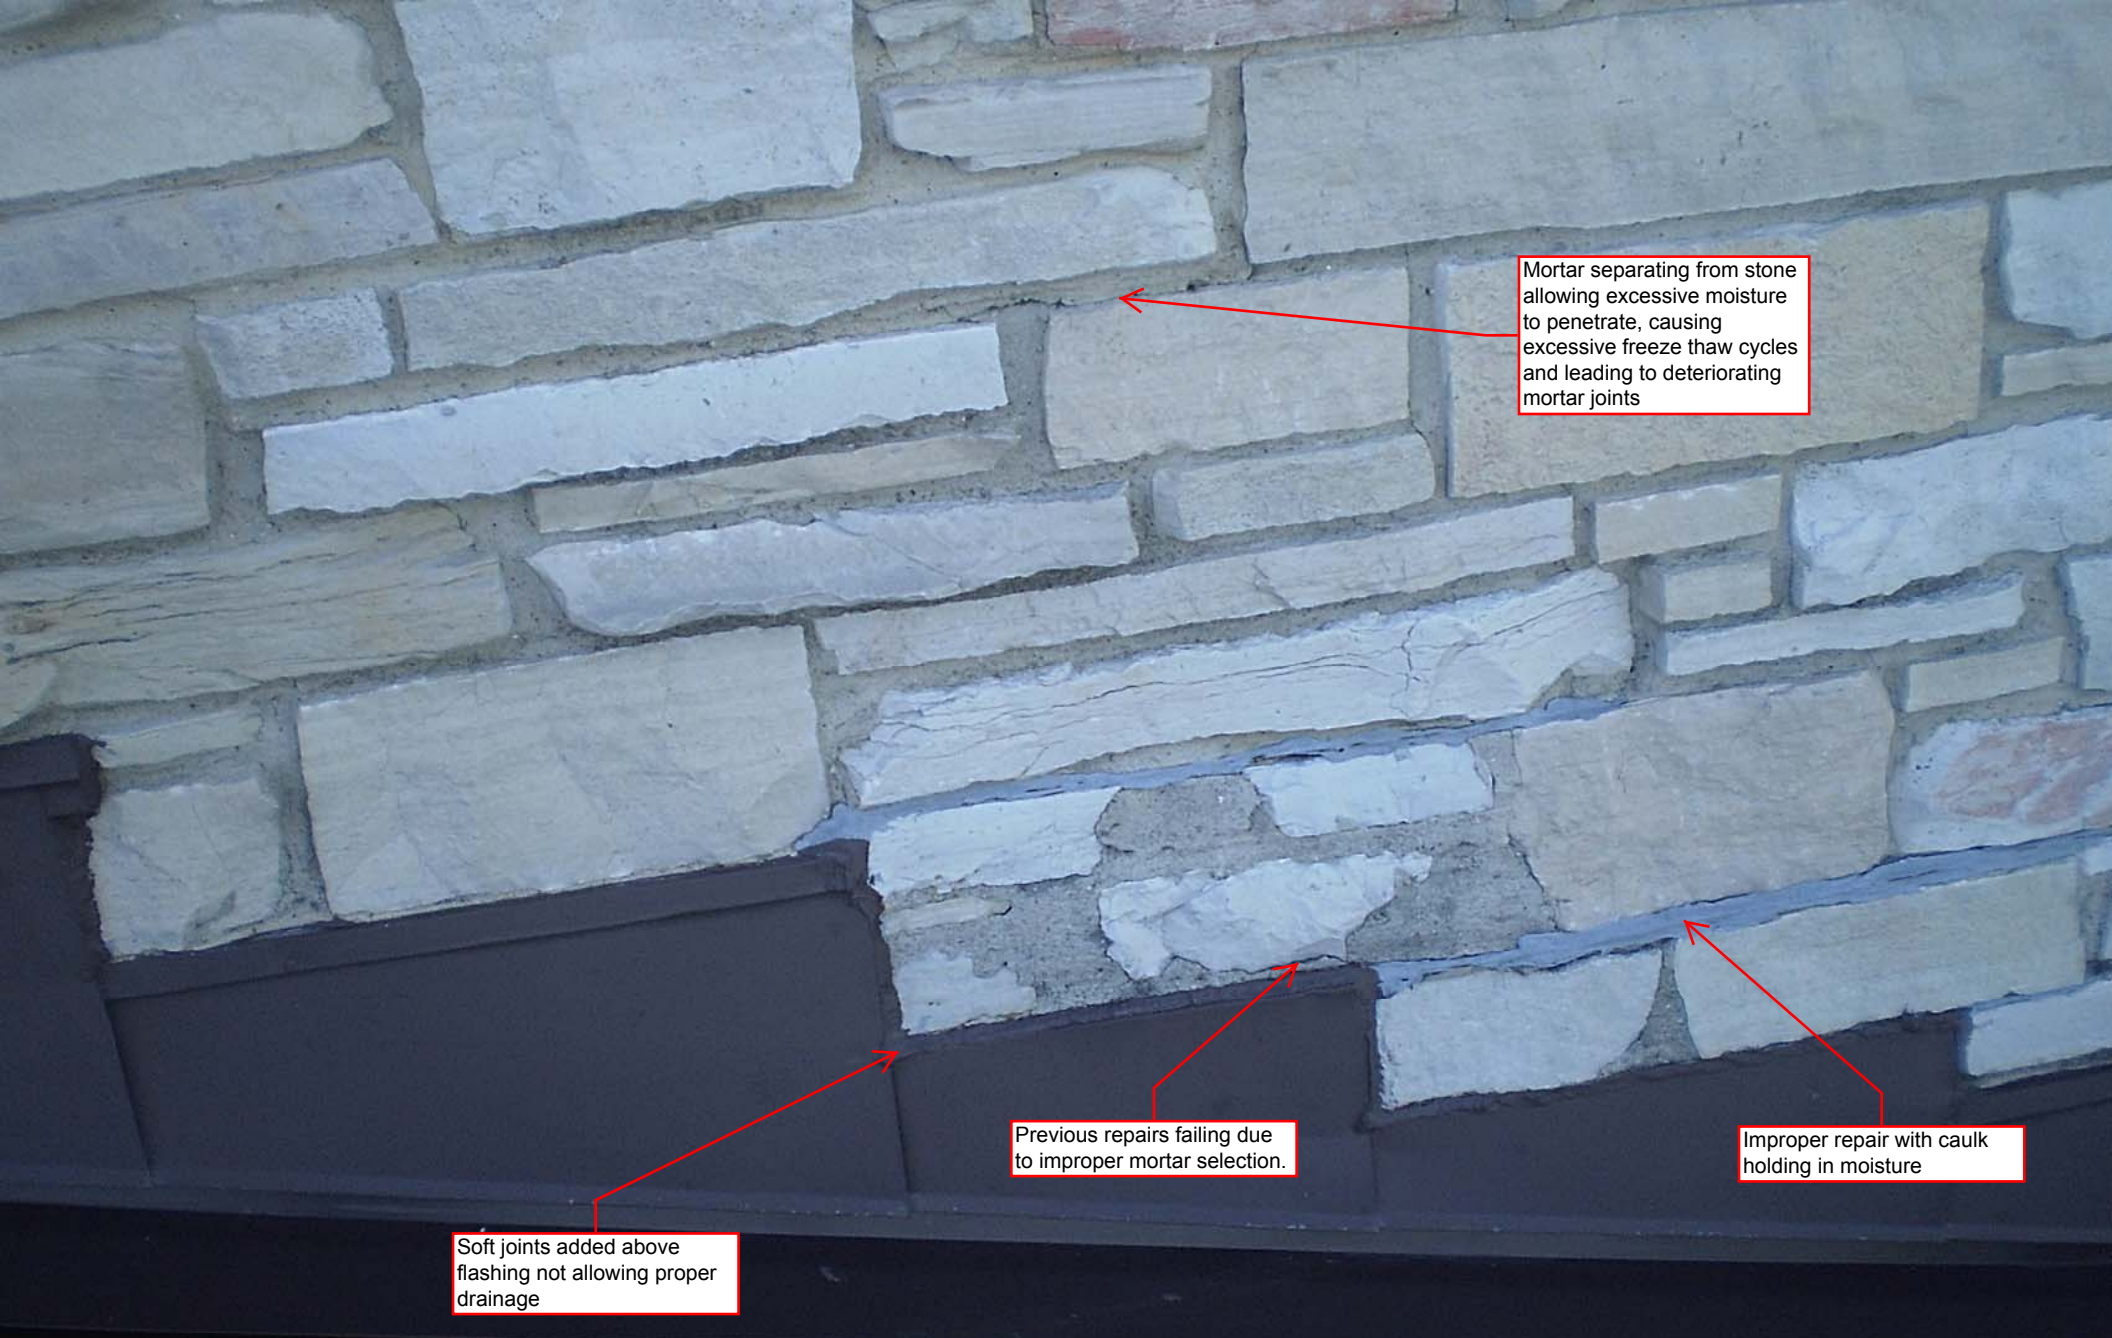
Mortar separating from stone allowing excessive moisture to penetrate, causing excessive freeze thaw cycles and leading to deteriorating mortar joints

Improper repair with caulk holding in moisture

Previous repairs failing due to improper mortar selection.

Soft joints added above flashing not allowing proper drainage
