# Assured Wetland Delineation Report

Reston Heights

City of Madison, Dane County, Wisconsin

Project Number: 20220853

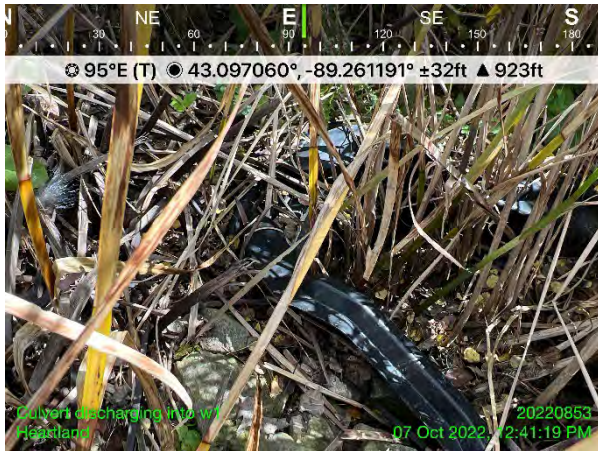
The boundaries of W-1 and W-3 corresponded to sediment basins observed in the field. No surface water connections were evident for the sediment basins but W-1 was observed to have a culvert feeding into it presumably discharging from roadway gutters.

Photo #33 Photo of culvert discharging into W-1

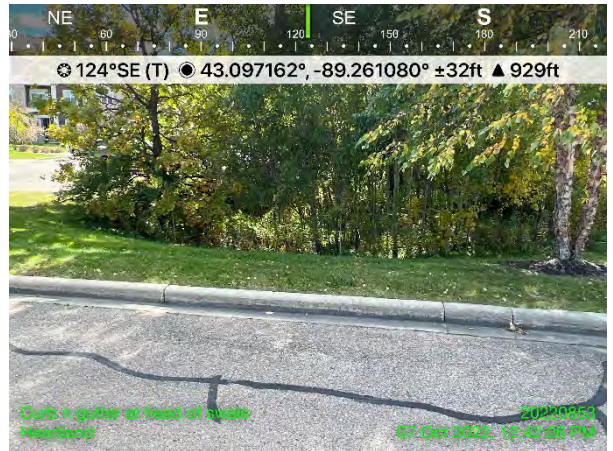
Photo #34 Photo of curb and gutter at head of swale (1 of 2)

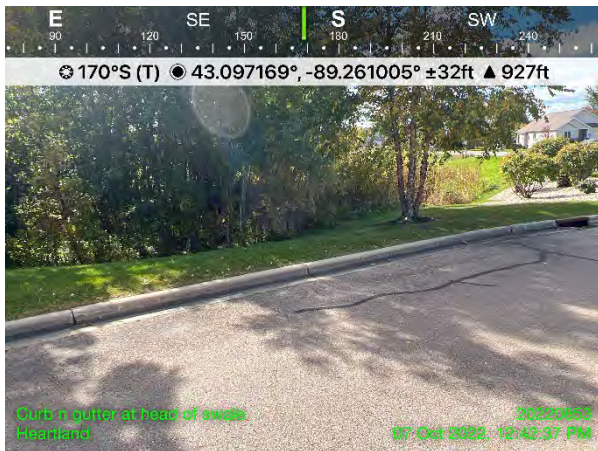
Photo #35 Photo of curb and gutter at head of swale (2 of 2)
