Bailey, Heather

From: Larry and Ginny White <lgwhites@gmail.com>
Sent: Monday, August 14, 2023 4:56 PM
To: PLLCApplications
Subject: Meeting Agenda Item #79099

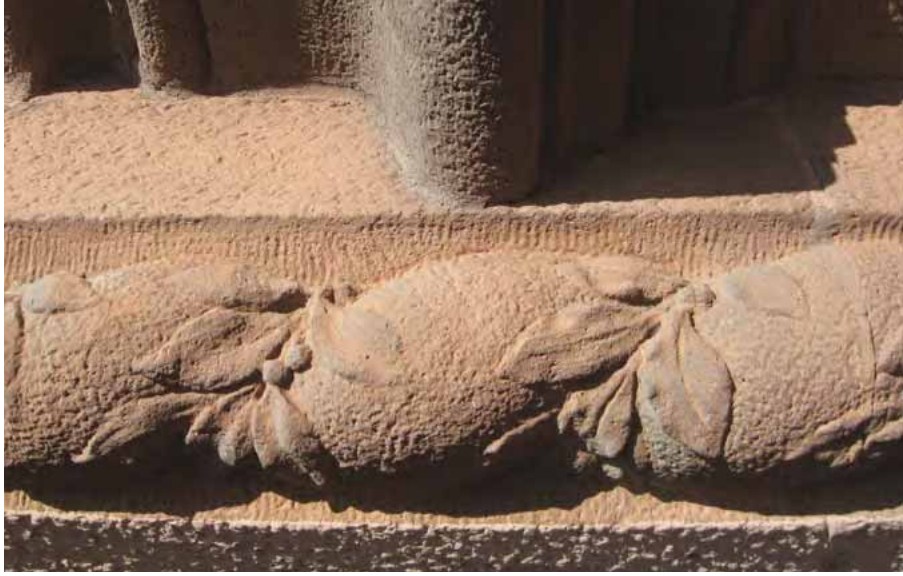
While masonry is one of the most durable historic building materials, it is also very susceptible to damage by exposure, improper maintenance or repairs, abrasive cleaning, or the application of non-permeable coatings.

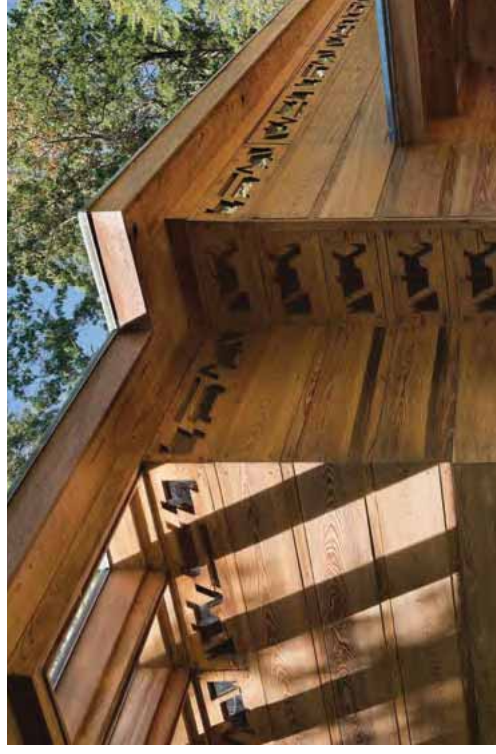
Many historic buildings have wood structural systems and features, such as stairs or columns. The majority of both practical and decorative features, particularly on the interior, are made of wood, such as flooring and paneling.

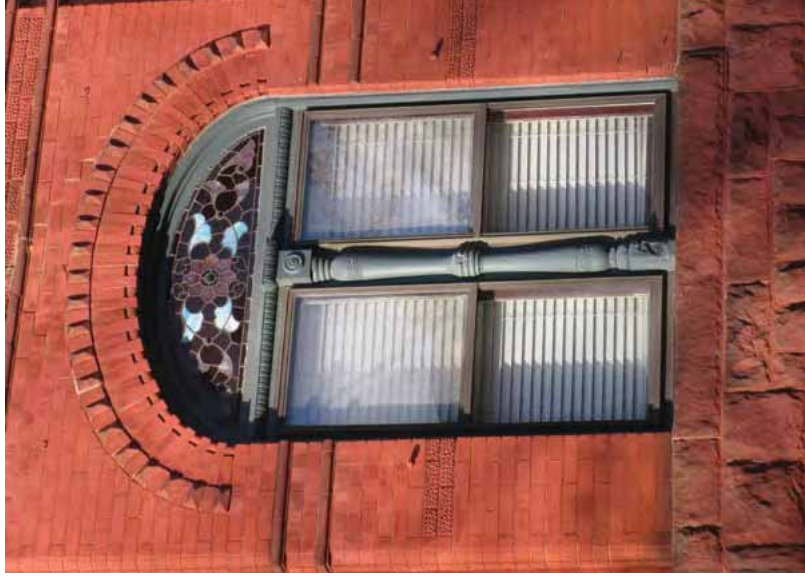
Entrances and Porches

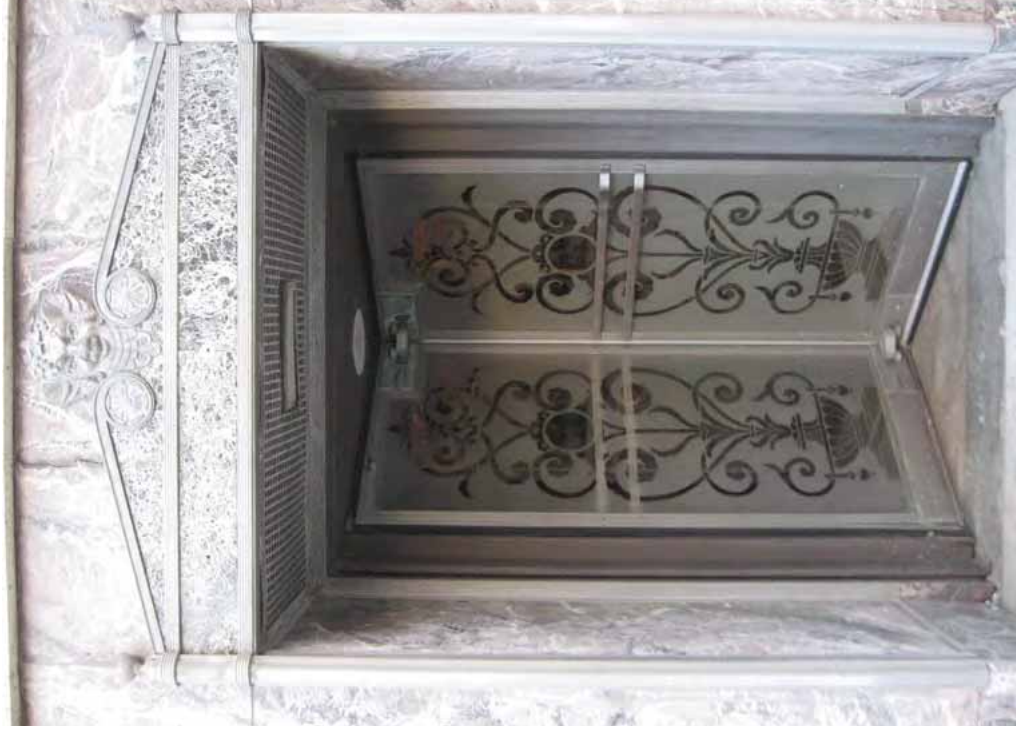
ally, entrances and porches were integral components of a historic building's design; for example, porches on Greek Revival houses, with pediments and Doric or Ionic columns, echoed the architectural elements and features of the building itself. Center, single-bay porches or arched porches are evident in Italianate-style buildings of the 1860s. Doors of Renaissance Revival-style buildings frequently featured entablatures or pediments. Porches characterized by latheturned porch posts, railings, and balusters were especially prominent and decorative features of Eastlake, Queen Anne, and Stick-style houses. Deep porches on bungalows and Craftsman-style houses of the early 20th century feature tapered posts, exposed posts and beams, rafter tails, and low-pitched roofs with wide overhangs.

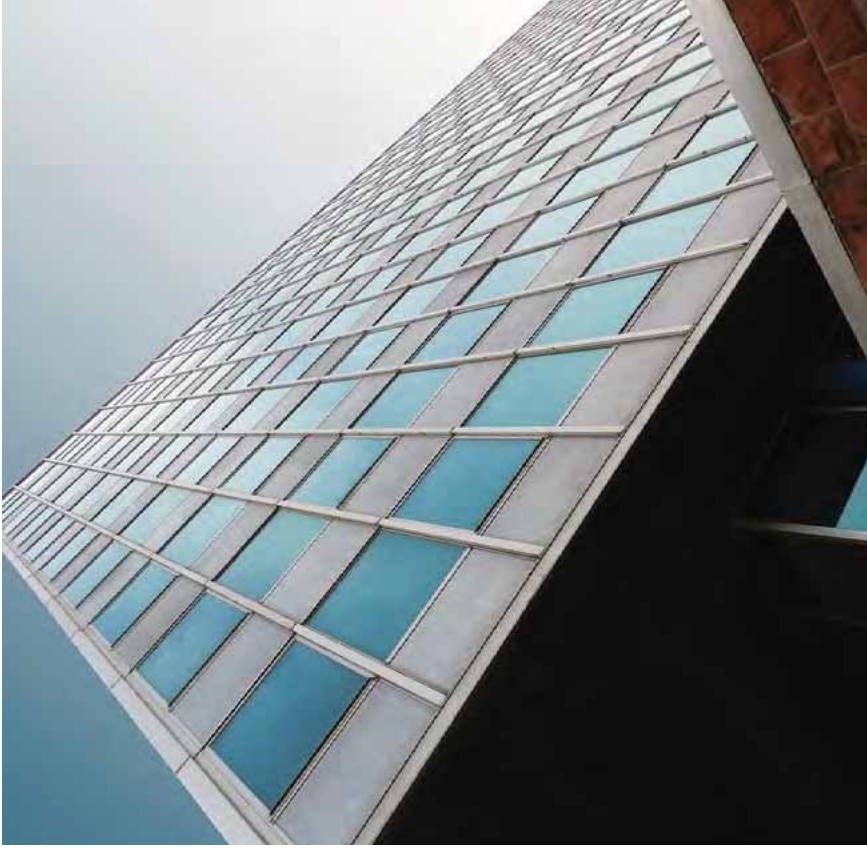
Glass panels in curtain wall systems can be fixed or operable and can include spandrel glass, clear, or tinted glass. Stone veneer panels may be slate, granite, marble, travertine, or limestone. Metal panels can be aluminum plate, stainless steel, copper, or other non-corrosive types of metal. Other materials used in curtain wall systems include composite panels (such as honeycomb composite panels, consisting of two thin sheets of aluminum bonded to a thin plastic layer or rigid insulation in the middle); architectural terra cotta; glazed ceramic tile; and fiber-reinforced plastic (FRP).

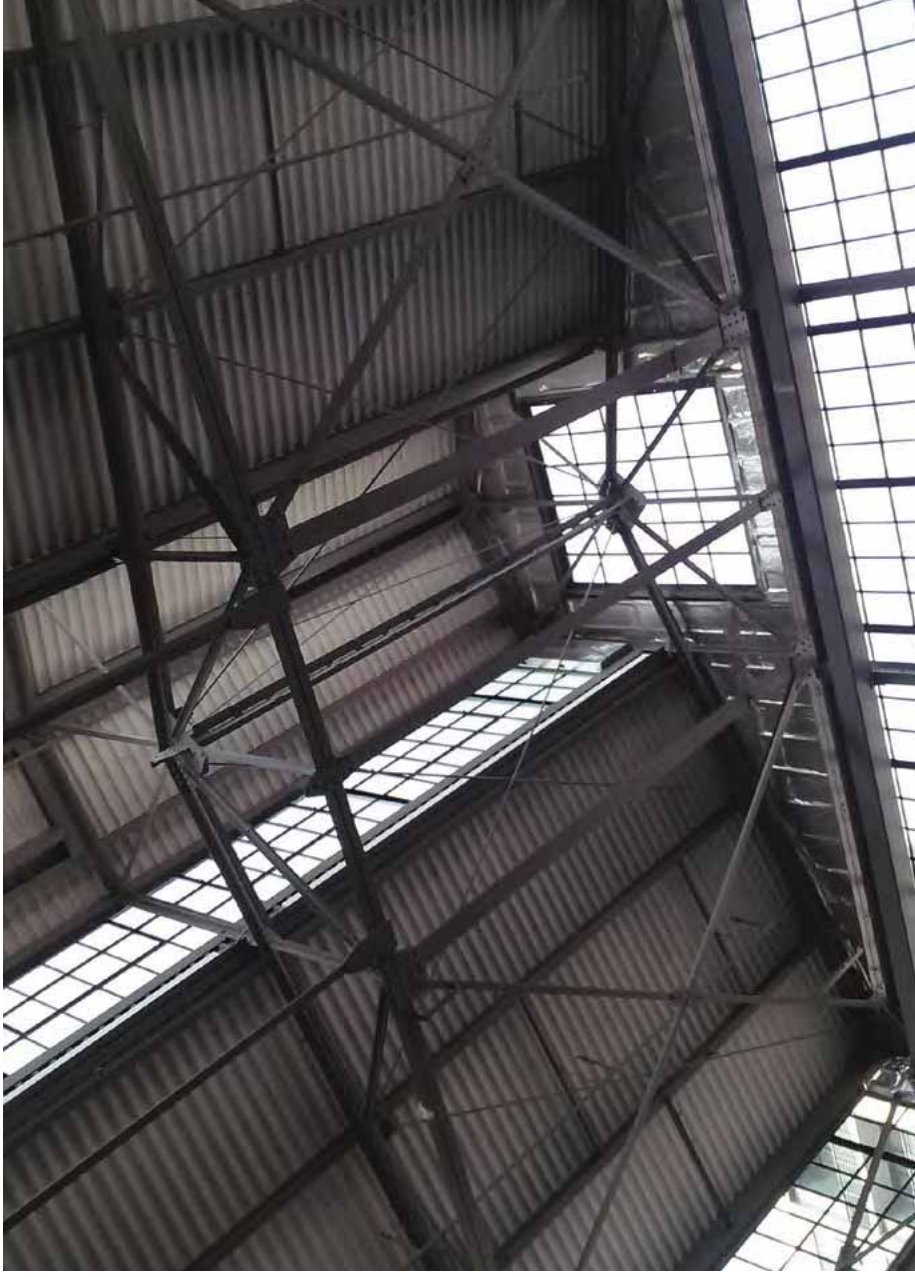
Exposed iron and steel structural systems are character defining in many utilitarian and industrial structures of the late 19th and early 20th centuries that have large open interior spaces, such as train sheds and armories. Exposed wood structural systems became an important interior decorative element during the Arts and Crafts period and in Craftsman-style bungalows in the early 20th century. Exposed cast-concrete structural systems and system components define the character of many industrial interiors and, later, other interior spaces in 20th-century buildings.

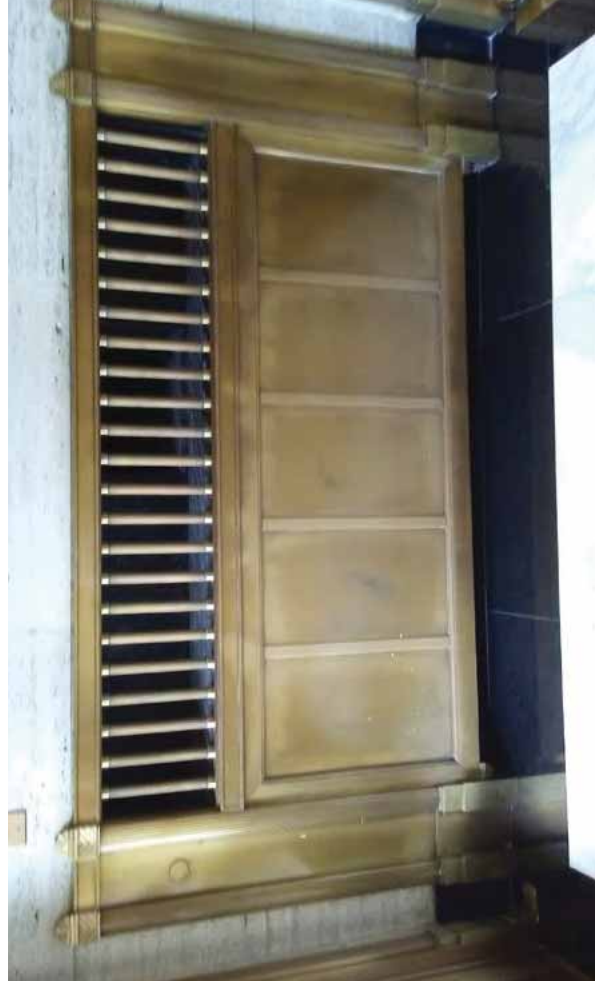
INTERIOR SPACES, FEATURES, AND FINISHES

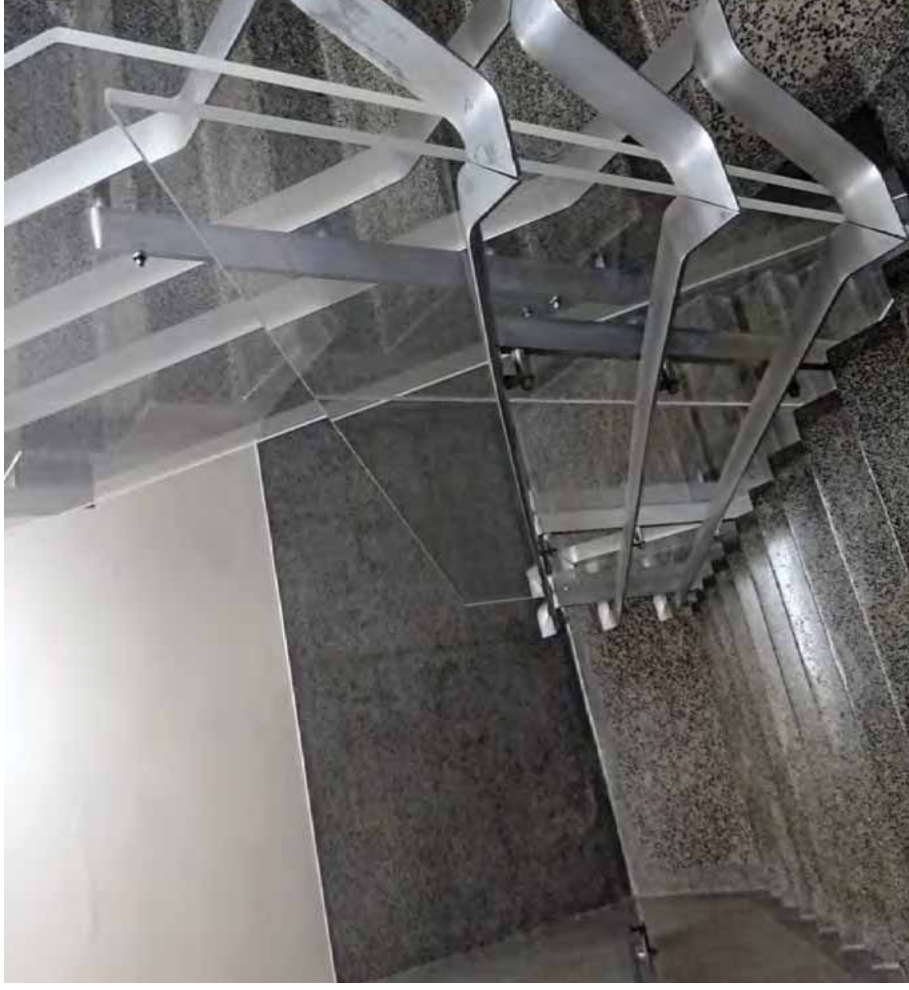
Resilience to Natural Hazards

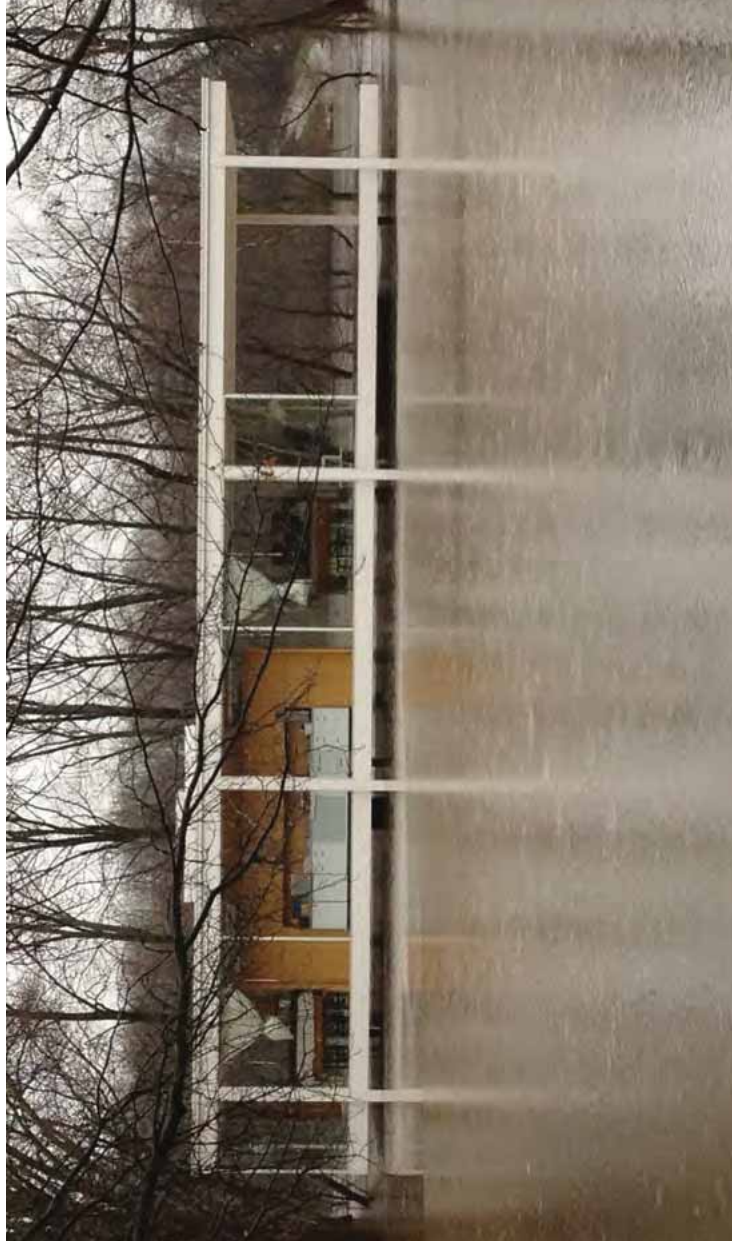
planning preventive treatments. The goal should always be to minimize the impacts to the building's historic character to the greatest extent possible in adapting the building to be more resilient.

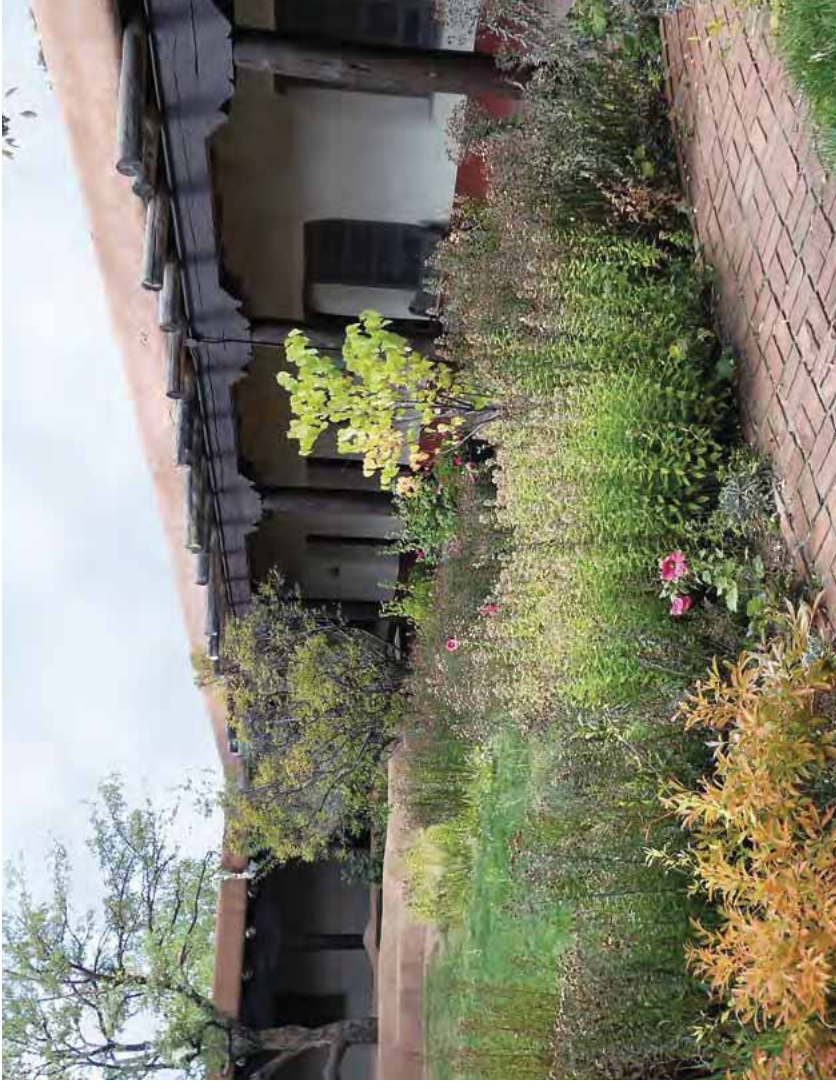
Standards for Preservation

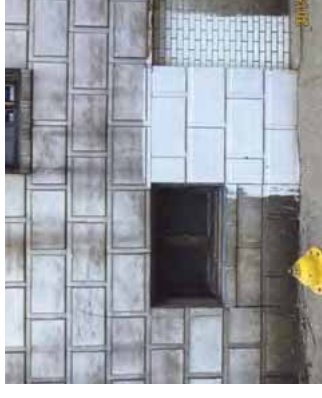
[1] A test patch should always be done before using a chemical cleaner to ensure that it will not damage historic masonry, as in this instance, terra cotta.

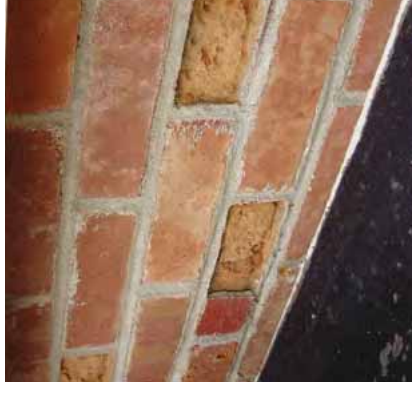
[2] **Not Recommended:**
The use of inappropriate Portland cement mortar to repoint these soft 19th-century bricks has caused some of them to spall. *Photo: Courtesy Nebraska State Historic Preservation Office.*

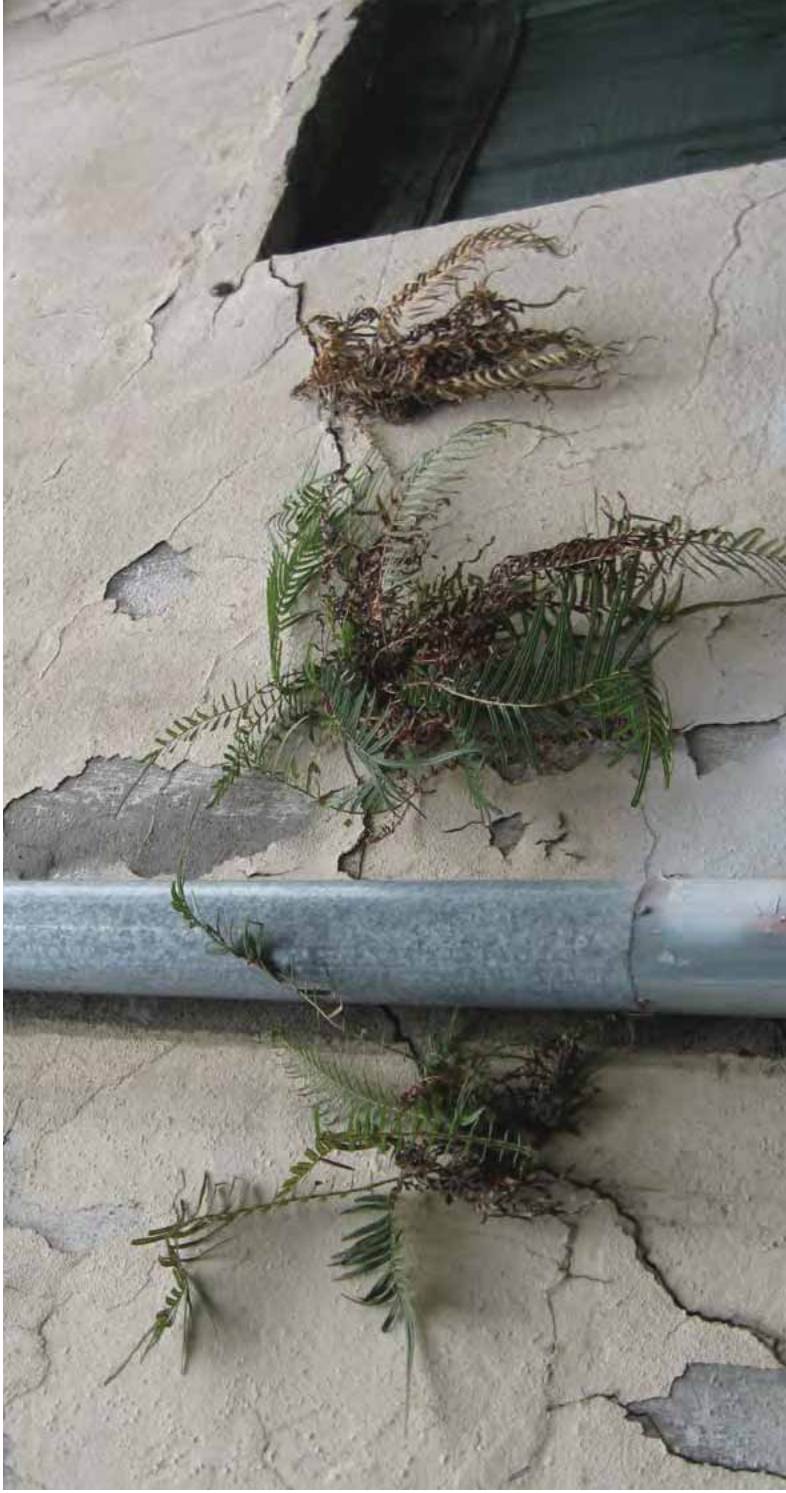
[3] **Not Recommended:** Cracks in the stucco have not been repaired, thereby allowing ferns to grow in the moist substrate which will cause further damage to the masonry.

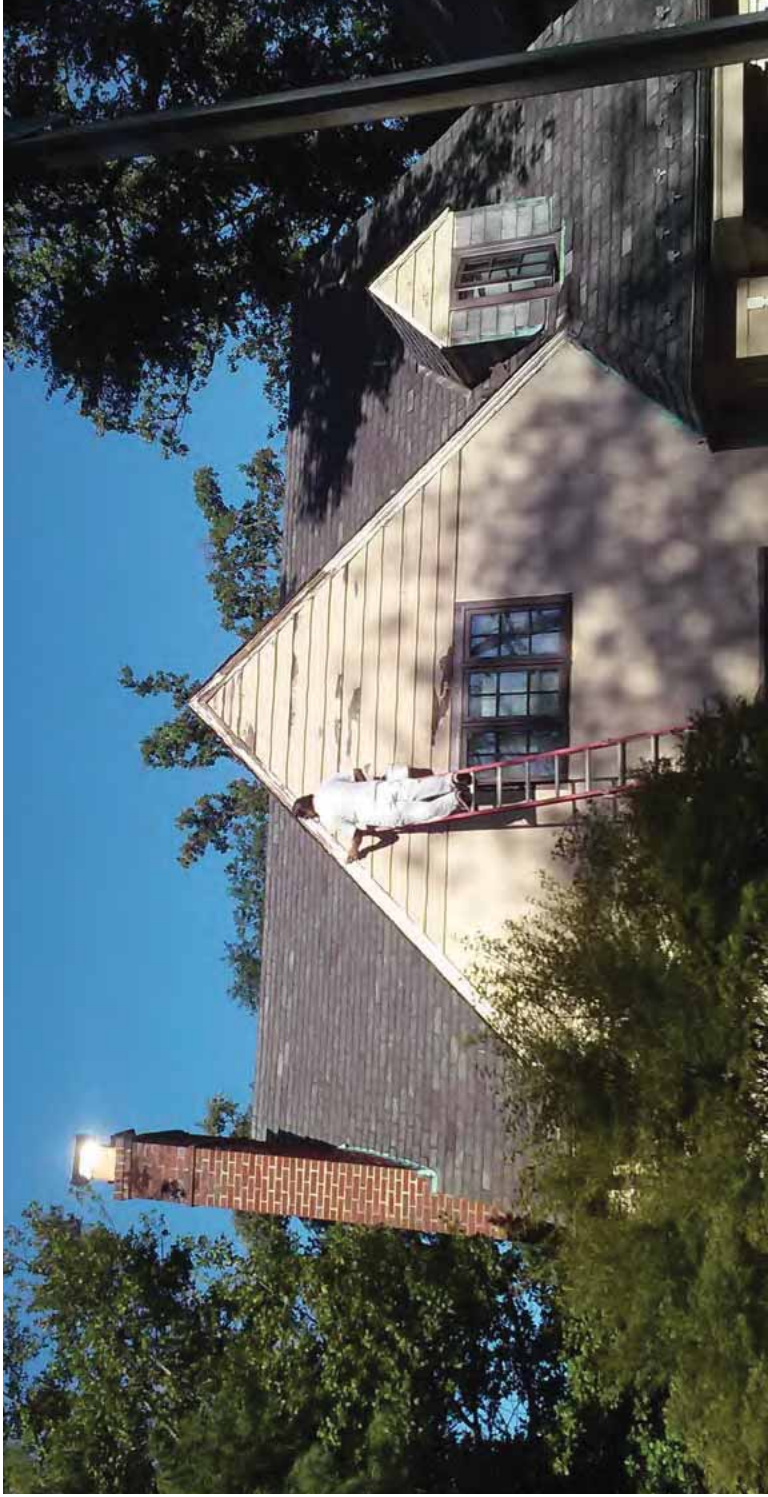
[4] Hand scraping to remove peeling paint from wood siding in preparation for repainting is an important part of regularly-scheduled maintenance.

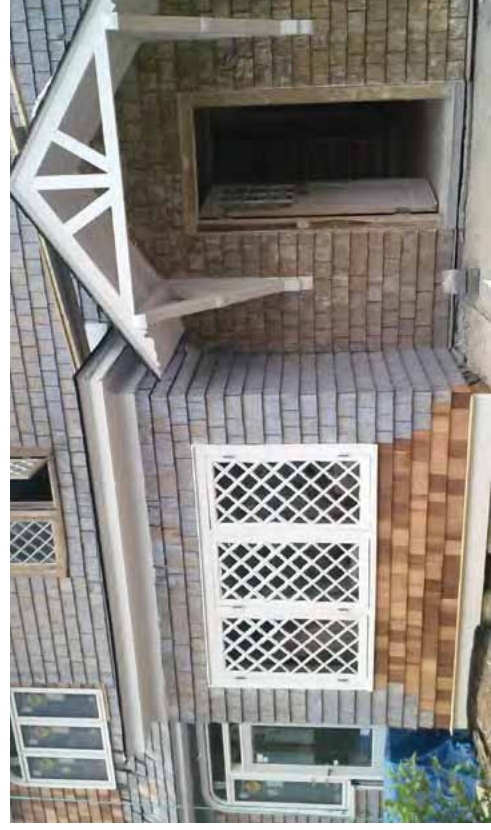
[5] Rotted wood shingles have been replaced in kind with matching wood shingles.

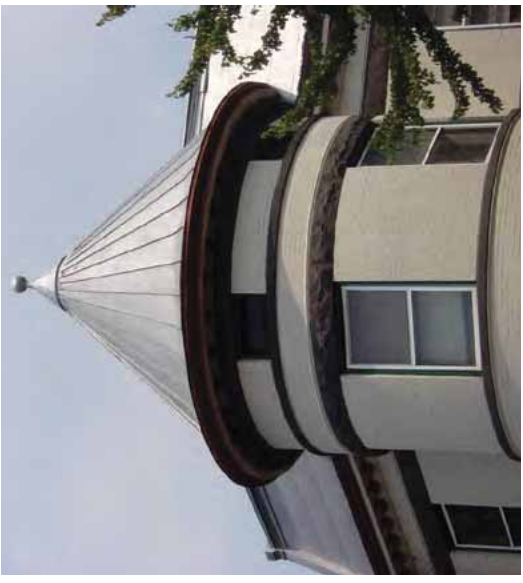
METALS: WROUGHT AND CAST IRON, STEEL, PRESSED METAL, TERNEPLATE, COPPER, ALUMINUM, AND ZINC

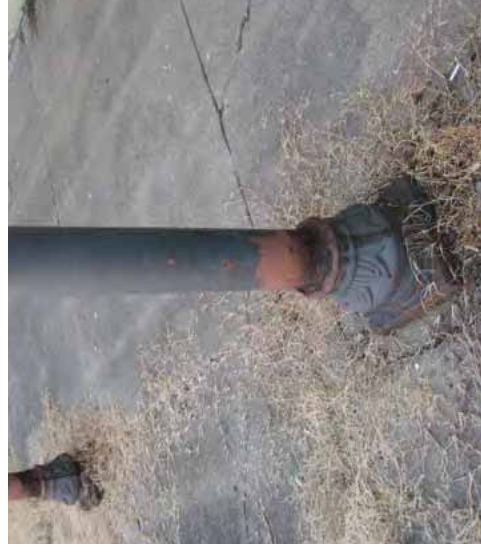
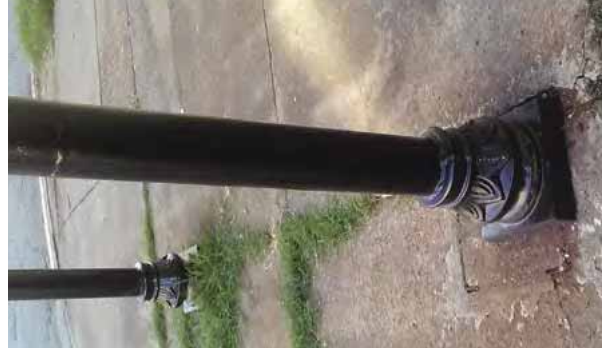
[7] (a) After the damaged portions of the base were repaired, (b) the cast-iron columns were cleaned and repainted to protect the metal from rusting.

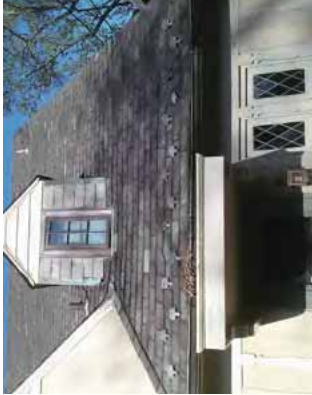
[8] Regular maintenance includes removing leaves that can clog gutters and cause water damage to the exterior and interior walls of a house.

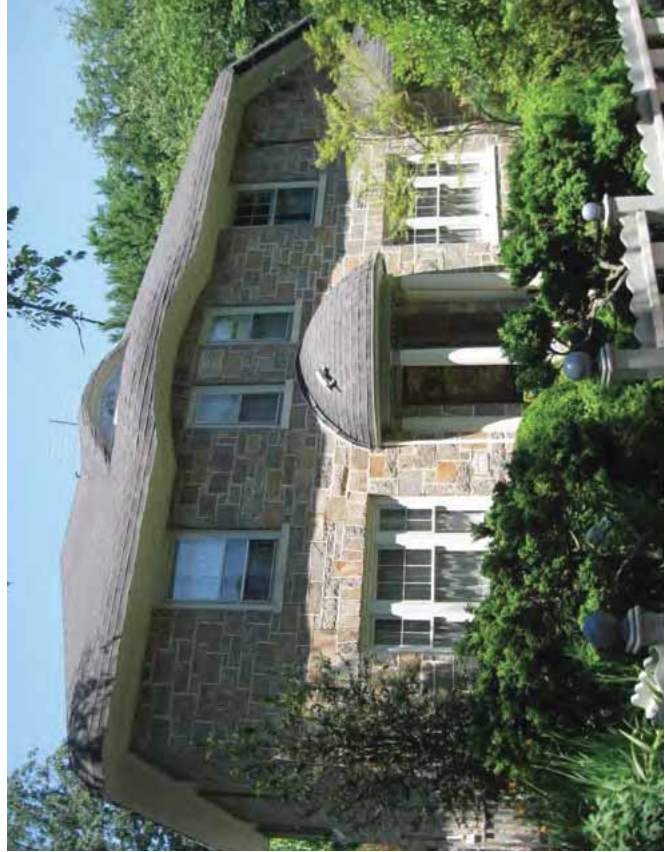
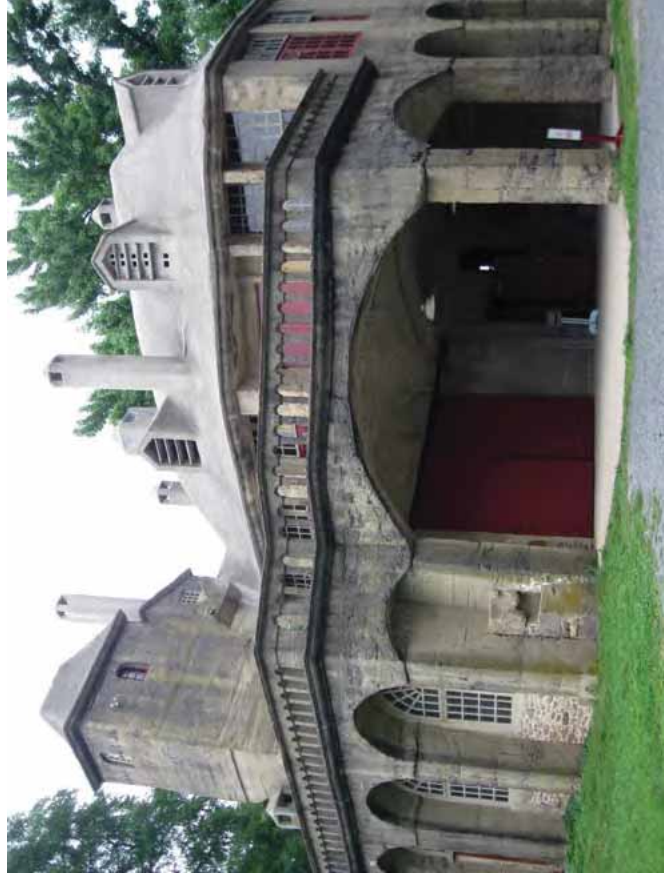
[9] Distinctively-shaped roofs are important in defining the historic character of these early 20th-century structures: (a) an asphalt shingle roof on a house; (b) and a concrete roof on Fonthill, Doylestown, PA (1908-1912), designed and built by Henry Chapman Mercer.

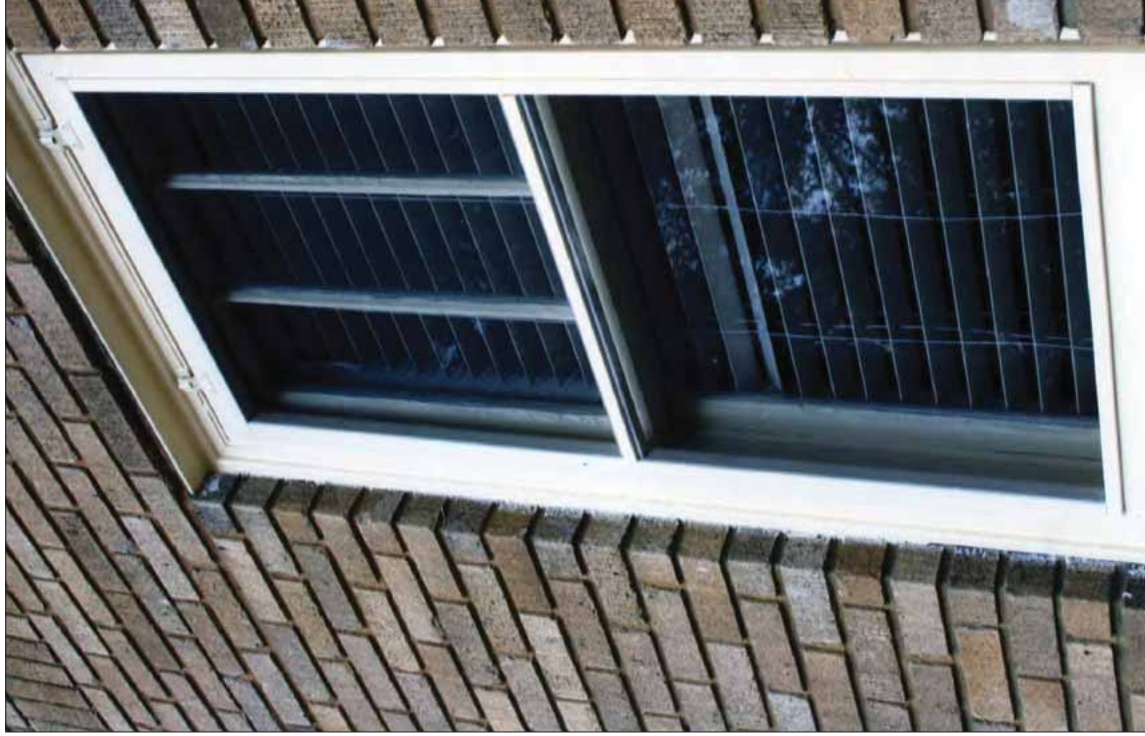
[10] Historic exterior storm windows preserve and help to insulate wood windows.

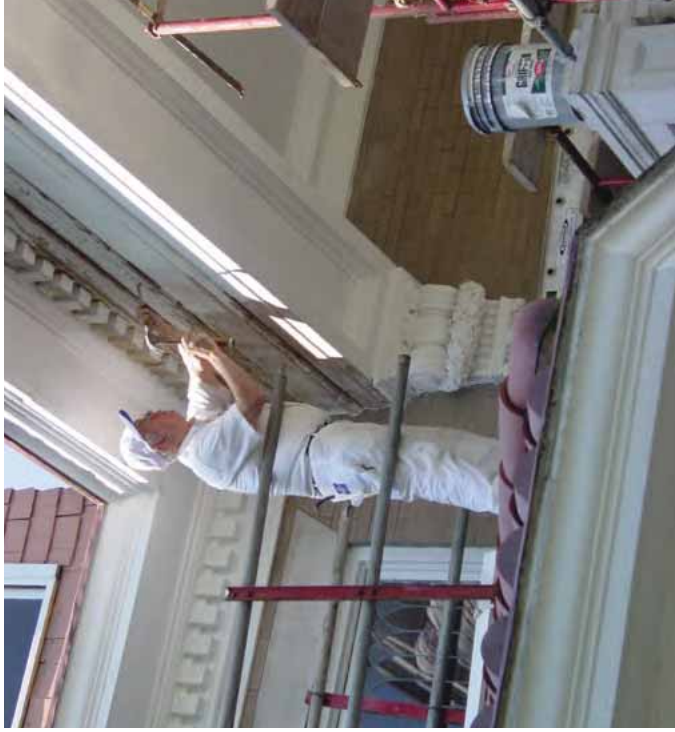
[12] Repair and limited replacement in kind to match deteriorated wood porch features is always a recommended preservation treatment.

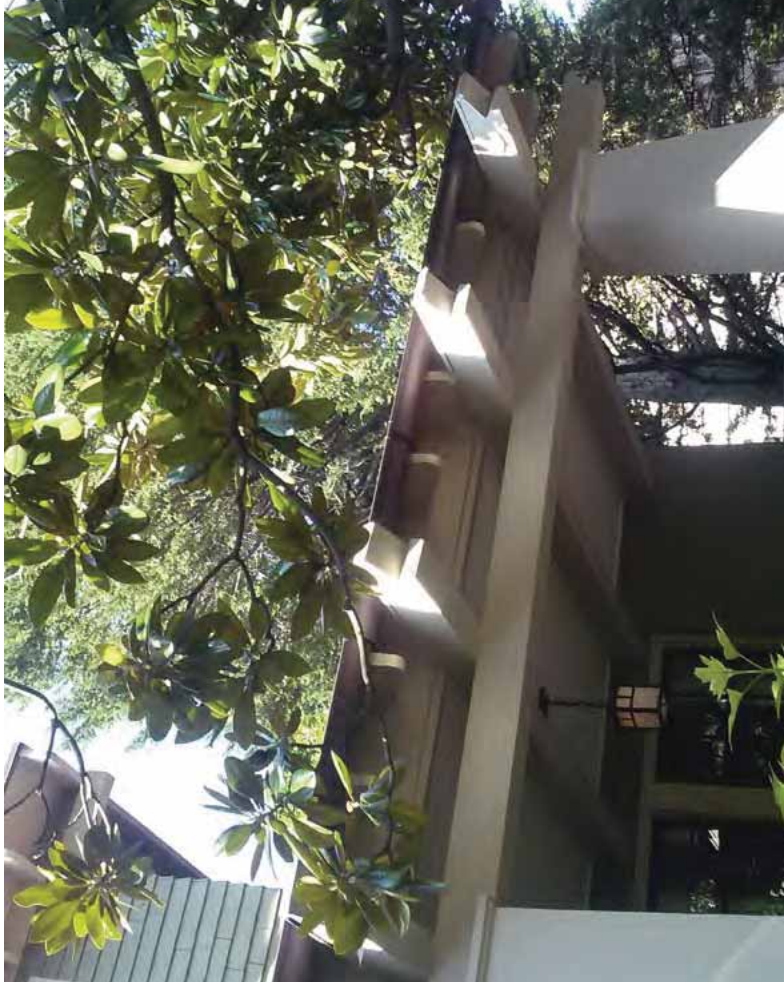
[13] It is important that exposed swallow tail porch rafters be kept painted to protect them from water damage.

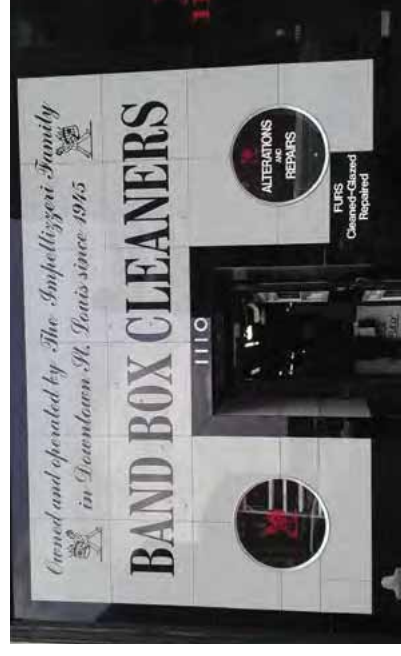
[14] The signage is an original and integral part of this historic Carrara glass storefront.

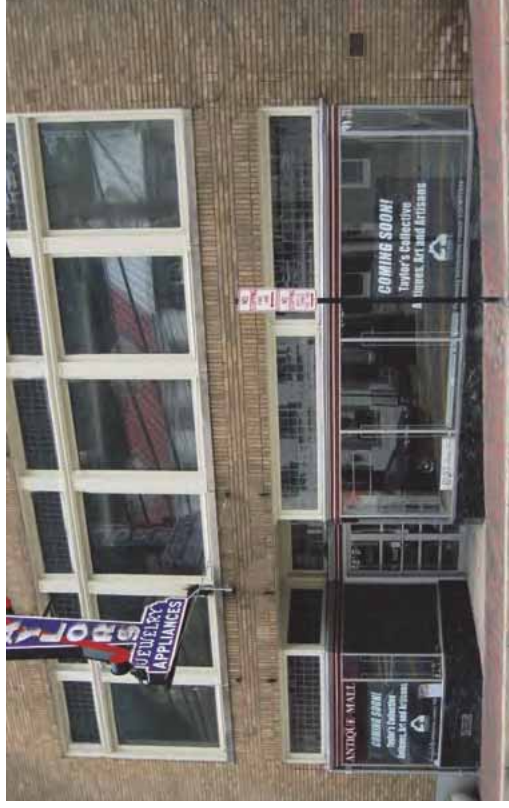
[15] Regular maintenance has helped to preserve this historic storefront, which retains all of its character-defining features, including the granite bulkhead, multi-paned transom glazing, and recessed entrance.

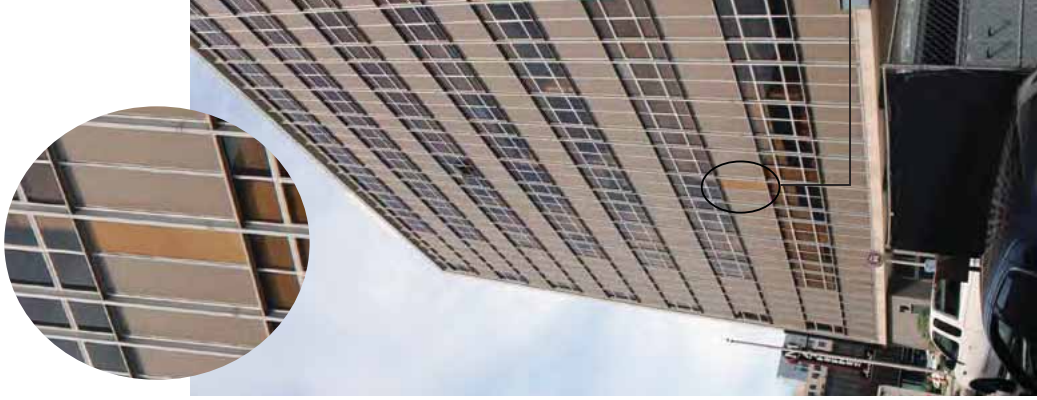
[16] Plywood provides temporary protection for an opening where a damaged spandrel panel was removed until a matching replacement panel can be installed.

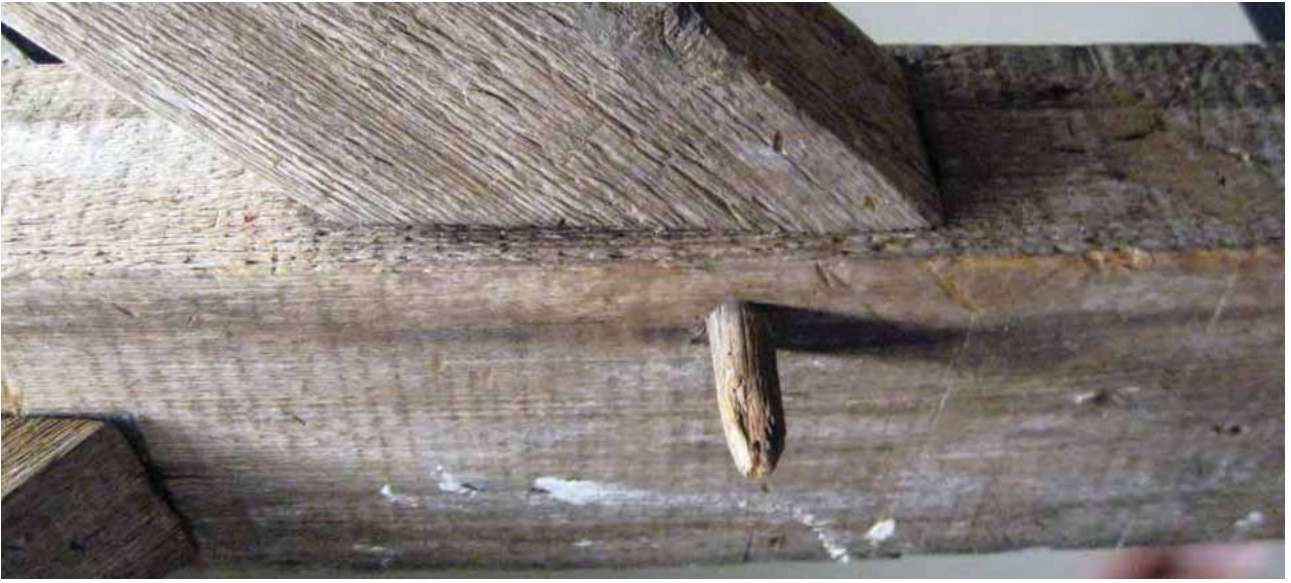
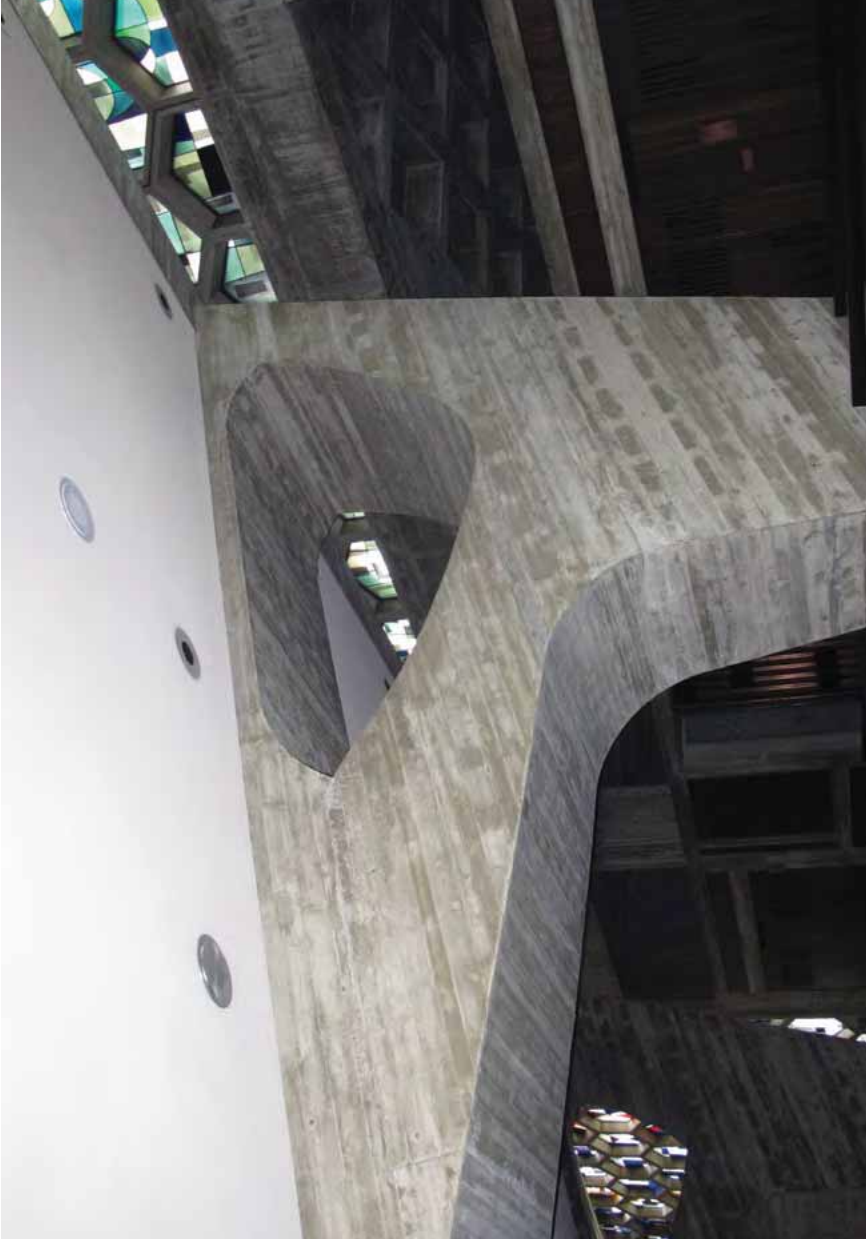
[17] Distinctive examples of traditional construction techniques should be preserved, such as this wooden peg, which is part of the structural system of this late-19th-century warehouse.

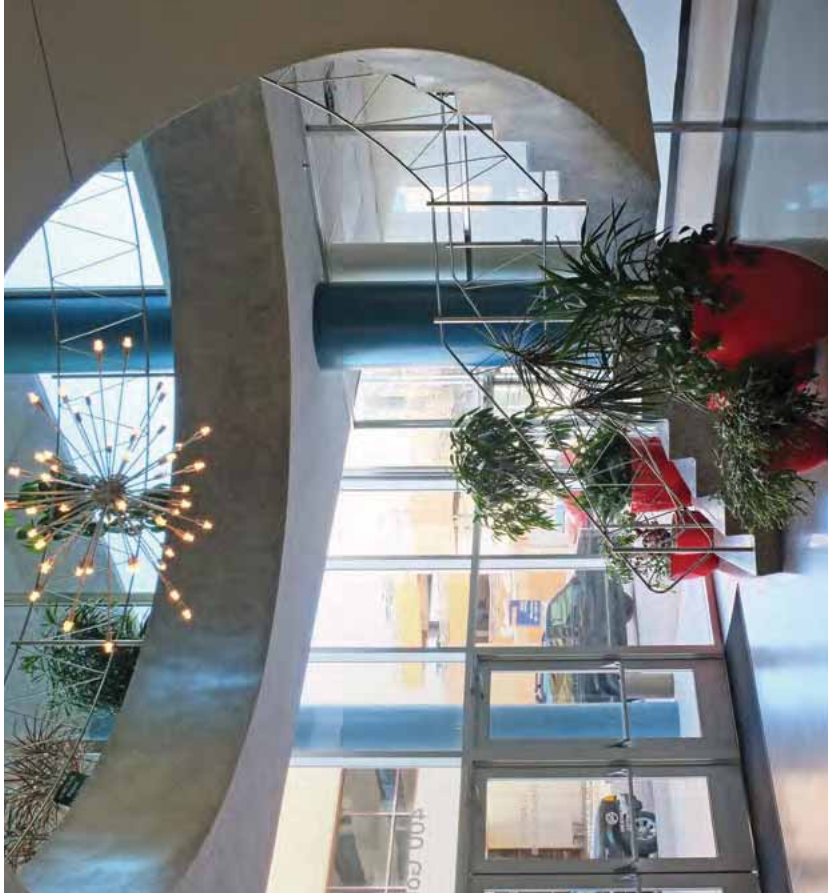
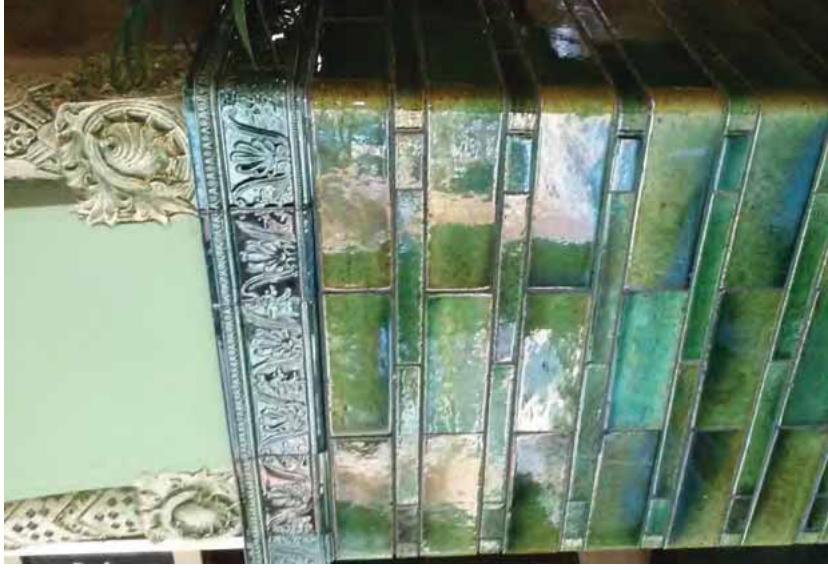
[19] The sweeping staircase with its metal railing, chandelier, and terrazzo floor in the lobby of the 1954 Simms Building, Albuquerque, NM, are character-defining features. Photo: Harvey M. Kaplan.

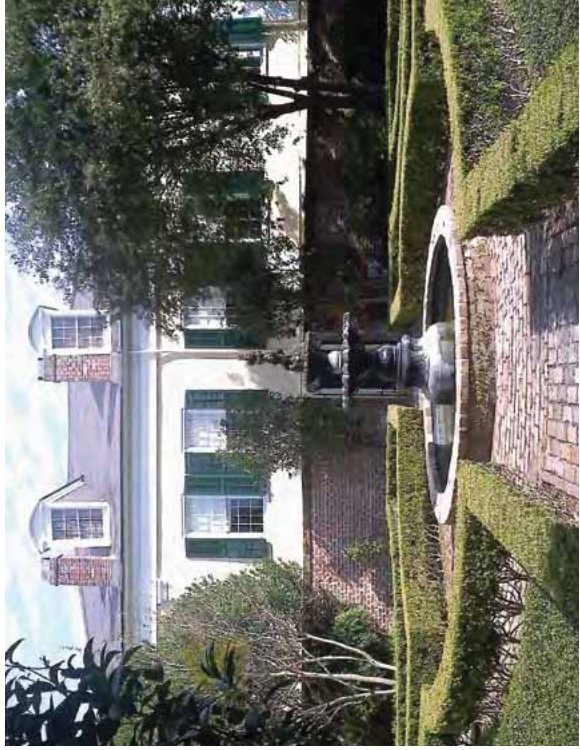
Retaining the historic relationship between buildings and the landscape.

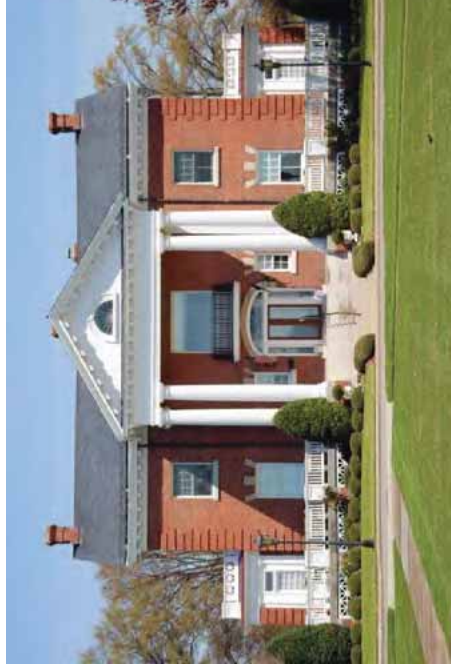
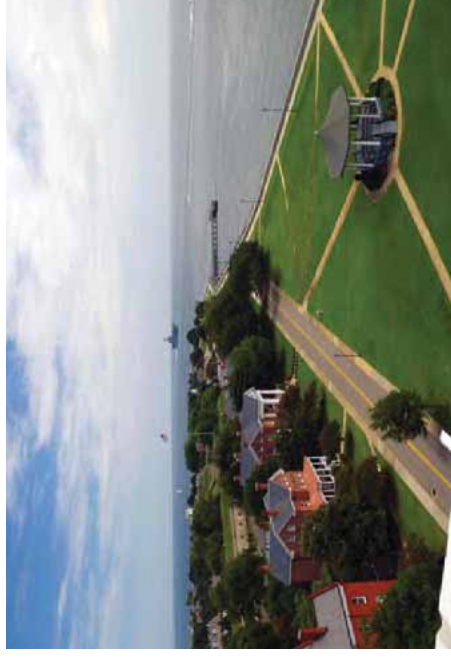
SETTING (DISTRICT / NEIGHBORHOOD)

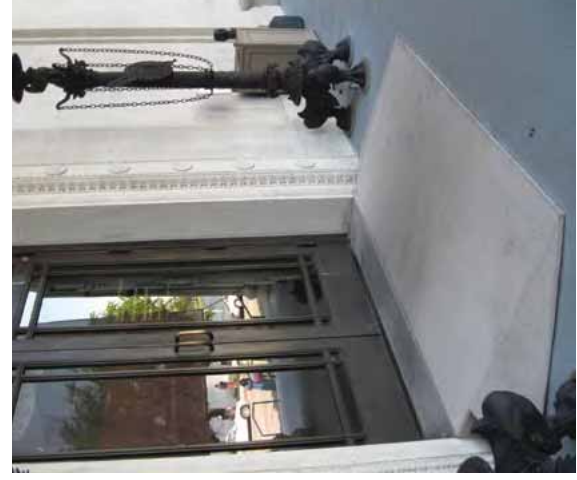
[27] The access ramp at the left of the entrance is concealed by a hedge which minimizes its visibility and impact on the character of the historic apartment building.

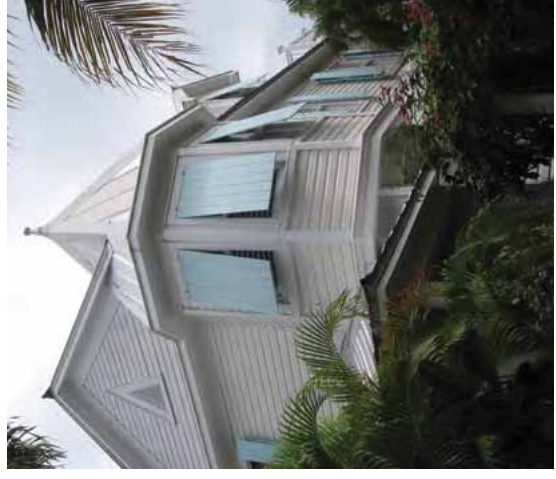
[30] Historic window shutters still serve their original function as protection in hurricane-prone areas.

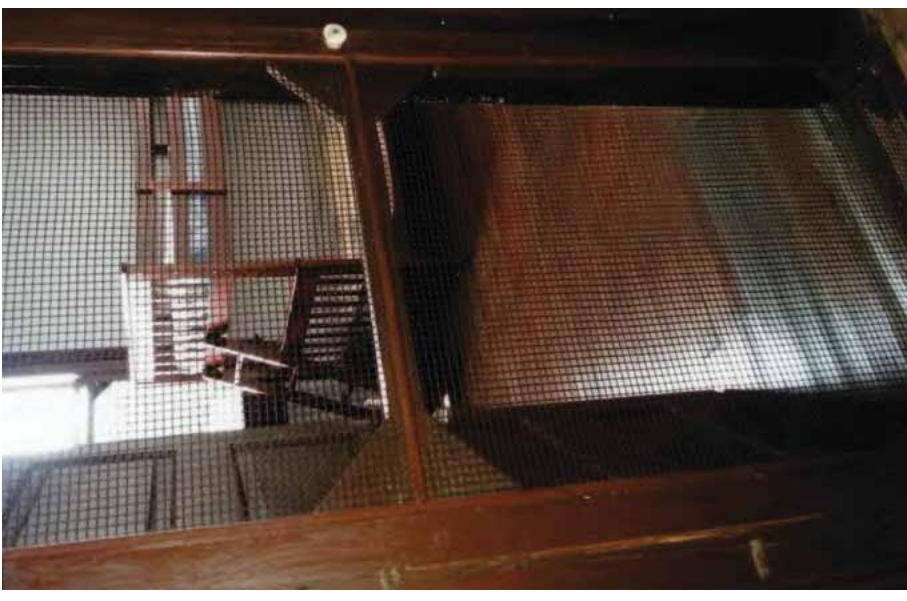
[31] An interior screen door at the entrance to individual apartments is a historic feature traditionally used to help circulate air throughout the building.
